QUINQUENNIAL INSPECTION

Document Title:	Quinquennial Inspection
Address of Inspection:	St George's Church 1-9 Inskip Terrace Low Fell Gateshead NE8 4AJ
Date of Inspection:	20 th October 2021
Weather Conditions:	Dry and overcast
Date of Report:	8 th November 2021
Date of Previous Report	Unknown
SIGNED BY:

Mrs. Philippa Ramsay BA (Hons) MArch.
REF:	29430-NNA-2021-11-08-PR-Quinquennial_Inspection
PREPARED BY:	Philippa Ramsay Nicholson Nairn Architects, Bishops Court, Rectory Lane, Whickham, Newcastle, NE16 4PA

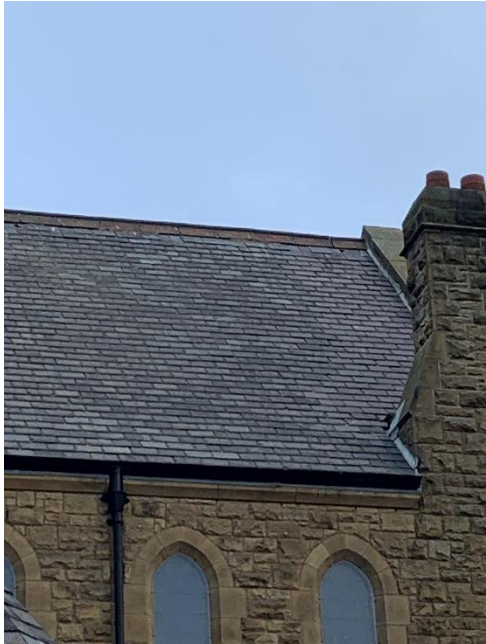
Item 1	Roof Covering		
Location	Condition	Repairs Needed	Category
1.1 - General Roof	Roof generally appears to be in a moderate condition but needs localized works carrying out.	Roof to be inspected in its entirety and leadwork checked.	B
1.2 - Nave, South elevation	Visible signs of missing mortar to ridge tiles

Ridge tiles to be pointed over nave	B
1.3 - Roof over toilets (originally Vestry), South elevation	Slipped slates

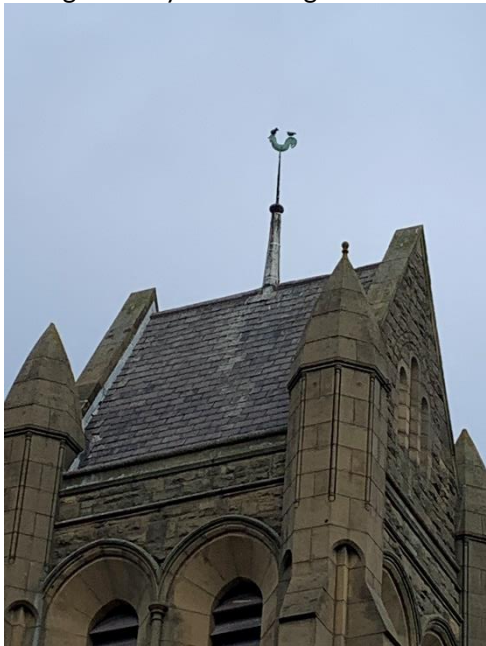
<p>1.4 - Bell Tower Roof, South-west corner</p>	<p>Visible signs that slates are giving out adjacent to flashing. No signs of any rainwater goods</p>

<p>Roof to be inspected in its entirety and lead flashings if applicable checked. Haunching to junction of roof to be inspected.</p>	<p>B</p>
<p>1.5 - Roof over café, South elevation</p>	<p>Visible signs that slates are moving and lifting. Visible signs that abutment flashing is lifting and moving. Pointing appears to be loose to top of lead flashing. Internal evidence of roof leaking at junction/abutment. Valley flashing appears serviceable</p>

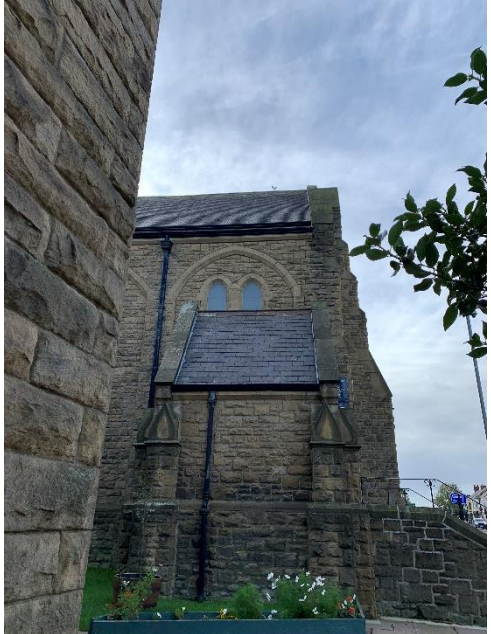
1.6 - Roof, North elevation	Visible signs of mortar bed and pointing deterioration	Roof to be inspected and mortar and pointing in corrected	B
1.7 - Entrance roof, West elevation	<p>Visible evidence of slipped slates and loose bedding to ridge slates</p>

Slates to be securely fixed back and ridge tiles to be re-bedded	B

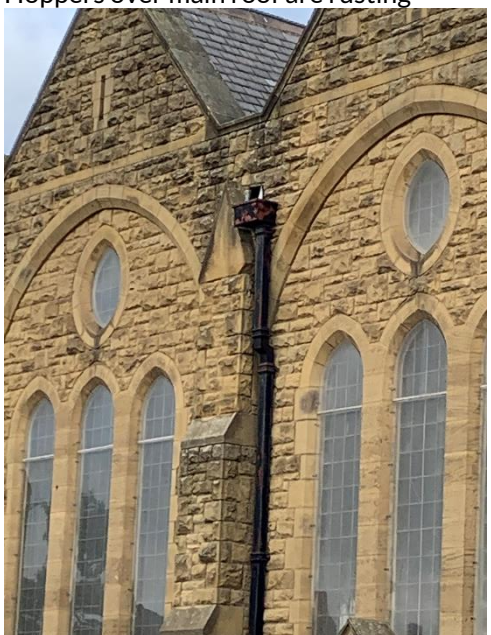
Item 2 Rainwater goods and disposal system			
Location	Condition	Repairs Needed	Category
2.1 - Main Roof, South elevation	<p>Gutters over main roof are rusting Hoppers over main roof are rusting</p>

<p>Gutters & hopper to be repainted and/or replaced if considered beyond salvage Putty to be checked Joints within guttering and rainwater goods to be checked and resealed where necessary</p>	B

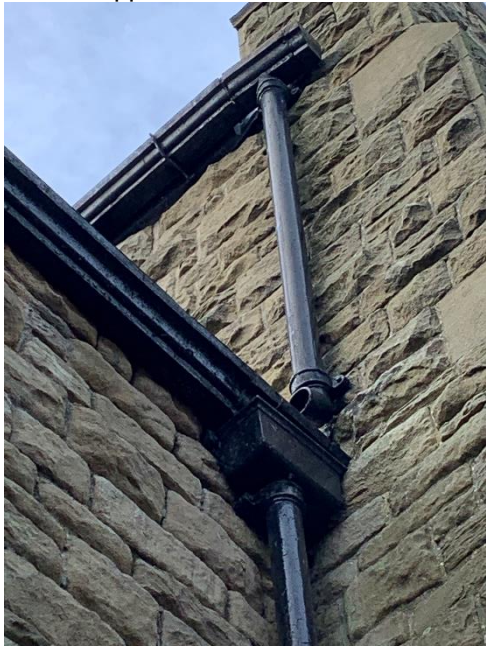
<p>2.2 - Gutter to rear entrance, North elevation</p>	<p>Gutter slipped</p>

<p>Gutter to be reconnected and fixed securely in place</p>	<p>A</p>
<p>2.3 - Gutter, East elevation</p>	<p>Gutter slipped and hopper missing</p>

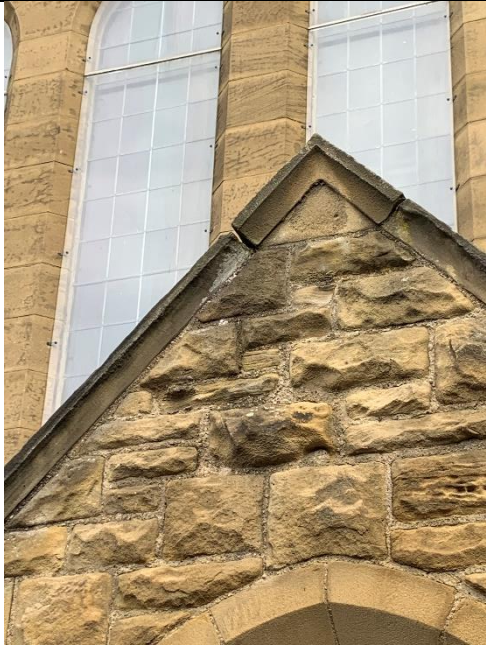
Item 3 Parapets and upstands walls, finials, crosses			
Location	Condition	Repairs Needed	Category
3.1 - General	Signs of mortar missing and deterioration	Water tables to be inspected generally across all roofs	B

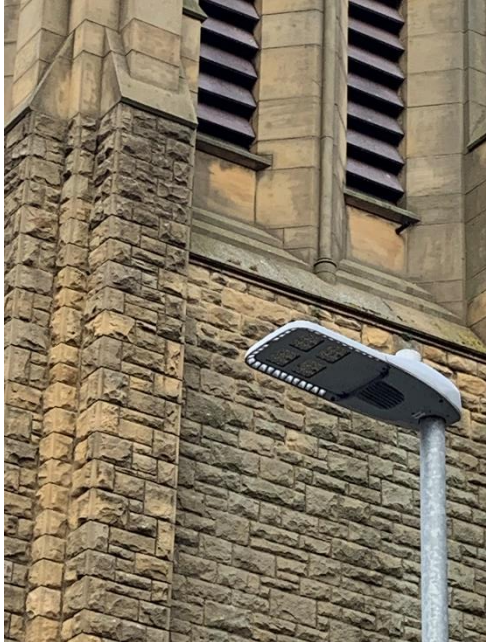
<p>3.2 – Bell Tower, South-west corner</p>	<p> Finials look to be in serviceable condition Inclined ledge, visible evidence of growth and vegetation </p>

<p>Vegetation to be removed and area inspected</p>	<p>C</p>
<p>3.3 – Parapet over toilets, South elevation</p>	<p> Parapet has tape and black mastic Visible evidence of mortar missing to water table </p>	<p> Tape and black mastic to be inspected Water tabling needs to be repointed </p>	<p>B</p>

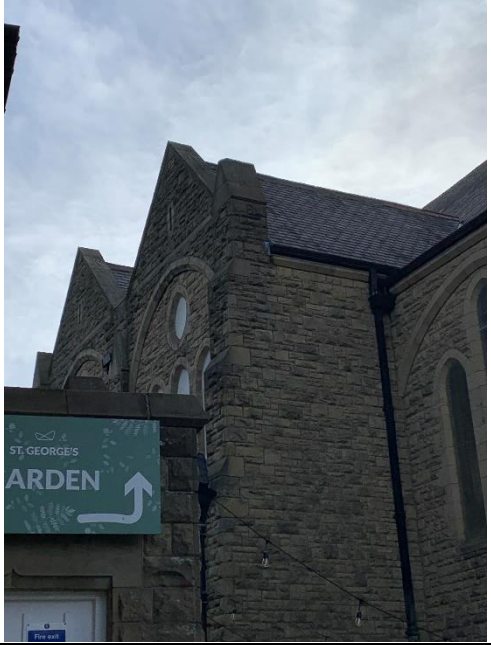
<p>3.4 - Water table, North elevation</p>	<p>Evidence of missing mortar at junction to water table and history of leaking</p>

<p>Water table to be repointed</p>	<p>B</p>

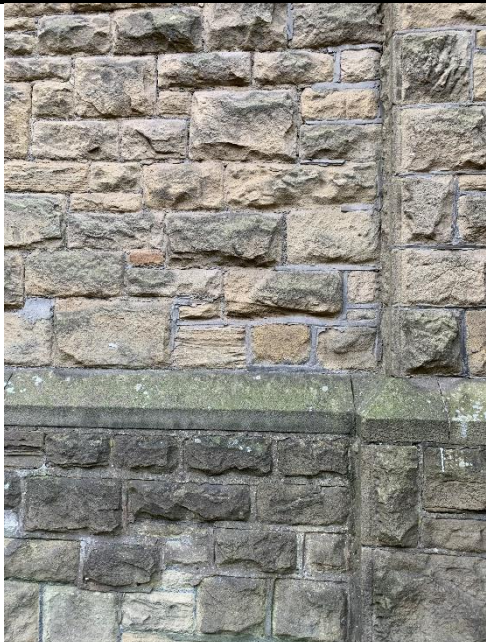
Item 4			
Walling and pointing			
Location	Condition	Repairs Needed	Category
<p>4.1 - General, All elevations</p>	<p>Areas of incorrect mortar used Visible evidence of an under layer of a dark mortar</p>	<p>Inappropriate mortar to be raked out and repointed using an appropriate mortar mix</p>	<p>C</p>

The structure appears to be generally sound. Recent repointing has been undertaken with incorrect mortar which is causing deterioration of the stone. Various areas of the external face of stonework have lost pointing creating 'ledges' where water can lie. This could result in water penetrating the outer leaf and under cold conditions causing frost attack of the stonework.

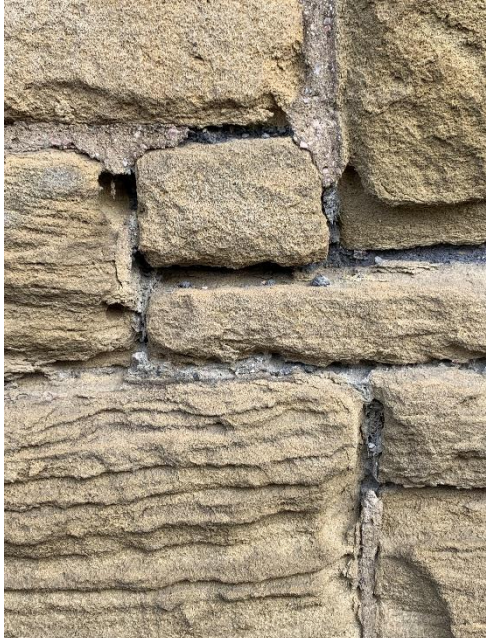
<p>4.2 – Wall above toilet roof, South elevation</p>	<p>Stone is friable in places generally across elevation. Stonework is breaking down in some locations. Corner missing next to gutter. Oval window areas of mortar missing.</p>

<p>Wall to be repointed Condition of stonework to be assessed by specialist to prevent further deterioration. Areas of mortar to be replaced where missing using an appropriate mortar mix.</p>	<p>C</p>
<p>4.3 – Kitchen overflow, South elevation</p>	<p>Kitchen overflow does not extend far enough away from the building causing staining and vegetation growth</p>	<p>Kitchen overflow to be replaced, stonework cleaned and mortar replaced where required.</p>	<p>A</p>

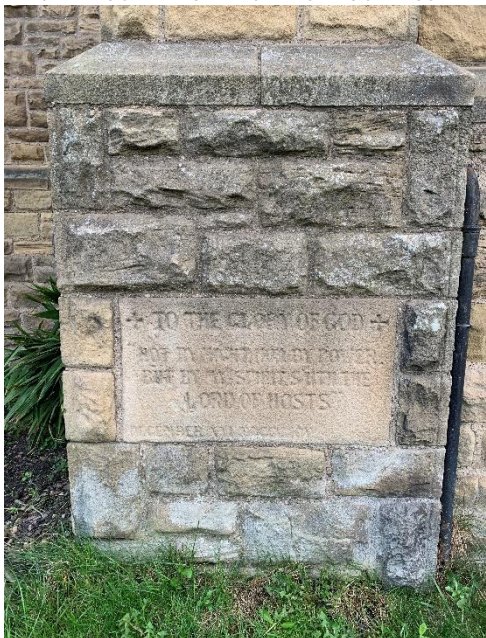
<p>4.4 - Foundation stone, West elevation</p>	<p>Deterioration visible to foundation stone</p>

<p>Foundation stone to be assessed by specialist to see if further deterioration can be prevented.</p>	<p>D</p>
<p>4.5 - Stone steps to entrance doors (2no.) West elevation</p>	<p>Mortar visibly missing in locations</p>	<p>Steps to be repointed</p>	<p>B</p>

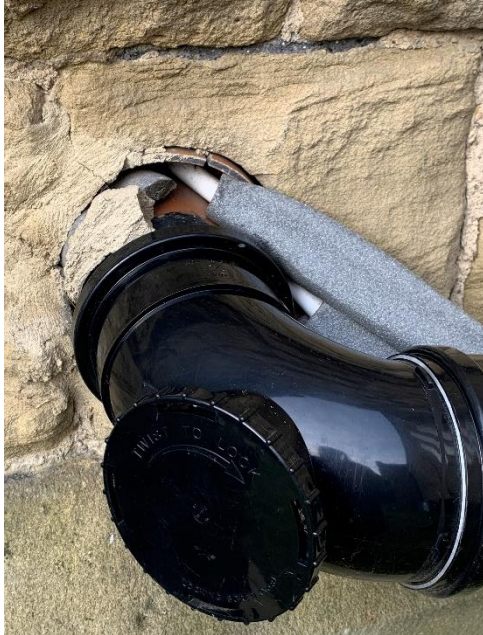
<p>4.6 – Junction to SVP, East side of bell tower</p>	<p>Mortar missing to junction</p>

<p>Junction to be reviewed and mortar correctly installed</p>	<p>B</p>

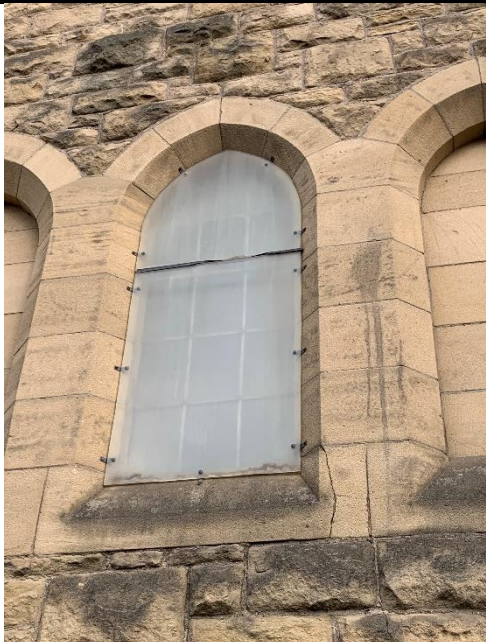
<p>General maintenance including decoration</p>	<p>M</p>
<p>5.4 – Windows Generally, All elevations</p>	<p>Many windows have a film/Perspex sheet external protection</p>	<p>Film and Perspex to be removed and replaced with a more heritage appropriate solution.</p>	<p>E</p>

Generally single glazed to the windows. All appears to be in reasonable condition however, many of the windows are covered in a film or Perspex, which is not ideal. Consideration to be given to a more conservation appropriate alternative to improve the longevity of these and the visual appearance.

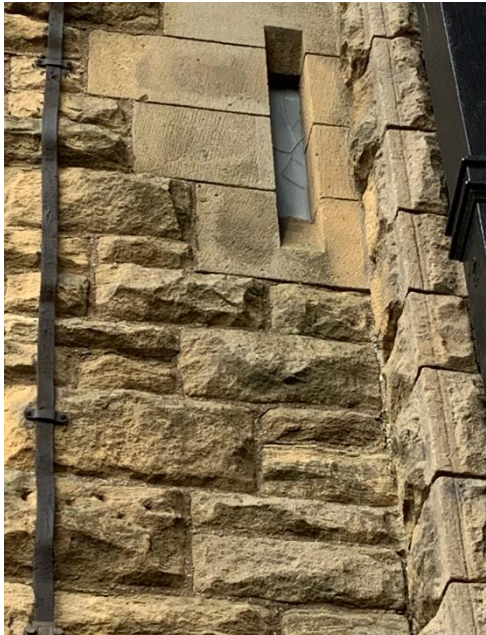
<p>5.5 - Window to bell tower, East elevation of bell tower</p>	<p>Window cracked</p>

<p>Glass to be carefully removed and replaced</p>	<p>D</p>

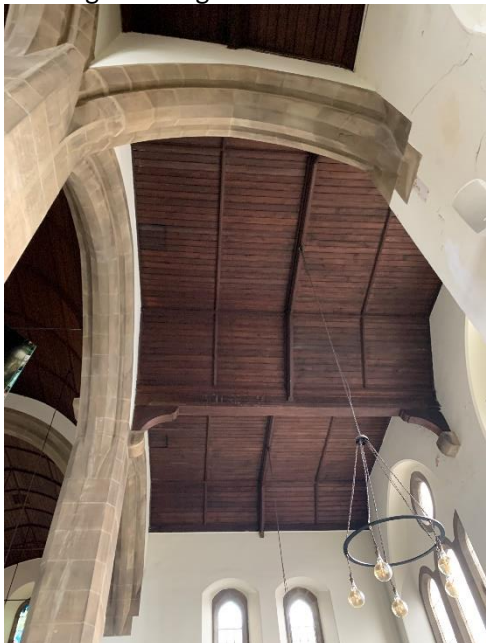
11.2 - South side of main ceiling	<p>Staining to ceiling beams</p>

There are signs of water staining to the ceiling to the south side of the main roof. This appears historic but could also align directly beneath the lead valley. Further investigation is required to ascertain if the source of this water ingress has been stopped.

<p>Advisable that when main roof is inspected an internal inspection of the interior particular the south side is undertaken</p>	B

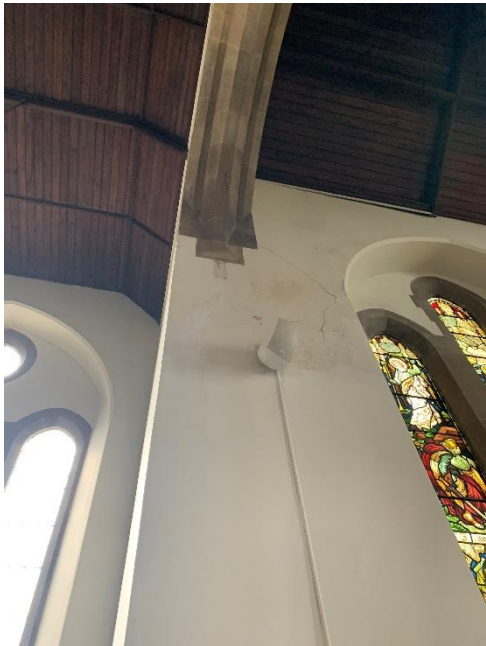
<p>11.3 – South side, east of cafe</p>	<p>Evidence of water ingress appearing to originate from junction of roofs above stone arch</p>

<p>Advisable that when main roof is inspected an internal inspection of the interior particular the south side is undertaken</p>	<p>B</p>
----------------------------------------	-----------------------------------------------------------------------------------------------------------------------------------------------------------------------------------	----------------------------------------------------------------------------------------------------------------------------------	----------

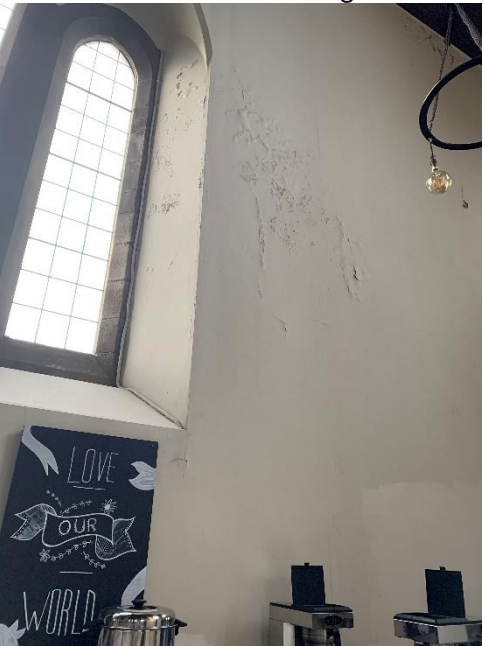
<p>12.2 – Internal face of external wall, South elevation</p>	<p>Further evidence of water ingress, plaster peeling off the wall External wall moisture reading of 12%</p>

<p>Pointing of stonework to be checked and any areas of defective pointing to be replaced with appropriate mix mortar. Once resolved decoration to be completed internally.</p>	<p>A</p>
<p>12.3 – Arch above Organ, North-east side</p>	<p>Arch above organ has some cracking</p>

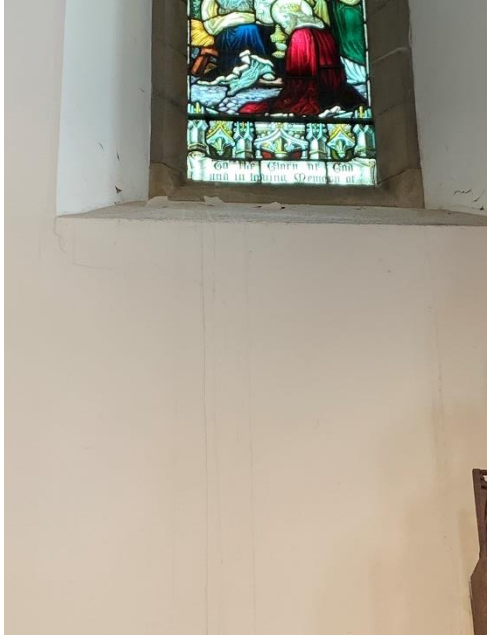
12.5 - Altar	<p>Paint and plaster flaking off</p>

<p>Condition of damp to be monitored once external pointing has been undertaken. Once dry condition of plaster to be assessed and replaced if appropriate and make good decoration.</p>

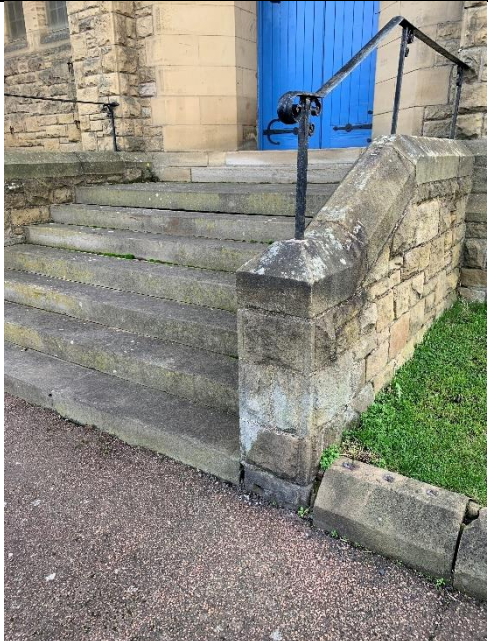
Item 18	Boundary walls, railings and fencing, gates and lynch gates		
Location	Condition	Repairs Needed	Category
18.1 - Boundary Wall	General cracking to boundary walls and steps	Cracking to be monitored and repointed	M

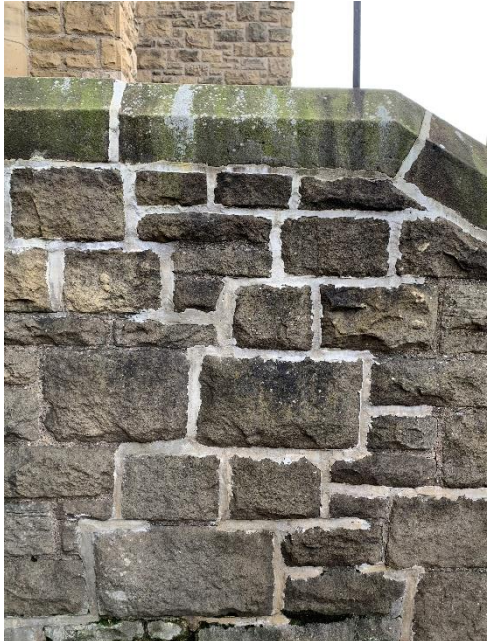
19.2 - Access	Steep steps to main entrance and limited accessible access to side entrance. Church to review accessibility.	Accessibility audit to be undertaken	E
19.3 - Steps	<p>Incorrect mortar used.</p>

Areas of mortar to be replaced where missing using an appropriate mortar mix.	D
