MAYA POLENZ ARB AABC

Accredited Conservation Architect

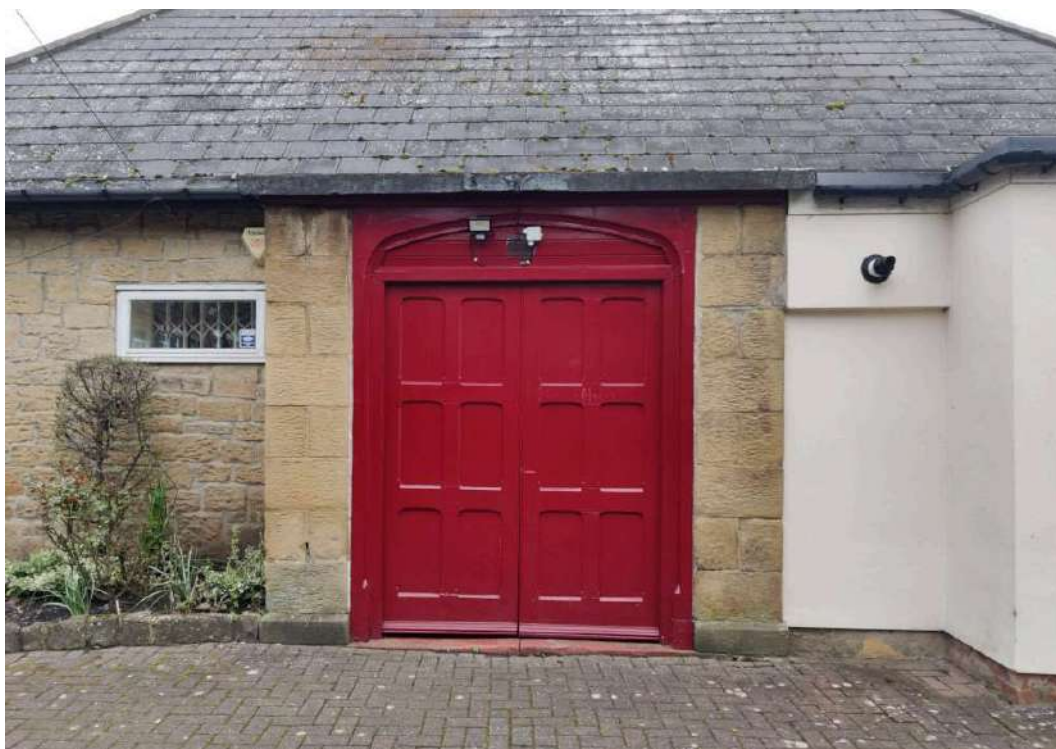
4 (below). Main entrance door to South

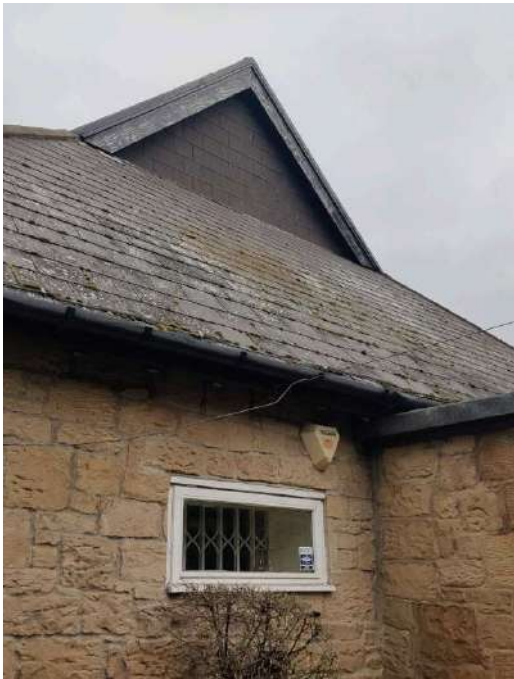
5. Timber barge boards to south gable require redecoration (recommendation 1.01)

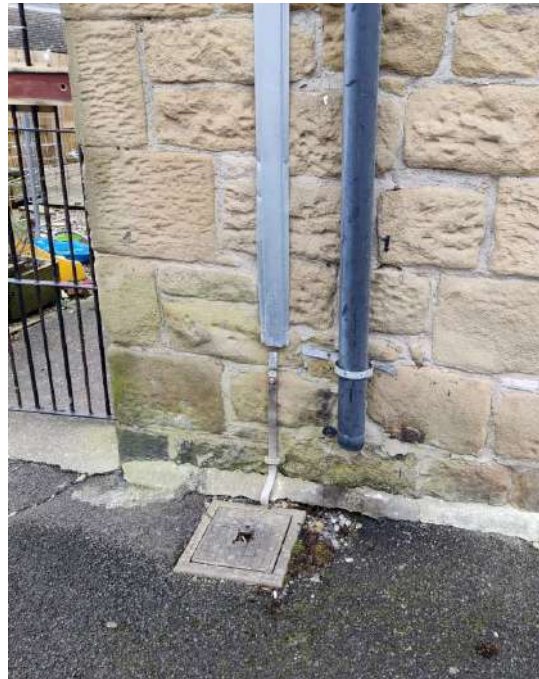
6. The missing shoe to the northwestern downpipe should be replaced (rec. 1.02)

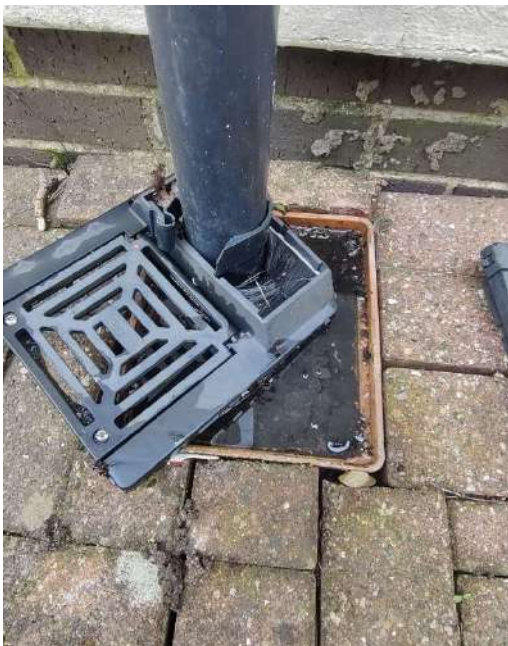
5. Example of blocked gully to the South requiring clearing (rec. 1.03)

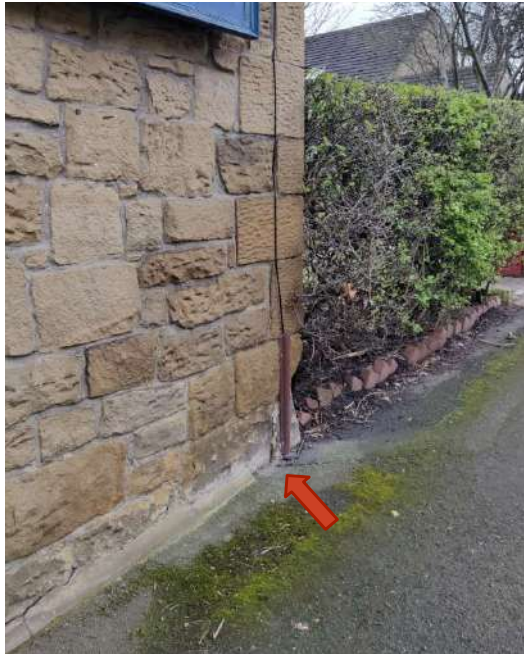
7. Replace missing or broken areas of the mortar fillet to the base of the W elevation (rec. 2.01)

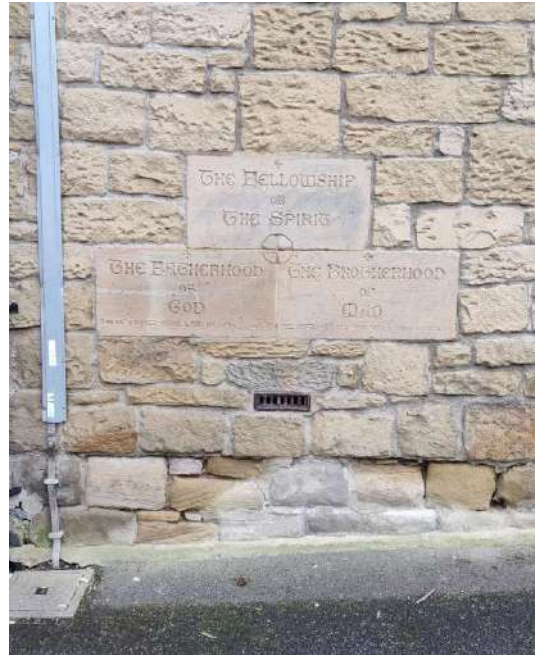
8. Repoint eroded joints using lime mortar. Take care not to bridge the DPC. Consider localised DPC repairs (rec. 2.02)

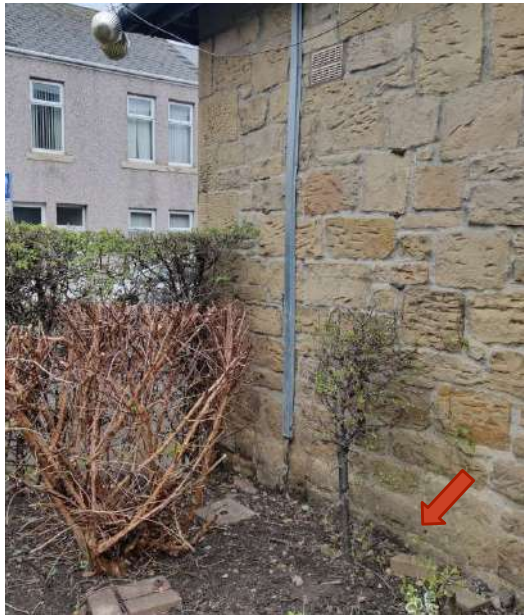
9. Lower ground floor levels at SW (rec. 2.03) ...

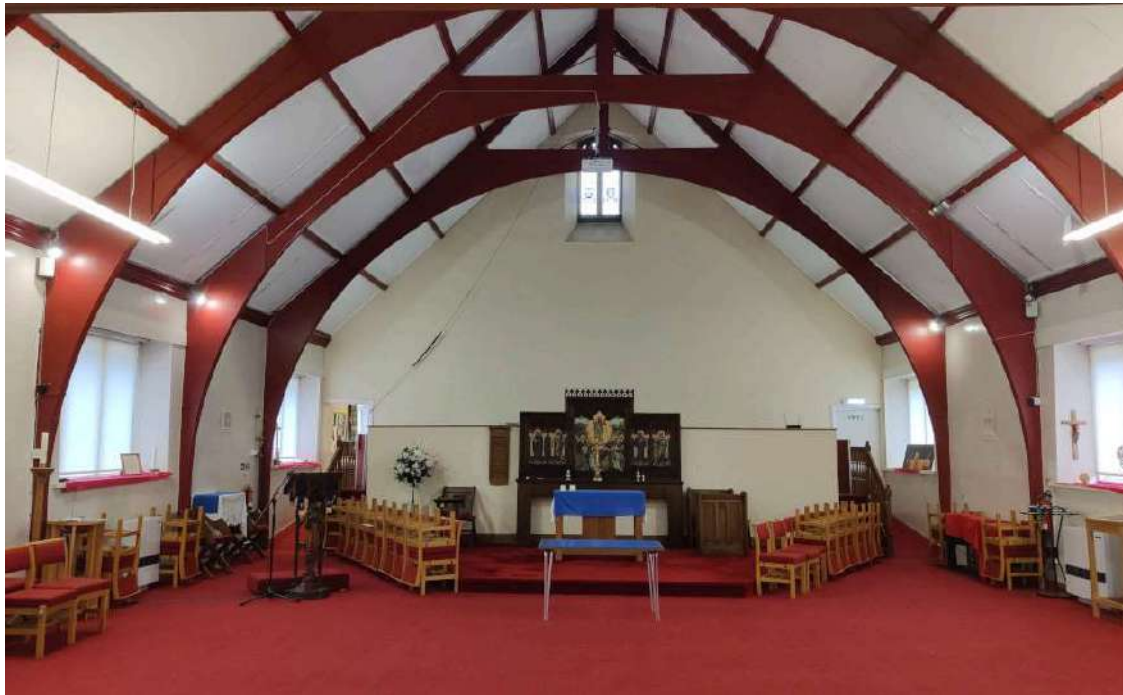
15. View of Nave. Consider replacing failing ceiling tape if funds allow (rec. 4.01)

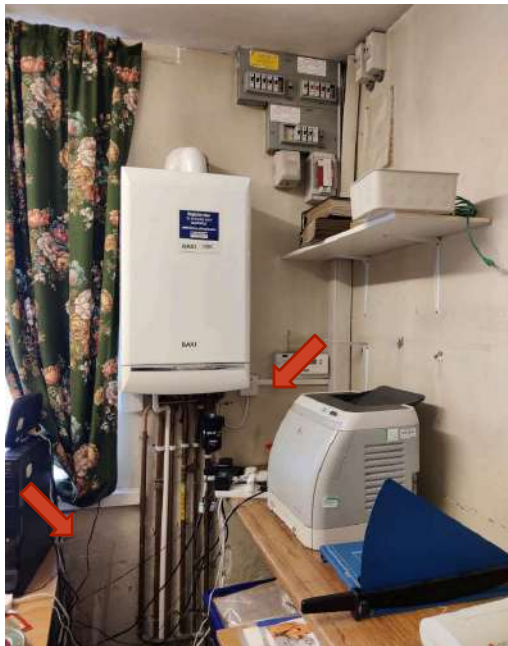
16. Vestry. Consider replacing failing plaster to W wall. (rec. 4.03)

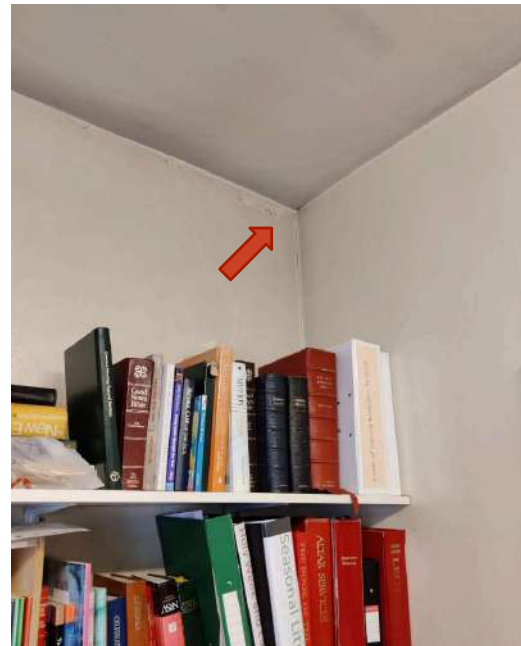
17. Vestry. Monitor cracked plaster to NE (rec. 4.02)

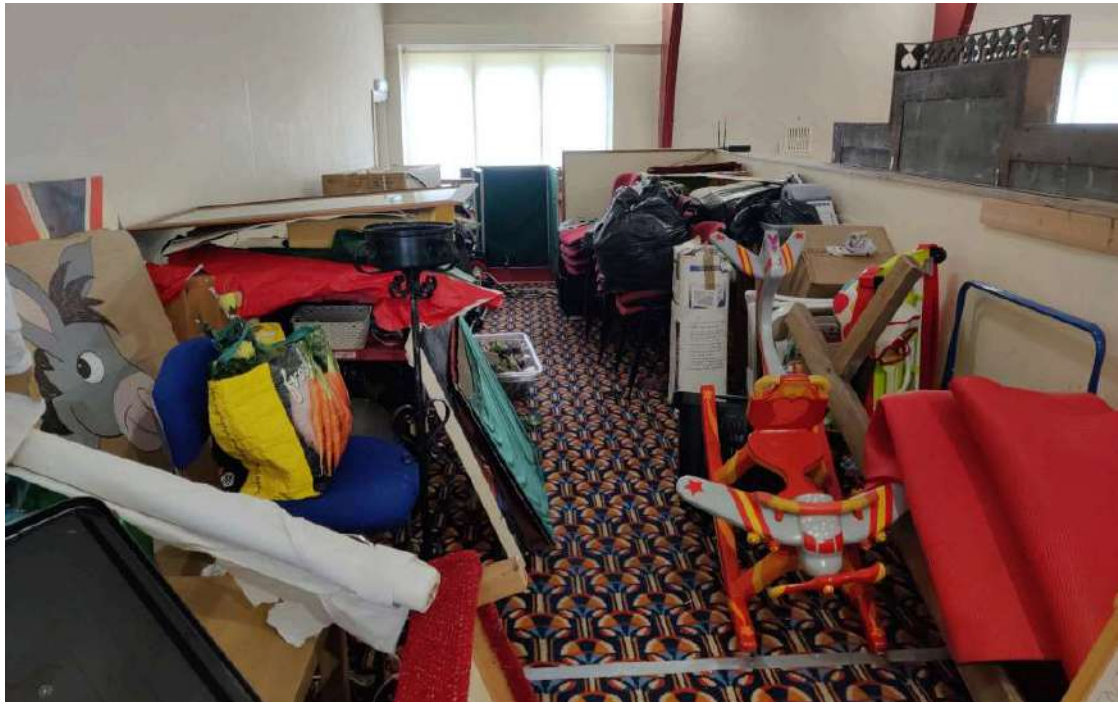
18 (above). Reduce storage on raised stage 19 (below). Consider decorating the unfinished boards

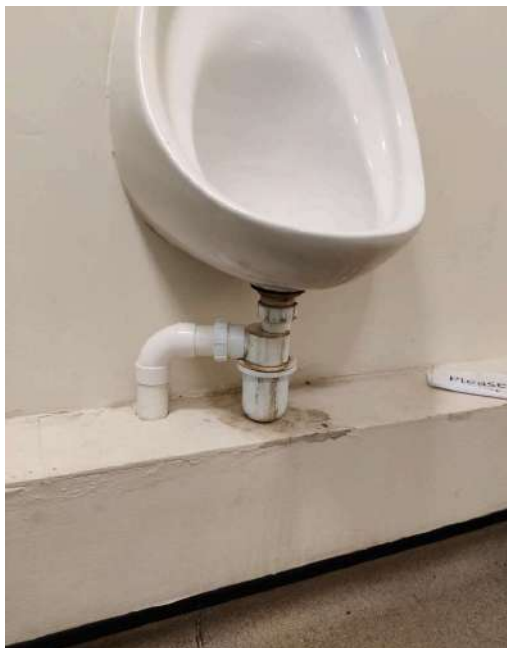
31. Fix leaking urinal & redecorate (rec. 4.07)

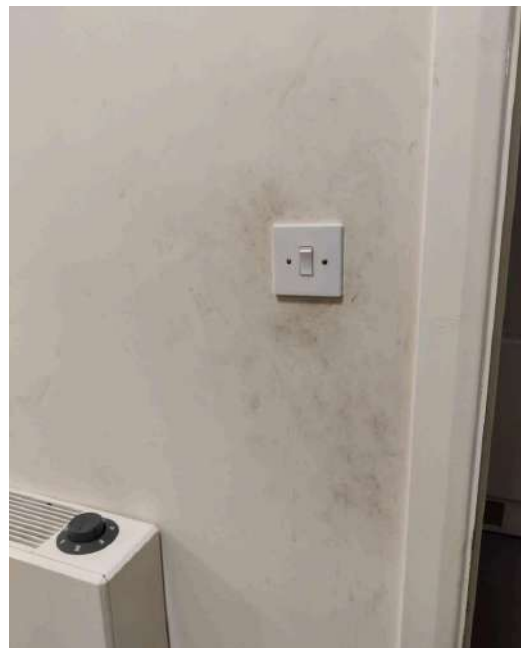
32. Redecorate & improve cleaning (rec. 4.09)

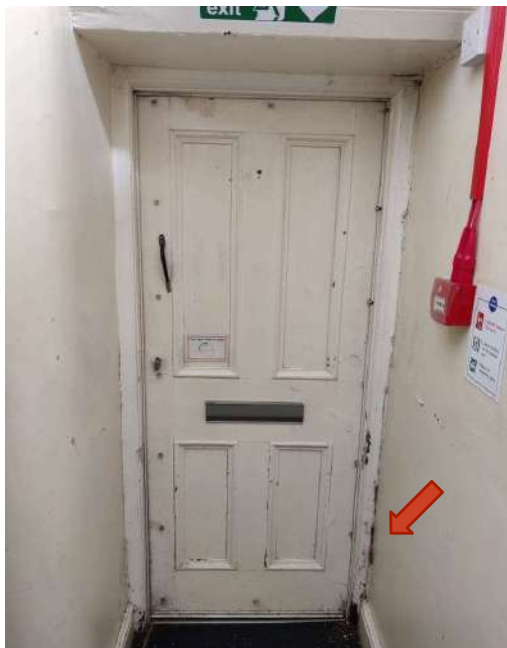
38. North fire exit door. Repair decayed base of frame. Redecorate door & frame. (rec 4.10)

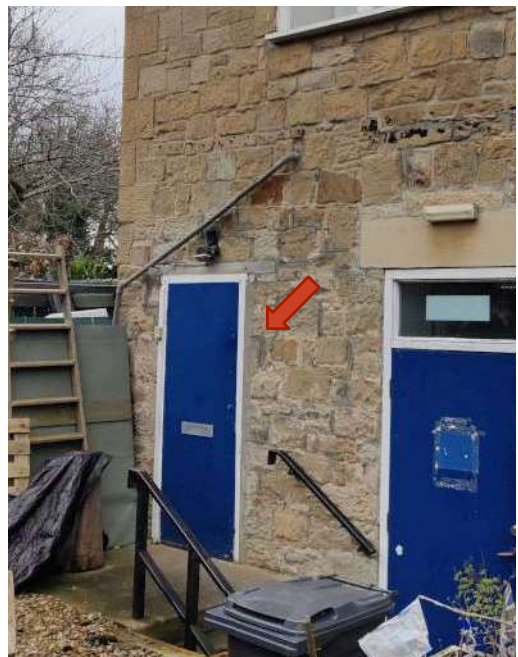
39. External view of north fire exit door

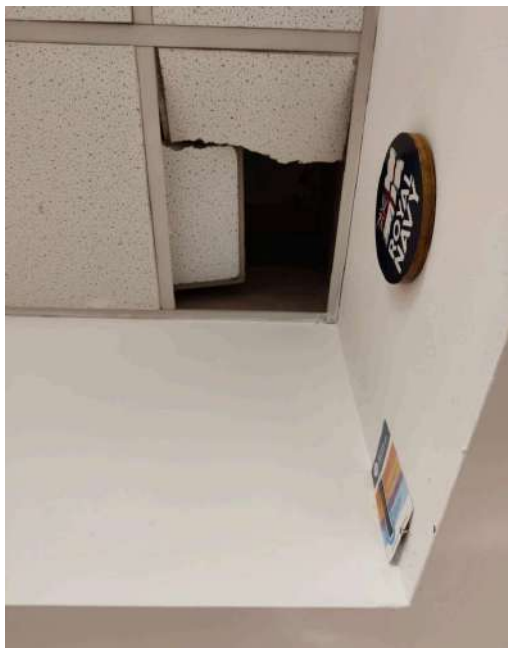
41. Replace broken ceiling tile (rec 4.11)

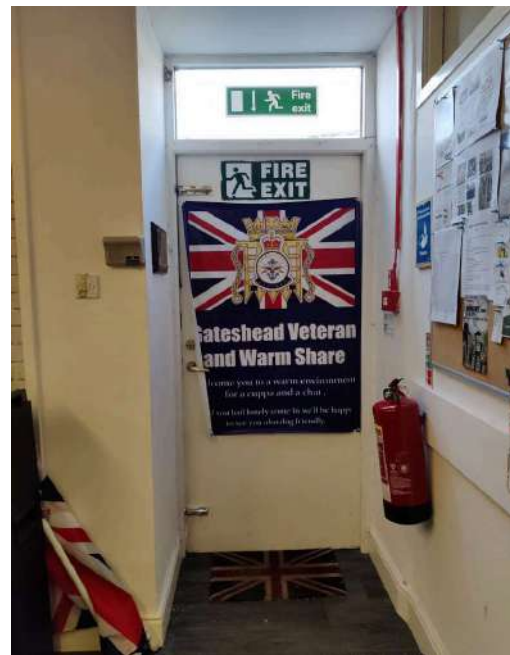
42. Entrance door to lower ground floor

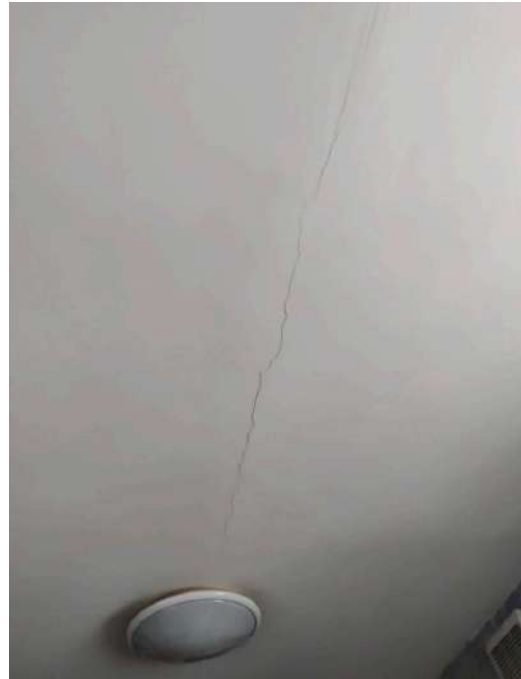
44. Room 1. Monitor ceiling crack (rec 4.12)

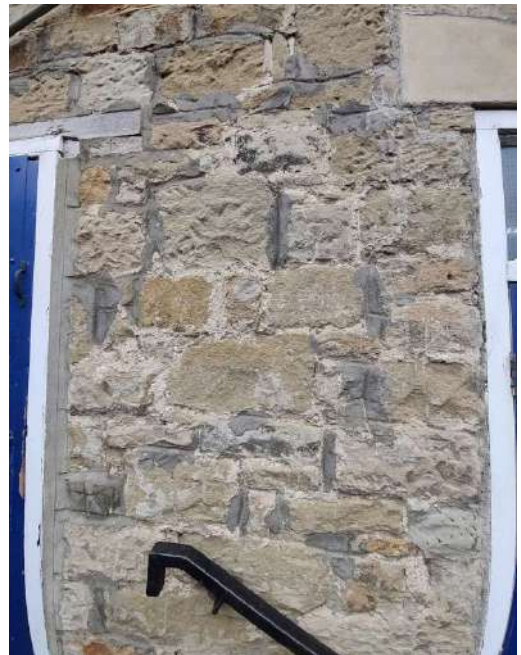
46. North yard. Unsightly cement mortar repairs.

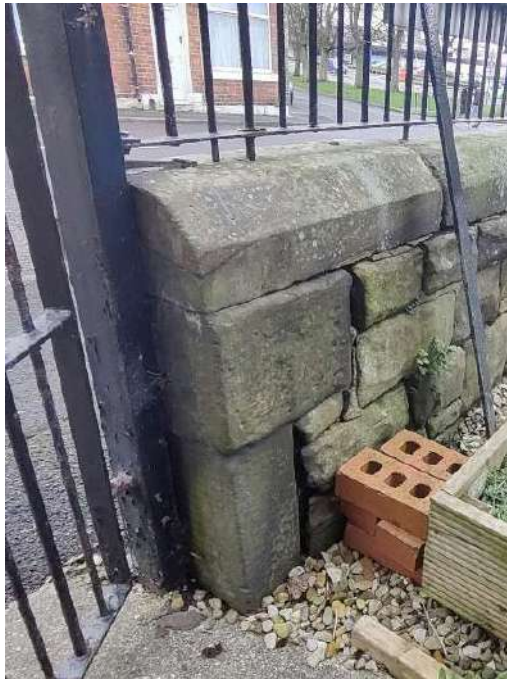
47. North Yard. Dismantle, rebed and repoint loose stonework and quoins (rec 8.02)

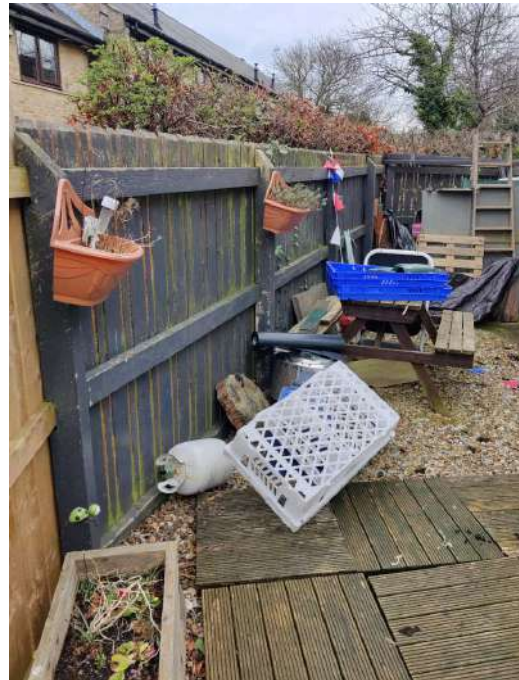
48. Tidy North yard (rec 8.05)

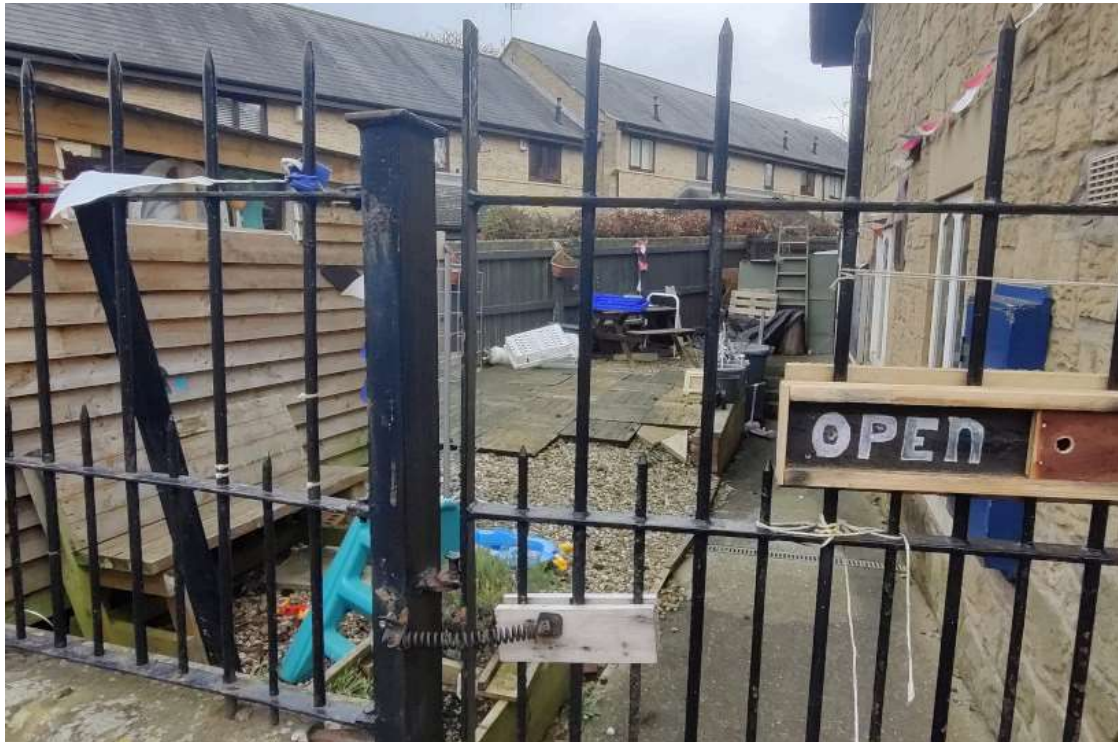
51 (above) Tidy north yard (rec 8.04) 52 (below) Rebed loose stonework to south yard (rec 8.01)
