INSPECTION AND REPAIR OF CHURCHES

QUINQUENNIAL REPORT on the

ST JOHN THE BAPTIST

GREATHAM

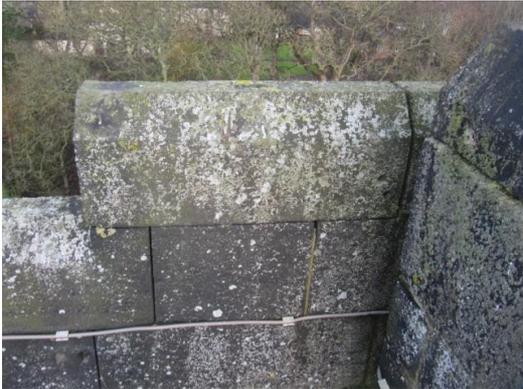
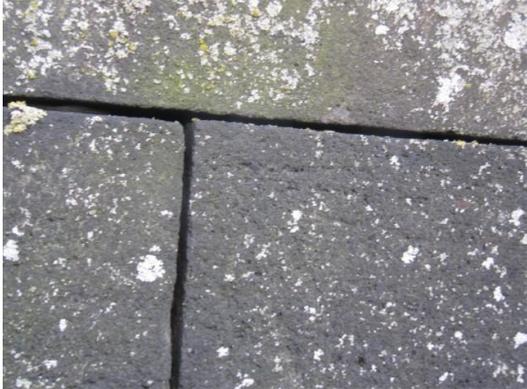
Open joints to the tower parapet viewed internally

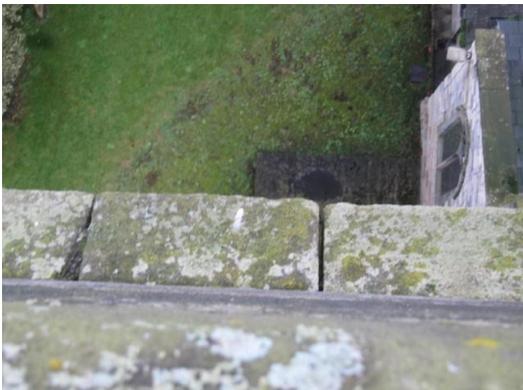
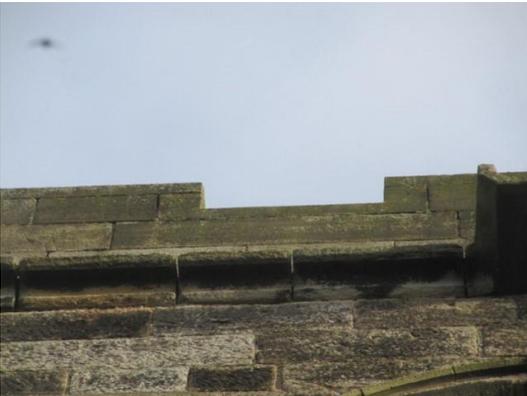
Open joints to the and tower parapet viewed externally

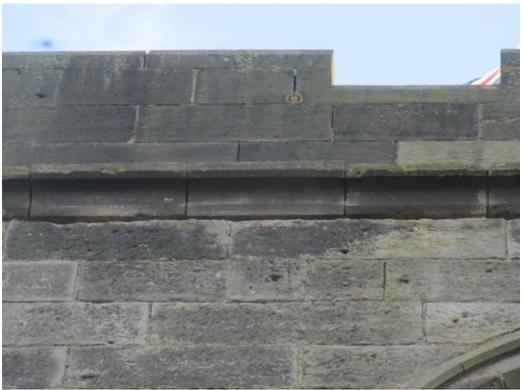
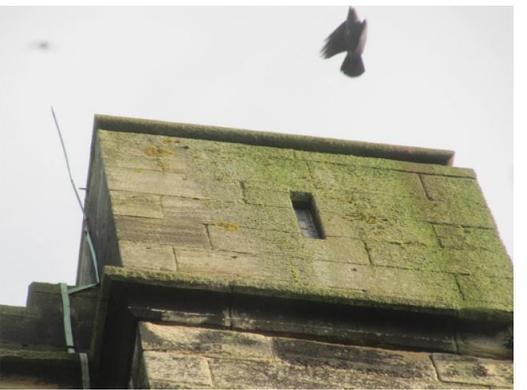
Open joints to the and tower parapet and associated stair turret

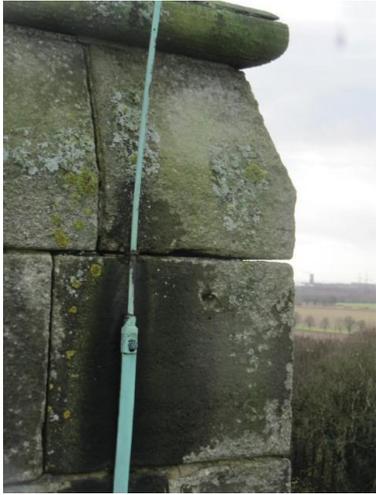
Open joints to the Stair turret

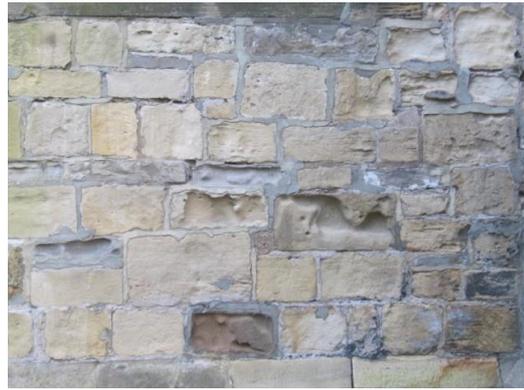
2. West Elevation of the North Aisle	Semi coursed squared Magnesium Limestone with sandstone dressings to window surrounds, buttress quoins and capping	Mortar in common with other walls is hard and starting to cause issues with the stonework. Stonework is weathered in places and there is a need for some replacements most notably below sill level. The whole elevation would benefit from repointing to try to reduce the speed of deterioration of softer stonework that is starting to show signs of weathering, but is not at the point of needing repair or replacement.	<p>Carry out a programme of stonework repairs and replacement to the worst of the damage stonework and repoint the wall in the areas of highest deterioration</p> <p>Repoint the remaining elevation with lime mortar to reduce the speed of deterioration of stonework.</p>	<p>2 – 3</p> <p>4</p>

Weathered stonework to the West Elevation of the North Aisle

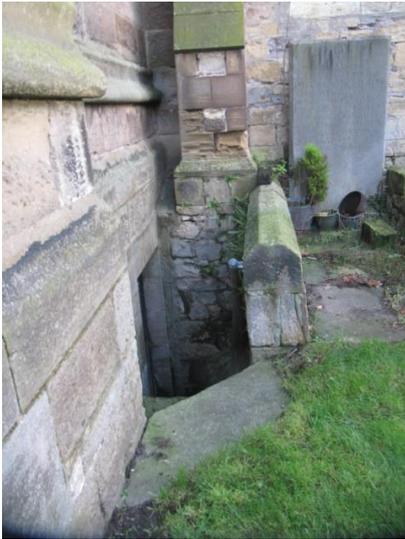
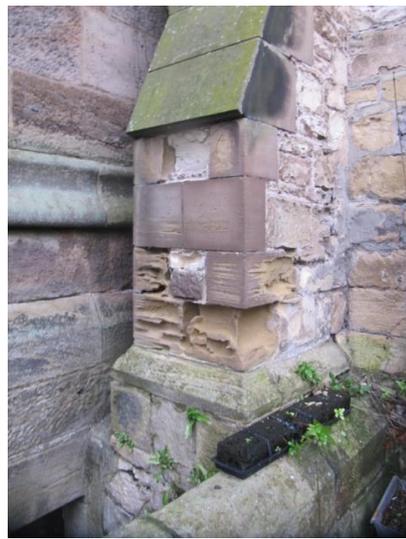
Vegetation and weathered stonework to the South Aisle buttress

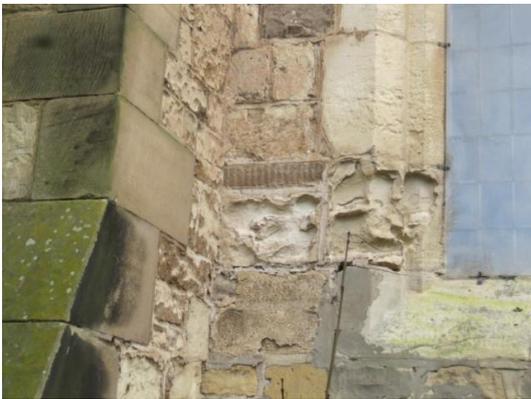
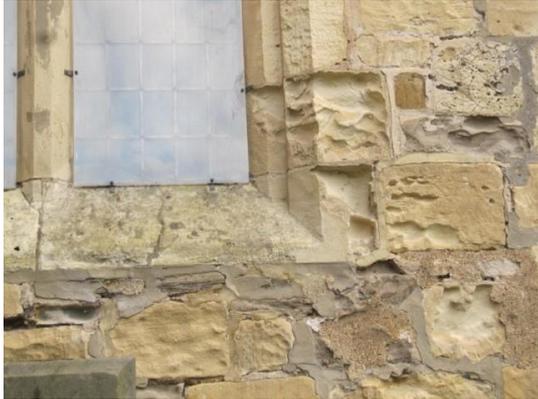
3. West Elevation of the South Aisle	Semi coursed squared Magnesium Limestone with sandstone dressings to window surrounds, buttress quoins and capping	Mortar in common with other walls is hard and starting to fail and cause issues with the stonework especially at lower level. Stonework is weathered in places and there is a need for some replacements most notably below sill level and to the buttress. Vegetation growth and open joints are visible to the buttress at low level.	Inspect water table and point/repair as required to reduce water run off down the wall.	2
		Irregularities with the stone to the water table is causing water to run off down the wall - green algae below one area indicates a long-term issue. This needs inspection and repair to try and prevent water run off down the wall.	Remove vegetation including roots to the buttress and point open joint with lime mortar	2
		The whole elevation would benefit from repointing to try to reduce the speed of deterioration of softer stonework that is starting to show signs of weathering, but is not at the point of needing repair or replacement.	Carry out a programme of stonework repairs and replacement to the worst of the damage stonework and repoint the wall in the areas displaying the highest levels of deterioration.	2 – 3

Weathered stonework to the West Elevation of the South Aisle

Repoint the remaining elevation with lime mortar to reduce the speed of deterioration of stonework.	3 - 4

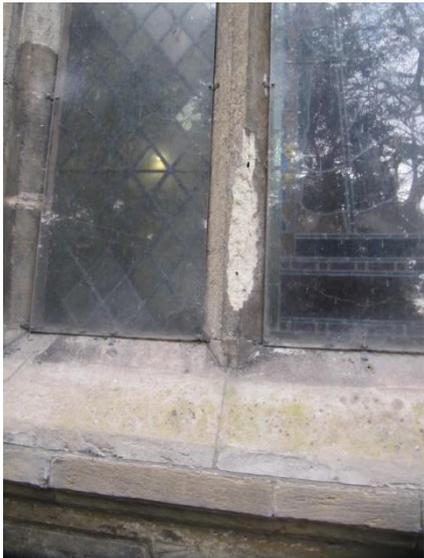
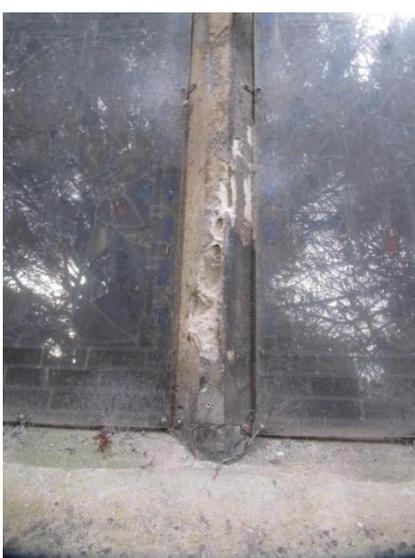
Eroding stonework to the mullions of the South Aisle

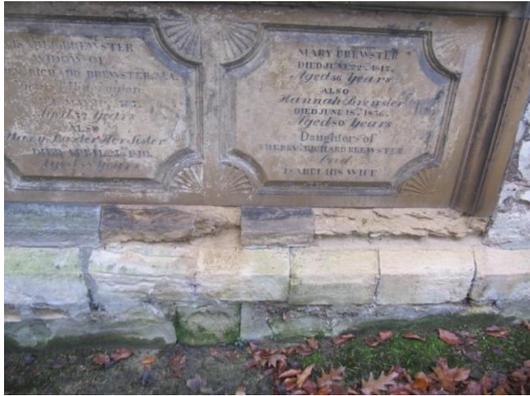
Weathered stonework to the Brewster Memorial

Replace two stones to the surround of the Brewster memorial	3
			Replace mullion to central window	3 – 4
			Repoint the remaining elevation with lime mortar to reduce the speed of deterioration of stonework.	4

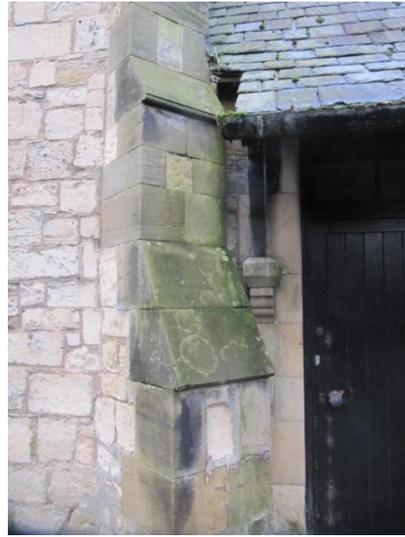
Damp stonework to the buttress to the side of the vestry door

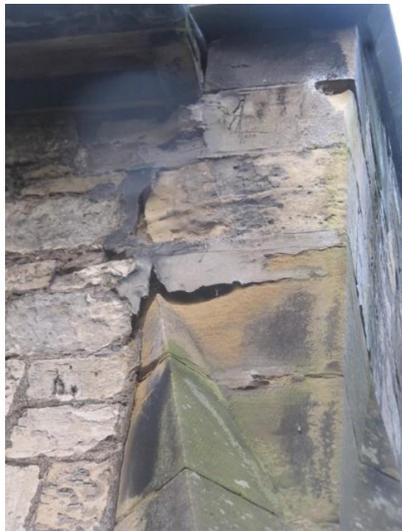
Failing mortar and weathered stonework in the same area

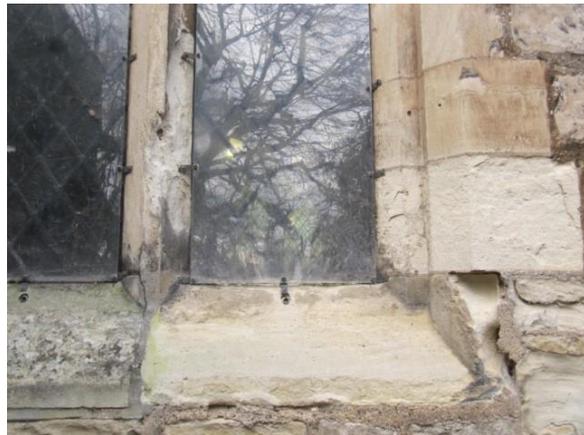
7. South Elevation of the Chancel	Semi coursed squared Magnesium Limestone to walls and window dressings	Mortar is hard and there are a number of weathered stones to the lower section of the wall that require repair or replacement. There is fairly significant weathering of the eastern edge of the window sill and to the mullion. Pointing is starting to fail in a few locations.	<p>Replace the most significantly deteriorated stonework including the sill and mullion.</p> <p>Repoint areas of failing mortar using lime mortar</p> <p>Repoint the remaining elevation with lime mortar to reduce the</p>	<p>2 - 3</p> <p>3</p> <p>4</p>

Eroding stonework to the sill and mullion on the South elevation of the Chancel

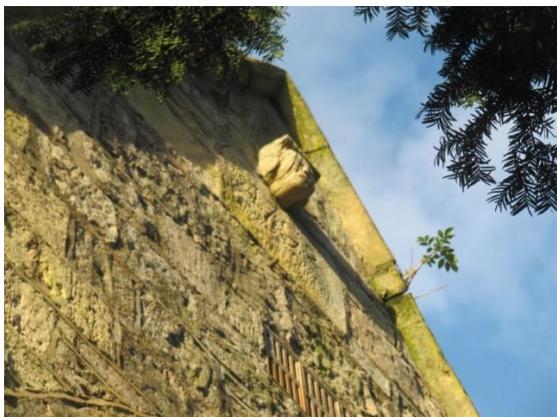
8. East Elevation of the Chancel	Semi coursed squared Magnesium Limestone with magnesium limestone dressings to window surrounds,	<p>Open joints and vegetation growth to the water table needs immediate attention as issues of water ingress are apparent internally.</p> <p>Mortar is hard and there are issues with failing pointing visible on this elevation, especially to the gable and the base of the wall. Stonework is weathering in the same two areas, but most noticeably to the base of the wall, with isolated weathered stonework to the centre of the wall. A crack to the sill should be pinned and pointed.</p> <p>There is a holly growing at the base of the wall in the drain which needs removing and roots removed or poisoned.</p> <p>The branches of the Yew are too close to the wall and need to be pruned back to avoid damage to the wall.</p>	<p>Remove vegetation including roots and repoint open joints to the water table.</p> <p>Remove holly including roots to the base of the wall</p> <p>Replace the most significantly deteriorated stonework and repoint areas of failing mortar</p> <p>Pin and point crack to sill</p> <p>Repoint the remaining elevation with lime mortar to reduce the speed of deterioration of stonework.</p> <p>Speak to the Local Authority about pruning the Yew trees</p>	<p>1</p> <p>1</p> <p>2 - 3</p> <p>3</p> <p>4</p> <p>2</p>

Vegetation and close proximity of the yew to the East Elevation of the Chancel

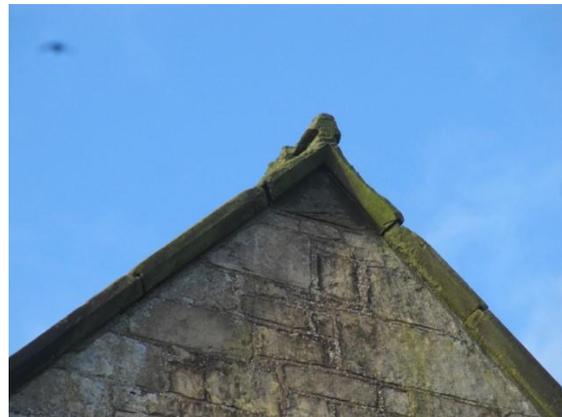
10. East Elevation of the Nave	Semi Coursed square Magnesium Limestone	Pointing is hard, but from ground level, this appears currently reasonably sound. Pointing to the water table should be checked when roof work is carried out, especially around the apex stone where mortar appears recessed	Check pointing to water table when roofing work is carried out and repoint any areas of failing mortar.	2

Hungry mortar joints around the apex stone to the East gable of the Nave

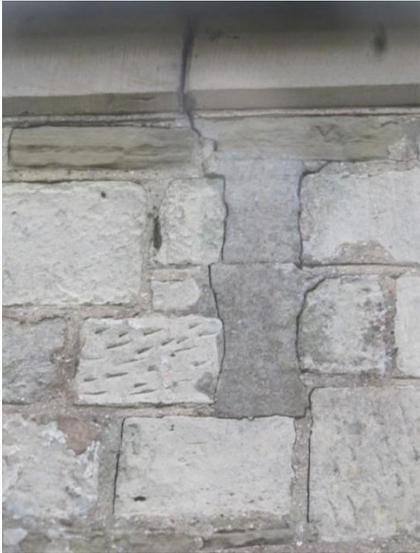
9. North Elevation of the Organ Chamber	Semi Coursed square Magnesium Limestone	There is cracking visible towards the east end of this wall at high level, which has been previously repointed but is starting to open up again, either due to seasonal movement or ongoing issues. This area should be repointed to allow visual monitoring, piecing in new stone to replace mortar repairs to stones adjacent to the crack.	<p>Repoint crack replacing stonework previously repaired with hard mortar repairs and visually monitor the area for signs of ongoing movement.</p> <p>Repoint the elevation with lime mortar to reduce the speed of deterioration of stonework and replace any damaged stones.</p>	3 5

Wide mortar infill showing signs of cracking
To the North Elevation of the organ chamber

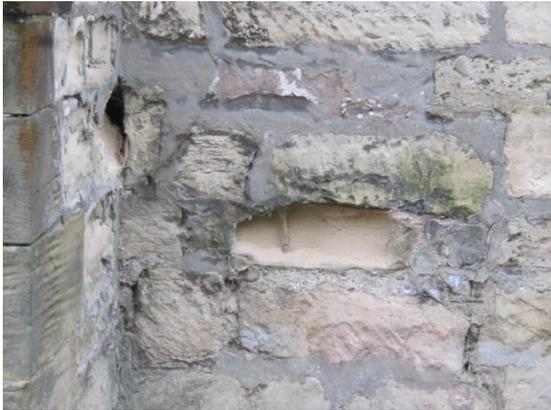
Weathered stonework to the North elevation
of the North Aisle

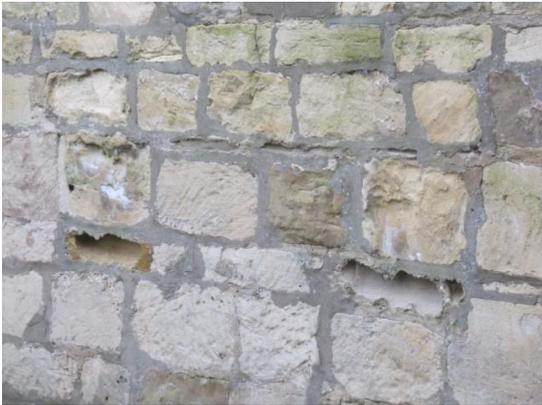
Weathered stonework to the North elevation
of the North Aisle

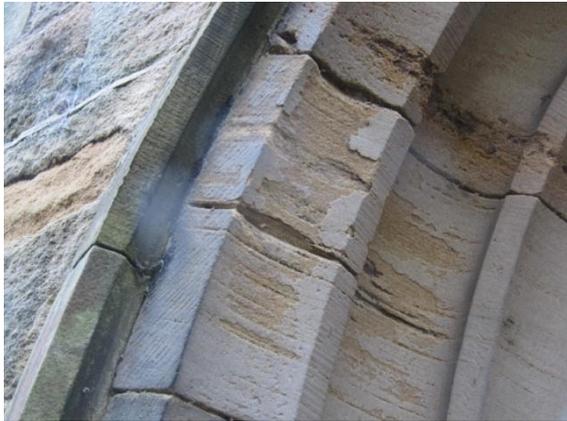
Weathered stonework to the porch doorway

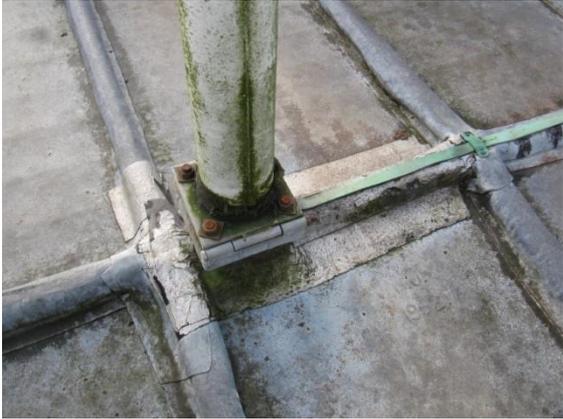
Failing flashband around the flagpole

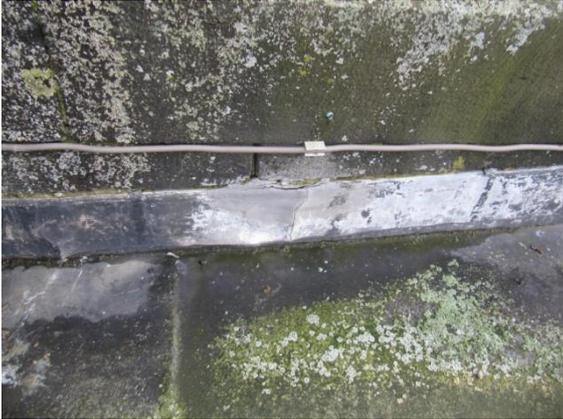
Split flashings to the tower

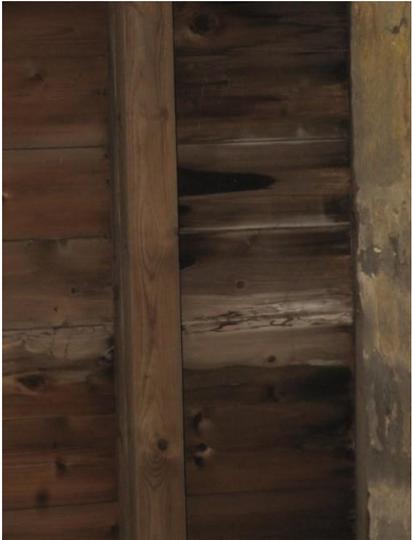
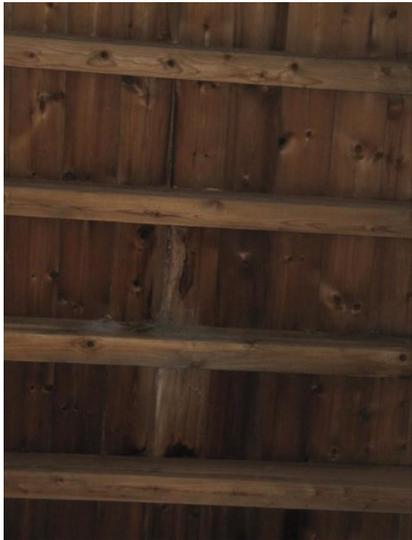
Damp and stained timbers to the tower roof

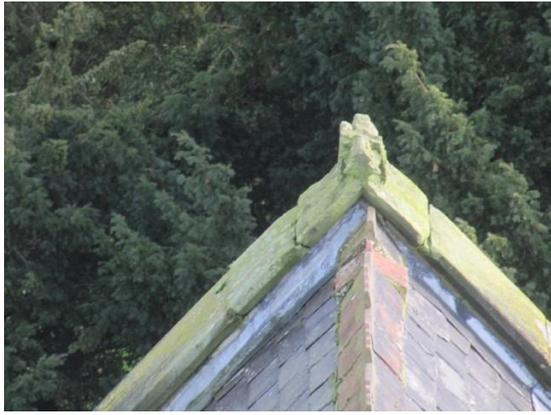
Failing mortar over flashings and damaged ridge tile to the Nave roof

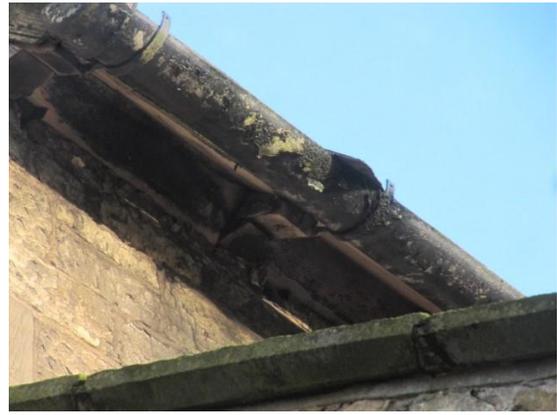
Slate in the South Nave gutter

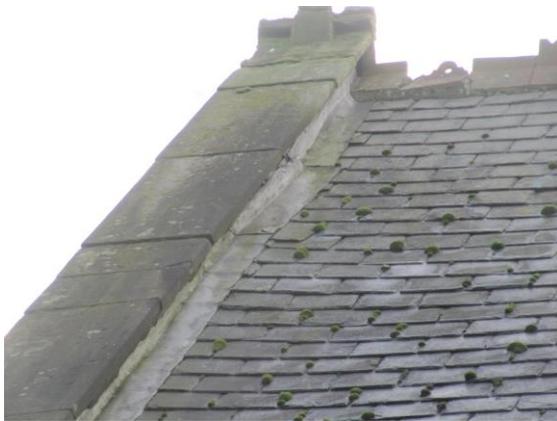
Failing mortar above the flashings and damaged ridge tile to the Nave

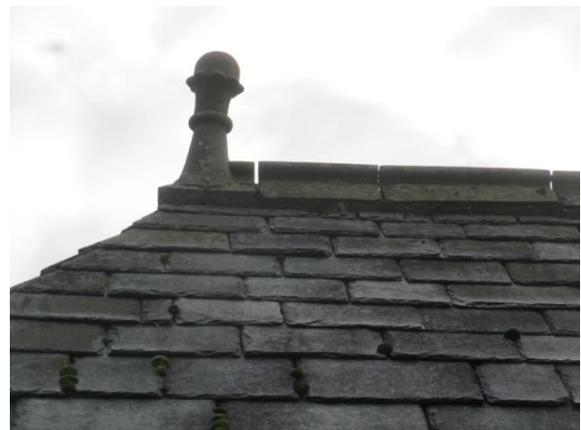
Open joints to the Organ Chamber ridge

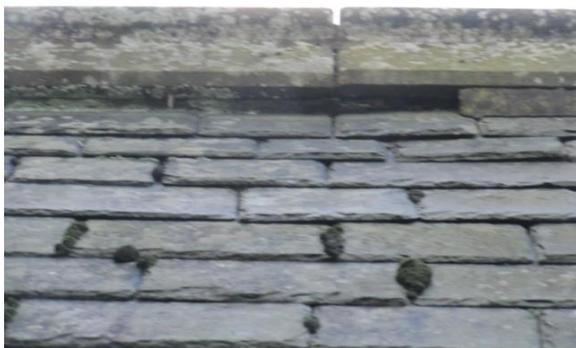
Open joints to ridge tiles and failing mortar bedding to other roofs

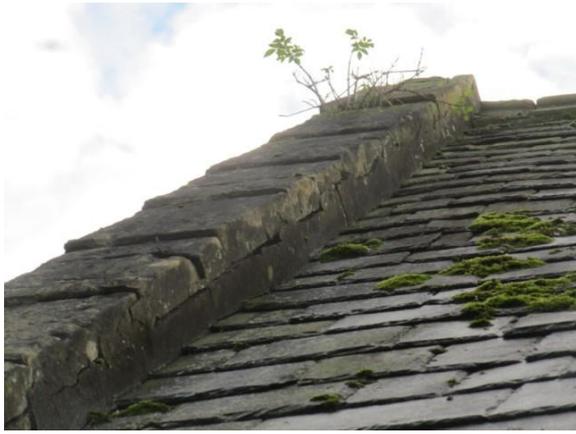
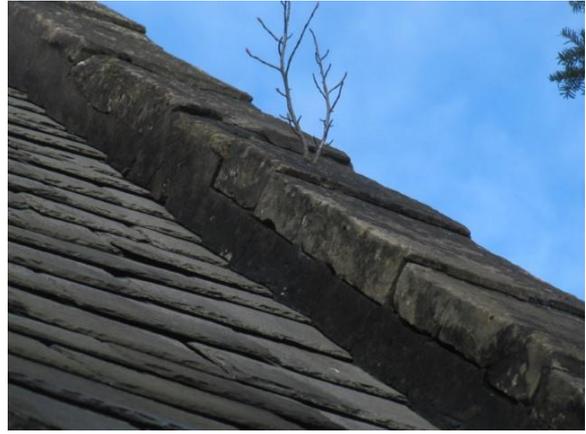
Vegetation and failing mortar fillets to both slopes of the Chancel roof

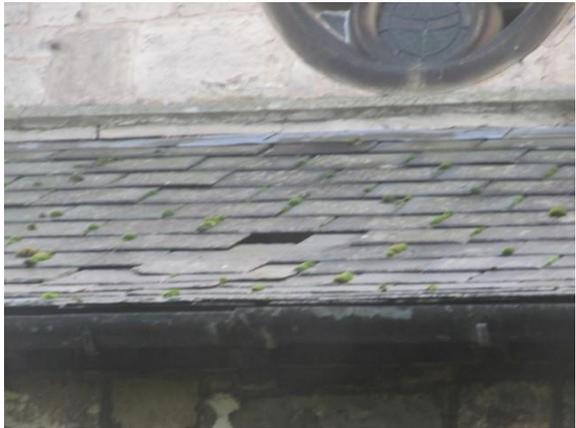
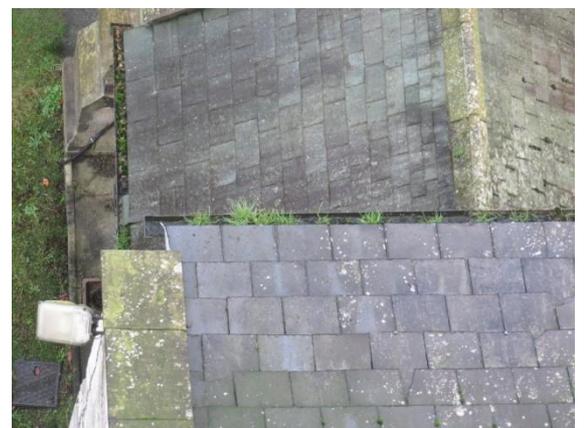
Missing and slipped slates to the North Aisle roof Vegetation to Northern gutters

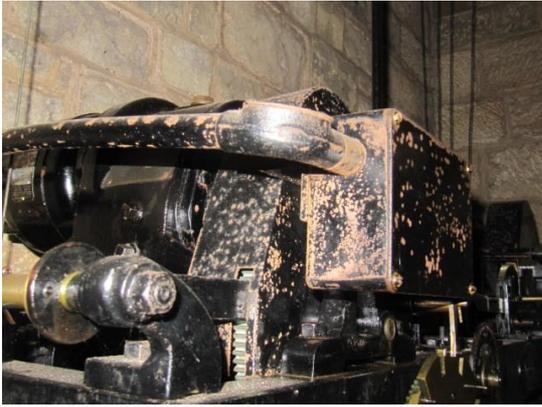
Rust to the clock

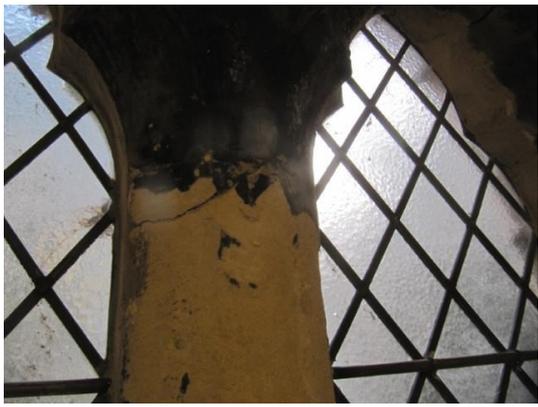
Crack to Vestry mullion internally

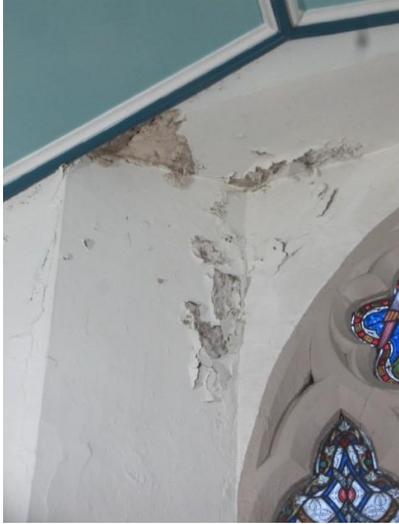
Failing paint and plaster to the East and south walls of the Chancel

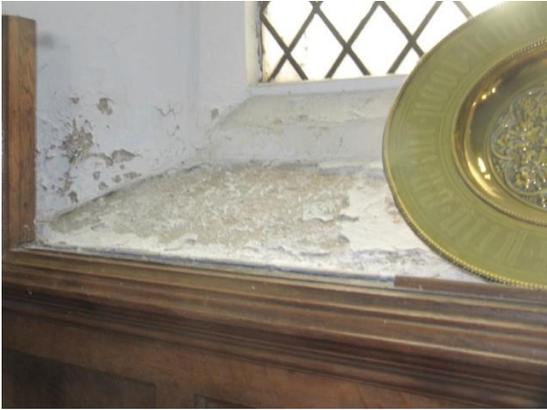
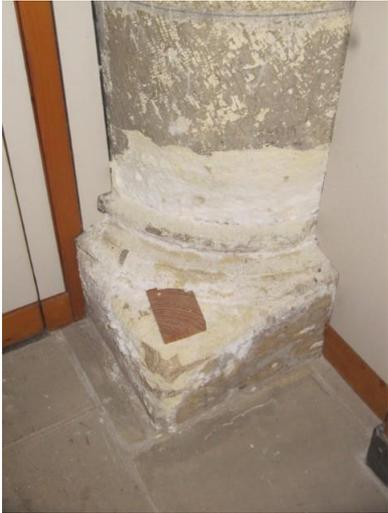
<p>5. Inner stair lobby (ground and first floors)</p>	<p>Painted plastered walls, modern partition to the South. Paved floor and exposed roof timbers with painted plaster between.</p>	<p>East wall – salt effervescence and sanding stonework to the base of the column partly embedded in the new partitions.</p> <p>South wall – no obvious defects noted</p> <p>West wall – significant issues with salt effervescence and dampness to the left hand side of the window reveal and wall below and also to the Northern side of the wall into the North West corner of the wall. Some areas of plaster may need replacing once the external defects have been attended to and the wall has dried out.</p> <p>North wall – paint and plaster are blistering to the side of the stairs with some salt effervescence. As per the West wall, some areas of plaster may need replacing once the external defects have been attended to and the wall has dried out.</p> <p>Open joints between some of the paving stones would benefit from repointing.</p>	<p>Gently brush of salts and sanding stonework to remove the worst of the loose material</p> <p>Repoint open joints between paving stones.</p> <p>Allow West wall to dry out once external defects have been remedied and replaster areas of damaged plaster</p>	<p>1 then M</p> <p>4</p> <p>5</p>

Salts and sanding stonework to the base of the column in the internal lobby

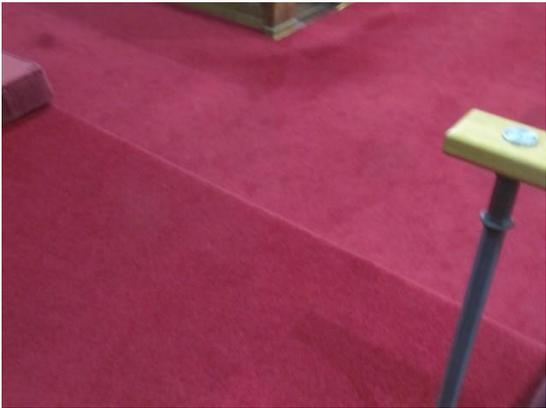
Poor definition of the edge of steps from the Chancel to the Nave

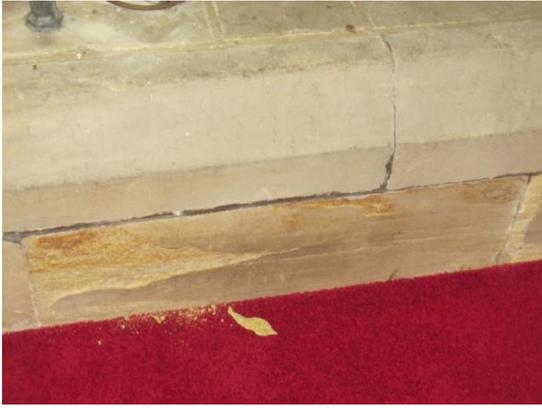
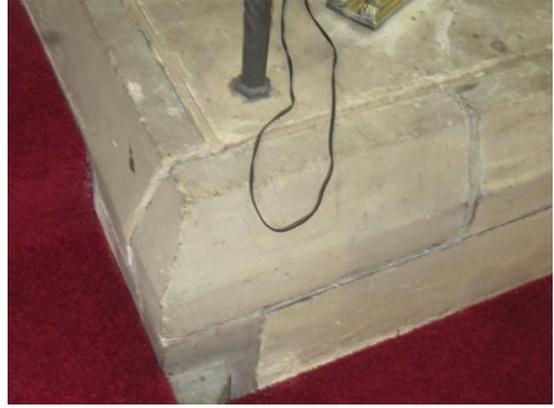
Damage to stonework and loose edge stone between the Nave and Chancel

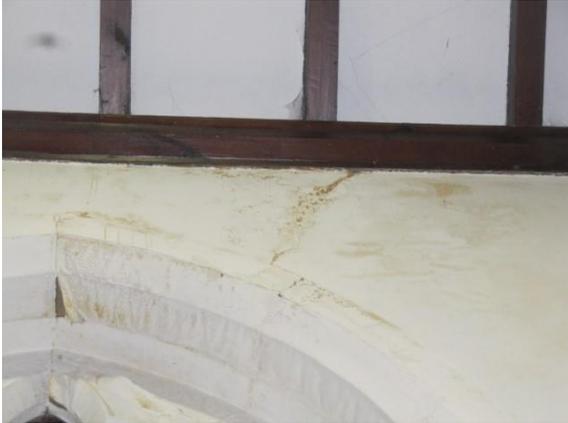
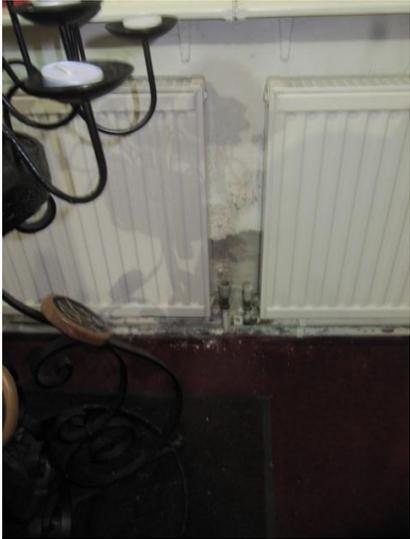
Staining due to water ingress to the South Aisle Plaster failing at low level in the North Aisle

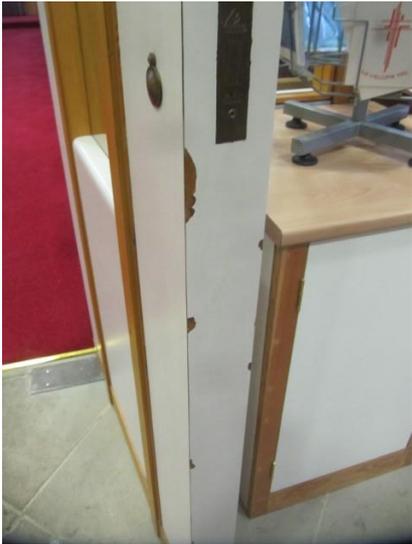
Damage to the edge of the doors into the Nave

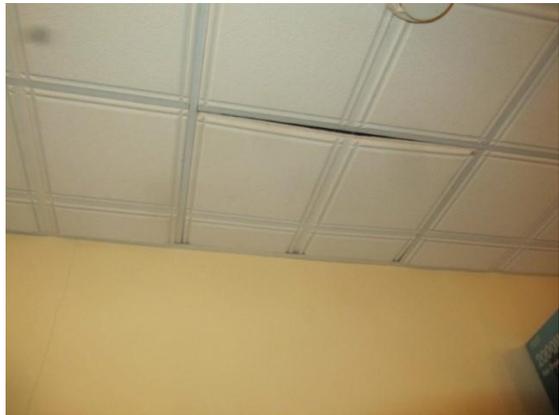
Failing ceiling tile over the servery/kitchen

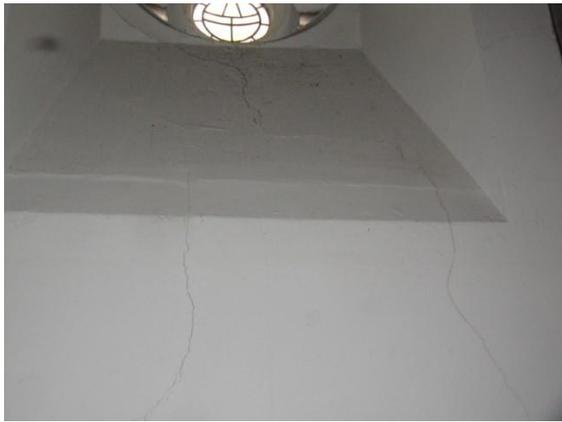
Cracking under Shannon room window

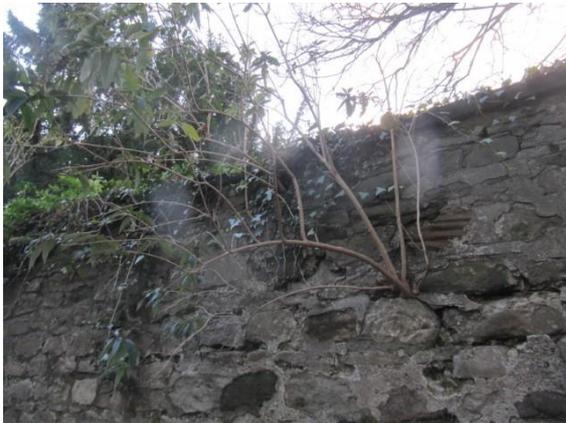
Vegetation growth to the Western boundary

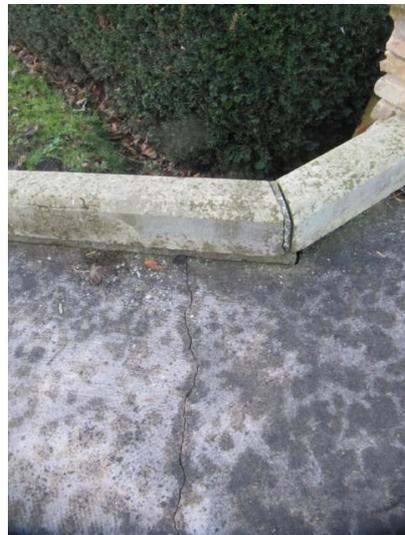
Open joints and cracked surface around War Memorial

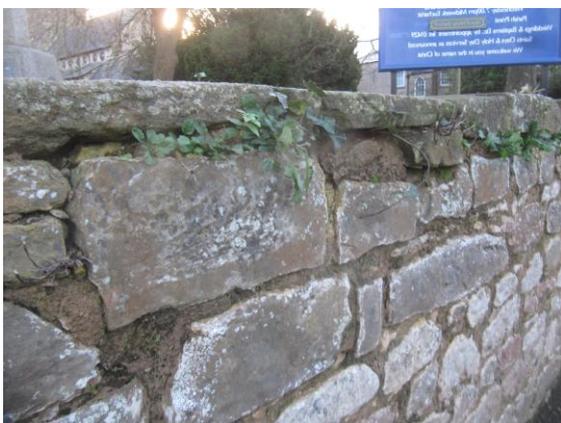
Vegetation growth and failing mortar to both sides of the Eastern boundary
