## QUINQUENNIAL INSPECTION REPORT **St Thomas, Harelaw**

### Crosby Granger Architects Ltd

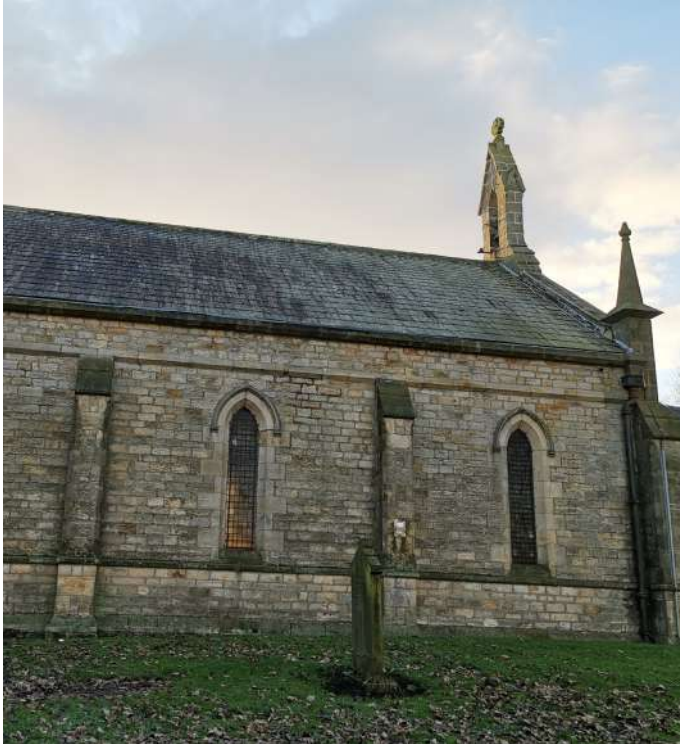
North roof pitch - repaired but still allowing water through during driving rain - headlaps only 50mm in general.

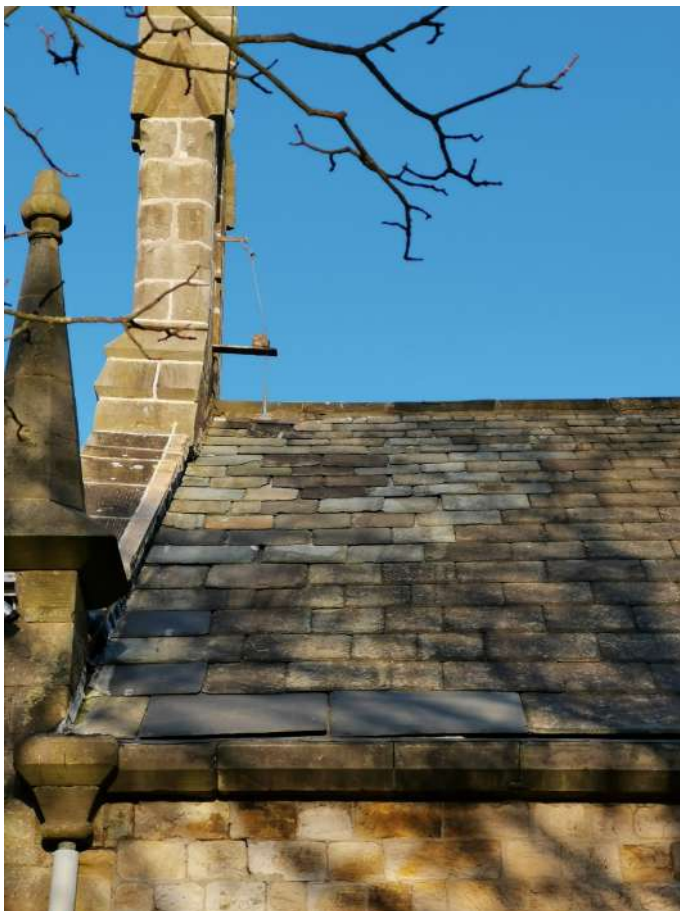
Newly patched slates to south-west nave

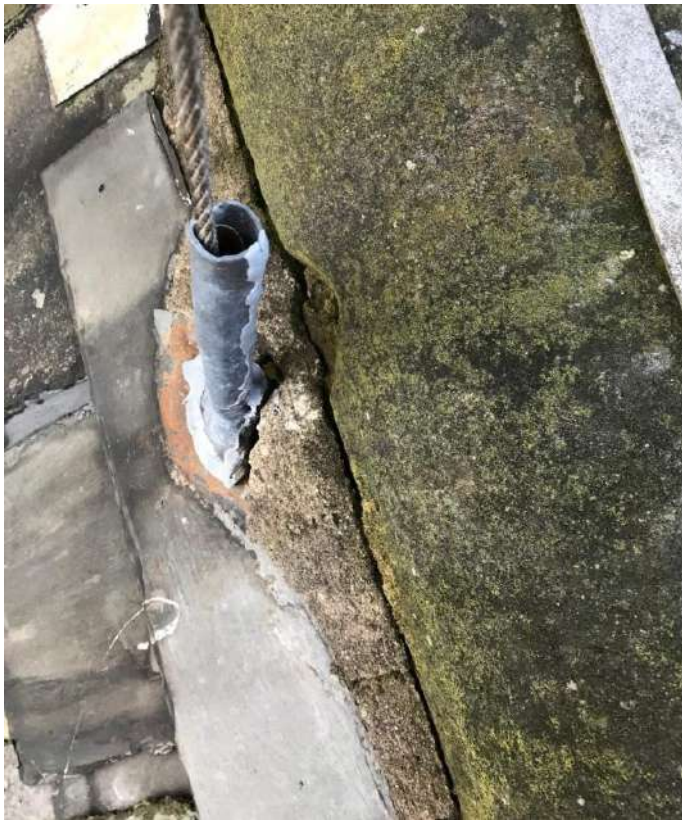
Lead sleeve taking bellrope through roof covering is inadequate - requires completely renewing during re-roofing

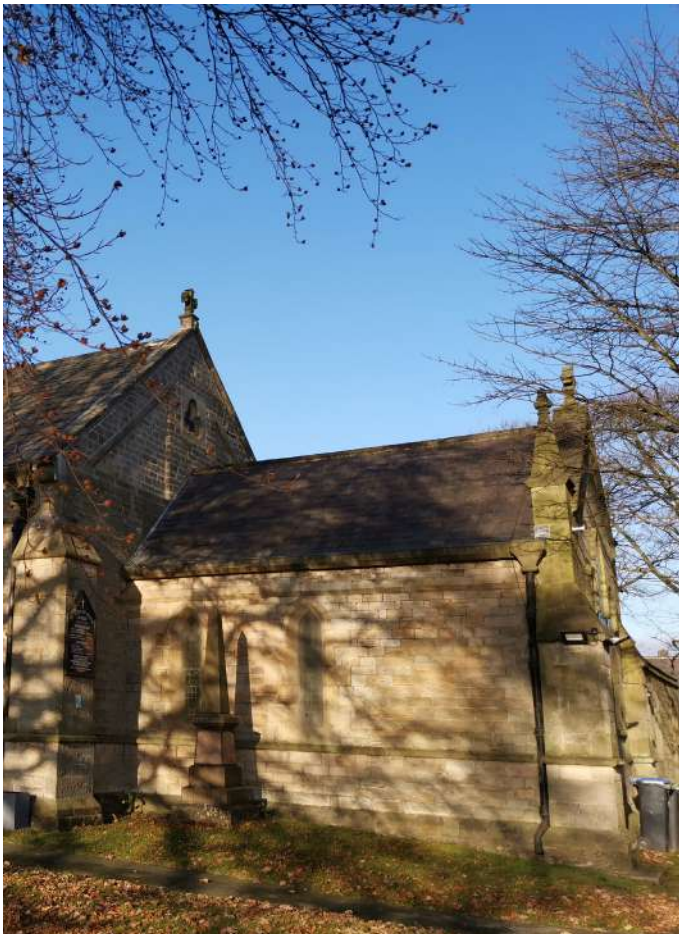
Chancel roof requires major repair, and likely re-roof

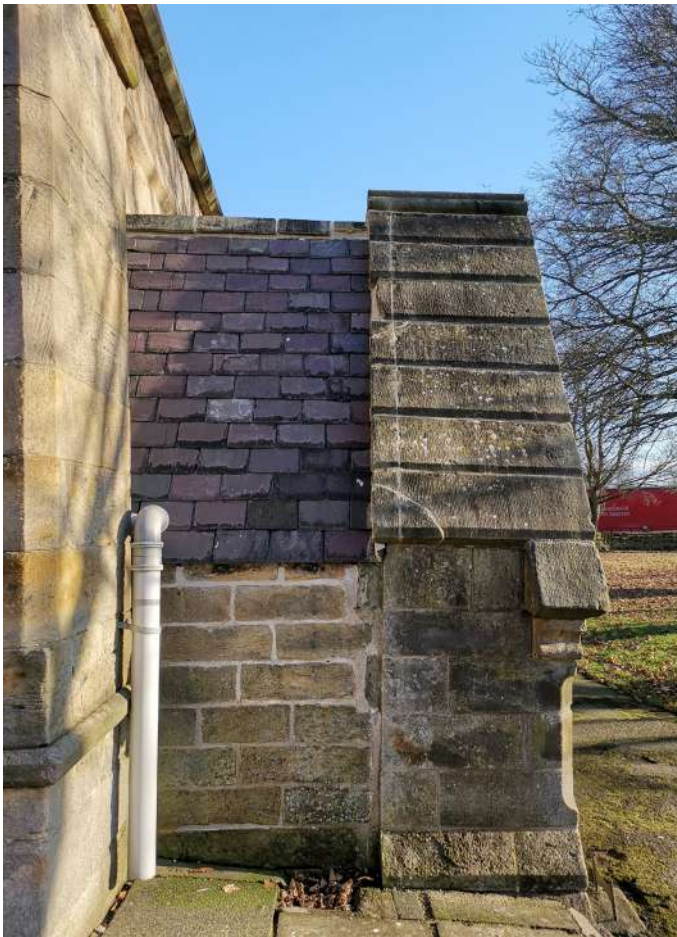
Porch re-pointed and re-roofed - grey plastic soil pipe taking rainwater from nave roof still not been resolved

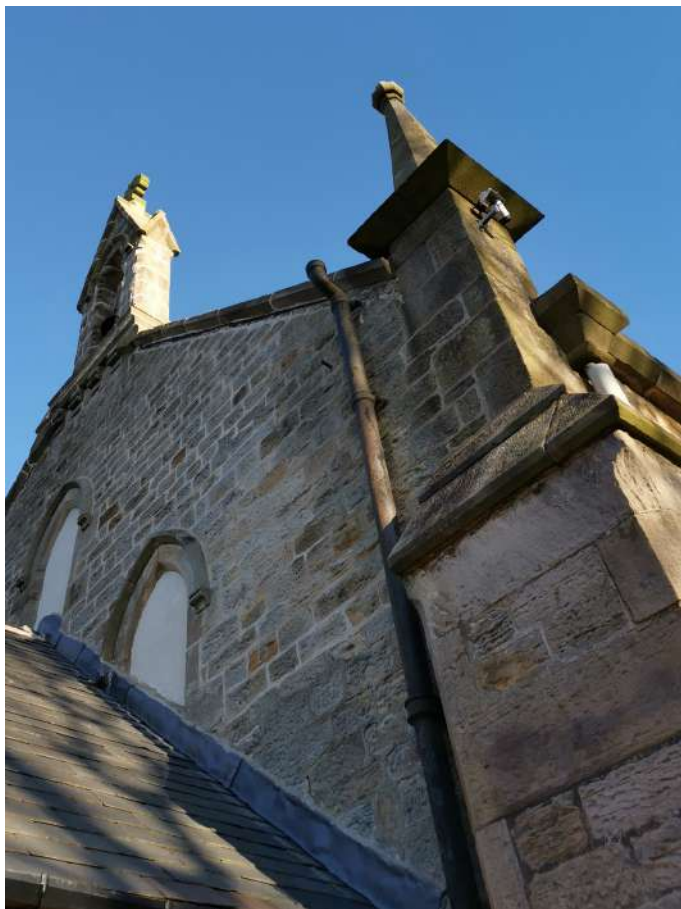
Western gable - watertabling re-bedded, gable re-pointed.

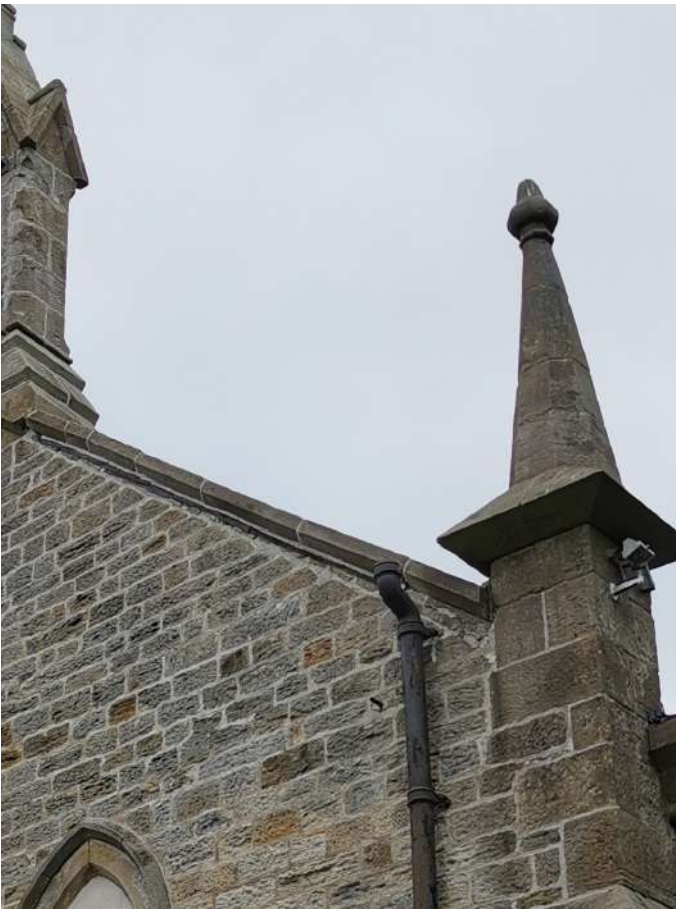
Pinnacles checked for stability, movement is notable - unknown whether there are dowels or lead joggles locating the stones - would benefit from re-building with stainless steel dowels

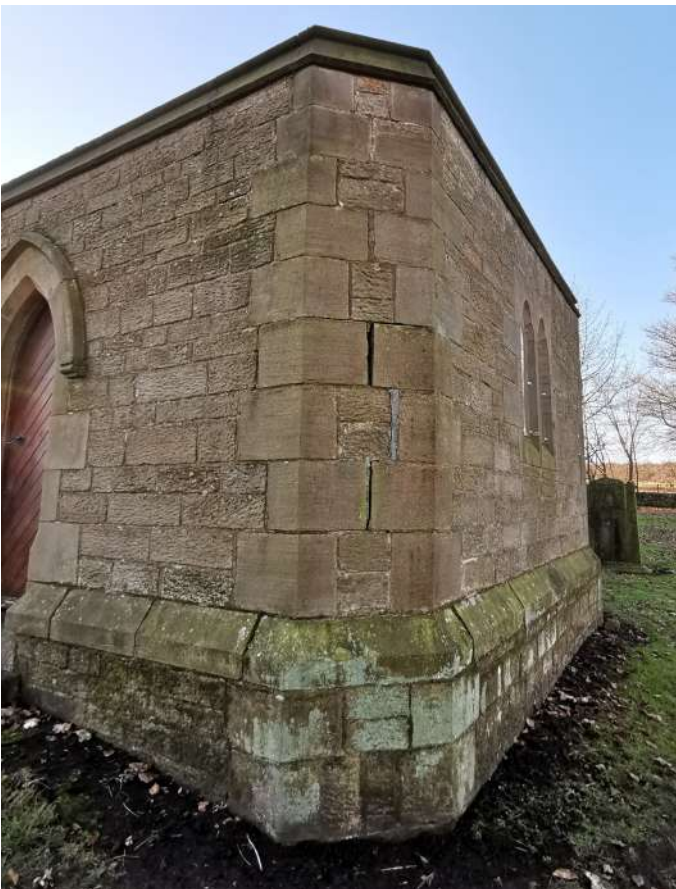
Cracking in north east vestry walling is substantial - point in lime mortar and monitor

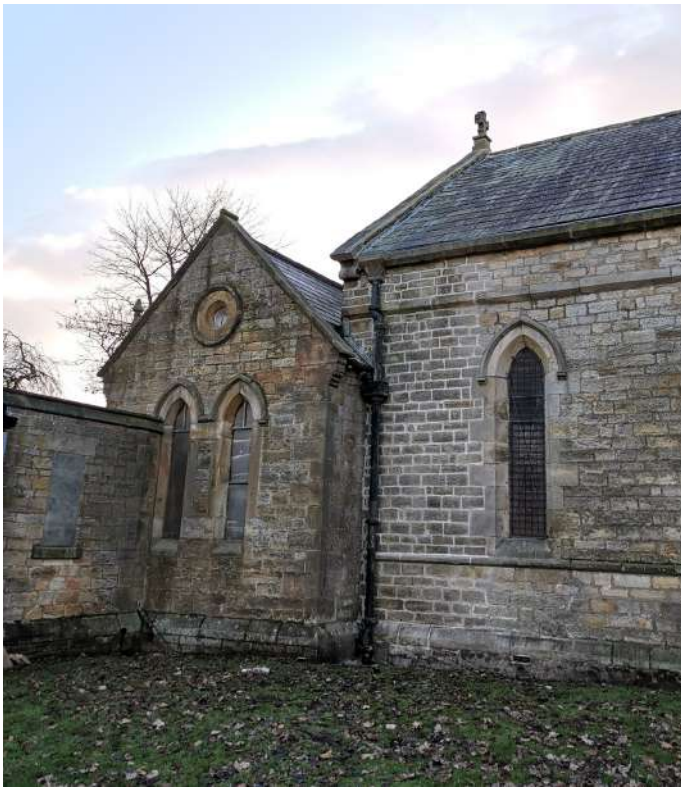
North elevation generally damp - area to east of nave repointed

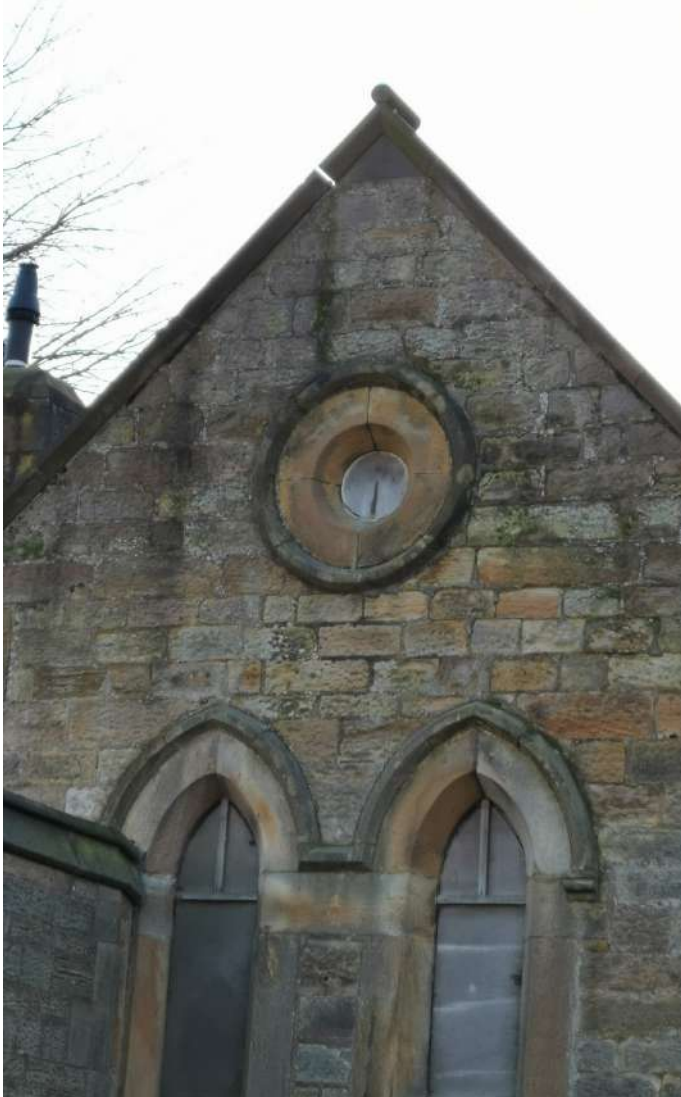
North elevation of organ loft in poor condition with water penetration through open watertabling

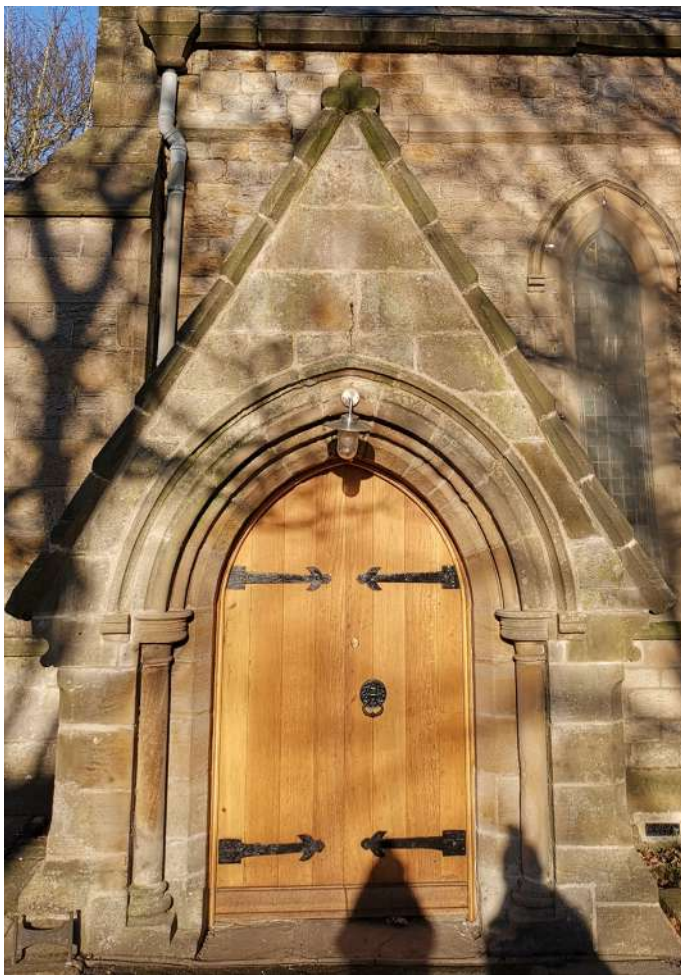
New oak door to porch

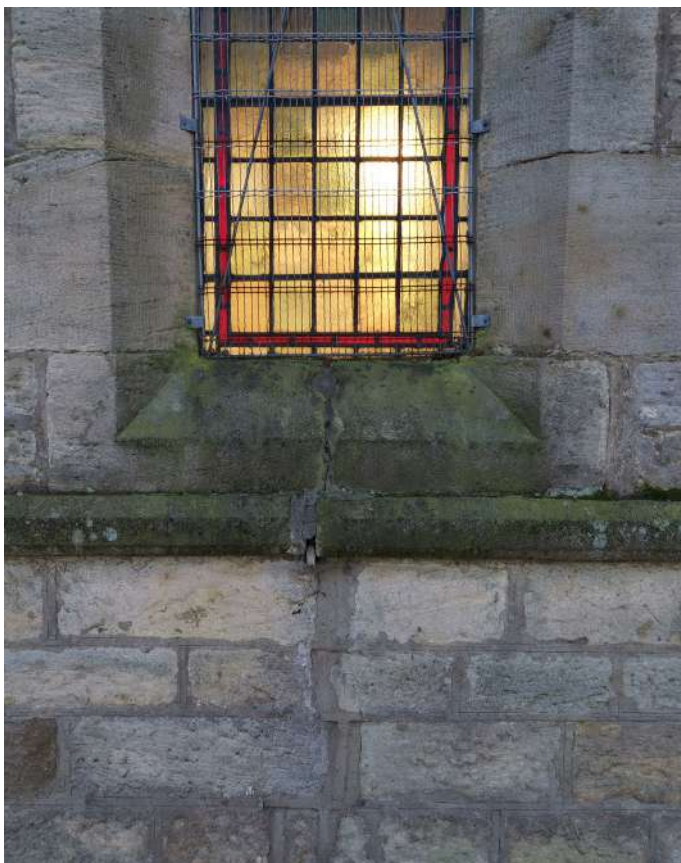
Crack through cill of middle window on north elevation of nave

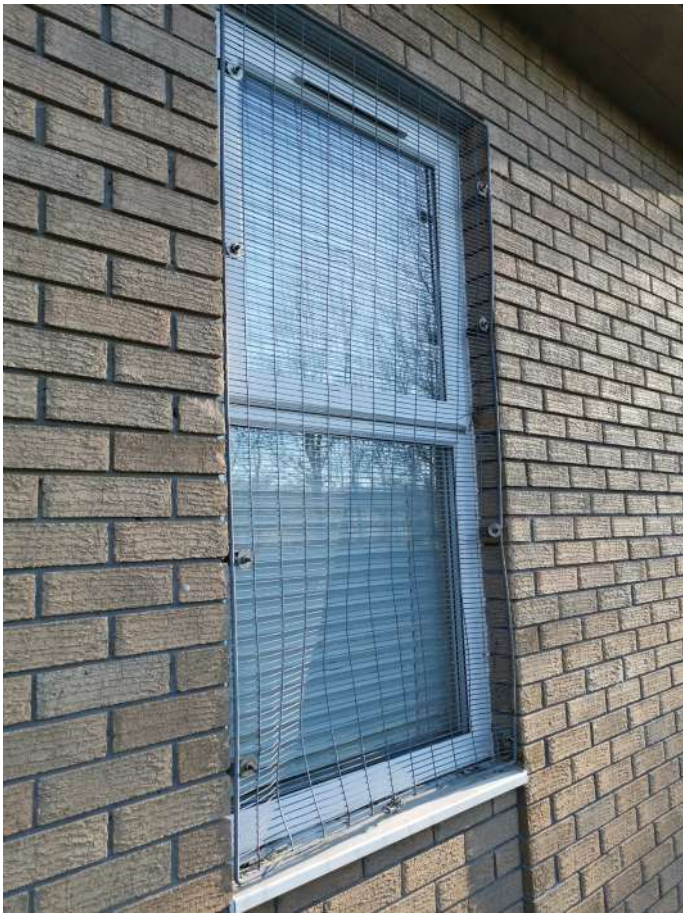
The blocked up windows of the organ loft would benefit from being permanently blocked in masonry, up or at least the temporary plywood should be painted. To the north elevation of the organ loft the roundel is delaminating and the hoodmould is holding moss.

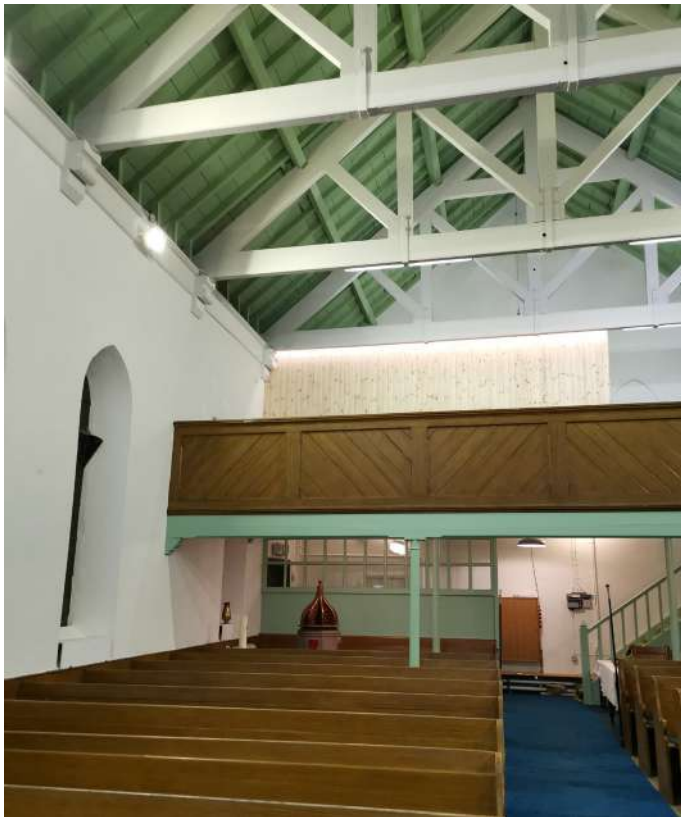
Newly painted ceiling boards and trusses - removal of fibreboard allows leaks to be noted immediately and monitored

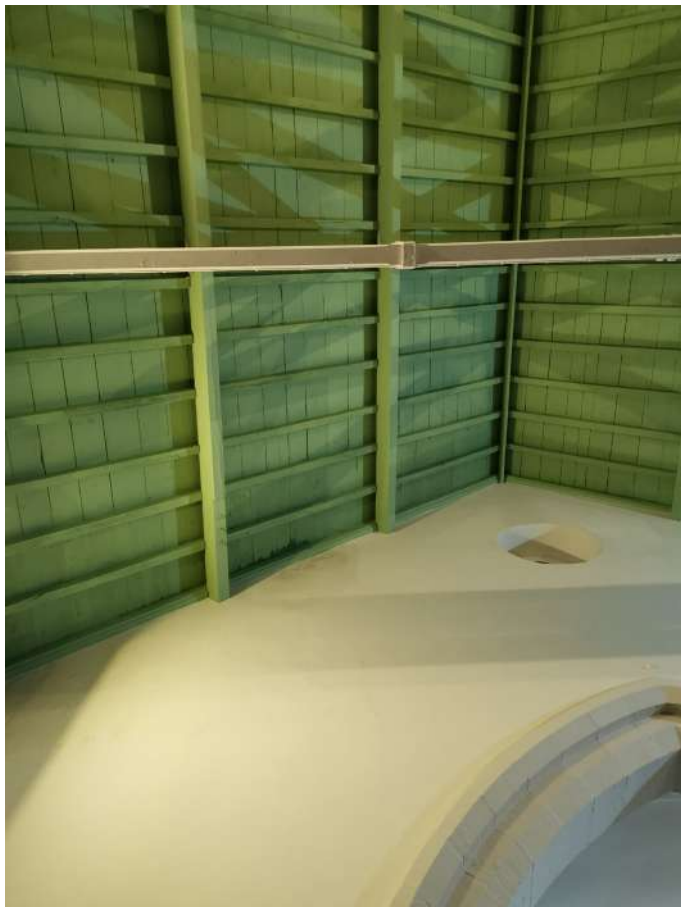
Purlin in east gable, north pitch repaired and area of sarking boards replaced where rotten

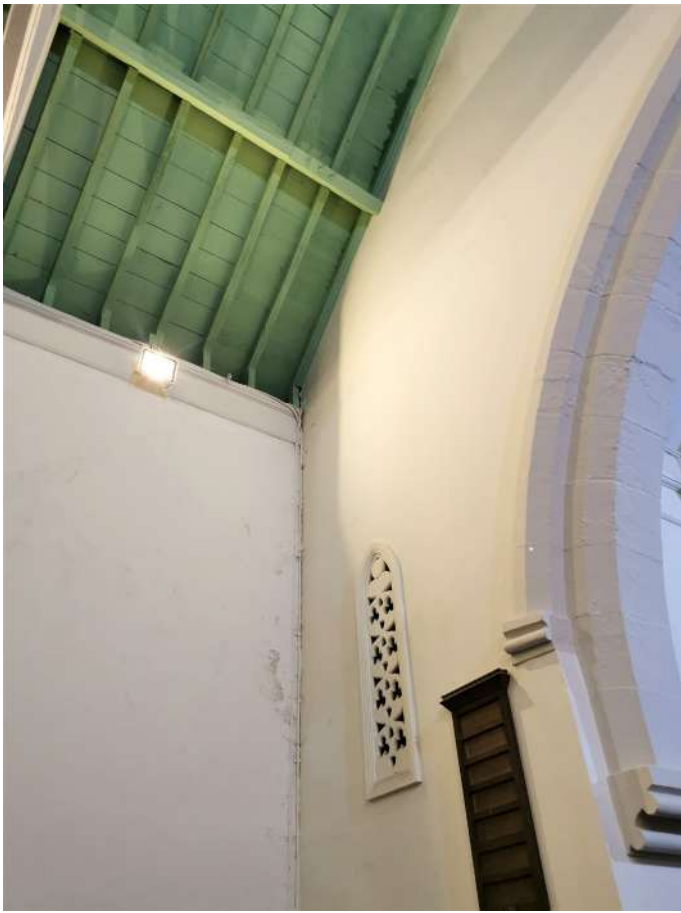
Blistering and damp in corner of north east nave - wall drying out from major long-standing water ingress, but also still signs of leaking at roof level following driving rain (above bottom purlin) despite major works to watertabling. See notes about slating in roof section

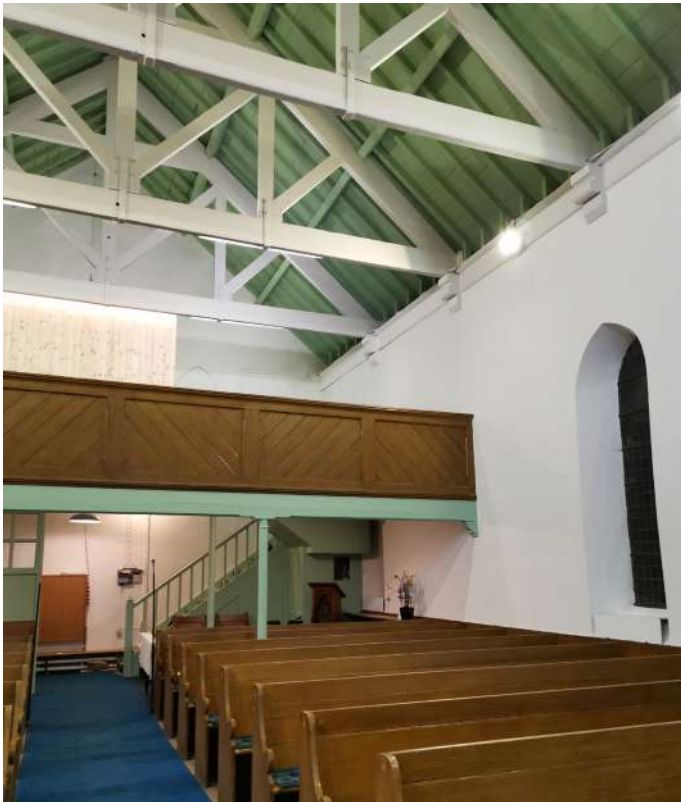
Gallery and stairs at west end also decorated

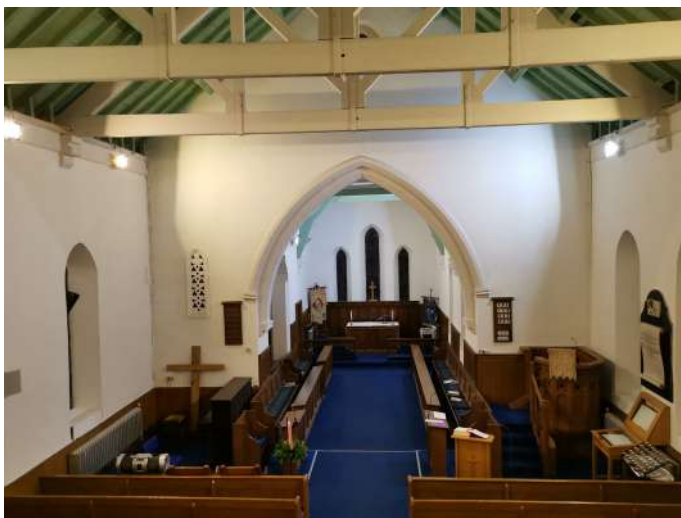
View from gallery - this area should be used once again

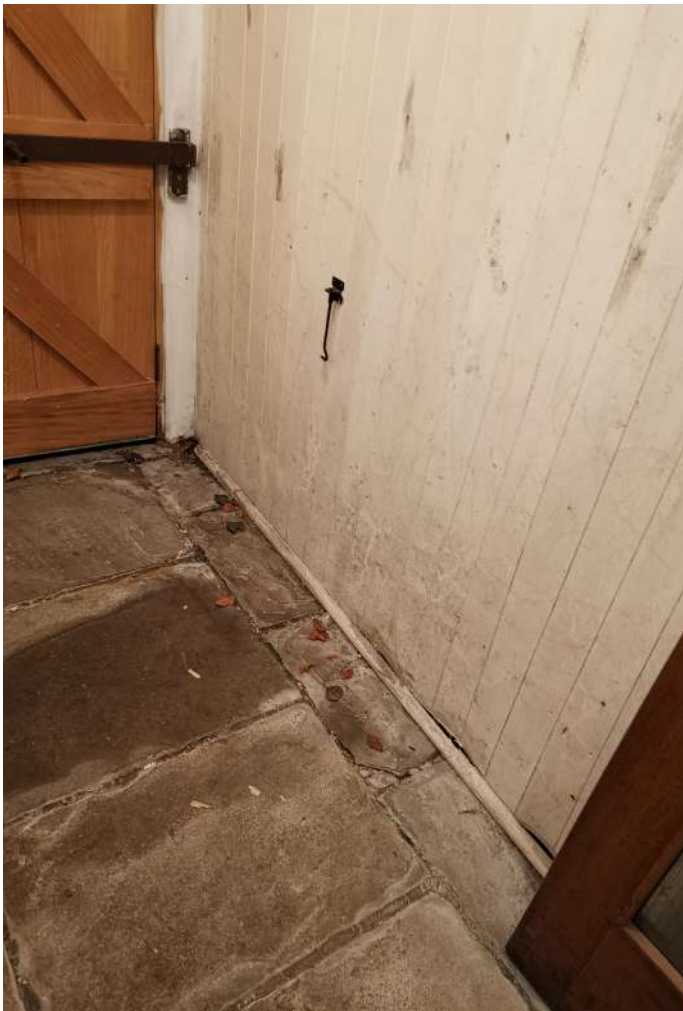
Timber panelling inside porch hiding damp masonry, restricting drying out. Damp seen on flags to floor

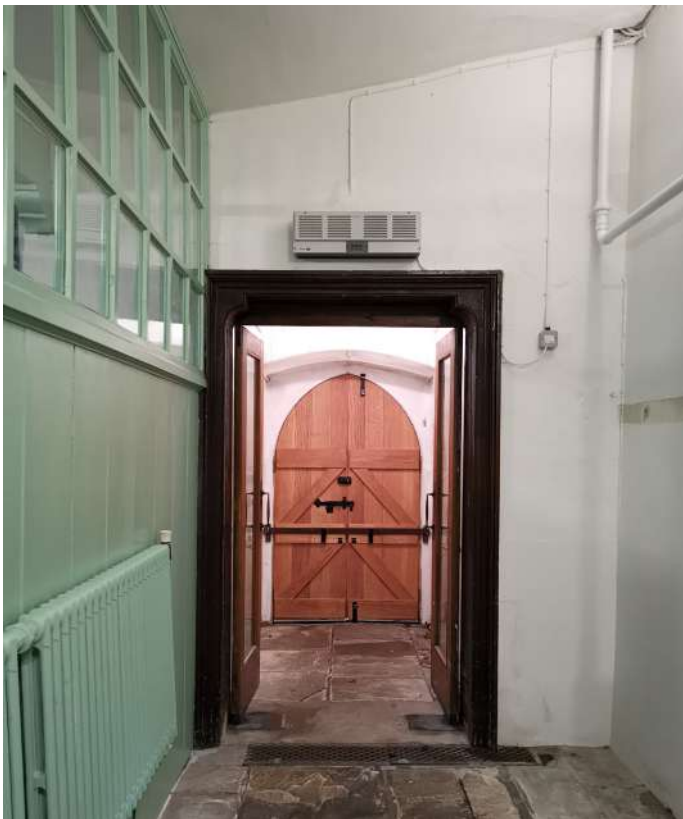
Narthex screen painted to western side - church-side remains shellac

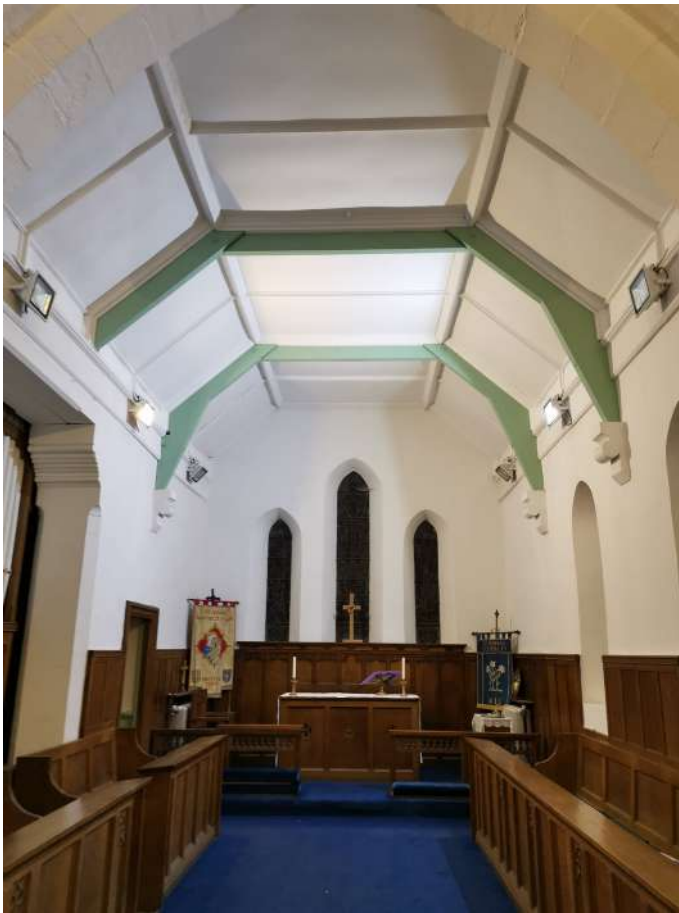
Furniture and panelling to chancel in good condition - ceiling also re-painted. Fibreboards left in situ

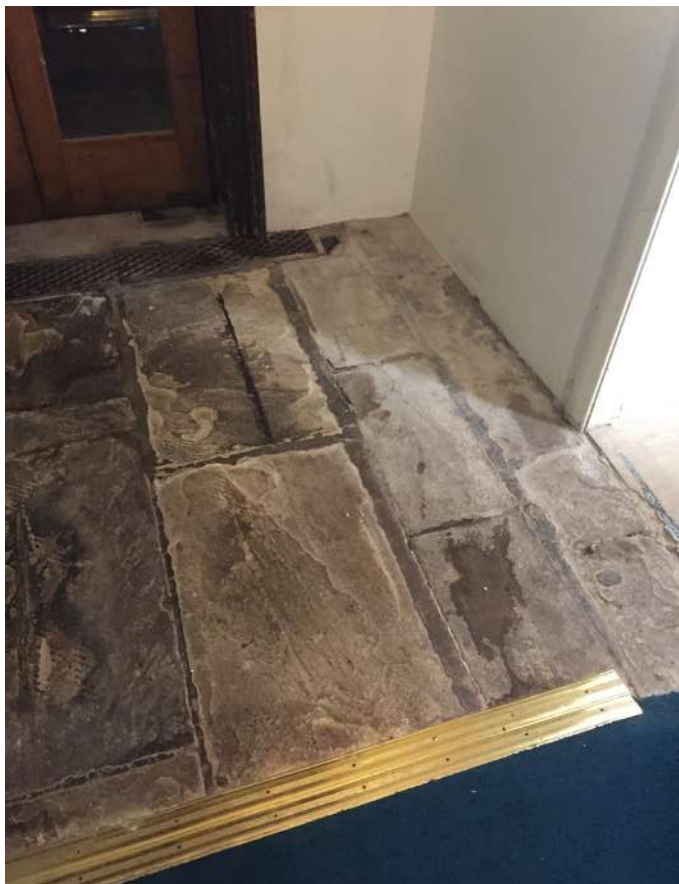
Stone flags still visible at south west entrance, before blue carpet begins

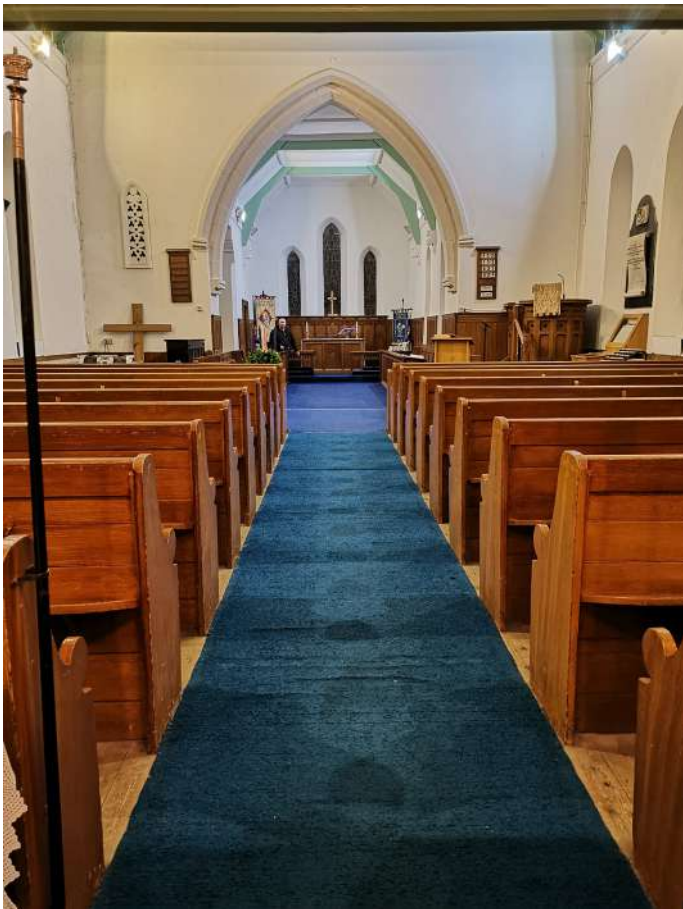
Carpet throughout, will be causing dampness within the original stone flags below

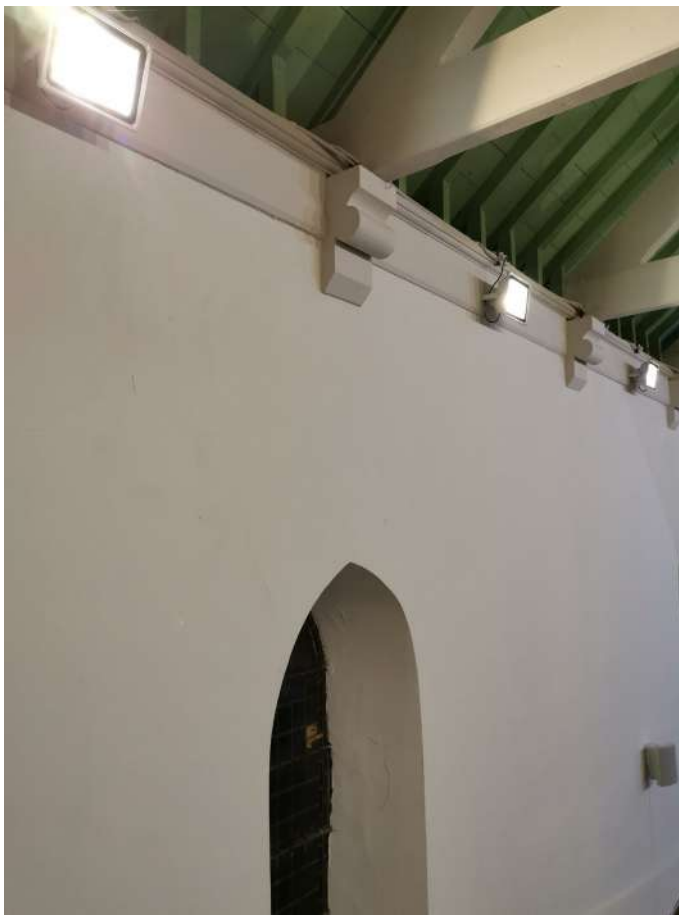
Full redecoration of plasterwork and timber roof structure

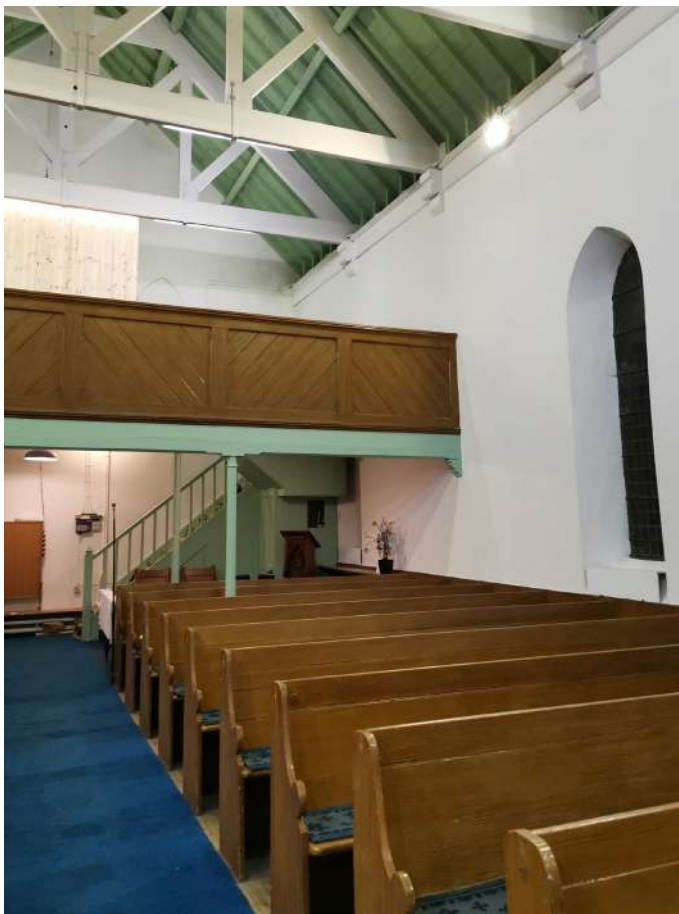
Good quality pews in good condition

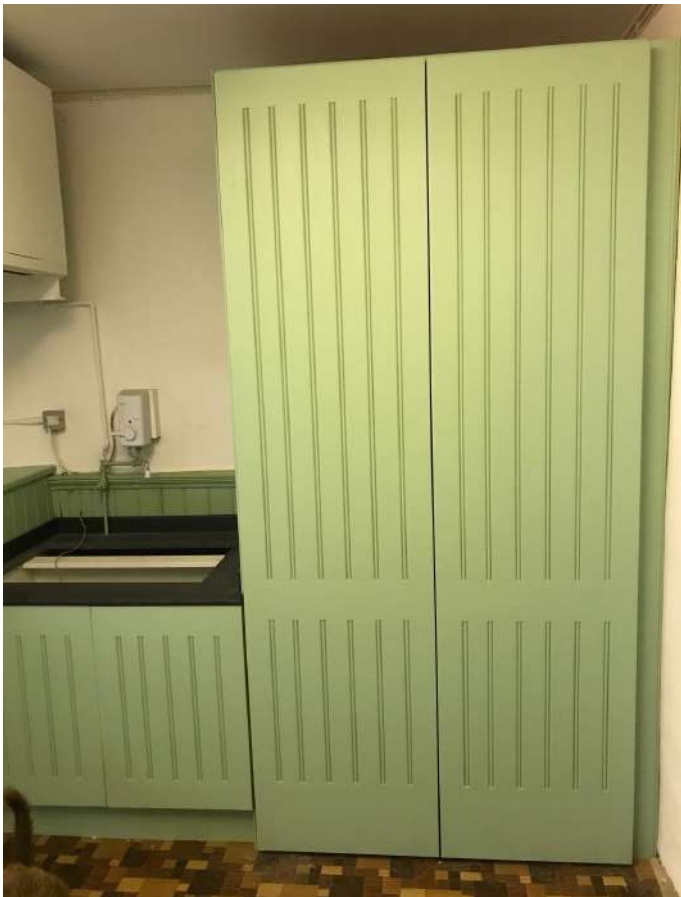
Units in refurbished vestry

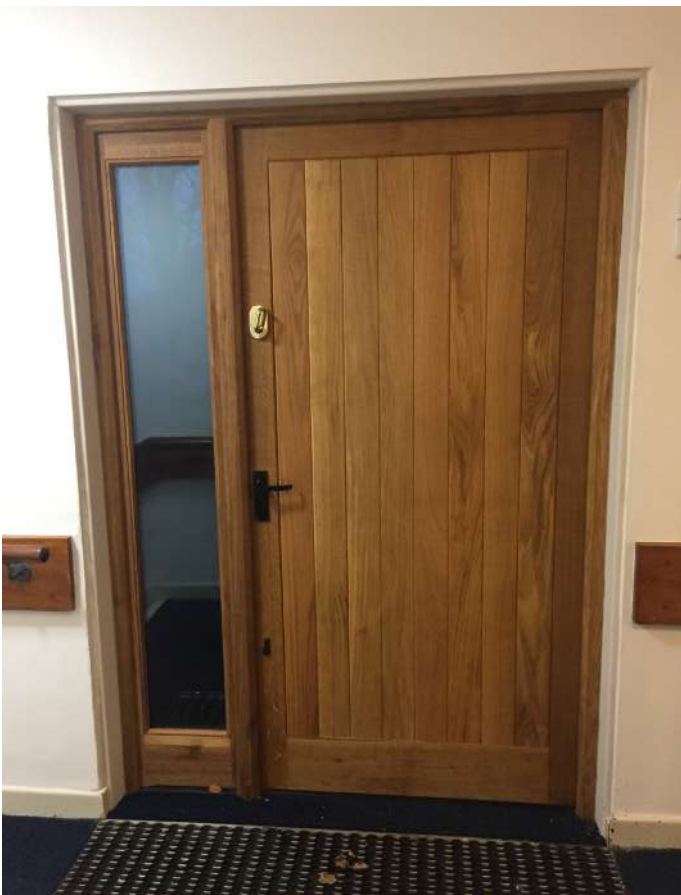
New oak external entrance into community hall

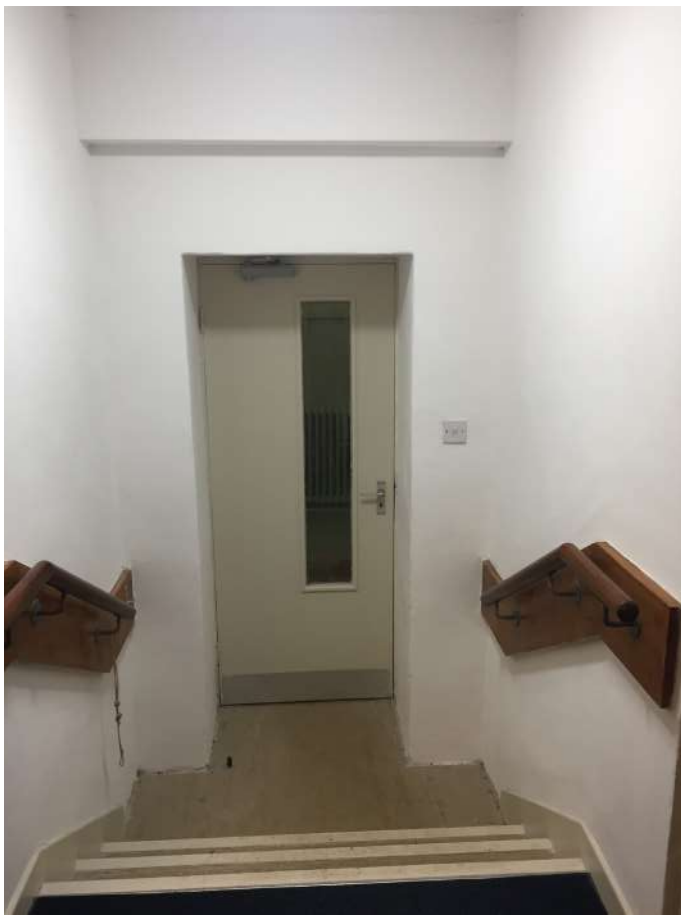
External wall to right hand side of link has been replastered in lime plaster to help deal with damp

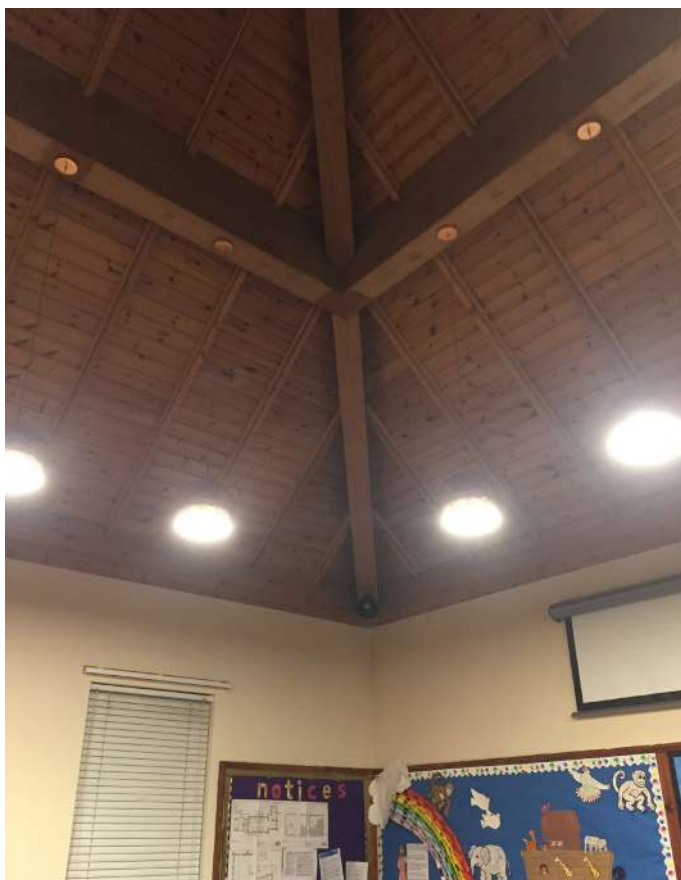
New pendant light fittings much more accessible

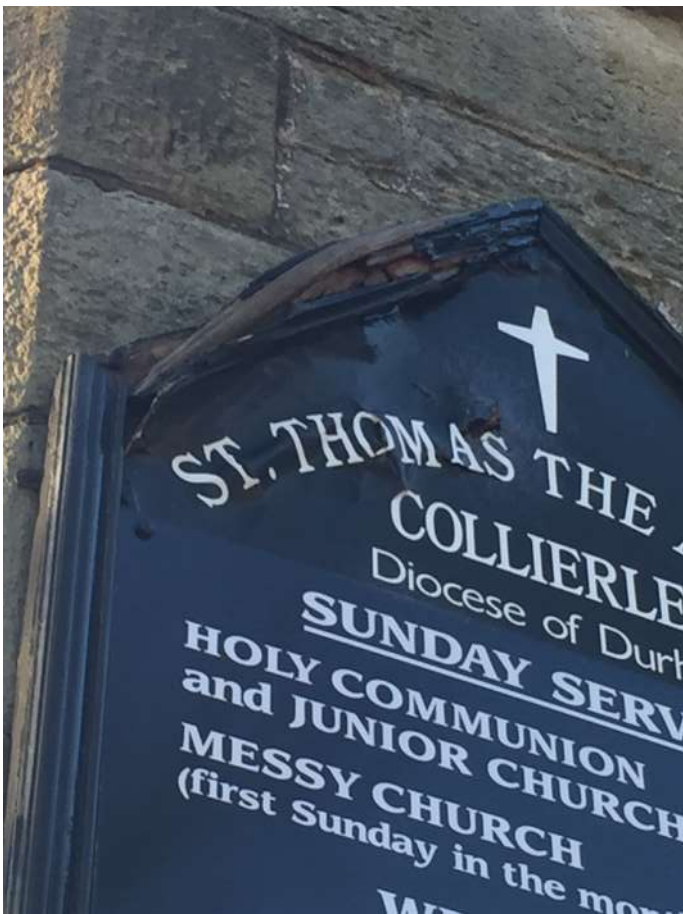
Damaged noticeboard, now required replacement, or repair
