**St Columba
Hartlepool**

Quinquennial Report
on the architect's inspection on

13th October 2023

Archdeaconry of Durham
Deanery of Hartlepool
An unlisted building | not in a conservation area

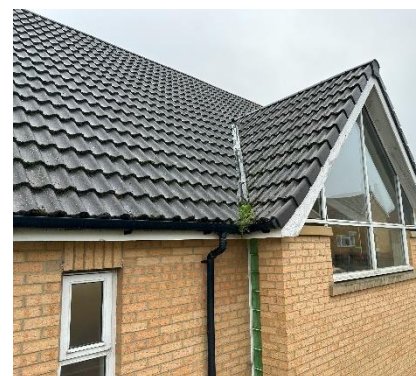
- 2.1 **West Hall:** Dry fix ridge tiles and twin roll concrete tiles. Dry verge system to all sides. The roof also has a projecting bay with a valley gutter, vegetation growing to the base. The lead to all valleys has been replaced with a plastic alternative following persistent lead theft.
- 2.2 **West Amenity Block:** has the same roof covering as the hall. In good condition apart from one cracked tile at the southern end. Open porch also looks in good condition.
- 2.3 **East Side Amenity Block:** is sound apart from at the Nave abutment the plastic flashing is turned up at one point. This also has replacement abutment flashing with non-matching mortar which gives a poor finish.
- 2.4 **East Hall:** has the same detail and matches the opposite side. Valleys are very mossy and would benefit from cleaning out to prevent further growth as seen on the west side.

Figure 1 – West Hall Valley

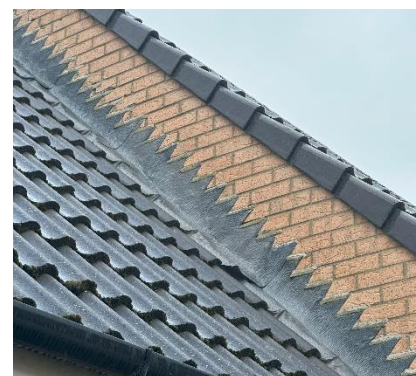
Figure 2 – East Abutment Flashing Lifting

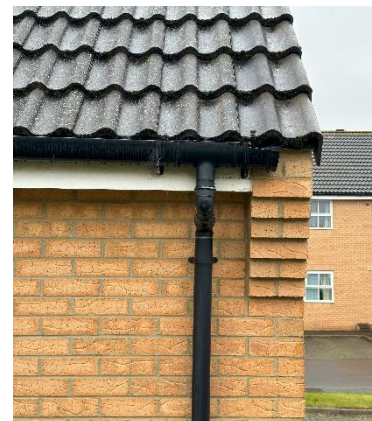
- i. Hall: Northern end – the gutter and downpipe is dropping at both ends and there is vegetation build up to the south, as per item 2.1.
- ii. Southern end – the gutter is full of moss and silt at the base of the valley.
- iii. Amenity Block: The end of the gutter to the south isn't correctly attached at the bracket. Both gulleys here are broken or have covers missing, it is reported this is due to vandalism.

Figure 3 – West side southern gutter clip

| Category | Description | Item ref | Budget Costs |
|--|--|---|---|
| 1 | Fix all gutters and brackets to ensure flow to outlets and clear all vegetation | 3.1, 3.2 | £0- £1,999 |

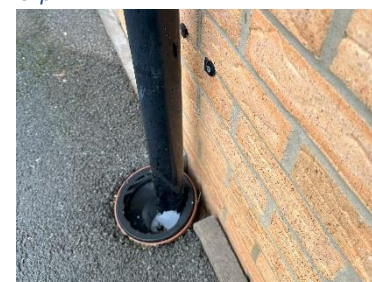
- i. Amenity Block: Plastic gutters and downpipes throughout the building. Downpipe at abutment to the hall has been poorly repaired with tape and should be fitted correctly to ensure no leaks.
- ii. The gulleys along this elevation don't appear to have their grids installed correctly as they are mostly loose.
- iii. Church Hall: Grass in the gutter above. The grid is loose in the gulley.

Figure 4 – West gulley

| Category | Description | Item ref | Budget Costs |
|--|--|---|---|
| 2 | Replace gulley covers | 3.2 | |

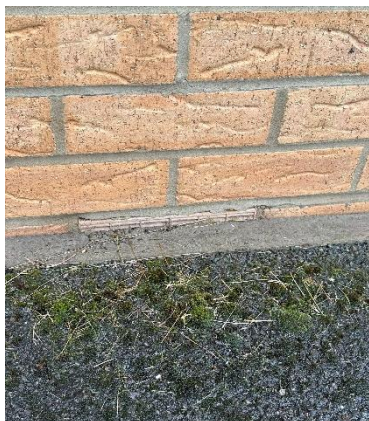
Figure 5 – Air Brick to South

4.3 SOUTH ELEVATION - All in good condition, though one plastic floor vent air brick is broken slightly. The same issue as the west persists with all air vents almost fully below ground level. There are some marks of paint on the walls.

| Category | Description | Item ref | Budget Costs |
|--|--|---|---|
| 2 | Ensure ground level at air bricks is 75mm below the base of the air vent. | 4.2- 4.4 | |

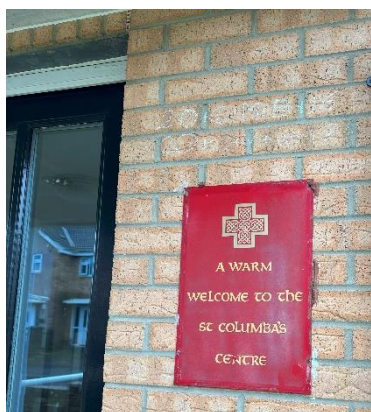
5.6 The sign next to the entrance door looks like it has been poorly silicone around and this has now partially worn away. The sign itself has faded slightly.

Figure 6 – Entrance Sign

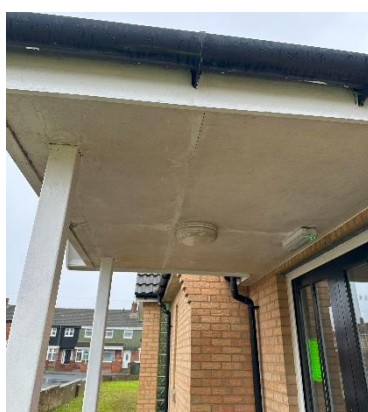
5.1 Decoration to all fascias and soffits is deteriorating. The front entrance apex has been recently painted but would benefit from another coat and the underside of the soffit decorating.

Figure 7 – Entrance Soffit

| Category | Description | Item ref | Budget Costs |
|--|--|---|---|
| 2 | Decorate underside of soffit | 5.1 | |

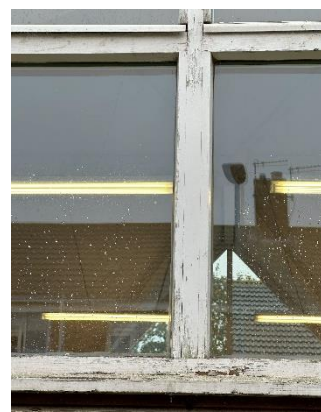
5.2 Large bay windows on the east and west elevations are in good condition apart from some bead shrinkage/ movement. The remainder of windows are small, double light units and these all require decoration.

5.3 All windows have had a series of breakages and repairs over time, as seen in the logbook, unfortunately this is often to the larger, triangular panes but the PCC are resistant of adding protection and I agree this would change the aesthetic and approachability of the building.

Figure 8 – Large Windows

| Category | Description | Item ref | Budget Costs |
|--|--|---|---|
| 2 | Re-decorate all windows and replace any beads that are too short. Redecorate fascias & soffits | 5.1, 5.2 | £0- £1,999 |

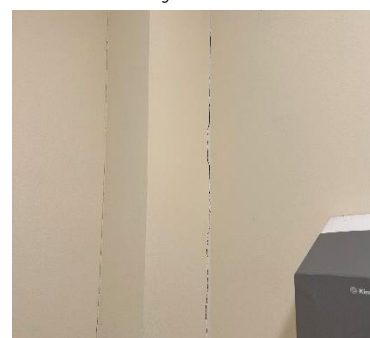
Figure 10 – Easing to SVP

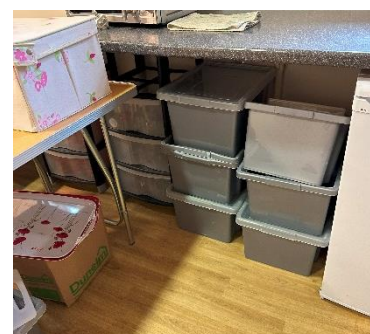
Figure 11 – Kitchen Storage

- 9.1 Plastered ceilings and walls in good condition. Solid floor with vinyl in wood effect. The room contains modest servery, sink and fridge, boxes below the counter for crockery. Additional storage may be useful here. The room also contains adjustable tables for separate worship.
- 9.2 To one side is a store cupboard which contains the boiler and cleaners sink. The boiler is a Vaillant Eco-Tech plus combination boiler and the room contains the timer and distribution board as well as the audio system. There is a range of mops and cleaning materials. Slight cracking showing in the corner against the hall, but this is only shrinkage. There is damaged decoration and plaster to the wall and ceiling, the PCC reported this was after a long period of the boiler being left on. This could have caused condensation build up as the room contains the sink,

| Category | Description | Item ref | Budget Costs |
|--|--|---|---|
| 5 | Consider storage to the kitchen | 9.1 | £0- £1,999 |

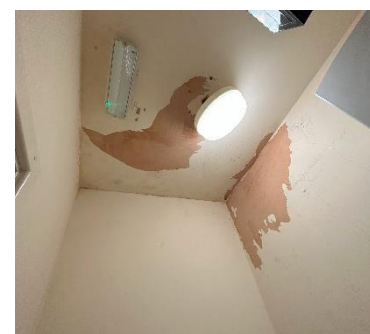
Figure 12 – Boiler Rm Damage

therefore an extractor fan or removal of the sink may need to be considered. Inspecting above this area shows no other obvious cause.

| Category | Description | Item ref | Budget Costs |
|--|--|---|---|
| 2 | Install extractor fan to boiler cupboard or remove sink if not used | 9.2 | |

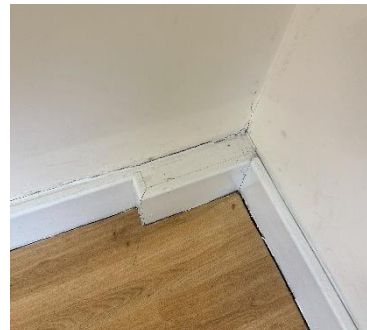
10.1 Exposed steel frame decorated with wind diagonals. Ceiling is plastered. Infill panels showing some shrinkage at the junctions of the steelwork and skirting boards, they only require decoration when it comes to redecorate. The walls are plastered and painted – in good condition.

Figure 13 – Hall shrinkage to walls

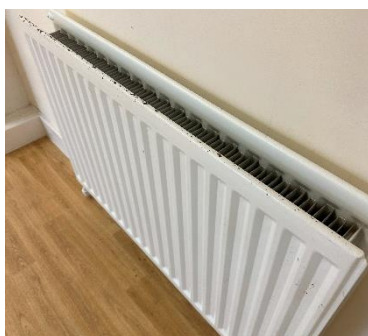
10.3 The radiators decoration is breaking down, this is unusual for radiators of this age and any warranties should be consulted, otherwise re-decorate.

Figure 14 – Radiator Rust

| Category | Description | Item ref | Budget Costs |
|--|--|---|---|
| 3 | Remove rust and decorate radiators | 10.3 | |

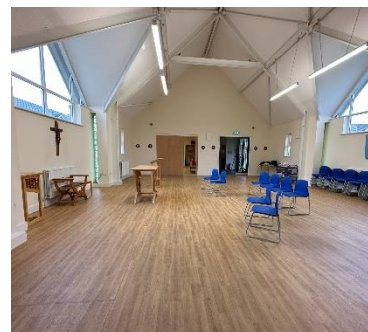
Figure 15 – Hall with Loose Furniture

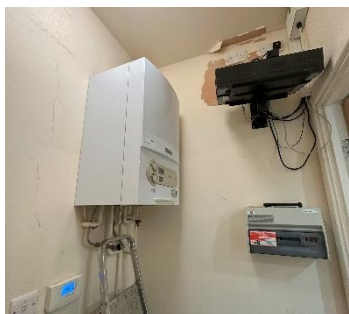
Figure 16 – Boiler and CU

18 HEATING by gas fired Vaillant Eco-Tech Plus combination boiler providing heating and hot water via plastic distribution pipes hidden within the walls. Two traditional steel panel radiators. Serviced in July 2023. Repairs were required to the top up mechanism and the boiler is reported to be at its capacity limit.

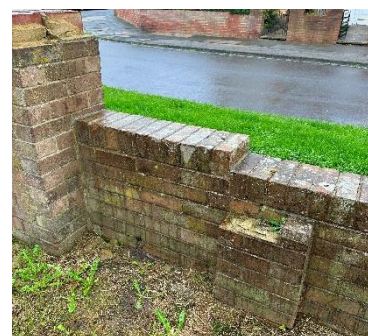
Figure 17 – Boundary Wall Pier

24.3 There is a low brick wall to the north and west elevations that is in ok condition, with a number of bricks missing from the piers, there are also open joints at the bottom of the wall on the west elevation.

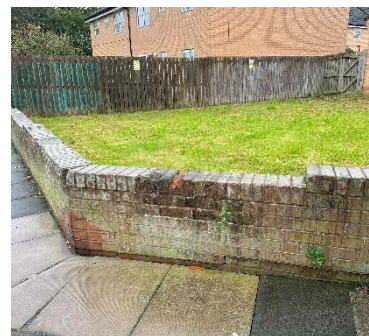
24.4 Some slight cracking to the wall at the Dryden Road sign. On the north side, there is also cracking and some slight horizontal movement on the corners, near the utility box. There is a timber fence to the northeast elevation which requires decoration and a gate in timber that is swollen into the frame, though this appears to be unused.

Figure 18 – Horizontal Movement

| Category | Description | Item ref | Budget Costs |
|--|--|---|---|
| 5 | Monitor boundary wall | 24.4 | |

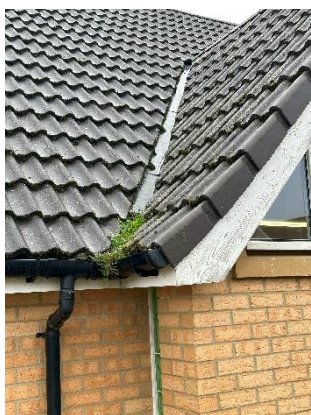
Figure 19- Gutters/ Valleys

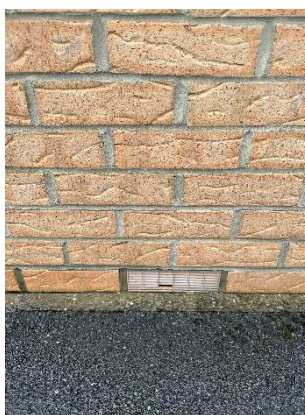
Figure 20 – Air Vents Below GL

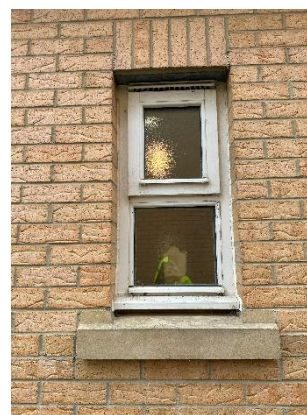
Figure 21 – Windows Require Decoration
