**Diocese of Durham**

**St Columba  
Hartlepool**

**Quinquennial Report**  
on the architect's inspection on

**13<sup>th</sup> October 2023**

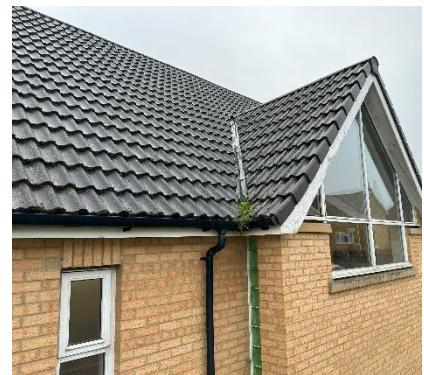
- 2.1 **West Hall:** Dry fix ridge tiles and twin roll concrete tiles. Dry verge system to all sides. The roof also has a projecting bay with a valley gutter, vegetation growing to the base. The lead to all valleys has been replaced with a plastic alternative following persistent lead theft.
- 2.2 **West Amenity Block:** has the same roof covering as the hall. In good condition apart from one cracked tile at the southern end. Open porch also looks in good condition.
- 2.3 **East Side Amenity Block:** is sound apart from at the Nave abutment the plastic flashing is turned up at one point. This also has replacement abutment flashing with non-matching mortar which gives a poor finish.
- 2.4 **East Hall:** has the same detail and matches the opposite side. Valleys are very mossy and would benefit from cleaning out to prevent further growth as seen on the west side.

*Figure 1 – West Hall Valley*

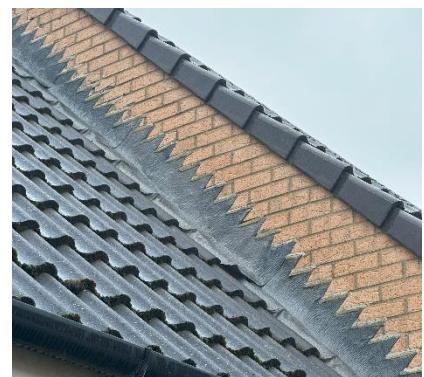
*Figure 2 – East Abutment Flashing Lifting*

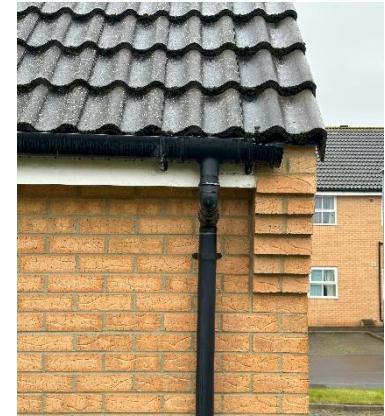
- 3.1 **West Elevation**
  - i. Hall: Northern end – the gutter and downpipe is dropping at both ends and there is vegetation build up to the south, as per item 2.1.
  - ii. Southern end – the gutter is full of moss and silt at the base of the valley.
  - iii. Amenity Block: The end of the gutter to the south isn't correctly attached at the bracket. Both gulleys here are broken or have covers missing, it is reported this is due to vandalism.

*Figure 3 – West side southern gutter clip*

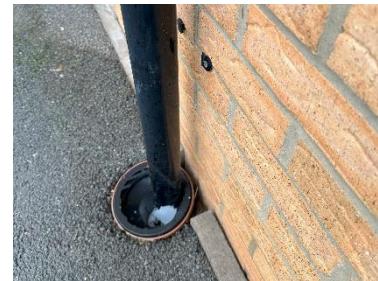
*Figure 4 – West gully*

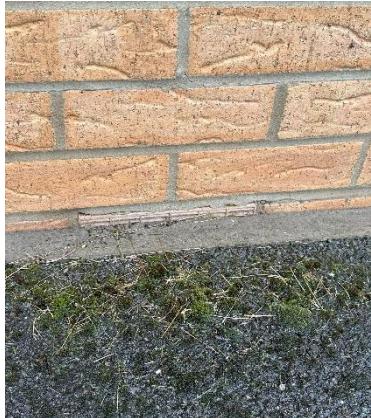
*Figure 5 – Air Brick to South*

4.3 SOUTH ELEVATION - All in good condition, though one plastic floor vent air brick is broken slightly. The same issue as the west persists with all air vents almost fully below ground level. There are some marks of paint on the walls.

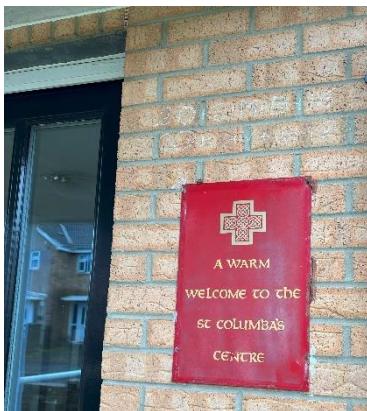
- 5.6 The sign next to the entrance door looks like it has been poorly silicone around and this has now partially worn away. The sign itself has faded slightly.

*Figure 6 – Entrance Sign*

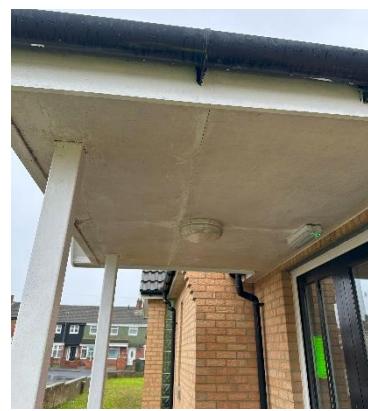
- 5.1 Decoration to all fascias and soffits is deteriorating. The front entrance apex has been recently painted but would benefit from another coat and the underside of the soffit decorating.

*Figure 7 – Entrance Soffit*

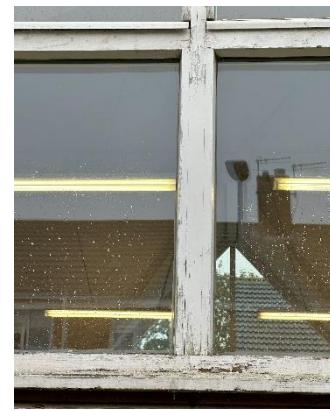
- 5.2 Large bay windows on the east and west elevations are in good condition apart from some bead shrinkage/ movement. The remainder of windows are small, double light units and these all require decoration.

*Figure 8 – Large Windows*

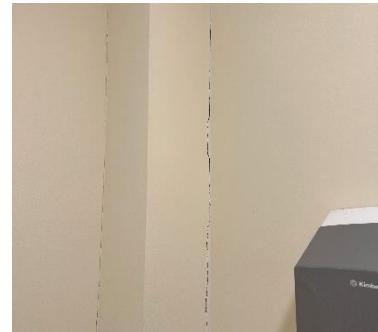
- 8.1 Plastered walls and ceiling and solid floor with safety vinyl. This is all okay. To the Baby change WC the grab rail to the sink is loose and there is one missing adjacent to the WC. Decoration breaking down on the radiator.
- 8.2 Both rooms have some easings to plaster finishes at the SVP boxing, which is usual to see in new builds with differential shrinkage of materials. This should be caulked and decorated when other areas of decoration are required.
- 8.3 Due to the loss of accessibility rails to the right-hand WC, these should either be replaced or could be fully removed and solely designated as a WC & Baby Change, with the necessary changing facilities provided. Whereas the left hand WC could become the assigned accessible WC.

*Figure 10 – Easing to SVP*

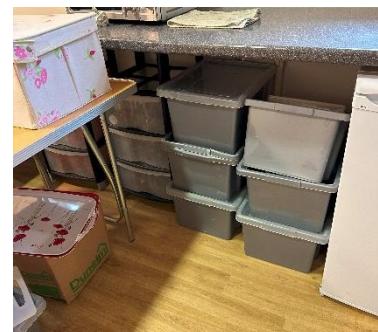
*Figure 11 – Kitchen Storage*

- 9.1 Plastered ceilings and walls in good condition. Solid floor with vinyl in wood effect. The room contains modest servery, sink and fridge, boxes below the counter for crockery. Additional storage may be useful here. The room also contains adjustable tables for separate worship.
- 9.2 To one side is a store cupboard which contains the boiler and cleaners sink. The boiler is a Vaillant Eco-Tech plus combination boiler and the room contains the timer and distribution board as well as the audio system. There is a range of mops and cleaning materials. Slight cracking showing in the corner against the hall, but this is only shrinkage. There is damaged decoration and plaster to the wall and ceiling, the PCC reported this was after a long period of the boiler being left on. This could have caused condensation build up as the room contains the sink,

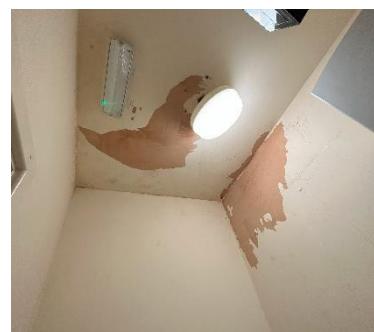
*Figure 12 – Boiler Rm Damage*

therefore an extractor fan or removal of the sink may need to be considered. Inspecting above this area shows no other obvious cause.

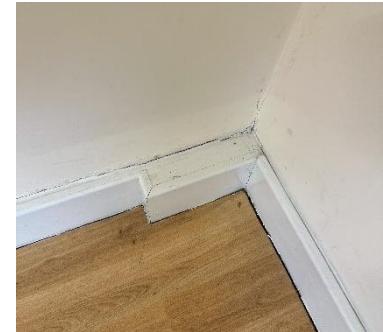
- 10.1 Exposed steel frame decorated with wind diagonals. Ceiling is plastered. Infill panels showing some shrinkage at the junctions of the steelwork and skirting boards, they only require decoration when it comes to redecorate. The walls are plastered and painted – in good condition.

*Figure 13 – Hall shrinkage to walls*

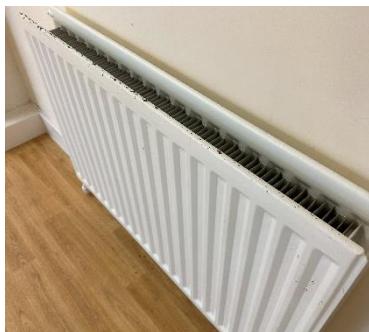
- 10.3 The radiators decoration is breaking down, this is unusual for radiators of this age and any warranties should be consulted, otherwise re-decorate.

*Figure 14 – Radiator Rust*

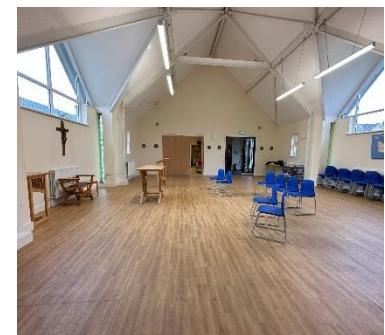
*Figure 15 – Hall with Loose Furniture*

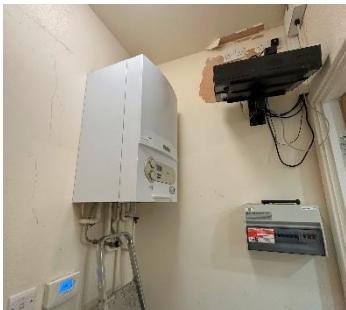
*Figure 16 – Boiler and CU*

**18 HEATING** by gas fired Vaillant Eco-Tech Plus combination boiler providing heating and hot water via plastic distribution pipes hidden within the walls. Two traditional steel panel radiators. Serviced in July 2023. Repairs were required to the top up mechanism and the boiler is reported to be at its capacity limit.

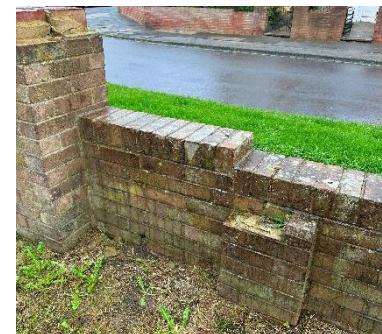
*Figure 17 – Boundary Wall Pier*

- 24.3 There is a low brick wall to the north and west elevations that is in ok condition, with a number of bricks missing from the piers, there are also open joints at the bottom of the wall on the west elevation.
- 24.4 Some slight cracking to the wall at the Dryden Road sign. On the north side, there is also cracking and some slight horizontal movement on the corners, near the utility box. There is a timber fence to the northeast elevation which requires decoration and a gate in timber that is swollen into the frame, though this appears to be unused.

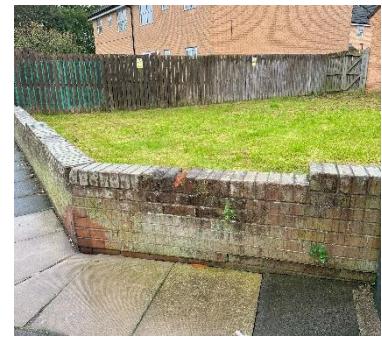
*Figure 18 – Horizontal Movement*

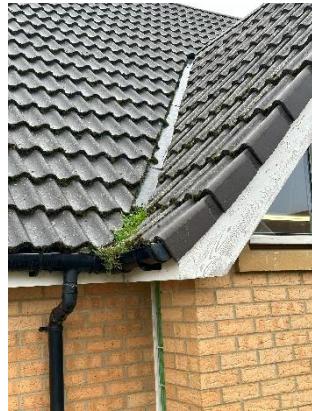
*Figure 19- Gutters/ Valleys*

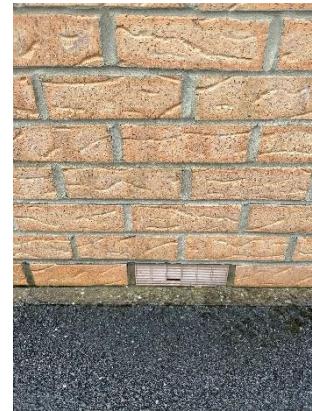
*Figure 20 – Air Vents Below GL*

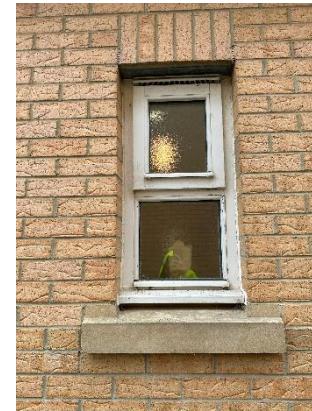
*Figure 21 – Windows Require Decoration*
