**QUINQUENNIAL INSPECTION REPORT  
OF  
HARTLEPOOL, ST. LUKE**

**DIOCESE OF DURHAM  
ARCHDEACONRY OF DURHAM  
DEANERY OF HARTLEPOOL**

**2017 QUINQUENNIAL INSPECTION AND REPORT  
November 2017**

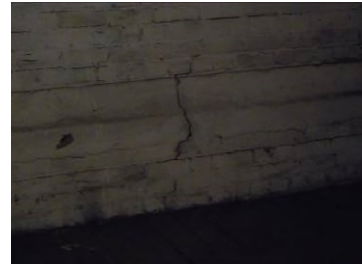
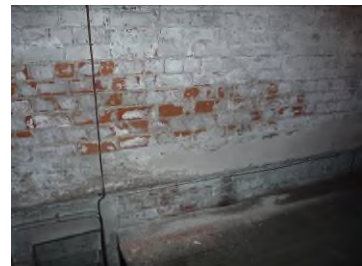
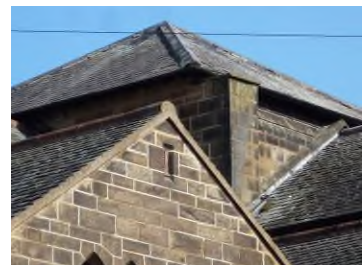
- Ceiling – boarding to pyramidal roof, daylight showing at the eaves but that is providing ventilation, there doesn't appear to be any water penetration of the hips and boarding, it has a large central truss and that seems to be in good condition.
- Walls –
  - North, OK.
  - East, this has a crack to the ring beam approximately 4mm doesn't look to have changed since the last inspection.
  - South, hairline crack approximately 1mm this looks old as well.
  - West, 4-5mm crack. No change.

Interestingly the widest cracks appear underneath the loading of the truss.

**Recommendation:** repoint hips

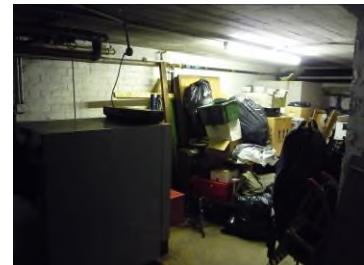
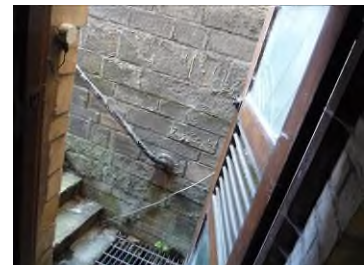
**Boiler Room:**

Ceiling – Shuttered precast concrete slab, crack in the middle of the wall but just hairline, the adjoining side room ceiling looks fine.

Floor – Screed concrete floor, some shrinkage cracking but appears sound.

The door hinges are rusting and its Georgian wired glass is broken in the top panel. The bottom rail is rotting away slightly as is the frame.

The stairwell has a sump at the bottom which isn't draining away and has a loose mesh grating sat on bricks the steps and surrounding wall are ok. The handrail could do with painting. The door is jammed into the frame when shutting. The top of the stairs has a simple timber fencing surround and this is easily climbed and does allow for some mischief perhaps. The timber could do with some redecorating.

**Recommendation:** remove lumber, update door, unblock gully, paint handrail, consider security, redecorate panelling

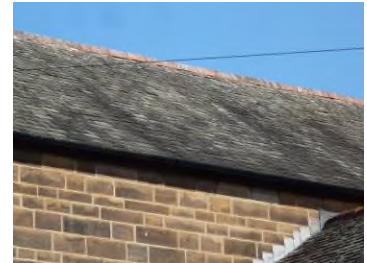
- Ridge – Open joints to the bedding and junctions.
- West abutment – Pointed verge, some slight cracking and mortar missing.
- East abutment – Lead flashing against the tower looks fine.

- Ridge – Same condition as south.
- West abutment – Lead flashing, view partially obscured.
- East abutment – Pointed verge same as south.
- General – West Moreland slating, seems to be in fair condition.

**Recommendation:** repoint ridge bedding but save up for when other works are required

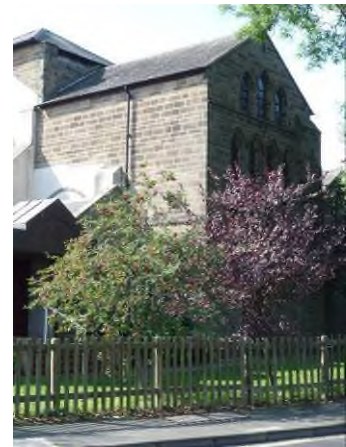
**M North Transept:**

- Ridge – Some bedding missing.
- West Abutment – Is a pointed verge and despite some cracking, appears ok.

- Ridge – Open joints to bedding.
- West Abutment – Lead work well covered by a stonework moulding. There is a slight box gutter formed where the buttress of the tower comes up and there looks to be grass growing in it.
- North Abutment – Is a verge and a piece of pointing appears to be about to drop out.
- The iron crosses to both transepts are rusting heavily.

**Recommendation:** repoint ridge bedding but save up for when other works are required, remove grass to gutter, refix verge pointing

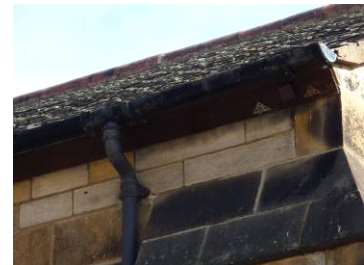
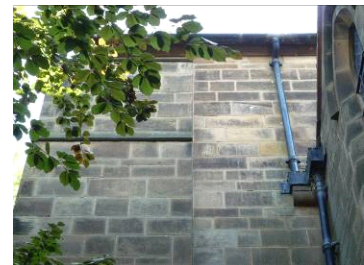
**B** Half round cast iron downpipes generally to the building and these are supported by gutter brackets onto timber fascias (mostly) or exposed rafter feet (tower). The timber fascia and exposed rafter feet require decoration.

The downpipes are cast iron with collars and they discharge down to gulleys and at the parish hall lobby entrance area these are overgrown with planting.

**North End** – Down pipe between to the two aisles slightly loose at the base and reported to be blocked.

**West End** – Two large downpipes coming down the west end generally ok apart from the southern one which is cracked at the foot.

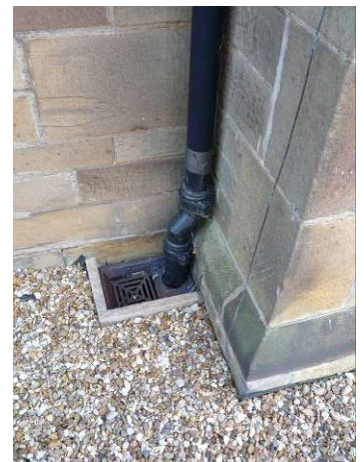
**South Porch** – The downpipe is rusting and loose and the back of the gutter is rusting heavily.

**South Side** – The middle of the aisle downpipe is missing its bottom collar.

**Recommendation:** carry out round of repairs, clean out gullies, investigate downpipe on south side east end for blockage/leaking (it's staining stonework)

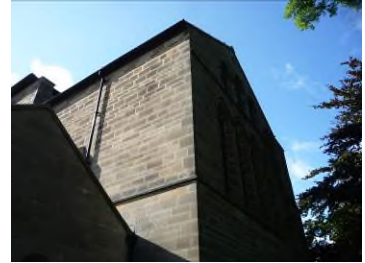
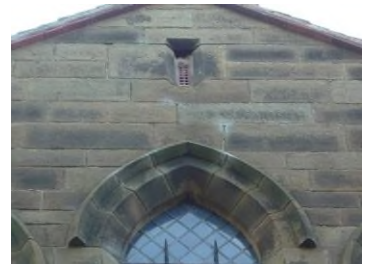
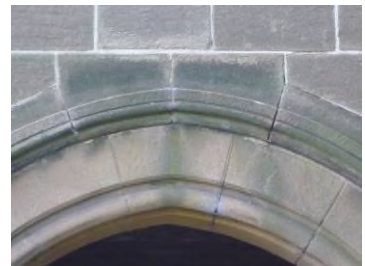
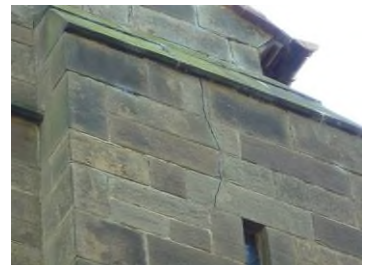
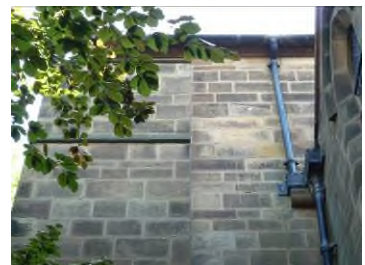
Open joints to the kneeler stones and slight crack to the stone close to the stair tower. Three individual single lancet windows slight open joints to the central hood mould running up just beyond the air brick.

Slight fracture to the stonework of the western most lancet at the springing point.

**Recommendation:** monitor cracking

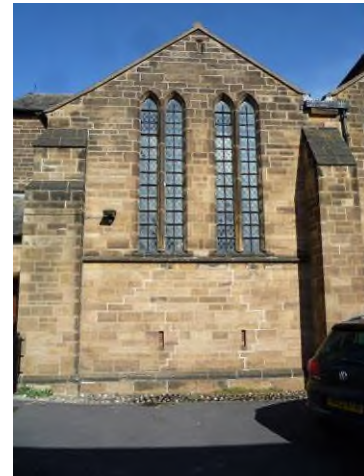
Clear glazed windows with a diamond leaded pattern covered with a metal ferramenta that is rusting in places and spoiling the decoration and these need decorating.

There are certain areas where the ferramenta is breaking the stonework where it joints into the mullions particularly and there have been the occasional patch repairs and the church will have to constantly face this issue. It particularly effects the south aisles. There is rust staining showing on the stonework.

**Recommendation:** repair window stonework and rusting ferramenta

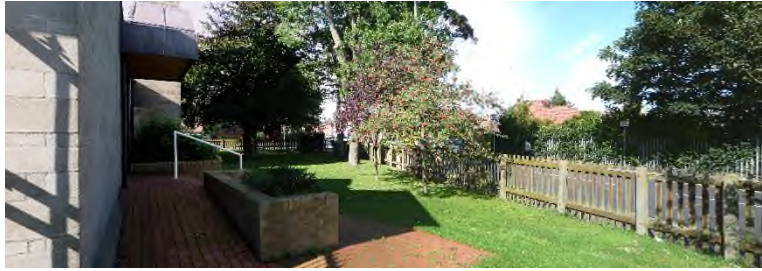
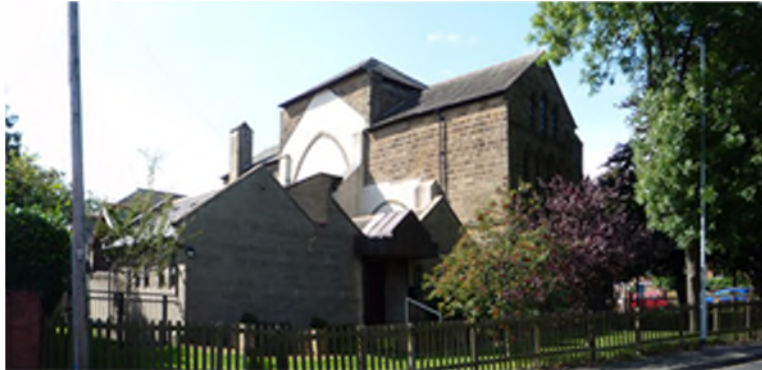
**D North side:**

Six major trees, one recommended for removal and two to be pruned as recommended by the engineer. All covered by Tree Preservation Orders.

Timber fence around the land that looks to need decoration soon. Grassed area mostly, small Yew tree. Ramped path in concrete paving slabs leads to the Parish Centre entrance and there is good hand railing around.

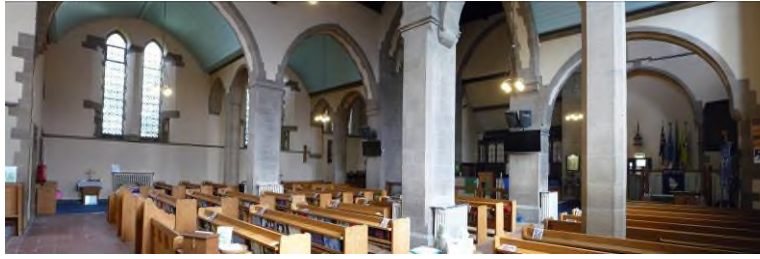
- **Nave:**

- Ceiling – Two decorative trusses with 2 stage purlins with diagonal supports onto large section rafters with boarding above in natural finish.
- Walls –
  - North, this is a pair of arcade arches with approximately 2mm crack to the keystone at the western arch. These eastern arch appears ok. The pier between the two arcades is ok.
  - East, this is the chancel arch, there is slight hairline cracking above the arch in the plaster of approximately 2mm and this doesn't appear to be any different from the last QI.
  - South, this is a repeat of the North arcade.

The Eastern arcade is ok, however the western arcade at the keystone has a 2-3mm crack running all the way up to the wall plate.

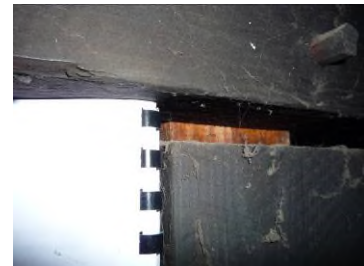
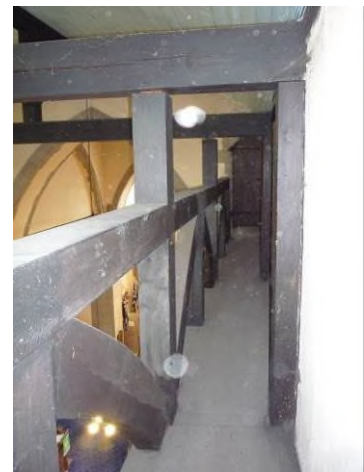
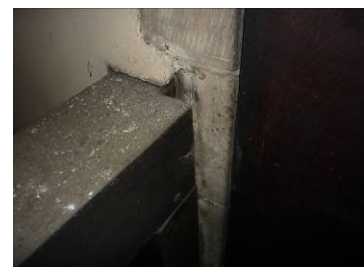
**A**      **Gallery:**

The gallery is suspended from the truss and it has dropped, the dowels have broken in them and they have moved since the last inspection. Number 1 is 15mm and number 2 is approximately 25mm, it creaks slightly, it looks also to have pulled out of the wall by approximately 10mm so this needs the engineer to look at it.

**Recommendation:** arrange for engineer review, carry out engineer recommendations. Ban access until repaired.

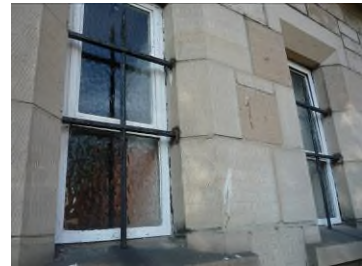
**D Walls:**

The walls to the 1960's extension are all in good condition, though it has seen some poor cement repoint. There are metal casement windows in obscure glass with ferramenta which is beginning to rust. The eastern side has had graffiti in the past that has not been fully removed, there is some stone erosion below the plinth.

**Recommendation:** remove rust and decorate the ferramenta
