CHURCH OF ST. OSWALD, HARTLEPOOL

Diocese of Durham

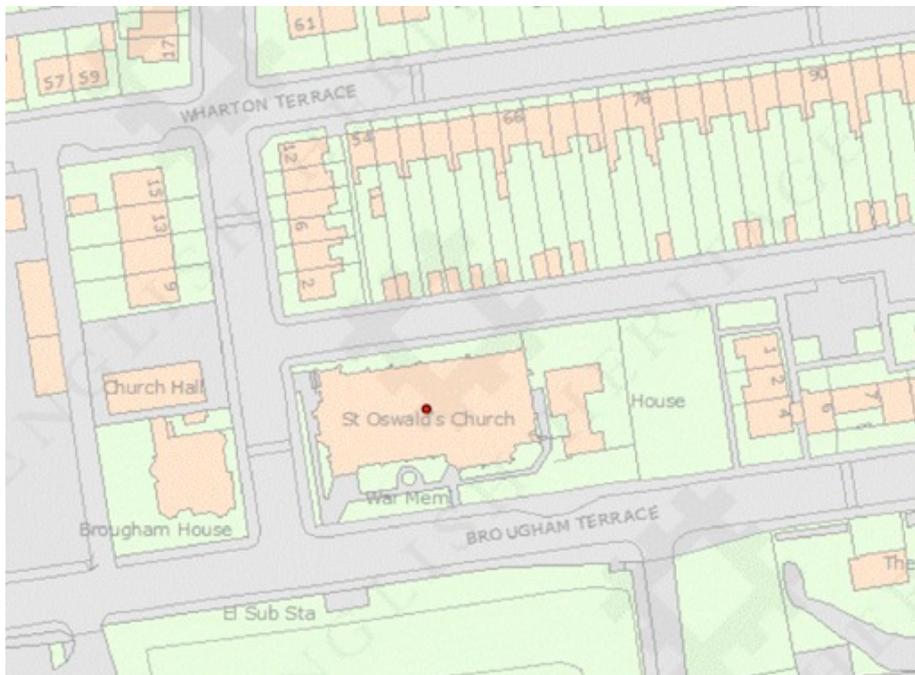
Location plan – not to scale

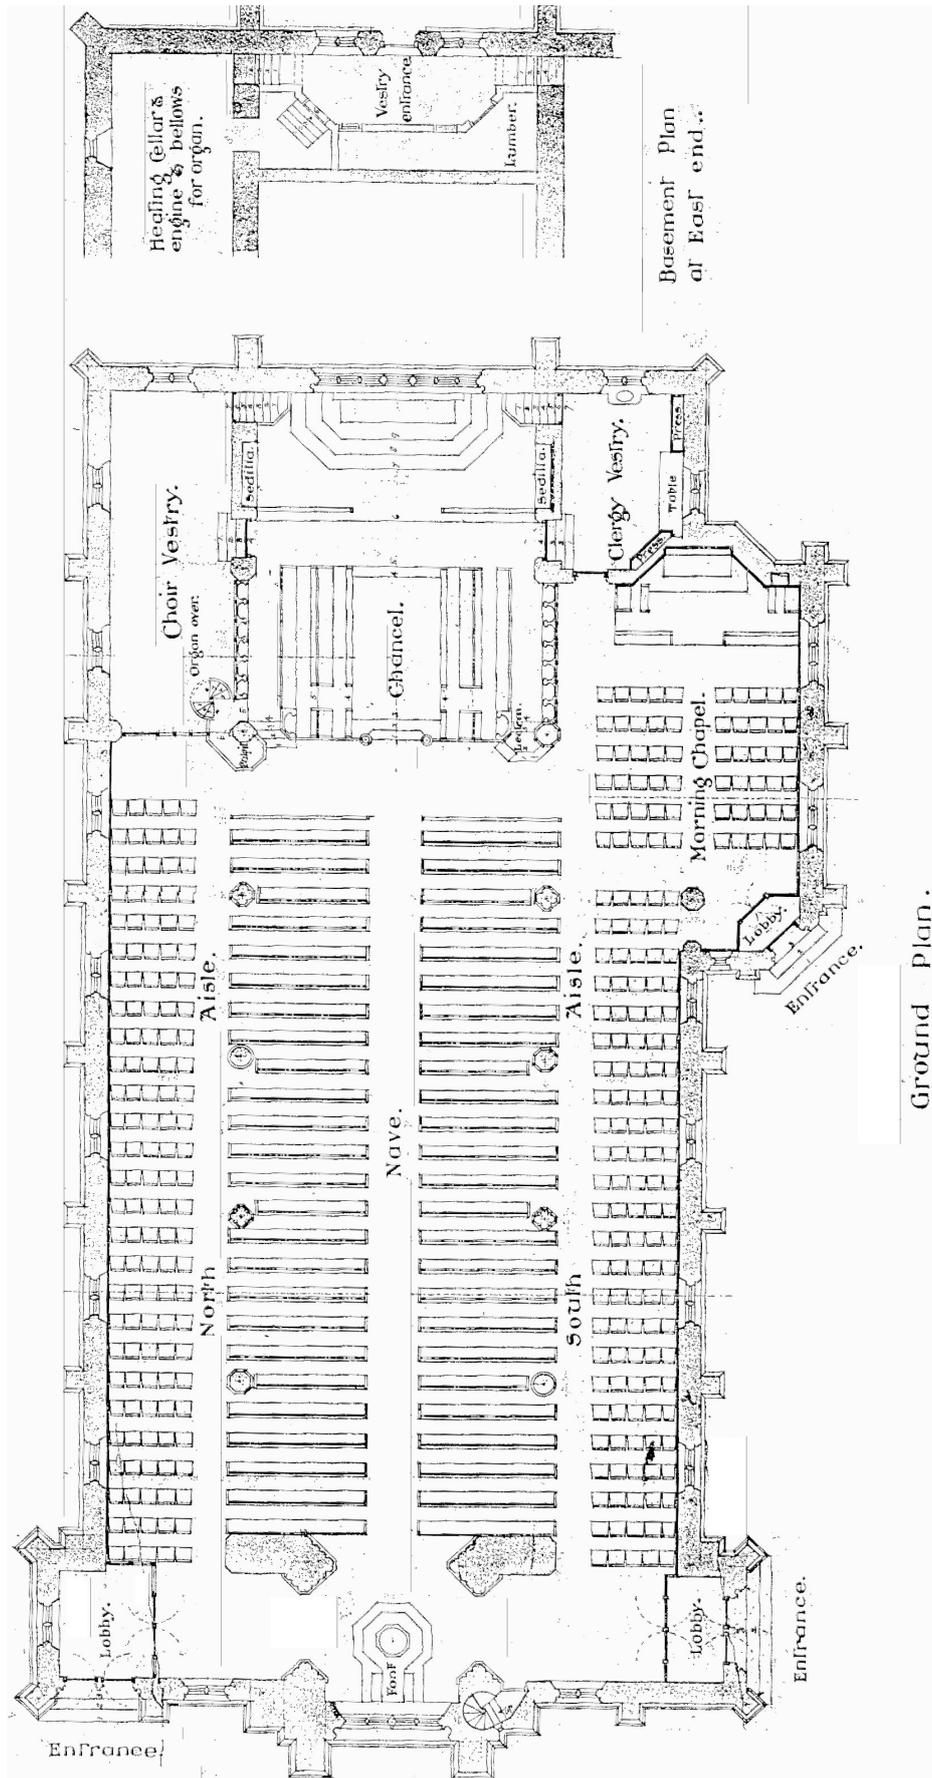
Appendix 2. Selected Photographs of a number of the Principal Defects and Items to Note

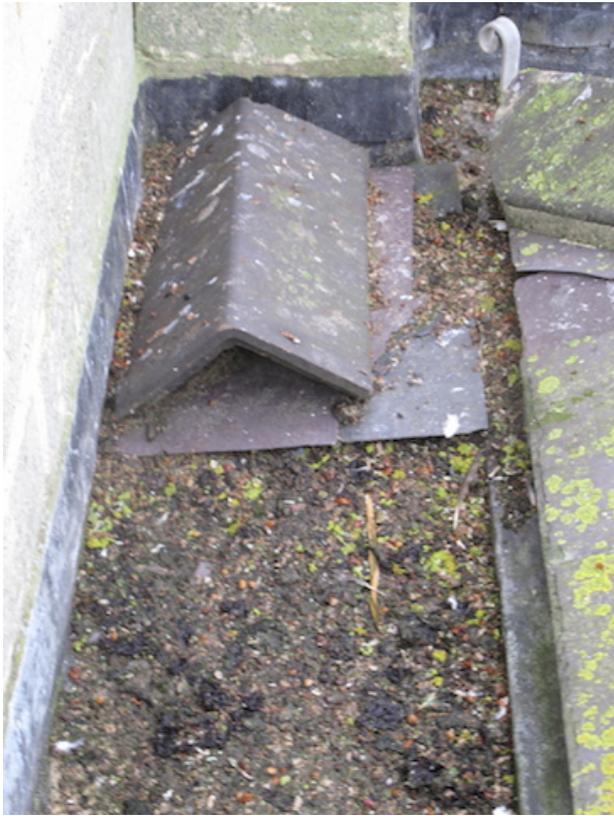
01 Tower Roof gutter south side

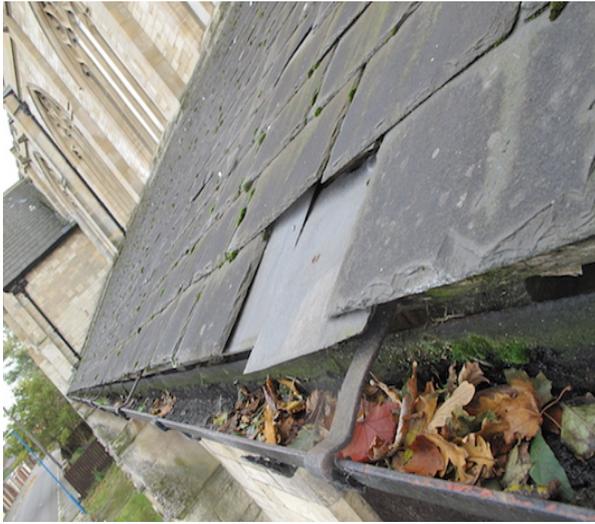
05 South Aisle roof – full gutter and missing slate

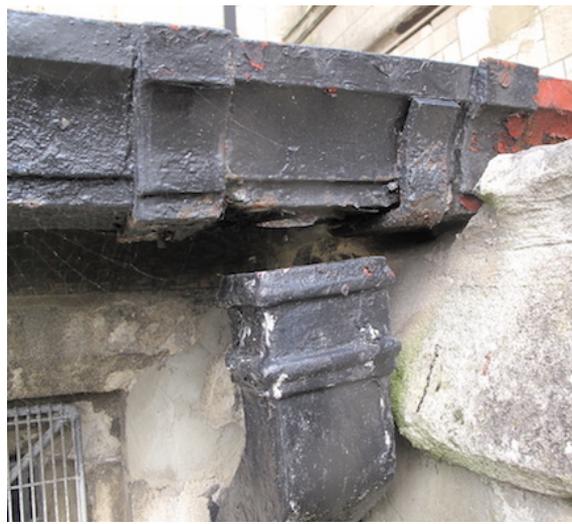
06 South Aisle roof - missing spigot at east end of gutter

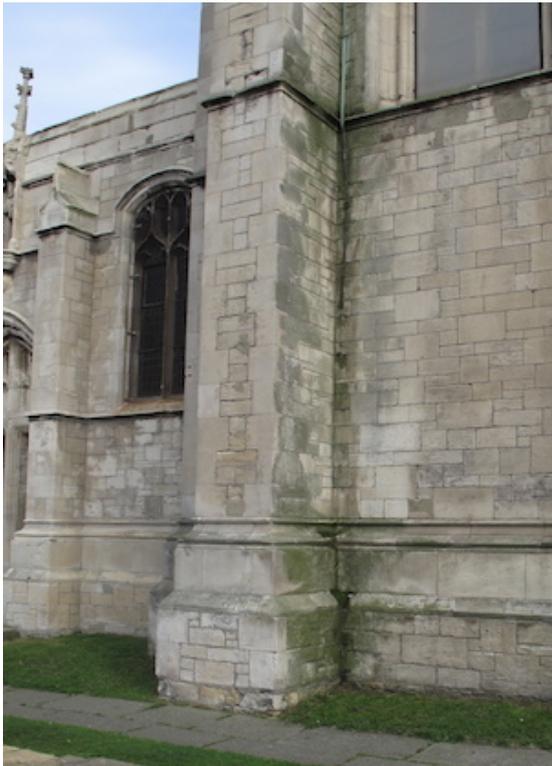
07 West side of Tower – missing lightning conductor tape

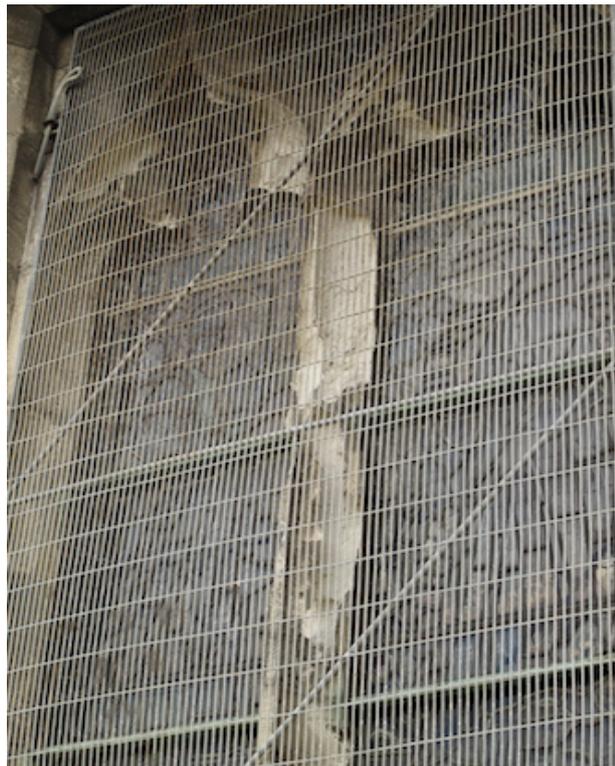
08 Clergy Vestry window – stonework erosion

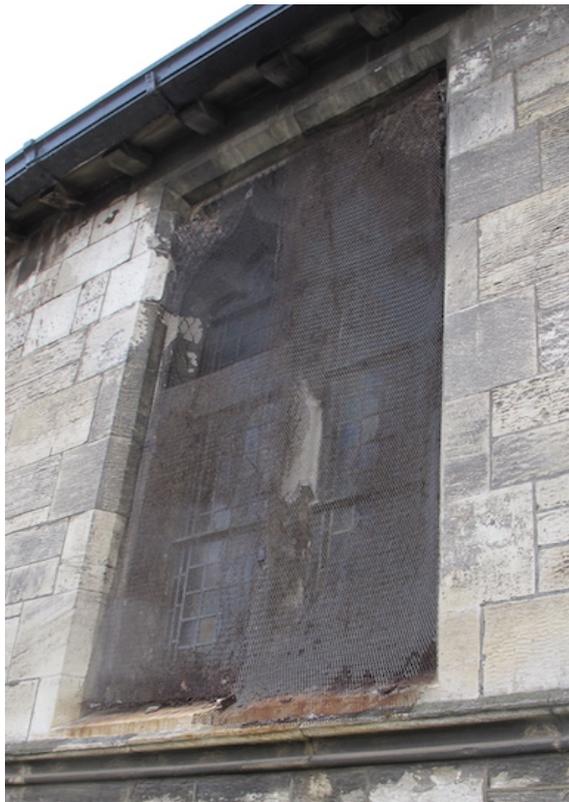
09 North Aisle – rusty and badly fitting window guard

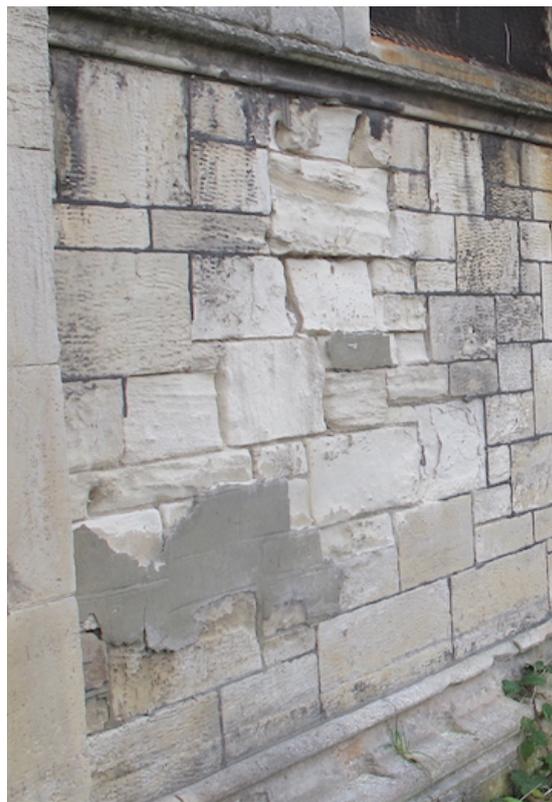
10 North Aisle – badly eroded stone at east end

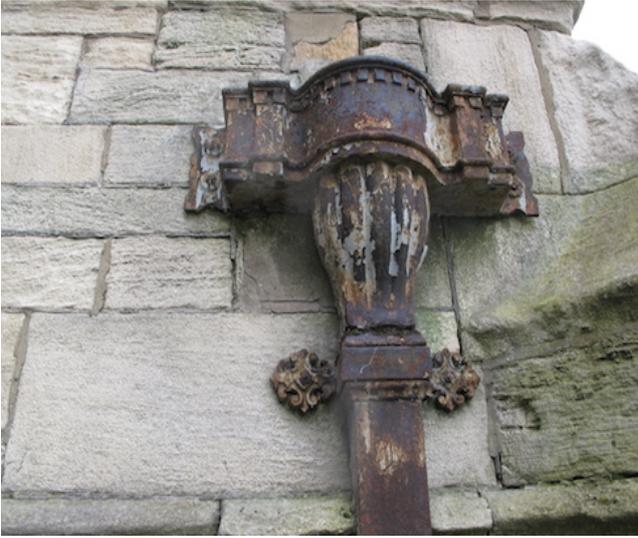
13 North Porch – rusty east gutter rainwater hopper and downpipe

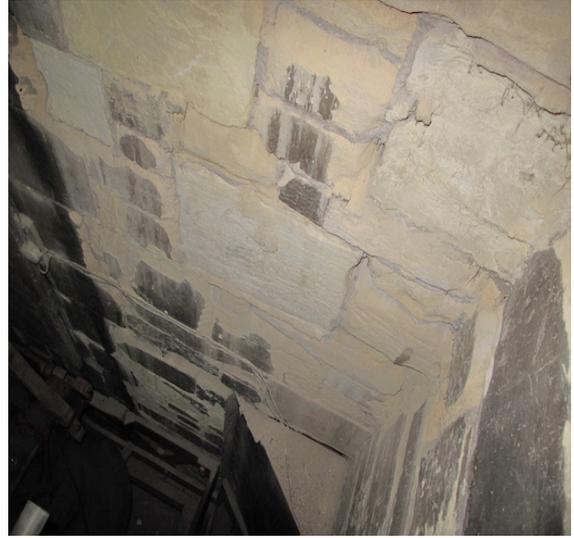
14 Belfry north west corner – deeply eroded stonework

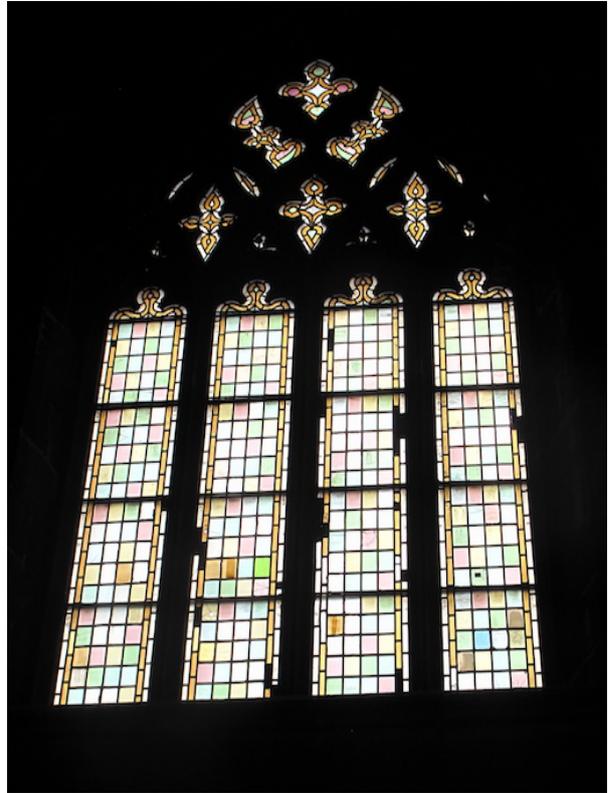
18 Nave clerestory glazing – typical condition

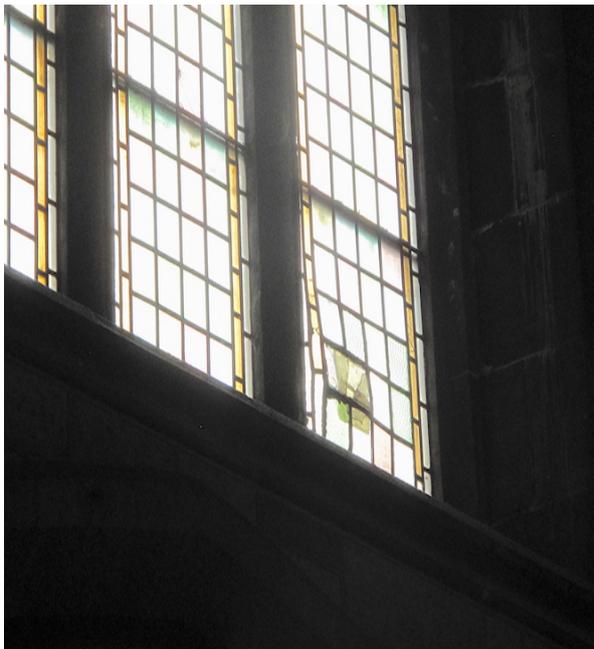
19 Nave west window – lower panel buckled at sill level

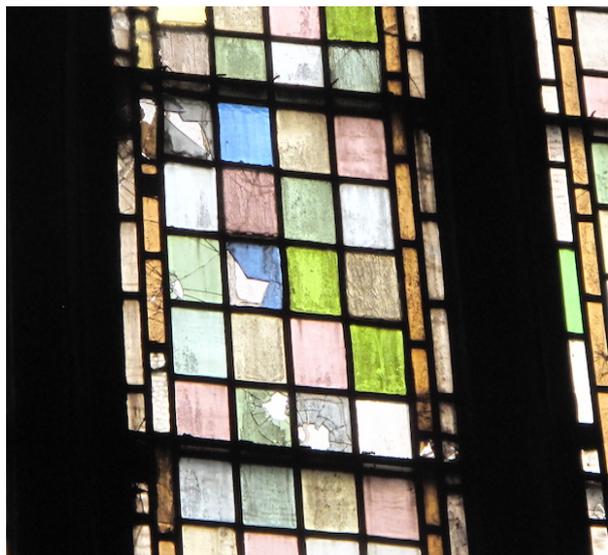
20 Chancel clerestory glazing – typical condition
