QUINQUENNIAL INSPECTION REPORT

CHURCH OF St. PAUL

CHURCH STREET, HASWELL, CO. DURHAM, DH6 2DT

Michael Atkinson Architecture + Heritage

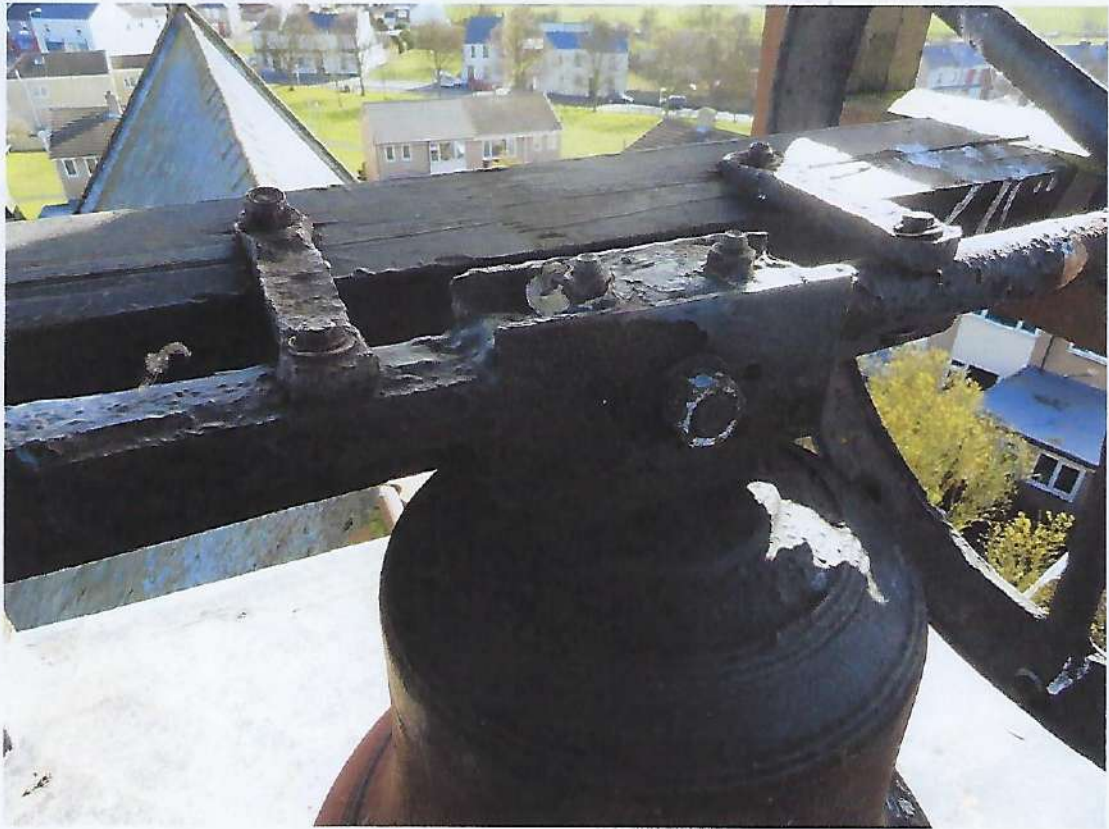
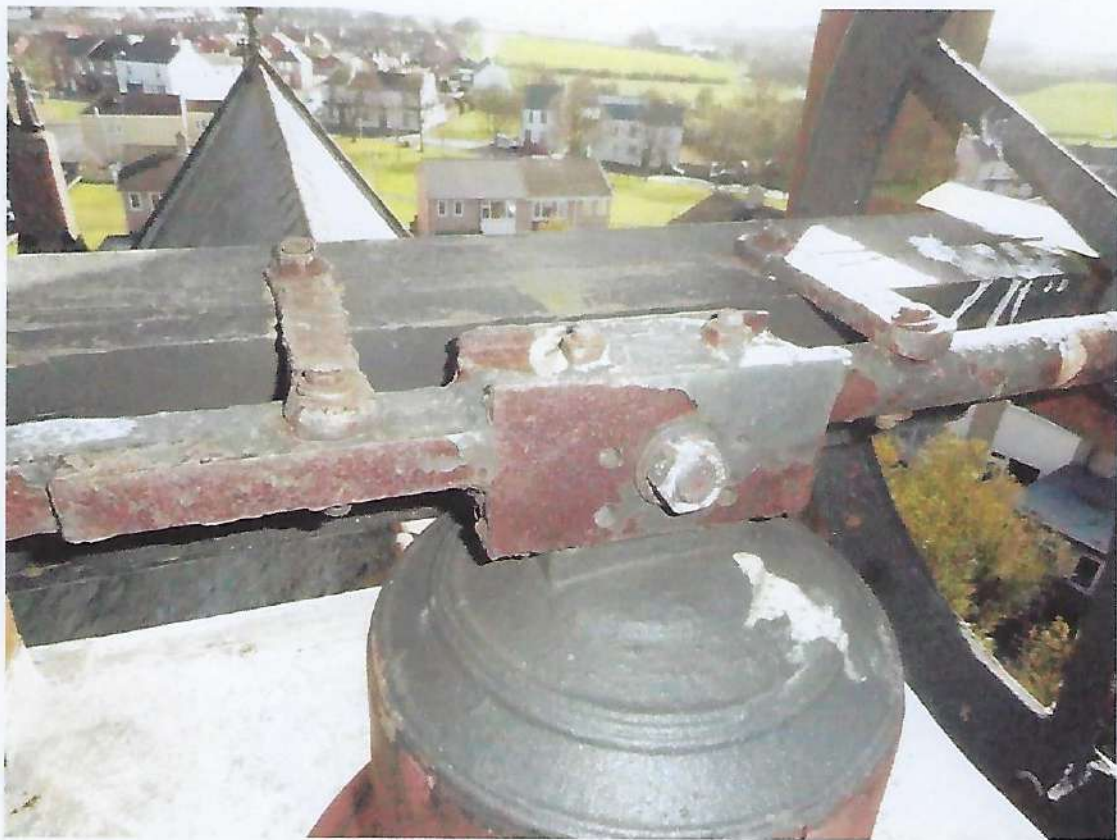
- The headstock and wheel is rusted and in need of painting. The surrounding timberwork needs wood preservative.
- The metal bell rope is rusted and is catching on the lead stay making it difficult to ring. The bell wheel needs a clamp fitting to prevent the bell rope from dislodging itself.
- The clapper to the bell has had a crude historic repair carried out, which causes the clapper to hang to one side on a rusted bit of steel. It is unbalanced which contributes to difficulty in ringing.
- The steel bolts to the timber bell weight are rusted, insubstantial for their use.

Examples of Headstock and timber bell weight.

R1	It is recommended to carry out the above-mentioned repairs to the bell and bell frame by a competent and experienced steeplejack.
-----------	---

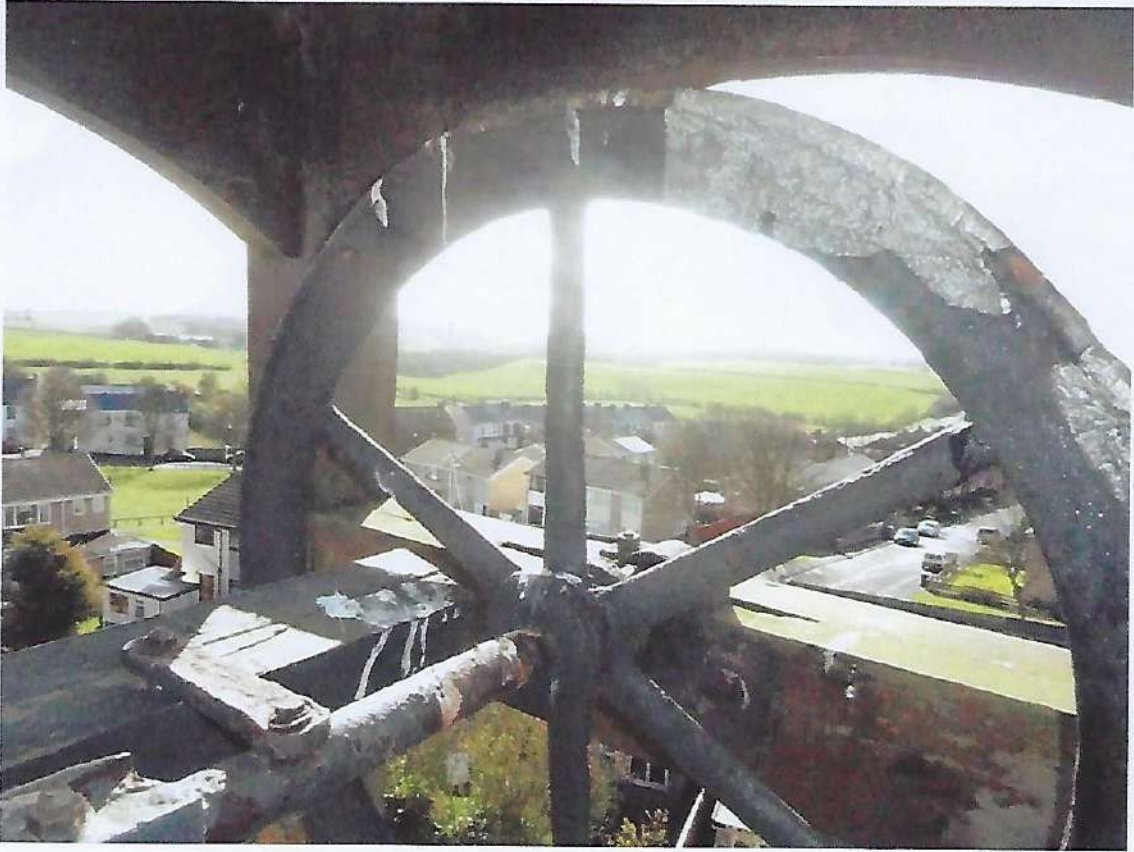
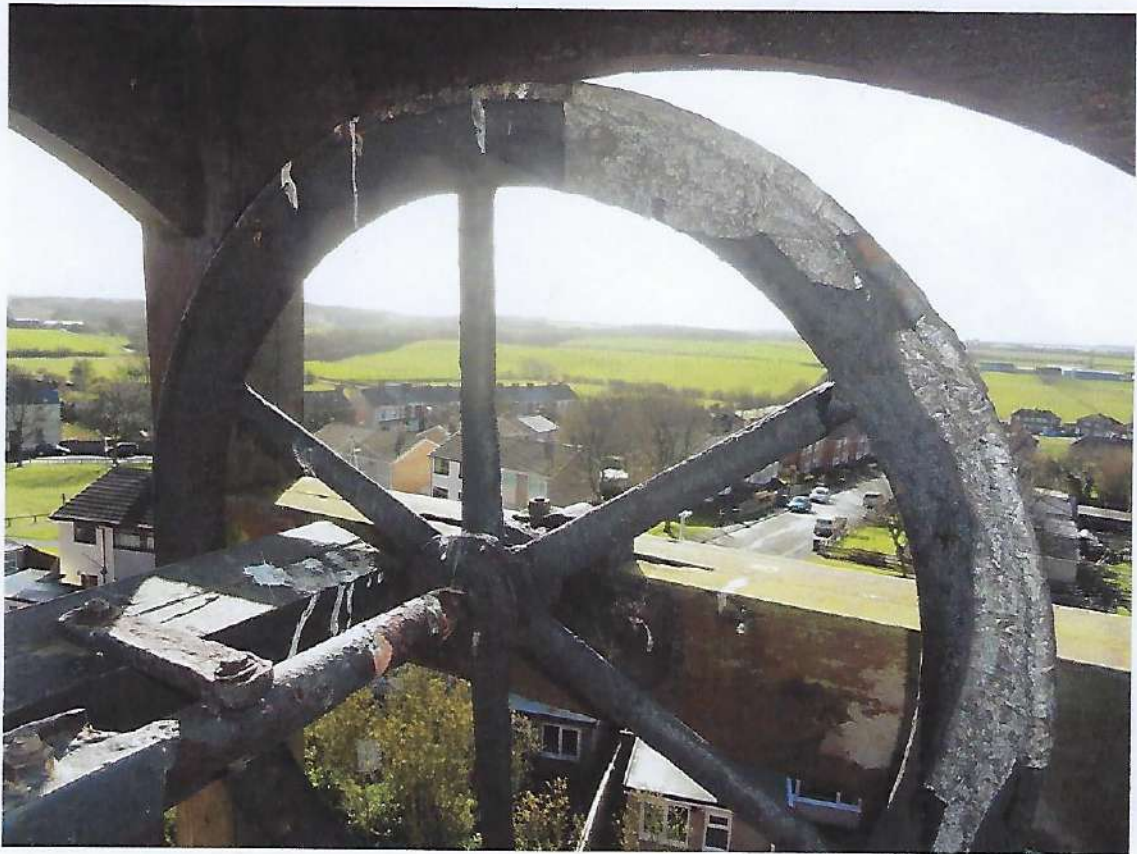
Examples of bell wheel.

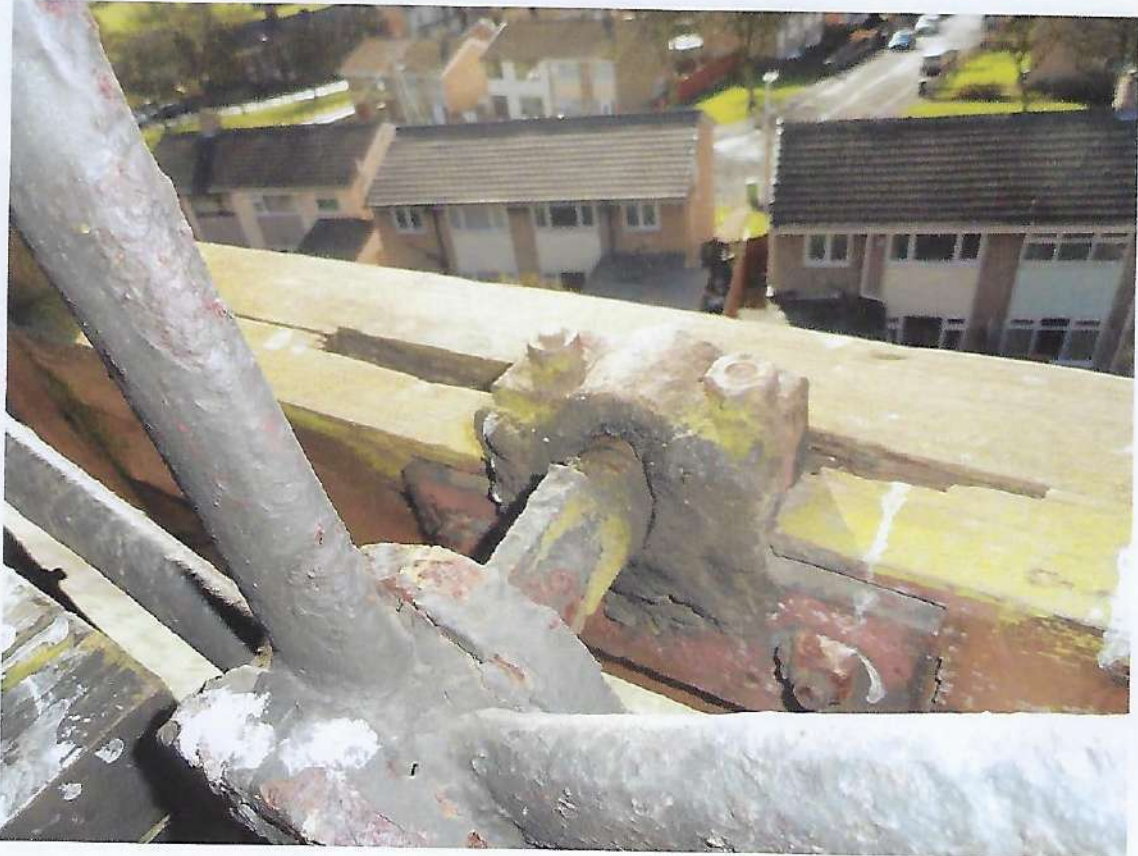
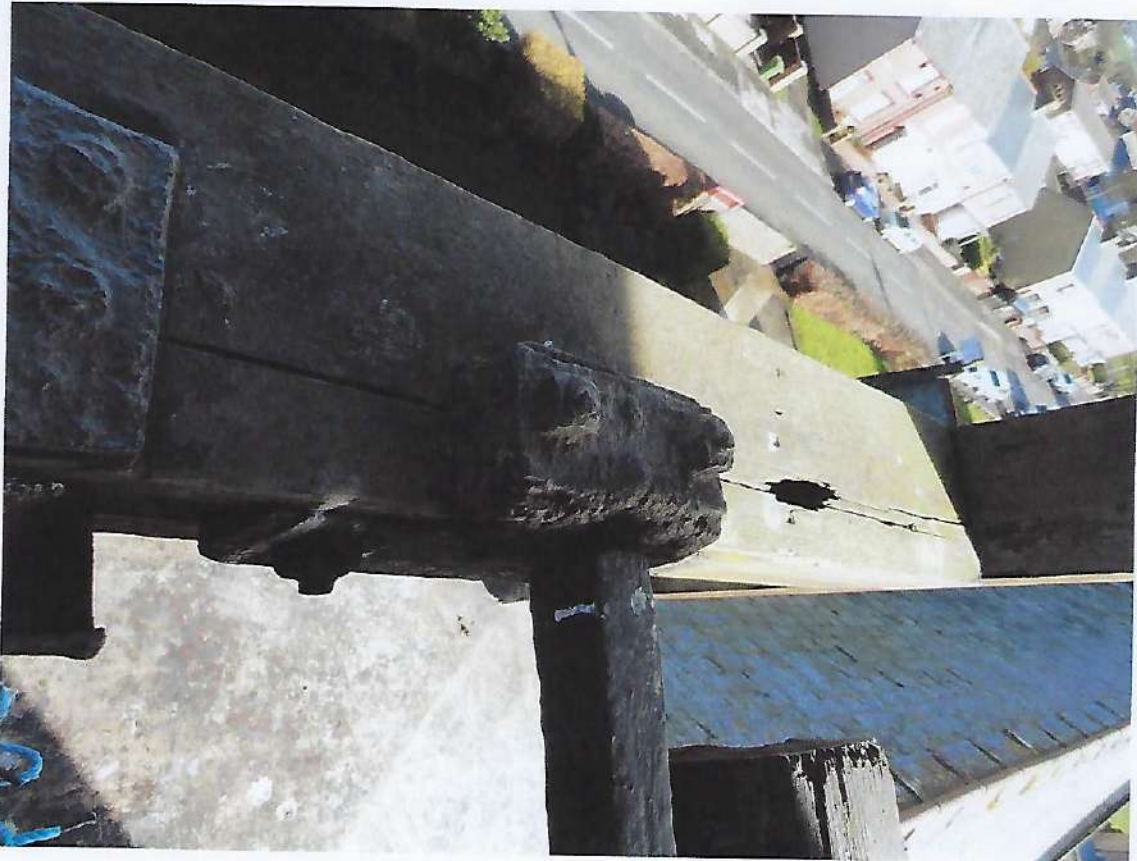
Examples of headstock bearings.

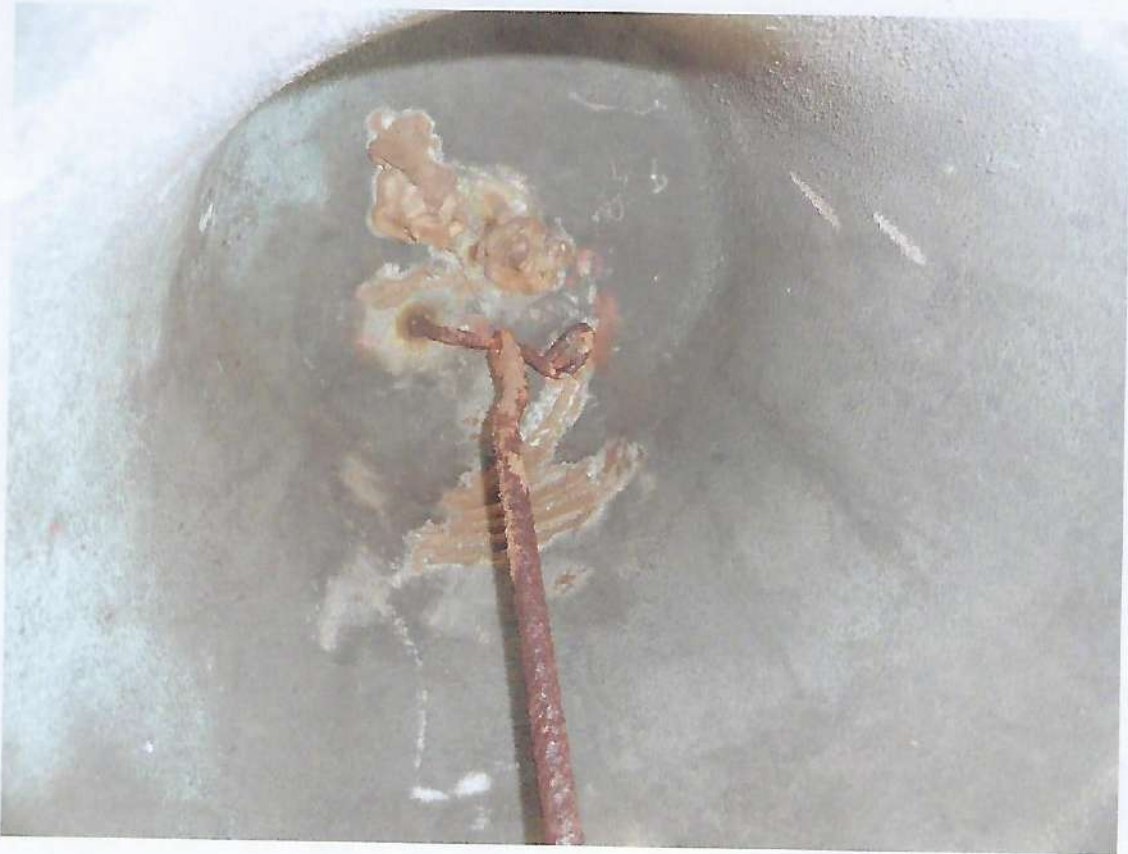
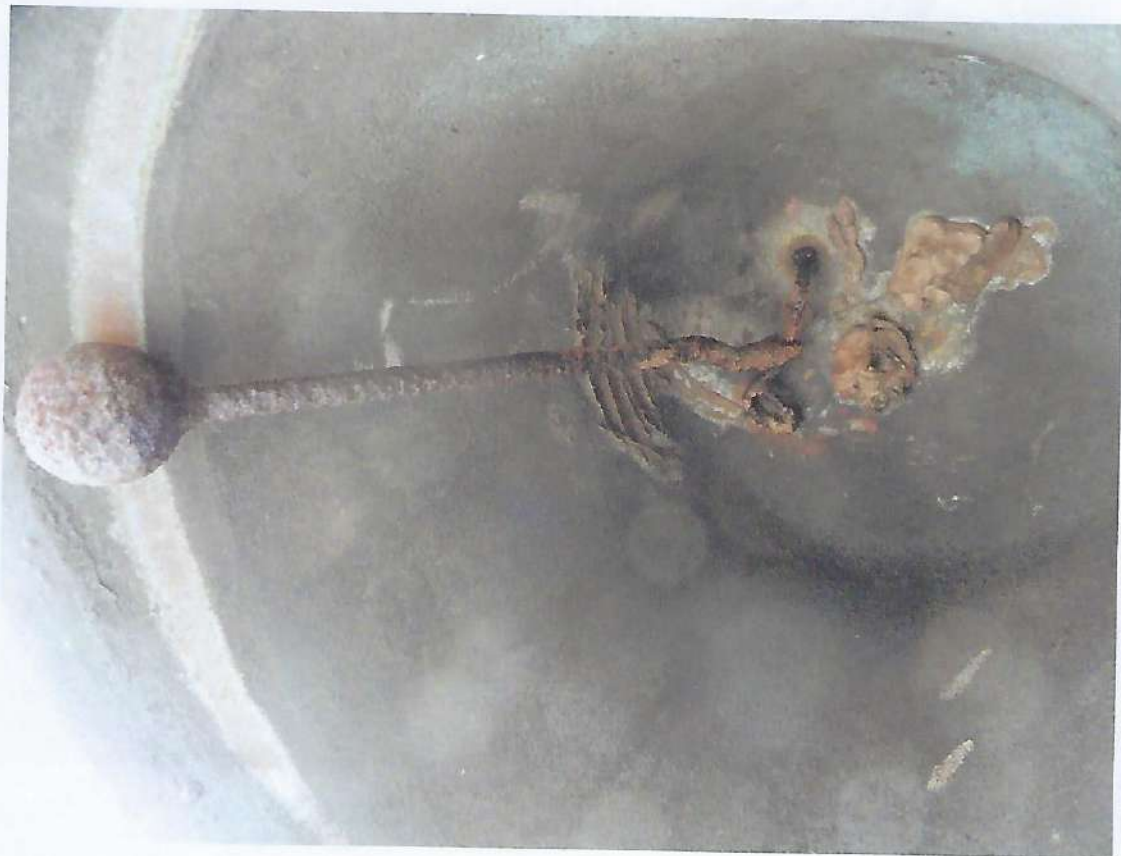
Examples of clapper.
