Church of St Thomas, Heatherycleugh

QUINQUENNIAL INSPECTION REPORT 2017

Crosby Granger Architects Ltd

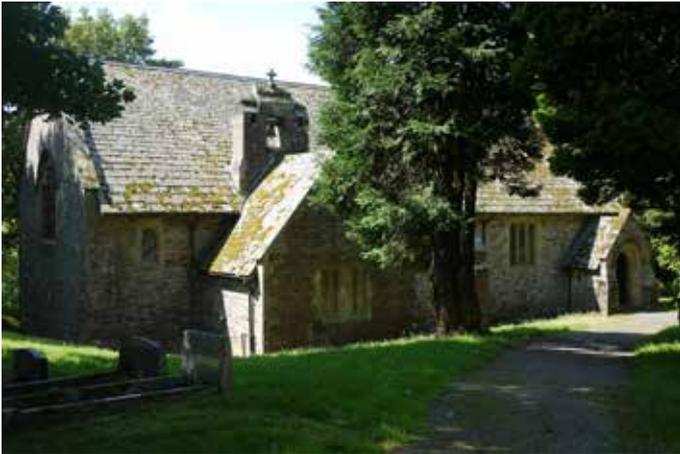
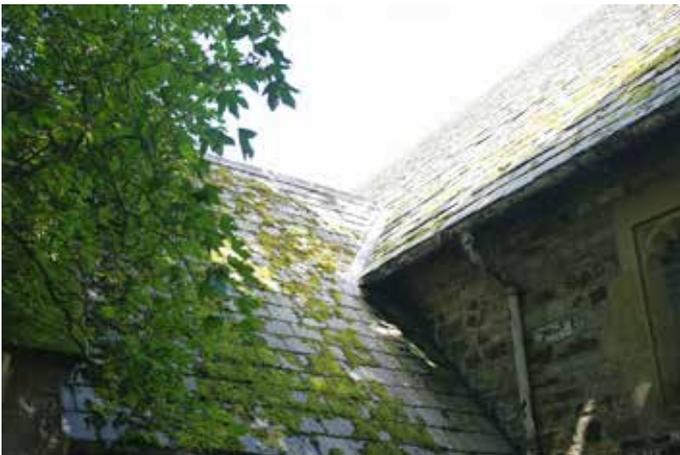
All roofs have heavy moss coverings to the slates due to the sheltered position of the church and the large amounts of trees surrounding the building. In some instances particularly on the south elevation the moss is growing beneath the slates possibly causing some uplift but certainly allowing moisture to be absorbed between the slates. The slate work in general is in fair condition though there are several slipped and broken slates across all elevations. The worst area appears to be at the western end of the south aisle pitch where there are a collection of dislodged and broken slates and uplifted courses that could cause issues in driving rain. There are approximately 15 slates on the south nave pitch which require either replacing or refixing and approximately 8 to 10 on the north pitch. On the vestry and organ blower roofs there are perhaps a handful on each pitch, with more noticed on the east pitch of the vestry. It is difficult to tell the exact condition of the slates beneath the moss covering, but it is assumed that where there are areas of very heavy moss build up there are perhaps more gaps for the moss to take hold.

Moss build up, encouraged by lack of light and proximity of trees

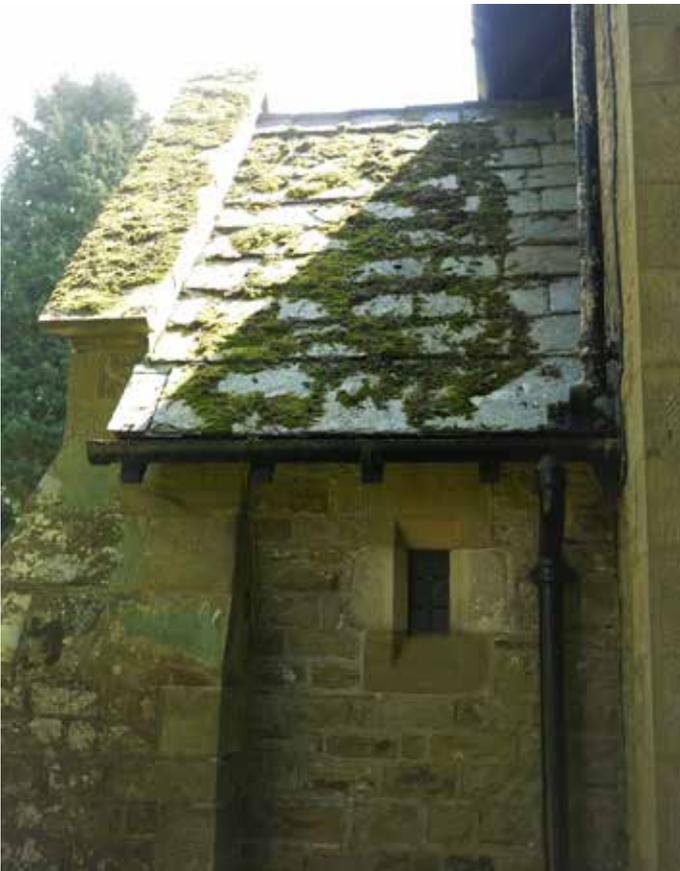
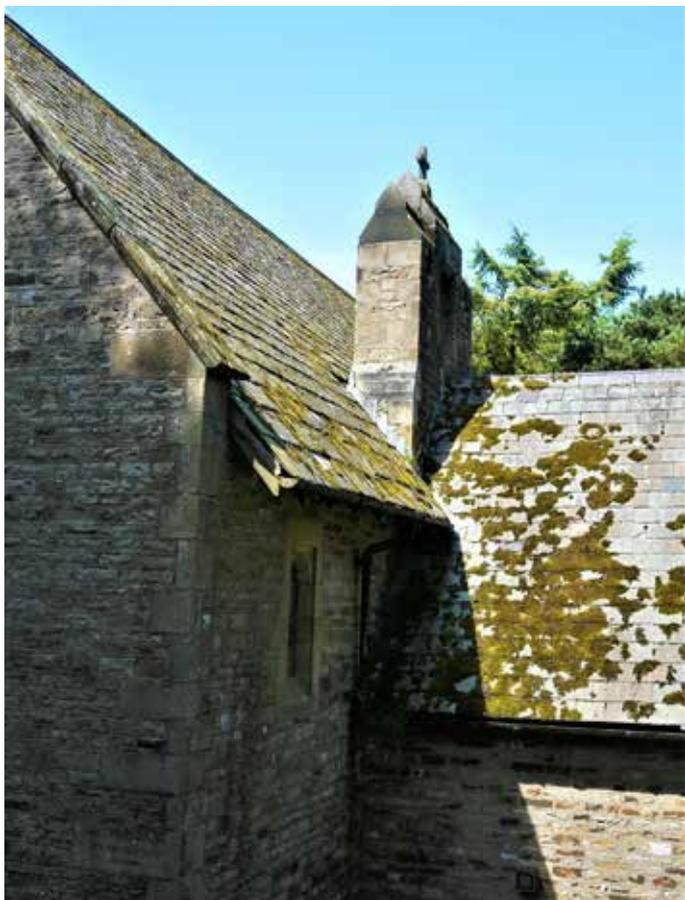
Timberwork and gutters require repair and redecoration, leaks from bellcote to be investigated

It is known that there are water ingress issues below the bellcote and so this area does need to be inspected at closer quarters. Moisture ingress will probably be a combination of lead work to the back gutter as well as moisture retention in the masonry itself, percolating down the chimney into the body of the wall below. The cementitious mortar will be exacerbating this situation.

The short length of verge bargeboards, beyond the water-tabling of the over-sailing roof, are in fairly poor condition some of them having been eaten or worn away quite substantially. There are substantial gaps between the underside of the slates and these verges which will be allowing birds, bees and wasps to create homes within the void above the soffit boarding and below the slate line. It would be beneficial if these verge boards were renewed.

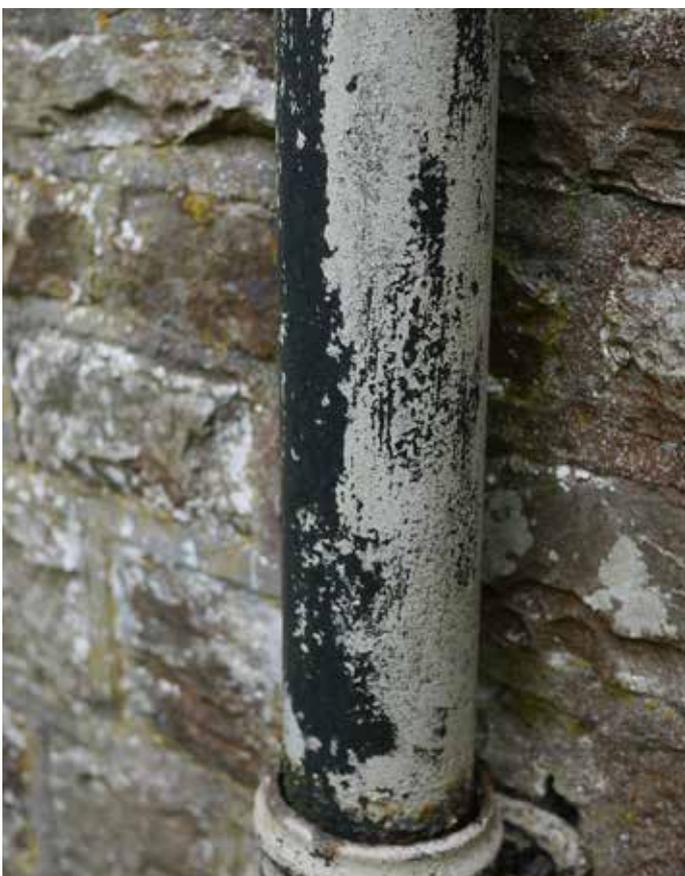
Rainwater goods would benefit from redecoration, as well as regular clearing out

All rainwater goods are cast iron consisting of cast iron gutters leading to cast iron downpipes which lead to ground gullies. The cast iron downpipes have historically been painted cream in colour but have more recently been painted in a black paint that is peeling off in many areas exposing the lighter colour beneath. Whatever paint was used, it was clearly the wrong type as it has not taken. This gives the appearance of looking rather unsightly and poorly maintained. There are signs of rust to the gutters in many areas. All rainwater goods would benefit from a good refurbishment, rubbing down, defrassing, removing rust, resealing and repainting.

There are several areas of grasses growing out of gutters indicating blocked outlets and build up of debris or moss in the gutters. It's essential the gutters are cleared at least twice a year to ensure that all gutters run freely and remove water from the wall heads. This is particularly important where the church is surrounded by trees as is the case here. All gutters are fixed to the rafter ends, the rafter ends of which are all painted timber. These exposed rafter ends would benefit from rubbing back and redecorating as many are showing signs of wear and tear, particularly at the end of verges as previously noted.

2.03		Works recommended to be carried out during the next two years	
a)	p.14	Re-seal and redecorate all rainwater goods, re-setting downpipes on new bobbins where out of plumb. Rub down and redecorate external timberwork to rafter feet and verges and soffits	£3,500

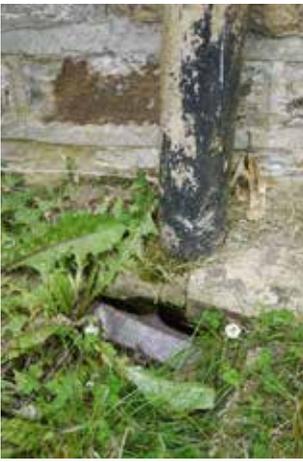
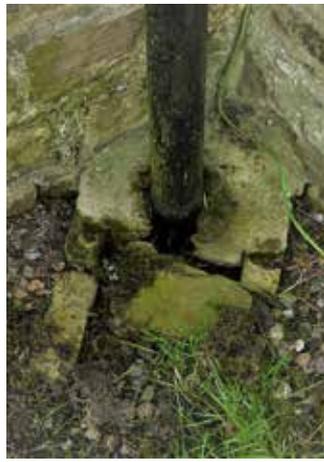
Stone/concrete caps over gullies can cause more of an issue with vegetation becoming trapped, and they less easy to clear out

At the time of inspection all the gullies were blocked with leaves, soil and grass, and therefore require clearing out and ensuring that water is running away freely. The gullies with protective stone/concrete caps are intended to stop the gullies from becoming blocked, but are in some instances causing issue. Broken bit of stone/masonry should be removed, and a proper clean out attempted.

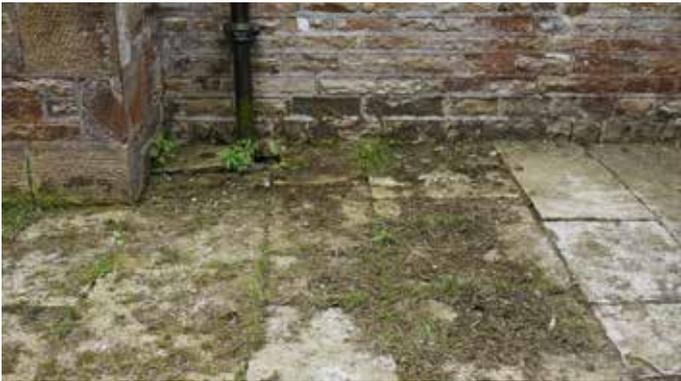
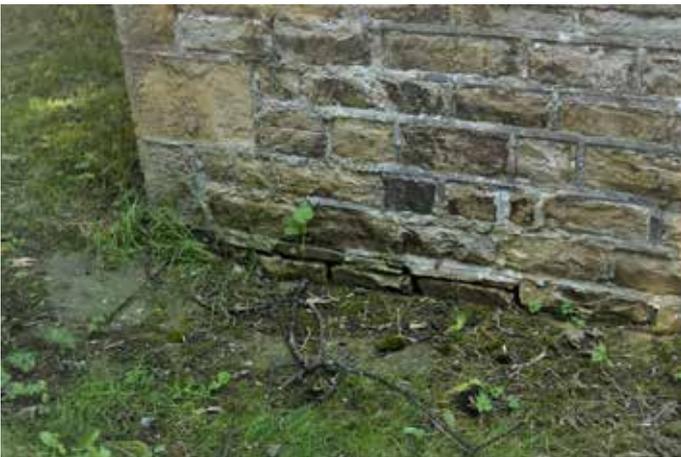
Stone flags laid up against the wall trap moisture in the ground and encourage damp to rise in the masonry walls. This is beginning to damage stonework and pointing at low level.

To the north of the nave, around the vestry, and to the north and east of the chancel there are flagstones laid right up to the walls of the building. This is causing some low level deterioration of the masonry as it encourages moisture to track up the walls rather than evaporate directly from the ground. It would be beneficial if these flagstones were removed at least just one course away from the building to allow a gravel strip to be inserted which would allow the ground immediately at the base of the walls to properly dry out.

2.02		Works recommended to be carried out during the next 12 months	
a)	p.15	Remove stone flags laid right up to the base of the wall, approx. 400mm wide minimum, to allow base of walls to dry out. Clear out gravel trenches that exist, (south east) ensuring they are free from grass and vegetation.	DIY / £250

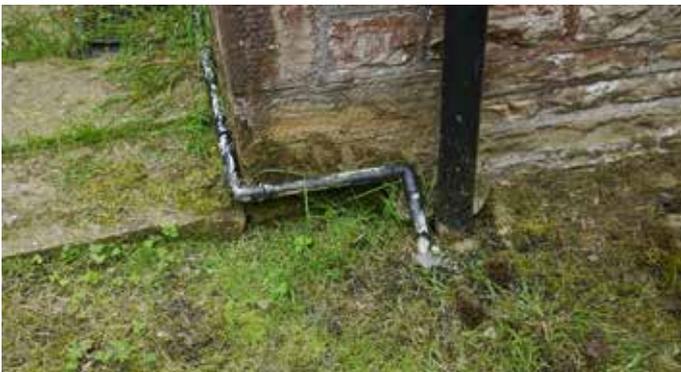
Outlet from vestry sink flows into blocked gully

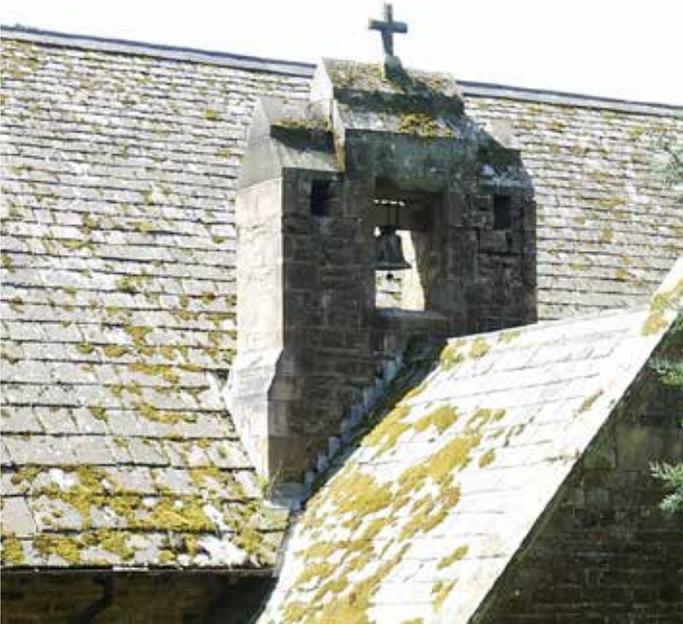
The bellcote at the junction of the north chancel and vestry houses one bell and a chimney flue to either side. The walling masonry is of rubble to match elsewhere with dressed stone cappings above the bell and to the chimney flues. The masonry itself appears to be in reasonable condition but the pointing is cementitious as elsewhere with various areas that are falling out, cracked, failed or missing. The top of the bellcote is covered in moss indicating retention of moisture. There are no caps to the tops of the chimney flues which will mean water will be driving down into the chimney flue stack itself.

Knowing that there is a substantial water ingress problem below it can be assumed that one of the contributing factors will be the masonry absorbing rainwater and the moisture becoming trapped. The lime mortar bedding is not able to draw the moisture out to the surface for evaporation because of the cement pointing to the outside. It is highly recommended that if the internal damp issues are to be resolved this bellcote requires raking out and repointing in a soft fat lime mortar as a minimum, and the tops to the chimney flues are capped. Further consideration could be given to re-building on a lead tray to stop water tracking down.

Bellcote requires some repair to stop water ingress below

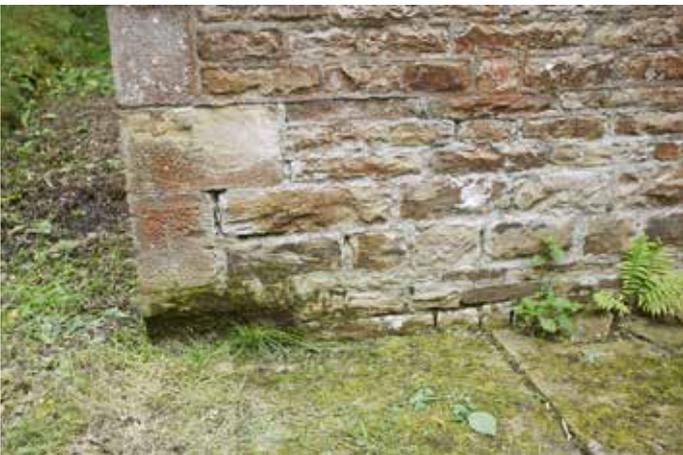
Damp and deterioration at base of wall

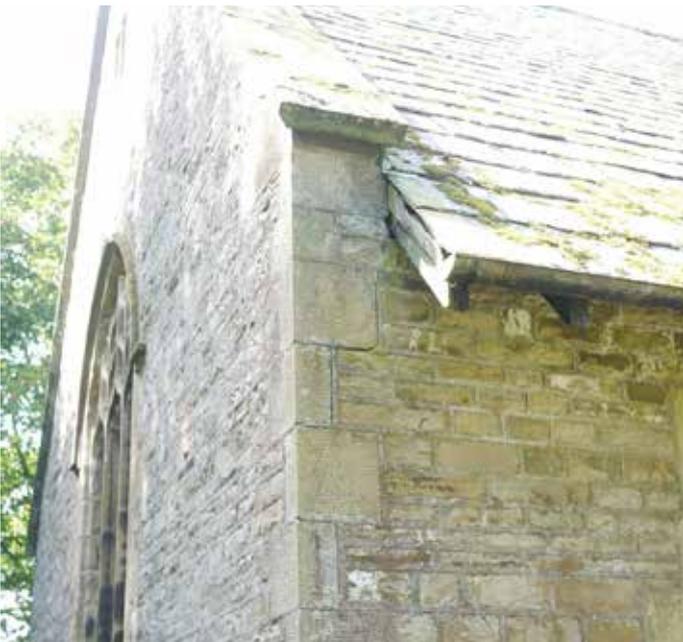
Hairline crack around quoins below watertabling at north-east corner of chancel

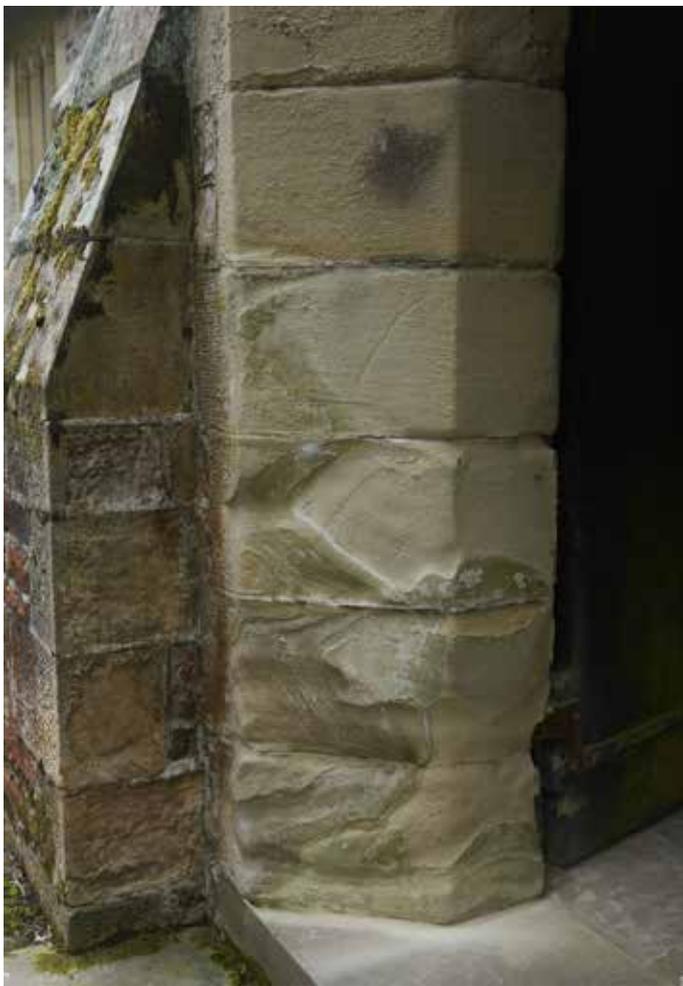
Severe deterioration to eastern jamb of porch archway

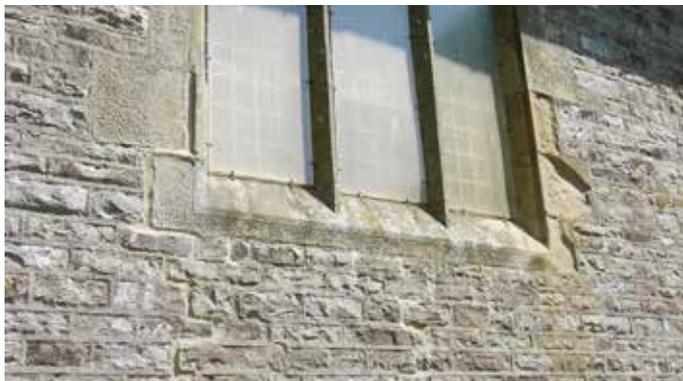
Cracking below windows (south nave) and deterioration of dressed sandstone reveals jamb stones

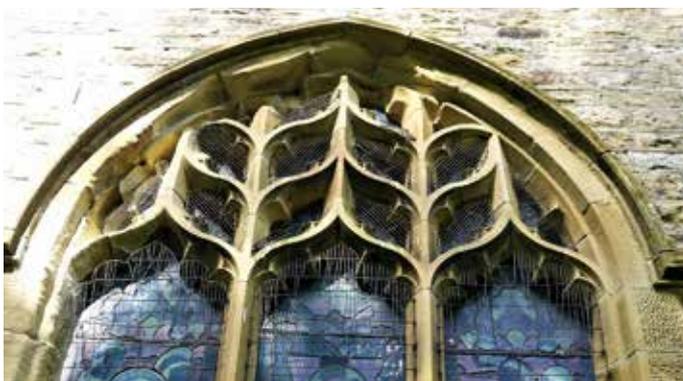
Deterioration of tracery at the top of main east window. Ferrous fixings of deteriorated wire guards causing localised rusting

e)	p.17 & p.18	Remove old wire window guards from east window, including ferrous fixings, and point up holes in soft non-hydraulic lime mortar.	£150
f)	p.17 & p.18	Stonework survey of the porch and main east and west windows by Architect to establish extent of repairs and produce drawing and specification for pricing.	£900

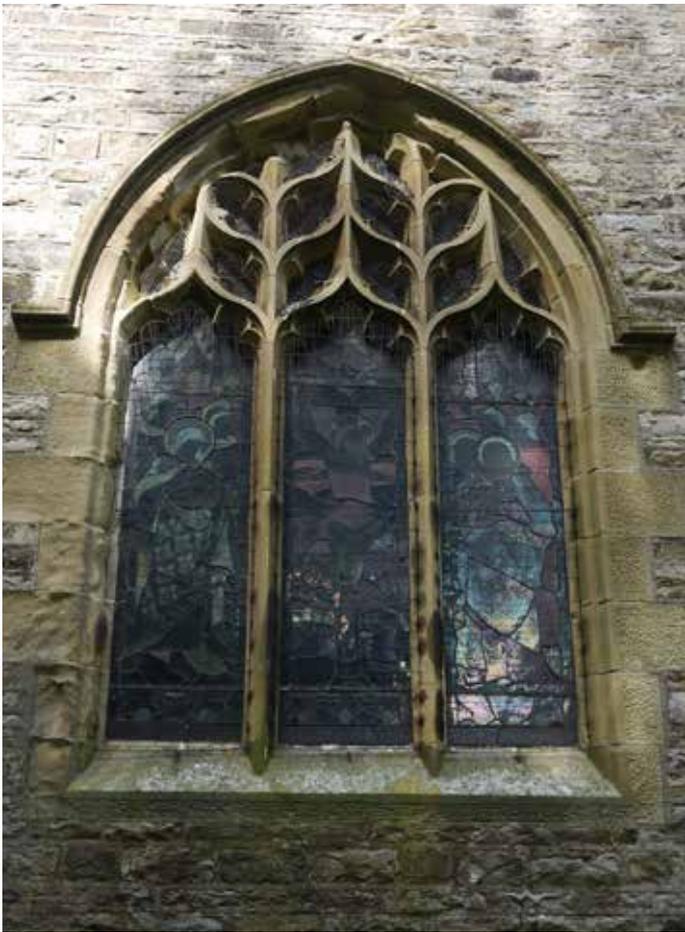
Main east window deterioration

c)	p.17 & p.18	Repairs to stonework in East and West windows, following assessment and specification by architect. Scaffold will be required to carry out works.	£15,000

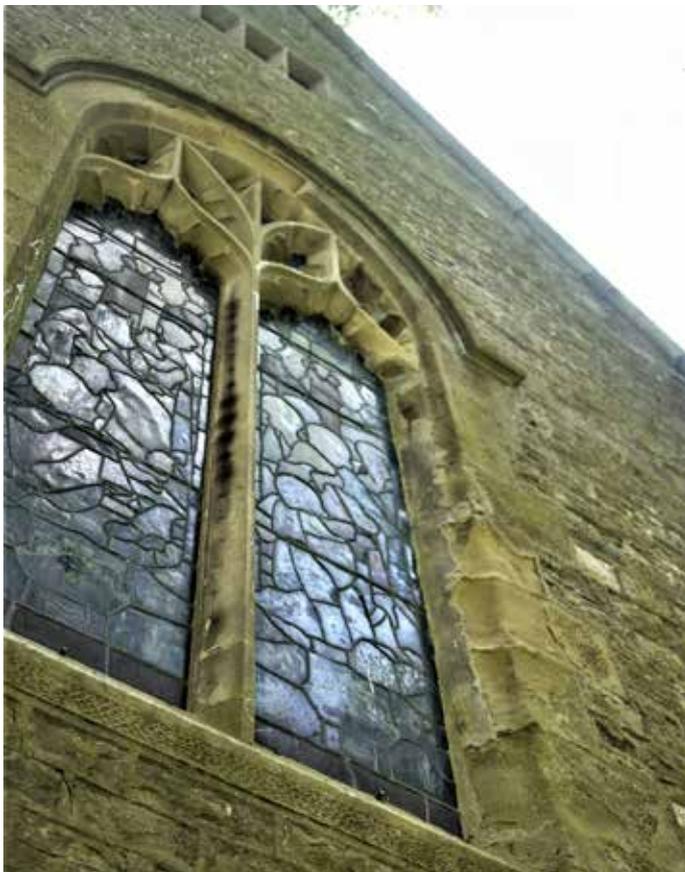
The main west window is in a similar condition to the main east window with very heavy deterioration to the southern jamb and to the tracery and to the voussoir stones of pointed arch, as an absolute direct result of cementitious mortar repairs that one can still see buttered over the stonework. These areas of vulnerable masonry will now be acting as a sponge absorbing even more water and causing damp issues internally.

Main west window deterioration

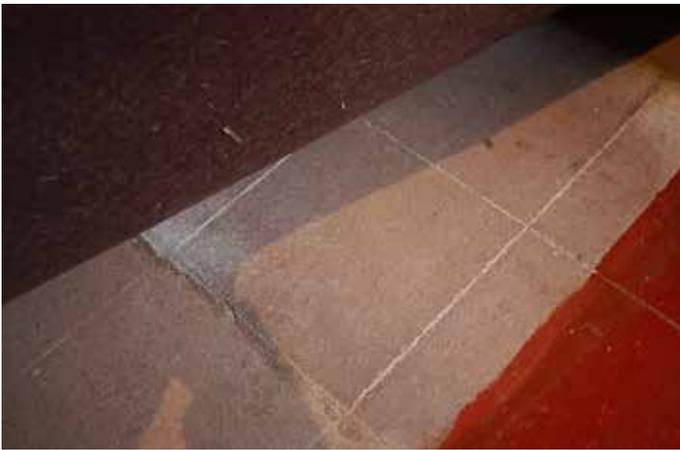
Beneath carpet - junction of original sandstone flags (top) with concrete floor, lined (below) and red paint to perimeter where exposed

is also painted over with red paint. There is a central run of carpet. There are several areas where the original sandstone is showing signs of spalling beneath the paint. There are also areas where the sandstone has been 'repaired' using cement, that will be causing advanced decay in that particular flag. It is assumed that the sandstone was deteriorating, and a decision was taken at that time to replace all of the stone that had spalled with widespread concrete. There now remains only a small area left of the original flooring, which is becoming more damaged due to the impervious floor paint that is preventing the stones from breathing. It is recommended that the paint is removed, the floor fully assessed, and a holistic approach adopted to prevent the original sandstone flooring from being lost.

f)	p.22	Remove red floor paint from front of nave to allow original sandstone flooring to breathe & prevent further deterioration. Architect to advise on paint removal specification.	DIY / £200

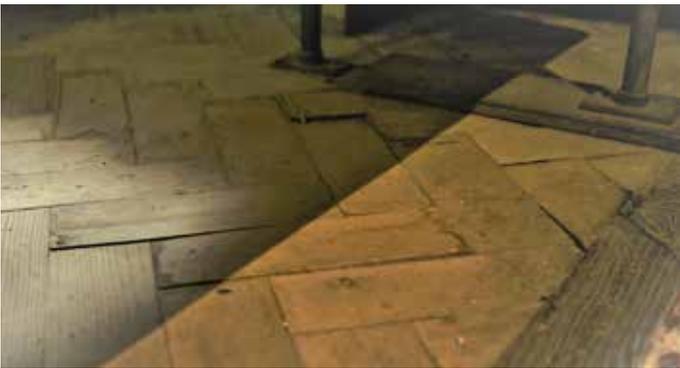
Movement in woodblock at east end of north aisle, indicating possible ground movement

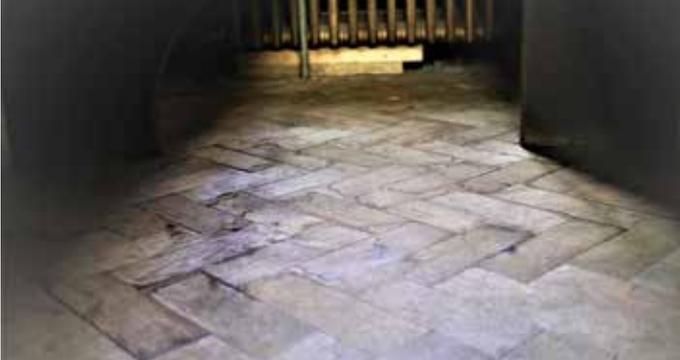
Staining to woodblock - could either be leaking pipework, or damp from below

g)	p.23	Investigate areas of woodblock floor that are showing signs of damp/water staining. Conservation minded joiner to carefully lift area of woodblock to allow inspection by architect. Check perimeter heating system for signs of leaks.	£250 DIY

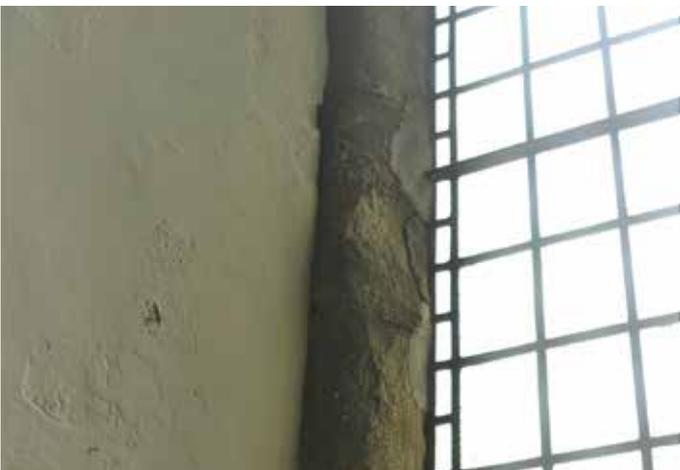
Deterioration of sandstone window reveals and plasterwork

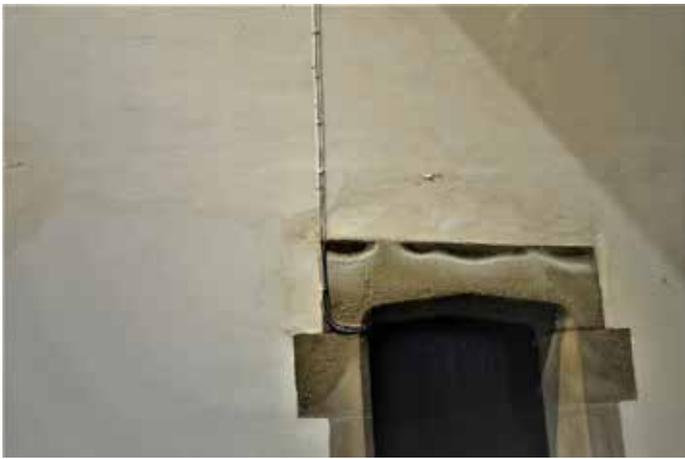
As previously noted, there is a particular issue over the vestry door and to its east side where there is clear damp coming

Deterioration of stone reveal to vestry and of plasterwork above, caused by issues with bellcote and chimney over

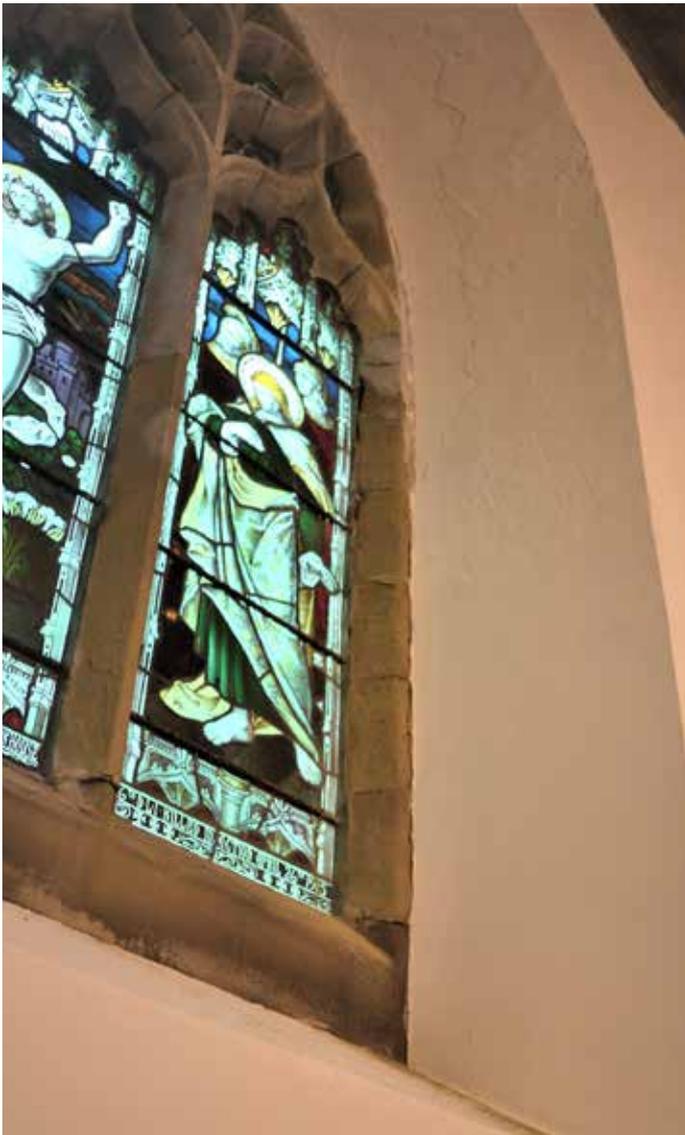
East window stonework deteriorating due to salt damage internally

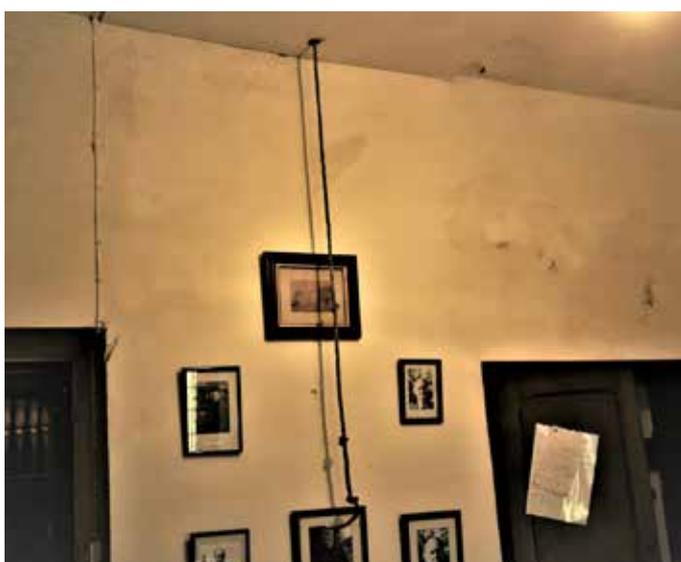
Damp in south wall of vestry, below chimney and bellcote

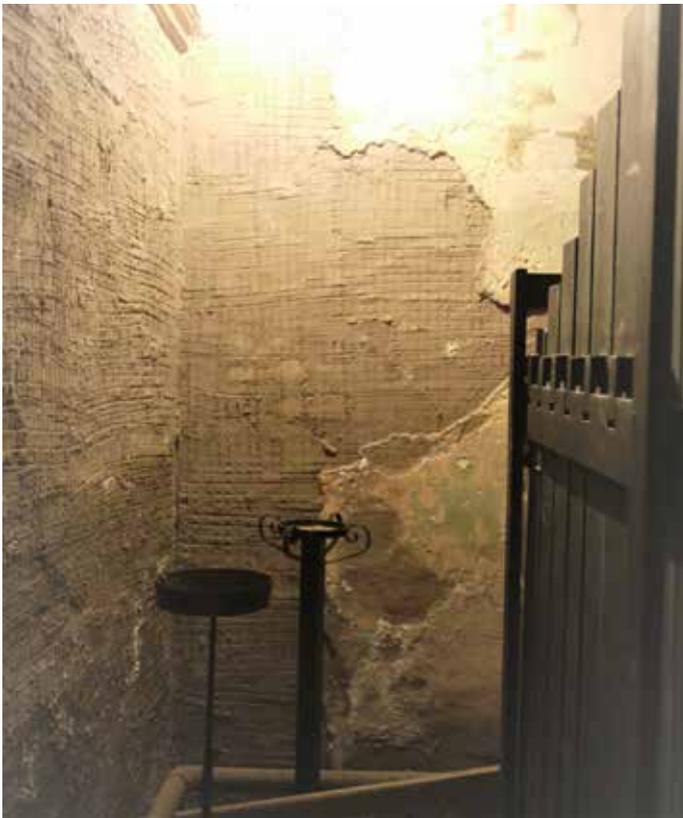
Organ loft / south transept - new render is too hard and not assisting the drying out of the walls - should be removed to expose stonework and walls allowed to dry out

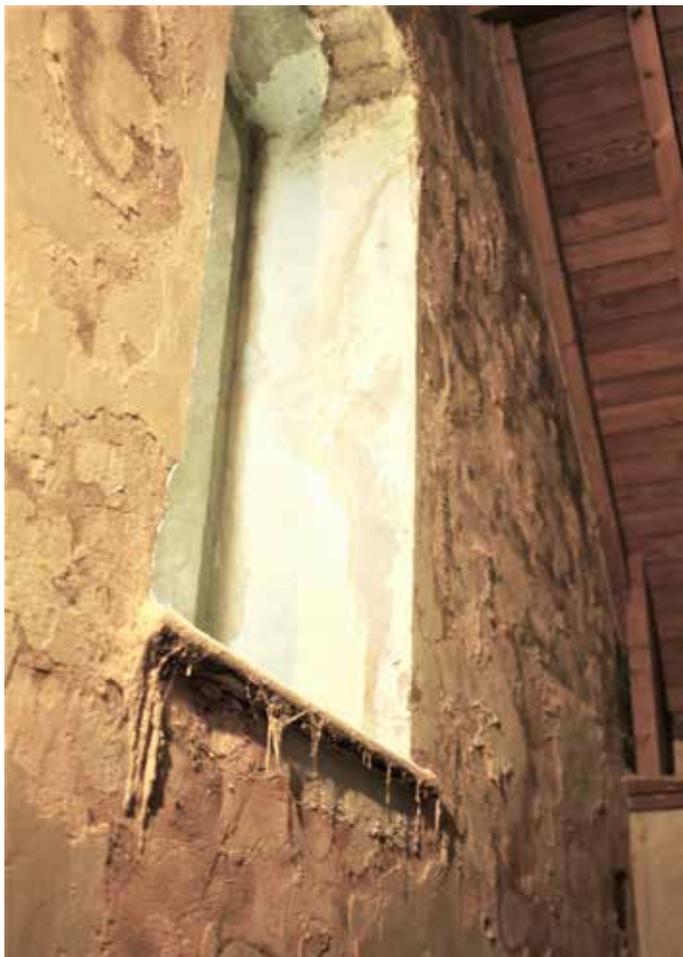
South gable of organ loft in poor condition due to salt damage

The South transept houses the organ, also accessed off the chancel. Inside the south transept the plaster work is in severely bad condition. A large area to the East and Southern walls has been stripped off and a proprietary render applied to the insides. It appears that this is to combat damp although salts are still coming through the coating.

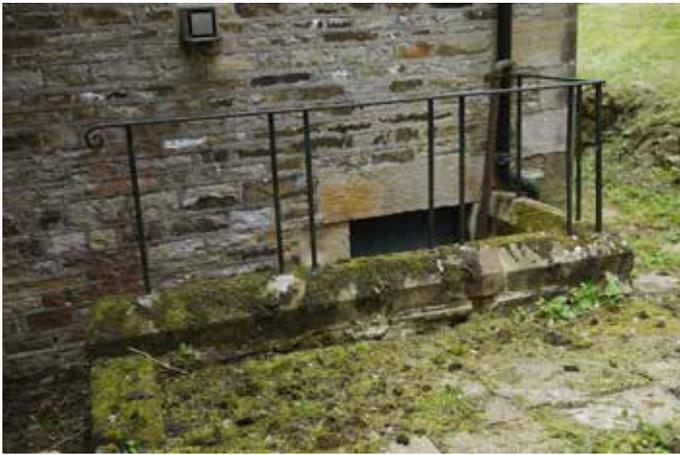
Flagged areas and cellar steps would benefit from a tidy up
