Church of St Thomas, Heatherycleugh
QUINQUENNIAL INSPECTION REPORT 2022

Crosby Granger Architects Ltd

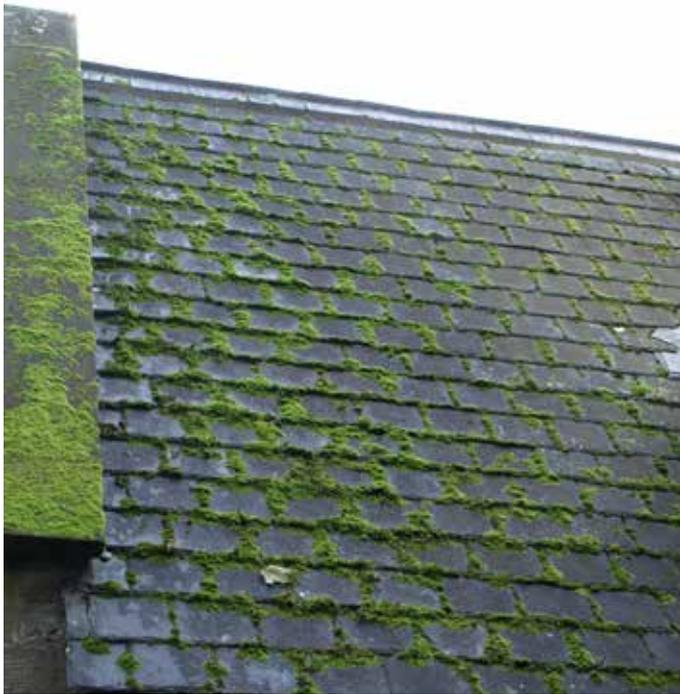
All roofs have heavy moss coverings to the slates due to the sheltered position of the church and the large number of trees surrounding the building. In some instances particularly on the south elevation the moss is growing beneath the slates possibly causing some uplift but certainly allowing moisture to be absorbed between the slates. The slate work in general is in fair condition though there are several slipped and broken slates across all elevations. The worst area appears to be at the western end of the south aisle pitch where there are a collection of dislodged and broken slates and uplifted courses that could cause issues in driving rain. There are approximately 15 slates on the south nave pitch which require either replacing or refixing and approximately 8 to 10 on the north pitch. On the vestry and organ blower roofs there are perhaps a handful on each pitch, with more noticed on the east pitch of the vestry. It is difficult to tell the exact condition of the slates beneath the moss covering, but it is assumed that where there are areas of very heavy moss build up there are perhaps more gaps for the moss to take hold. A number of slates have been replaced on the main roof. Care should be taken to ensure that any new slates are an accurate match in colour and texture to the existing.

Moss build up encouraged by lack of light and proximity of trees. Will hold water in the slates and prevent ventilation. To be removed

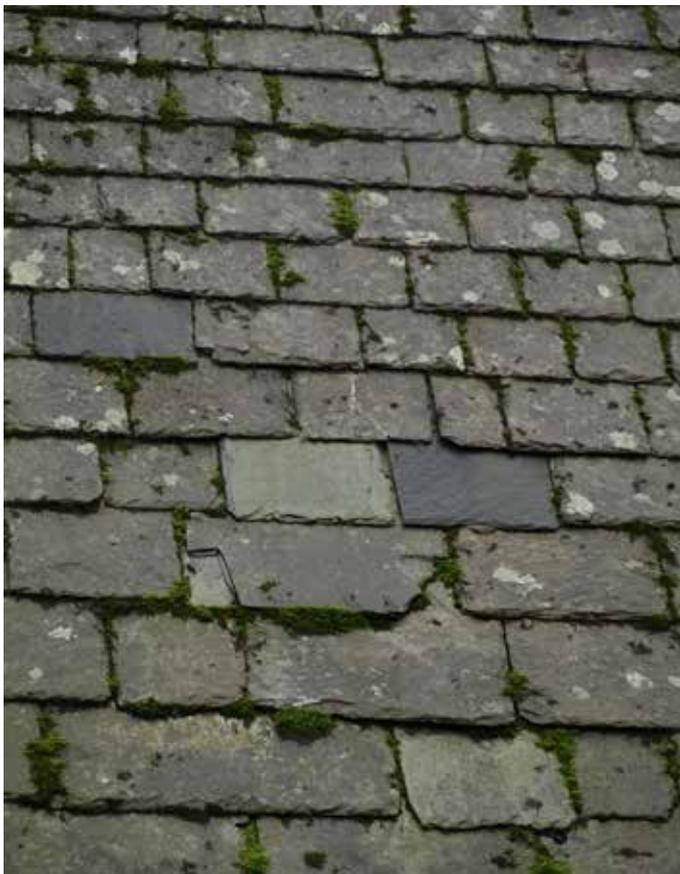
Poorly matched replacement slates. Adjacent slates appear to have been damaged during the work

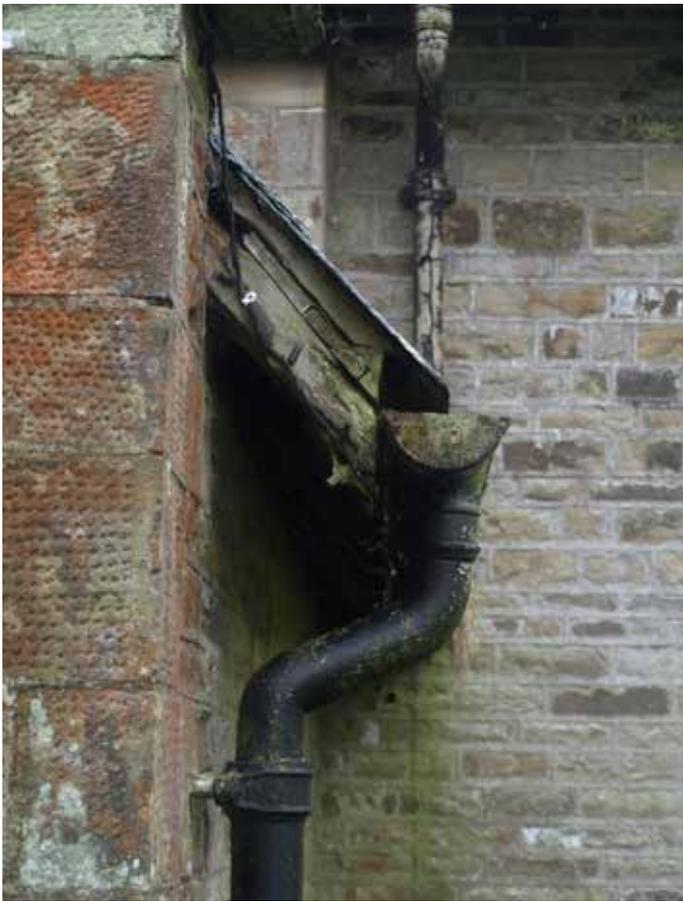
Rafter ends in poor condition, and covering bargeboard missing

The short lengths of verge bargeboards, beyond the water-tabling of the over-sailing roof, are in fairly poor condition some of them have decayed quite substantially. There are substantial gaps between the underside of the slates and these verges which will be allowing birds, bees and wasps to create homes within the void above the soffit boarding and below the slate line. It would be beneficial if these verge boards were renewed.

b)	p.14	Rub down and redecorate external timberwork to rafter feet and verges and soffits. Splice repairs as necessary. Replace bargeboards	£3,000
		Glazing specialist to survey windows and prepare Schedule of Works required	£500

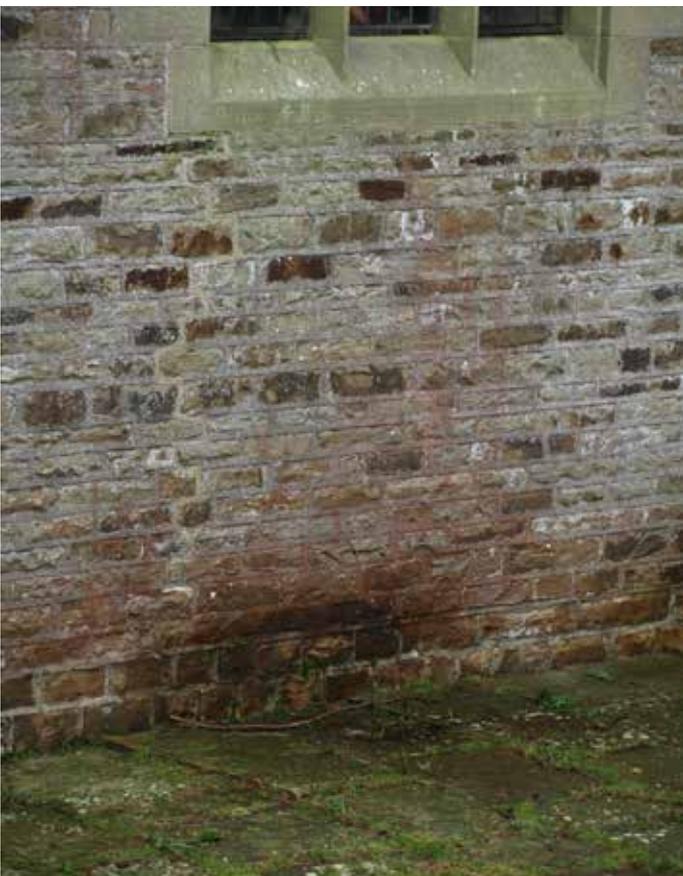
The gutter to the Nave north slope has two leaking joints - splashback from these leaks is saturating the wall locally. They urgently need repair.

Splashback from leaking gutters causing damp walls

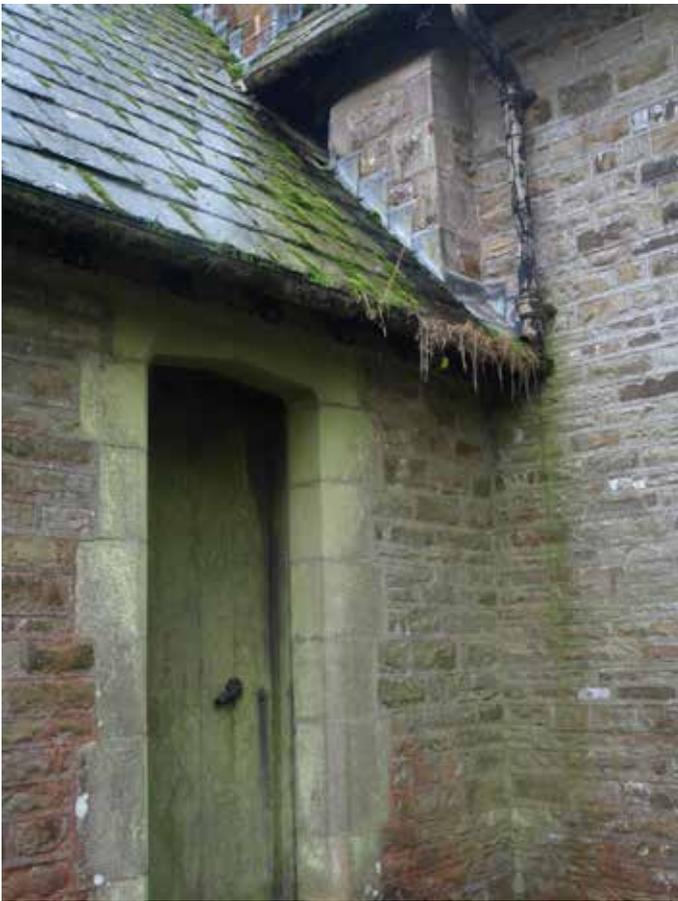
Gutters are full of debris and vegetation in places. Clean out every 6 months to avoid overflow and resultant water ingress

indicating blocked outlets and build up of debris or moss in the gutters. It is essential the gutters are cleared at least twice a year to ensure that all gutters run freely and remove water from the wall heads. This is particularly important as the church is surrounded by trees.

d)	p.15	Unblock all gullies at ground level and ensure water is running away freely, clear all gutters and outlets.	DIY
e)	p.15	Clean out all gutters, check for leaks, repair as necessary. Clearing of gutters to be carried out twice a year given the number of surrounding trees.	£1,500

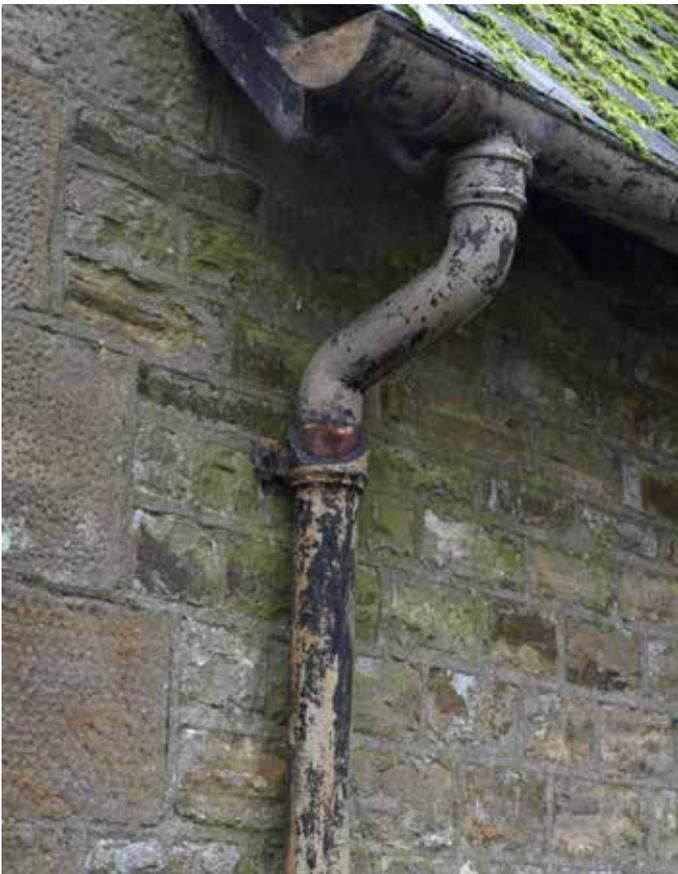
One downpipe to the Organ Loft (east elevation) has a broken cuff and needs replacement.

Broken downpipe collar, to South Transept

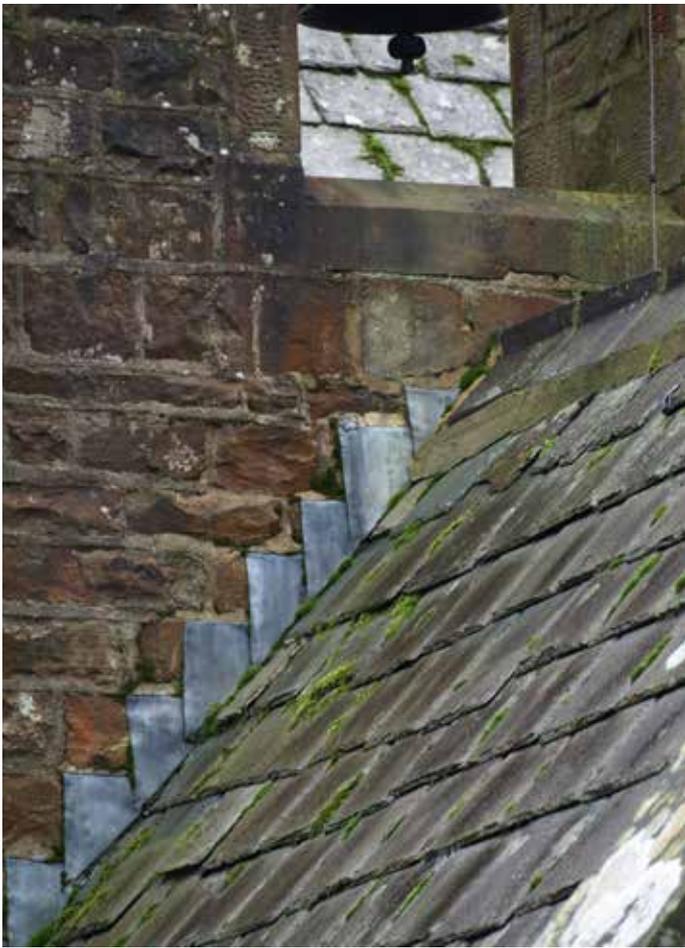
Masonry to the bellcote requires fully re-pointing. Ideally the structure should be re-built on a lead tray

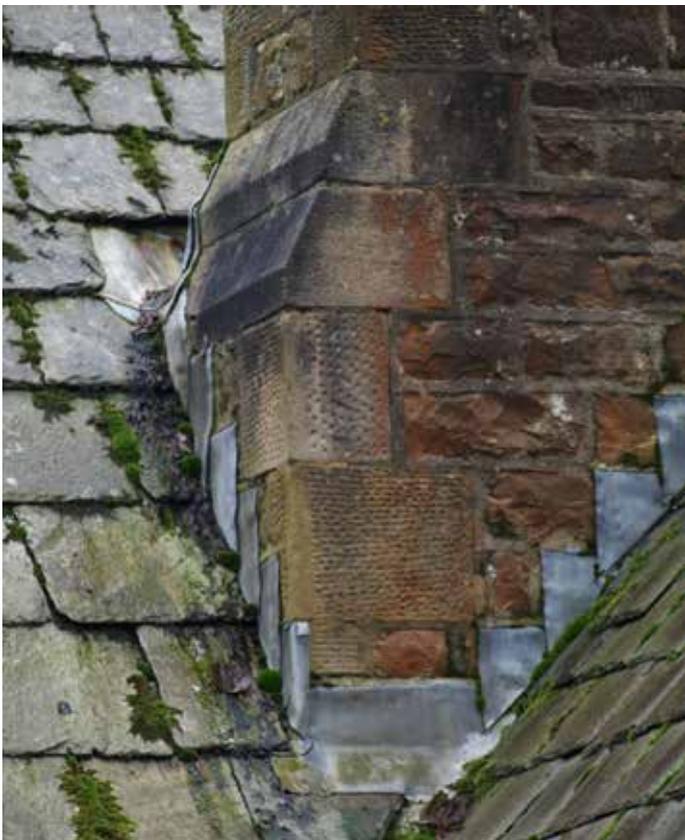
The back gutter behind the bellcote to the northeast of the nave could not be closely inspected however it is assumed that this may be in the similar condition as the lead valley to the organ loft and may therefore require some form of repair.

It is known that there are water ingress issues below the bellcote and so this area does need to be inspected at closer quarters. Moisture ingress will probably be a combination of lead work to the back gutter as well as moisture retention in the masonry itself, percolating down the chimney into the body of the wall below. The cementitious mortar will be exacerbating this situation. The condition of the internal wall below is a clear indicator of a problem in this area.

The back-gutter to the bellcote is almost certainly leaking - it should be renewed

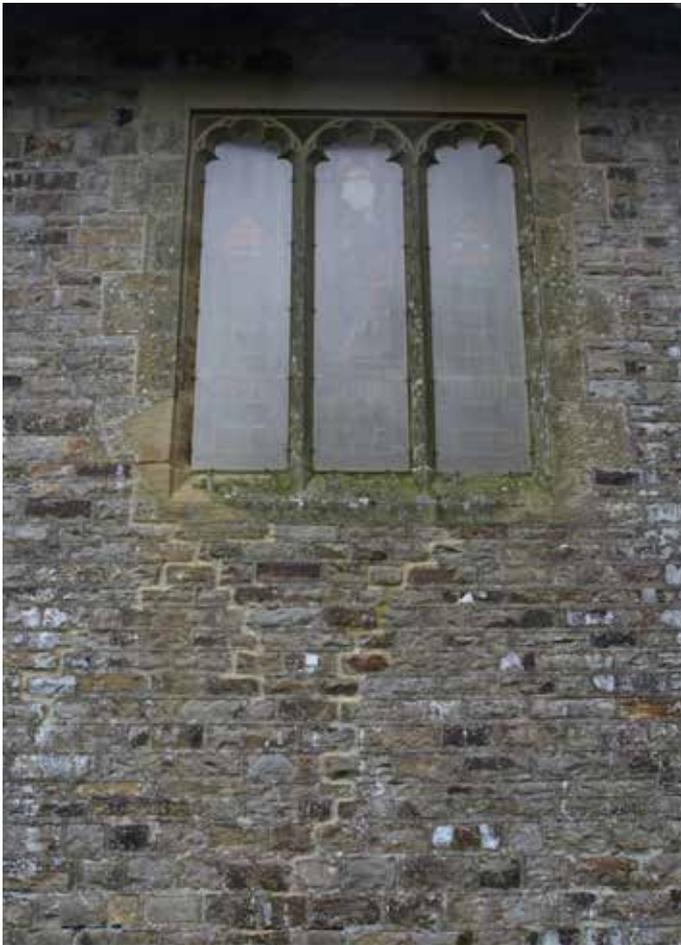
Earlier cracking below south windows, pointed up and in places opening up again

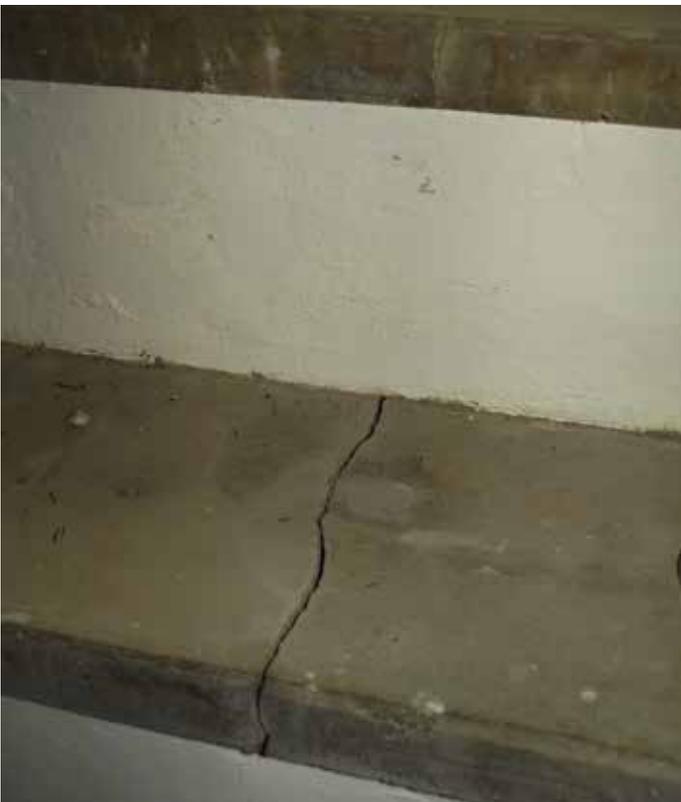
The movement in the church is most notable at the westerly Nave windows. On both the north and south sides of the Nave they have cracked through, with open cracks of approximately 2.5mm to the north, and 4.5mm to the south. These cracks should be monitored at each quinquennial inspection to determine the rate of movement.

Cracking in the internal cill of window sIV - should be monitored for change over time

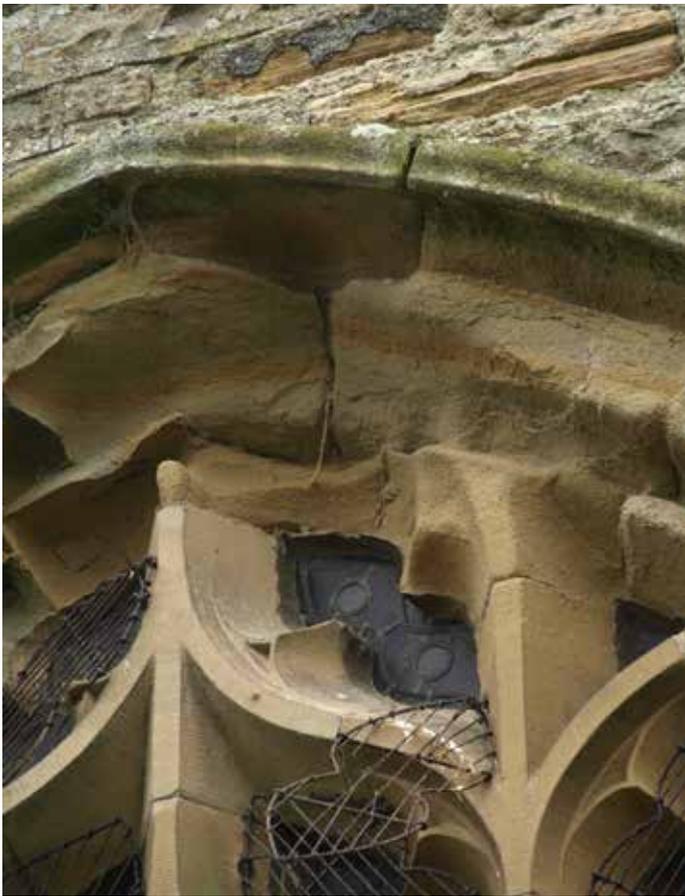
East window - deterioration of masonry surround, failure of grilles

g)	p.18	Remove old wire window guards from east window, including ferrous fixings, and point up holes in soft non-hydraulic lime mortar.	£400
h)	p.17 & 18	Stonework survey of the porch and east and west windows by Architect to establish extent of repairs and produce drawing and specification for pricing.	£1500

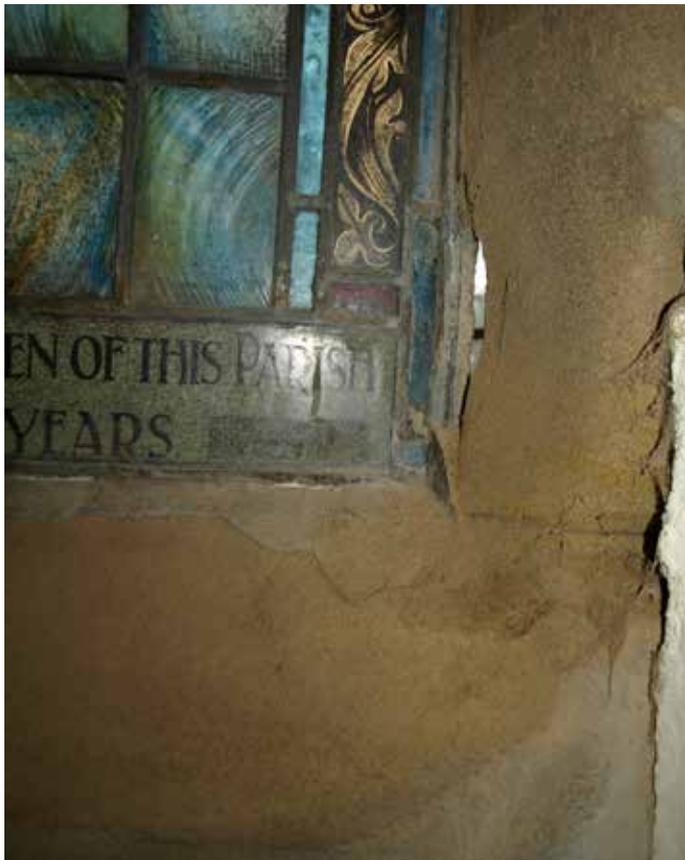
Window sIII - severe stone decay has opened up a gap against the glazing which will admit rain. Urgent repair required

The masonry to the south aisle windows, sIII and sIV, is as noted previously in less good condition with a couple of jamb stones to sIV in pretty poor condition. sII also has severe stone decay to the lower left and side, resulting in a gap to the glazing which will admit rain. Lime mortar repairs must be made in the short term. In the longer term parts of the masonry will need to be replaced with new stone.

f)	p.18	Emergency pointing & filling to East, west and south windows to make watertight and prevent further deterioration, all with soft lime mortar	£3,000

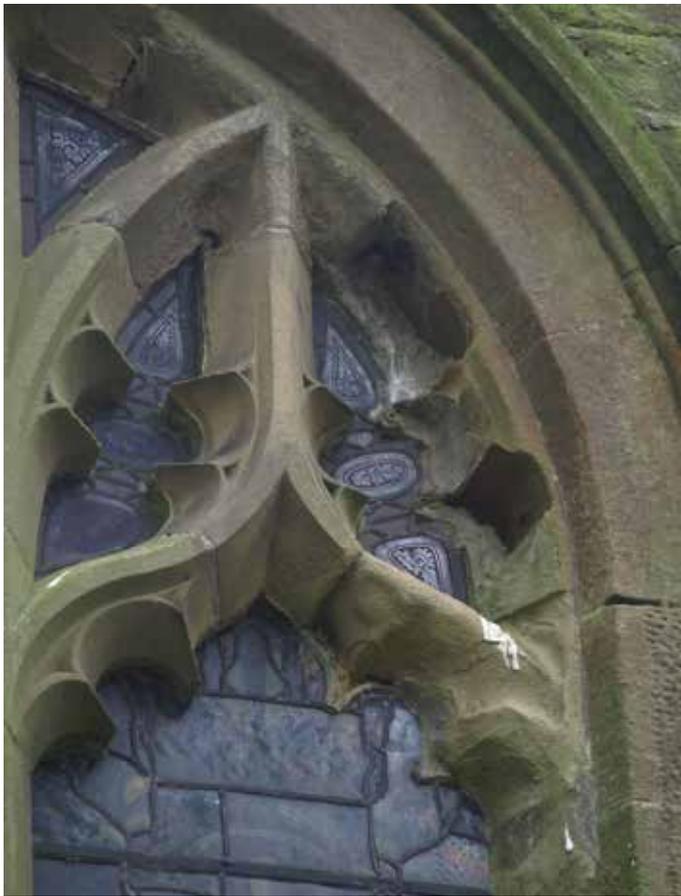
West window - deterioration of masonry and poor quality repairs

c)	p.17 & 18	Repairs to stonework in East and West windows, following assessment and specification by architect. Scaffold will be required to carry out works.	£20,000

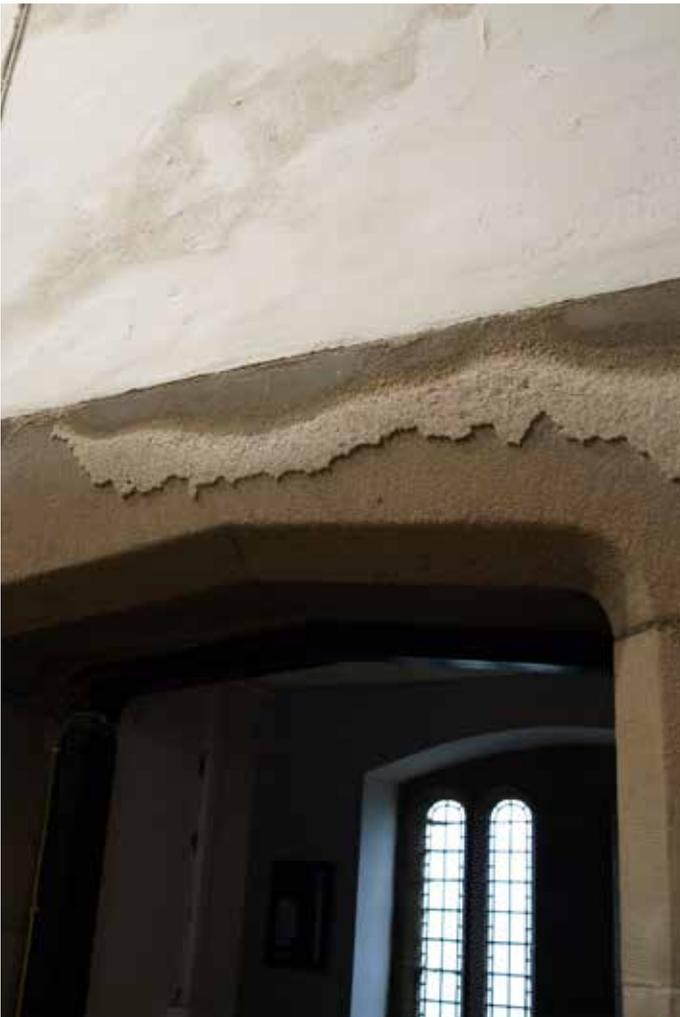
Wall over the Vestry door is wet, causing stone decay to the door surround. Due to leaking bellcote above

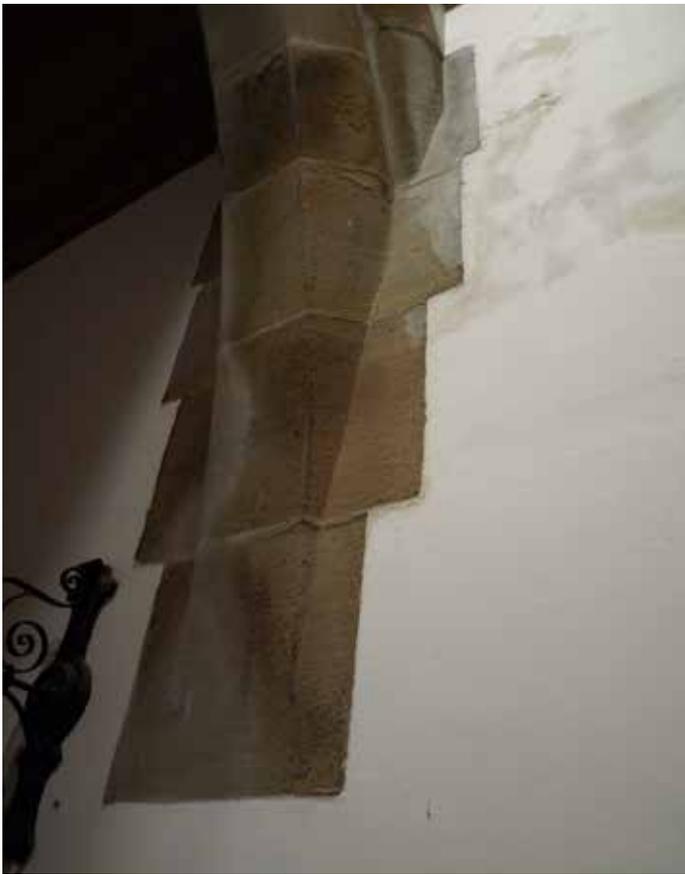
Leaking bellcote is now affecting the Chancel arch, causing rapid decay of the dressed stone

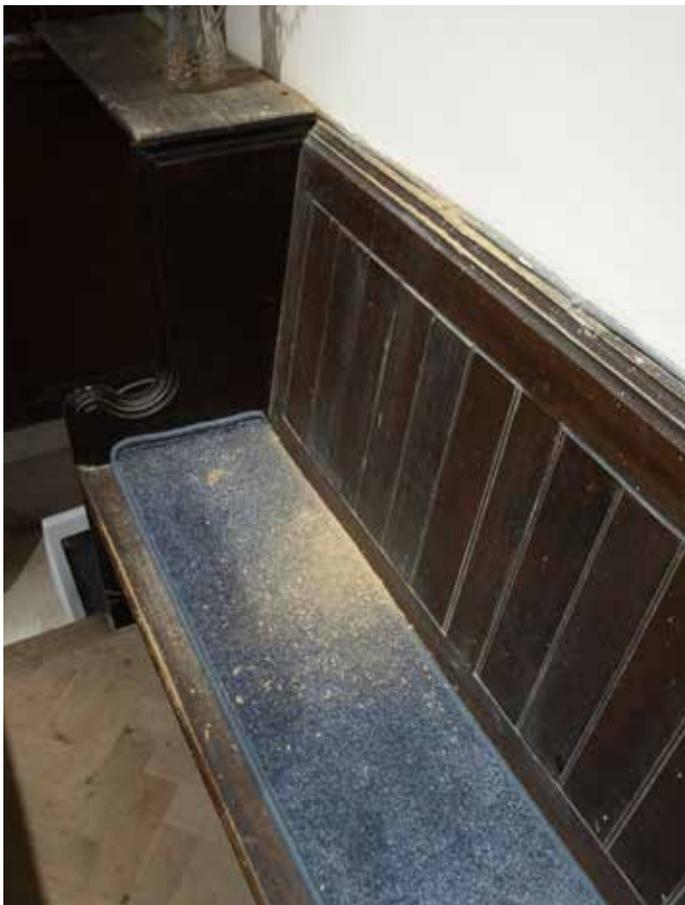
Deposits of stone dust are indicative of the rate of decay. This should be removed by vacuum cleaning

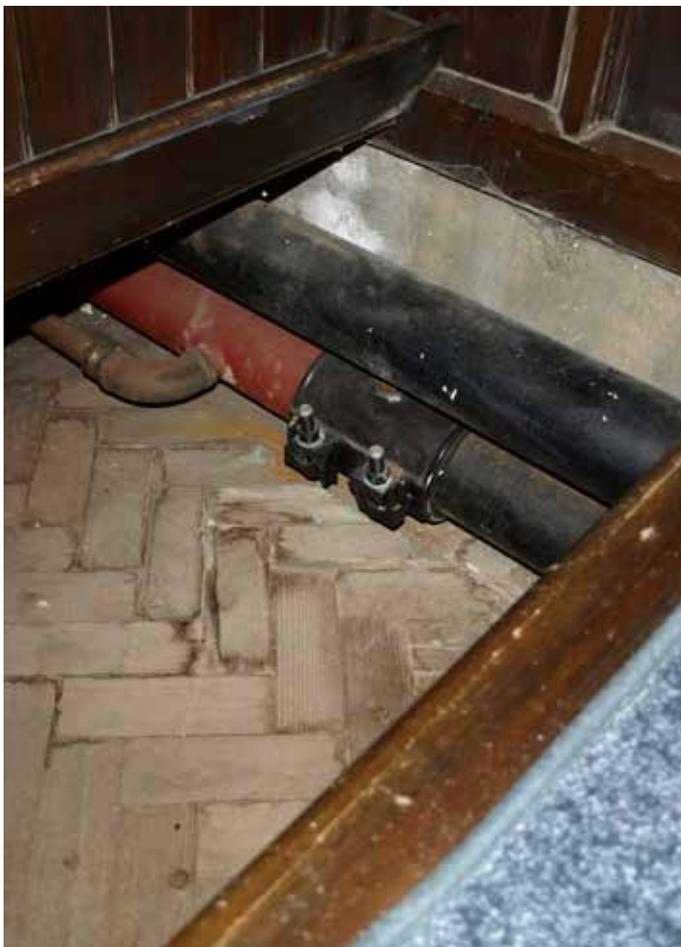
Recent heating pipe repairs have stopped the leaks which were affecting areas of the woodblock flooring

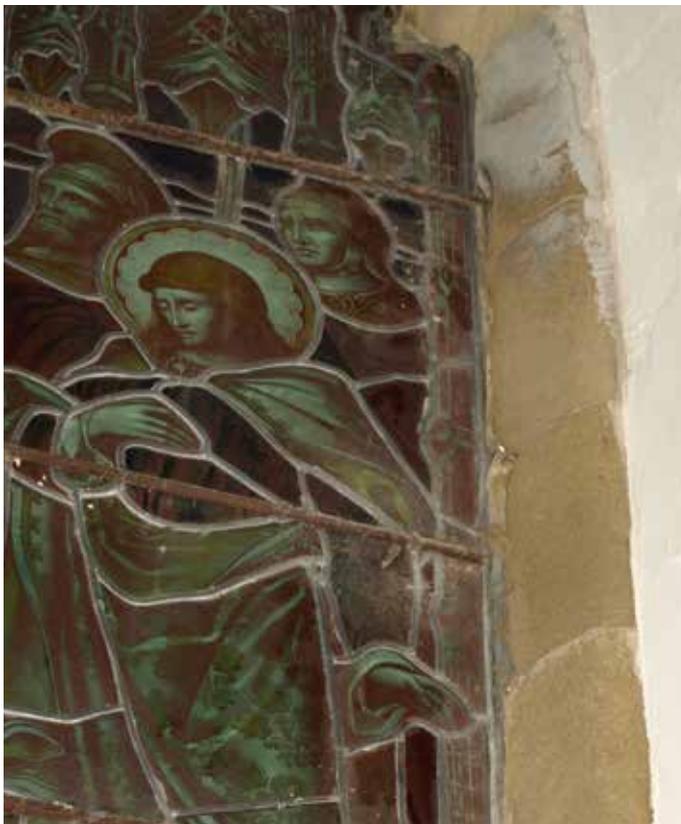
East window - no longer weather-tight due to erosion of the sandstone surround. Note also rusting saddle bars

The East window panels appear to be in reasonably good condition. However the window is compromised by the stone decay of the surround, and there are now visible gaps around the glazing in placed. Saddle bars are corroding. In urgent need of re-pointing in the short term.

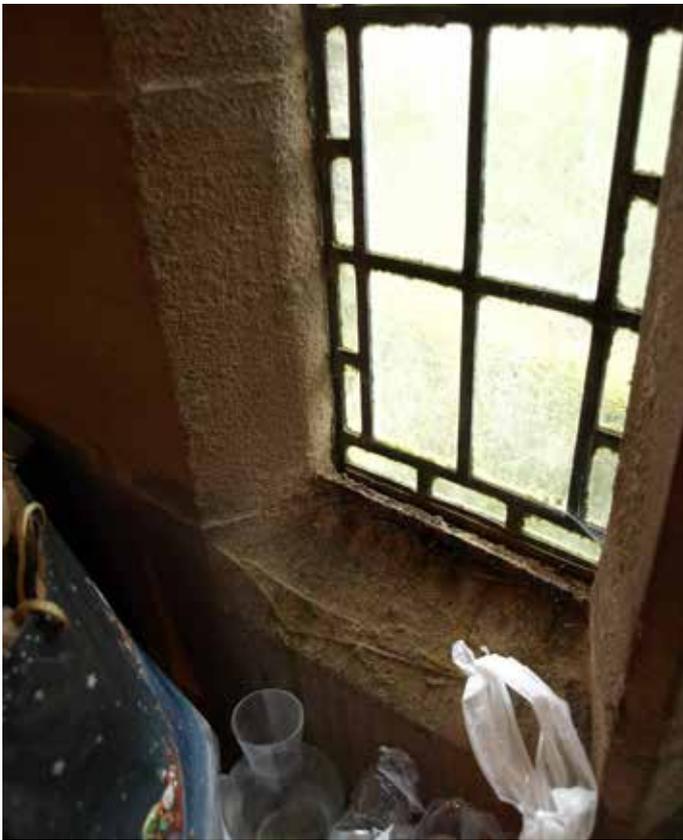
Vestry window (nII) in poor condition due to algae, stone decay, rusting metalwork

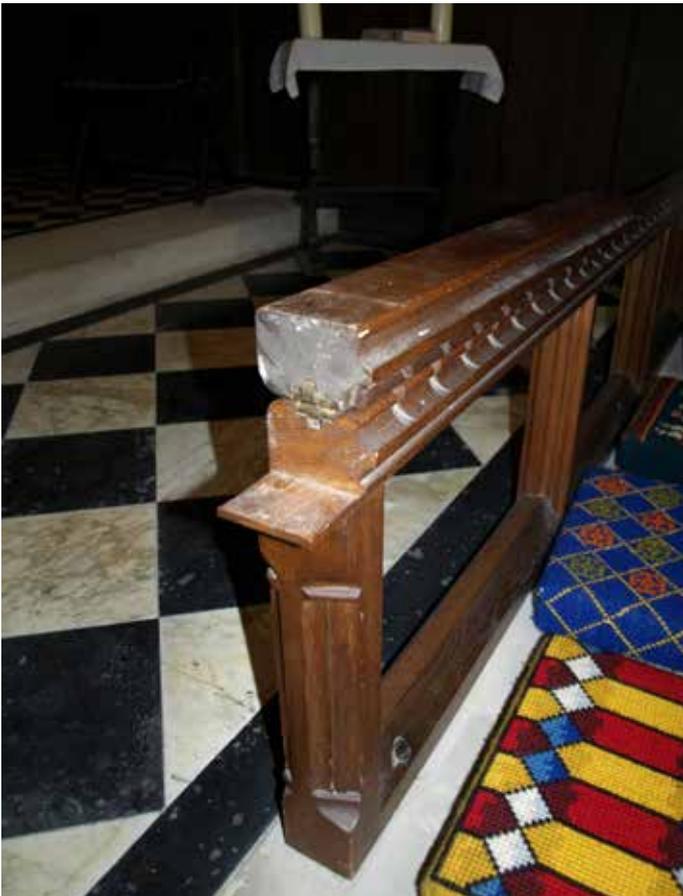
Altar rail hinges are badly worn, and the opening section lacks any proper support

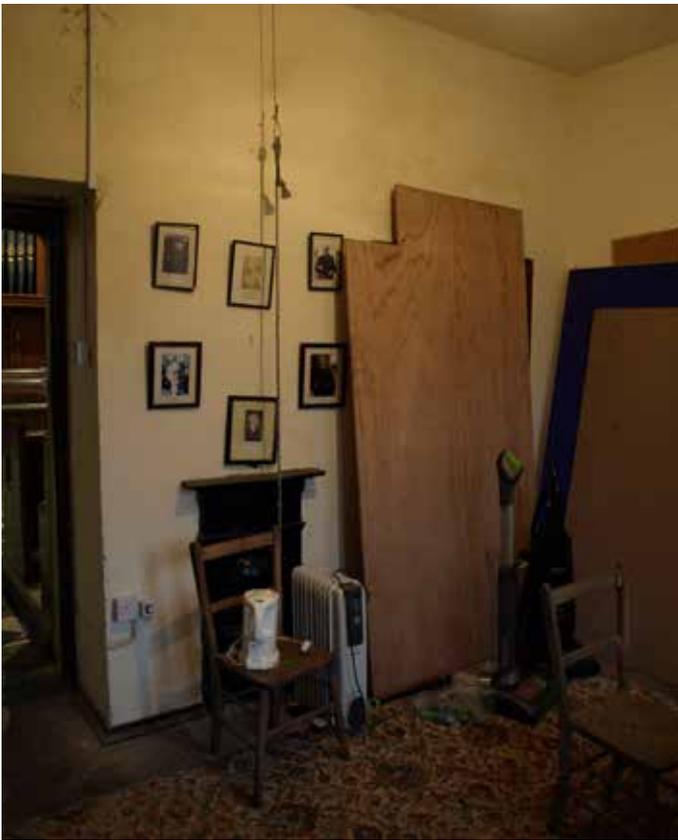
The Vestry is very damp. Remove stored materials, open the built-in cupboard, increase ventilation, remove pictures from damp wall. Fix source of water ingress

The walls and ceiling of the vestry are plastered and painted. As noted within the chancel the wall below the chimney and bellcote is suffering from severe damp. The moisture in the walls will be trapped, unable to evaporate due to the (suspected) cementitious plaster repairs and impervious paint finishes. To the fireplace wall there is a built-in cupboard which was inaccessible due to stored building materials. This should be made accessible and left permanently open to prevent a build-up of moisture within. The clutter should be cleared.

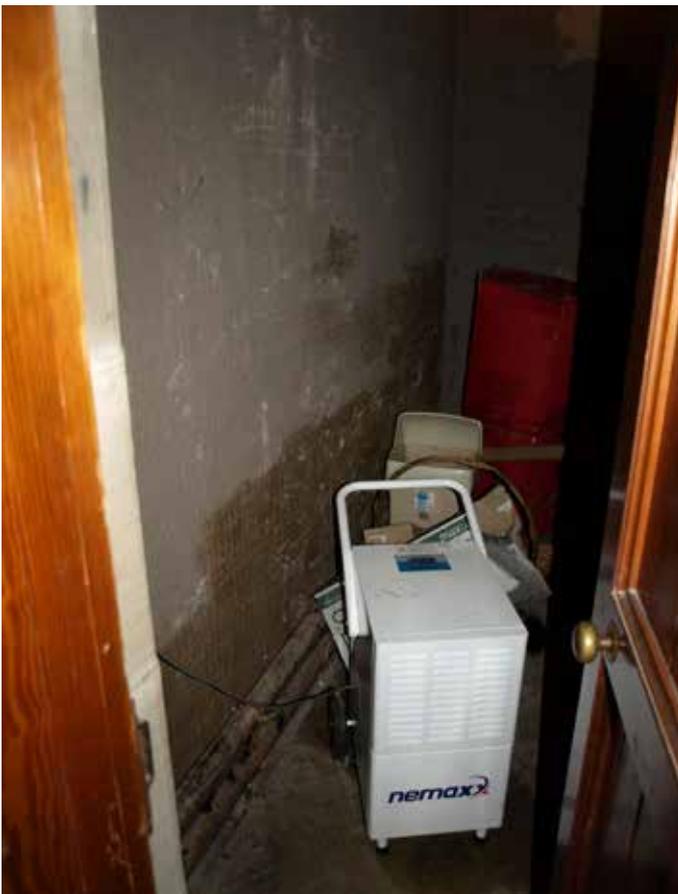
South Transept is extremely damp. Fix sources of ingress, remove plaster from walls, provide drain for dehumidifier so it can work, increase ventilation

g)	p. 26	Strip off internal render and plaster to east and south walls of South Transept (organ loft) back to exposed stone to allow walls to dry out. Monitor for water ingress above entrance to Chancel. Provide drain facility for dehumidifier	£1,500

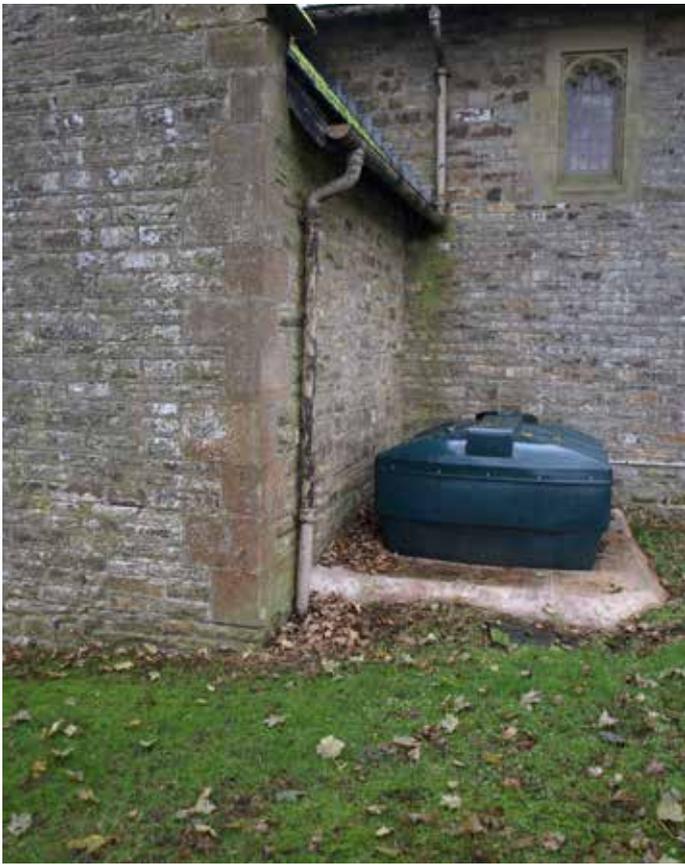
The plinth to the recent oil tank has been built above ground level against the Transept wall, causing damp to the base of the wall internally

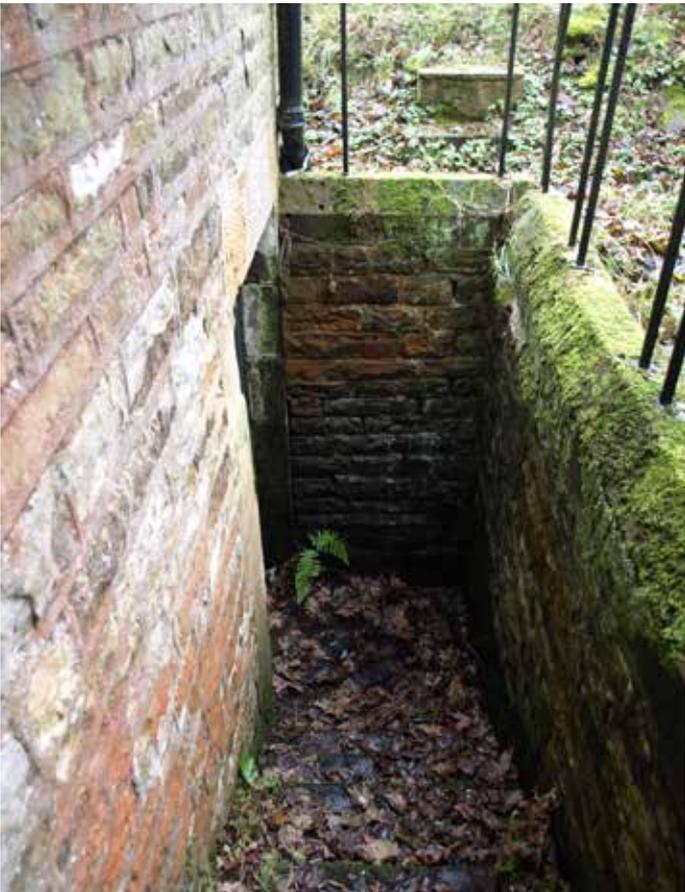
Boiler Room is very wet - a pump system should be arranged to drain the collecting water

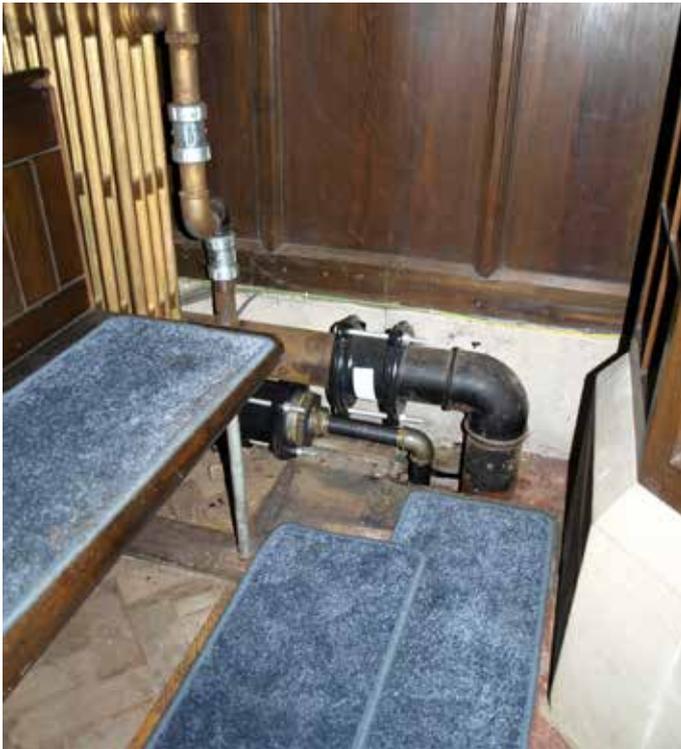
Floor trench to be filled following recent heating pipe repair

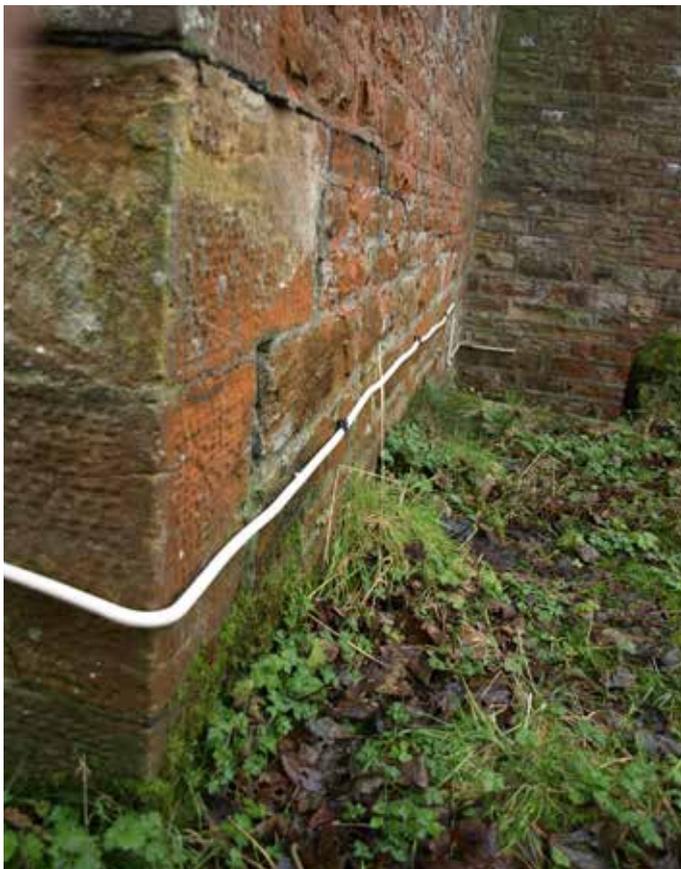
New feed pipe to boiler from recent oil tank installation

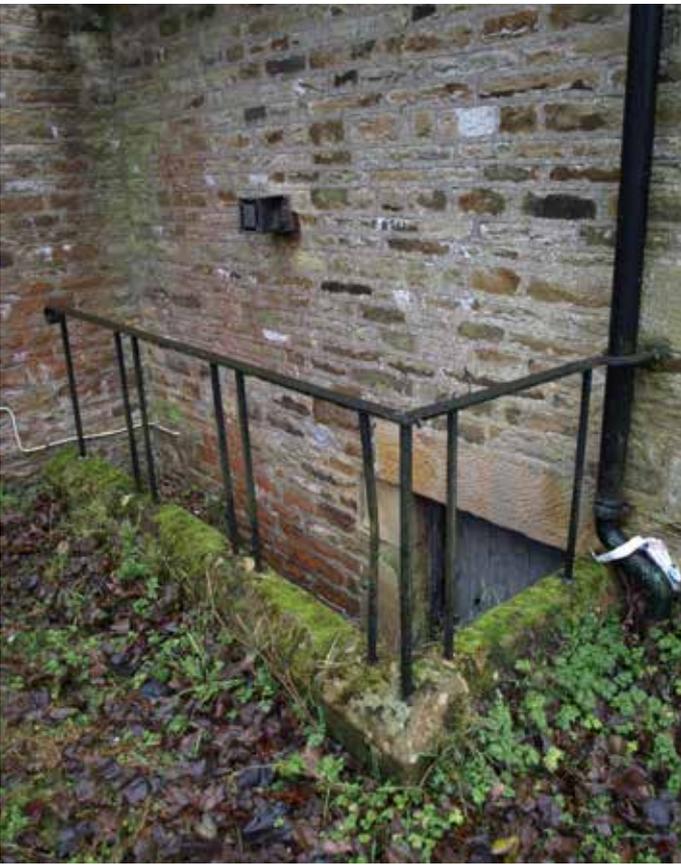
The railing around the Boiler Room steps is in need of repair - several of the vertical balusters are missing.

Railings to Boiler Room steps need to be repaired

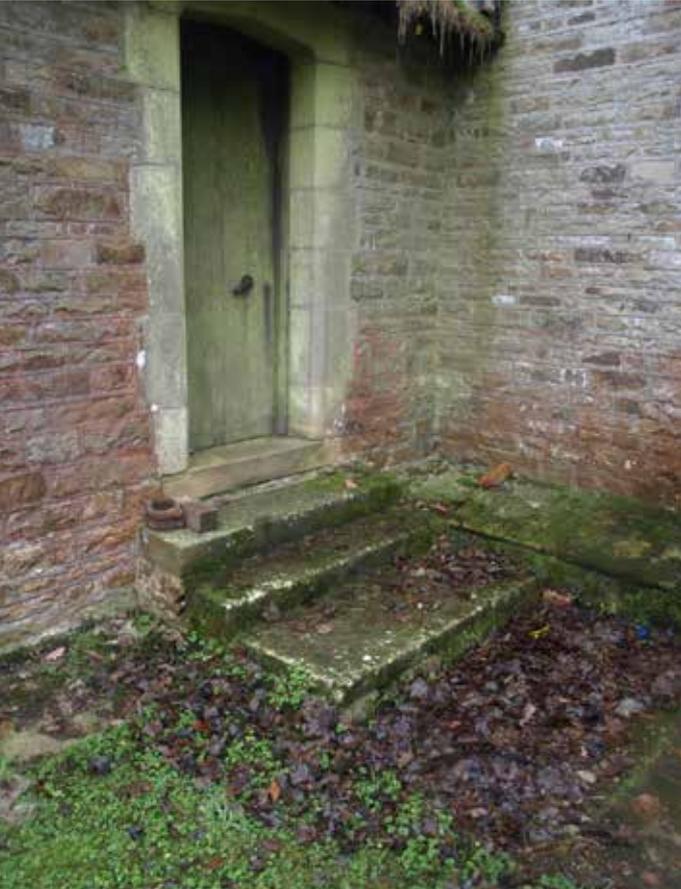
Accumulation of debris, moss, and vegetation to surfaces prevents drying out and leads to further colonisation. Debris on steps and paths is a safety hazard

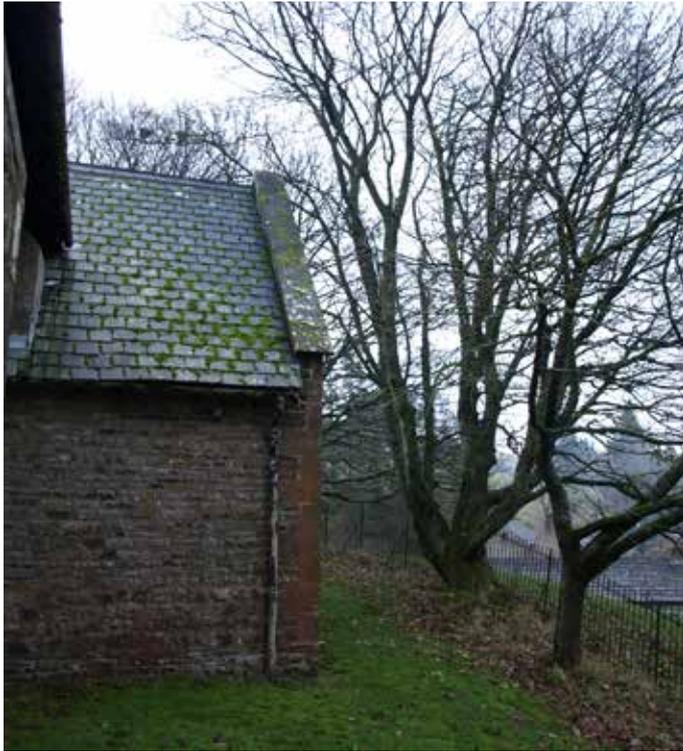
Trees adjacent to the South Transept are causing problems

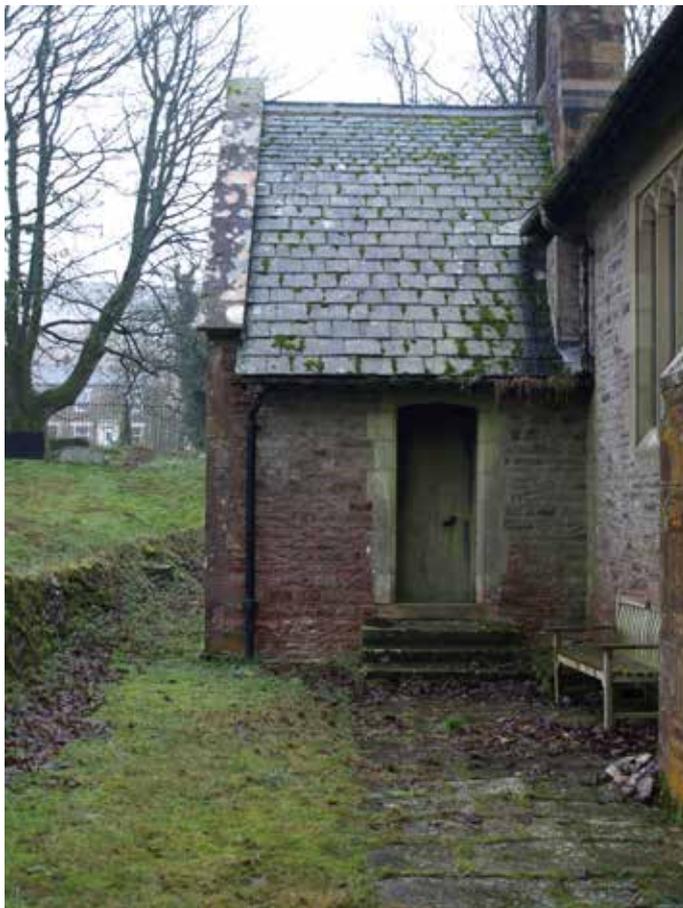
A build-up of vegetation around the building encourages damp conditions and prevents drying of the ground and walls at low level

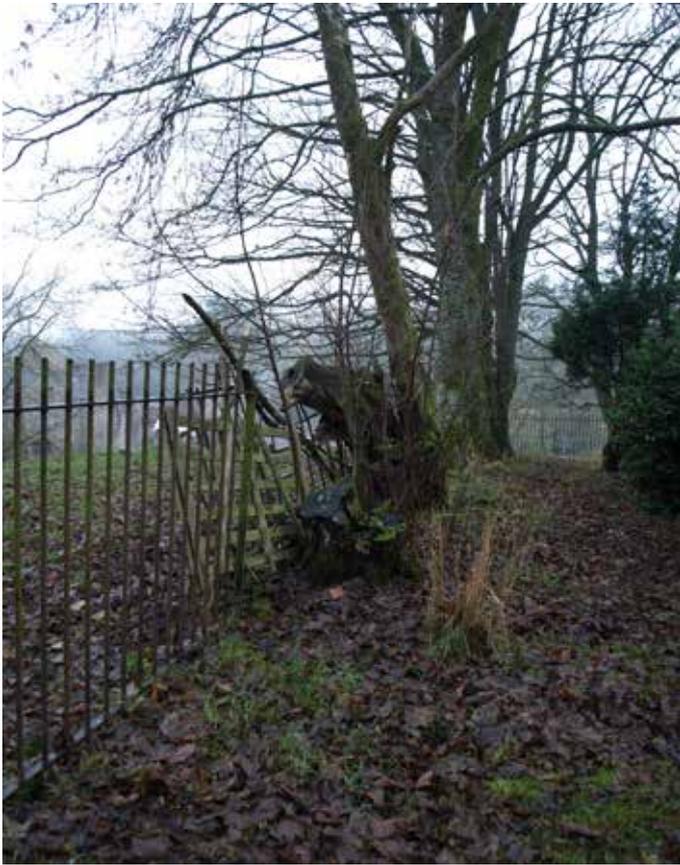
Damage caused by trees to boundary fencing should be made good

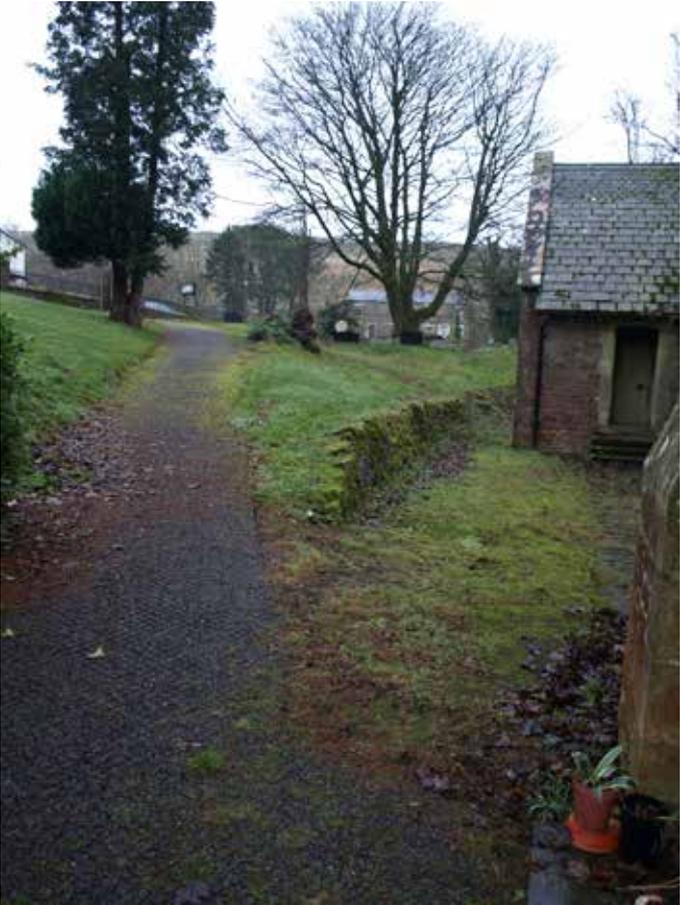
Gravel path with cellular reinforcement grid continues to work well

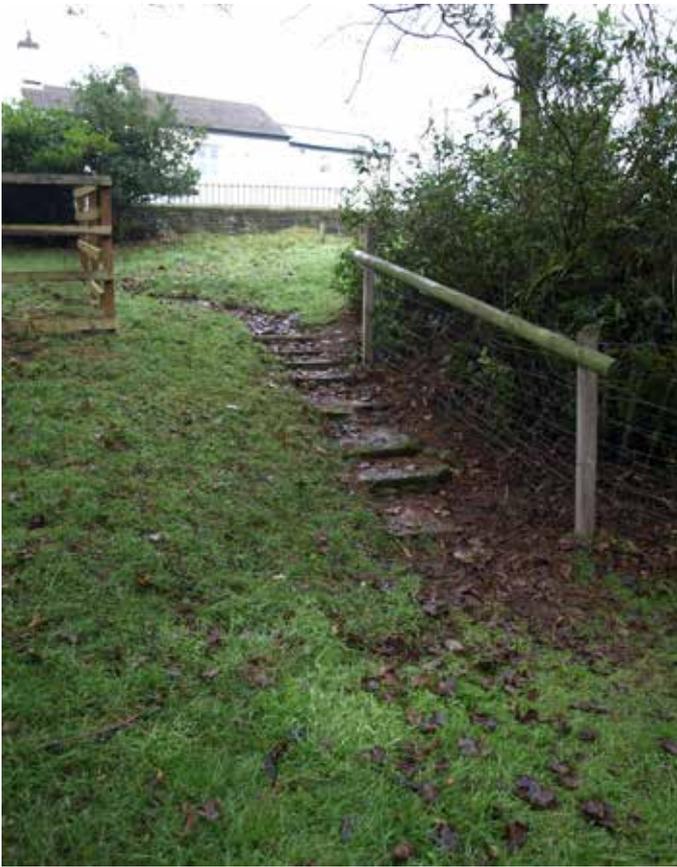
The path and steps up the adjacent Village Hall would benefit from a more formal handrail arrangement to assist those with impaired mobility

Steps up to the Village Hall would benefit from more appropriate handrailing
