# QUINQUENNIAL INSPECTION REPORT

## CHURCH OF CUTHBERT, HEBBURN

**Date of inspection:** 07.04.2022

**Date of report:** 11.04.2022

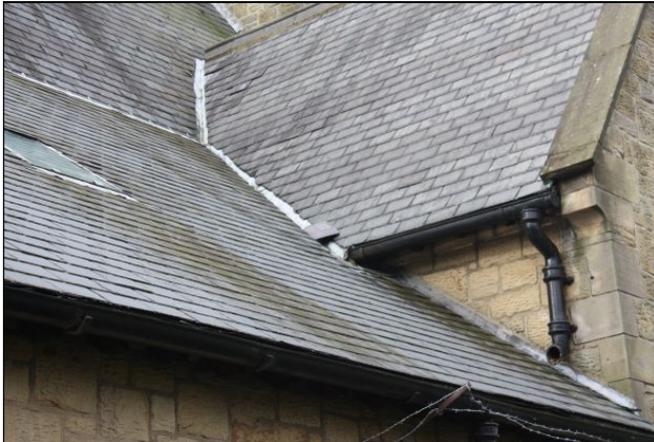
There are missing slates near the valley gutter between the Vestry and the Organ Chamber. These need to be refixed as soon as possible to prevent water ingress. The Vestry gutter is blocked with vegetation and is leaking badly at the eastern end. Clearing the blockage and sealing the leaking joint is needed. There is also some vegetation blocking the Nave north side gutter which needs clearing to prevent water overflowing to the wall heads.

Missing slates by Organ Chamber valley gutter

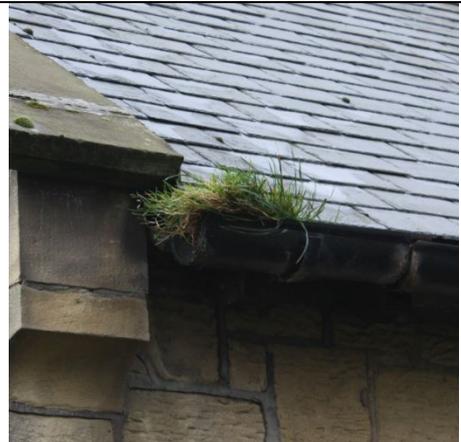
Blocked and leaking Vestry gutter

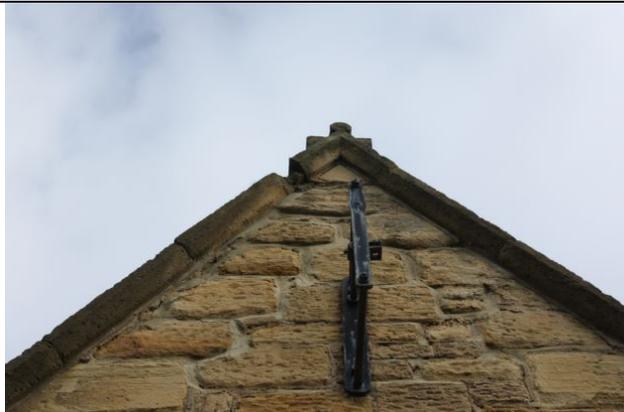
There are open joints to the gable copings (or water tabling) to the Porch and Chancel. These should be repointed to prevent water penetration of the wall heads.

The external walling and pointing are generally in fair condition. However, there is hard cement pointing to the Porch gable (above the door arch), and some parts of the Nave west gable buttresses. The hard pointing is resulting in some spalling of stone faces (as explained in the previous report). Removal of the old cement pointing and re-pointing in lime mortar set slightly back from the wall face is recommended to prevent further deterioration.

Porch gable - hard cement pointing, open joints to gable copings etc.

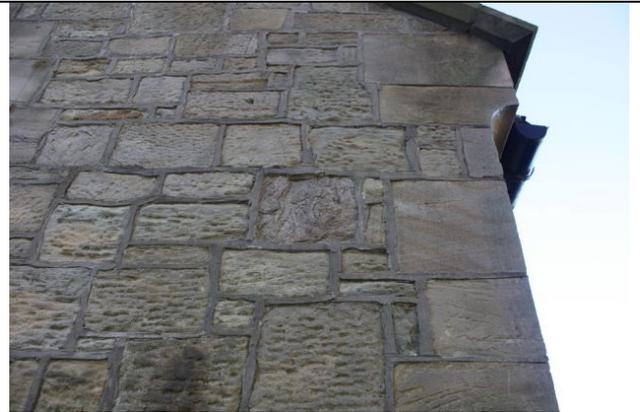
The Vestry east wall has ribbon pointing (the joints are set forward of the wall face), the mortar is also cementitious. Ideally it should be removed and replaced with lime mortar. Having said this the pointing and masonry are generally sound and if the hard ribbon pointing were removed it might cause more damage than good. I think it would be best to leave this for now.

Vestry east gable – hard cement ribbon pointing

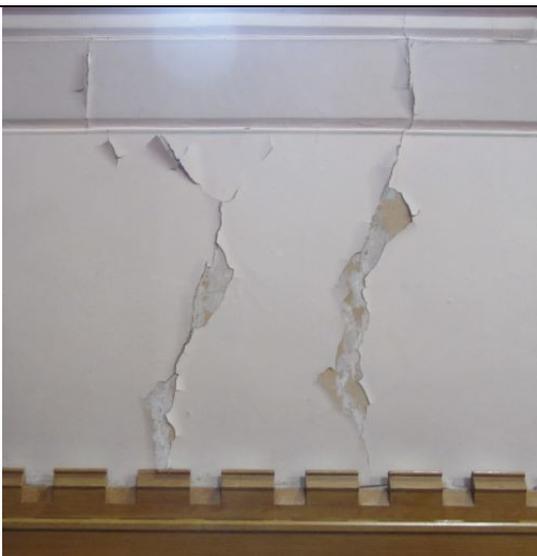
There are a number of historic cracks and localised areas of blistering plaster and paint (recorded in previous inspection reports). Most prominent is the cracked plaster near the pulpit which is unsightly and needs attention. The walls would benefit from redecoration should funding be available.

Nave walls – unsightly blistering paint

The blistering plaster & paint patches would best be repaired. D

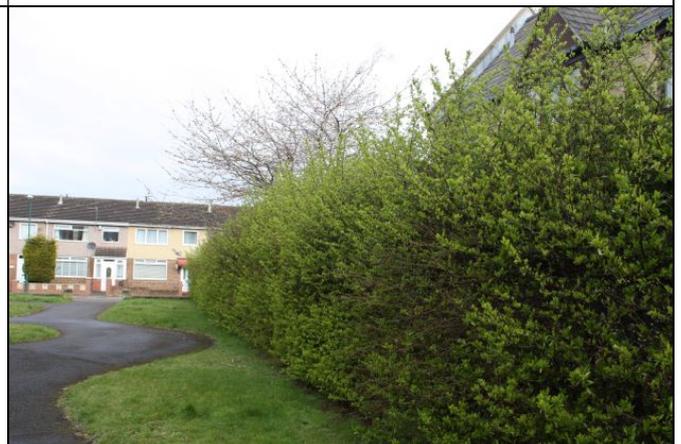
Hedge to Vicarage in need of pruning

The churchyard is in a tidy condition. Pointing of open joints in the boundary stones is recommended along with pruning of the hedge on the vicarage boundary.
