ST NICHOLAS, HEDWORTH

DIOCESE OF DURHAM

QUINQUENNIAL INSPECTION 2023

Tony Barnes, BA, B'Arch RIBA

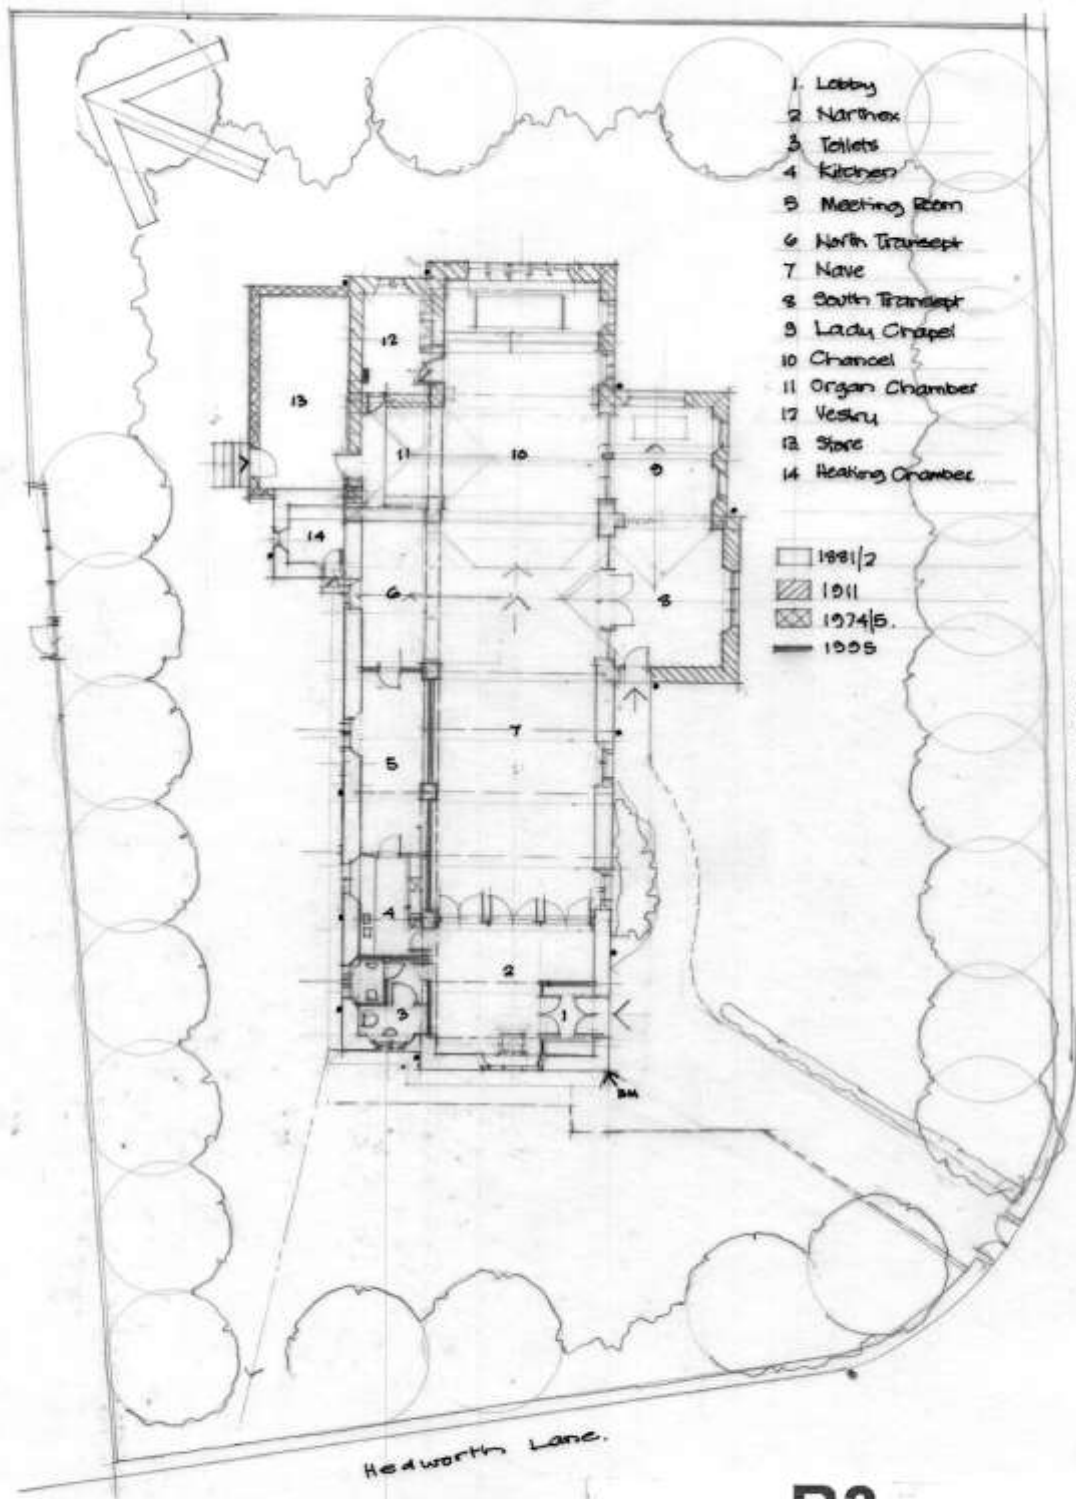
St Nicholas, Hedworth 1603
 Floor Plan SK1
 Nts Feb 2016

- 1 Lobby
- 2 Narthex
- 3 Toilets
- 4 Kitchen
- 5 Meeting Room
- 6 North Transept
- 7 Nave
- 8 South Transept
- 9 Lady Chapel
- 10 Chancel
- 11 Organ Chamber
- 12 Vestry
- 13 Store
- 14 Heating Chamber

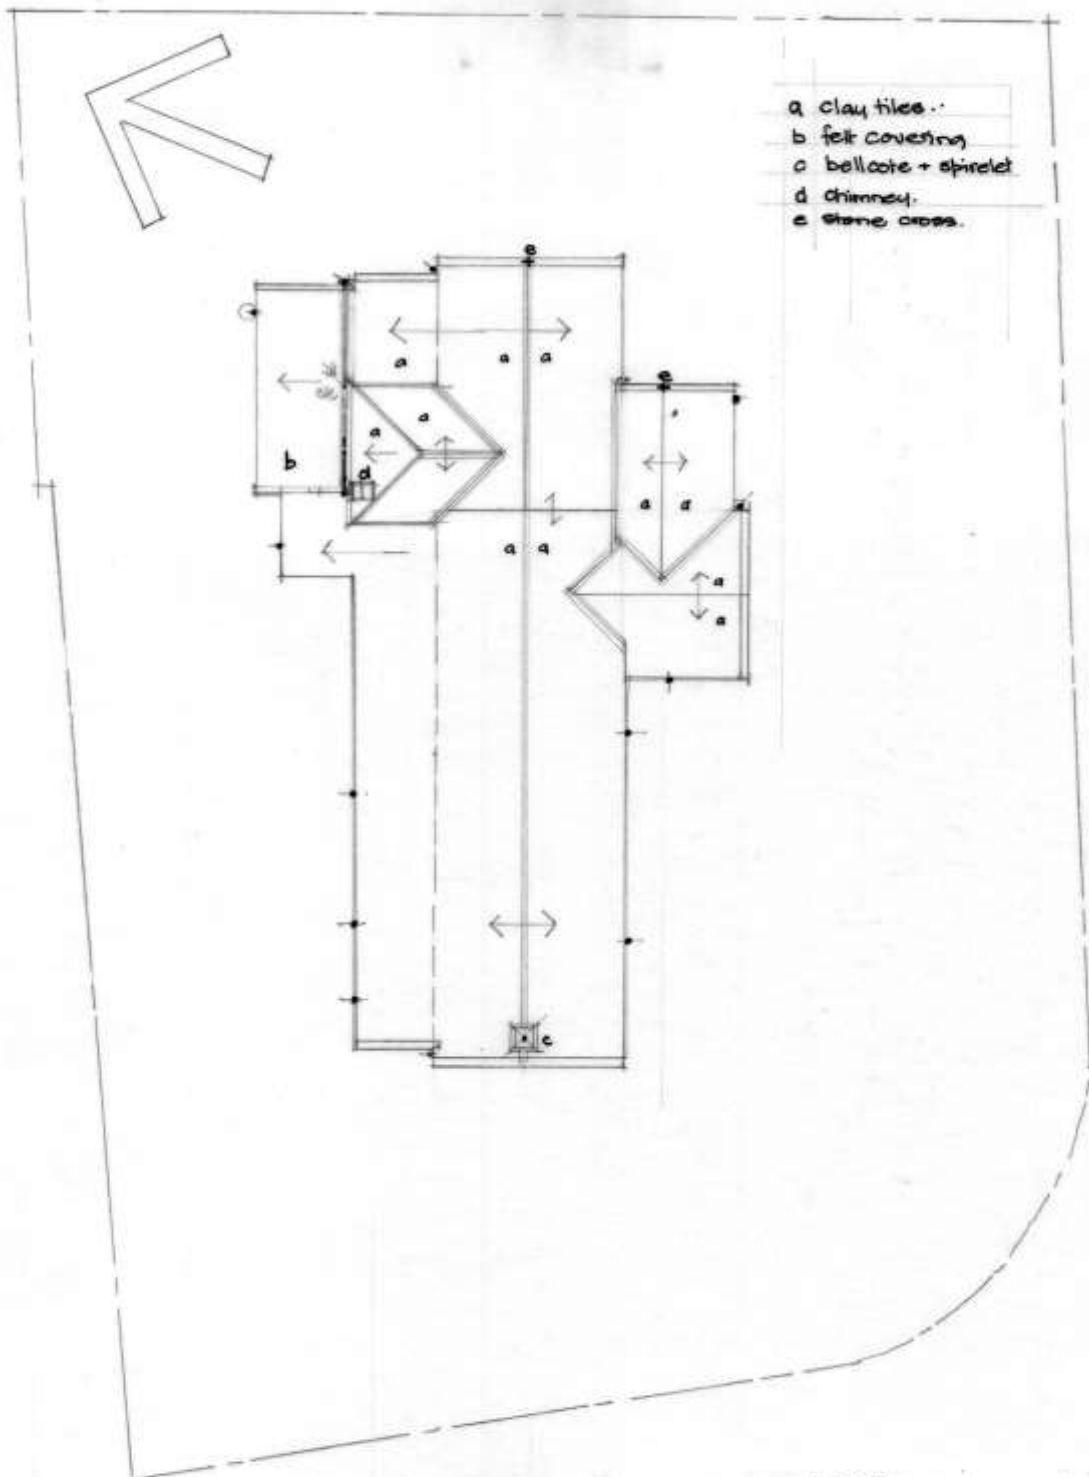
St Nicholas, Hedworth 1603
 Roof Plan SK2
 Nts Feb 2016

- a clay tiles.
- b felt covering
- c bellcote + spirelet
- d chimney.
- e stone cross.
