2021 QUINQUENNIAL INSPECTION REPORT

CHURCH OF ST. JOHN, INGLETON (Ref.2120)

Date of Report: 10th September 2021

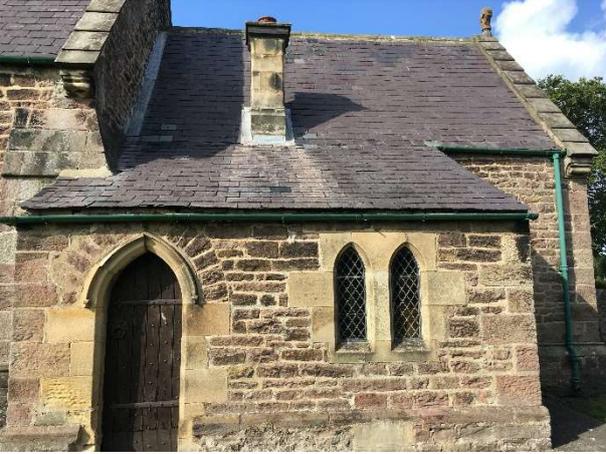
1. All roofs are Welsh slated at 55° pitch except for vestry and former boiler at 30° pitch.
2. Nave south intact though 2No. slipped upper slates and several repaired slates on upper courses. Mortar fillets cracked and loose against gable copings. North side also intact with several repaired upper slates and light moss growth. Stone ridge intact.

3. Chancel south intact though 2No. slipped and many repaired slates especially around stack and at swept junction to vestry. Mortar fillet intact to gable coping, wide remedial lead flashing at nave abutment. North side intact, flashings as south, light moss growth between slates. Stone ridge intact.

<p>Condition: Welsh slate roofs in reasonable condition though many previous repairs and chipped slates. 2No. slipped to Chancel south ad nave south.</p> <p>Repairs: Securely clip 4No. slates and check remainder.</p>	B(M)	120

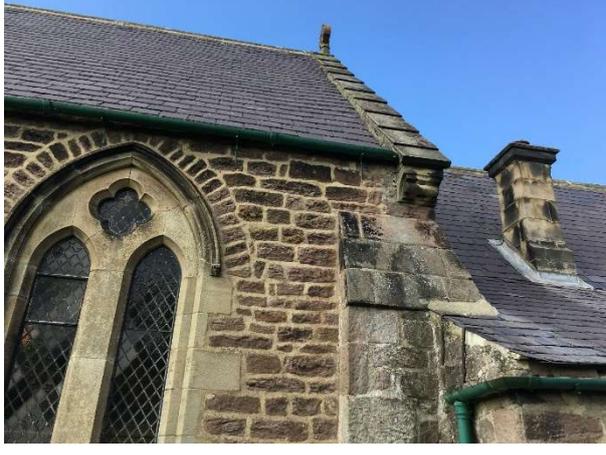
<p>Condition: Cracked mortar fillets to nave copings, vestry verges and porch ridge.</p> <p>Repairs: Replace mortar fillets and pointing</p>	D(M)	120

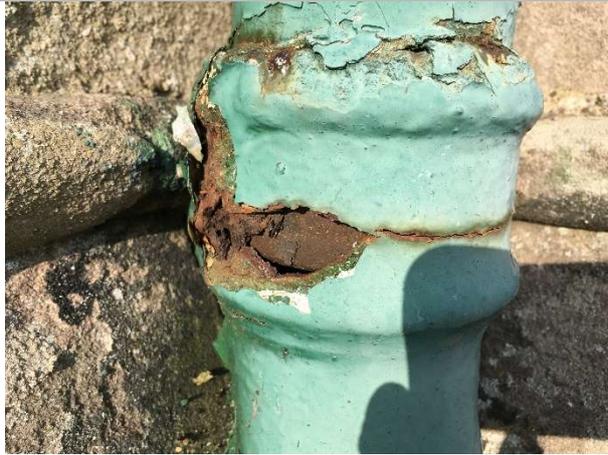
1. 120mmØ half round cast iron gutter on drive-in iron brackets to north and south, painted green. Poor alignment nave south side to central outlet. Leaks at joints and open end to east appears to be leaking down stonework. Nave north also leaking at joints and ponding east end. Chancel north and south sides are corroded and leaking adjacent outlets. Vestry gutter appears in good condition.
2. 80mmØ cast iron RWP, except for 65mmØ north side of nave, are secured by iron straps. South side of nave has broken and corroded collar, north side has reducer at head which can lead to a blockage. Paint flaking and missing generally.
3. No gutters are present on porch, water just splashes onto wall and ground adjacent.

Condition:
Gutters corroded and leaking at joints. Also poor alignment to nave.

Repairs:
Dismantle all but vestry gutter, clean, repaint and reassemble with new where required.

B 800

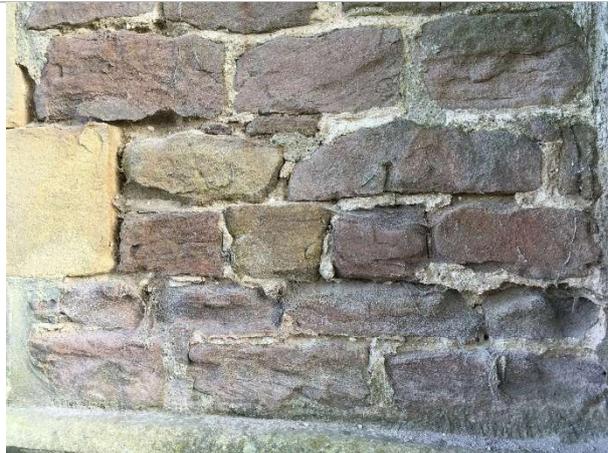
1. Pale lilac sandstone with buff sandstone window and door surrounds and copings. Original lime mortar eroded and weak. Patch pointing mainly in cement mortars is contributing to damp ingress and erosion of stones adjacent. Also 2No. areas of cement render south side of nave and at low level on vestry.
2. Minor crack through west cill south side of nave.
3. Shallow corner buttresses have open joints below copings where rainwater is entering.
4. 2No. small plastic airbricks to nave south, 2No. cast iron airbricks to north blocked with gravel and metal covers, preventing subfloor cross ventilation. Third cast iron airbrick to nave north and fourth to chancel north, though partly blocked by soil.
5. Many joints have eroded mortar at ground level.

Condition:
Eroded lime mortar, unsuitable cement repointing and missing mortar at ground level.

Repairs:
Prepare specification to replace defective mortar, beginning with the worst affected areas.

D 1800

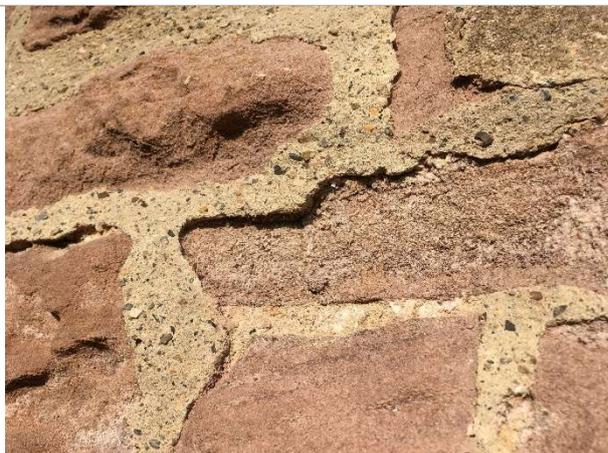
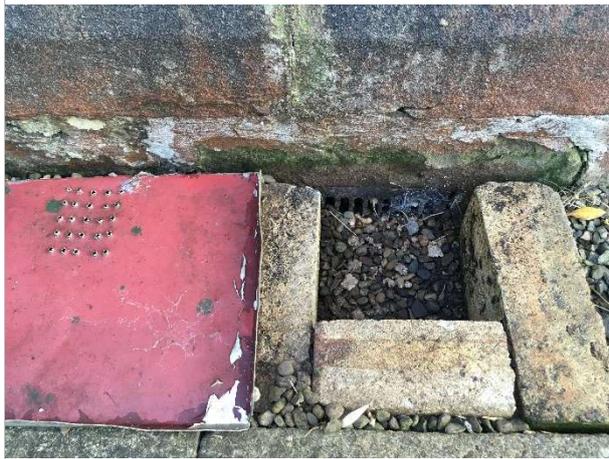
Condition: Insufficient ventilation to sub-floor caused by blocked air bricks and sheet metal covers. Also corroded air bricks.		
Repairs: Clear all obstructions.	A(M)	30
Replace corroded airbricks.	E	300

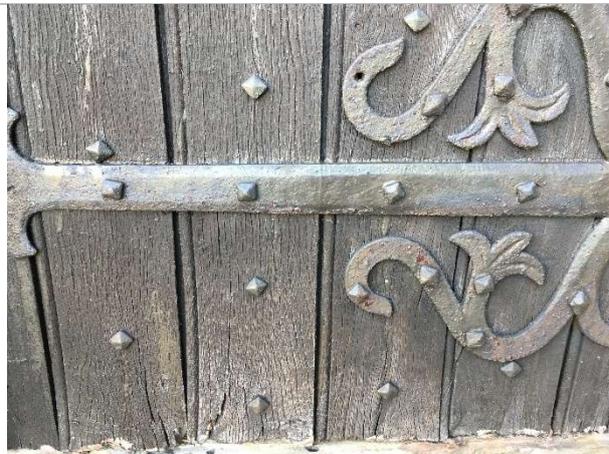
1. Porch has wide arched oak door which closes against stone face, with ornate strapwork, ring pull and studs. Timber weathered on lower face, ironmongery beginning to corrode.
2. Vestry has similar narrow door, again with weathered lower face.
3. Former boiler room is similar to vestry, except for 250mm extension on lower edge where floor level appears to have been lowered.

Condition: Weathered oak on 3No. external doors, ironwork corroding.		
Repairs: Prepare, repaint ironwork and oil timber.	B(M)	300

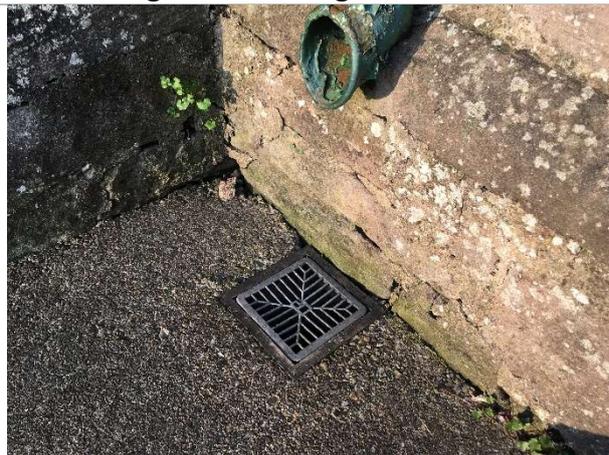
1. South nave and vestry RWP shoes discharge over flush plastic grilles in concrete paths causing much water to miss and run to ground. This is especially so on Vestry where shoe is 350mm above grille, and concrete runs down towards building.
2. Chancel north and south sides, and nave north side run to clay dishtops but informed that there are no drains beneath. A wet area of ground adjacent the north dishtop where ground level runs down towards the building means that water could be running beneath the church.

Condition: Water missing gully and running below foundation.		
Repairs: Neatly cut out concrete, reposition gully away from wall and form kerbed funnel to catch water.	A	200
Condition: Informed that 3No. RWPs run from dishtops to ground.		
Repairs: Investigate, install new gullies and pipes to new soakaways.	A	?

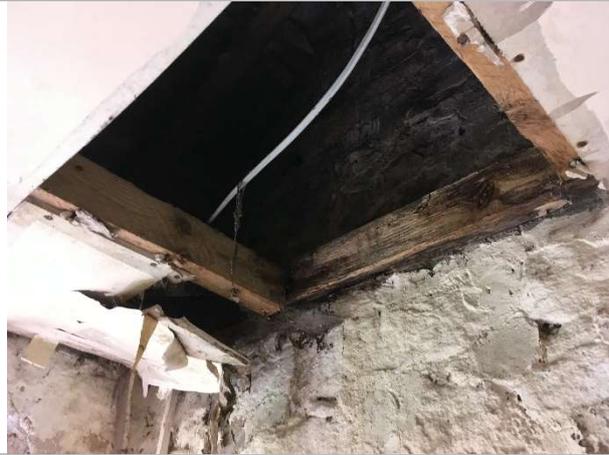
Condition:
Former boiler house has decayed joists and plasterboard.

Repairs:
Remove defective plasterboard and joists, investigate cause of water ingress.

B(M)

100

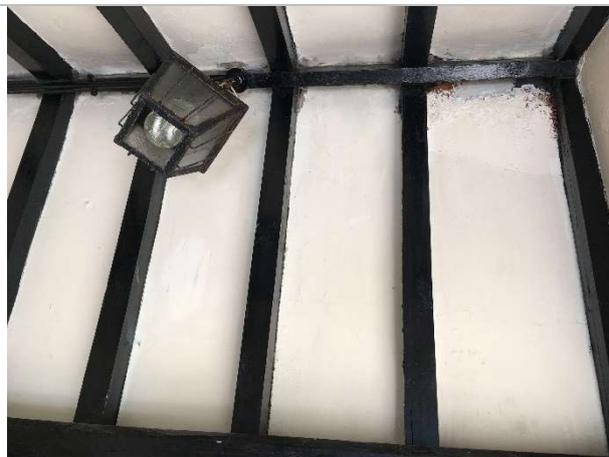
Condition:
Porch plaster ceiling damaged by water ingress.

Repairs:
Replace damaged plaster and repaint.

E

400

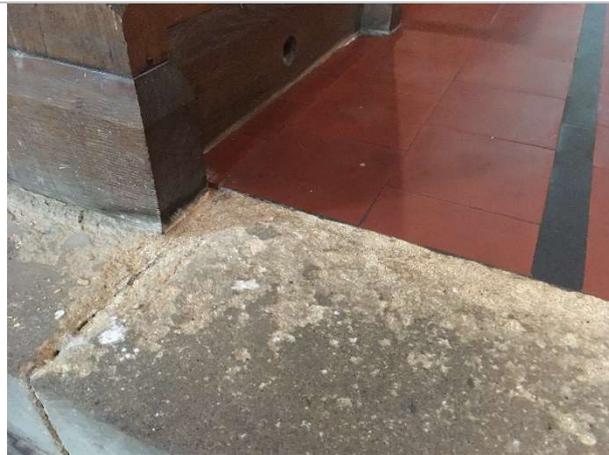
Condition:
Stone steps damaged by dampness from below.

Repairs:
Repair drainage (see 9.7) and improve ventilation (see 9.4).

A

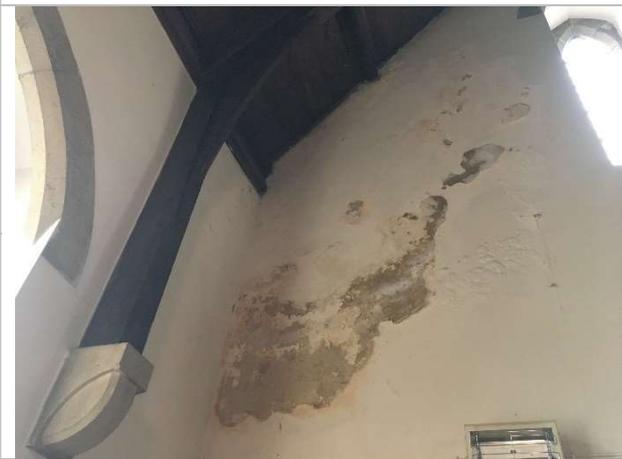
<p>Condition: Plaster damage southwest corner of nave.</p>		
	<p>Repairs: Cut out and replace plaster, re-paint.</p>	D	600

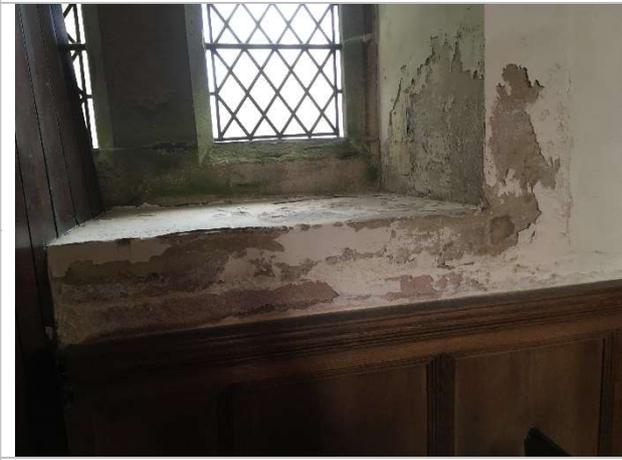
<p>Condition: Plaster damage north side of nave.</p>		
	<p>Repairs: Cut out and replace plaster, re-paint.</p>	D	180

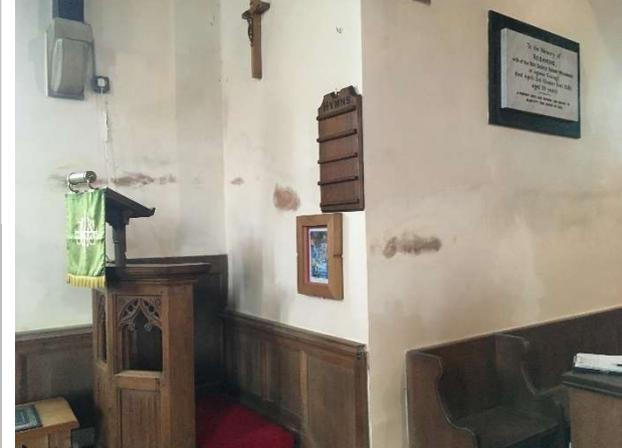
<p>Condition: Plaster damage around pulpit.</p>		
	<p>Repairs: Cut out and replace plaster, re-paint.</p>	E	400

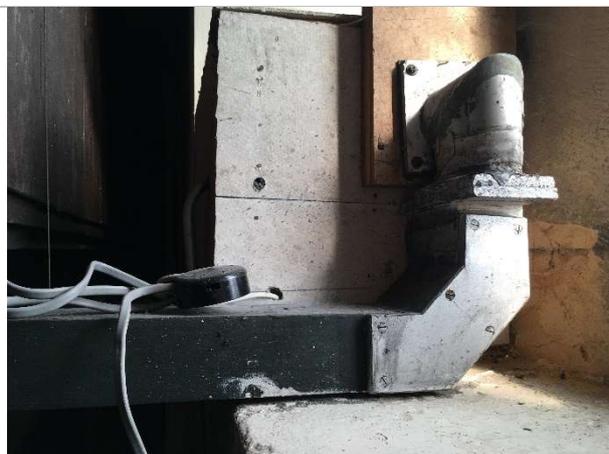
1. Harrison & Harrison organ refurbished recently and said to work well. Blower box noisy, situated on window cill behind with asbestos cement panel cladding.

1. Asbestos panels to organ blower box.
2. No evidence of an asbestos survey having been carried out.

Condition: Asbestos in organ blower.		
Repairs: Carry out asbestos inspection and report. Remove or mitigate as necessary.	A	?
