**St ANDREW
LAMESLEY**

QUINQUENNIAL REPORT

on the architect's inspection on

11 October 2021

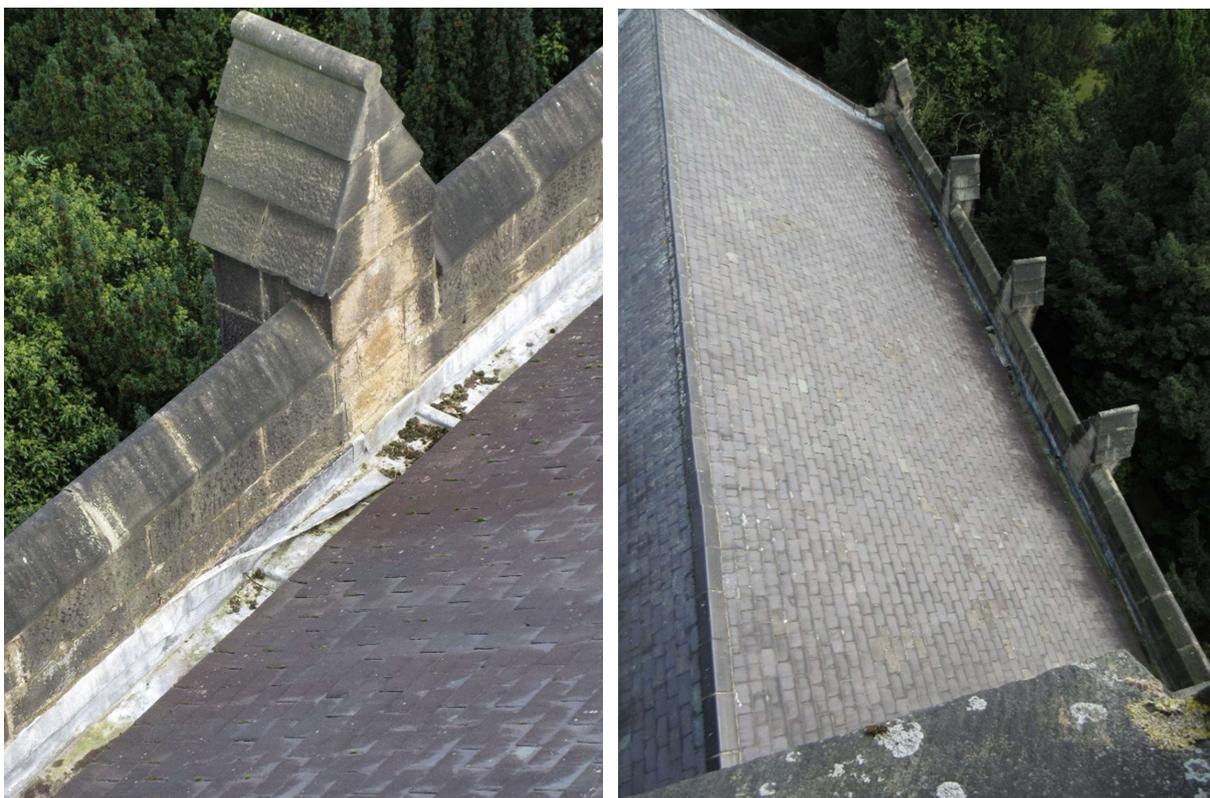
12. Nave slates probably fully relaid in 1957 when it is recorded the parapet gutters were reformed on concrete. Large welsh slates with lead soakers and tall lead cover flashings. Access to slates by door from Tower with hand rail.
13. The lead parapet gutters have centre roll joints, and two sumps with large side outlets. Minor silt in gutter ends. At N gutter two lengths of lead cover flashing are loose or fallen into the gutter so some risk of leaks.

Cover flashing at centre of N Nave fallen out

Refix loose lead cover flashings at N Nave roof gutter	13
Obtain new periodic electrical test report	74 and Addendum
Obtain new Lightning Conductor test report	81 and Addendum
Service fire extinguishers	82

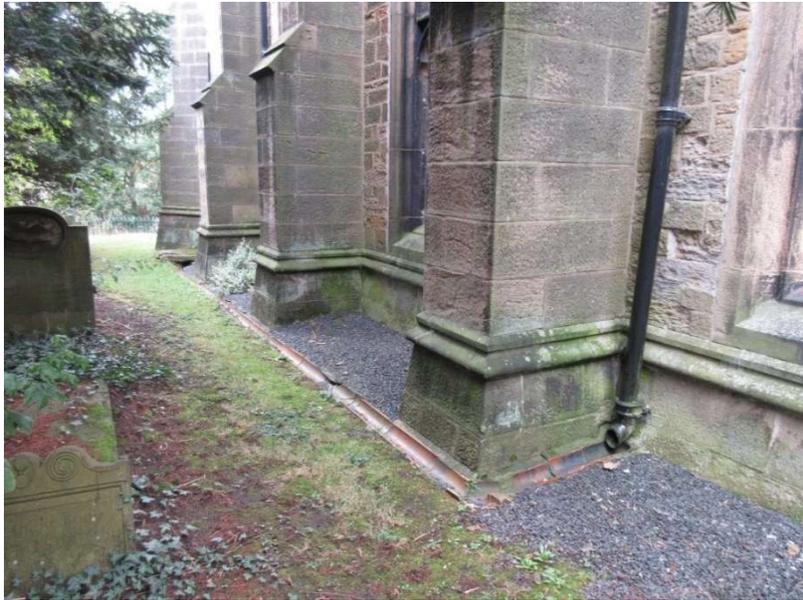
16. S Chancel – plain small half round cast iron and round pipe to earthenware gully, well painted, sound. Assumed short drain to soakaway.
17. S Nave – hoppers and larger cast iron round pipes to ground channels made of socketed earthenware half pipes in the ground to an apparent soakaway pit near the SW corner. Some channels are cracked and some part clogged with stone chippings which could stop good storm drainage.

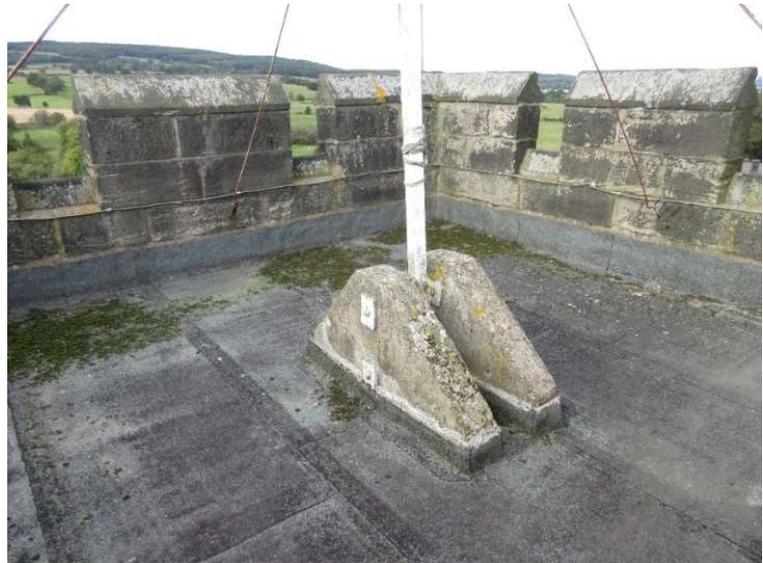
26. The Tower roof is flat felt falling E to a box gutter with bottom outlet through wall to a hopper. Plants at the outlet removed at the inspection. Silt may need removal every other year. Felt slightly mossy but appears sound except a small blister next to the turret. High upstands well pointed into parapets. The hatch covered with sheet metal, tied down.

Outlet from Tower roof, before plants removed at inspection

Continue to clean and where practical improve ground drainage to send water further from building	47, 48, 54, 56
Clean tower roof and gutter say every 2 years	26
Check rainwater pipe at SW Nave remains clear	57

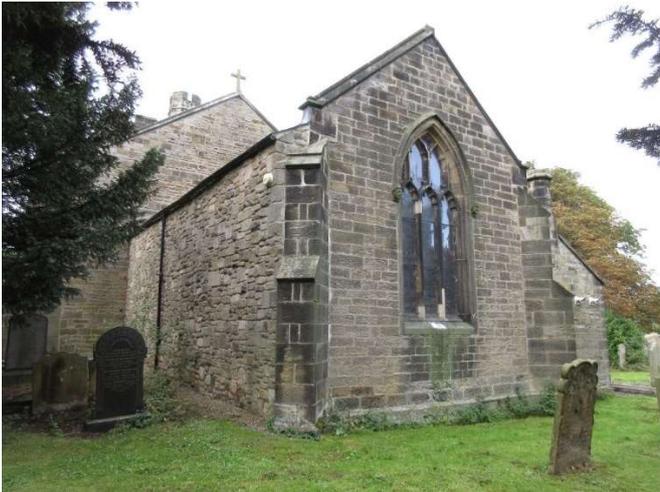
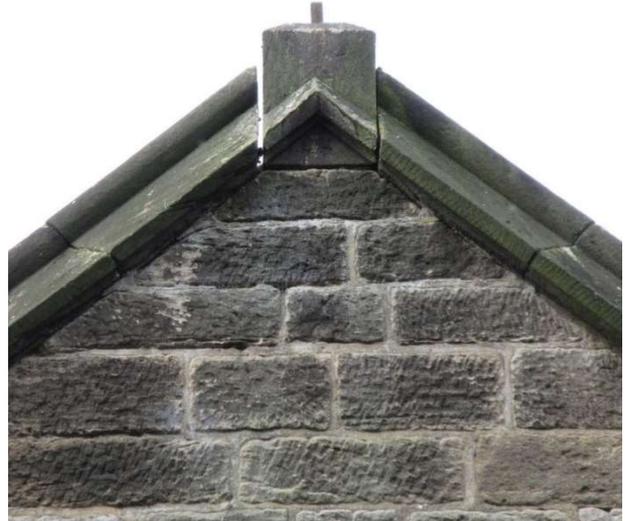
31. E gable - Ridged coping, coursed stone and pointing good. Open joints each side of the peak block which looks like the base of a missing cross.

Prepare and paint flag pole and its stays	27
At E gable lift and rebed the peak block filling joints	31

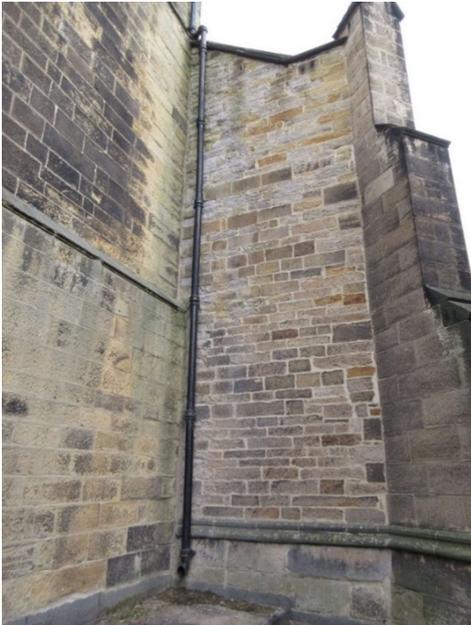
36. W Nave S side – good but some surface decay in some courses, mainly behind the tower rainwater pipe especially towards top where some joints open. Mostly modern cement pointing which may speed decay. N side good but scattered surface decay mid to bottom.

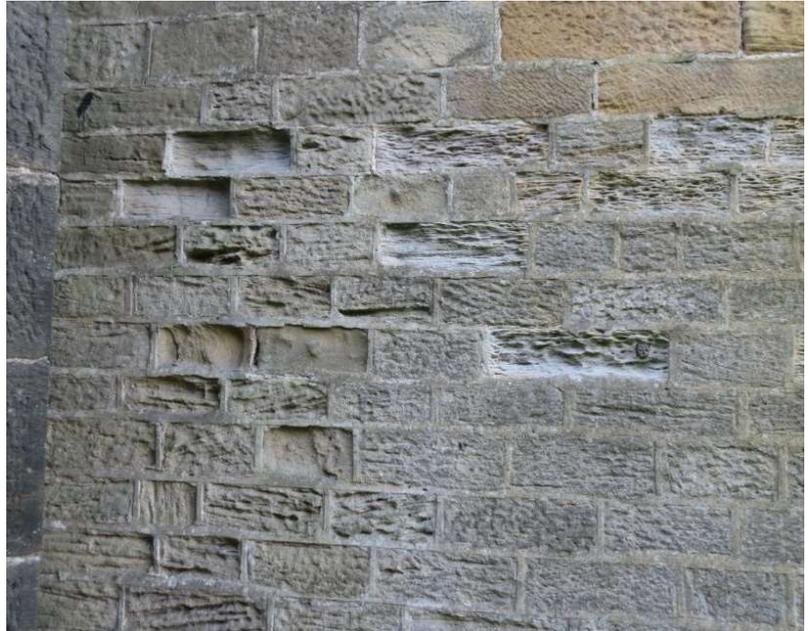
E wall of vestry

37. N Nave – good. Wide pointed joints over 2nd window from E means minor past spread, now ceased.
38. Vestries – good except a very few open joints. E side good except about 10% scattered stones decaying very slowly. Chimney good.

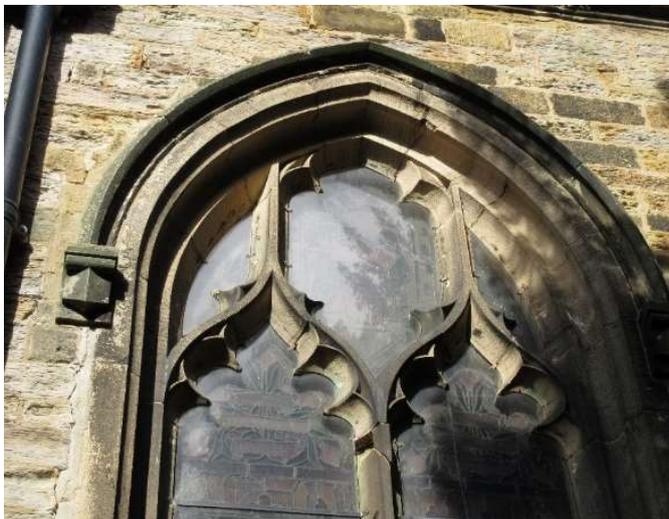
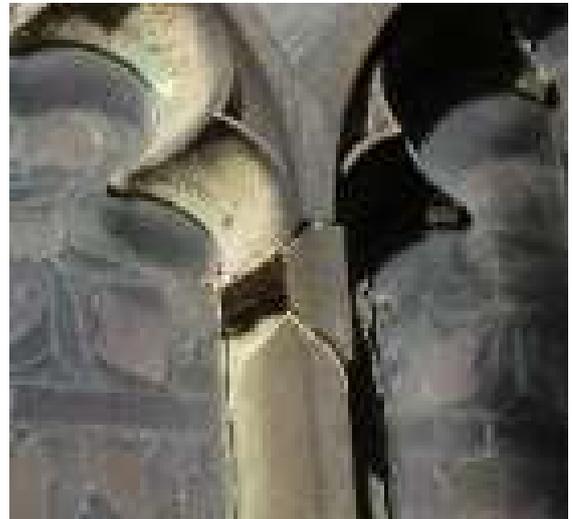
S Nave 3rd from E

S Nave 3rd - one mullion well repaired with stone indents but further small loss of stone from the broken top of the mullion. Very minor displacement of tracery.

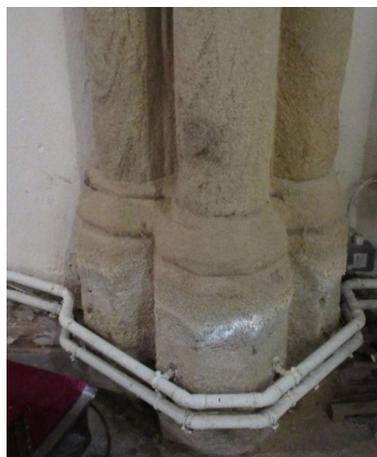
47. Chancel arch good. Tower arch good, minor stone decay at head height S side (corresponds to stone decay behind the Tower rainwater pipe – para 18).

decayed SE respond

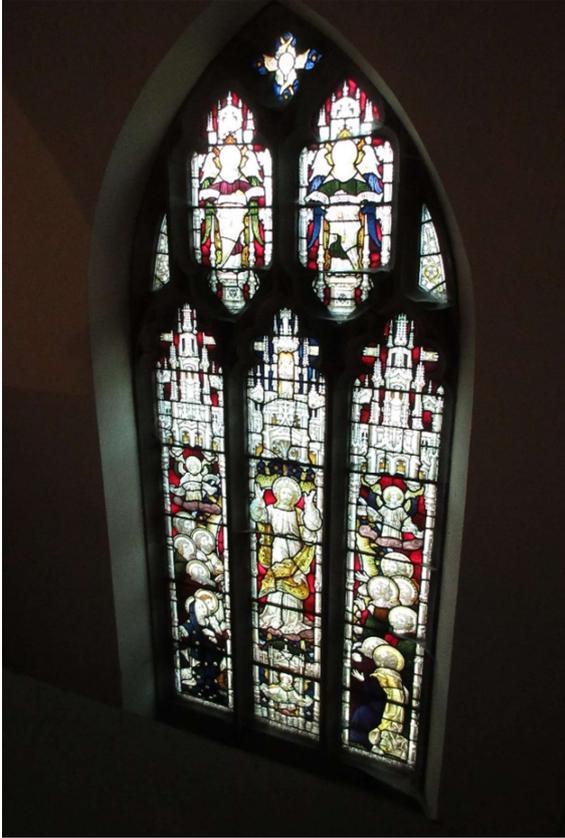
W window hidden by Organ
