**Quinquennial Inspection Report
Parish Church of St Andrew Leam Lane
Diocese of Durham**

Report prepared by

David Jowett - Architect, BA, DipArch, RIBA
25 Roseworth Avenue
Gosforth
Newcastle upon Tyne
NE3 1NB
Tel: 07788 710 204
email: david@davidjowett-architect.co.uk

27 February 2023

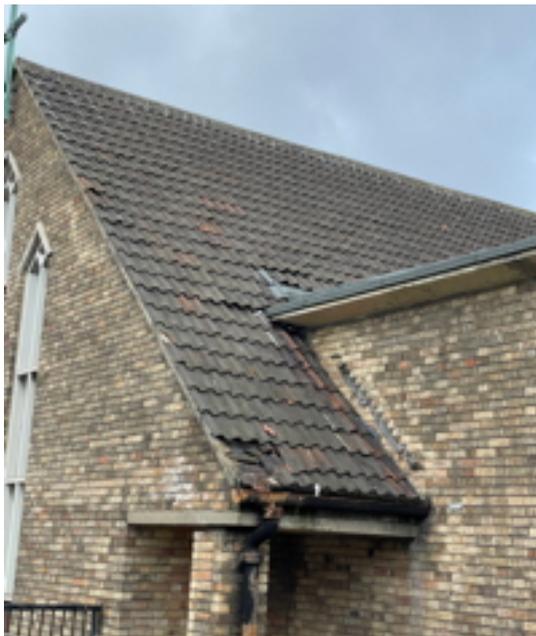
**Missing tiles and flashing
south west corner**

There are missing tiles and lead flashings to the south west corner that appear to be the result of vandalism. Loose tiles to the south side flat roof may be where the original tiles have been deposited. The flat roofed areas are not generally visible from ground level but extensive areas of staining internally indicate past or present leaks. Staining internally indicates problem with junction of clerestory and panelled rods at both north and south elevations east end. An area of felt pin over the eaves fascia to the link corridor west elevation indicates a temporary repair. A section of timber along the eaves to the hall north side again indicates temporary repair.

Undertake full inspection of roofs and flashings by reputable roofing company and implement recommendations. Cost Band 2– £2,000-£9,999.

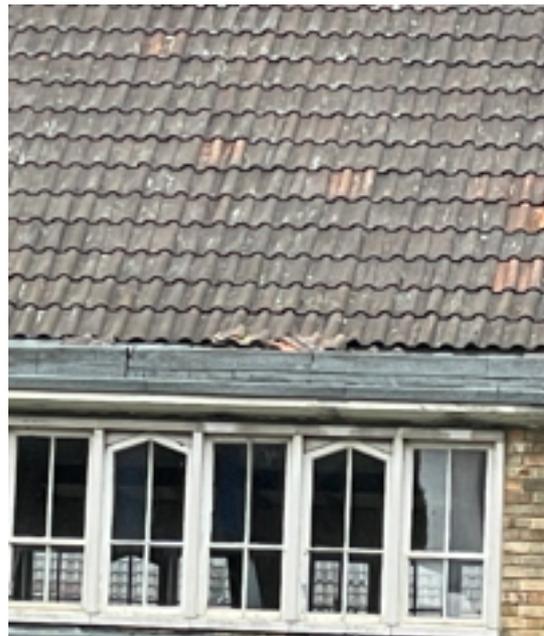
Loose tiles to south flat roof

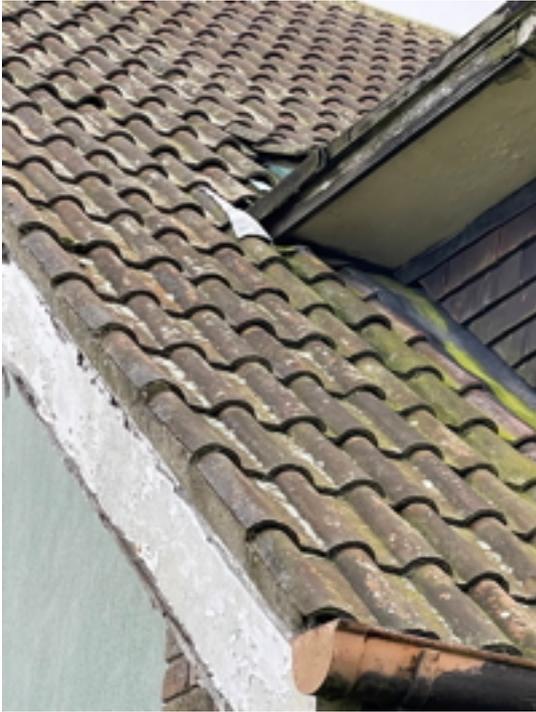
**Possible leaking roof junction
north east corner**

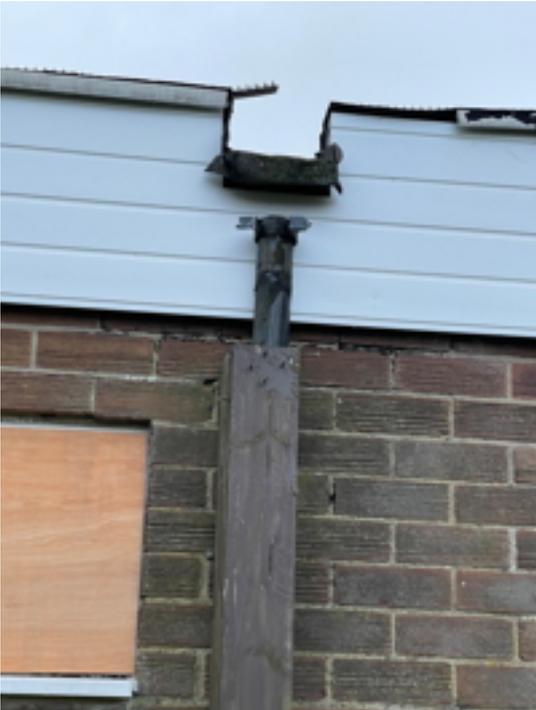
Missing hopper head to Hall west elevation

It was not possible to tell if everything is fully watertight, as it was dry at the time of the inspection. However there are clearly issues with a number of cast iron rainwater pipes that have split. There is a missing hopper head to the Hall.

Replace split sections of rainwater pipe and replace missing hopper head Cost Band 1– £0.00-£1,999.

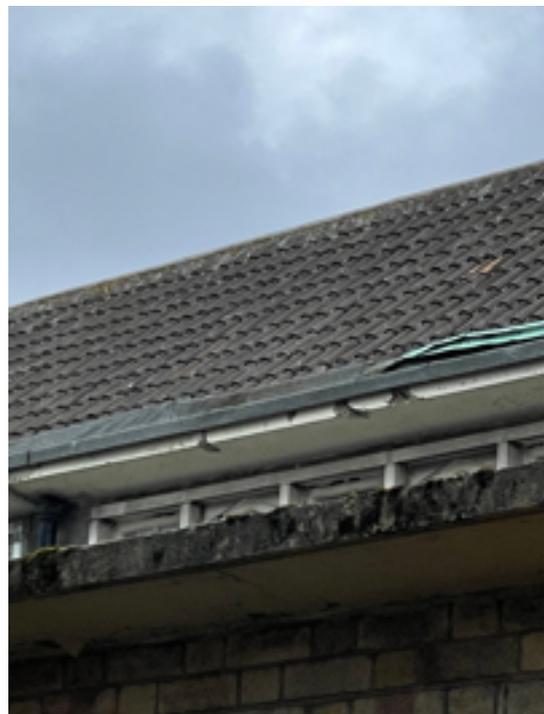
Spalling to concrete eaves

Timber fascias to east end rotted and in need of replacement. Spalling concrete at eaves to concrete sections in many locations and some actual splitting to Meeting Room eaves. Generally all areas require decoration. Fleche appears generally sound and in good condition when viewed from ground level although some of the timber work has become dislodged. Finial in satisfactory condition. Chimney in satisfactory condition.

Repair all sections of spalling and other damaged concrete eaves to church and ancillary roofs and redecorate eaves. Note the repair method for the concrete needs to be carefully specified. Cost Band 2 £2,000-£9,999.

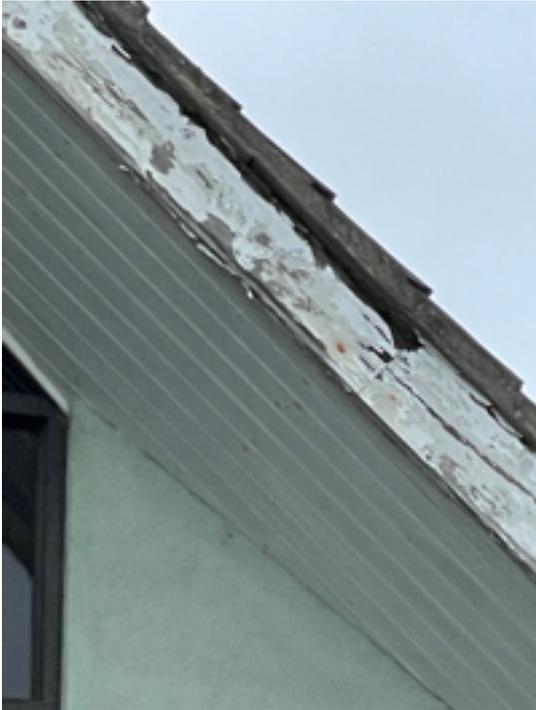
Rotten verge boards east elevation

Replace rotten sections of timber verge and redecorate timber east end verge and soffit. Cost Band 2 £2,000-£9,999.

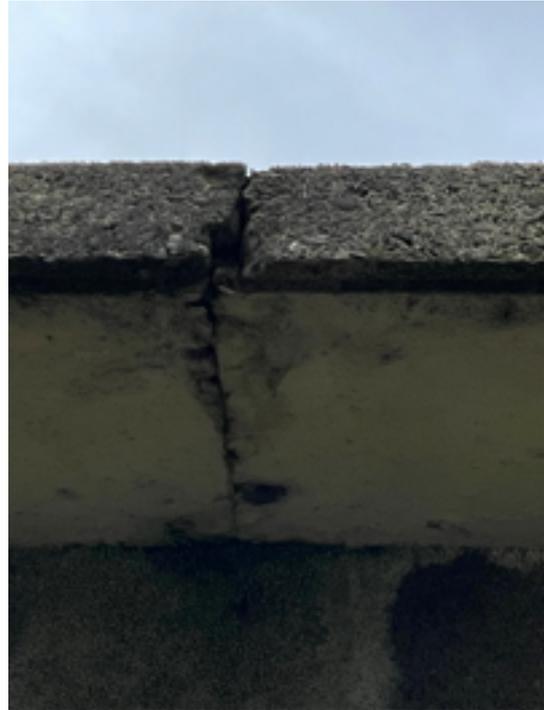
**Split to Meeting Room eaves
concrete**

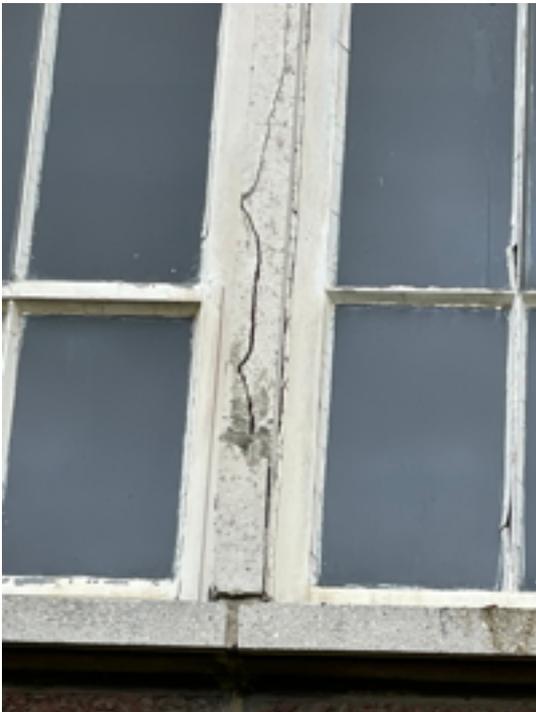
Clerestory windows cracked concrete surround

Concrete surrounds split and spalling in several locations.

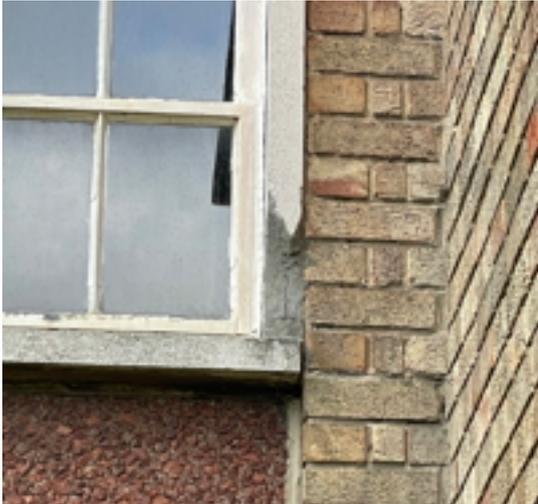
Clerestory windows damaged concrete surround

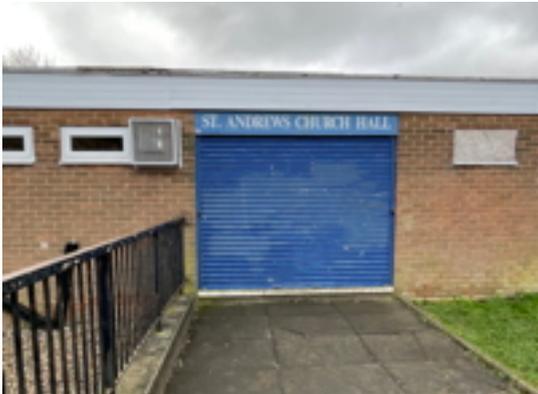
Hall north windows and doors

Broken windows to Hall north elevation. Broken panes to west window.

Replace broken window panes two Hall with laminated glass and protection. Cost Band 1– £0.00-£1,999

Replace doors to hall with ‘secured by design’ quality doors. Cost Band 2 £2,000-£9,999.

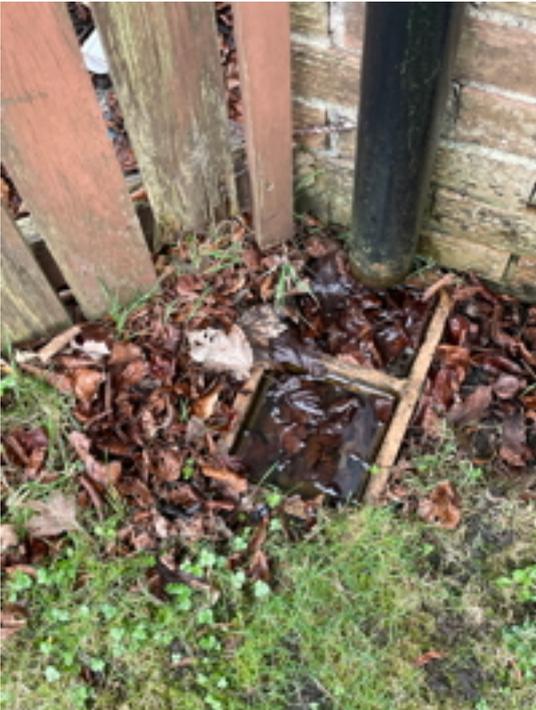
Typical blocked gully to Courtyard Garden

Some gullies partly blocked by leaves but otherwise all appears in satisfactory condition.

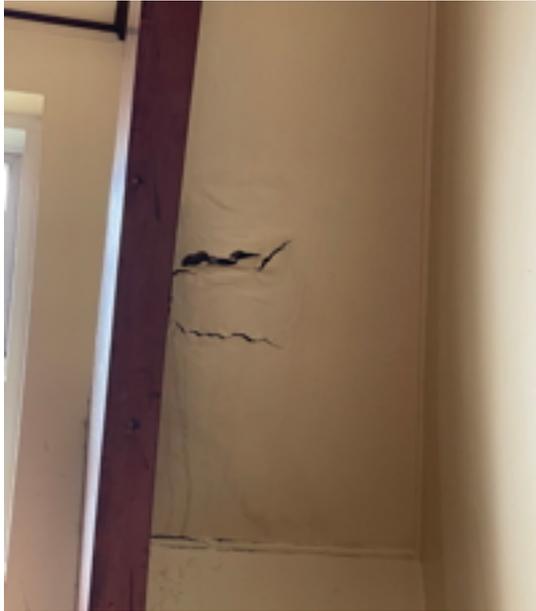
Damage to ceiling east end north elevation

All appears generally in good condition. East end north and south sides shows signs of water ingress.

Undertake full inspection of roofs and flashings by reputable roofing company and implement recommendations. Cost Band 2- £2,000-£9,999.

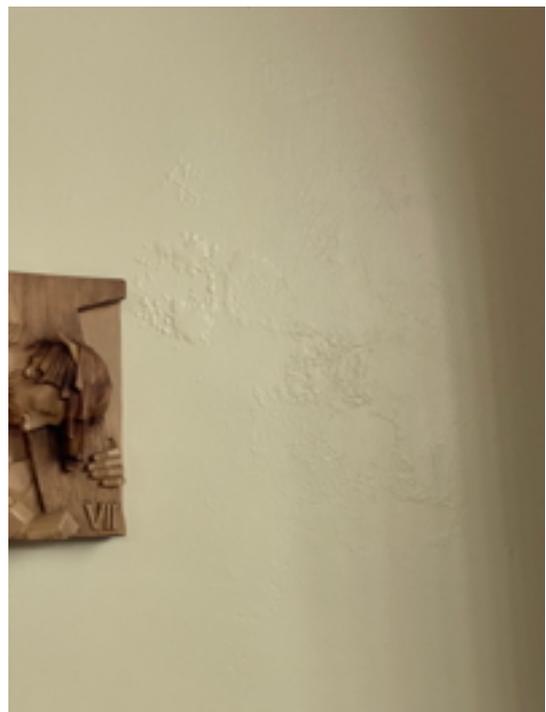
Salts to plasterwork north wall east of North Porch

Signs of salts to plasterwork on north wall to east of North Porch that coincides with entrance of external rainwater. Plasterwork is in satisfactory condition.

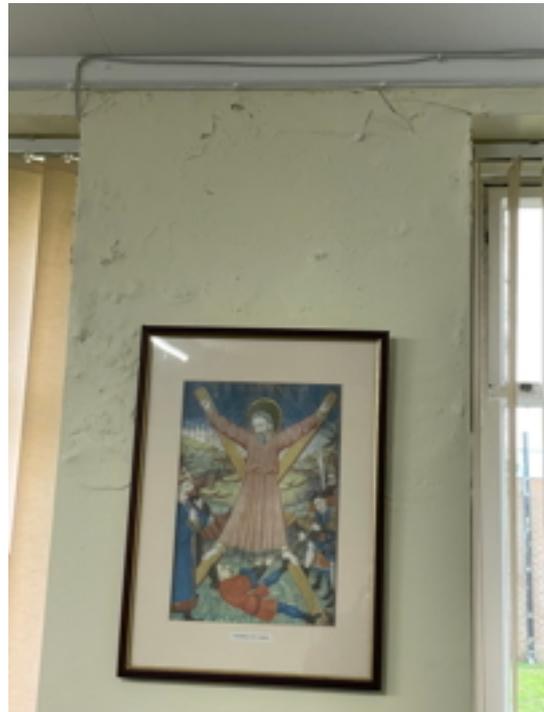
Choir Vestry/Meeting Room salts south wall west end

Inspect roof as item 9.1 and repair as necessary. Allow wall to dry (approx 1 years) if repairs are necessary and redecorate. Cost Band 1 – £0.00-1,999.

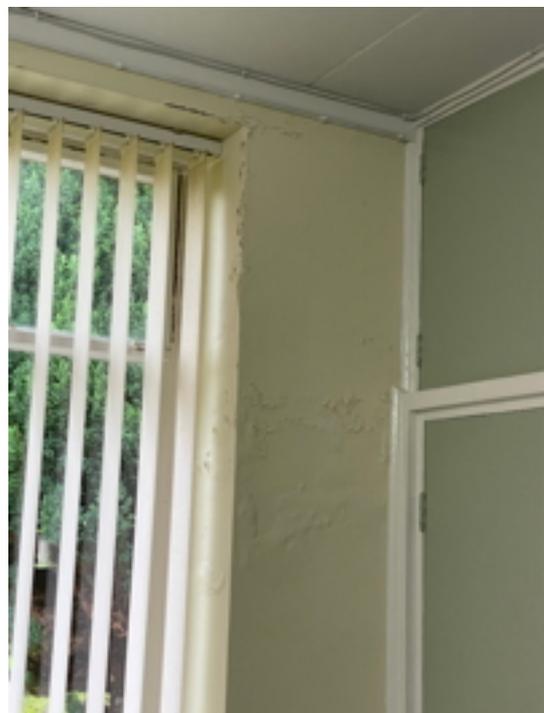
Choir Vestry/Meeting Room salts south wall west end

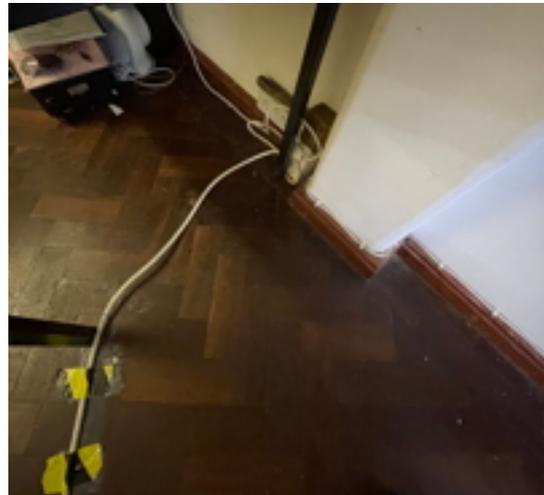
Cabling running across floor

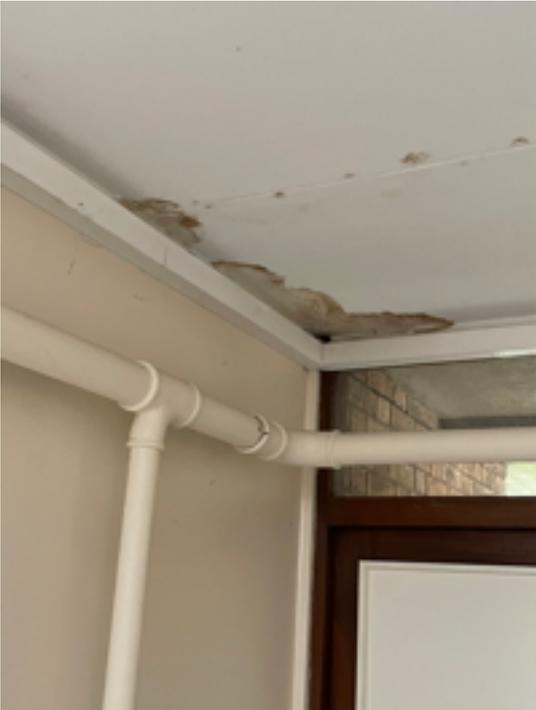
East Corridor staining to ceiling

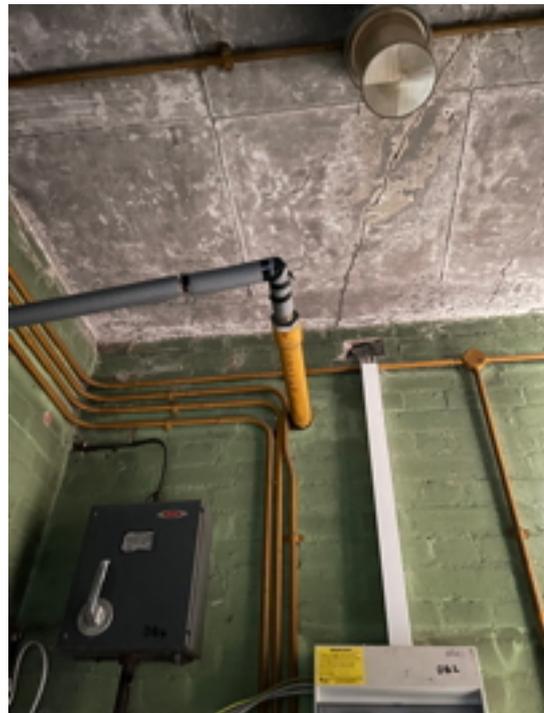
Heating Chamber ceiling

Inspect concrete ceiling/roof as part of concrete repairs noted in section 9.3. Cost Band 2 – £2,000.00-9,999.

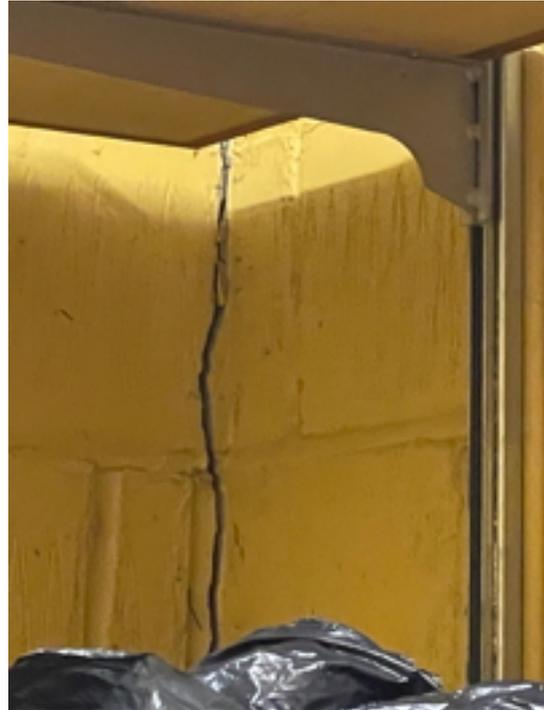
Cracking to Stage Area Store Blockwork

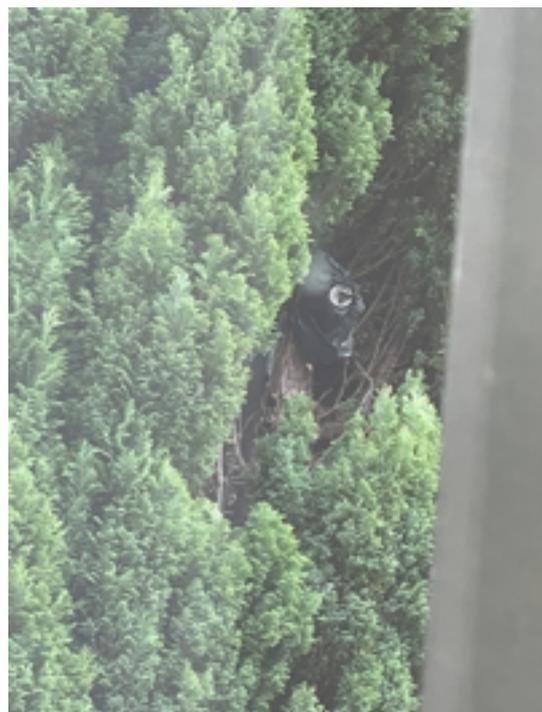
Concealed security camera

Consider a strategy to combat vandalism (including considering whether hidden cameras provide any deterrent or whether they should be more apparent). Cost Band 1– £0.00-£1,999
