Ref: 466-0101 LP  
Date of Quinquennial Inspection: 16<sup>th</sup> June 2022

St Mary's PCC  
St Mary's Church, Norton

## QUINQUENNIAL INSPECTION 2022

**SHAW &  
JAGGER**  
ARCHITECTS

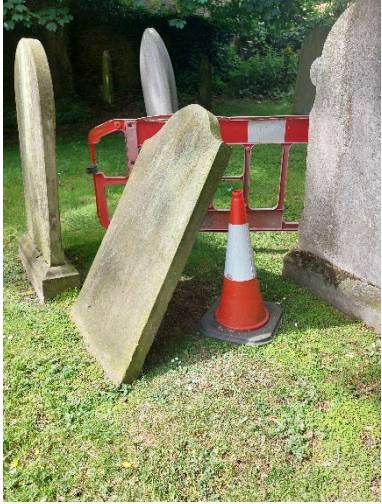
<p>Gravestones mostly intact, and generally in reasonable condition.</p> <p>Several were found to be loose, some in a very vulnerable condition.</p> <p>The PCC, the Diocese and the Council have been notified.</p>	<p>It is believed the responsibility is of the council and they should undertake a full condition survey and any repairs required.</p> <p>Consent may be required.</p>
C	<p>Boundary wall</p>

The PCC notified the architect that the churchyard is the responsibility of the council. The PCC and the Council have since been notified that some of the graves are dangerously loose and must be dealt with as soon as possible. A full survey should be completed on all the graves.

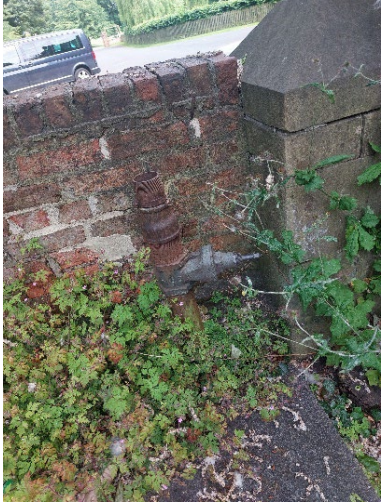
<p>Generally, brick boundary walls in good, stable condition.</p> <p>There are some boundaries where the walls are heavily grown with ivy and therefore harder to inspect.</p> <p>Some repointing required to a number of small areas, as would be expected given the extent of the boundary.</p>	<p>Re-point locally. Clear back any grown ivy for a more thorough inspection to be undertaken in due course.</p>

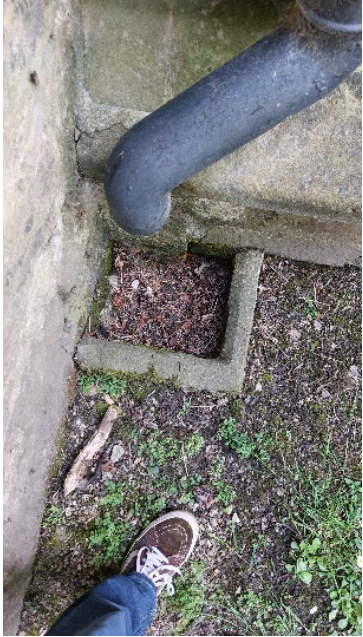
<p>Drainage locations unknown</p> <p>Some gullies gather vegetation and appear blocked.</p>	<p>Survey to be completed if it does not exist.</p> <p>Ensure gullies are clear and regularly maintain.</p>

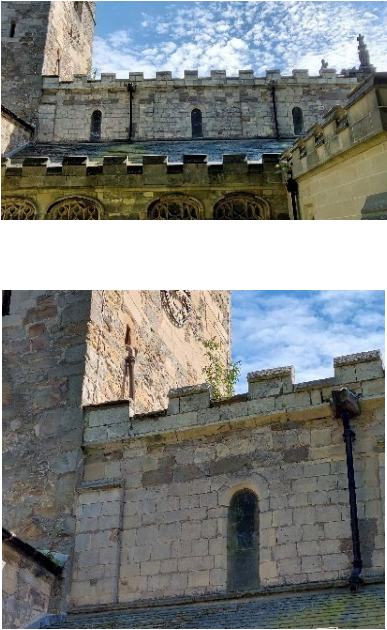
<p>Stonework: Vegetation growth to parapet.</p> <p>Some loss of mortar</p> <p>3 no. decayed stones.</p> <p>Some cementitious repairs refilled</p> <p>Glazing/ window openings: Fair condition</p> <p>Abutment with north aisle roof: Flashings appear in reasonable condition</p>	<p>Repoint</p> <p>Replace stones</p> <p>Cementitious repairs</p>
<p>C</p>	<p>North side aisle</p>

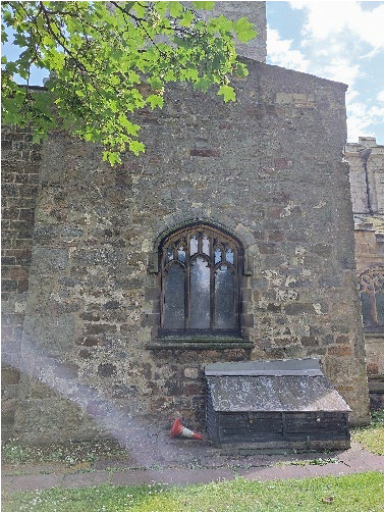
<p>Stonework: 1 no. partially lost stone to quoin, but seems fair</p> <p>Various mortars</p> <p>Copings: Some lost faces and open joints</p> <p>Glazing/ window openings: Sound protective glazing in good condition</p>	<p>Repoint open joints</p>
C A	<p>North transept (west face)</p>

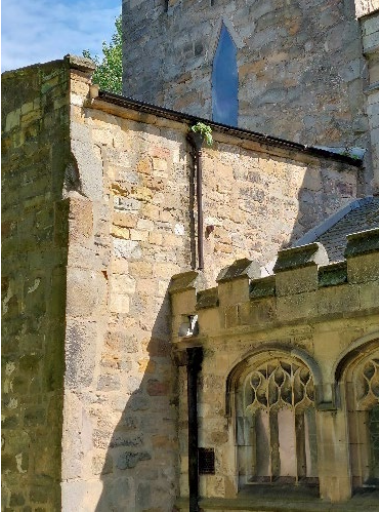
<p>Stonework: Several areas of failed mortar</p> <p>Gutters and downpipes: Vegetation in hopper</p>	<p>Rake out and repoint whole face</p> <p>Clear out hopper and gutter</p>
B	<p>North face chancel</p>

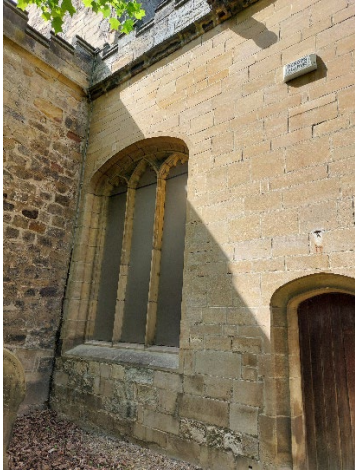
Stonework: Much replaced modern stone  Minor stone decay  Parapet: 7 no. string course stones decayed	Monitor stones  Repoint  Mortar repairs to string course

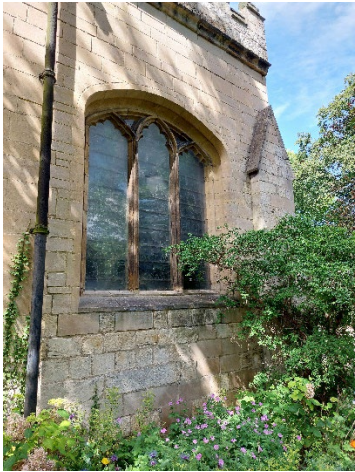
Glazing/ window openings: Good condition  Downpipes Blocked and external staining

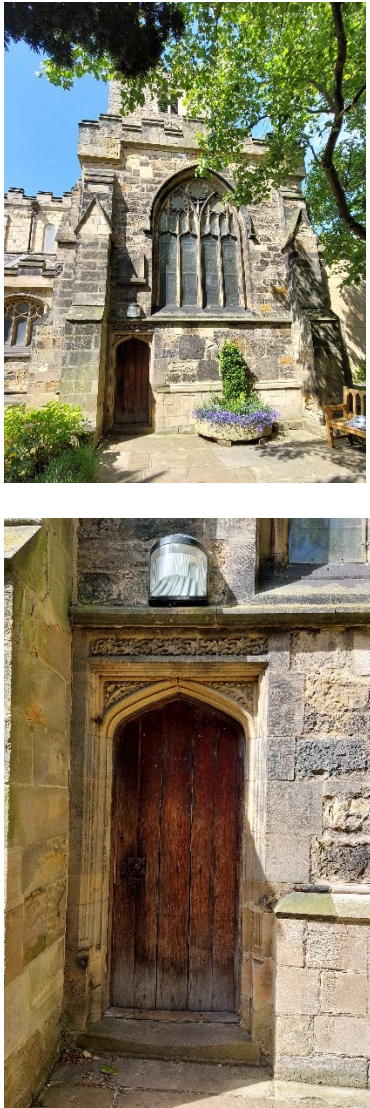
<p>Stonework: Some localised decay of stones</p> <p>Right hand buttress has decay and loss of stone face.</p> <p>Parapet: 2 no. decayed stones</p> <p>Glazing/ window openings: Good condition</p> <p>Entrance door: Regularly used, in good condition</p>	<p>Monitor stone faces</p> <p>Monitor</p>
<p>C</p>	<p>South transept (east face)</p>

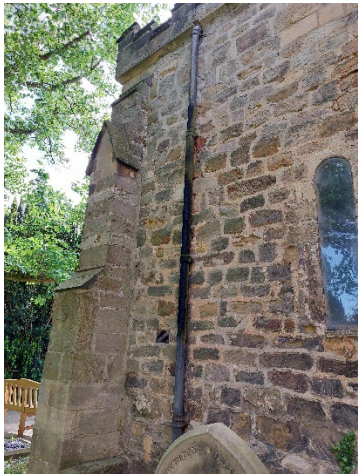
<p>Stonework: Decay to the base</p> <p>Glazing/ window openings: Good condition</p> <p>Downpipes: Blocked</p>	<p>Replace</p> <p>Unblock down pipe</p>

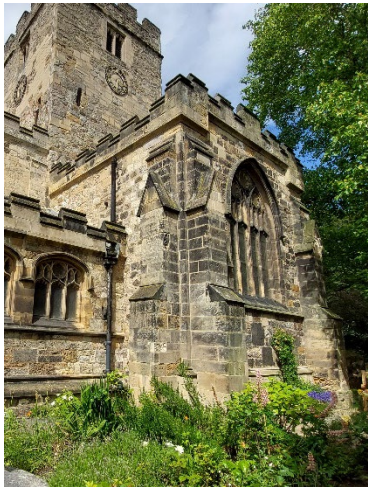
<p>Stonework: 6 no. decayed stones to face</p> <p>Downpipes: Good condition</p> <p>Abutments; Good condition</p>	<p>Monitor</p>
<p>C</p>	<p>Clerestory</p>

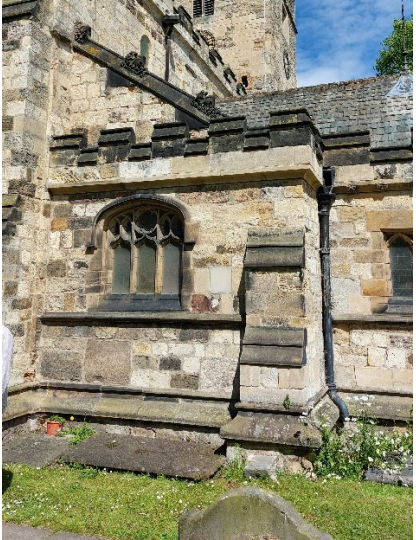
<p>Stonework: 3 no. decayed stones</p> <p>Glazing/ window openings: Good condition</p> <p>Abutment with the ground: Good condition</p>	<p>Monitor</p>

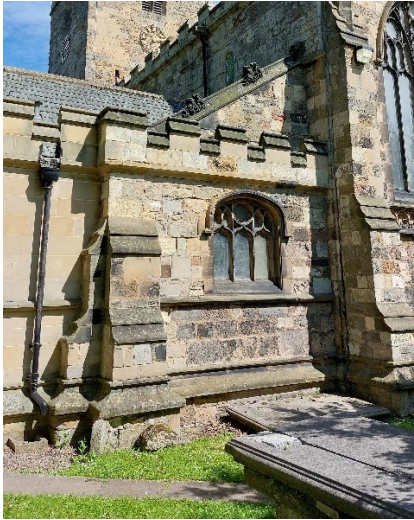
<p>Stonework: Some decay above window and string course</p> <p>Glazing/ window openings: Good condition</p> <p>Abutment with the ground: Good condition</p>	<p>Monitor</p>
----------	------------------------------------------------------------------------------------------------------------------	-------------------------------------------------------------------------------------------------------------------------------------------------------------------------	----------------

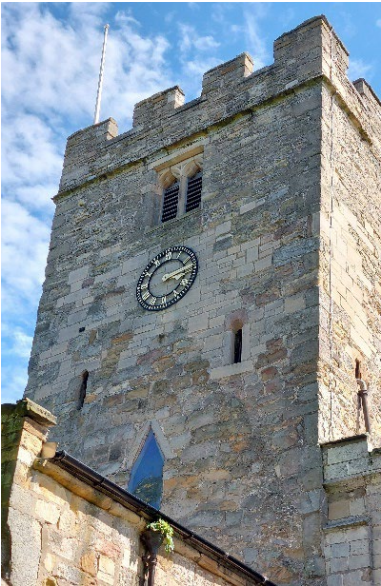
<p>Stonework:</p> <p>Heavily weathered stones</p> <p>Previous QI Report observed:  <i>Some erosion to the string course, though not as bad as the south and west elevations</i>  <i>Some holes in the stonework and breakdown of pointing.</i></p> <p>Cementitious pointing in fair condition.</p> <p>Couple of minor open joints.</p> <p>Parapet very low with some open joints and stone decay</p> <p>Timber Louvres: Fair condition</p> <p>Clock: Operation</p> <p>Abutment with the north transept: Not visible</p>	<p>Monitor, but assume up to 20 no. replacement stones to upper level and 10 no. repairs</p> <p>Localised repointing</p> <p>Repoint and monitor</p>

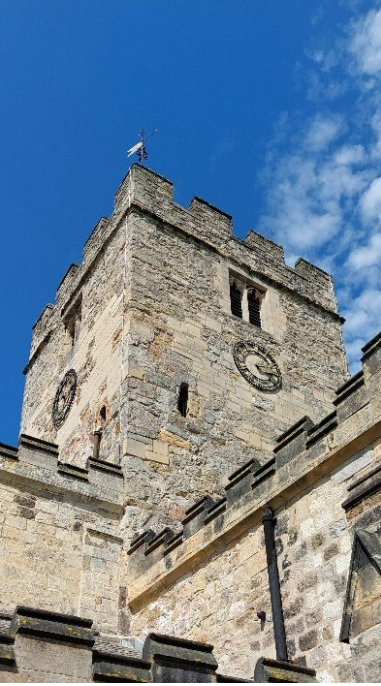
<p>Stonework:</p> <p>Previous QI Report observed:  <i>Erosion to the concave high level string course; quite broken in lots of places.</i>  <i>Walling has patches of modern replacement stonework and poor quality cement works.</i>  <i>General erosion to the stonework but nothing major.</i>  <i>Stonework not set horizontally where tower abuts the nave.</i></p> <p>Continued high level erosion, most of string course is heavily decayed and open joints.          Assume 30 to 40 no. heavily decayed stones</p> <p>Timber Louvres:          Good condition</p> <p>Clock:          Operational</p> <p>Abutment with the south transept:          Not visible</p>	<p>All require observation over the next twelve months.</p>
---	--------------------------------------------------------------------------------------------------------	-------------------------------------------------------------------------------------------------------------------------------------------------------------------------------------------------------------------------------------------------------------------------------------------------------------------------------------------------------------------------------------------------------------------------------------------------------------------------------------------------------------------------------------------------------------------------------------------------------------------------------------------------------------------------------------------------------------	-------------------------------------------------------------

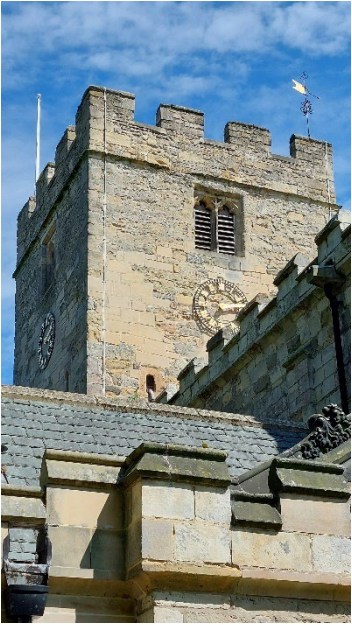
<p>Stonework:</p> <p>Previous QI Report observed: <i>Deeper erosion to the joints on the parapet.</i></p> <p>Similar to South elevation, continued high level erosion. Assume 30 to 40 no. heavily decayed stones</p> <p>Timber Louvres: Good condition</p> <p>Clock: Operational</p> <p>Abutment with the nave: Not visible</p>	<p>All require observation over the next twelve months.</p>
---	-------------------------------------------------------------------------------------------------------	------------------------------------------------------------------------------------------------------------------------------------------------------------------------------------------------------------------------------------------------------------------------------------------------------------------------------------------------------	-------------------------------------------------------------

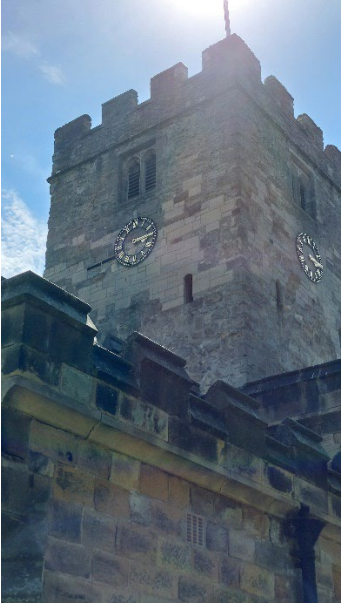
<p>Stonework:</p> <p>Previous QI Report observed:  <i>Open joints to the merlons and general erosion to the pointing above the string course.</i>  <i>More erosion to the stone on this face, but only to the small stuff. Patched with more modern stonework.</i>  <i>Slight shaling to one of the sandstones above the small window.</i>  <i>Keystone to the triangular headed window looking onto the chancel is badly worked..</i></p> <p>Similar to South elevation, continued high level erosion.          Assume 15 no. heavily decayed stones</p> <p>Timber Louvres:          Good condition</p> <p>Clock:          Operational</p> <p>Abutment with the chancel roof:          Not visible</p>	<p>All require observation over the next twelve months.</p>
----------	-------------------------------------------------------------------------------------------------------	-----------------------------------------------------------------------------------------------------------------------------------------------------------------------------------------------------------------------------------------------------------------------------------------------------------------------------------------------------------------------------------------------------------------------------------------------------------------------------------------------------------------------------------------------------------------------------------------------------------------------------------------------------------------------------------------------------------------------------------------	-------------------------------------------------------------

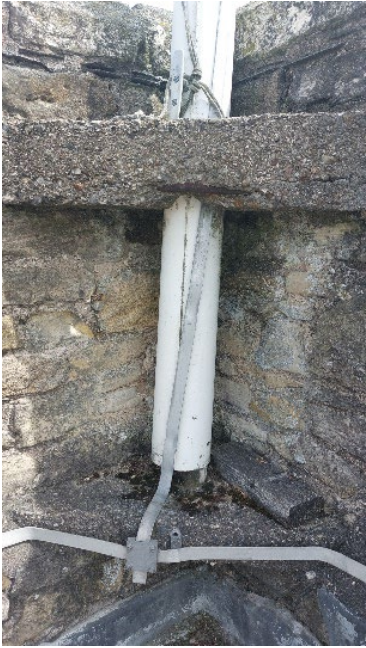
<p>Flag pole: Fair but concrete support failing – rust blowing face</p>	<p>Repair pole fixing.</p>

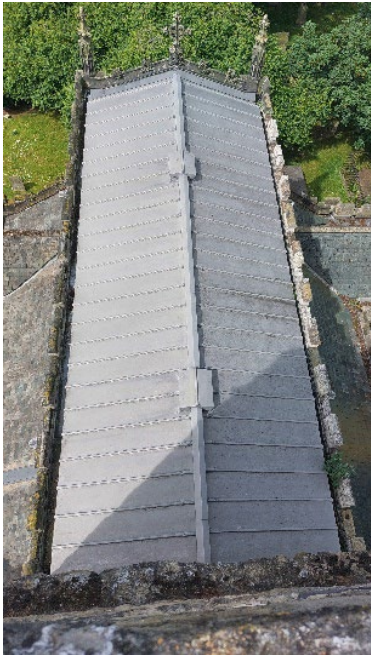
<p>Generally, pitched steel roof in good condition. <i>(Installed 2008)</i></p> <p>Stone parapet with a few open joints.</p> <p>gutters, clogged with dead leaf collection and some vegetation growth.</p>	<p>Replace/pinback open joints</p> <p>Repoint</p> <p>Clear gutters of debris and vegetation</p>

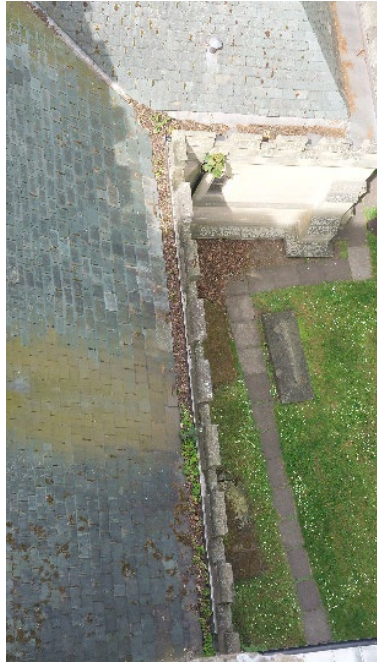
Copings and Flashings in reasonable condition but evidence of damp/water ingress to windows – may need repairing to match south aisle detail

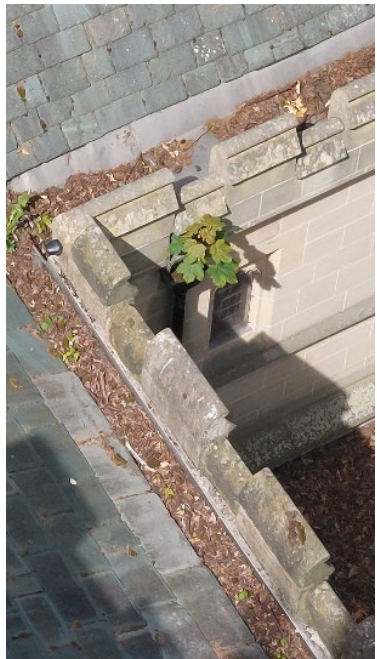
Gutters full of leaf debris.

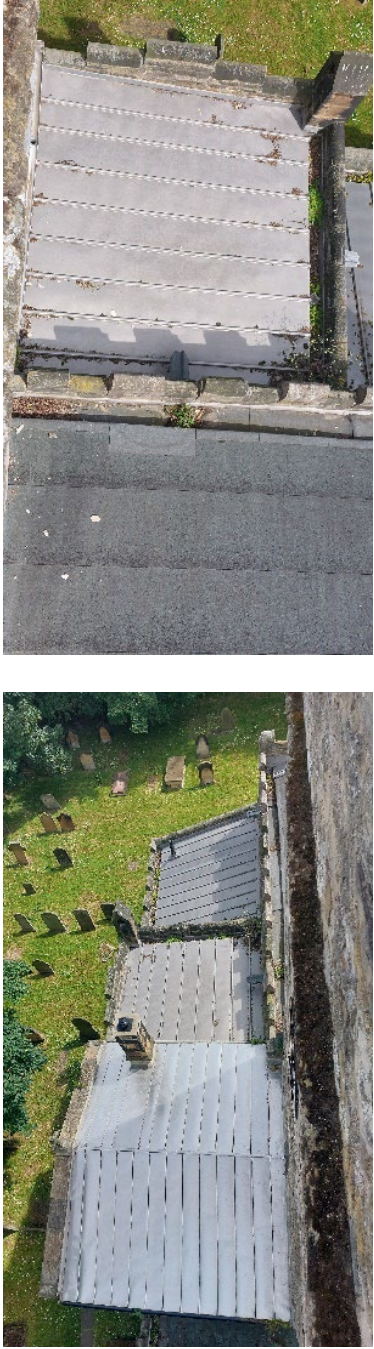
<p>Steel roof in good condition <i>(installed 2008)</i></p> <p>Water ingress by hopper/spout blocked</p>	<p>Clear gutters and re-inspect.</p>
<p>B</p>	<p>Kitchen</p>

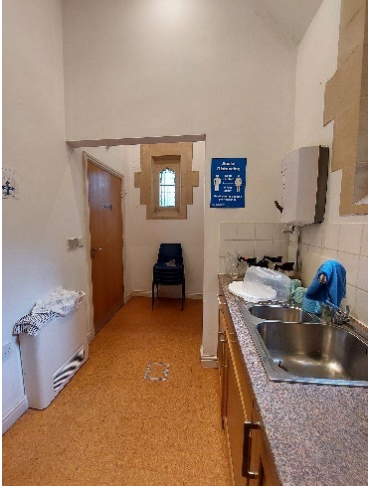
<p>Generally in good condition.</p> <p>Cabinetry tired</p> <p>Not enough ventilation resulting condensation and peeling paint.</p> <p>Deteriorated since last QI Report</p>	<p>Update when feasible</p> <p>Improve ventilation</p>
<p>E</p>	<p>Kitchen storage generally</p>

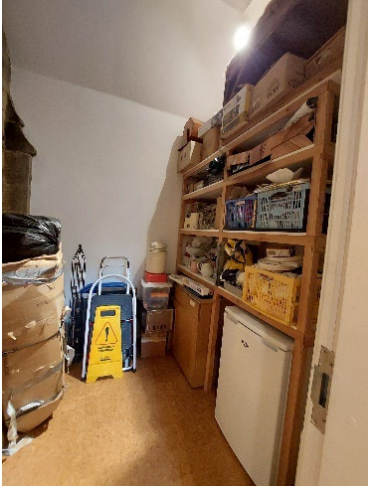
<p>Storage generally in good condition</p> <p>Cabinetry tired</p> <p>Not enough ventilation resulting condensation and peeling paint.</p> <p>Deteriorated since last QI Report</p>	<p>Update when feasible</p> <p>Improve ventilation</p>
<p>E</p>	<p>Kitchen wc generally</p>

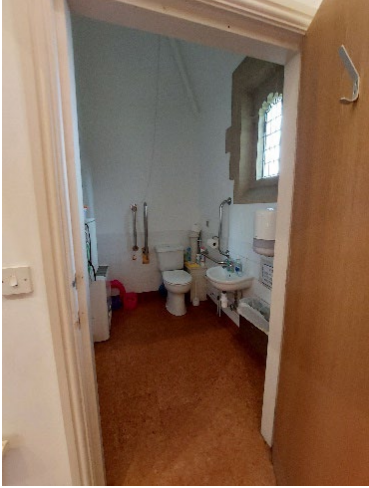
<p>Generally in good condition</p> <p>One light bulb not working.</p>	<p>Change light bulb</p>

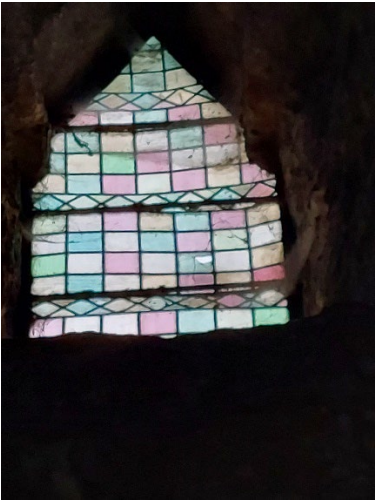
<p>Triangular headed with projecting shoulders for lintels.</p> <p>Coloured glass in diamond and square panes backed up with chicken wire – glazing sagging to all three windows</p> <p>Previous QI Report observed: <i>Hole to northern window visible.</i> Hole to north window still present</p> <p>Previous QI Report observed: <i>some cracking on the north elevation just above the arch to the left hand side of it but this doesn't look structural.</i> Crack still present</p>	<p>Fix glazing</p> <p>Monitor cracking</p>

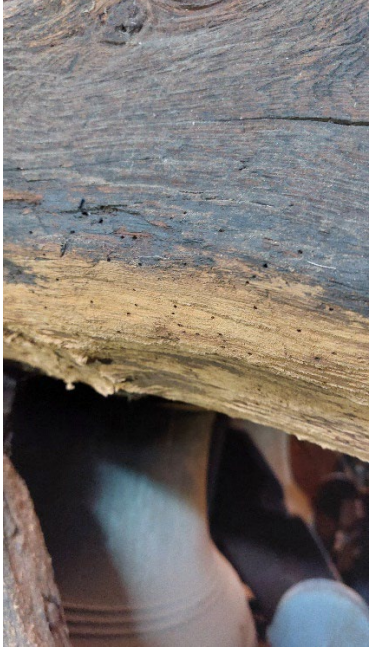
<p>Small area of what appears to be wood boring activity.</p>	<p>To be investigated further by specialist after cleaning</p>
	<p>Bells</p>	<p>Three Bells by Mears of London, dated 1664 and recast in 1893.</p>	<p>N/A</p>
	<p>Belfry Louvres</p>

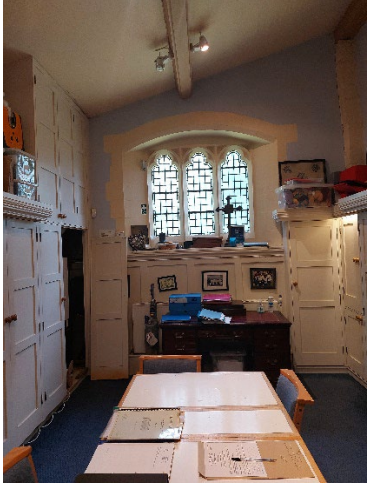
Generally in good condition. Up level above window (LHS of photo) has signs of water ingress.	Once water ingress has been resolved it should be left to dry out and redecorated.
	Vestry floor	Carpet in good condition	N/A
	Vestry Ceiling	plaster boarded in good condition	N/A
A	Vestry Window surrounds

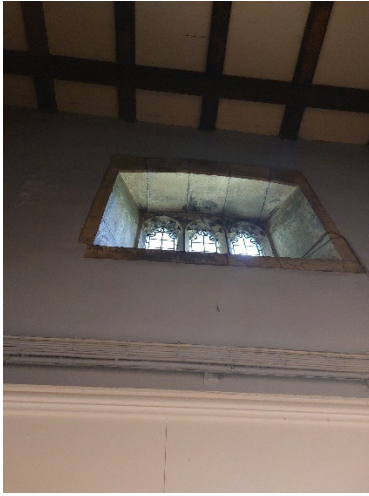
North window to vestry has some water ingress, mainly in joints	Clear gutters and inspect further
	Vestry Door and rear wall	Good condition	N/A

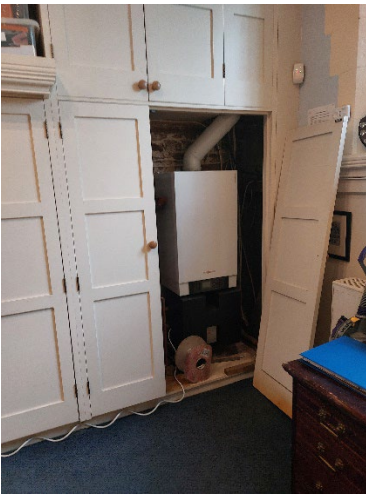
<p>Door to boiler cupboard not fixed. Presume removed to allow access to boiler for maintenance and/or to allow space to dry out – see below</p>	<p>Re-hang cupboard door.</p>

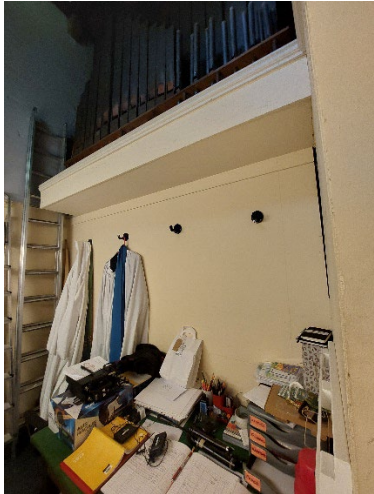
<p>Plastered walls in good condition</p> <p>Crack to abutment to chancel.</p>	<p>Monitor crack</p>
	<p>Vestry Office ceiling</p>

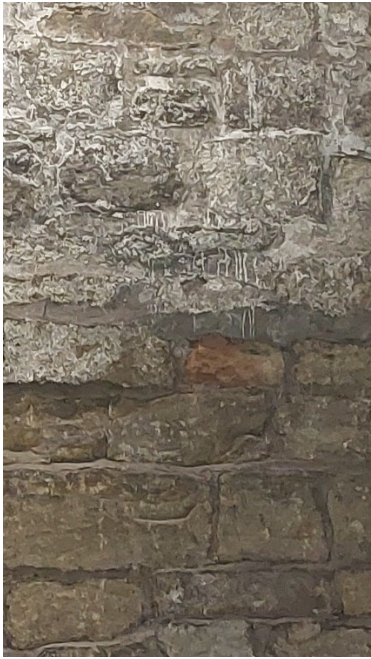
<p>Generally sound.</p> <p>Later cementitious repointing to east wall</p> <p>Some ingress of some kind to north side (pictured), requires further investigation.</p> <p>South side, later repairs to wall plate appears sound</p>	<p>Investigate and monitor</p>
	<p>Chancel floor</p>	<p>Good condition</p>	<p>N/A</p>
	<p>Chancel ceiling</p>	<p>Good condition</p>	<p>N/A</p>
E	<p>Chancel windows</p>
