**St James the Apostle
Owton Manor**

Care of Churches and Ecclesiastical Jurisdiction Measure 1991

Quinquennial Report
on the architect's inspection on

5th October 2023

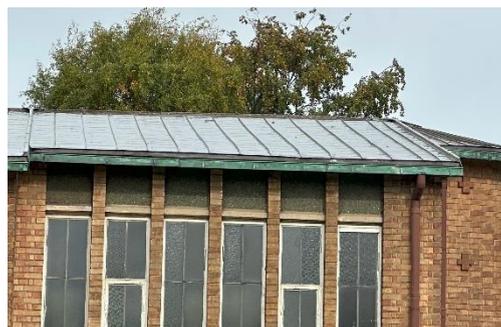
- i. South slope – standing seam copper roofing divided into bays, ripples in the metal.
- ii. North slope – same condition as south, ripples not as bad as the south as more sheltered.
- iii. West slope – barge board is in copper, no defects to report, the cross at the ridge was unable to be checked for stability.

Figure 1 - Undulation to copper roof and debris on top

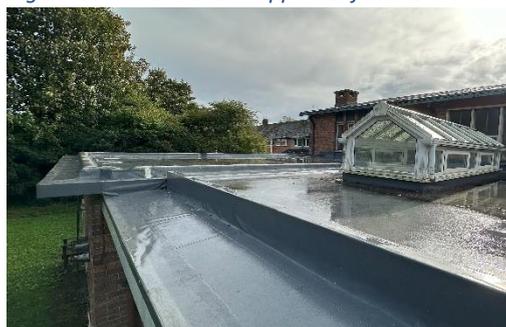
- i. This has single full ply 'Flagon' roof membrane installed as part of the 2010 extension.
- ii. Following a period of rain, there was a lot of sitting water on this roof, especially to the east section and the west side. All outlets were completely blocked, and water was pooling in outlets.
- iii. The roof remains slight spongy underfoot with it being laid on insulation boards but is also incredibly slippery with moss build-up from standing water.
- iv. The flashings to the nave appear ok.
- v. The rainwater outlets from the Nave discharge onto this roof – see section 3.
- vi. There are pipes penetrating the membrane with no form of cowl to prevent water ingress.
- vii. The **lantern** has of moss and algae build-up on the glass needs clearing and gutters require regular clearance as the moss build-up was significant.

Figure 2 – Stella Maris roof

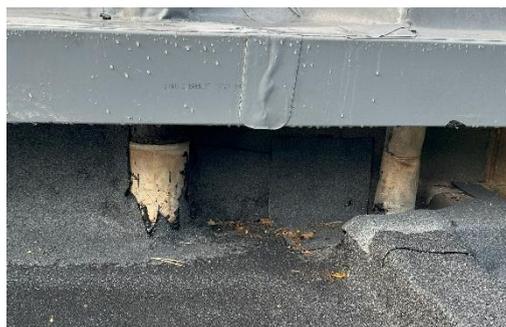
- i. The felt roof to this area was replaced recently following a leak in the Stella Maris room. The installation is average, cuts around pipe penetrations are not flashed correctly and could lead to future issues. There is also an area of pooling to the southeast of this roof, at the base of the outlet, felt is not designed to withstand large areas of standing water.

Figure 5 – Felt finish to pipe penetrations.

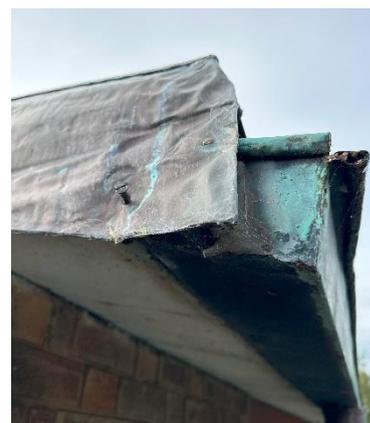
- i. North side – Copper gutter leading to plastic downpipes. The far east end is dropping as there are screws missing and loose to the fixings. The base of the downpipe is loose as a bracket has been lost, it has also been replaced with underground soil connectors, this is liable to cracking as the material not UV protected.
- ii. South side –Copper leading to plastic, as per North. Gutter bracket loose on far east and west of the nave, causing gutter to slump at the ends.

Figure 6 – North Nave Gutter

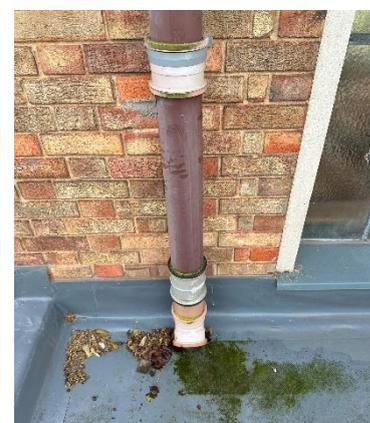
Figure 6 – North Nave Downpipe

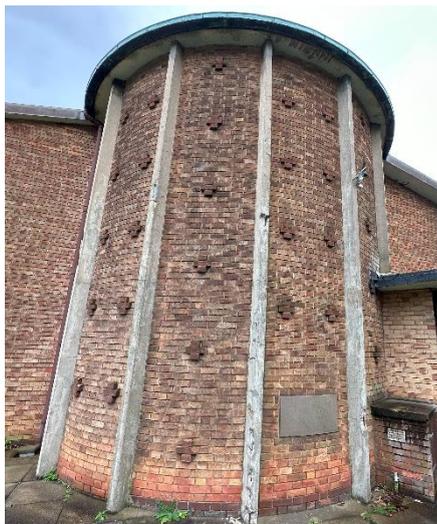
Figure 7 – Apse concrete fins

4.2 **Apse:** Semi-circular brickwork in good condition with projecting crosses in brickwork, some of these have chipped corners. The structure has reinforced concrete fins leading up to the concrete frame within the roof. These are spalling in many locations, as it would appear that the reinforcement was installed too close to the surface. It has been patch repaired in the past, those have come away and so this requires a greater level of intervention than just patching. At several locations the rusting reinforcement is showing which will only worsen the spalling, all of the fins see this issue to varying degrees. It is suggested that a concrete specialist is consulted. Concrete also spalling at soffit in several locations to the apse.

| Category | Description | Item ref | Budget Costs |
|---|---|---|---|
| 1 | Contact expert to progress plan for concrete spalling issue* | 4.2-4.8 | |

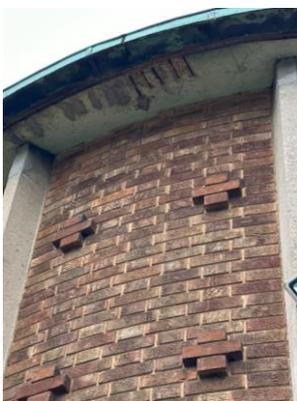
Figure 8 – Soffit

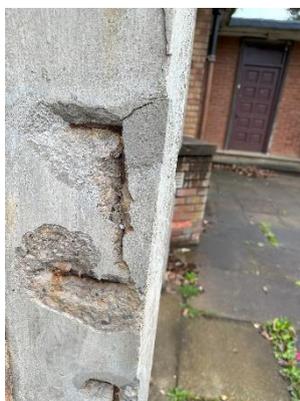
Figure 9 – former repair

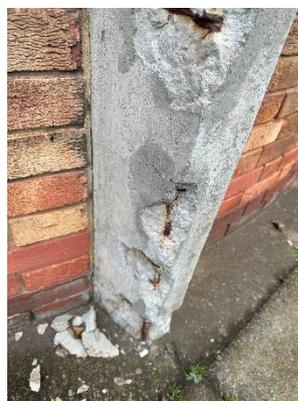
Figure 10 – new spalling

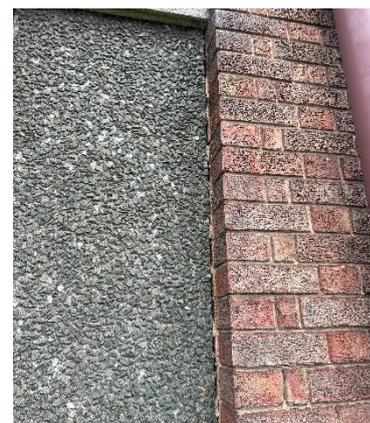
- i. South side – some slight cracking at the soffit. Wall has brickwork piers with green chipping aggregate panels and these are in fair condition, lower panels have gaps in pointing to the sides. Generally, the brickwork here is all sound. Windows within are all in poor condition and losing putty in several locations, multiple glass type replacements in several styles.
- ii. North side – as seen from the roof of the Stella Maris Room construction as per the south side– brickwork appears ok, concrete heads and cills chipped in places. Windows in poor condition.
- iii. East end – brickwork is in good condition, concrete spalling at soffit to the north.

Figure 12 – Gap in aggregate panel

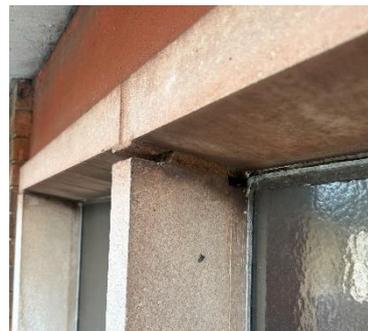
- iv. North side – same design as the south but now enclosed by the Stella Maris room. Brickwork ok generally, minor open perp joints to upper west end. There is significant loss of mortar at the top of the mullions at high level to a number of window openings. The windows themselves are in slightly better condition to the south side, but still deteriorating. There is a small crack to the lower mullion, dowel pins may be rusting and leading to joints opening up.

Figure 13 – North Nave Mullion

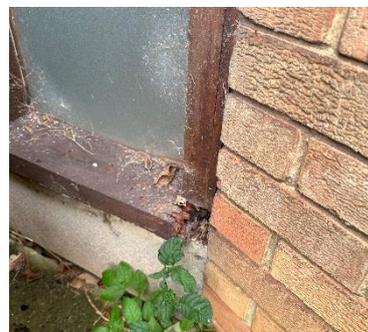
- i. South side – decoration coming away to the eaves overhang. Brickwork in fair condition. Doorway has concrete surround with some slight cracking to the base at the western side. Pair of double doors in fair condition, the slave leaf catches and is difficult to lock in place.
- ii. West side – eaves overhang the same as the south. Diaper patterned brickwork in good condition. Foliage and debris to the base of this wall should be managed/ removed as per the last report to allow inspection and control invasive species such as ivy.
- iii. North side – mostly enclosed by a glazed timber screen in reeded obscure glass. Loss of one piece of reeded glass, severely rotten at west end of cill.

Figure 14 – Rotten cill

| Category | Description | Item ref | Budget Costs |
|---|---|---|---|
| 2 | Replace rotten cill to porch | 4.5iii | |

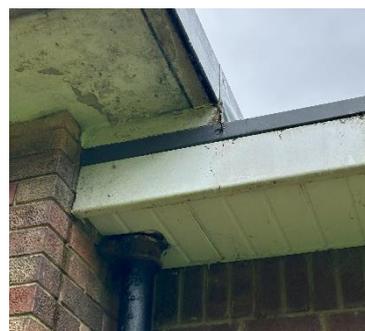
- i. North side – eaves overhang decoration deteriorating. Brickwork okay. Some slight loss of pointing to the bottom of the window surrounds. 2No UPVC windows in fair condition and two boiler flue penetrations ok.
- ii. West (small return to new construction) – staining as water drips down wall, appears to be tracking from junction with roofing membrane and small piece of wooden fascia between, this should be changed for a continuous seamless solution.
- iii. East side – damp patch at the base of the wall, appears as if the flags could have a fall to this area. Vegetation growing to

Figure 16 – Timber fascia at item 4.7.ii

base of wall should be removed. Consider removing flags and inserting French drain to aid good drainage. 3no windows in concrete frame, all UPVC and in average condition.

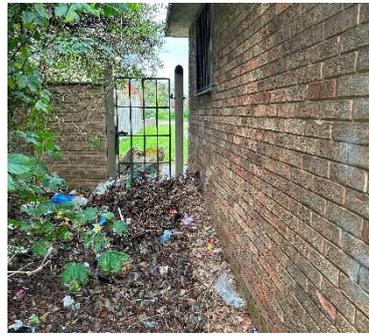
- iii. East side - brickwork in reasonable condition. Rusting window with guarding. There is a very large build-up of leaves and debris against this elevation next to the gate which requires clearing as brickwork to the bottom few courses is beginning to green.

Figure 18 – East of Ancillary rooms

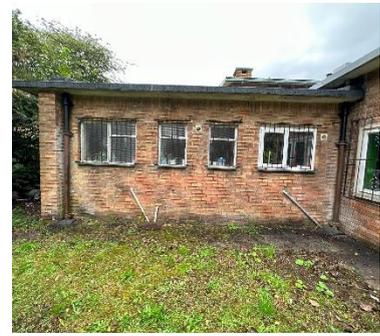
- iv. North side - decoration needed on the eaves overhang; the new felt is not finished well. The brickwork is fair but has some damage to service penetrations. One new plastic window to the kitchen and three older galvanised windows all with loss of decoration. Damp staining to base of wall, particularly to paved area near gulley. Ensure all gulleys are clean and flowing.

Figure 19 – North Ancillary Rooms

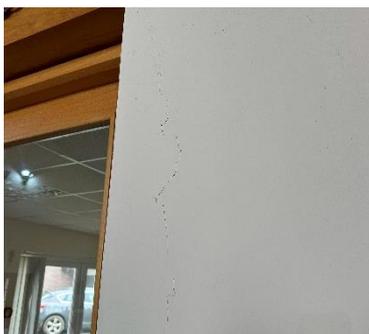
Figure 22 – Plaster near Nave door

- 7.2 Walls – plastered walls generally in good condition, slight cracking below cill to northwest window though not of concern. There is also cracking to the plaster near the new door, however this could be where new plaster has not been well bonded to existing – monitor. The condition of the paint behind the radiators is poor, most likely due to condensation build-up.

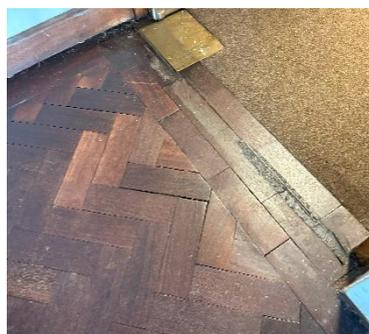
- 7.4 Floor – hardwood herringbone block flooring in good condition overall with the exception of some raised loose blocks near the side doors and poorly filled in places.

Figure 23 – Floor raised/ loose

| Category | Description | Item ref | Budget Costs |
|---|---|---|---|
| 2 | Fix loose floor blocks | 7.4 | |

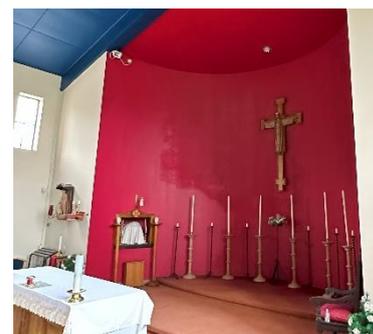
Figure 24 – Apse wall discolouration

- 9.1 Ceiling – curvilinear, painted out ceiling in good condition.
- 9.2 Walls – Curved painted wall, to the north side there is some staining/ discolouration which initially looks to be from condensation but is much worse on the north side, therefore

could be linked to rainwater issue at item 3.6.

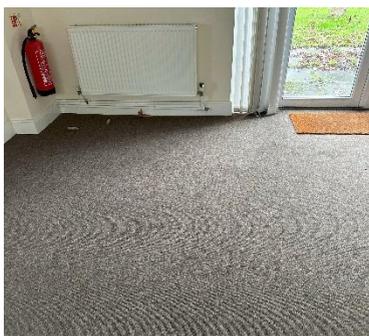
9.3 Floor - Some marking to the carpet, two steps up to timber suspended dias (platform).

Figure 25 – Staining to floor

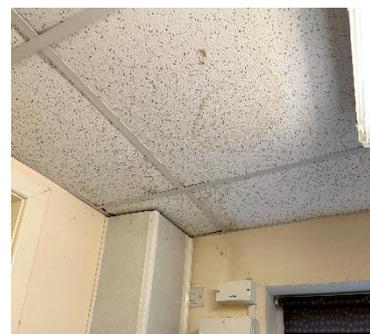
12.1 Ceiling – Ceiling tiles in metal grid, there is an area near the window where the tiles are stained, this is reportedly from the kettles over boiling and condensation forming. The tiles should be replaced and the issue monitored.

Figure 26 – Staining to kitchen ceiling

| Category | Description | Item ref | Budget Costs |
|---|---|---|---|
| 2 | Replace kitchen and Stella Maris ceiling tiles | 10.1, 12.1 | |

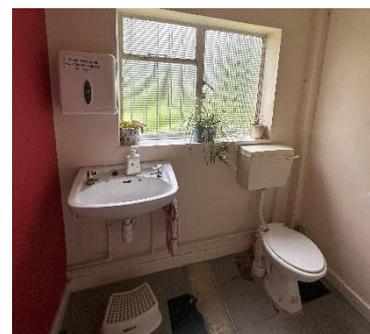
14.1 All finishes as per Accessible WC. Flooring in poor condition, would benefit from replacing.

14.2 General – All acceptable but very dated, one wall has been painted, paint and clutter fill room and should be stored elsewhere. Locking is by bolt and is not acceptable as people can become trapped inside with no emergency access.

Figure 26 – Alternative WC

| Category | Description | Item ref | Budget Costs |
|---|---|---|---|
| 2 | Ease WC door and replace locking mechanism | 13.4, 14.2 | |

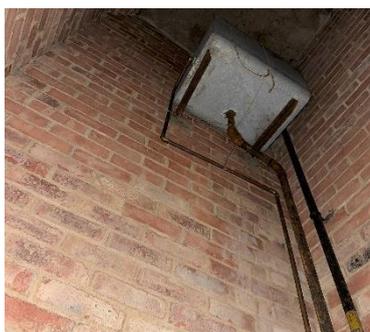
Figure 27 – Water tank above vestry

15.1 Ceiling – Fibreboard ceiling, showing condensation marking and water damage. Hatch to void adjacent to nave, containing water tank. Tank should be emptied/ removed.

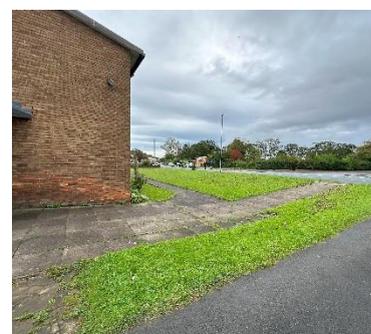
26.6 **General:** Paths to front generally concrete paviours, some undulation to finish. The plastic grille over a road gully by the side of the porch entrance is partially missing. At the vicarage entrance, the area just to the side of the footpath is eroded now. A tin shed to the rear stores goods for the church, consider additional storage internally.

Figure 32 – Footpath undulation to bottom left of picture

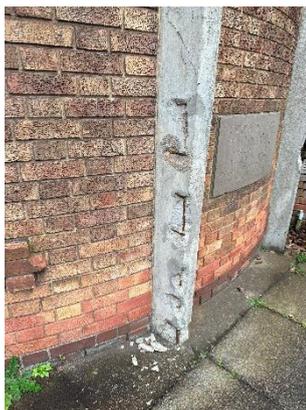
28.1A characterful church, with interest added from the concrete curvilinear forms and generous level of lighting. The most pressing issue is the deterioration of the reinforced concrete fins at the apse and soffits throughout the rest of the Apse, Chancel and Nave. Specialist advice should now be sought to create a strategy for their repair. Secondly, with a drive to more sustainable churches, the large windows would benefit from replacement, alongside the smaller windows to the ancillary rooms.

Figure 35 – Reinforcement exposed
