St Mary, Piercebridge

Quinquennial Inspection Report

February 2024

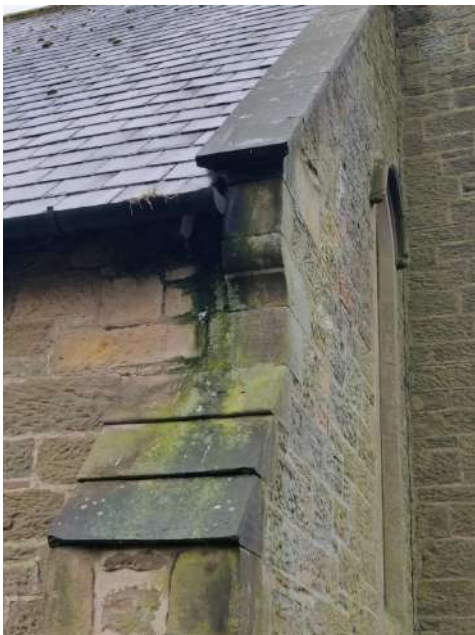
The N slope is mossy, but not excessively so. The W end of the gutter needs clearing.

3. NW Nave roof: clean gutter; add lead upstand to roof to prevent water running onto stonework.

The rainwater disposal systems are in working order. On the NW end of the Nave, the gutter needs cleaning. Also, water runs off the roof onto the below buttress causing erosion and greening of the sandstone; a small lead upstand should be added to direct rainwater into the gutter below. The deformed rainwater pipe near the boiler house remains fully working but should be watched for blockages; if these occur, consideration should be given to replacing the damaged section. Damaged paintwork on rainwater gutters and downpipes should be made good to prevent decay.

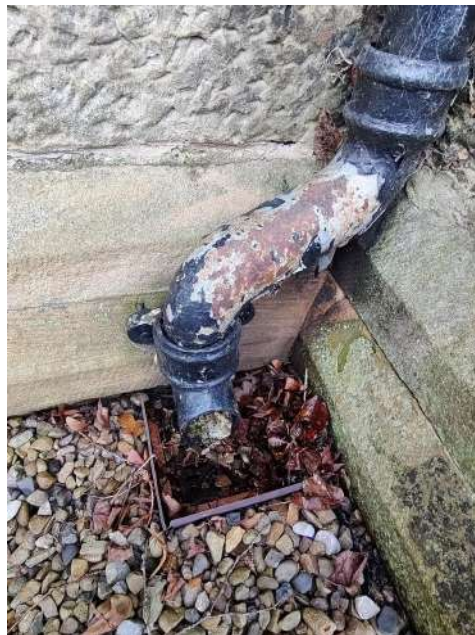
4. Localised need to repaint downpipe.

1.04	Monitor the deformed rainwater pipe near the boiler house. Consider replacement should blockages occur.	O	PCC	£0
1.05	Make good to damaged paintwork on rainwater gutters and downpipes. Consider the potential presence of lead paint.	B	Builder	£100

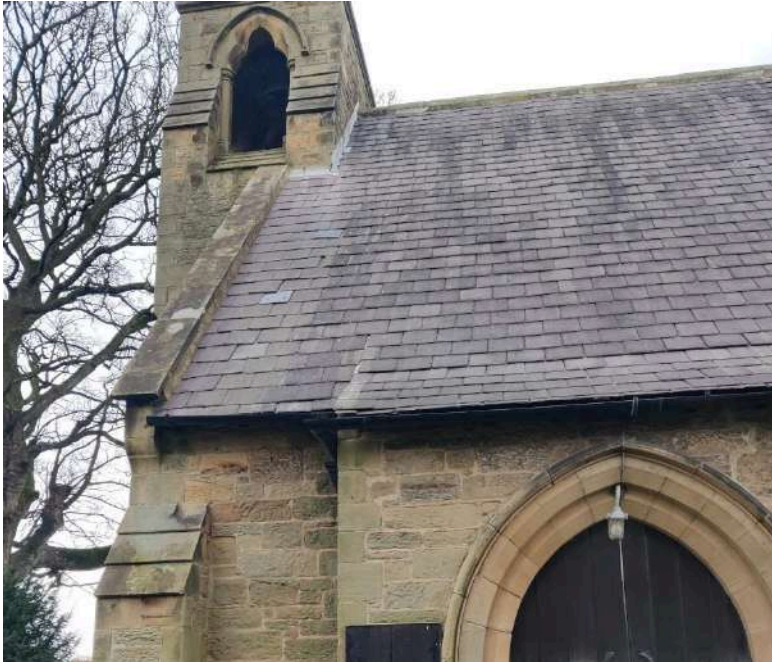
5. S slope of Nave Roof, over main entrance: fix all slipped slates including failed previous non-matching repairs.

1.02	Employ a competent roofer to refix slipped slates using traditional methods and to address the failing and non-matching previous repairs at the southwest abutment of the Nave.	B	Roofer	£500

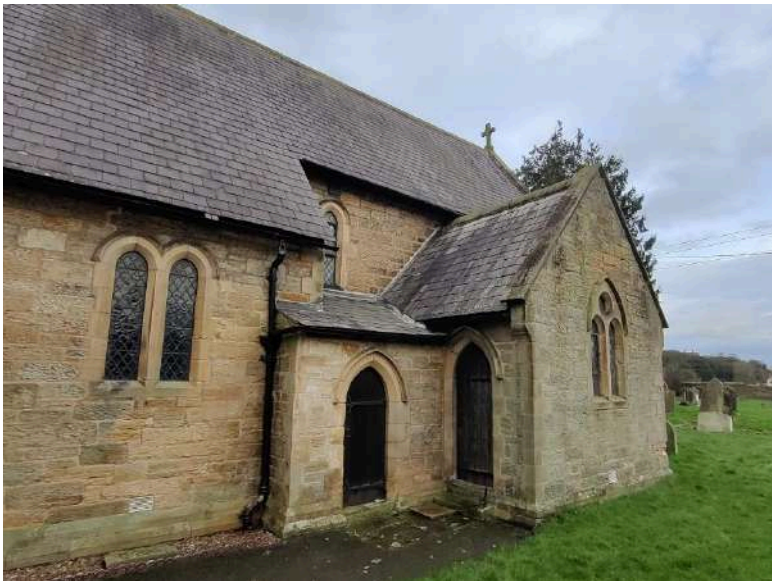
6. View onto S roofs over Nave, Chancel, Vestry and Boiler Room.

Green appearance of Vestry elevation despite the southern aspect is a first indication of long-term water ingress.

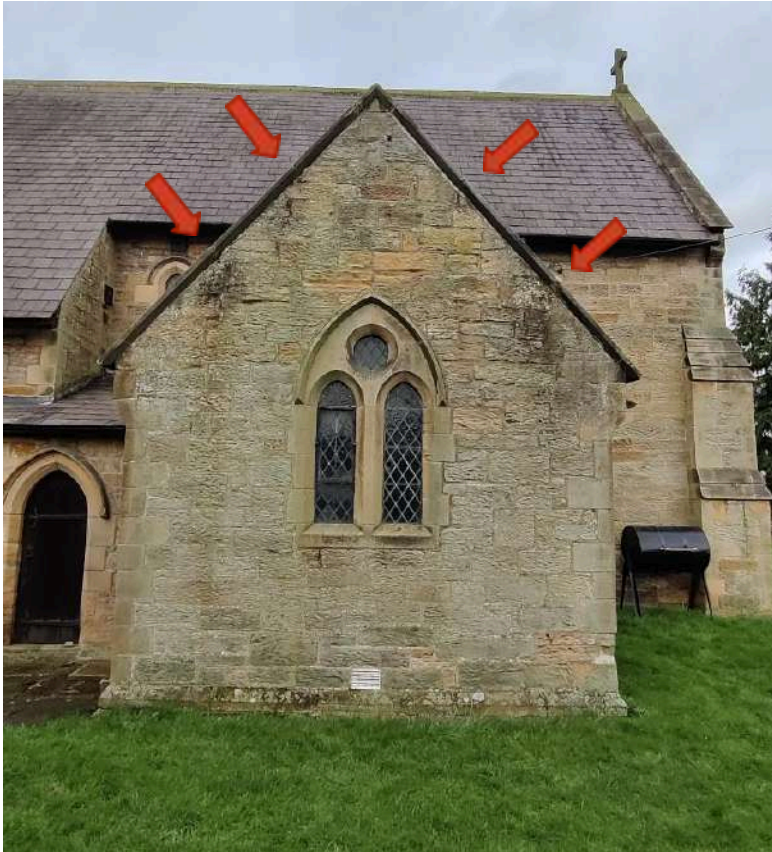
To the Vestry gable, there are signs of water ingress through open joints in the coping stones and it is beginning to affect the stonework. The joints should be re-pointed and kept in good repair at all times.

As noted in QIR 2015, there is some localised erosion of stonework and pointing to the south elevation. The areas should be repointed once the water ingress from the coping stones has been arrested. These coping stones are laid with straight joints. If not well-pointed, such joints will allow water to back-track into the masonry below. In comparison, the coping stones to the Chancel gable are laid with staggered joints, which prevent this from happening.

7. Vestry S elevation. Organic growth patterns indicate that water ingress is linked to open joints within coping stones (marked by arrows).

These joints require repointing.

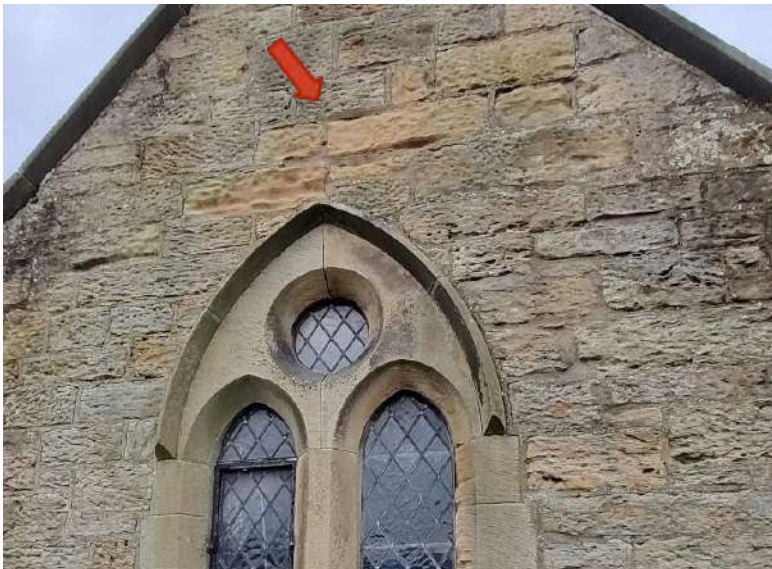
8. Closer view of eroding stonework over window apex, which might indicate voids or eroded bedding layers within the stonework along which moisture travels within the wall.

Repointing of eroded pointing is recommended.

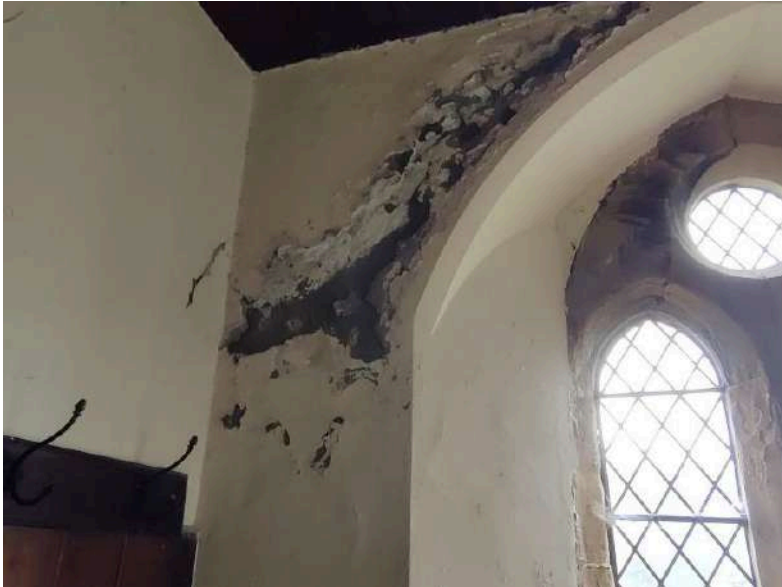
A large area of plaster failed around the Vestry window, likely due to water ingress. The window reveals and the stonework to the window are also affected. The plaster should be repaired once the coping stones have been re-pointed (see [External Stonework](#)) and the wall has dried out. Condensation might also affect these walls and was present during the inspection. But this was a prime day for such an occurrence - the building was cold following winter, the external temperatures had risen considerably over the last two days and the air was moist from earlier rain, the Vestry door had been open for some time for access thus allowing warmer moist air to hit cold stonewalls. The PCC should monitor if condensation persists once the heating system has been installed. If so, the room would benefit from careful ventilation.

9. Inside of Vestry: Plaster damage due to ongoing water ingress. Also some stonework decay.

4.04	Vestry Window. Repair failed plaster once point 2.02 (repointing coping stones) has been completed and the wall has dried out. Redecorate.	B	Builder	£500
5	Fittings & Fixtures			
	<i>no recommendations made</i>			
6	Installations & Fire Safety

Localised plaster repairs and redecorations will be needed following external re-pointing and a drying-out period.

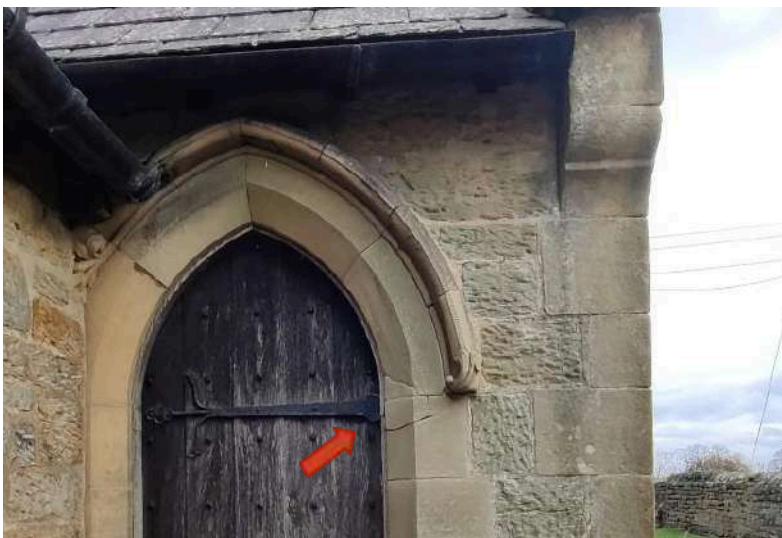
The cracked stonework to the RH springing point of the arched doorway to the Vestry was noted in the 2010 and 2015 QIRs. As it has not worsened, it is unlikely to be caused by rust jacking. It might not require pinning but it should be pointed to prevent further water ingress.

10. Internal door leading from Chancel to Vestry: long-standing crack in stonework (arrow).

2.03	Carefully point the cracked stonework to the RH side of the Vestry door using lime mortar or putty.	B	Builder	£100

The cracking requires re-pointing to prevent water ingress.

The oak door would benefit from resaturation.

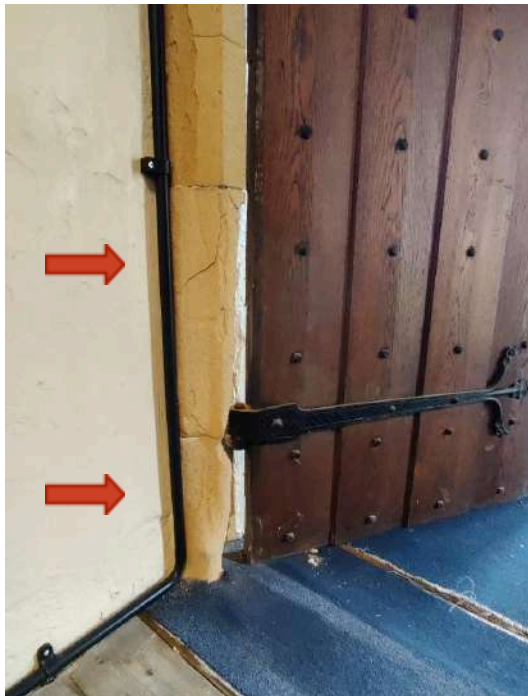
The stonework at the base of the door leading from Vestry to Chancel is eroding due to rising dampness. The church has no general problem with rising dampness. The PCC confirmed that there is no concealed water pipe in the area. If the investigation of the adjacent below-ground gully and drainage does not yield an explanation, it might be necessary to investigate whether the dampness could be linked to the localised sinking of the churchyard ground some 15m SE of the Vestry - see discussion under [Churchyard](#).

Localised rising damp has led to severe decay to the stonework surrounding the internal Vestry door. This may in time affect the stability of the bottom hinge. As recommended in QIR 2015, a first action could be to lower the ground level from the south side of the chancel to expose the plinth. If this does not arrest the problem, the condition of the adjacent gully needs to be looked at as described under [Rainwater Goods](#)). Once the area is dry, the condition of the internal stonework needs to be inspected and a repair specified.

11. Internal door leading from Chancel to Vestry: bottom two stonework courses decaying.

1.06	Carefully reduce the risen ground to the S side of the Chancel, exposing the plinth. Make good. Monitor for 6-12 months to see if the damage to the stonework at the base of the Chancel/Vestry door stabilises.	O	PCC	£0

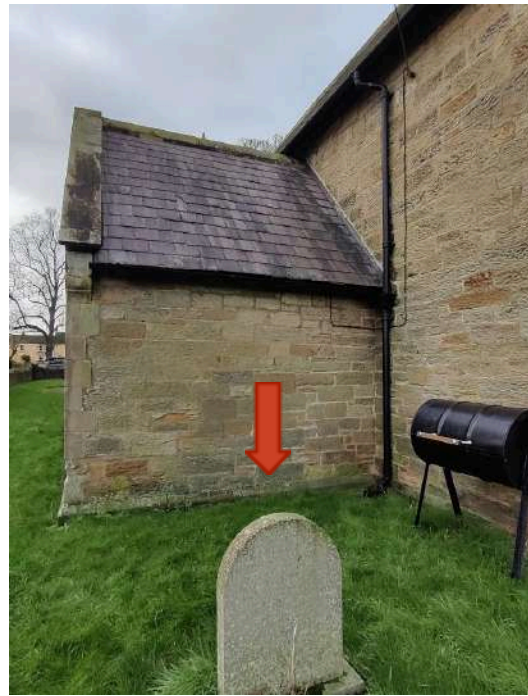
12. Risen ground level obscuring base plinth could contribute to rising damp problem in photo 11.

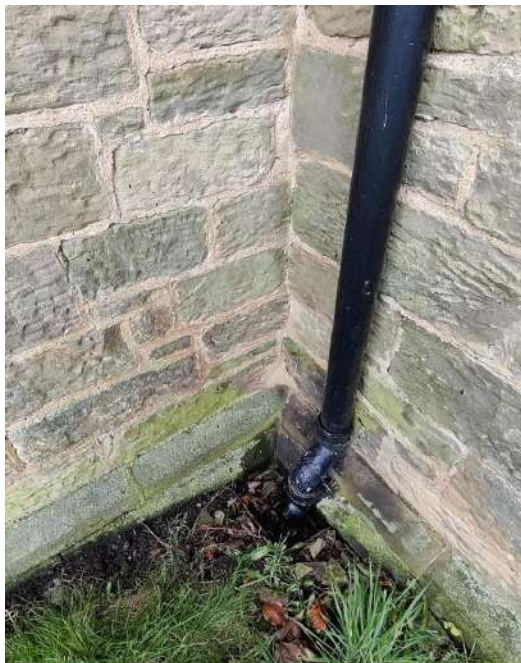
13. Gully at abutment of Vestry & Chancel indicates original ground level. If cracked or not discharging, it could be the source of rising damp.

1.07	If 1.06 above is not successful, investigate the below-ground gully and drainage to the east of the Vestry for any defects that could cause the erosion of the stonework at the base of the door leading from Vestry to Chancel. Repair any damage found and make good.	O	Builder	£750
2	External Stonework

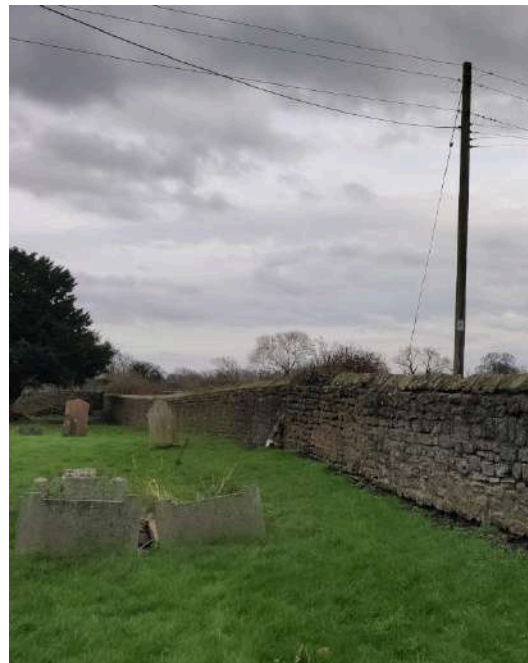
14. Sinking graves SE of Vestry reportedly due to archaeological remains, but could also indicate a localised drainage issue.

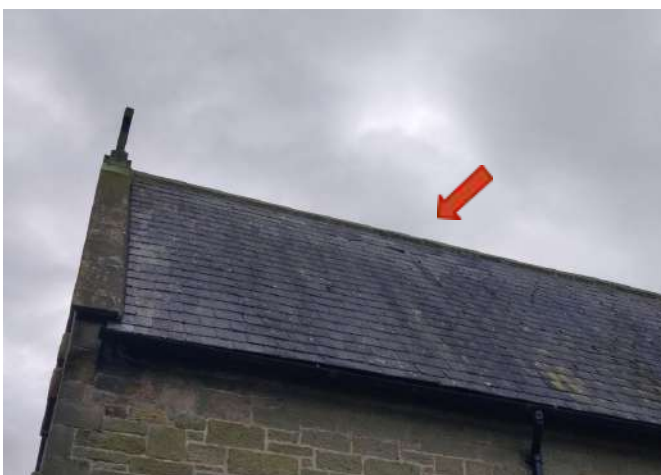
Pitched roof covered in purple Welsh slate, generally in good condition. The PCC reported that the ridge stones were recently re-bedded and the mortar flaunching renewed. The PCC reported a history of slipped slates. Except for the recently re-laid slates below the ridge, slipped slates are generally single occurrences and not numerous. I observed a number of failing poor and partially non-matching slate repairs at the Nave. As the current roofer is retiring, the PCC is in the process of choosing a new roofer to rectify these issues. The PCC should keep a record of new slate slippages. An increasing rate could indicate 'nail sickness', the rusting away of the nails which hold the slates in place.

17. N slope of Chancel roof: there are a number of slipped slates just below recently re-laid slate courses near the ridge.

These slates require re-fixing by a competent roofer to prevent damage to adjacent areas.

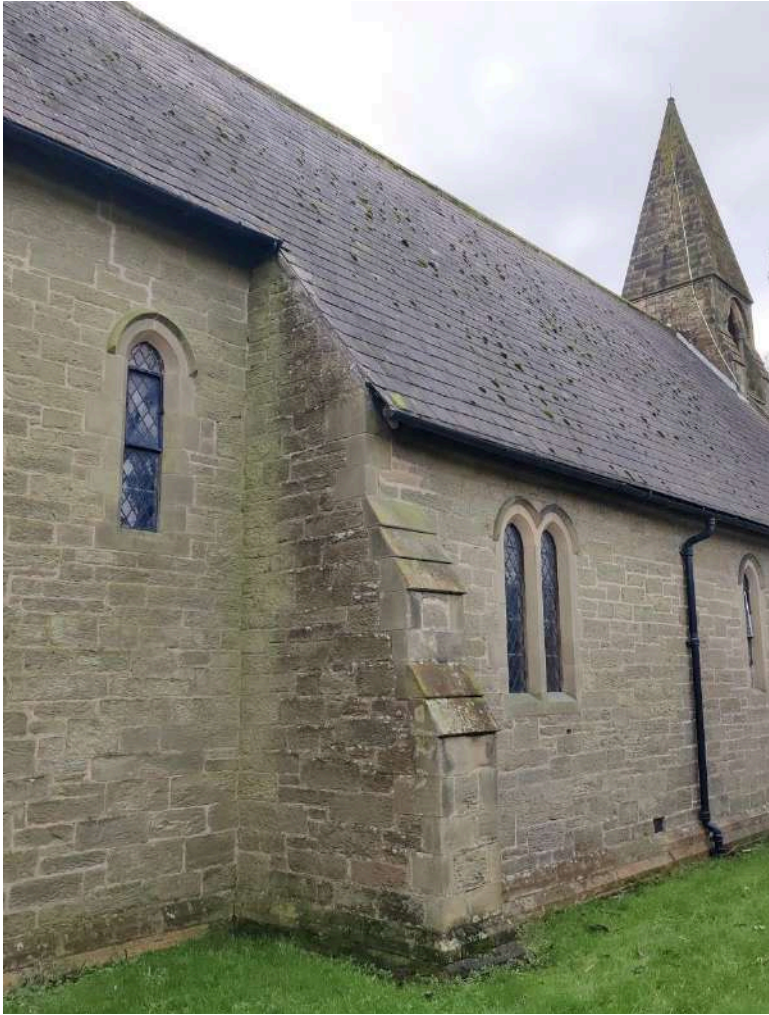
The walls to each side of the main door and to the E end of the Nave are exposed to rainwater run-off. There are no obvious problems beyond the green colouration of the sandstone, but the walls will be somewhat wet and thus colder. Should problems arise, or when the time comes for renewing the slating, consideration should be given to extending the roofing beyond the wall lines in order to protect the below stonework from rainwater run-off.

In future re-roofing, consideration should be given to extending the roof overhang at the Nave abutment to prevent water draining onto the stonework below. This is leading to staining and colder wall surfaces.

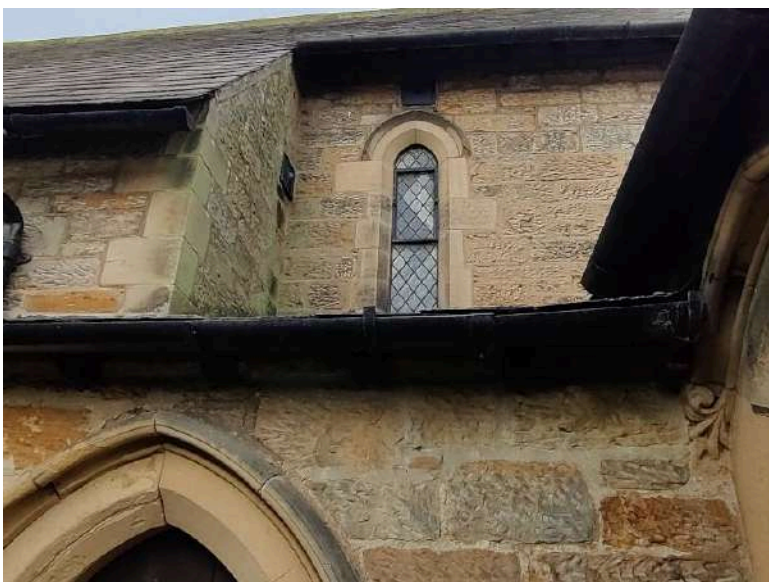
20. Same issue at the SE abutment of the Nave marked by the greening of the sandstone wall.

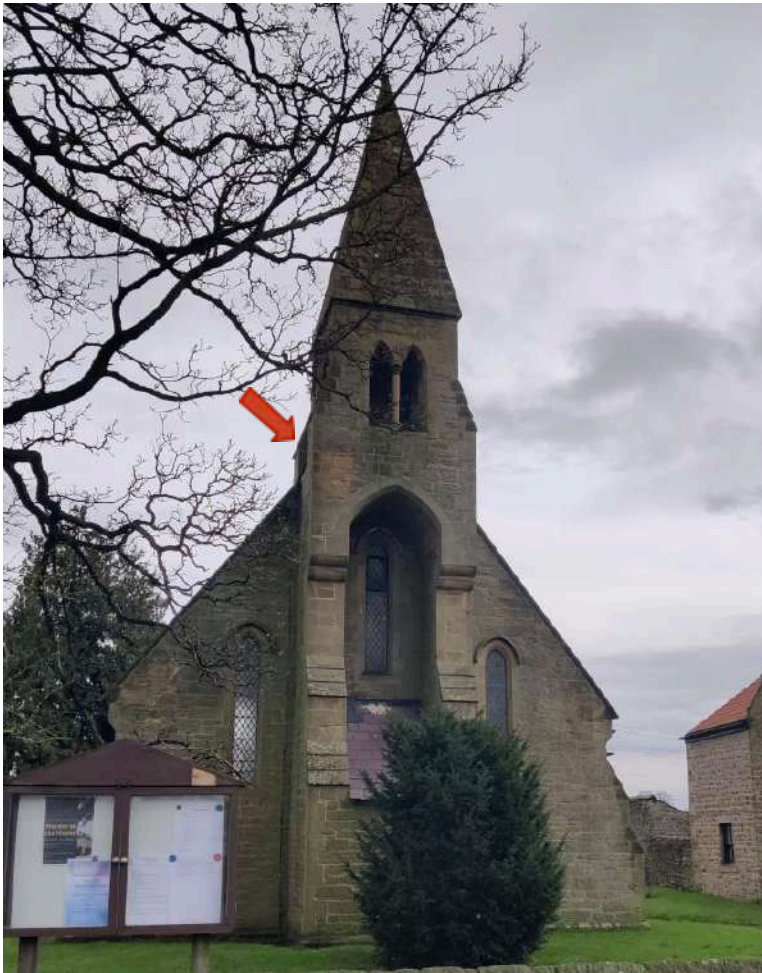
22. View from W: Small area of stonework erosion (arrow) is consistent with condition reported in QIR 2015.

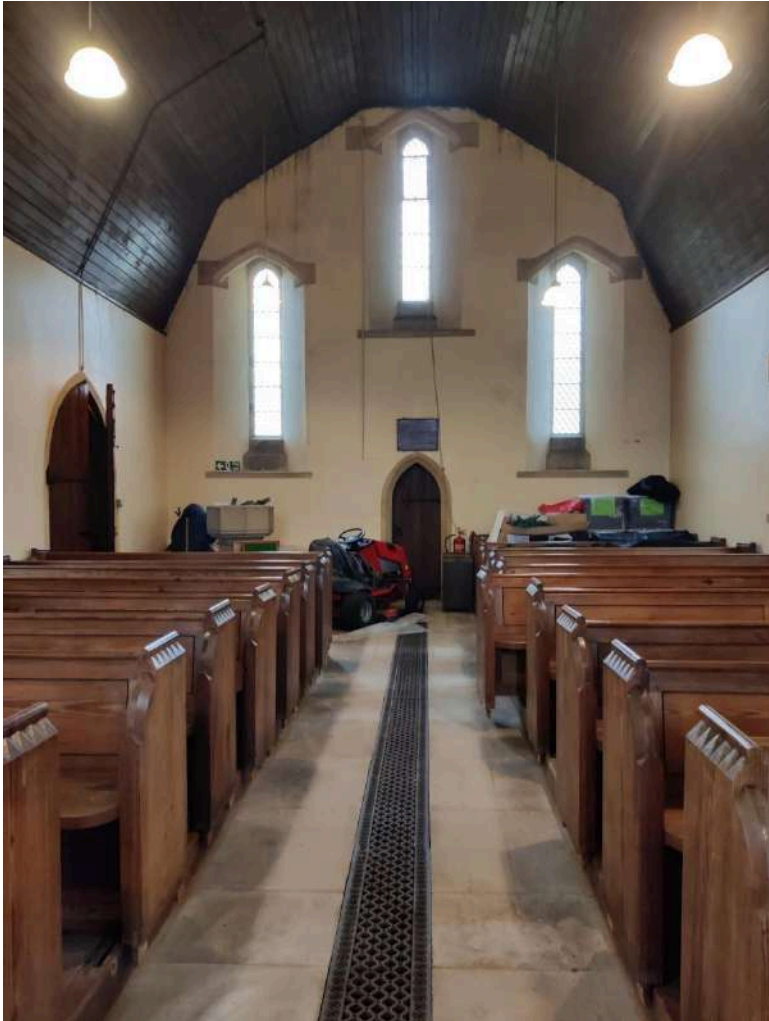
23. View of Nave. The church was being prepared for the upcoming Reordering works, with pews being lifted and other items stored temporarily at the W end.

The staining of the walls is reportedly historic.

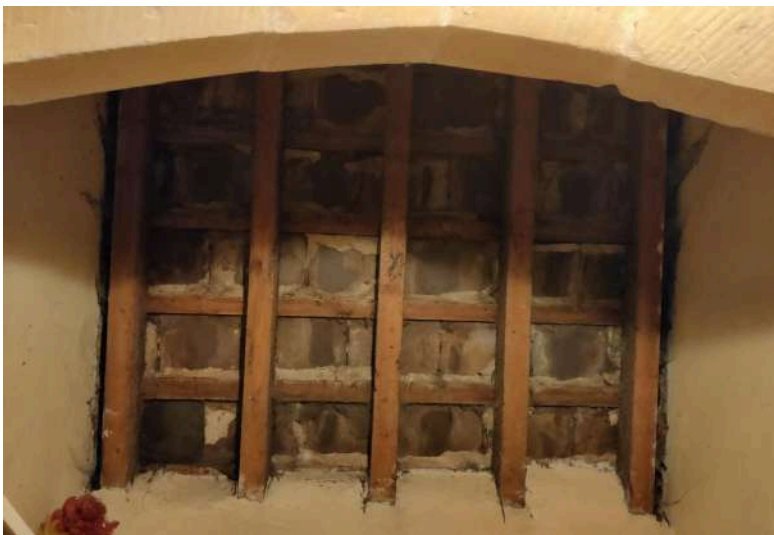
26. Below LH: Roof over small tower room

The top of this slated roof appears to have been repaired with a non-matching material.

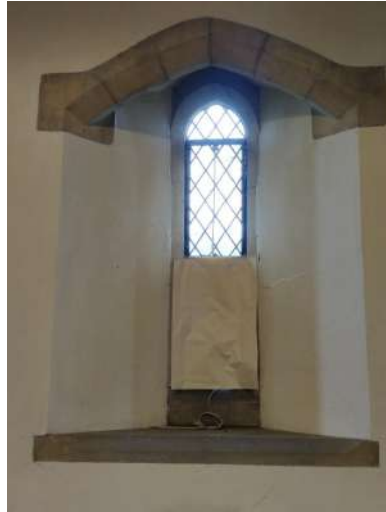
28. Nave N wall: broken leaded light

The broken leaded light & frame on the N side of the Nave should be repaired by a suitably qualified glazing workshop. The small number of cracked glass quarries in other leaded lights should be replaced as in-situ repairs at the same time.

3	Doors & Windows			
3.01	Resaturate the external oak doors.	C	Joiner/ decorator	£250
3.02	Repair to the broken window in the Nave. Whilst reinstating, replace in-situ a small number of cracked glass quarries in other leaded lights	B	Glazier	£1,250
4	Church Interiors

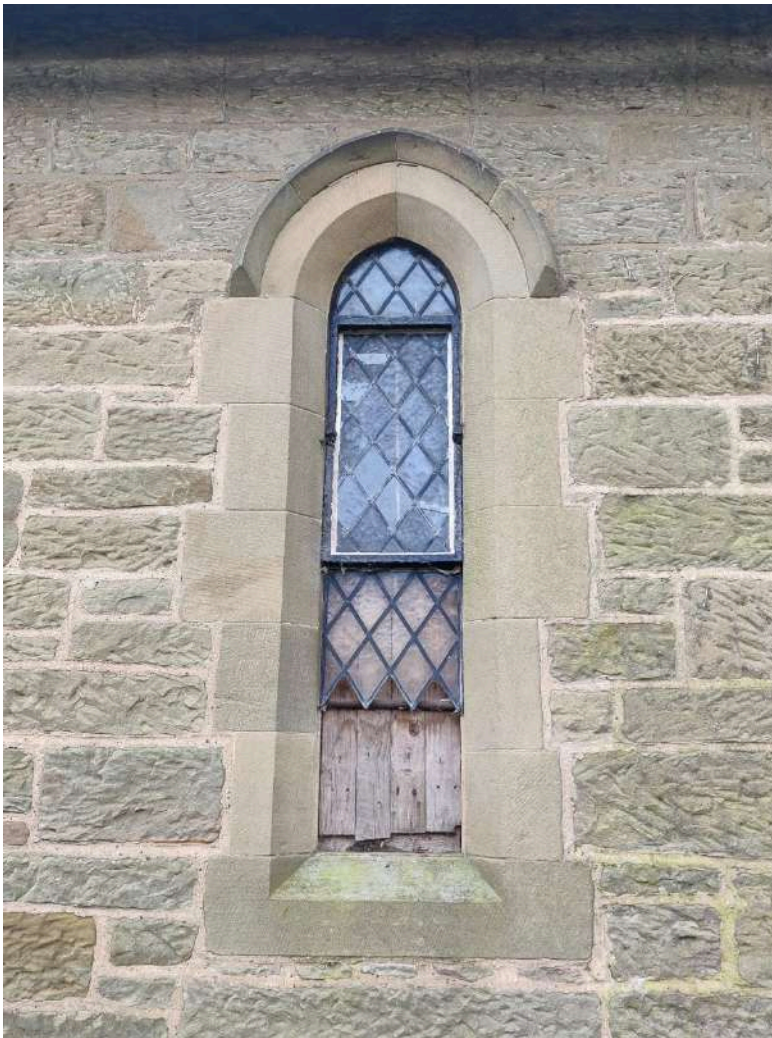
29. Same light seen from the outside

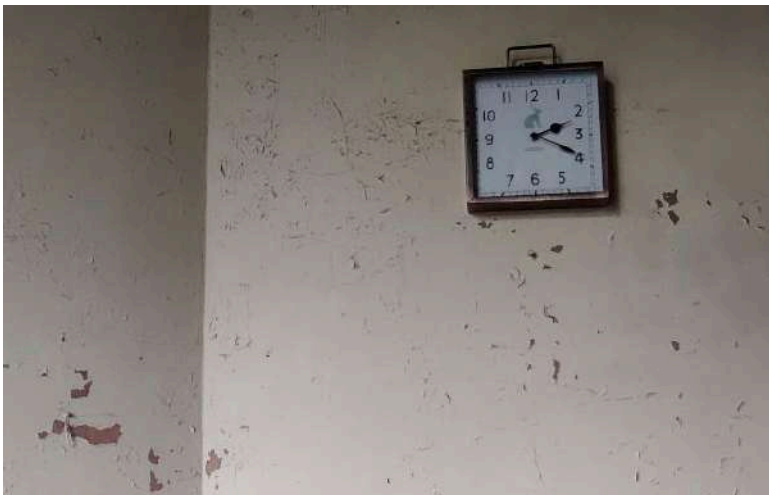
Generally, there is wide-spread cracking within the uppermost paint surface. This paint has reportedly been in the church for a long time. It is washable, whereas the paint below appears somewhat chalky. Not every paint type is compatible with another, and an underlying problem might already exist. Reassurance should be sought that this has been considered as part of the proposed redecoration.

33. Cracking paint seen throughout Nave and Vestry

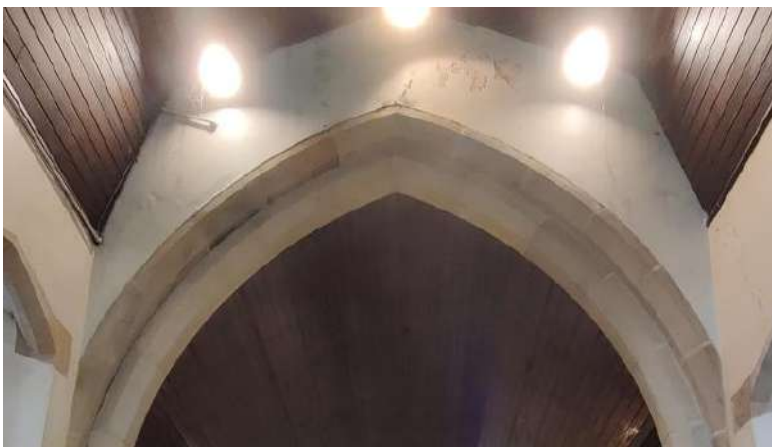
35. Historic water ingress and cracking above Chancel arch.

Monitor for recurrence following redecorations.

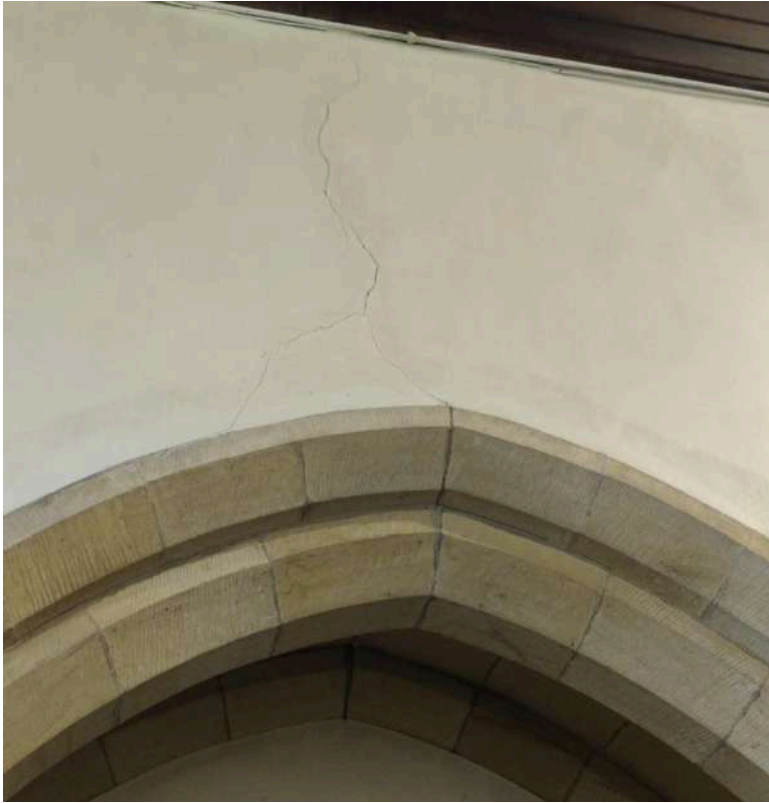
36. Previous cracking above arch between Chancel and Vestry has recurred but does not appear to worsen.

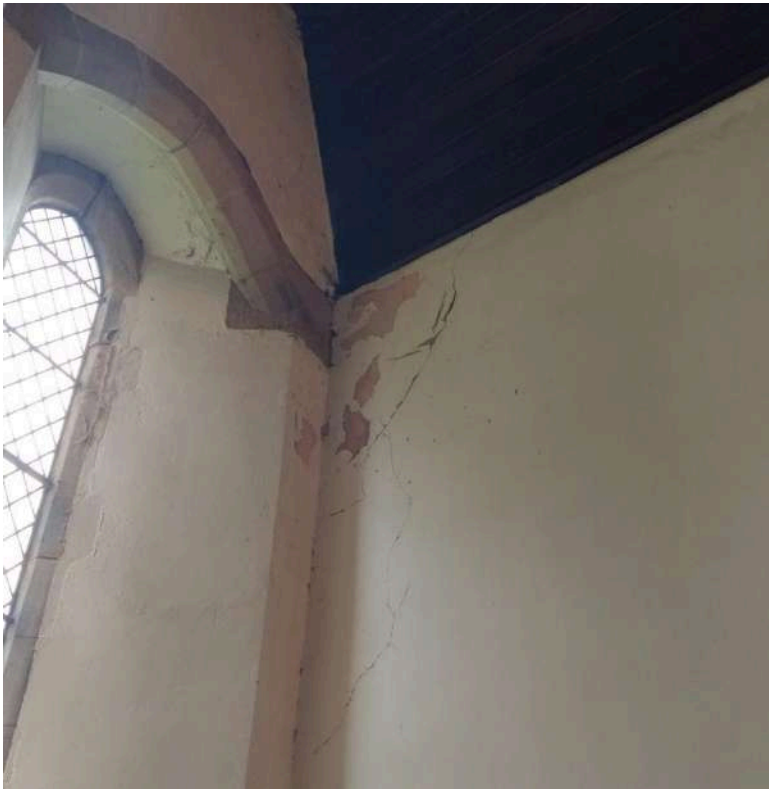
There is cracked plaster at the SE corner, just below the ceiling. This was also noted in QIR 2015 and has not worsened. Similarly, the staining at the E and W ceiling abutments noted in QIR 2015 has not worsened and is likely historic. The same exists within the Nave.

37. Cracked plaster at SE abutment of Chancel is reported to be longstanding.

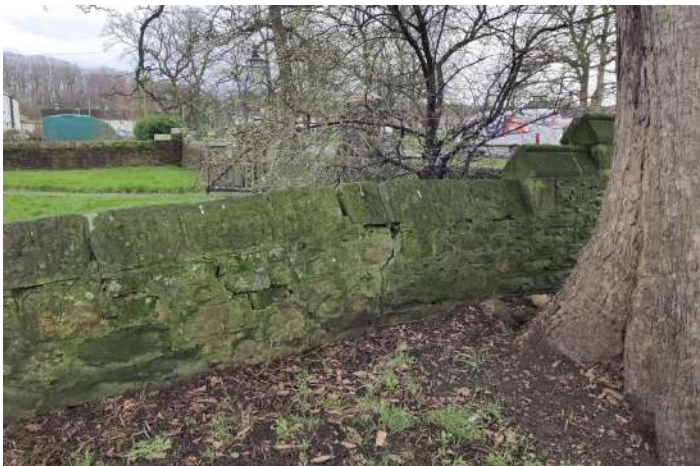
39. NW boundary wall. The cracking and loose copings require periodic re-setting and pointing.

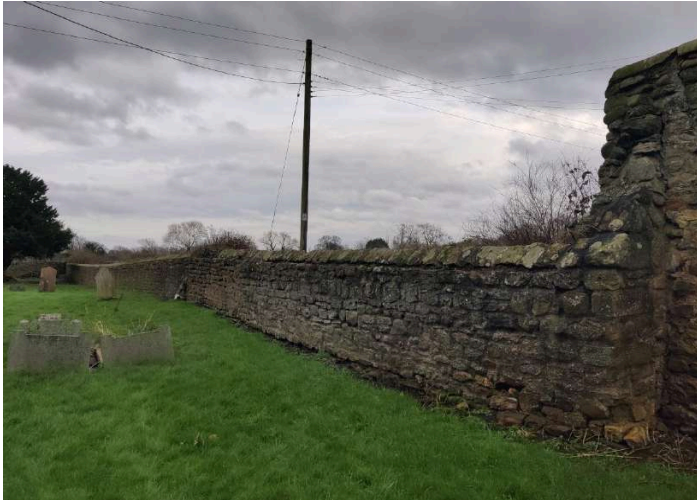
43. S boundary wall

The base of the wall requires repointing.

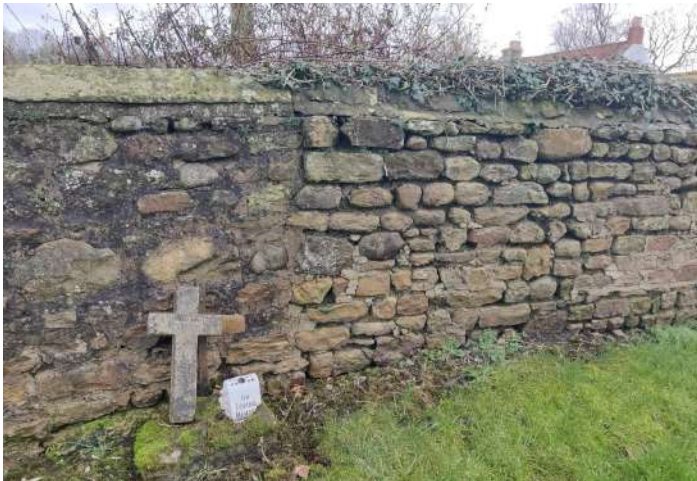
44. S boundary wall

Some sections of the wall would benefit from repointing.

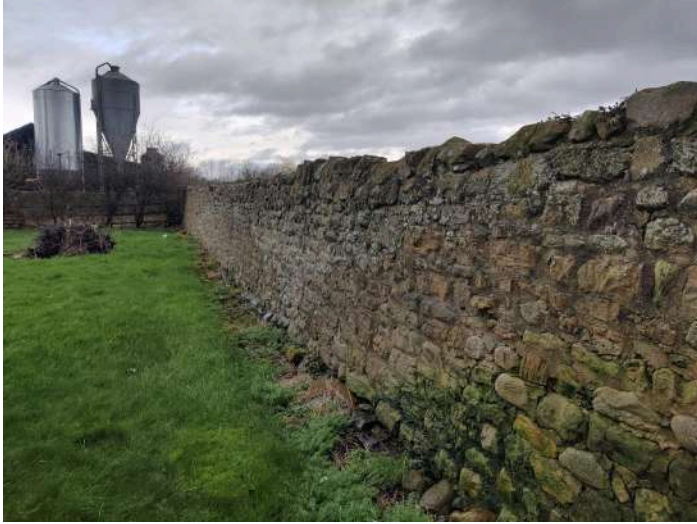
46. The E boundary wall has a historic lean that does not appear to have worsened since QIR 2015.

The base of the wall needs repointing.

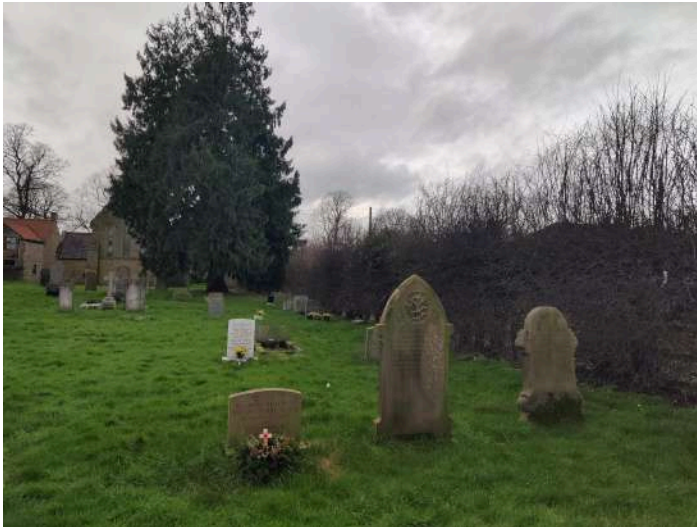
47. The deciduous hedge at the NE boundary should be topped to keep it at a manageable height.
