Care of Churches and Ecclesiastical Jurisdiction Measure 1991 – Quinquennial Inspection
ALL SAINTS, EAGLESCLIFFE

Diocese: Durham
Archdeaconry: Auckland
Church Code: 613 312

Date of Inspection: 23rd June 2022
Inspection undertaken by: Jamie Holden BA (Hons) RIBA RIAS
Previously Inspection: Nov 2014 by D Beaumont

Studio Tamacoco Architects

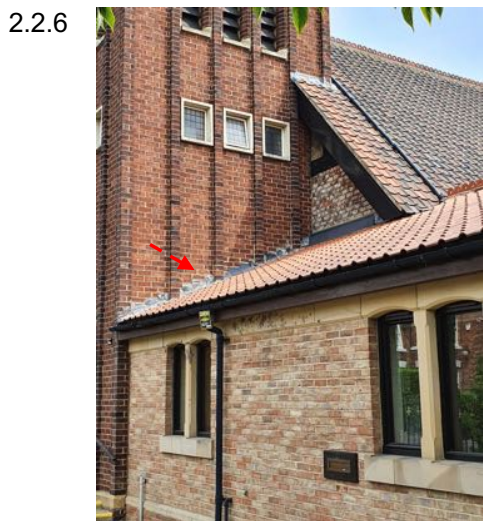
2.2.3 The abutment flashing where the Narthex adjoins the tower at both sides is quite weathered, and some sections appear to have been replaced. All in reasonable order.

a) Abutments flashings weathered with some replacements.

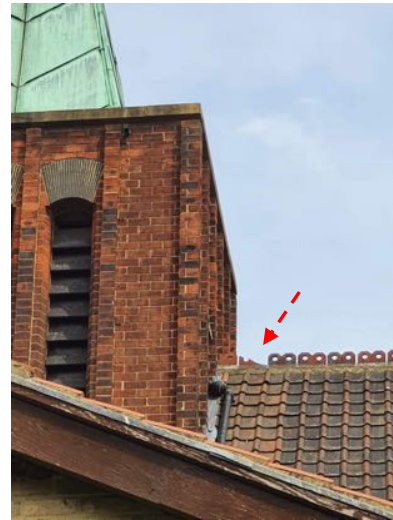
2.3.2 The Nave and Library are covered with single roll clay tiles with decorative ridges. One of the ridge tiles at the west end of the Nave next to the Tower is broken. This has no effect on weathertightness and on the whole the roofs are in reasonable condition.

b) Broken ridge tile to Nave roof.

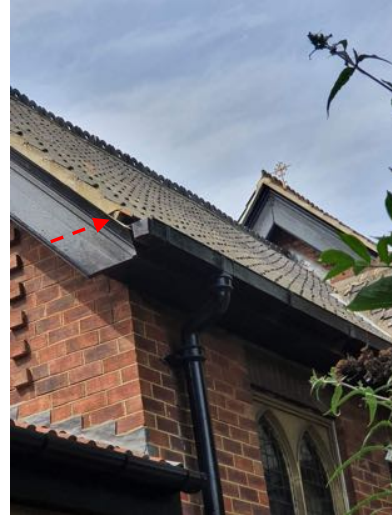
- 2.4.3 From what can be seen of the Chancel and Organ Loft roofs from ground level they are in good order, there is a small area of pointing missing from the verge but does not require attention at this stage.

b) Small section of pointing missing from the east verge on the north side of the Chancel.

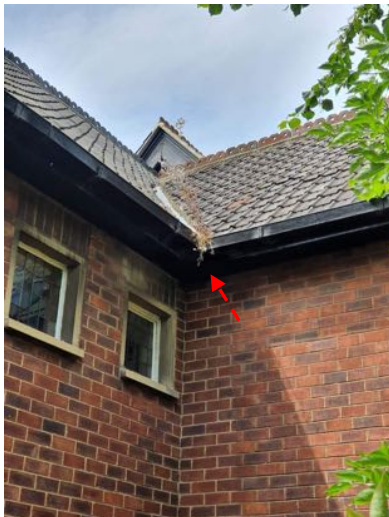
- 2.4.4 There is a blockage in the bottom of the valley gutter between the Chancel and Organ Loft on the north side which has led to some localised minor decay on the fascia board. The gutter should be kept clear as a matter of routine maintenance and the fascia board redecorated in that area at the same time.

a) Remove blockage in the gutter at the valley between the Chancel and Organ Loft roofs.

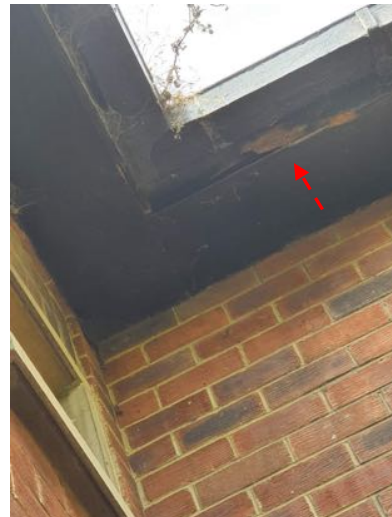
b) Minor damage to the fascia board. Probably due to the blocked gutter above. Localised redecoration required.

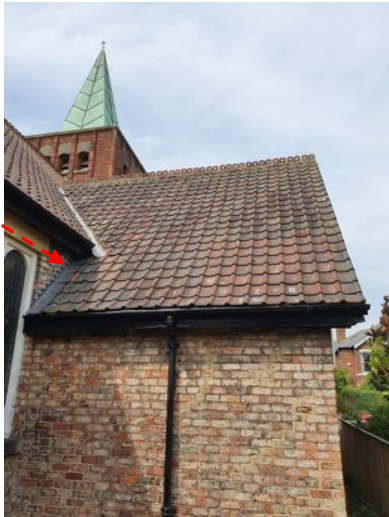
a) Replacement lead where the Office roof abuts the Nave.

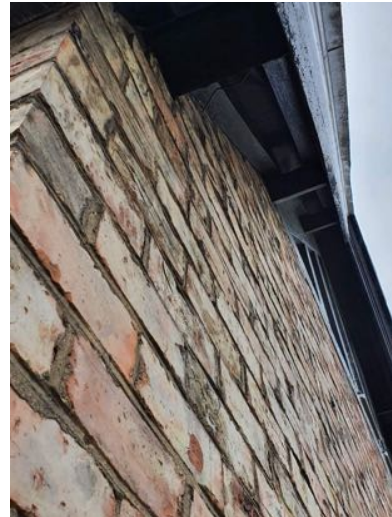
b) Bargeboard to north facing gable end.

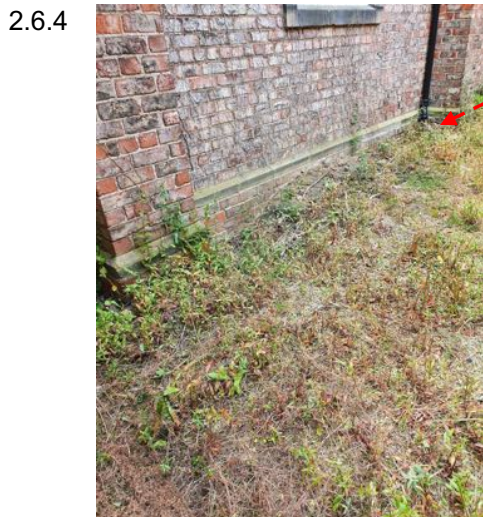
2.6.2 Not all gullies are visible due to planting and on the north side those downpipes draining the Nave and Office roofs do not appear to have gullies or they have been buried over time. All gullies should be checked (exposed where currently concealed) and tested to ensure they are draining freely. **2**

a) Gullies buried should be exposed and tested.

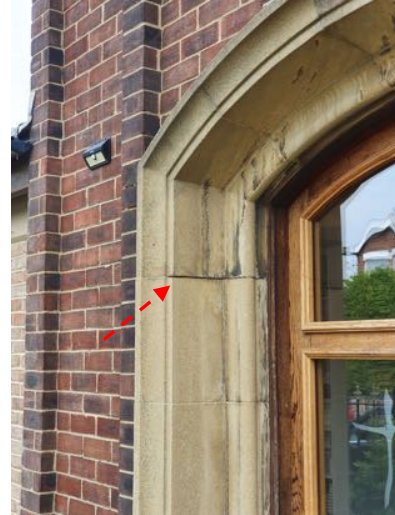
- 3.1.2 There is a central entrance doorway at the base of the west elevation with a profiled cast stone surround. The doors are oak with glazing panels. The stone surrounds have developed dark staining in places and the top mortar joint on the left-hand side is starting to deteriorate. This joint ought to be repointed when other masonry repair is carried out. It is not urgent in its own right at this stage.

b) Washed out mortar joint and staining to the cast stone surround.

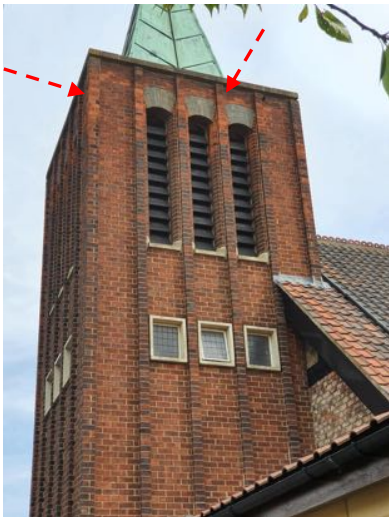
a) South elevation. Note the concentration of orange coloured bricks where surface erosion is taking place.

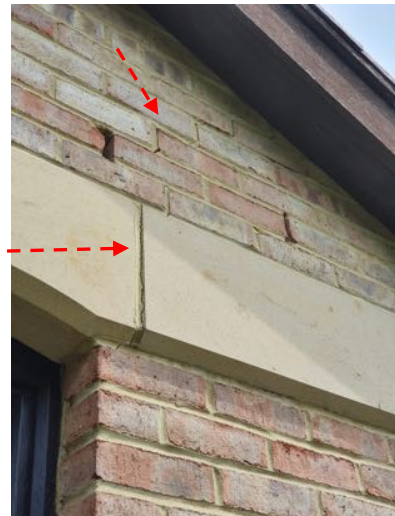
3.2.2 The masonry is generally in good order, however, there is a stepped crack that runs through the mortar joints from the head of the easternmost window on the south elevation of the Meeting Room. This crack occurs in the corresponding location internally as is noted elsewhere in this report. The crack should be carefully raked out, repointed with matching mortar and then monitored. The crack is probably the result of minor settlement but if it reappears further investigation will be required. **2**

b) Stepped crack to be repointed.

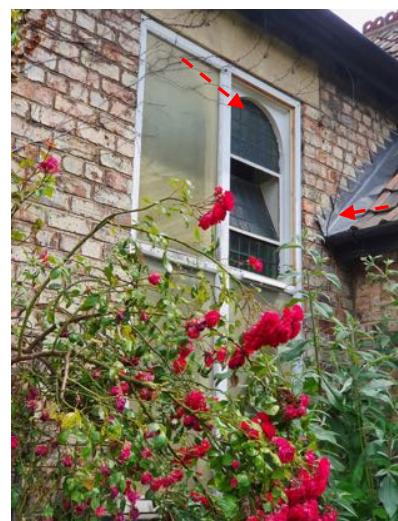
3.3.3 The lead flashing at the abutment where the library roof meets the Nave elevation is a relatively recent replacement but appears to have worked loose at the gutter. Not urgent but ought to be repointed. **2**

b) Panel removed to allow ventilation. Abutment flashing is working loose.

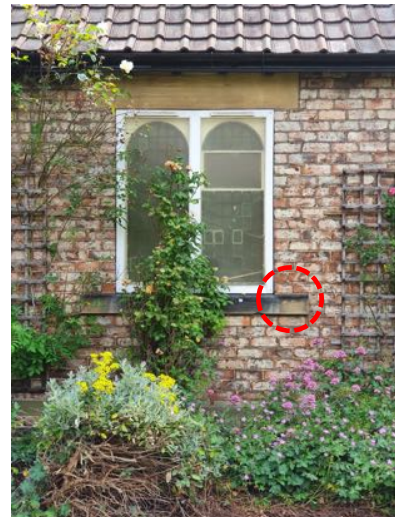
b) Cracks to cill in the west elevation

- 3.4.6 The Library needs to have its windows refurbished, ideally in conjunction with a relatively modest package of work to remove previous cementitious mortars and repoint using an appropriate lime mortar. To prevent further decay the PCC would be advised to start planning the repairs outlined above. **2**

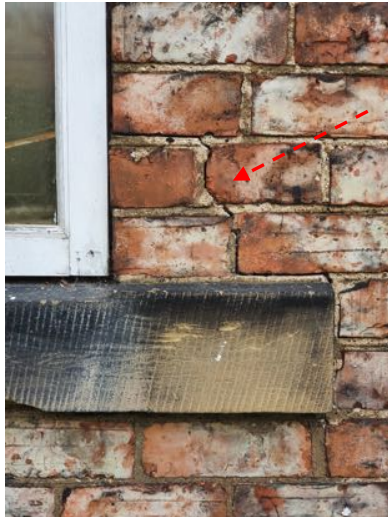
a) West elevation – crack above the cill

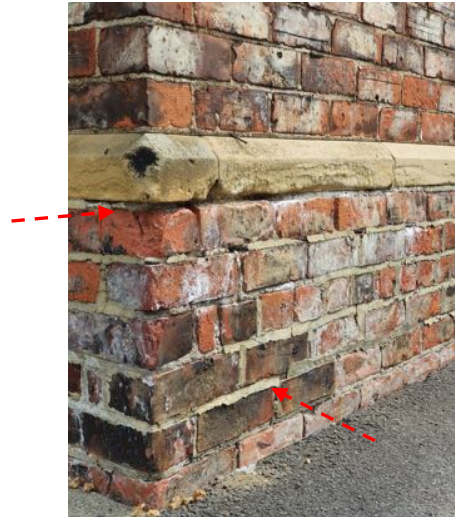
- 3.4.4 Salt deposits on the stone plinth and brickwork below it are evidence of dampness effecting these lower areas. The plinth has been repointed using cementitious mortar which is unfortunate. Cement based mortar often prevents moisture absorbed into the wall from evaporating properly and it is likely that this has, to some extent, contributed to the deterioration of the brickwork and stone plinth course.

b) Mortar loss around the stone plinth course probably caused by rising damp and the use of cementitious mortars.

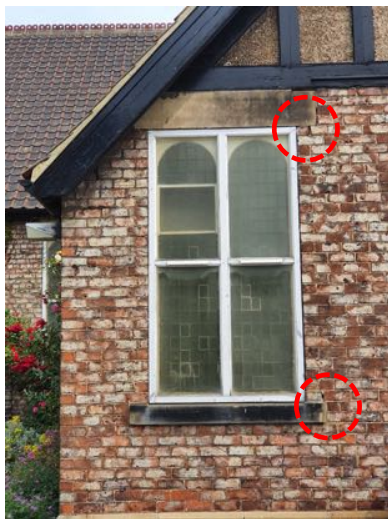
- 3.4.3 There is some mortar lost around the lintel and cill of the left-hand window which ought to be repointed to prevent moisture ingress causing further accelerated damage to the fabric.

a) Mortar loss at the head and cracking around the cill

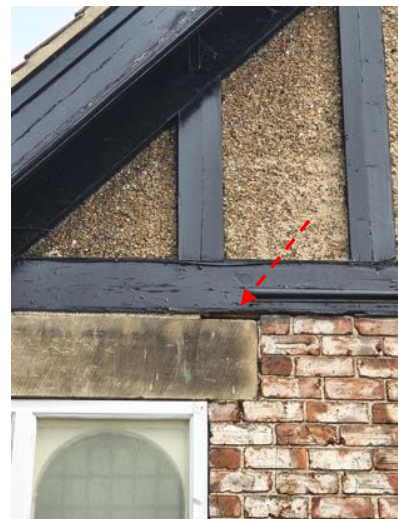
b) Mortar loss between masonry and timber beam.

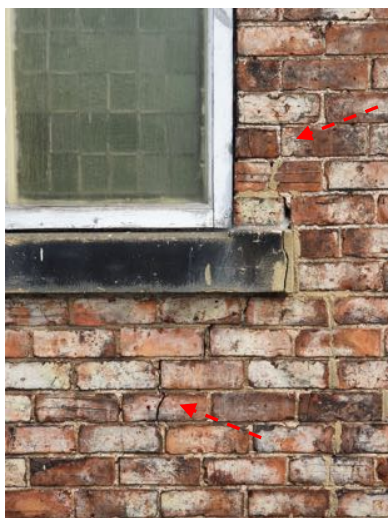
a) South elevation – cracking around the cill

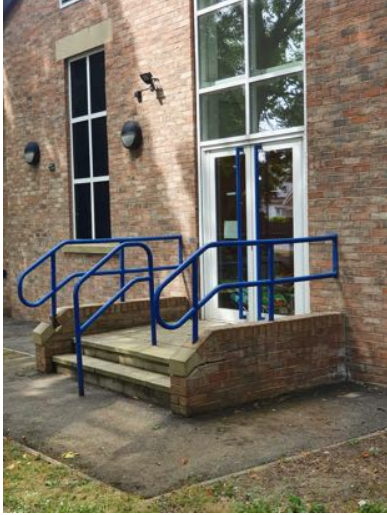
3.5.1 The Community Hall is outside the scope of this report but a brief inspection identified defective masonry supporting handrails to the stepped access from the east elevation. This seems to be the result of corrosion where metalwork it is imbedded within the wall.

a) Cracked bed joints

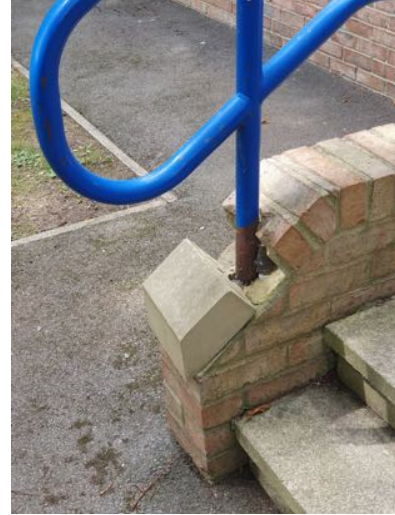
b) Loose masonry block was removed by the Architect as a precaution to avoid the risk of injury.

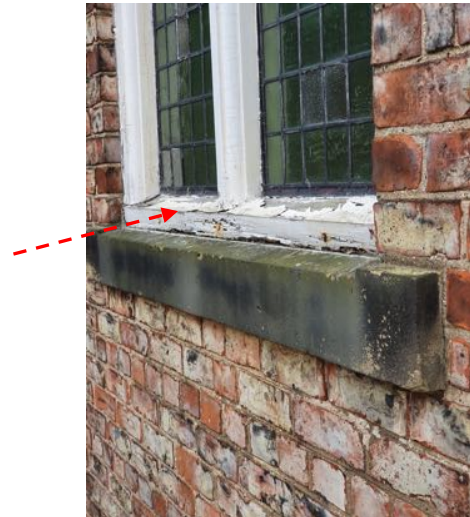
- 3.7.1 The north elevation of the Nave has a projecting gable at the east end which might once have housed a church organ. This gable has a tall window opening with a stone head and cill. The window frame is timber with a central mullion creating two round arched lights. Each light is infilled with clear rectangular leaded glass and the left-hand one has a ventilation hopper. The window frames are in reasonable condition apart from the nose of the cill which is rotten and needs to be replaced and redecorated. **2**

b) Replace rotten cill to window in the north gable elevation.

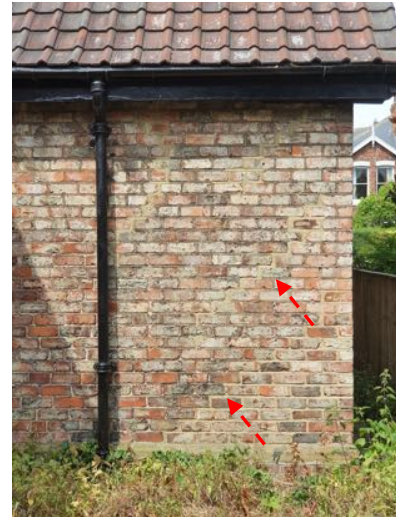
- 3.8.3 A large stepped crack has been repointed on the east elevation. It is understood that the Office/ Chapel was underpinned in 1993 and it is very likely that the repointing took place then. At present all the masonry appears in good order.

b) Stepped crack has been repointed

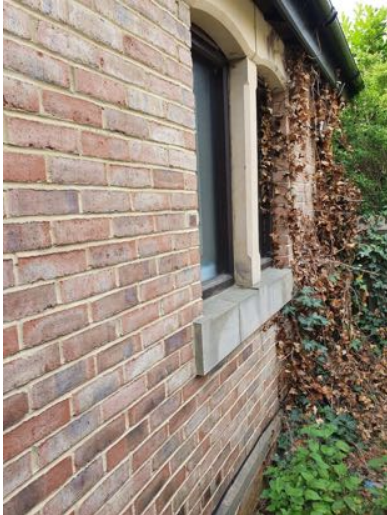
a) Cut back ivy infesting WC windows

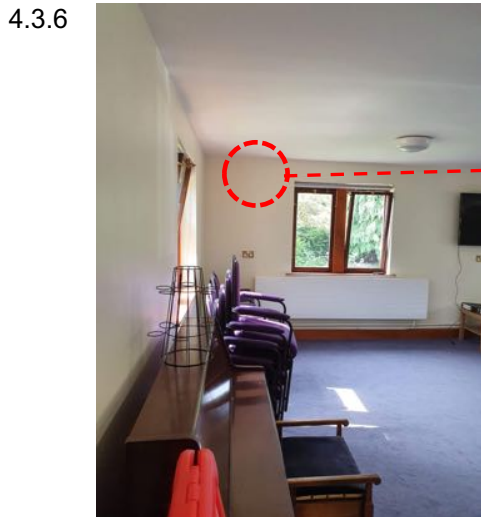
4.3.1 As per the Office, the Meeting Room has plastered and painted walls and ceiling which are all in good order except in the SE corner above the window where there is a vertical crack which corresponds to the one noted in the external brickwork. Monitor and if there are any notable changes inform the Architect. ○

a) Cracked plaster in SW corner

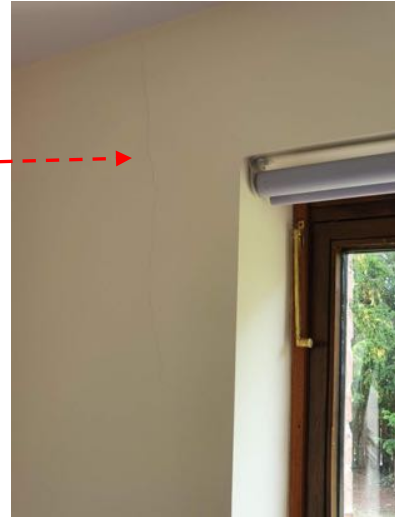
b) Crack to be monitored.

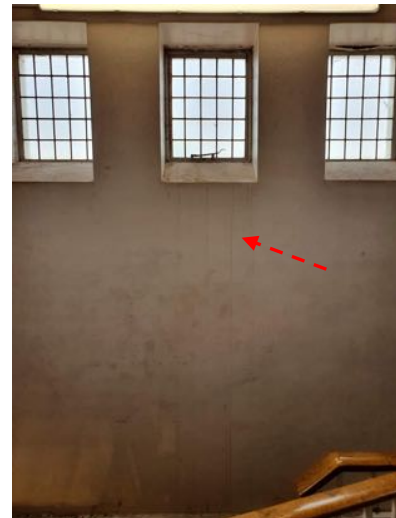
4.4.2 Each wall, except the east, has three windows with clear leaded glass. There are a number of windows with cracked panes and on the west wall there are runnel streaks from moisture entering the Tower through broken glass. These broken panes ought to be repaired. **4**

b) Runnel stains

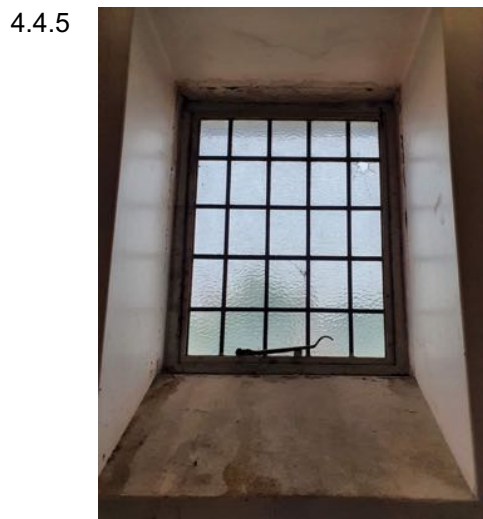
a) Broken panes to be repaired/ replaced.

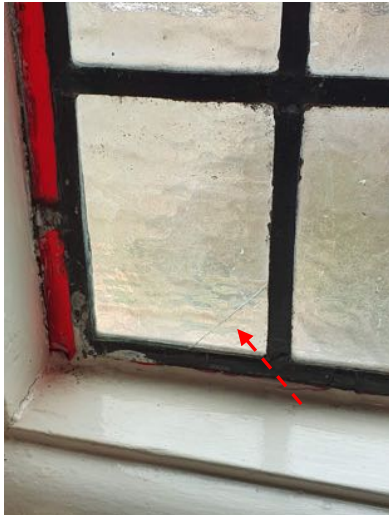
a) A minor crack to a pane in the north alcove.

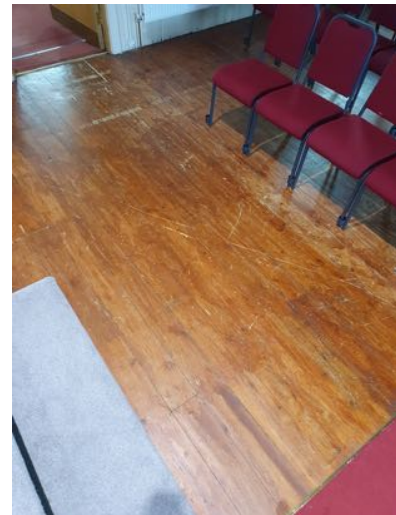
b) Pine boarding is heavily worn in places but remains serviceable.

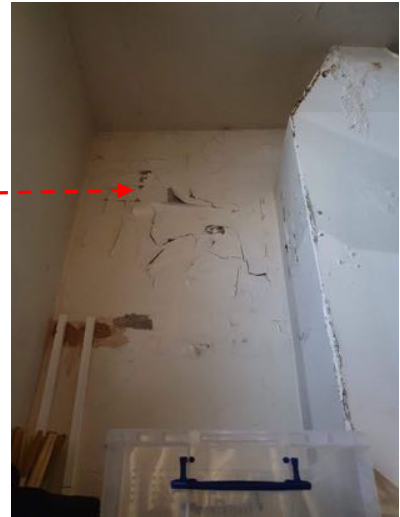
b) Corroded plaster beads and flaking paint work to be investigated.

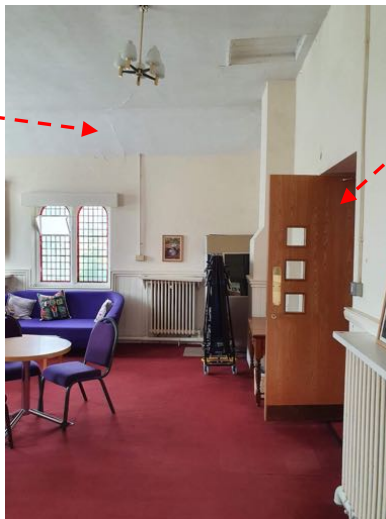
a) Entrance from the Nave on the right of picture. Plaster cracks in the west wall and ceiling are visible.

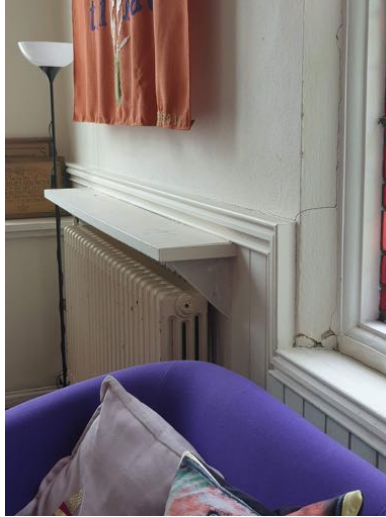
a) Cracked plaster reveals

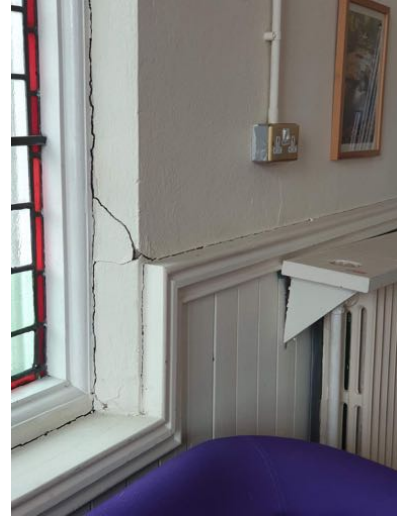
b) Cracked plaster reveals

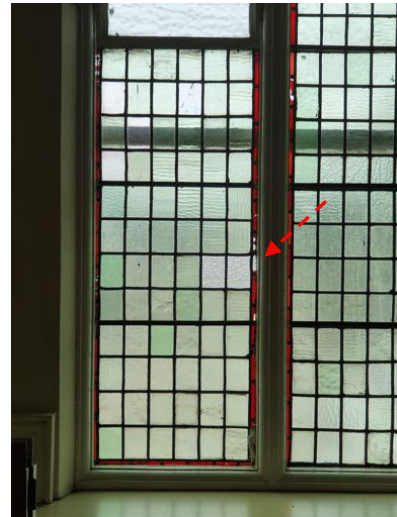
b) Numerous broken panes

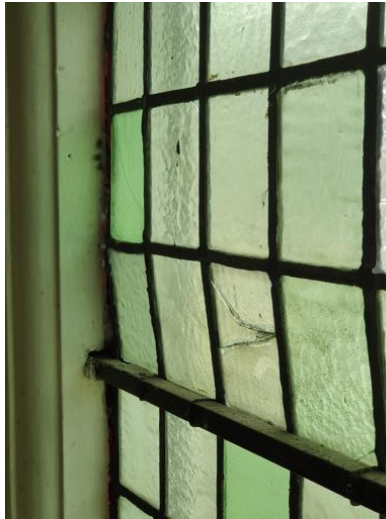
a) Buckled glazing

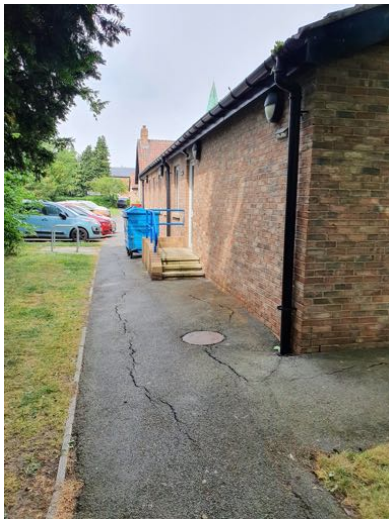
a) Tarmac has large splits, probably caused by tree roots.

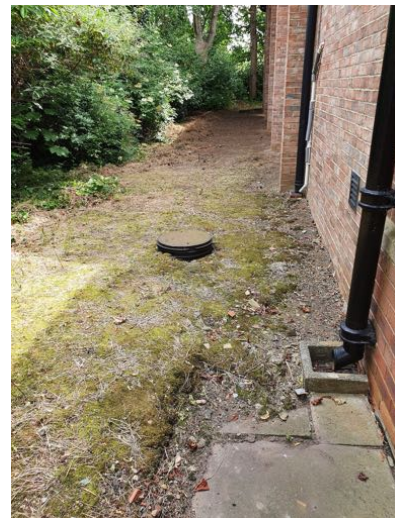
b) Manhole cover set quite high above ground level and vulnerable to damage if machinery is brought into the area.
