ROWLANDS GILL St BARNABAS
(22A)

QUINQUENNIAL REPORT

15 May 2018

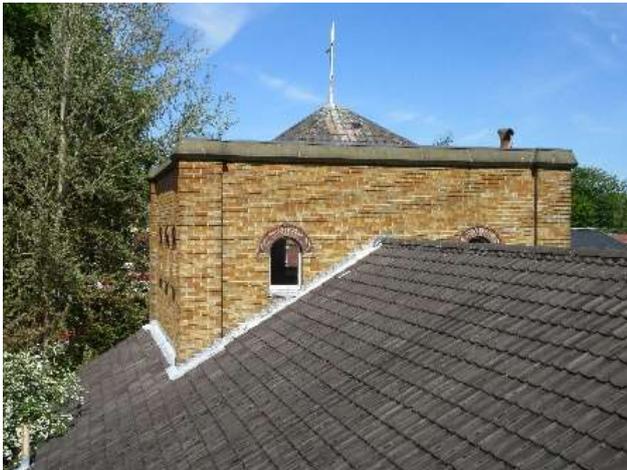
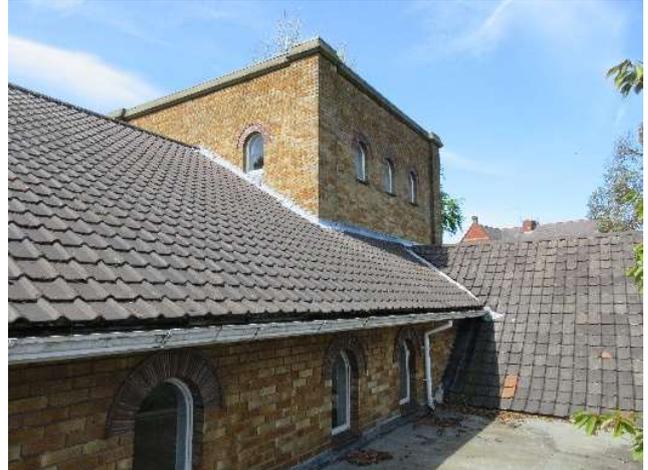
15. Tower roof a pyramid with interlocking roll clay tiles with metal cross at the peak and wide stepped gutter inside a deep parapet (no access at this inspection). 2009 repairs included relaying most gutter boards and bearers to better falls and drips. Since the last inspection most of the gutter lead lining was stolen and replaced in dark grey Sarnafil carried on ply up the insides of the parapets and over their copings. The gutter lining was carried over remaining lead in the two N outlet chutes.

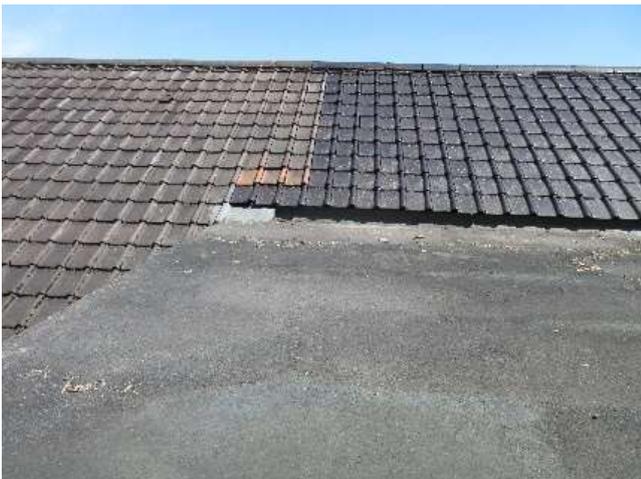
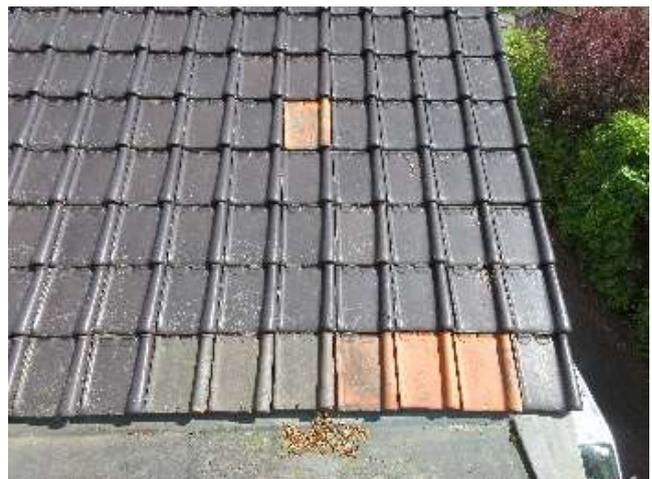
16. The church pitched roofs have tiles slightly sprocketed at the overhanging eaves. Round ridge and hip tiles. The verges are mortared and the valleys lead lined except where substitute fitted at E after theft. Apron and abutment flashings where roofs meet the Tower lead except flashband at the W Nave slope. Reinforced felt underlay seen at the only accessible loft (Vestries) assumed used generally.
17. The older church tiles are reddish brown with minor spalling and much moss in the joints. A few replacements. Broken rolls at a few tiles have been patched with flashband (self adhesive foil tape), now itself mossy.

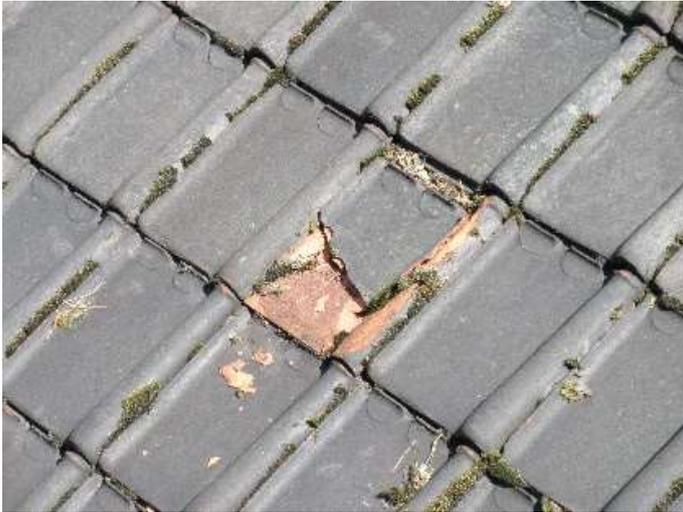
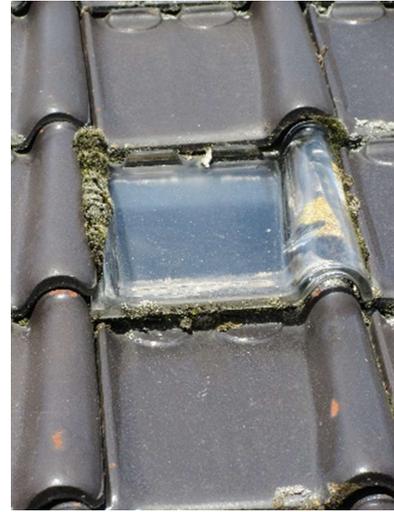
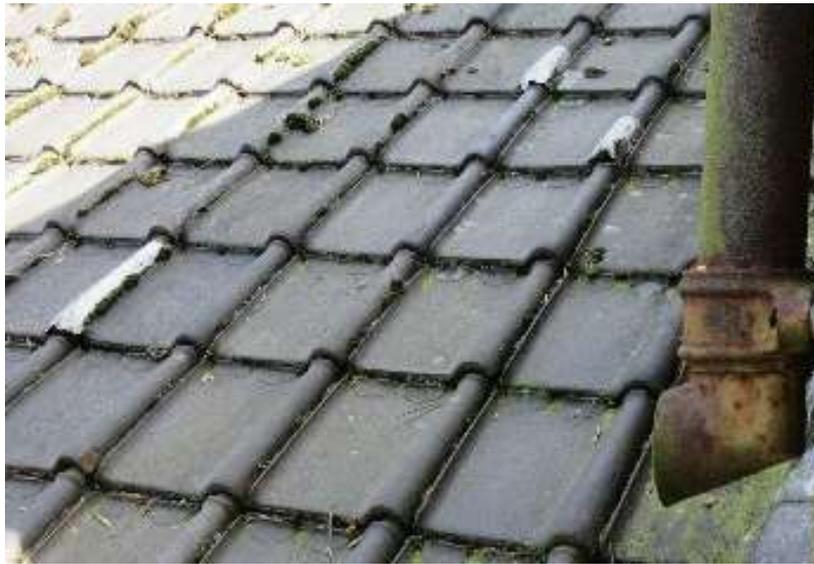
18. On the E side some tiles are spalling and one cut tile at the Vestry valleys has slipped exposing interlocks under. Two flashband patches on the Vestry valley lead. The W side is fair but three broken tile rolls remain patched with flashband and one tile is decayed. The lead cover flashing at the abutment to the Tower has been changed to short life flashband. Ivy on parts of the hidden W wall needs to be controlled to stop it reaching the roof tiles, where it would cause damage and leakage.

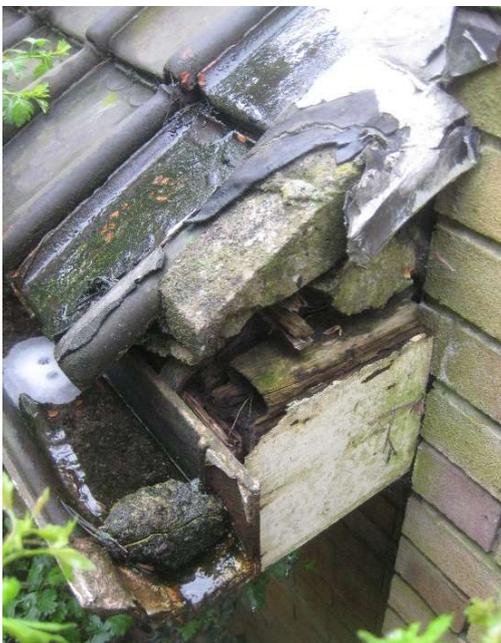
2013

19. The Nave SW corner (accessible from the fire escape) has a poor detail where the higher Hall dormer abuts the church roof. A short verge, fascia and bearer timbers have been recovered in flashband which is beginning to peel and fail again. Lead cladding would be desirable but interference from the escape is too easy. New battens and an end tile with slate undercloak OR tiles with dry verge lapped over a new upvc fascia might be a permanent solution.

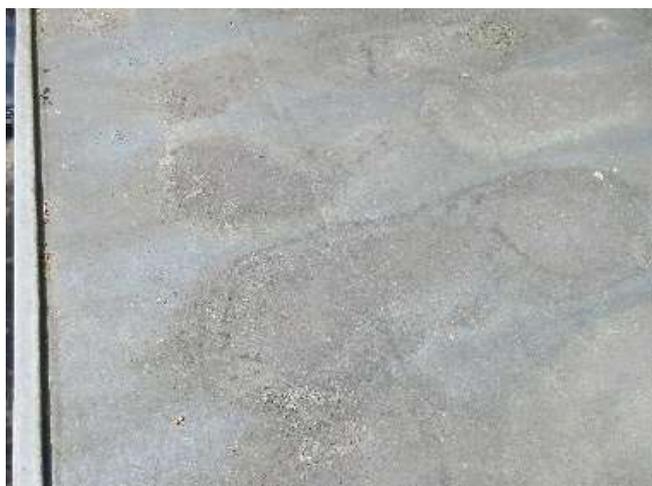
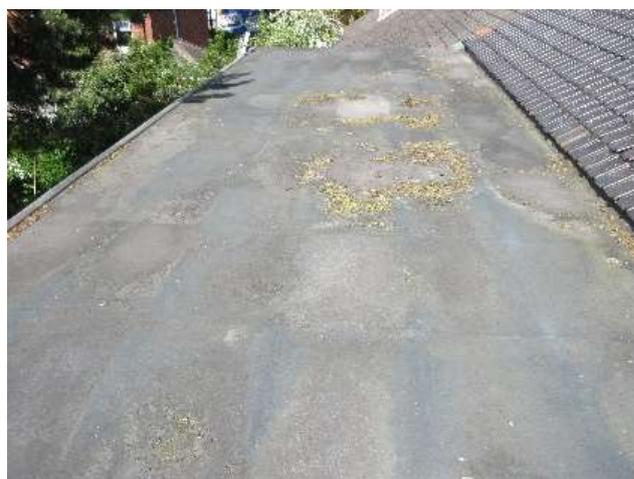
21. The large 'dormer' along the upper Hall W side, formerly felted, is now covered with fibreglass, over a timber deck. No apparent insulation over the deck ('warm deck') and no alternative ventilation of the voids between joists ('cold deck') either of which might prevent condensation in the roof structure. Extensive ponding especially at the deck inserts in the former rooflights. Other parts of the deck feel soft. There are buckets under the N end of the dormer and reports of occasional leaks after rain. Water marks on the ceiling around the former rooflights and on their bellied infillings just under the deck (para 62).

22. There are no visible defects in the fibreglass though any pinhole would be very hard to see in the dirt in the dried ponds. Another possible cause of the marks and drips is *condensation* of internal water vapour on the undersides of the cold deck, likely to have no ceiling insulation at all at the former rooflights. In either case the problem is likely to be solved by stripping down to the joists, laying new joists across the rooflights for stronger support, firrings for better fall, new stouter deck, vapour barrier, at least 100mm insulation foam and top membrane (Sarnafil or similar).

62. **Upper Hall** minor cracks in the ceiling plaster under the flat 'dormer' roof. Water marks in and around three of the four wells at the former rooflights. Most ceiling inserts at the former rooflights are bowed as if affected by water. Buckets on the floor under the dormer NE corner show present drips (para 21).

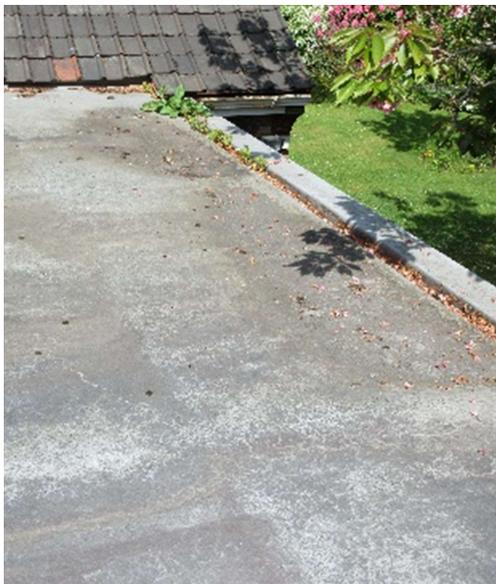
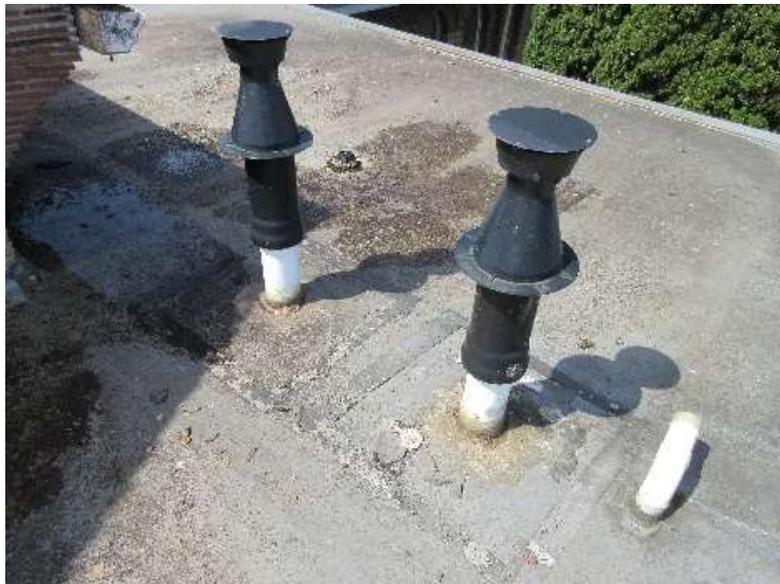
23. Recent flat Sarnafil on the W baptistery extension with upstand against the Nave, appears good.
24. Church entrance flat roof is glass reinforced plastic to slight fall, with lead cover flashings against Nave. An integral gutter along the outer edge with two sumps which were again part blocked and cleared at the inspection. The gutter and sumps should be cleared more regularly. A leaking small hole in the lead pipe from the sump into the top of the S rainwater pipe. The corner by the Hall is raised above the general level. Its high GRP upstands are mortar pointed at the top. The GRP seems sound though some ponding.

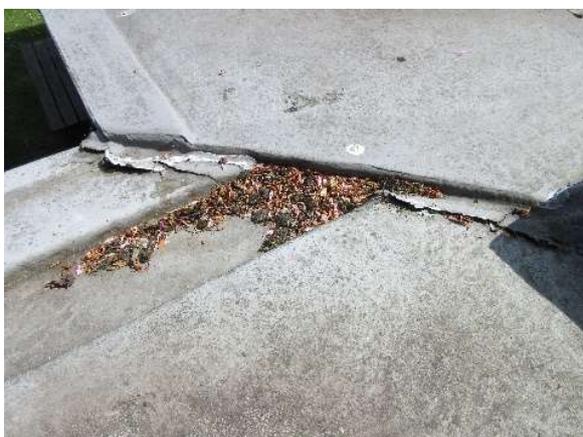
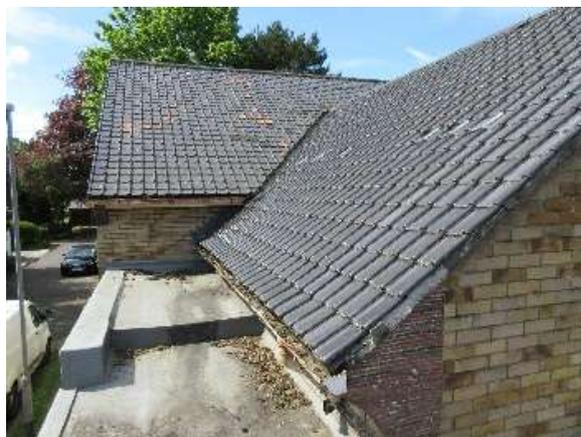
25. The Boiler room and Kitchen flat roofs also changed from felt to glass reinforced plastic with very slight falls, seems sound. Its lap over an upstand edge at the earlier flat roof has lifted but may not leak. Ponded at the N end around two disused tall metal flues with collars sealed down. Its two internal outlets were both unblocked at the inspection.

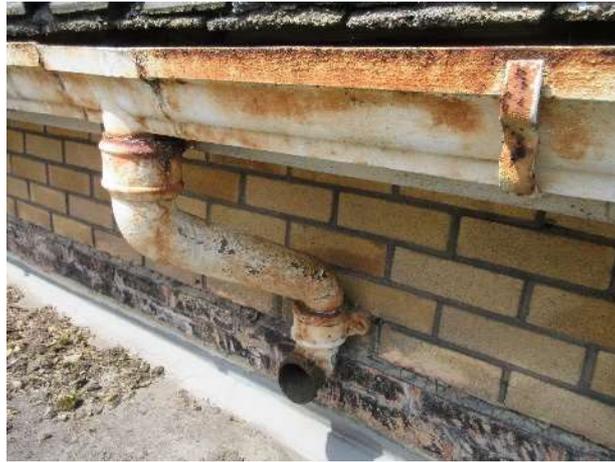
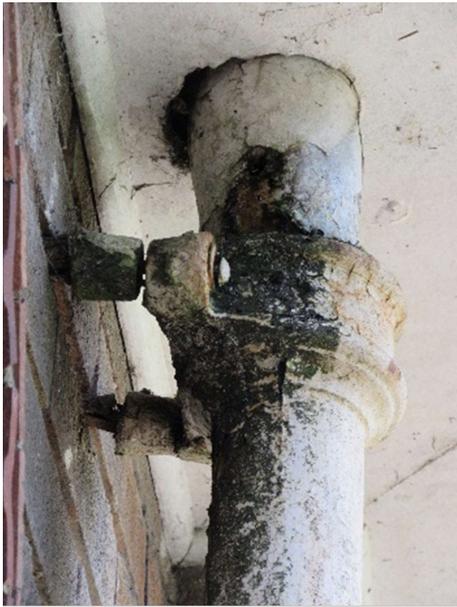
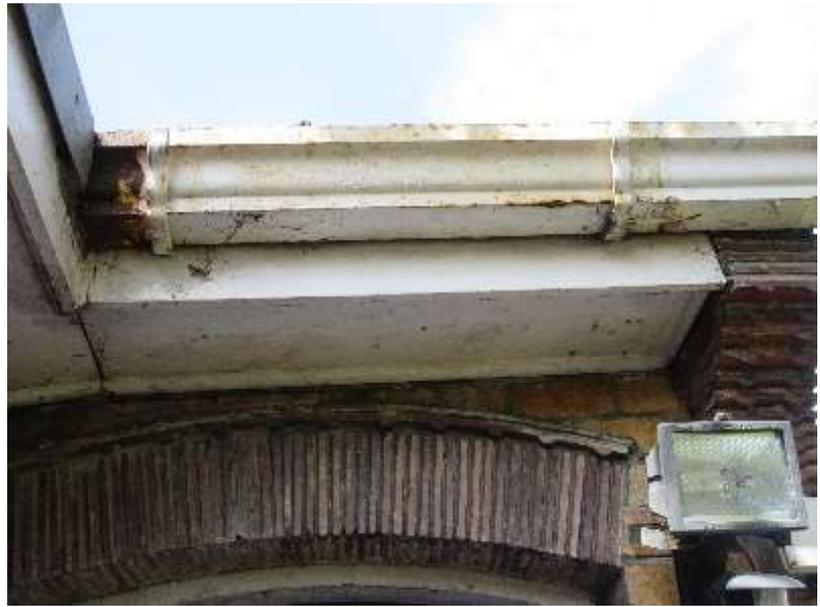
27. Most gutters are level cast iron ogee pattern on rafter straps with swan neck pipes (to pass the wide ply eave soffits) and round eared cast iron pipes to shoes and gullies. Most gutters at least part blocked by leaves and silt. Most are rusting and need cleaning and painting.
28. Straight pipes from the church flat roof eave (one iron with bandaged crack at bottom, one plastic). Internal down pipes at the flat roof at Hall and Boiler room with cage over Boiler room to keep leaves out, cleared at the inspection. In the Boiler room the internal down pipe is rusted cast iron with a broken socket but does not seem to leak.

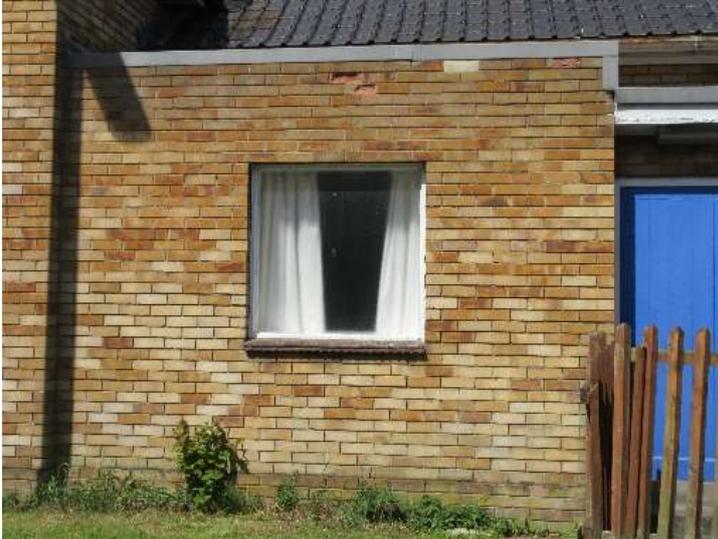
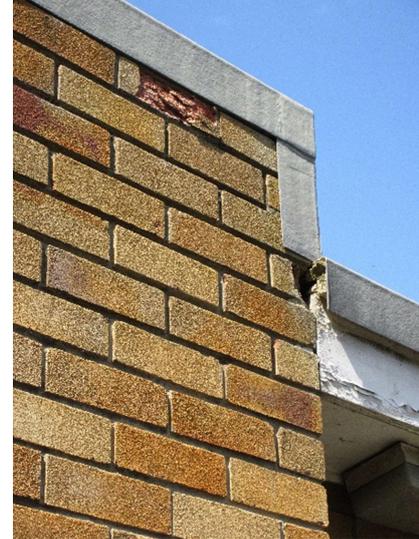
38. Attractive tile corbels at the gable eaves. Segmental tile arches at the main door openings and round arches at the narrow windows and the large upper Hall window. Running brick over steel lintels at the Kitchen S end. Brick on edge at the long lower Hall window. Tile cills generally good but one broken at lower Hall.
39. At the E end a short parapet wall formerly very decayed was reduced and capped with roof membrane, a much sounder arrangement. Three bricks with damaged faces remain exposed and seem unchanged.

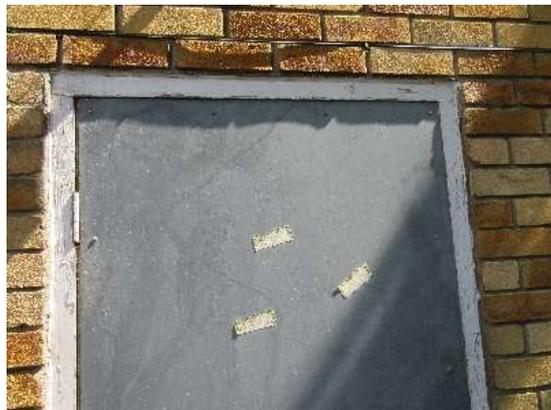
44. The large flush escape door from the upper Hall is tight to the frame which having no drip mould and being nearly flush with the brick face will tend to make the door and frame swell in damp weather. The door works stiffly. The frame needs paint and the hinges oil.

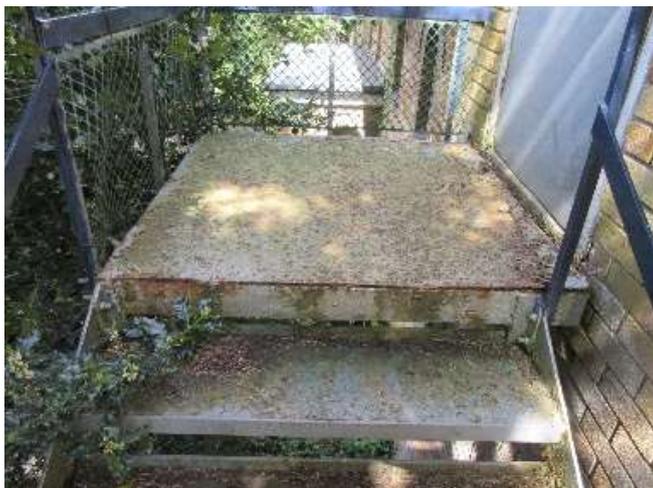
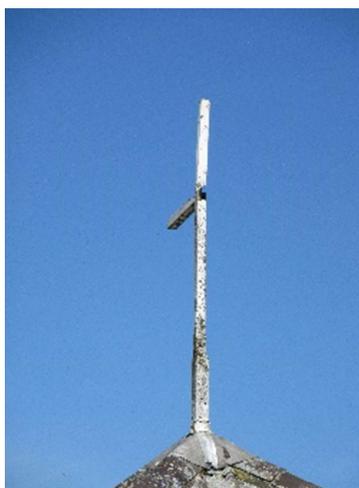
46. One arm of the metal cross on the Tower pyramid roof is missing.

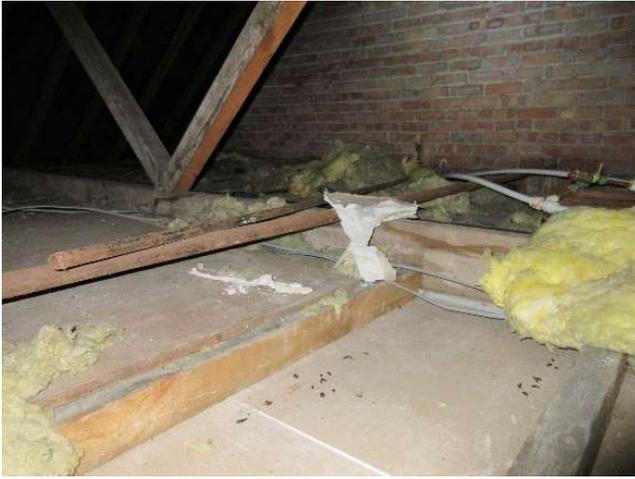
Over Vestry

no ceiling insulation

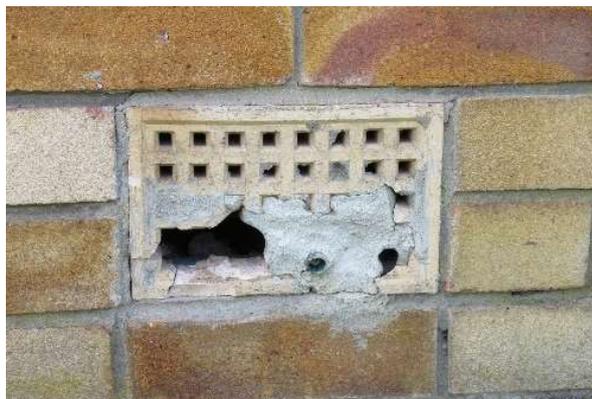
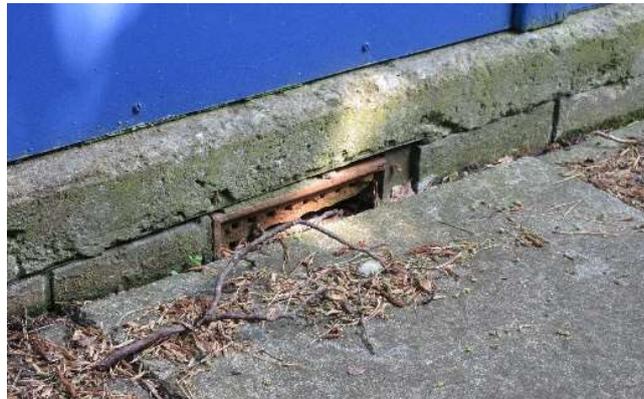
78. The only suspended floor needing ventilation is the lower Hall which seems well provided with air bricks IF the air bricks at the solid floor Kitchen connect by ducts to the Hall floor void. A broken Kitchen airbrick has been mortar patched, part missing which could attract vermin. Under the fire escape stair the ground level and plants have risen too close to the two (or three?) vents. The air brick under the escape doors is mostly blocked by the paving.

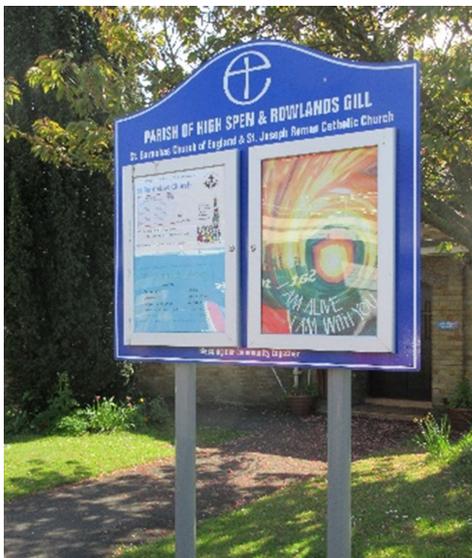
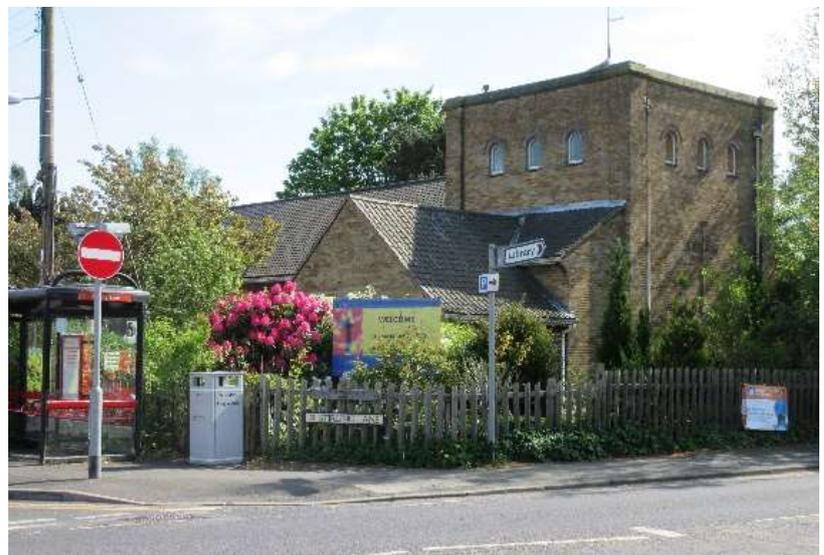
118. A timber paling fence on timber posts of varied age, some decaying.
