INSPECTION AND REPAIR OF CHURCHES

CARE OF CHURCHES MEASURE 1991

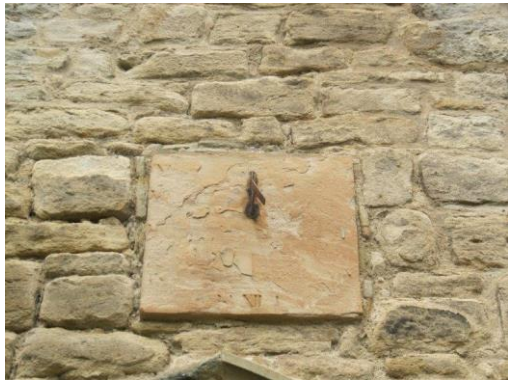
Weathered stone to sundial and bent on porch

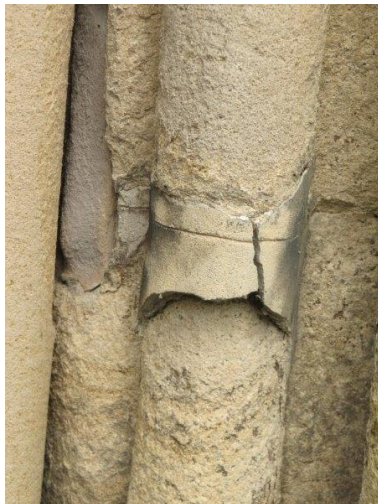
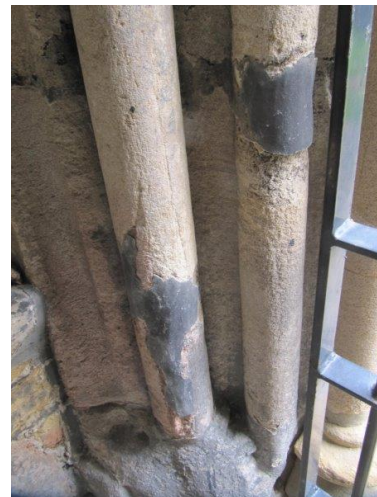
Hard mortar repairs to porch colonettes and associated weathered stonework

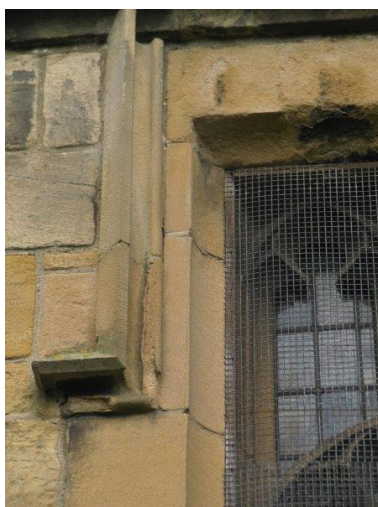
Weathered stonework to South Aisle

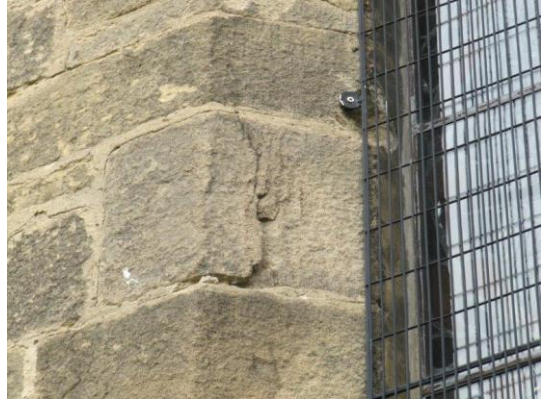
Cracked stone to jamb of S(vi)

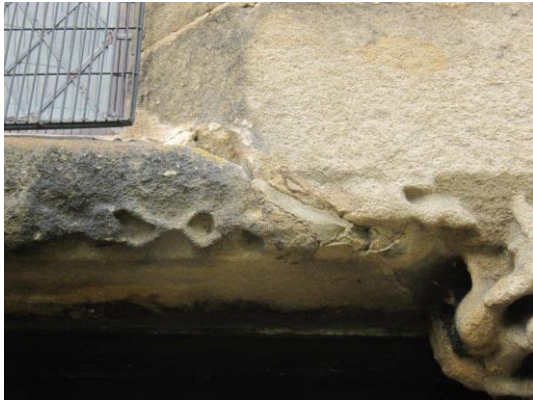
Cracked lintel and weathered jamb stone and lack of mortar around door frame to Chancel door

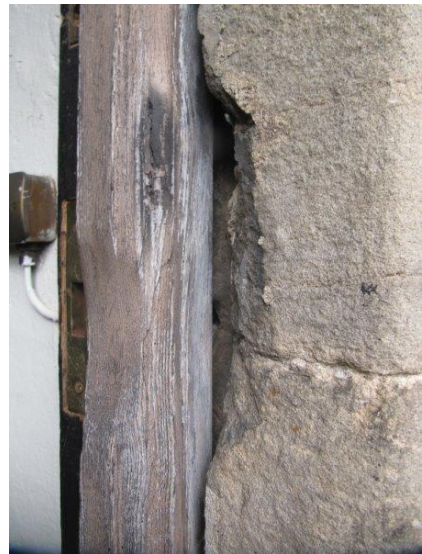
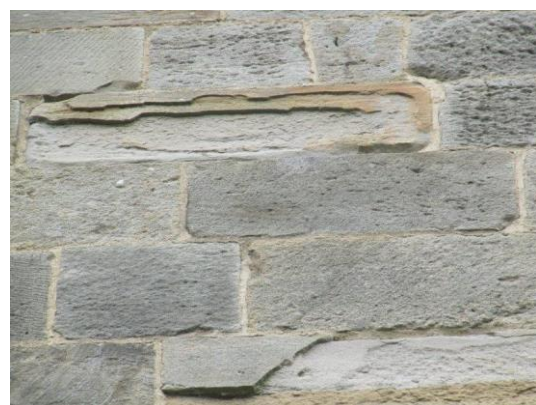
Delaminating stonework to East elevation of Chancel

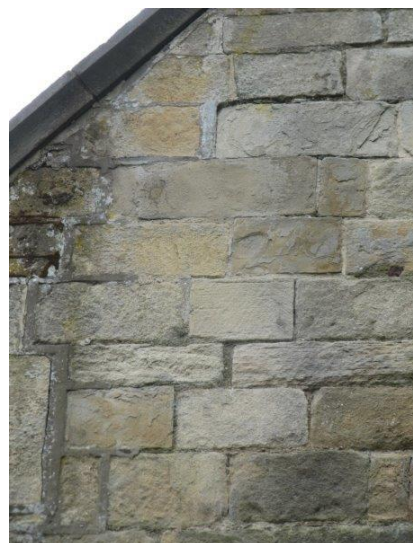
Cracking and failing mortar to North of Elevation of organ chamber

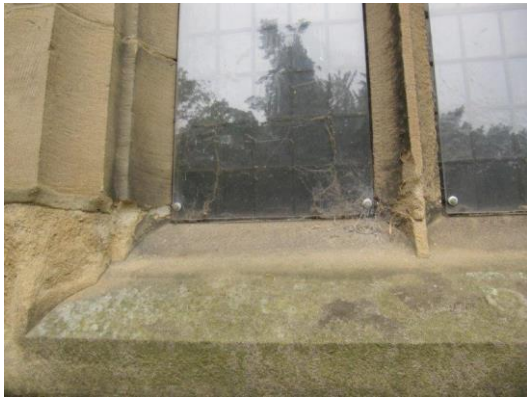
Weathered stonework to Vestry window

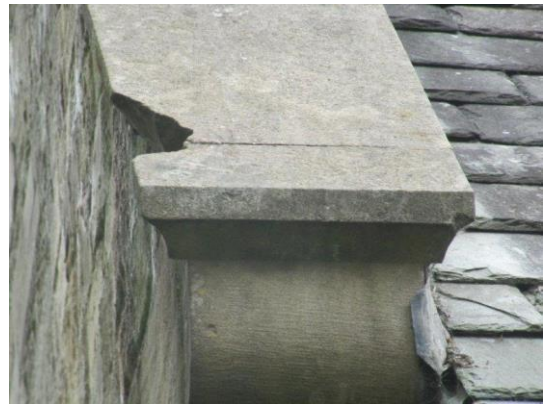
Damaged section of water table to organ chamber

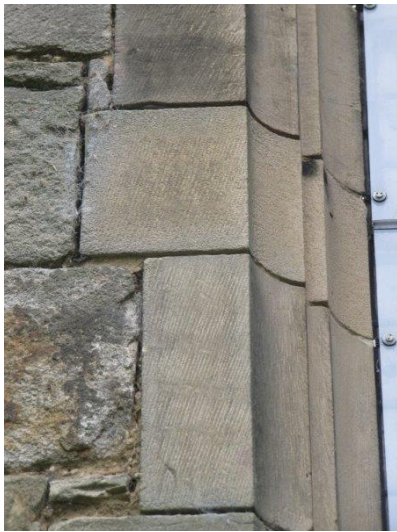
Open joints to jamb of window n(iv)

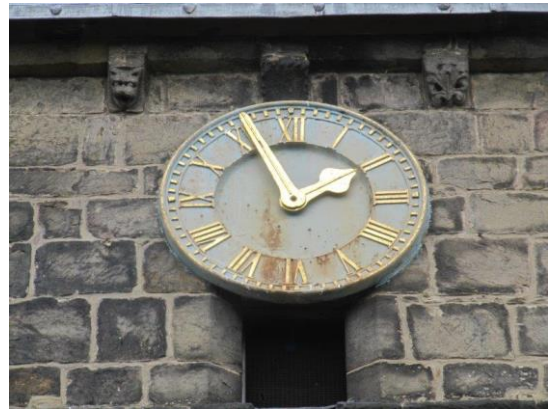
Rusting face to tower clock

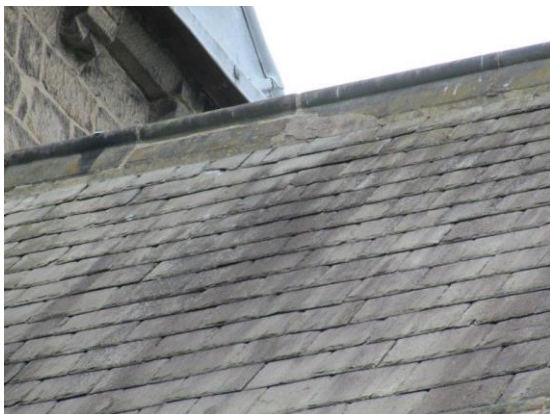
Slate starting to slip on Nave roof and repaired ridge tile

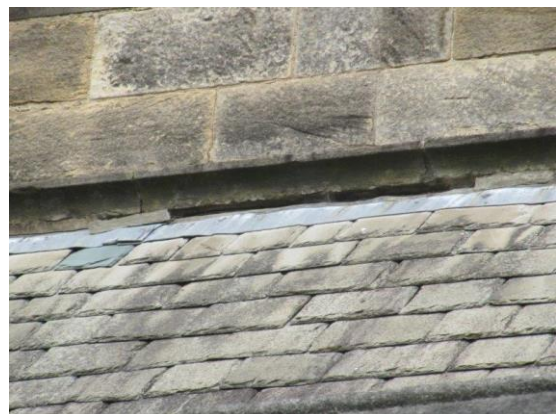
Failed mortar to South Aisle roof

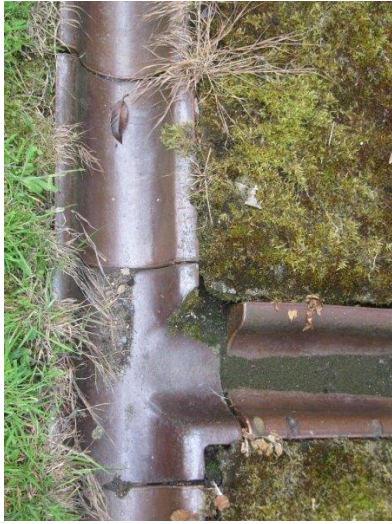
Open joints to drainage channel to North of the church and vegetation

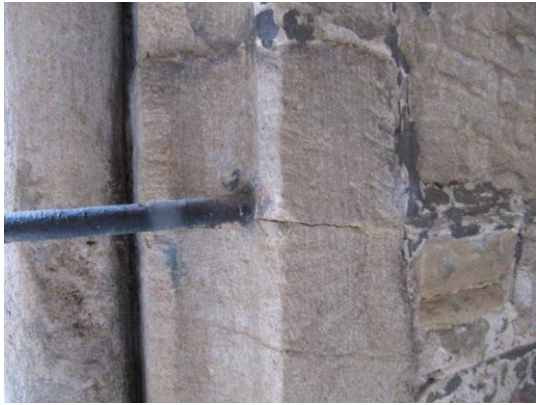
Metalwork to porch jamb with cracked stone

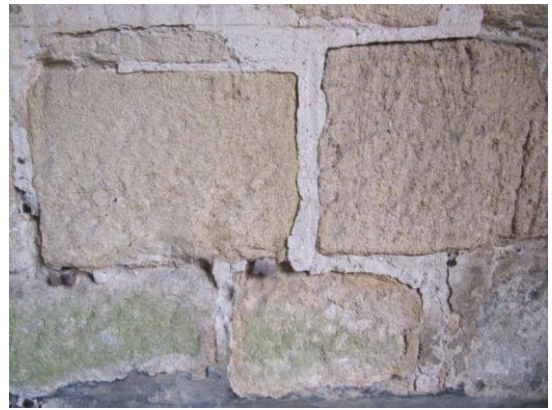
Open joints/failing mortar to porch

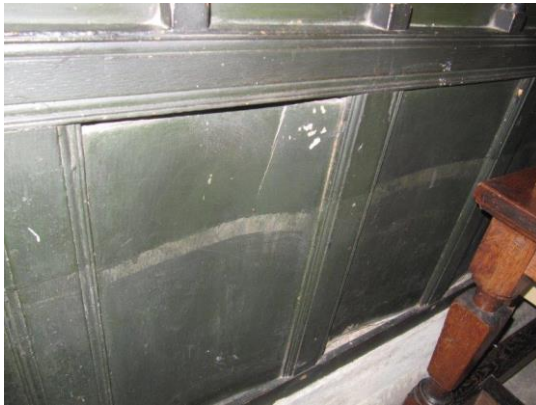
Bowed paneling to South Aisle

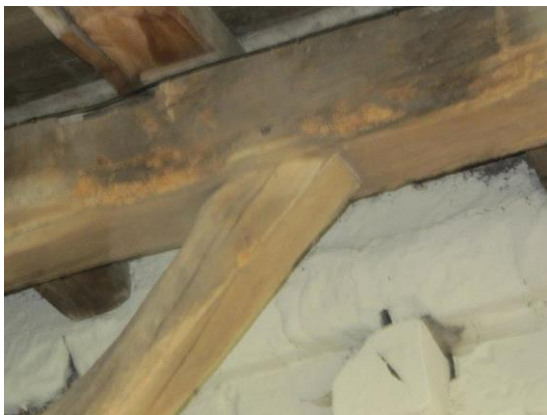
Lighter patches to timbers in Tower ringers chamber coming loose

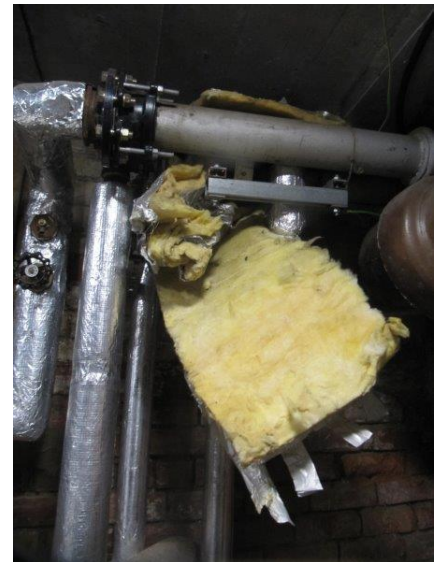
Insulation to cellar pipework
