Sadberge St Andrew
(CH. No 215)

Quinquennial Report
On the architect's inspection of

25th November 2021

Sarah Harrison RIBA

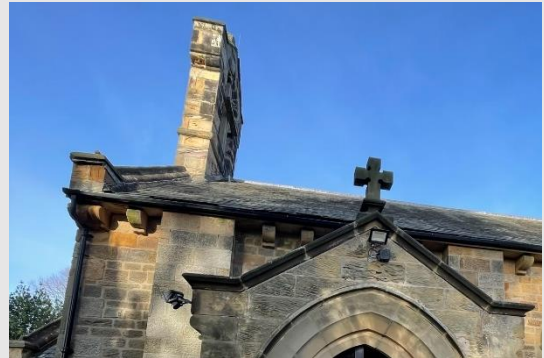
Item 7.1- Slates near south west bellcote

- 7.1 **South Nave** - Lead roll ridge cracked in 3No. places, which may have been patch repaired, but not immediately apparent. West abutment in mortar early 2010's repairs. East abutment flashing recently renewed with lime mortar. Large area of replacement thinner Welsh slates by the bellcote. There are some tingles supporting the repairs. At the Western end near the bellcote and by the ridge there are some cracked slates, additionally there is one cracked slate centrally near the ridge, and one to the East.

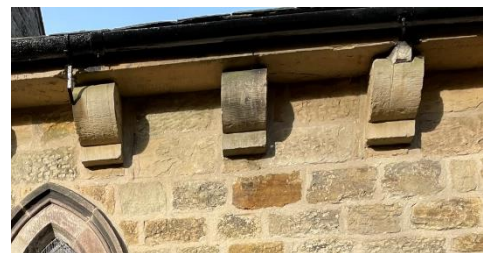
8.5 S Chancel: Half-round cast iron gutter which has been recently redecorated. There is a mixture of brackets, some of which are loose, particularly the middle bracket which is poorly set with a brick infill. The downpipe is original and discharges to salt glazed gully. Fixed back to timber pattresses which have recently been decorated but the middle pattress had already lost some integrity and will need replaced if it continues to deteriorate.

Item 8.5 – Gutter brackets

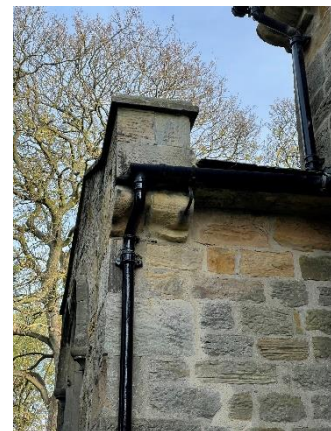
8.8 Vestry West elevation – half round plastic gutter that is set too far into the wall and does not look to be catching the water run-off adequately. It is on a collection of different brackets. Downpipe is okay, held back by a loose plastic gutter bracket to the base. The pattresses are as east elevation. The collars are caulked and this is wearing away.

8.9 N Nave: Plastic angular self-finished gutter on decorated timber fascia, as the South side. It has two outlets in plastic, leading to original cast iron on the Eastern side and this discharges on to the vestry roof with a directional shoe. Recommendation to reconfigure it so it discharges directly into the gutter of the vestry. The Western end has cast iron downpipes,

8.8 & 8.9 N Nave/ Vestry RWP

and these appear okay apart from some rot to the bracket bobbins. The pipe requires lead clipping into the socket and the bottom section fixing needs refixing.

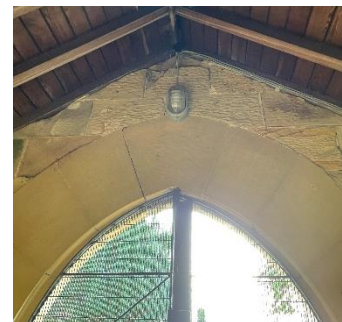
Generally, the walling on East and West elevations is okay. There is a slight crack at high level where both sides about the south elevation there is 3mm additional movement on the East (reported last as hairline) and a 1mm crack on the West which has not increased, suggesting there is some slight rotation to the structure. Some face erosion of the stones in these locations additionally the bottom three courses have erosion, particularly around the bottom hinges (item 12.3) This has been re-pointed with cement mortar in the past.

On the South there is some erosion below the ridge and there are open joints to the walling above the arch. The arch has dropped by approximately 5mm, an increase of 2mm since the previous QI. Also, the springing point is opening up on both occasions and there is a 1mm crack to the keystone of the arch on to the Nave entrance, so this suggests eaves spread is occurring, probably due to a lack of triangulation in the roof structure combined with seasonal ground movement. The porch is behaving as additional porches do when later added to churches as the foundation and ground condition is different from the church.

9.1.4 Porch South above entrance

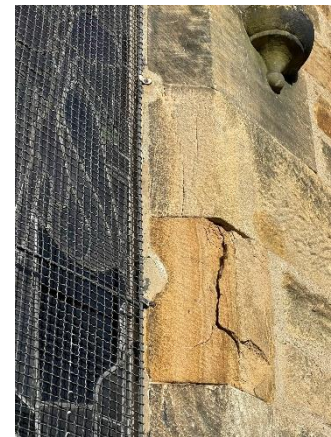
9.3.4 – Stone at RHS of lancet

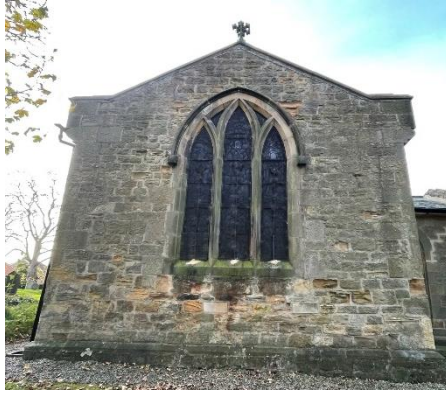
9.4.2 **East** - General walling is sound with minor open joints at plinth. There is some erosion to the stonework below the cill above the hoodmould and one quoin stone, although this has not significantly worsened since the previous report. The 3-light window is okay, although there are slight open joints to the hood mould.

9.4.2 – East Chancel

There is a minor hairline crack on the right-hand side running down the wall from the right-hand side of the cill approximately 1mm (not changed since last report) which looks historic. There is a small crack to the top left-hand side of the lancet up to the coping, this could link to item 15.2.3 internally. The bottom of the feature stone to the ridge has cracked and assumed to be fallen/lost, this is reportedly due to the lightning conductor fixing and the new attachment point should be checked for cracks.

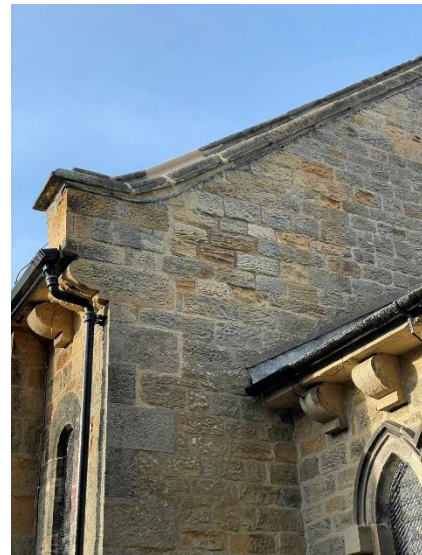
- 9.5.1 **South side of gable** – slight movement to the kneeler of the water table, has previously slid forward on the leadwork and has been fully repointed, and re-bedded including stainless steel dowels to prevent future sliding of the upper watertable stones down the slope on the leadwork. They are bedded onto lime mortar and existing leadwork. The cracks to the kneelers on both the south and north sides have been stitched with 3 and 4 crack stitch bars respectively. The lightning conductor comes down the middle of the apex here. The bedding of the upper coping stones is cracking at high level. At lower level there is a hole to the south, which appears to be from a former service penetration.

9.5.1 – Repair to S Nave

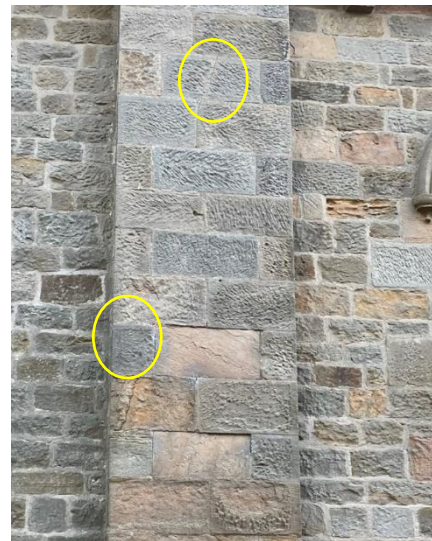
9.7.6 Buttress 3 defects

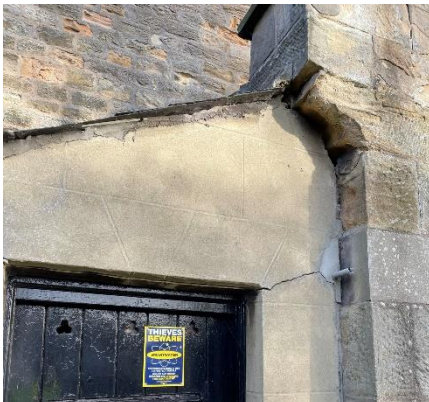
9.9 Boiler room abutment to West Porch

9.9 **Boiler Room:** Describing both South and East elevations. This is a brick structure which has been rendered in sand cement on the outside, some of which is coming away at the side, and there is cracking at the Western doorway. It will continue to come away and repaired render will always fail- however- patch in the meantime- unless replacement of the oil tank means a renewal in this area. The cracking to the door is worsening (4-5mm currently) as the lintel may be moving. There is a 10mm gap at the abutment to the west porch/WC, with a large gap beneath the kneeler which should be filled to prevent animal infestation.

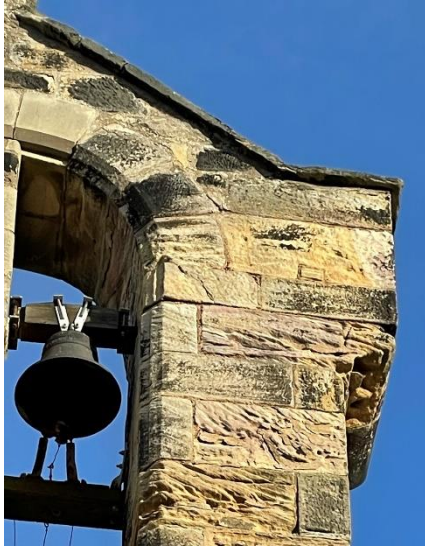
10.2 – kneeler to bellcote

to have been a cement repair of stonework up at high level, however no documentation available to check if this is the case. There is erosion and what appears to be a vertical crack on the Southern side to the high-level kneeler, this urgently needs inspecting more closely to fully understand the level of erosion or replacing. Reportedly, there is also an air grate by the central part. From ground level, there looks to be two large stone cappings to the base of the bells, closer inspection on the condition of these and the presence of any additional flashings is needed. Looking from the Southeastern side, there is quite a bit of erosion from stonework just above the abutment flashing. Might it be that the water penetration at the abutment of the roof has wet the stone below the bellcote, softened it and weakened its stability, the flashing has recently been replaced and this area should be monitored for any further weathering (to be read in conjunction with item 15.1.1 internally).

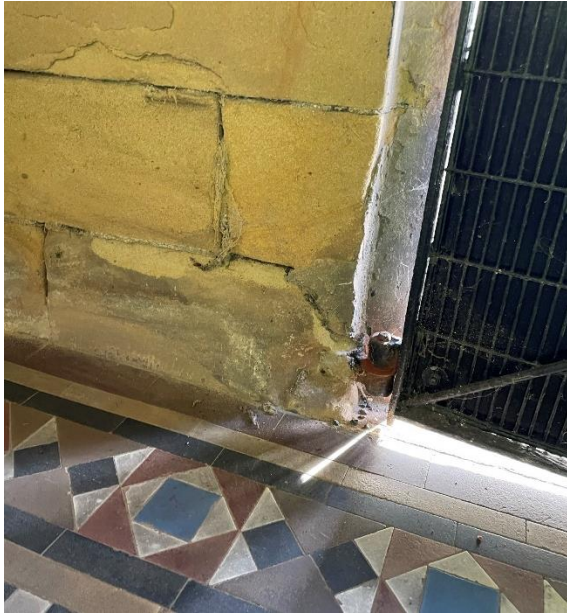
Item 12.3 – hinge to south gate

12.3 The South Porch has a metal gate to exclude people from the porch. This is showing some slight signs of rust but is serviceable. The internal bottom hinges to both sides are rusting and the stone around is deteriorating as per item 9.1.4.

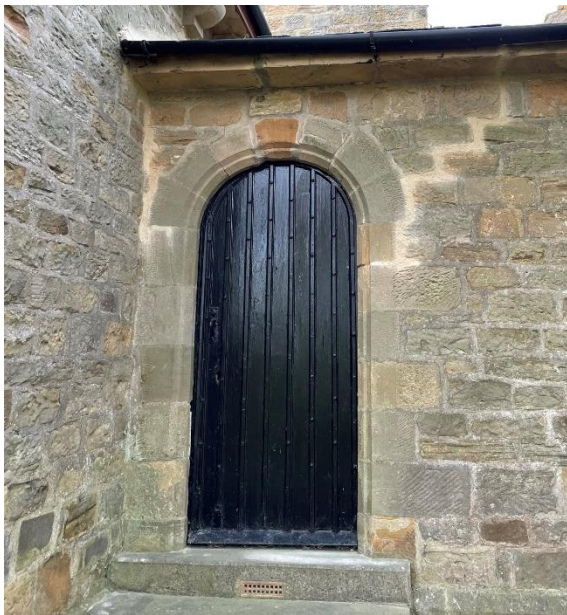
12.1 Vestry door boarded oak with protruding beading in good condition.

Item 12.1 Vestry Door

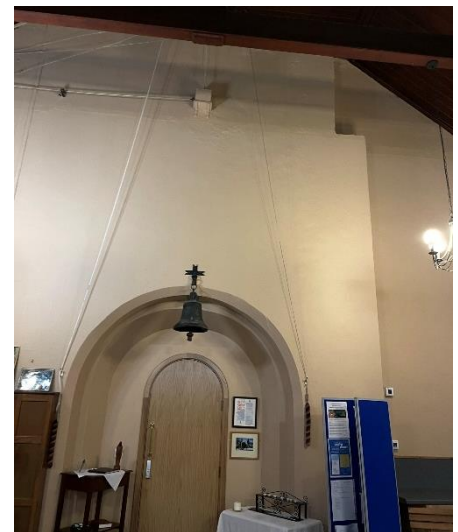
- 15.1.1 West** – plaster flaking at high level, probably due to water penetration and failure of abutment flashing in the past, recent decoration will show any signs if issue is ongoing, currently no staining. Cracking to the arch on the right-hand side, previously reported in the last QI now filled having not shown any additional movement in the last report. There is some evidence of the crack only from the raised filled surface. This arch is probably taking the load of the bellcote and has been strengthened in the past, perhaps by an additional wall thickness. A measured drawing of the area would establish this better and further investigation of roof void. However- the arch doesn't seem to be in distress.

15.1.1 West end of Nave – all cracking filled

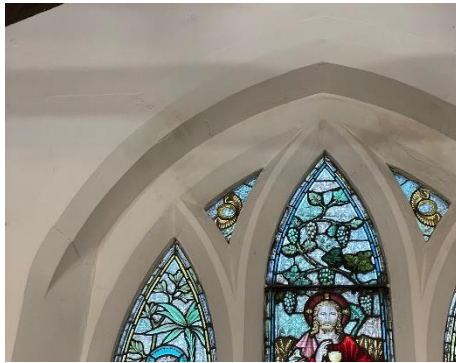
15.2.3 Cracking and discolouration to lancet

15.2.3 **East** – this contains the 3-light lancet where there is slight movement to the left-hand side just above the springing point and the arch decoration within is very discolored (water penetration from outside as per open joints noted at 9.4.2). Slight hairline crack to the right of the apex. Plaster breaking up on the right-hand side where there is also some water staining. Not possible to inspect behind the reredos screen. Further staining to the south area in the location of the kneeler.

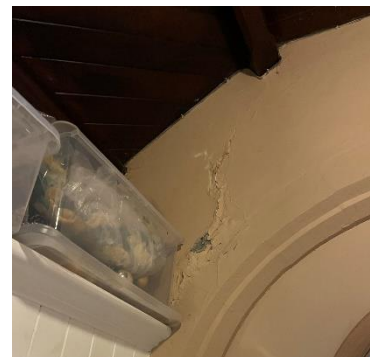
15.3.3 The East wall arch has some cracking at the northern purlin where decoration and plaster has blistered. Any other cracks have been filled.

15.3.3 – crack and blistering

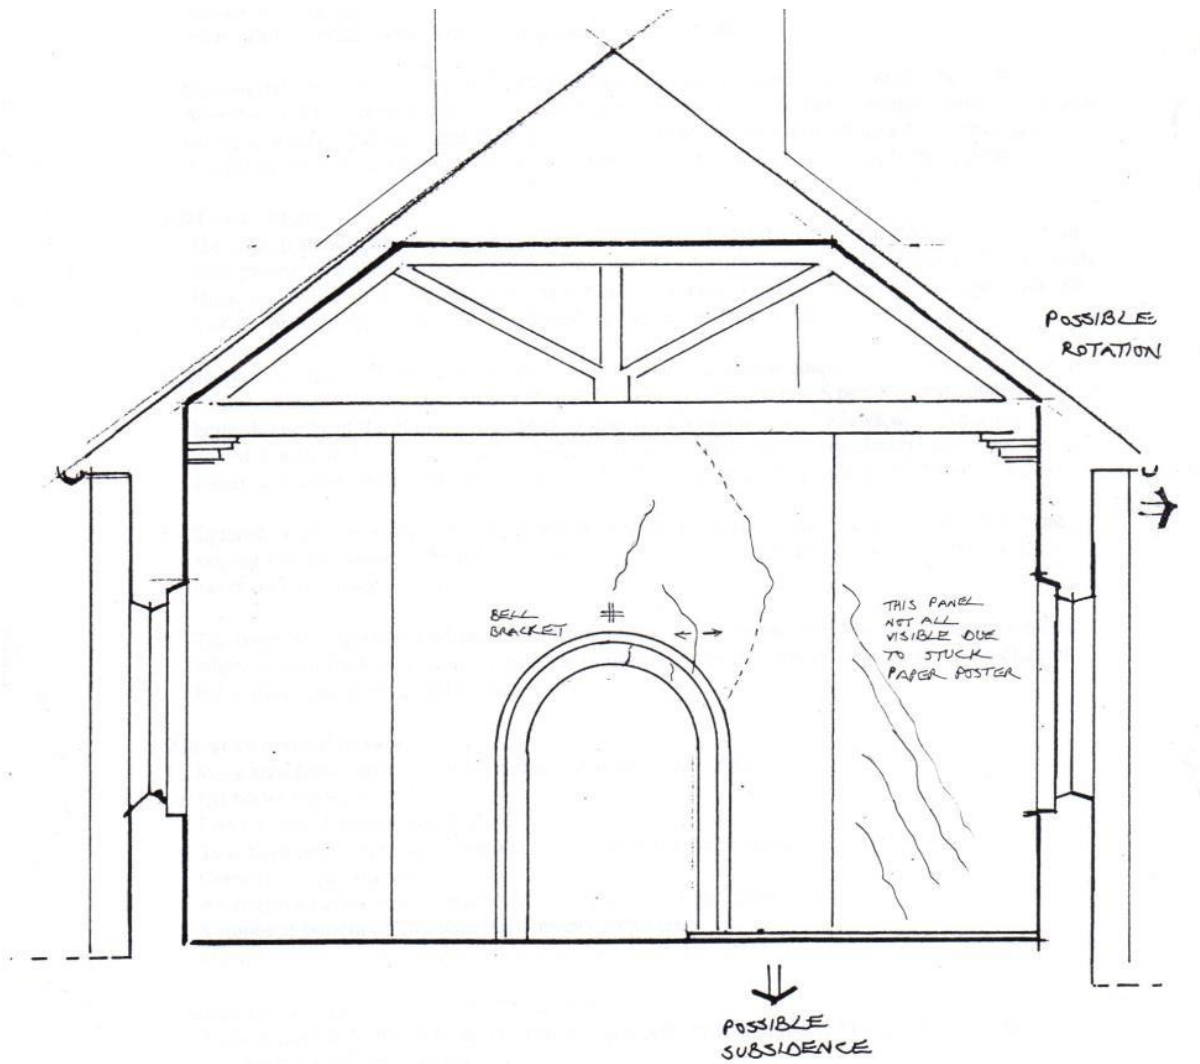
Appendix A – West Gable cracking drawing by Mr Ian Ness (June 2009)

SKETCH OF CRACKS IN WEST END OF NAIVE PLASTER
25 JUNE 2009
