## St John, Seaham

Church No 94

### Quinquennial Report

**25<sup>th</sup> July 2023**

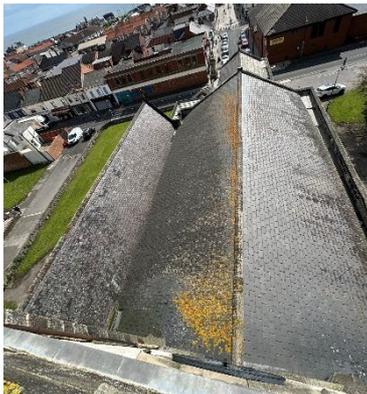
*Figure 1- Nave roof*

- 6.1 **Nave** – a broad shallow pitched roof, covered in modern Welsh slate, breather felt and battens. The last inspection reported one broken slate at W end of N eave and one very large slate broken at middle of S eave, these were not noted in the logbook as being repaired, but couldn't be seen from tower level at the time of inspection.

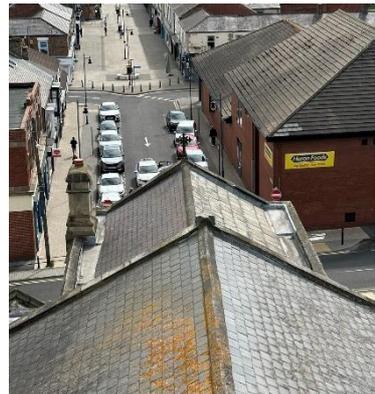
*Figure 3 - Limited view of Chancel*

- 6.5 When the Chancel was lengthened in 1886 it seems the original diminishing Welsh slates were refixed on the S side and new regular slates fixed at N. In 2003 the N side was recovered in new Welsh with lead soakers and plain cover flashings at the Nave abutment. The very large, aged S slates were reportedly patched with salvage from the Nave and new lead flashings installed, lapping over the slates at the Nave abutment. All appears sound from the limited view from the tower and ground level.

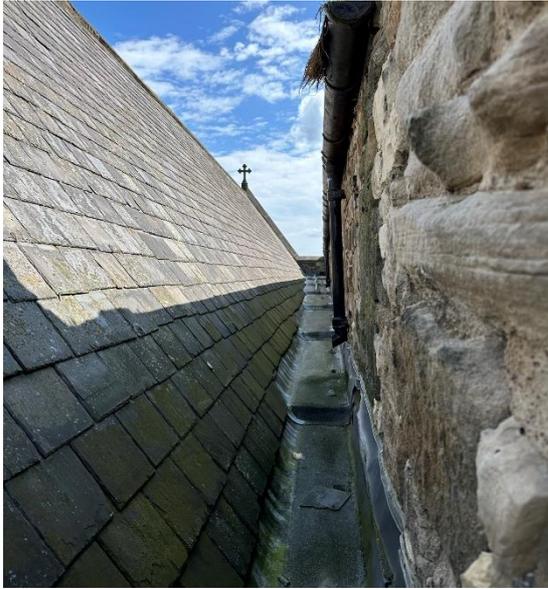
*Figure 4 – Aisle abutment to Nave*

7.3 The Aisle abuts the Nave wall 1.5m below the Nave eave. A long internal tapered lead gutter draining the Aisle and Nave falls W through an opening in a stone parapet to a hopper onto the flat lobby roof, this hopper is loose at the top. The gutter is sound but has vegetation build up at corners and loose tiles stored at the E end.

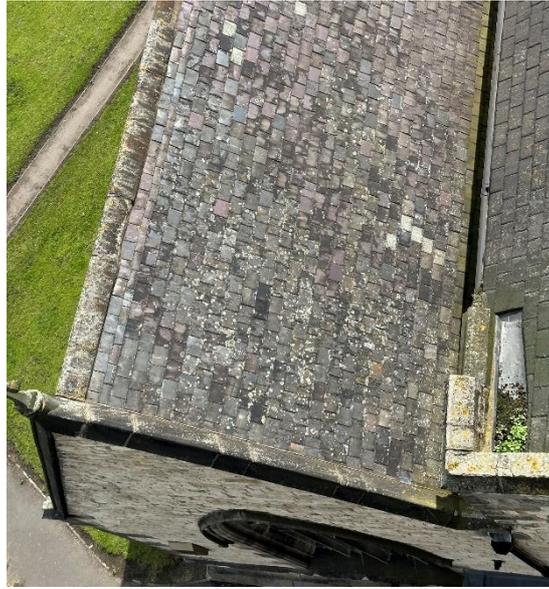
*Figure 5 – N Aisle outlet*

7.4 Aisle N gutter bracketed from the rafters is rusting. Silt and plants in E end and a birds nest at the W end. The downpipes are rusted at the rear.

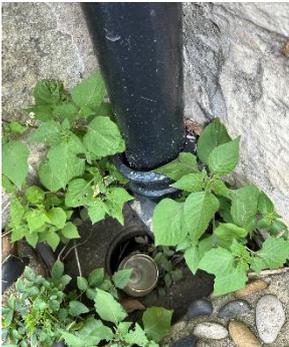
*Figure 7 – Gully*

7.8 All gullies should be kept clean, the south gully has weeds growing and a pint glass in it. The downpipe is also rusty at the swan neck.

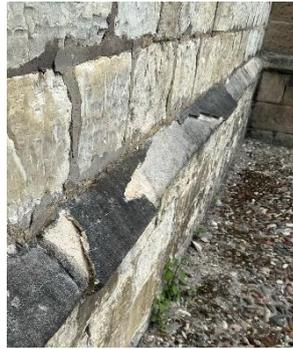
*Figure 9 – Delamination*

8.2 There is surface erosion, delamination to watertables and mouldings and loss of pointing behind some rainwater pipes and exposed walls, notably at the parapets, gable peaks, buttresses, and plinths. Replacement of certain stone dressings and local pointing in suitable mortar would slow decay.

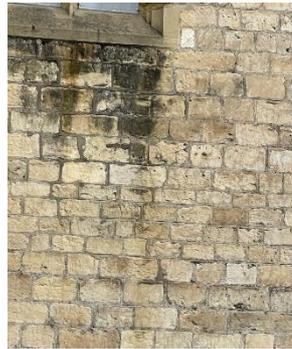
*Figure 10 – Crack to SE*

8.3 A crack to the SE corner of the Chancel runs from the bottom RHS of the easternmost lancet.

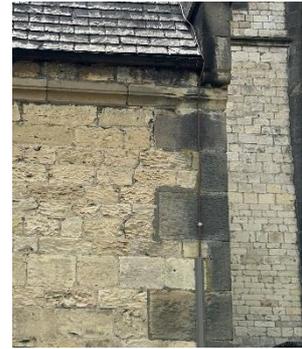
*Figure 11 – Crack at NW*

8.8 North Aisle, W end crack to the top RHS, low level water table needs pointing.

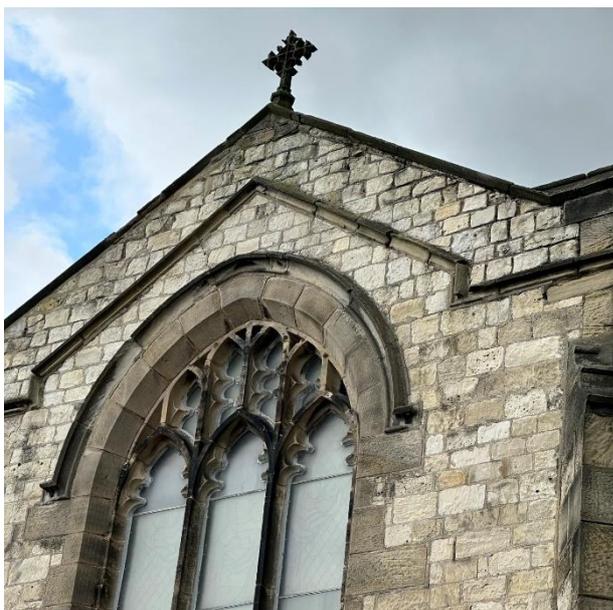
*Figure 6- East gable*

8.9 High level pointing is breaking down at the E end and the stability of the cross cannot be checked, therefore when re-pointing is carried out the cross should be inspected. There is a crack to the organ tower radiating from the highest joining point of the Vestry. There are also open joints and cracks around the Vestry window. These should be monitored as it is the authors first inspection.

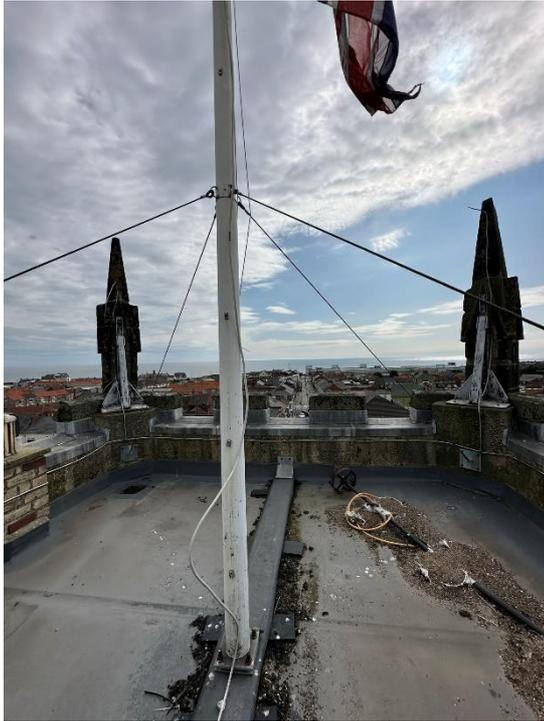
*Figure 8- Tower roof*

9.5 A metal pole with a 'crown' top sits loose on the tower roof and should be removed, it has gathered a lot of silt and debris which now has vegetation growing from it.

- 9.6 It appears the tower roof covering has recently been replaced with a single-ply membrane, it is dressed up the hatch kerb and parapet and turned in under the concrete ring beam as far as can be seen. The hatch has also been covered with a single-ply membrane, apart from one section in bare timber. It is still hinged but the hinges are not attached to the hatch, therefore the cover is loose, heavy and unstable. A sapling still grows in a crack at the middle of the E edge of the roof, as reported at the last report, it is unclear if this is the same vegetation. The installation looks poor as per item 9.8 referencing the preparation of the deck.

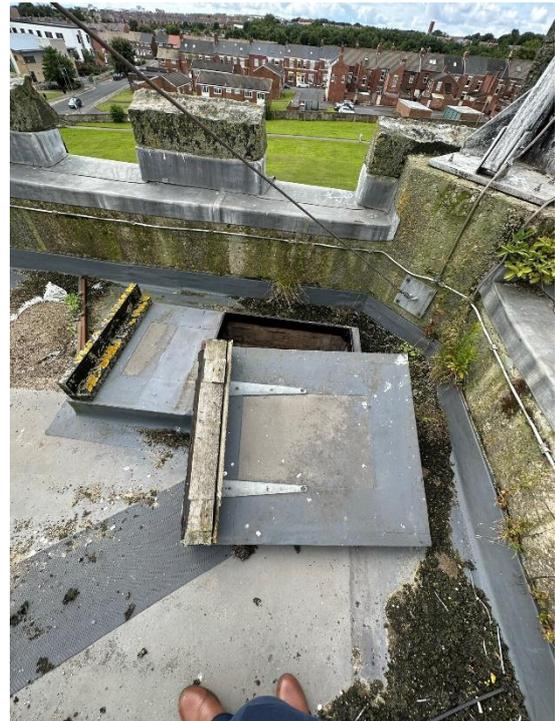
*Figure 9- hatch detached from structure*

- 9.10 The hatch is loose, heavy to lift and the ladder internally is a little unstable. Around the inside of the hatch, there is evidence of woodworm, not having been reported in the last QI, I am unable to report if this is historic or active and should be checked by a specialist.

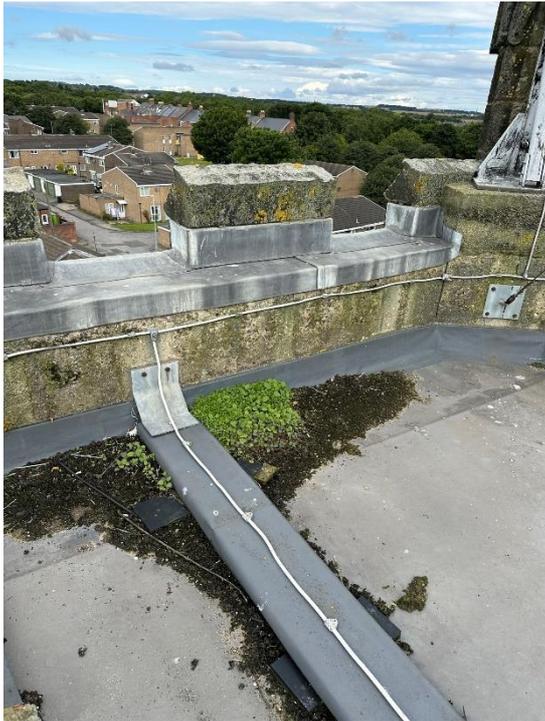
*Figure 10- flag support beam*

- 9.7 The timber which supports the flagpole has simply been covered with a piece of single ply to its top side, this is likely to trap moisture beneath, there are a number of rubber supports between the timber and the main single-ply roof. It is unclear if the timber was removed to correctly install the new membrane underneath this, the ends are also exposed. There is a large build up of soil & vegetation around this.

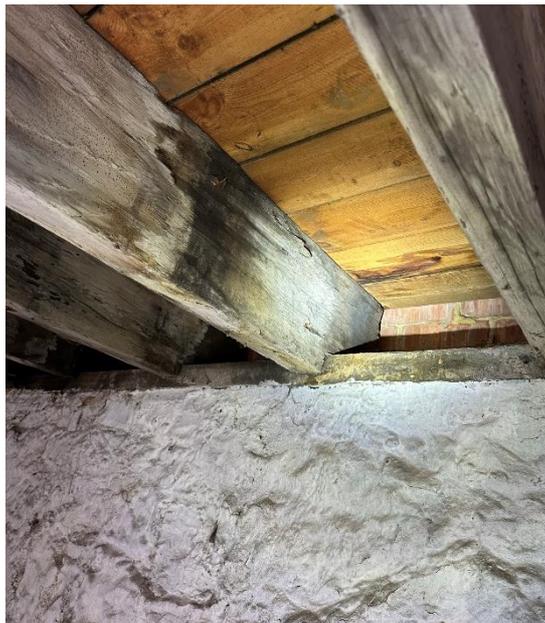
*Figure 12 – damp ends of timbers*

- 9.8 It is clear that the deck supporting the roof is still rotten in places, as recorded at the last quinquennial, timber which should have been replaced appears to have been left in place and has trapped water in the structure. This is particularly evident to three areas, beneath the outlet to the rainwater pipe, to the northwest section, at the end of the rafters and to the entire east side at wall plate level, which was damp to the touch at the time of inspection.

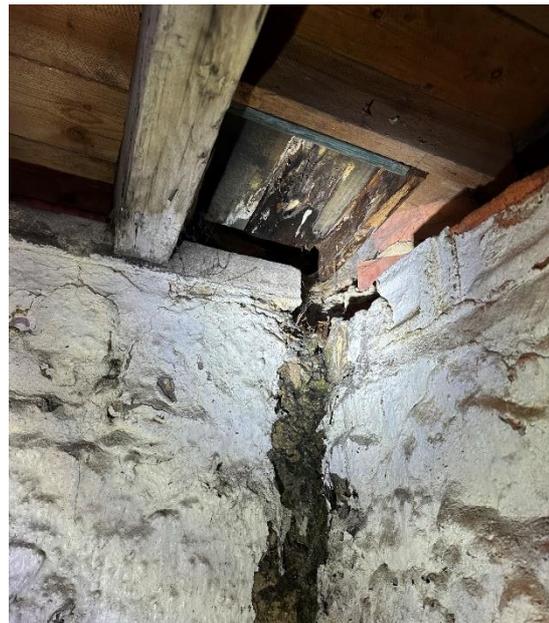
*Figure 13 – rotten timbers under outlet*

- 9.9 Evidently, in addition to the trapped moisture there must be new moisture entering the structure, it is unknown if this is through the masonry at high level or the poor installation of the single-ply roofing.

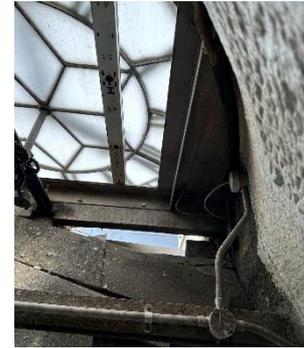
Figure 14 – clock stage floor

9.11 This **clock dial stage** remains well ventilated, however the floor joists still appear altered, uneven and damp in places, as per the last report. The walls have some severe stone decay above the lancets, this is worst to the E, the N&S also see the stone losing its integrity but largely ok to the W side. The clock framework is bolted to the stonework, there is a significant gap between the support plates and stone in some areas, but this could be how it was fitted. There is a large hole in the flooring behind some of the clockfaces which leaves a large gap to open air, vulnerable to vermin and unsafe. There is a piece of damp timer in the wall, which is loose, the reason for which is unclear. There is a steel I-beam across the spring point of each arch, all of which are rusting.

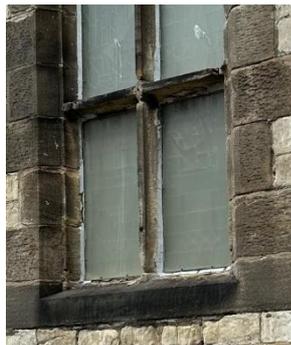
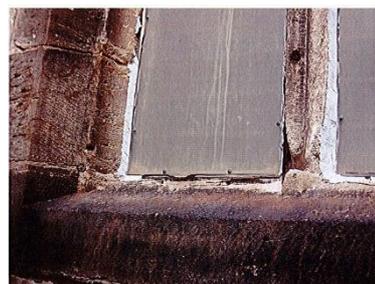
Figure 16 – 2023 mullion

10.3 Decay at the Nave window hoodmoulds lets water run over the lintels and top reveal stones which show some surface decay but is very minor. There is also some erosion of the mullions to all windows to the south elevation, with very little change from the last inspection.

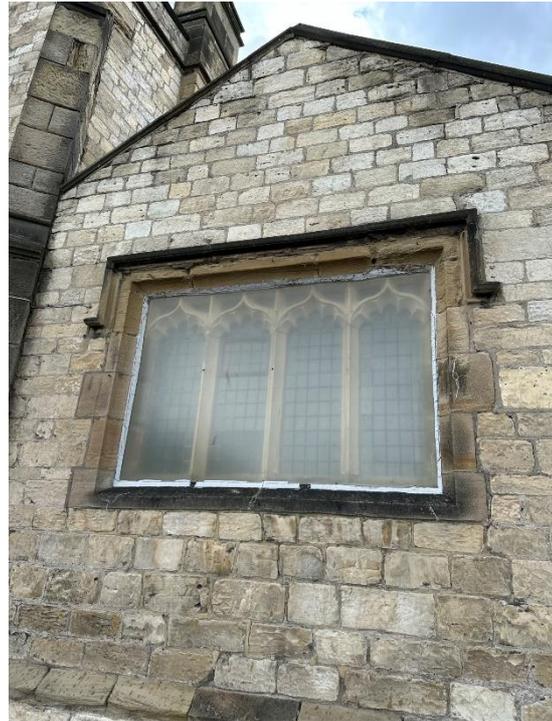
*Figure 19 – East Vestry window*

10.8 The later Vestry openings are softer sandstone, and the E window continues to decay, particularly at the head, these stones should be monitored for replacement (figure 19). The north window has a crack to the cill and slight open joints but otherwise the sandstone is in fair condition.

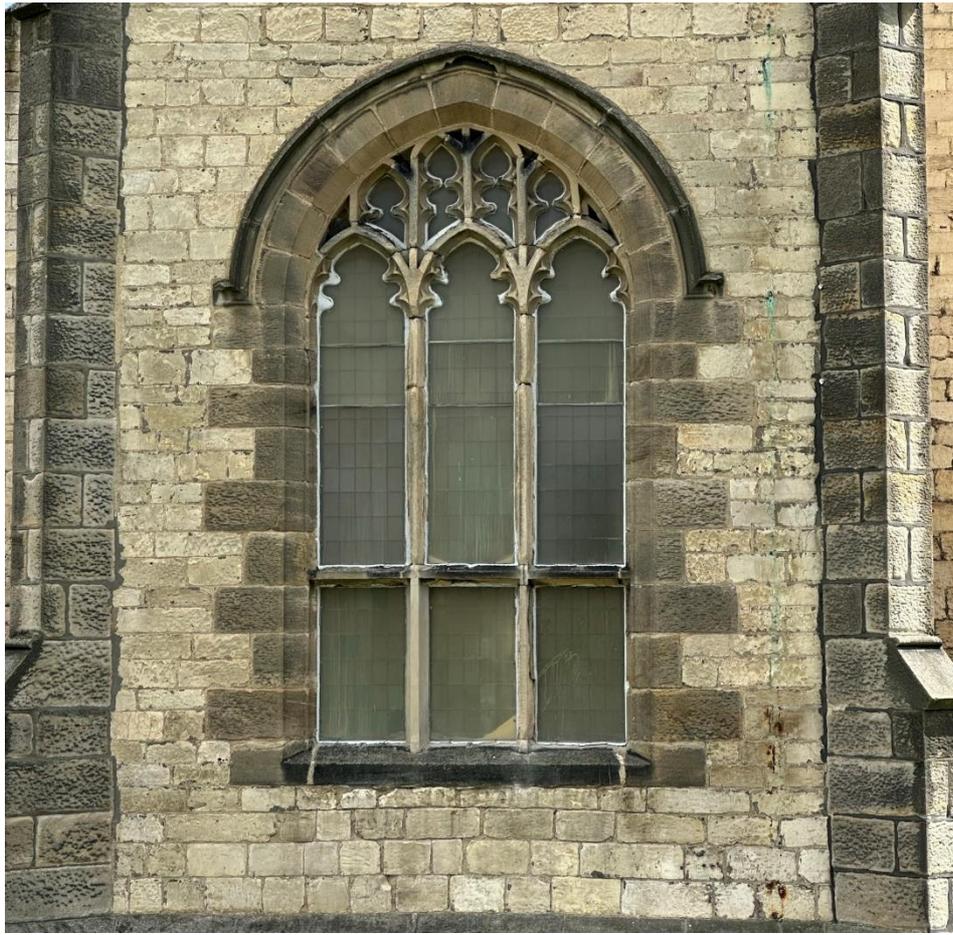
*Figure 20 – Tower west window*

10.7 At the Tower west window, the hoodmould is fair. There are losses from the cusps and front faces of the tracery at the tops of the mullions (figure 20). Inside, the transom and mullions further decay rapidly, suggesting damp is trapped, perhaps by the sealed glass protection. This will need to be a planned replacement as the window support is now failing as per item 18.7.

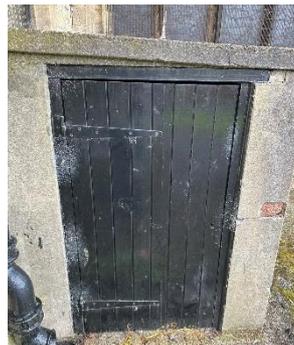
*Figure 22 – blower room door*

11.3 Blower house door is ok but would benefit from cleaning, the room itself looks dry but the ends of the roof joists are rotten.

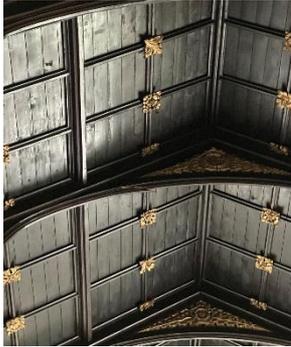
Figure 24 – cracked truss timbers.

12.1 The **Chancel** has ornate exposed trusses with timber boards above. The third truss in from the east gable has a significant crack to the bottom chord. Looking to the other trusses, there appears to have been a repair at the same point on the eastern most truss in the past, suggesting it may be a weak point, possibly due to some minor eaves spread, as noted at item 8.11 and 16.2. This requires urgent repair.

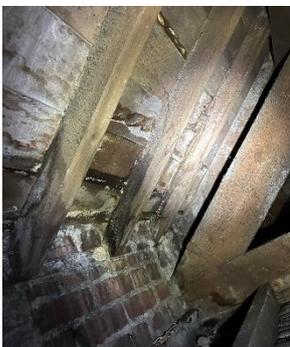
Figure 24 – Vestry rafters

12.3 The **Vestry** trusses are accessible in the roof void, several stains and a visible damp patch directly above the hatch, at the abutment to the Chancel. This could be due to the issue reported in the last QI of the gutter above being filled with silt, as item 6.10. This area needs to be monitored closely to ensure it dries out.

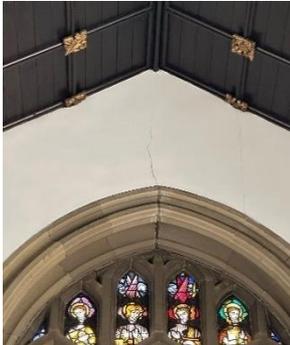
*Figure 25 – East gable*

- The vertical plaster crack over the E window peak was previously described as 'minor' but had no reference photograph, the crack is shown at figure 25 and should be monitored, it currently runs  $\frac{3}{4}$  of the way to the ridge. This could be caused by some slight eaves spread. Small cracks to the underside of each purlin.
- In Tower entry flaking paint under the W window and large areas of decoration and plaster breaking down to all external walls. The W window mullions are severely breaking down and stone dust has built up in the glass cavity. More on glazing at item 18.7.
- At SE lobby flaking of ceiling and wall paint on plaster.

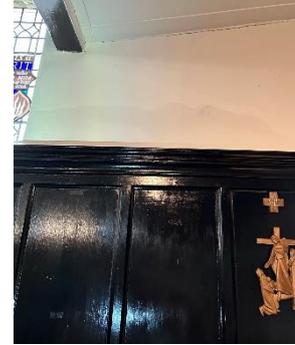
*Figure 27 – SE Nave damp*

- There is a damp patch above the panelling on the south wall at the west end of the Nave, this should be monitored and carry out pointing externally if this has not already been completed.
- Flaking paint to the bottom RHS of the mid-window to the south Nave.
- There is a water stain to the SE corner of the Nave, potentially due to the poor pointing externally in this area, this should be closely monitored.

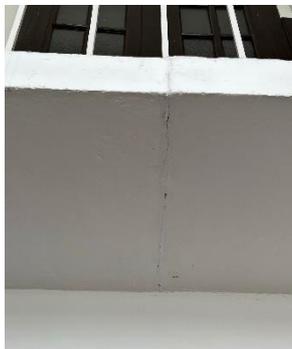
Figure 30 – cantilever

19.1 The Nave Gallery has two rows of pews on softwood & plywood steps. Tracery in the balustrade, leaves large gaps between. Two cast iron supporting columns, are well designed and made. Its stair and landing in the tower are cantilevered stone with elegant handrail, mostly in good condition, slight hairline crack to the cantilevered stair entrance.
