INSPECTION AND REPAIR OF CHURCHES

CARE OF CHURCHES MEASURE 2018

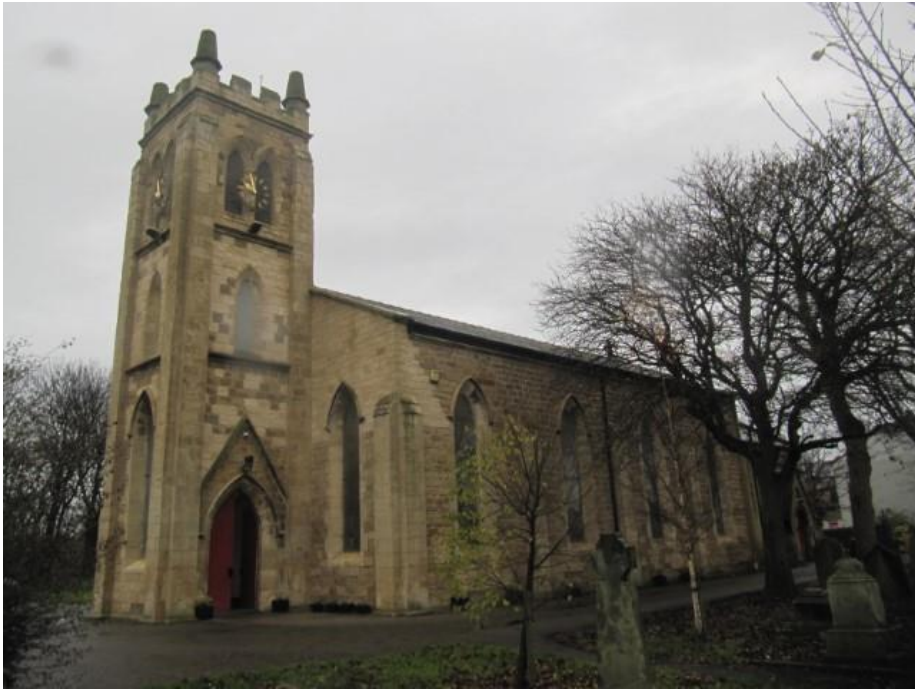
General View of the South Elevation from the West

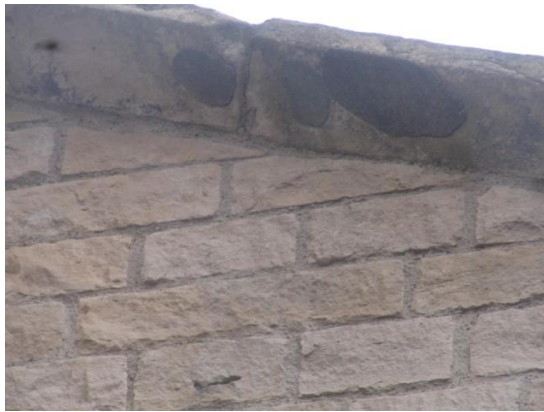
Area of mortar repair to the water tabling to
The Nave (West)

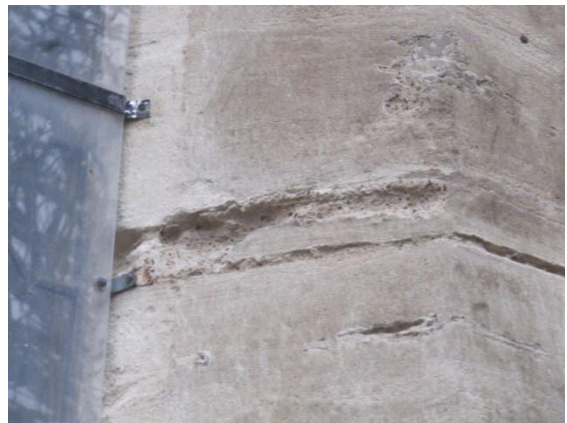
Mortar repair starting to weather to the
South Elevation of the Nave

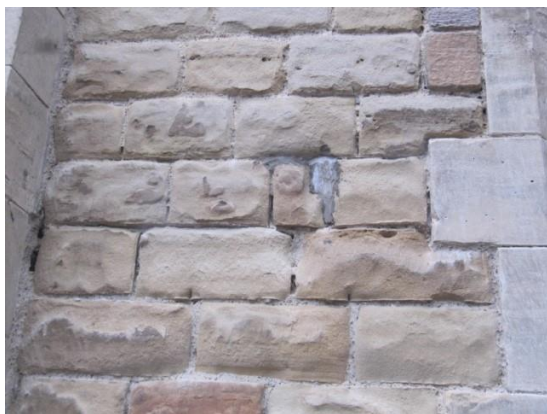
Hungry/Open joints to the South Elevation
Of the Nave

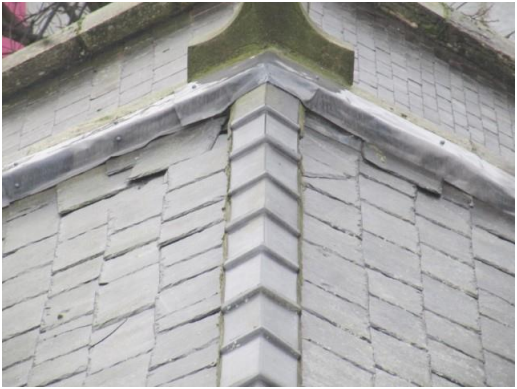
Damaged and slipping slates to the East end of the Nave roof

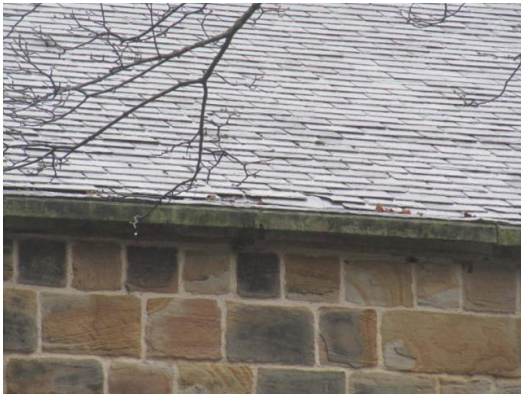
Slipped missing and damaged slates to the South Nave roof and failing pointing to the ridge

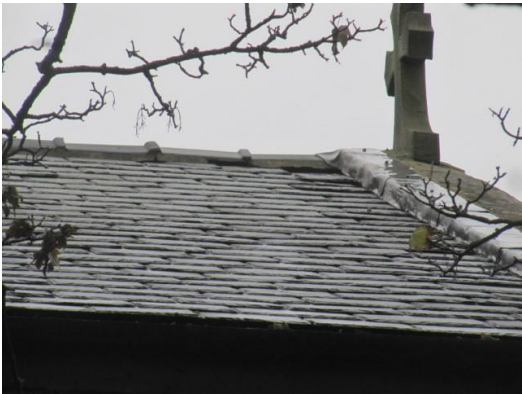
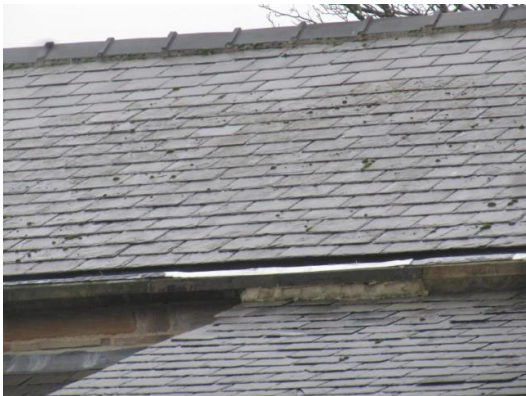
Mortar fillet over the organ Chamber roof

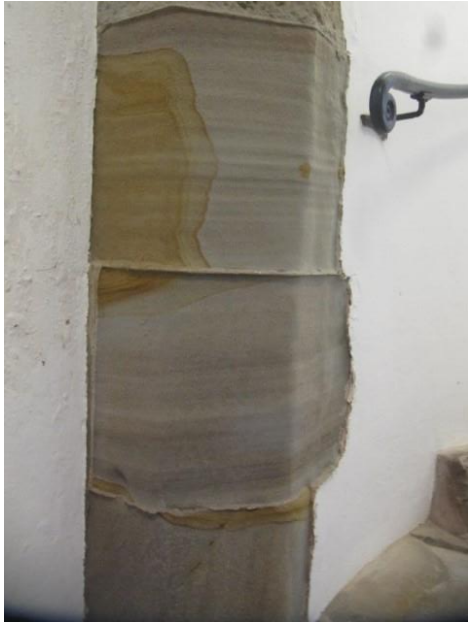
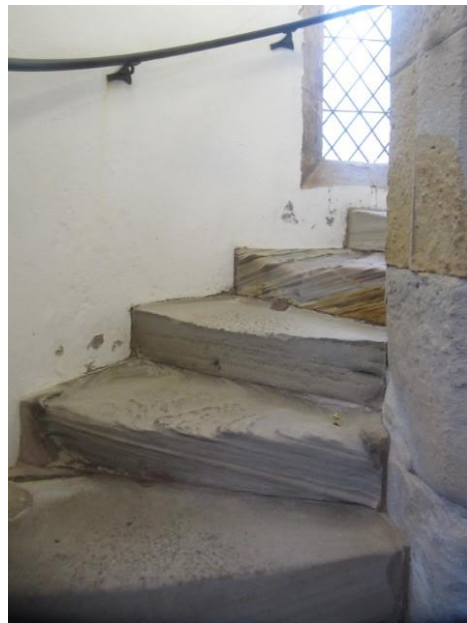
Deteriorating stonework to the entrance to the gallery stairs and variable condition of the stonework to the stairs themselves

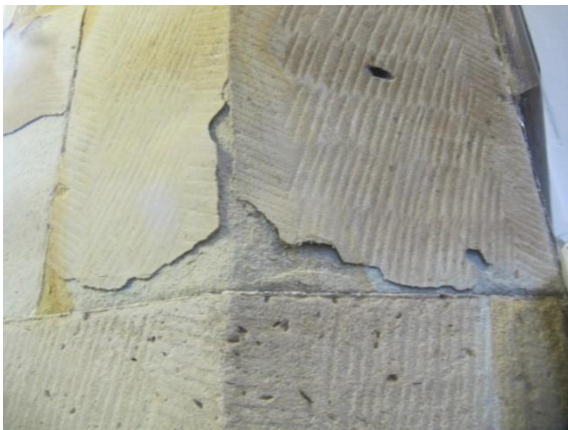
Descaling stonework within the base of the tower

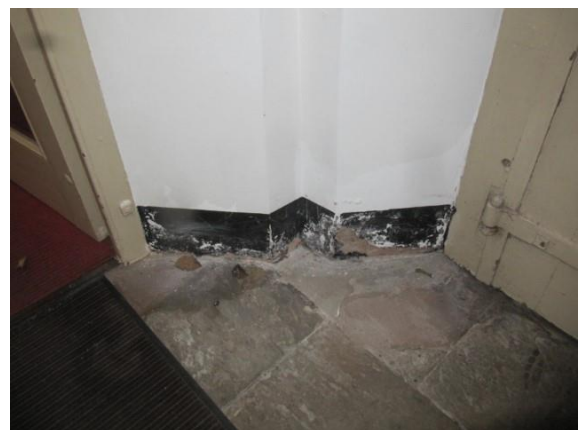
Damage to painted skirting in the same area

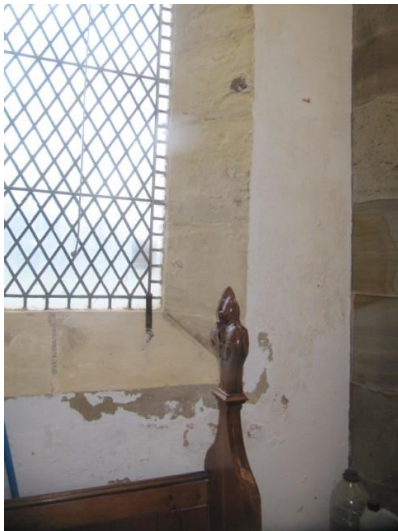
Dampness, salts and failing paint to the West wall in the base of the tower

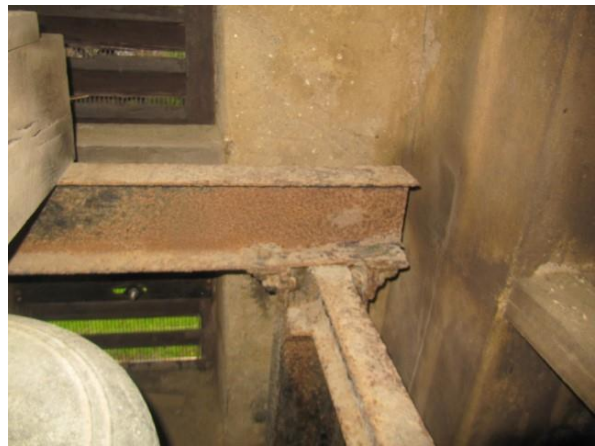
Rusting metal within the bell Chamber

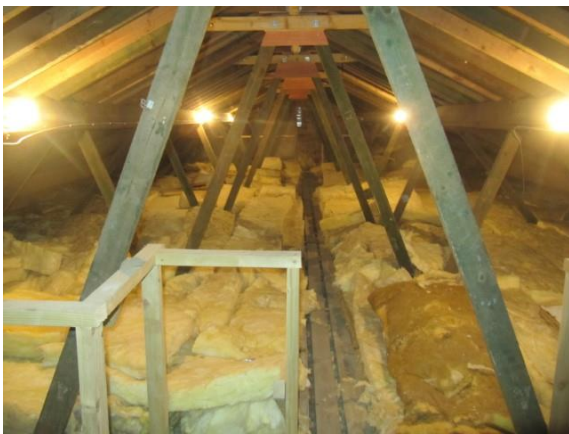
Good levels of insulation above the Nave

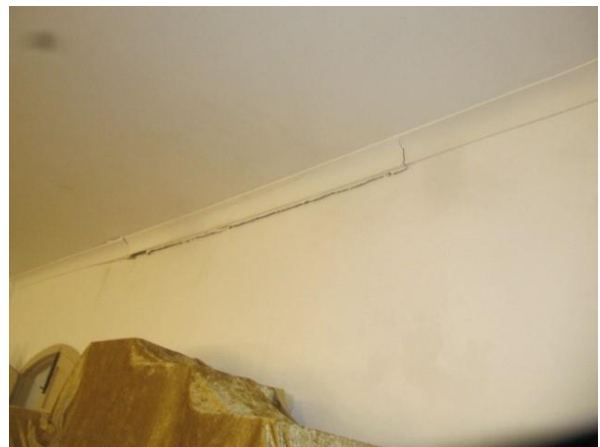
Failing coving to the West wall in the gallery

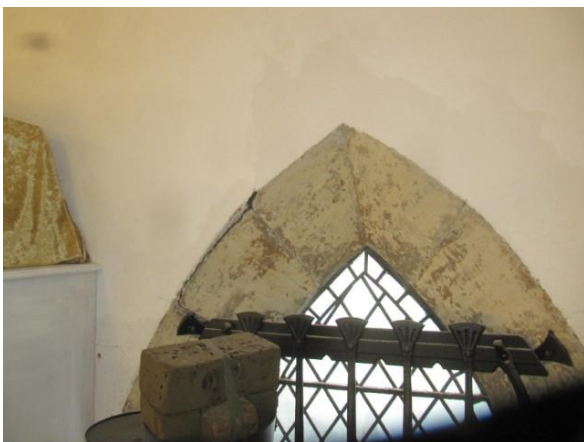
Cracking over the North Gallery window head

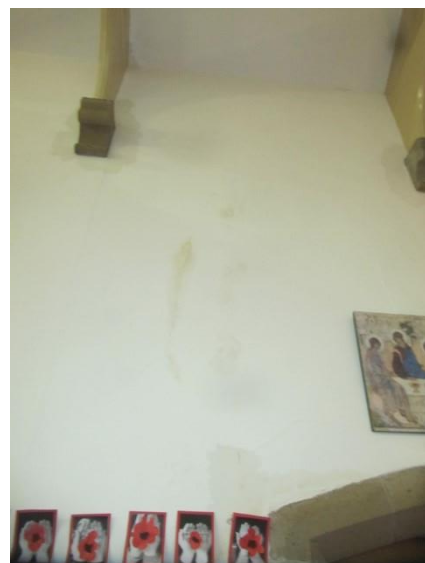
Dampness to the North wall of the Chancel

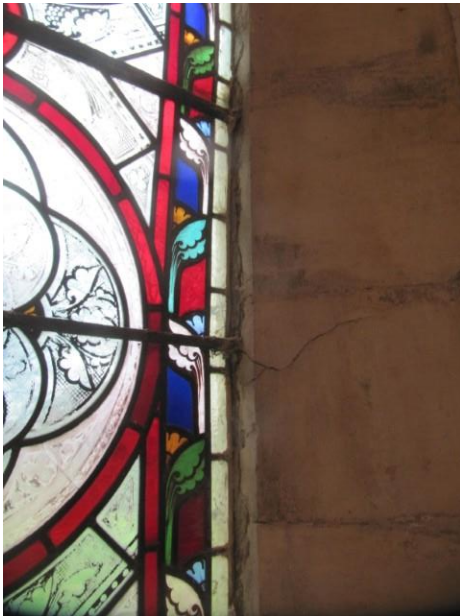
Glazing bars causing damage to masonry to a window reveal in the Nave

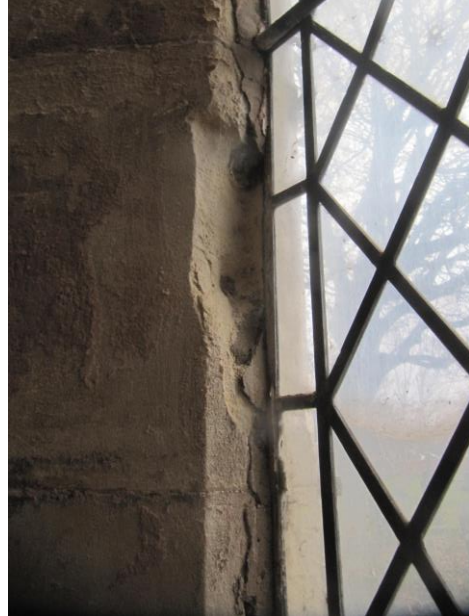
Failing stonework to reveal of Nave window

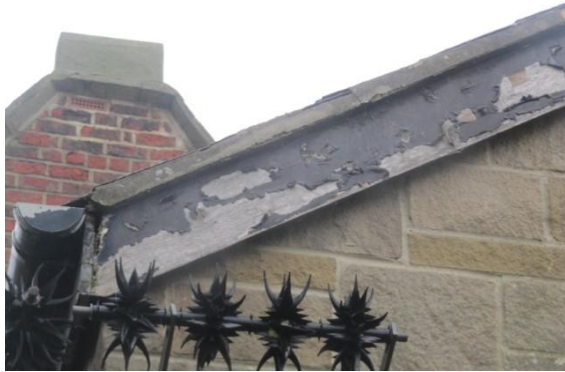
Failing paintwork to East wall of the Hall

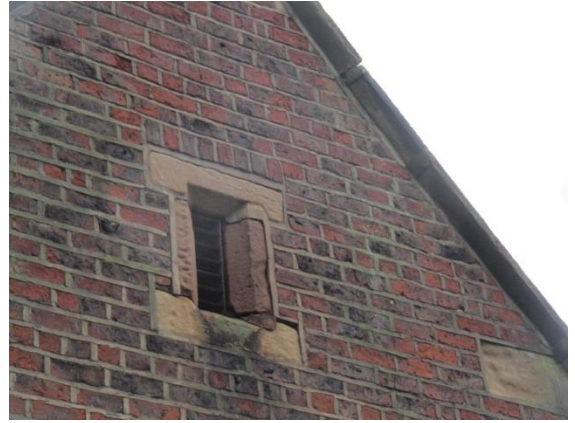
Open joints to the water table, cracking/open joints around the vent and weathered stonework to the East gable of the hall

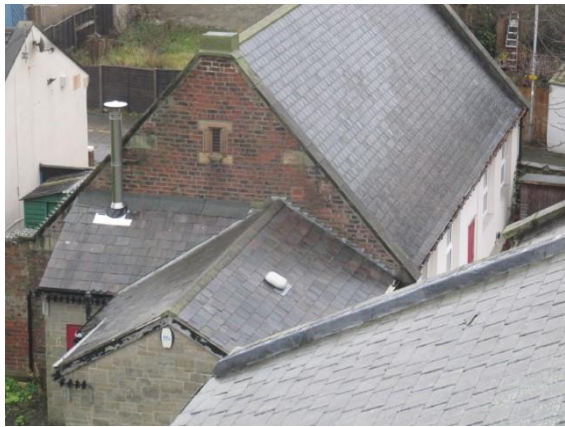
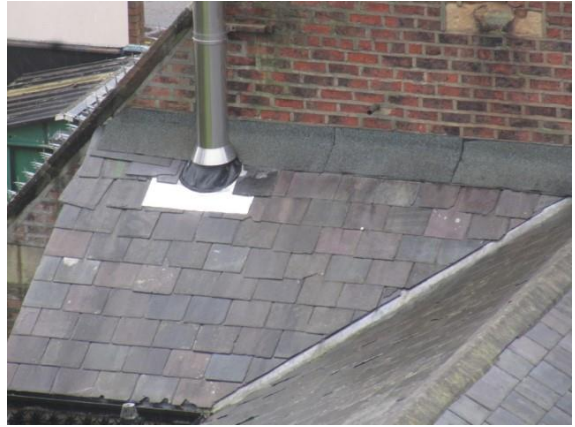
Hall roofs (left) with a close up showing disturbed states over the boiler house

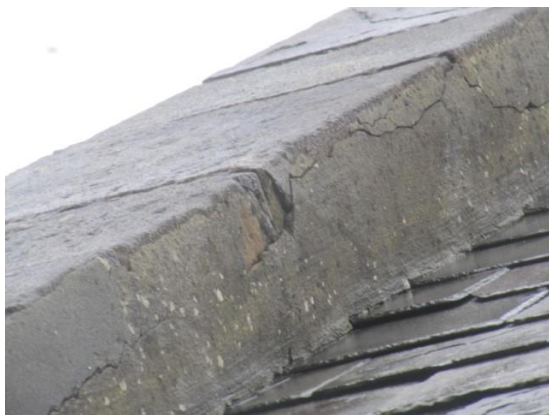
Cracked mortar fillet to the hall roof

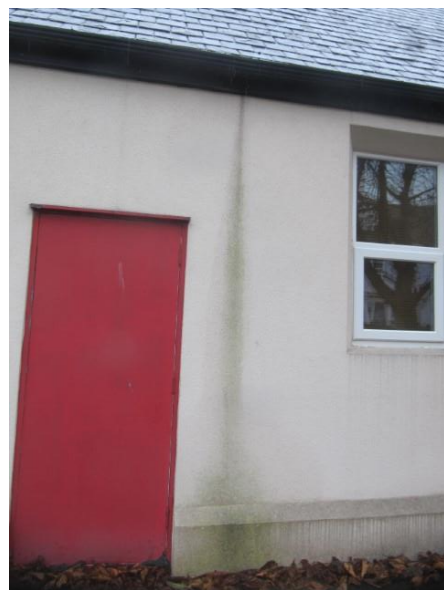
Damp staining under the leaking gutter

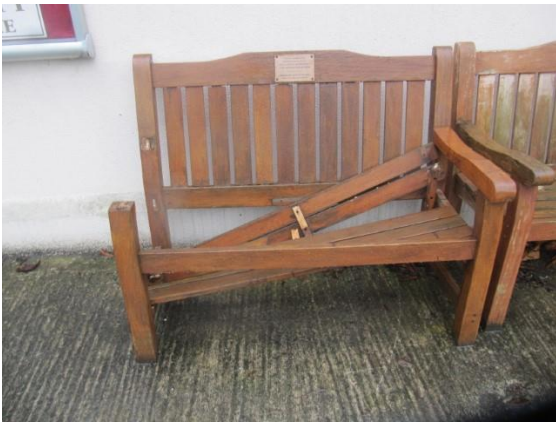
Damaged memorial bench in front of the Hall

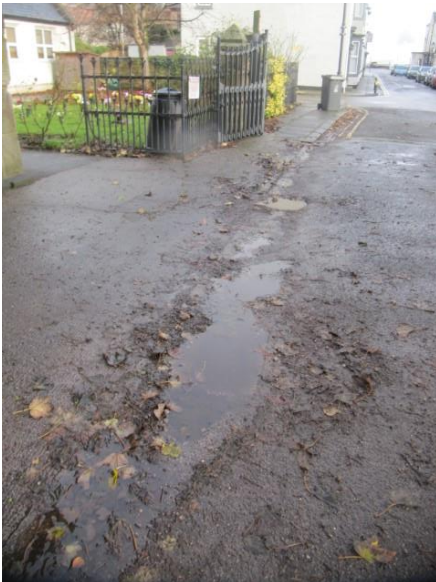
Potholes and ponding to the access road adjacent to the footpath

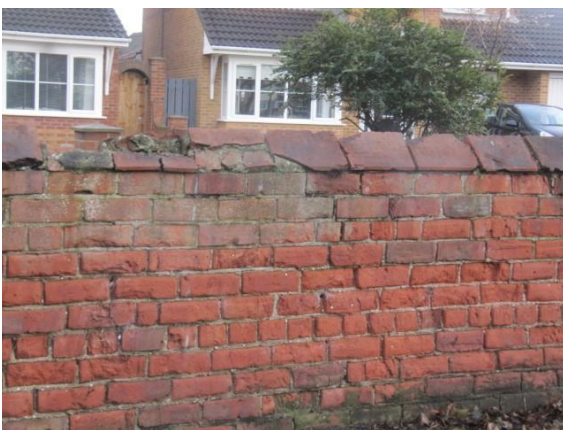
Failing capping, cracking and hungry/open joints to the boundary wall

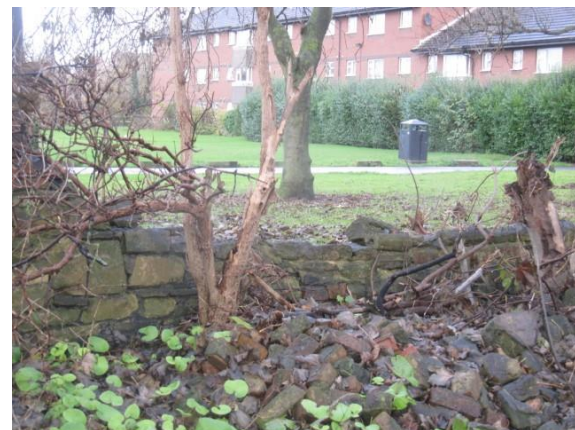
Fallen sections of the Northern boundary wall

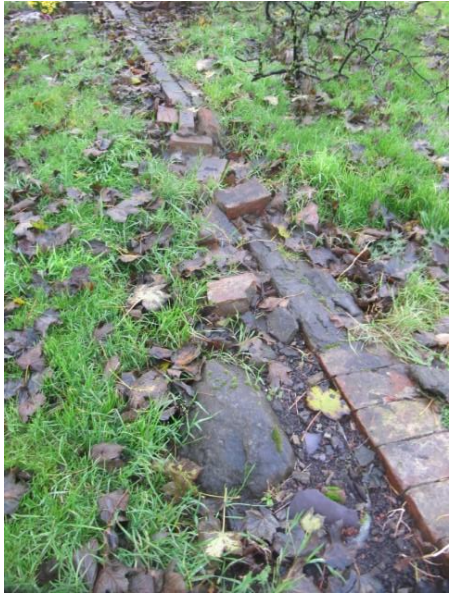
Loose bricks and low wall perpendicular
To the Western boundary
