**QUINQUENNIAL INSPECTION REPORT
OF
SEDGEFIELD, ST. EDMUND**

**INSPECTION OF CHURCHES MEASURE 1955
CARE OF CHURCHES & ECCLESIASTICAL JURISDICTION MEASURE 1991**

January 2021

Beaumont
Brown
Architects LLP

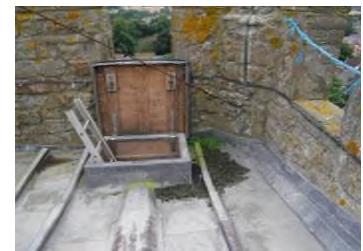
The flashing solder is coming away at the pole lead joint so there may be a bit of water going down, we will have a look on the inside next. The stay cables are rusting, the shackles are generally ok, and the collar is a bit rusty. It all depends on the bolt whether that is good enough it looks ok and the ropes are fixed to the corners and there is some oil cloth on them just to try and keep the rust off.

There is a build-up of moss and grasses in the high point of the gutter in the S W corner and a little bit of litter in the gutters.

Recommendation: carry out minor repointing and pole flashing works

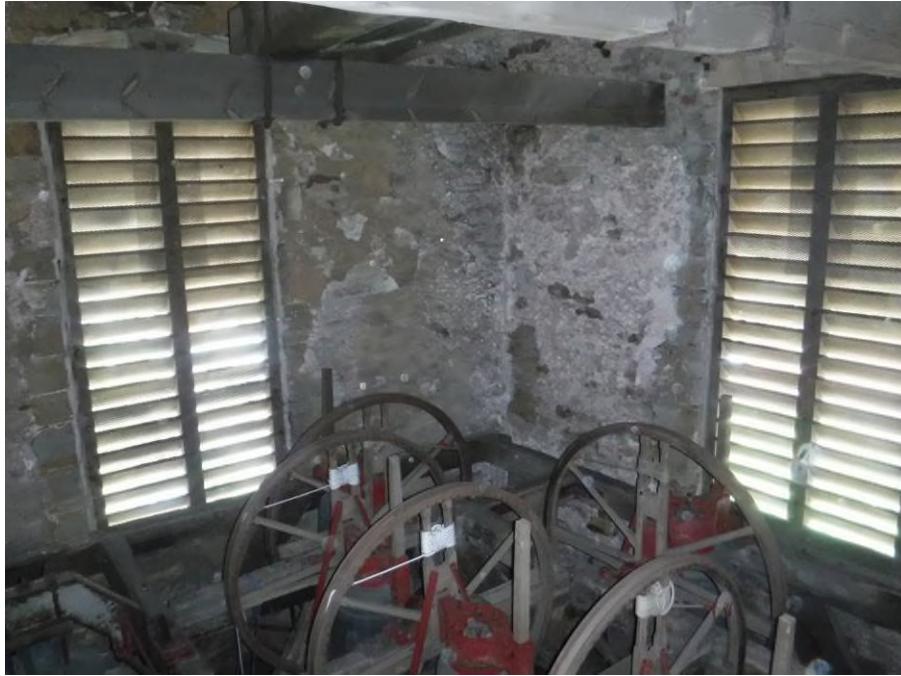
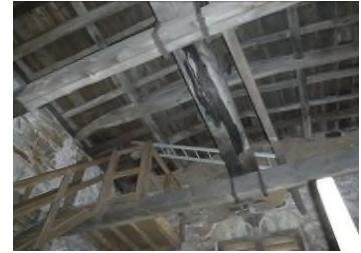
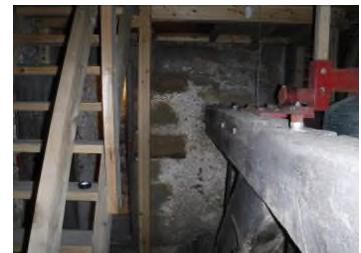
- **Bell Chamber:**

- **Ceiling** – The roof is in good condition, there is no obvious leaks through it. Apart from some staining on the pole beam from leaking pole flashing.
- **Walls** – The walls are a bit patchy, the render is coming off but not significantly, there has been some repairs to the tops of the belfry openings on three sides, E is the one left undone and it's been parched up with a bit of mortar and looks ok. Some pockets in the wall from previous beams, odd bit of funny patching that isn't so good but it will do in here I think.
- **Floor** – The floor has got a mineral felt covering that seems ok, there is a bit of water that gets through.

- **Recommendation:** none

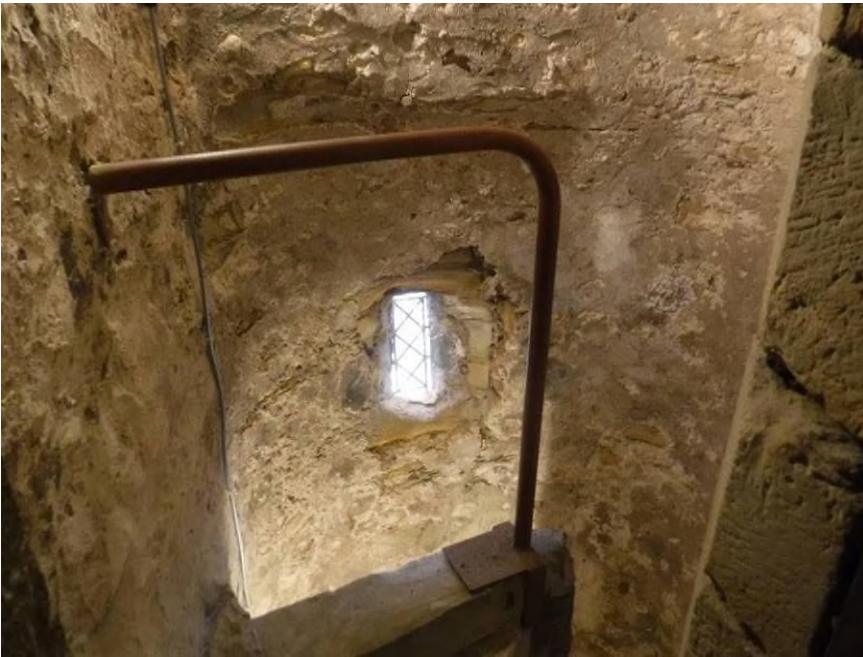
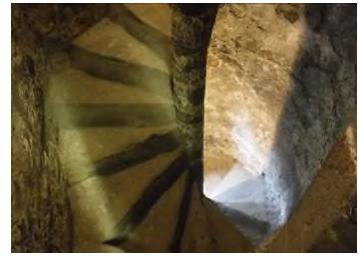
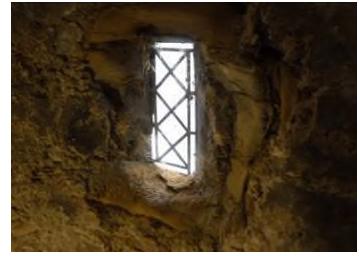
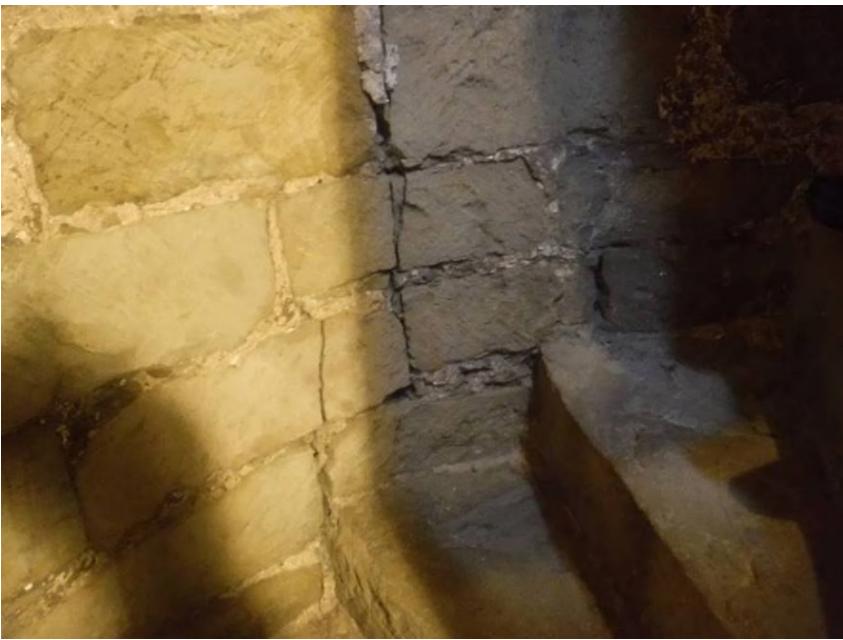
M Stair Tower:

The walls are thin at the south and showing efflorescence, some crumbling, have been plastered in the past and replastering is probably wise though there could be some repairs at the window reveal at the window above the ringing room - just a tall rectangular on the S side. But this could all last past 5 years. Perhaps repair in 5-10 years.

Spiral stair with stone treads, the majority are reasonably good and those are either the originals or have been repaired with concrete toppings of variable quality and the top ones aren't as good as the lower ones.

It is the bottom eighth that has the worst of the walling and there is a crack at around about eight risers up in the wall which looks ancient. Not mentioned in last QI. Monitor the crack

Recommendation: Monitor the crack

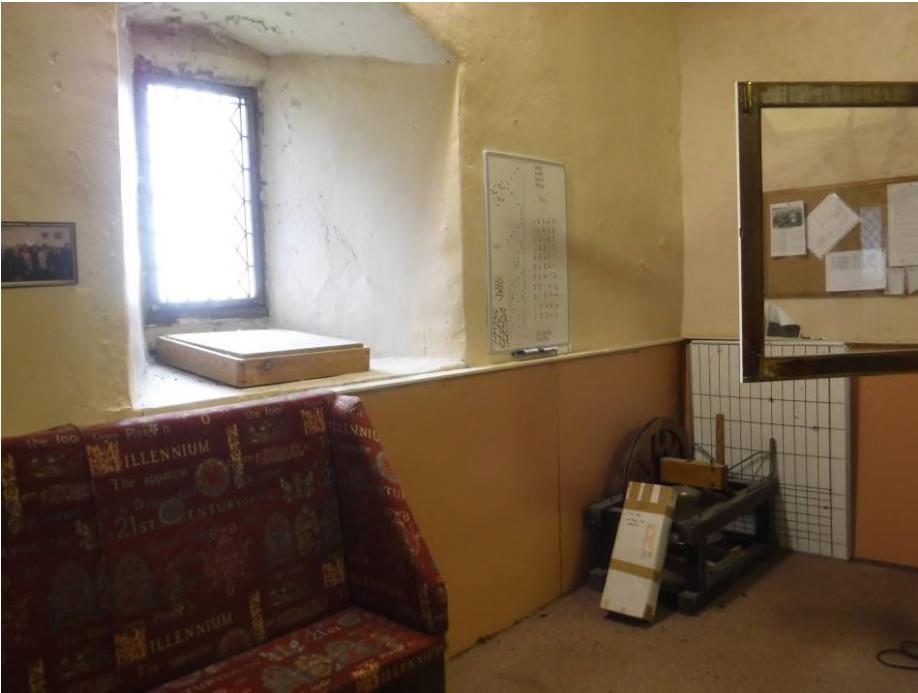
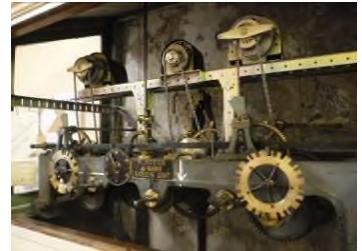
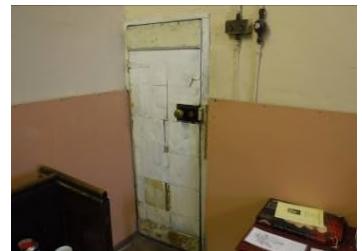
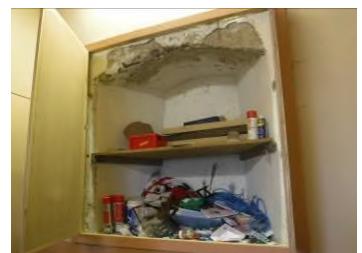
D Ringing Room:

- **Ceiling** – Boarded out, looks ok.
- **Walls** – The walls are plastered with a fibre board dado running round it, in fair condition. The W window has a hole in the glazing,
- **Floor** – Carpeted floor a little bit worn now but serviceable.
- **General** - The room features the clock which is a Potts and Son, Leeds, 1897. The dial is rusting and loss of decorations. The Friends are fundraising to restore it.

Recommendation: repair glazing

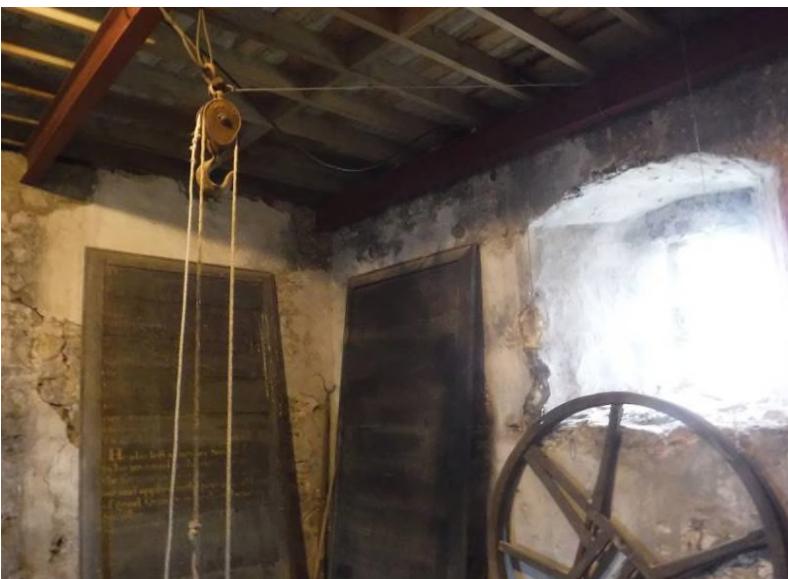
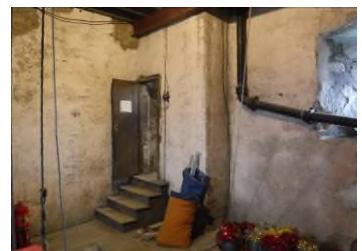
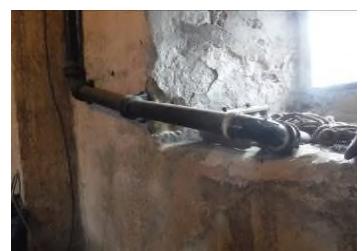
D First Floor Tower Room:

This is a room generally used for storage, a disused space effectively. This is where the rainwater downpipe comes and exists through the S window which has got a couple of cracks in. The N window is a mixture of obscure in diamond panes.

- **Ceiling** – Joisted modern ceiling, it is ok, and it had to have three steel beams put in for the bell restoration and is generally ok.
- **Walls** – lime plastered and that is broken down in some places. In the middle of the wall on the W elevation the plaster surface suggests the hint of a flue or former boxing.
- **Floor** – The floor is dropping into the centre and a bell trap door which is in need of repair.
- **General** – There is some hoisting gear in the room and some old bell wheels and various bit of lumber that could do with clearing out.

Recommendation: sweep up and repair hatch

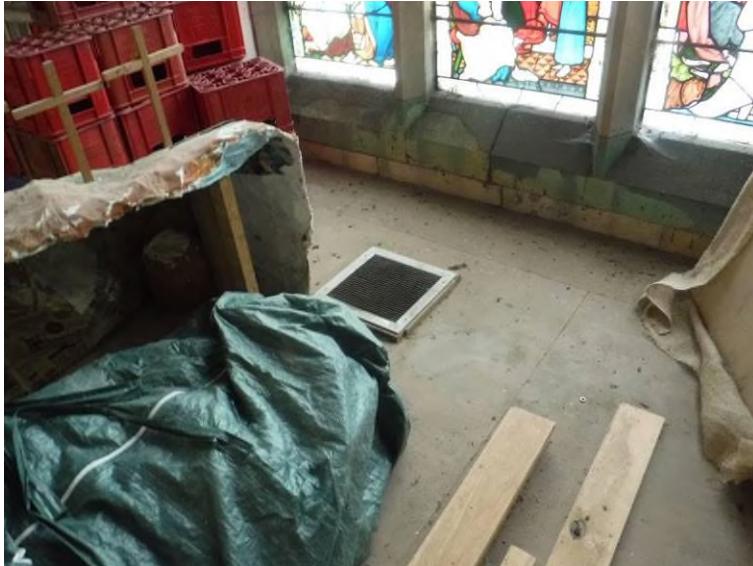
D Tower Meeting Room Attic:

This double height space has a meeting room at ground level and an open attic space above it. The following describes the attic space.

Recommendation: repair window

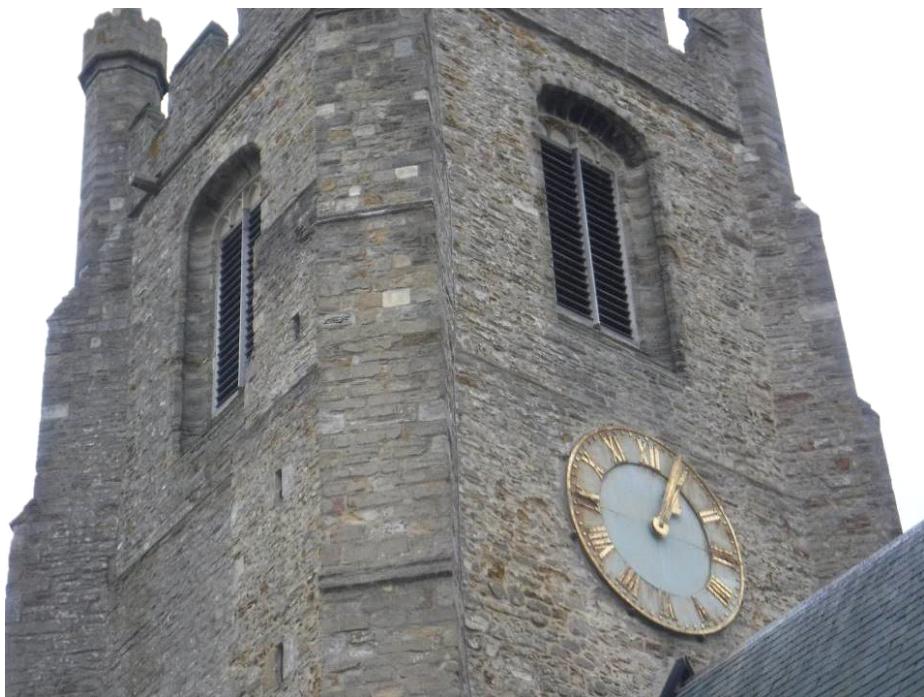
- Tower

East Elevation – Some pockets of erosion to the stonework mostly around the belfry window on the N side, clock dial below very rusty The dial is rusting and losing decoration (The Friends are fundraising to restore it), buttresses looking good as does the louvres and there has been a partial repair to the lancet top of the belfry.

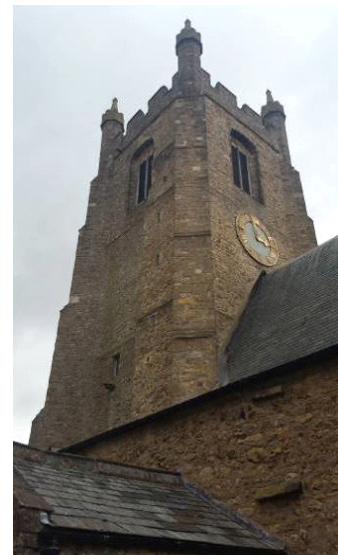
There are individual bits of erosion all the way up but the walling is generally sound apart from the bottom stage which is hollowing out quite a bit. There is a stone roof on the top of this, it will be interesting to know what that condition is like, and it wasn't obvious on the inside if there was any water coming through. Is it time to carry out repairs? It would probably last another 5-15 years but if there were other works planned and scaffold could be utilised then they could be brought forward.

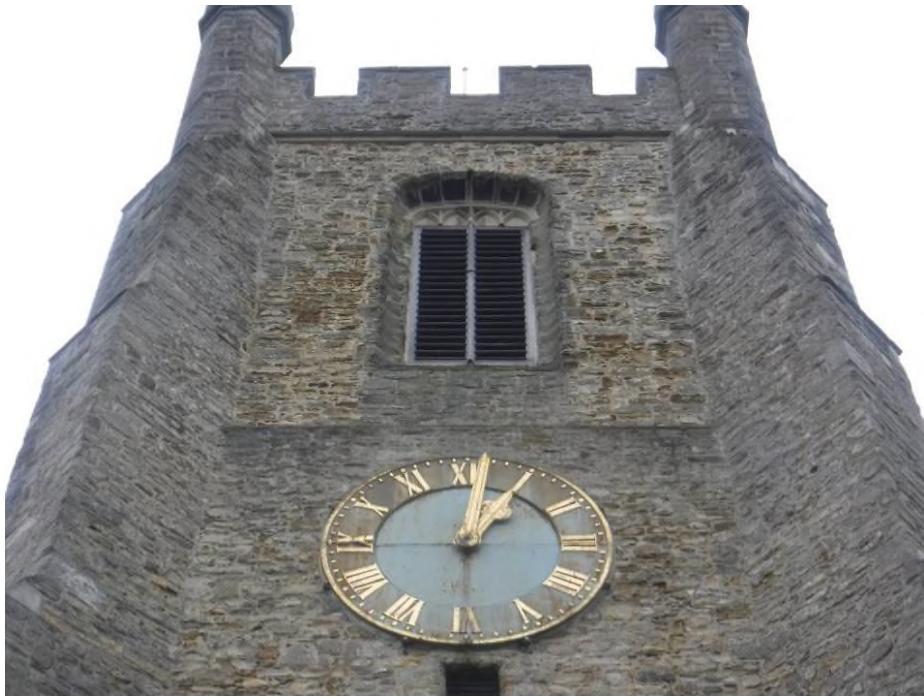
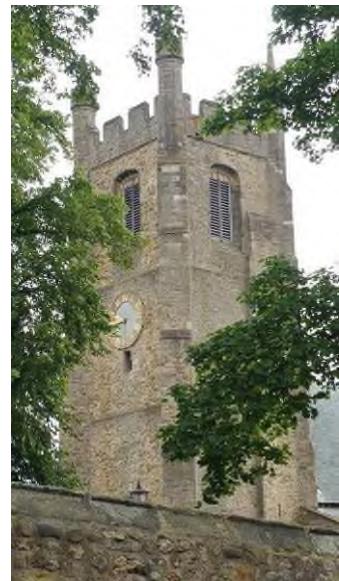
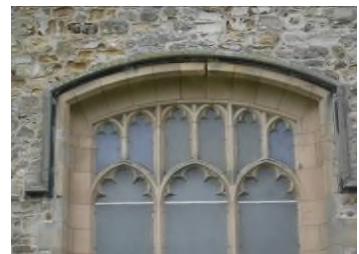
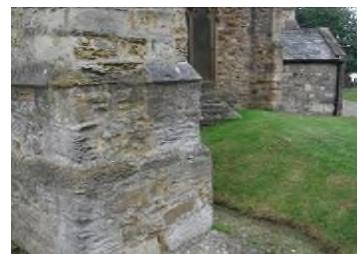
- **West Elevation –**

Quite a bit more honeycombing at high level particularly above the parapet string though it is not a major amount. The stonework either side of the belfry opening looks poor a bit like the E. Top dial below that same as E rusty, window below that has got a hole in it. Area of masonry below the window either side of it some hollowed out stonework there and there is also some hollowed out stonework above the segmental arch ground floor window which has a hole in the keystone and at the bottom of this window, the glass is rattling on the inside. Stonework below that course is generally ok. The N W buttress foot is broken up, not at all like the S one.

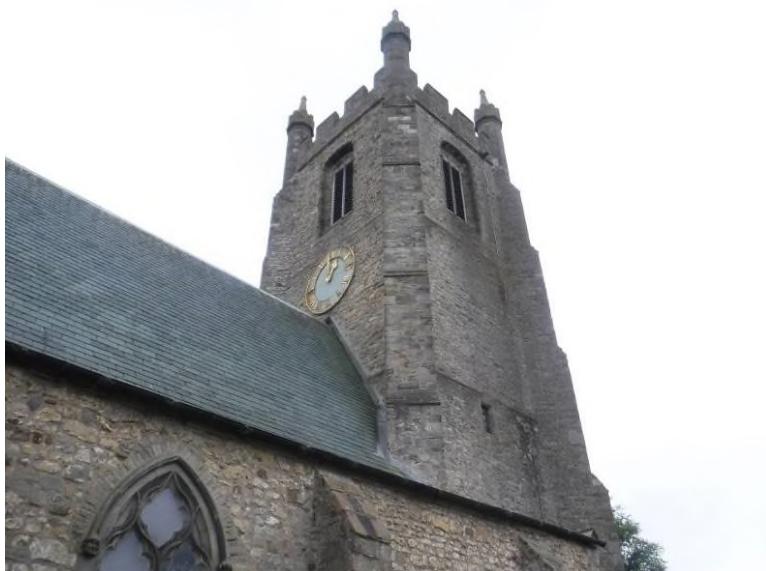
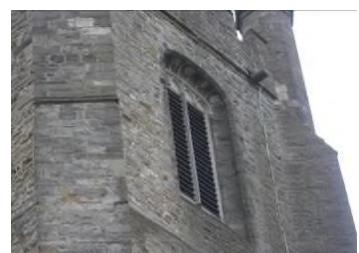
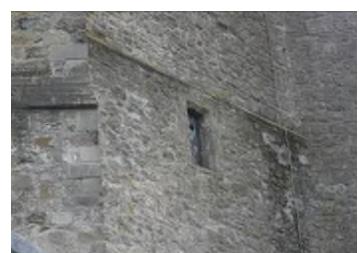
D North Elevation

A little bit mossy from the spitter overflow. The water drips and catches the first stage capping.

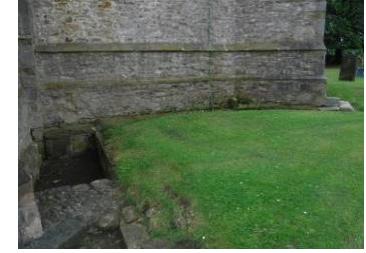
This elevation looks all fine apart from the lower part of the wall where there is some open joints, and most of the foundations are partially exposed.

Recommendation: consolidate the exposed foundation

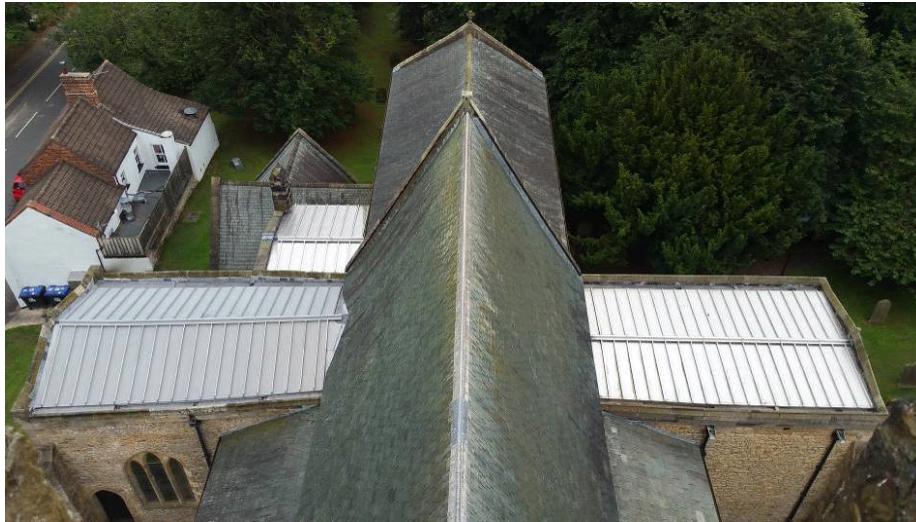
B Chancel:

Not easily seen from the ground but Westmoreland slating, I think a couple of slipped loose ones on the N side from the evidence from the tower roof. The roof is scissoring on the chancel gable, there is a bit of lead work just at the very end and I wonder if this is the cause of the damp inside, there might be a lead flashing which is backed up by mortar, which probably is the case because there is not much overhang on the water table. What are the watertable joints like? Abutment to the nave not able to be seen. Same story on the S side. The chancel flashings abutment to the nave is ok.

Recommendation: inspect chancel gable watertable and roof junction at eaves

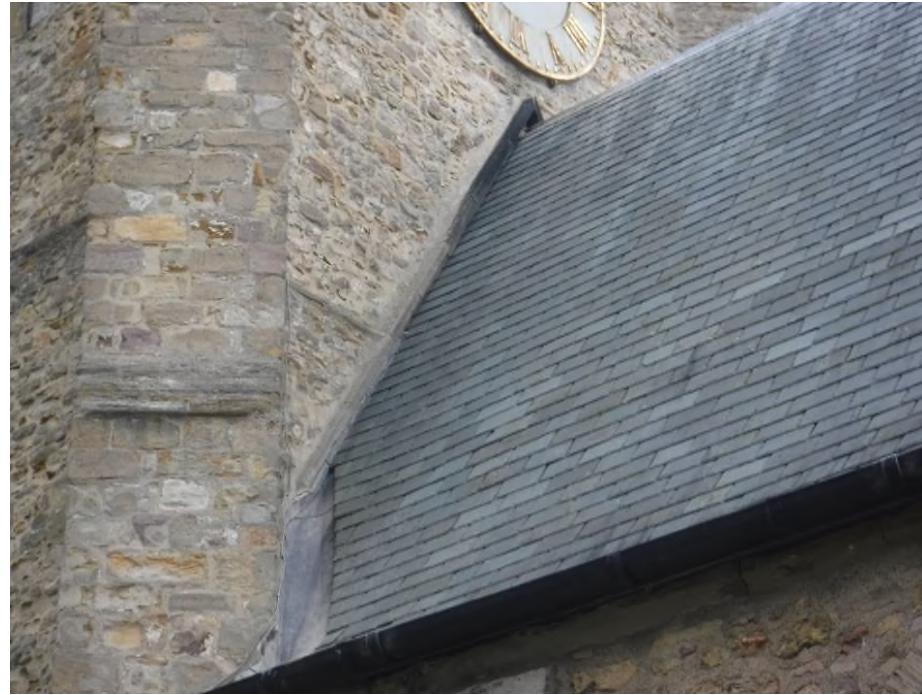
- **Nave:**

S side – ridge in lead – ridge in lead has had a repair in the past, slating generally looks ok, a couple have got a chip in closer to the tower and their abutment flashings in lead look sound. The one to the tower is hidden under a projecting stone moulding and there are instances reported under heavy weather when water

N side – there are a few irregular slates up at the ridge mostly at either ends of the roof, looks as though there has been some losses and some poor patching as well, and a few cracked within the body of the roof. Same flashing arrangement as the other side and the eaves protection which is lifting slightly up at the tower end.

Repair the slating when there is sufficient to warrant the work. They could be held off for the present

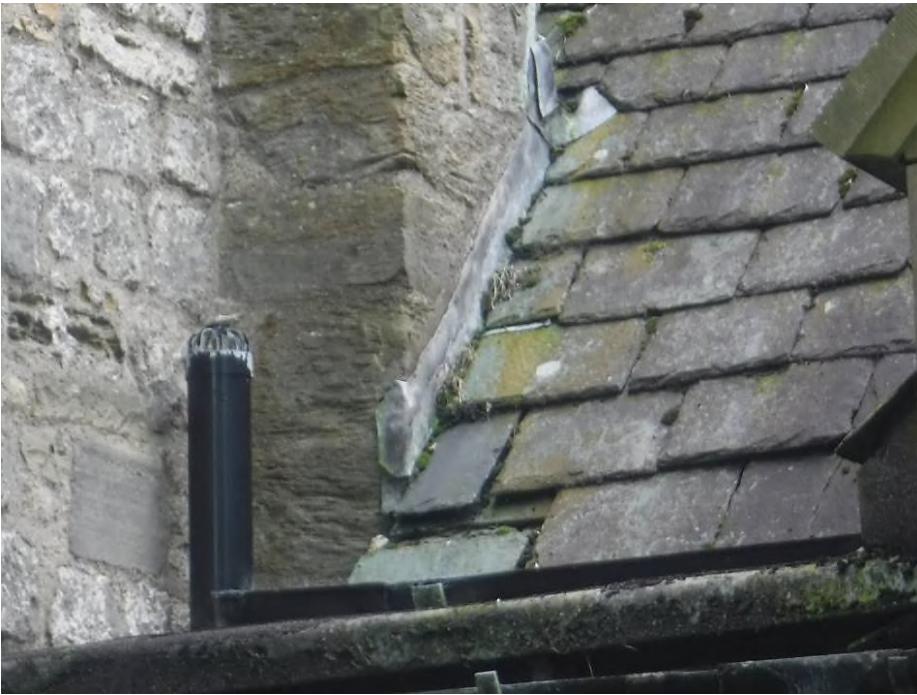
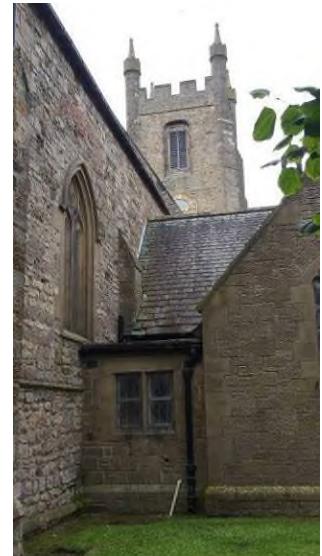
B Vestry:

Two roofs here made of angled ridge tiles and Westmoreland slating, now have been swept up and are looking clean and tidy, all of their abutment flashings look ok and the valley flashings too, there is one slate missing on the E slope of the vestry.

Mineral felt flat roof over this looks a little ancient now, worthwhile checking its condition, this seems to be a good access point for getting onto the roofs, though there is no intruder damage to the tiles it seems, all of the flashing in place.

Recommendation: replace missing slate, inspect disabled wc felt condition

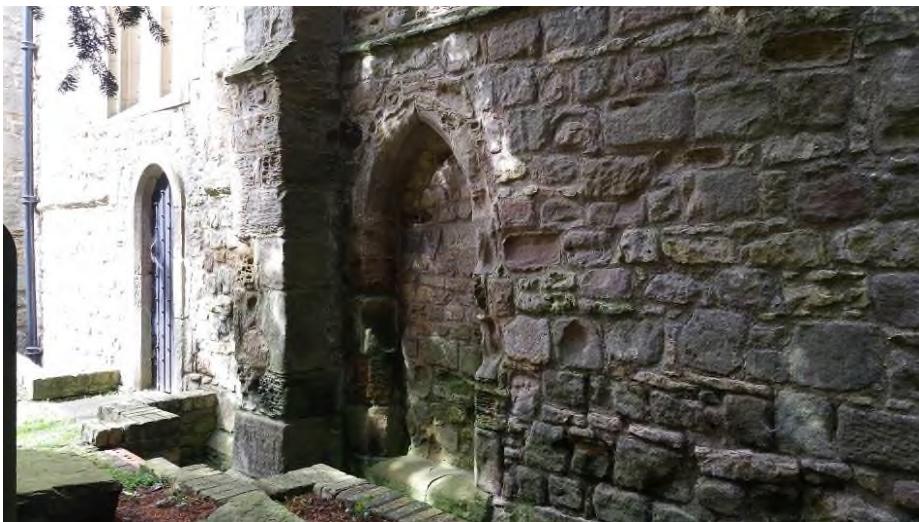
At the E end a blocked doorway who's reveals are eroded but relatively sound and there is a rounded arch door to the W of it, looks in fair condition, doesn't look as if it is used, door joinery is ok, a little bit of rot at the bottom of the door, a patch repair in mortar over the left hand jamb.

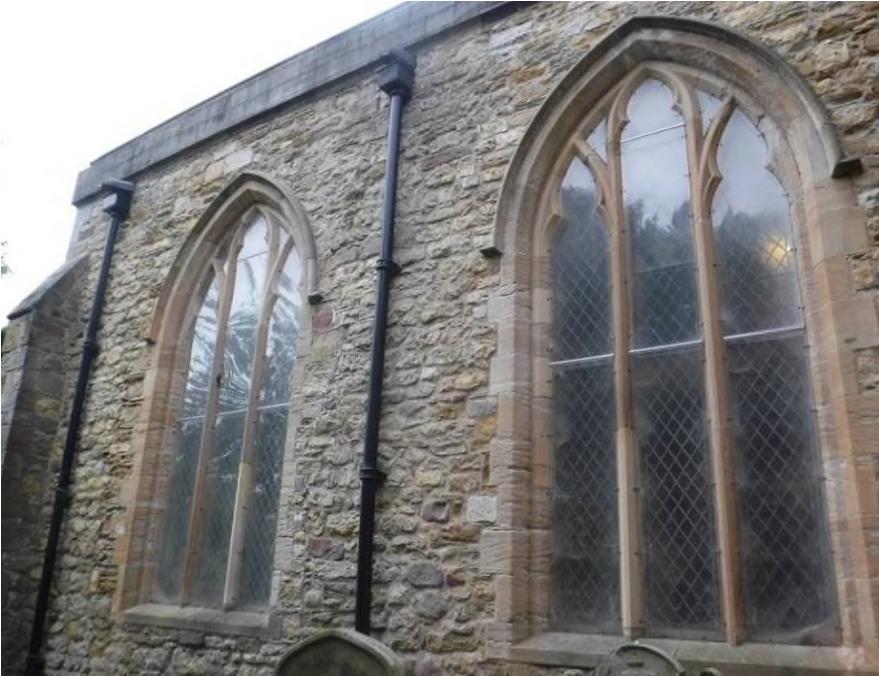
C South Transept:

Two, three light perpendicular style windows with cusped tracery. Has had reveal stone repairs which has left them now in good condition, there is still erosion to the reveals and original stonework, which is now filling the bottom of the windows protection with sand. The previous QI identifies the rate of erosion as slow and this appears to be the same condition now.

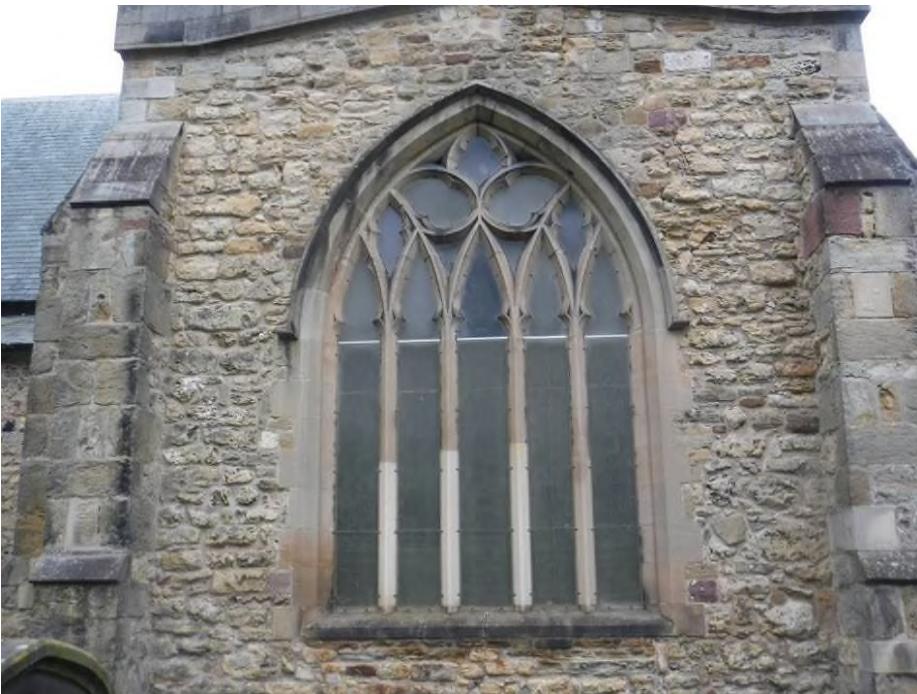
South – Five light window of the same style as the E, bottom mullions have been replaced in none matching stone, there is some erosion to the reveal on the W side and open joint to the top of the window.

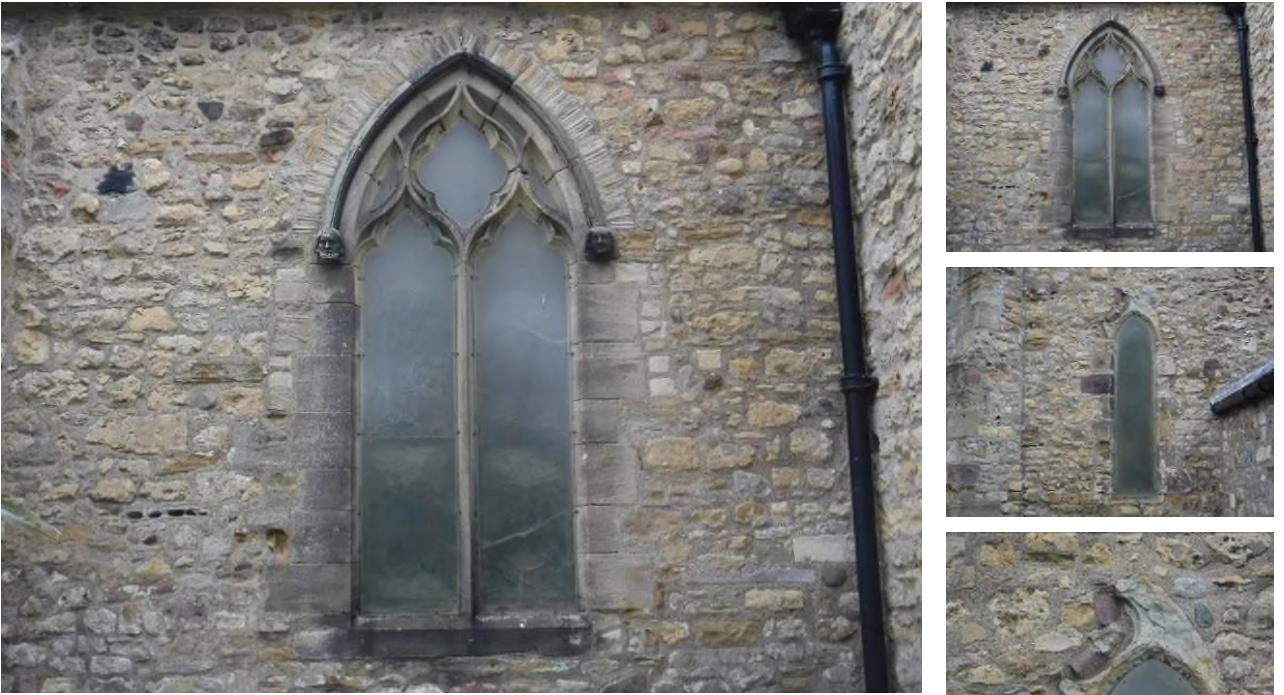
C South Aisle:

Two, two light windows, slightly different pattern in the apex with hood moulds and head sculpture label stops, look in good condition, though the polycarbonate is managing to contain quite a few cobwebs. E window decaying a bit at the tracery where there is a big open joint, probably just needs those joints attending to.

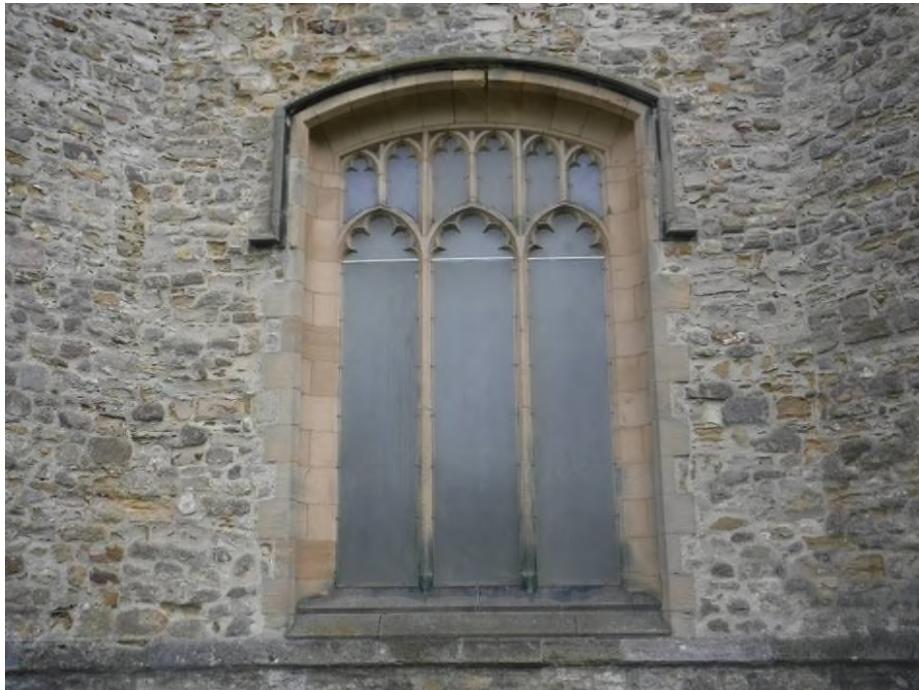
Below that three light segmental arch whose masonry appears to be all sound apart from some slight wear and open joint at the hood mould and the apex inner arch, also the sill joint is slightly open.

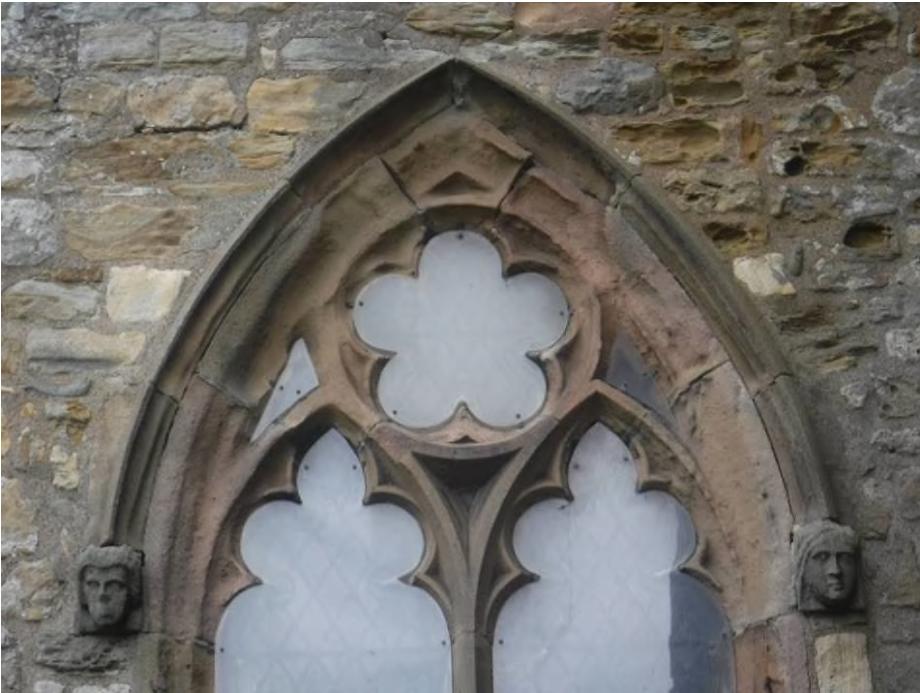
C North Aisle:

West – More eroded than its S counterpart and there is a ledge forming right up at the apex above the cinquefoil that needs a sloping mortar infill, the reveals are also eroding quite a bit, one edge of the cill is broken away.

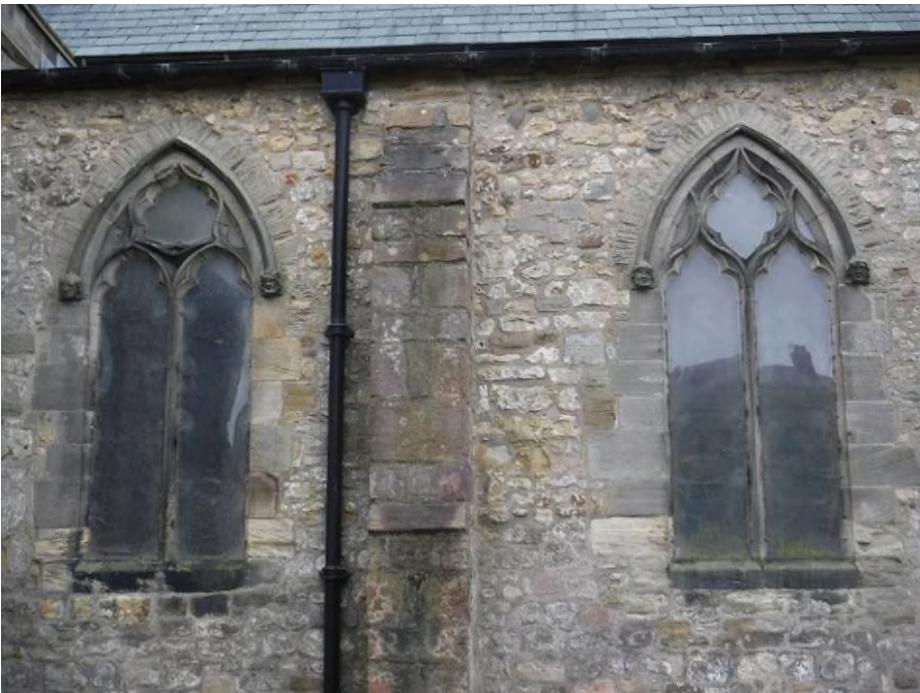
North – Pair of twin lights matching the same as the S side and these are in slightly better condition to them, there is some slight erosion to the jamb stones just above the cills but they will do, this decay is quite slow.

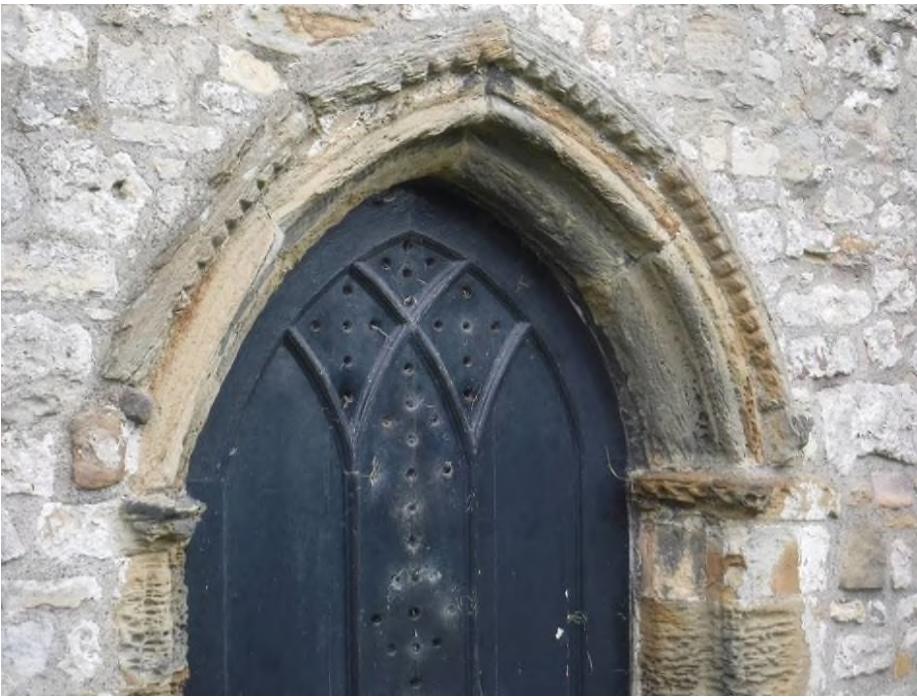
N door nail head lancet pointed hood mould, no label stops at all and quite a lot of erosion to the hood mould, as there is also honeycombing to the stonework jambs. The cill is a rather made up affair of bits. The door within is not used, it has been drilled for ventilation and paint is beginning to break down on it.

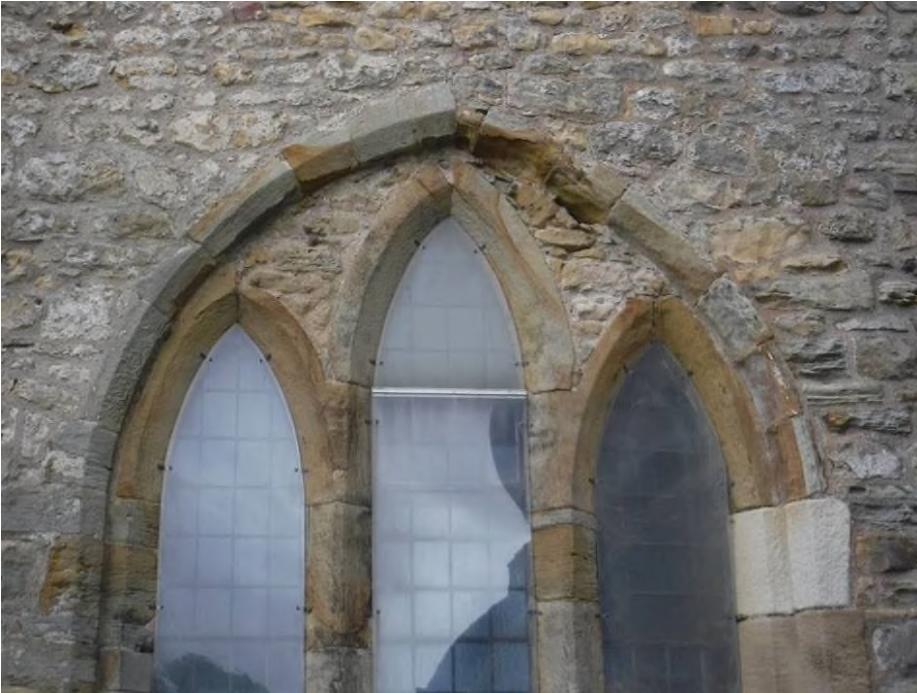
C **North Transept:**

West – Three light window. The S side apex of the arch is badly formed and the infill within the lancets is breaking down. There is some erosion to the

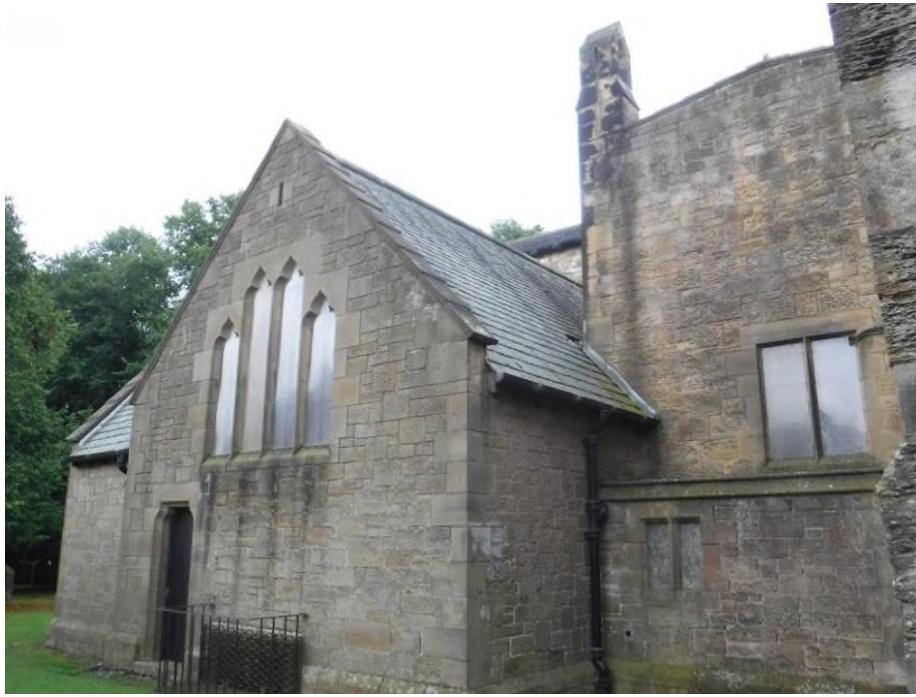
C **Vestry:**

North – Four light cusped pointed arched heads in ashlar fairly good condition, slight open joint at the cill, one joint is wider than the other. Below this door is a shouldered linteled, the lintel has just drifted slightly or rather the doorway the W side of the door has dropped slightly. Door within it is in fair condition, could do with decoration.

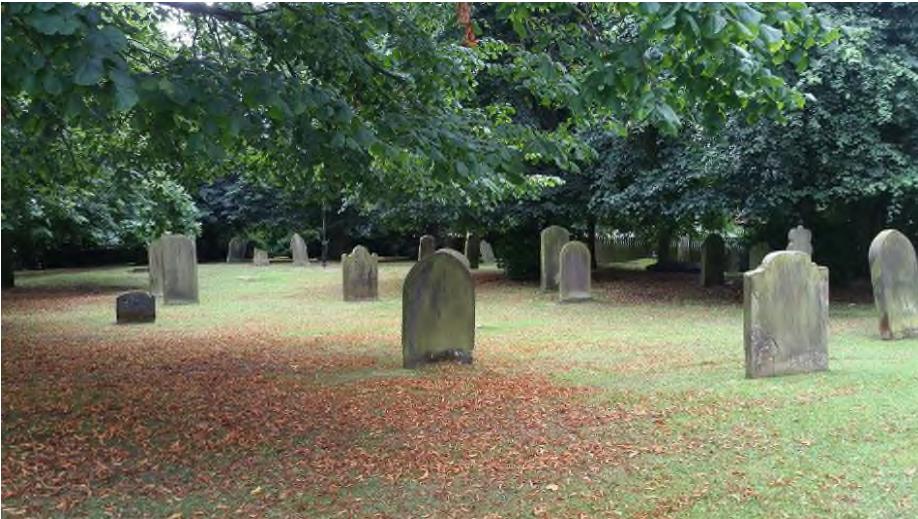
Within the graveyard which is laid to grass quite a few ancient and standing memorials some laid flat, circulation is in natural stone paving undulates slightly and a little bit grassy in the joints but all reasonably serviceable. The grounds are kept very well, it is all very neat and tidy.

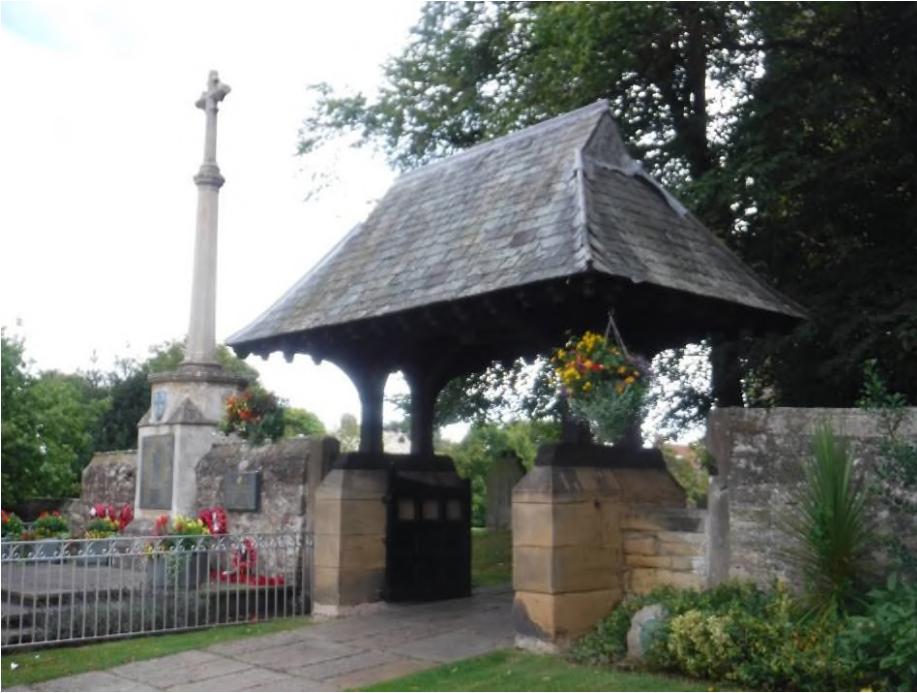
C **West Boundary:**

This comprises the War Memorial and lychgate. The lychgate lead missing on a couple of the hips and some graffiti to the inside, all of the timber joinery is reasonably fair, some slates missing.

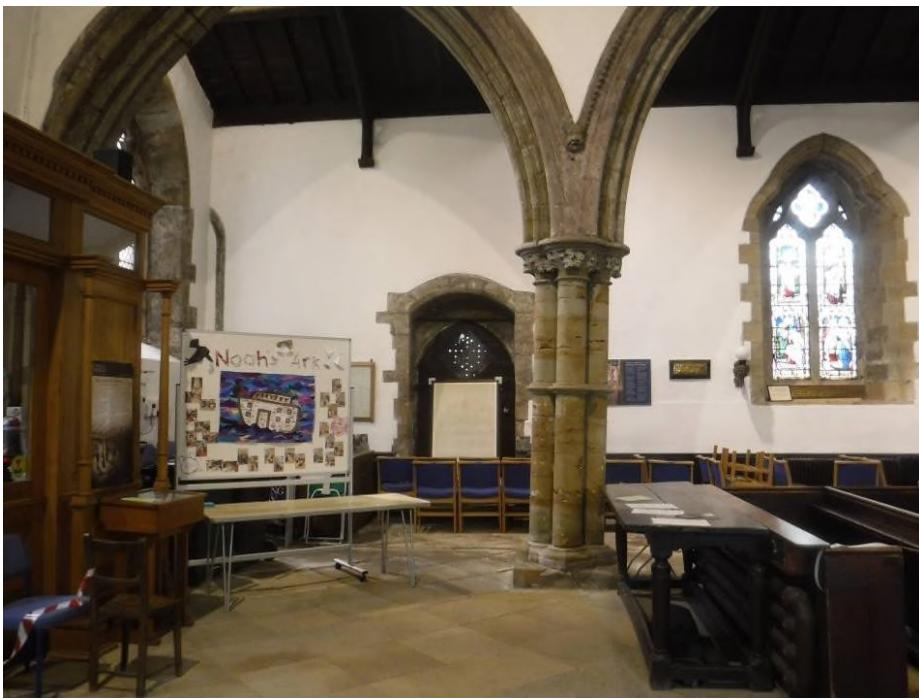
The N side is slightly out of perpendicular particularly at the W end but there is no evidence of distress, all of the arcade stones are sound, there is the odd minor open joint but they don't need attention presently.

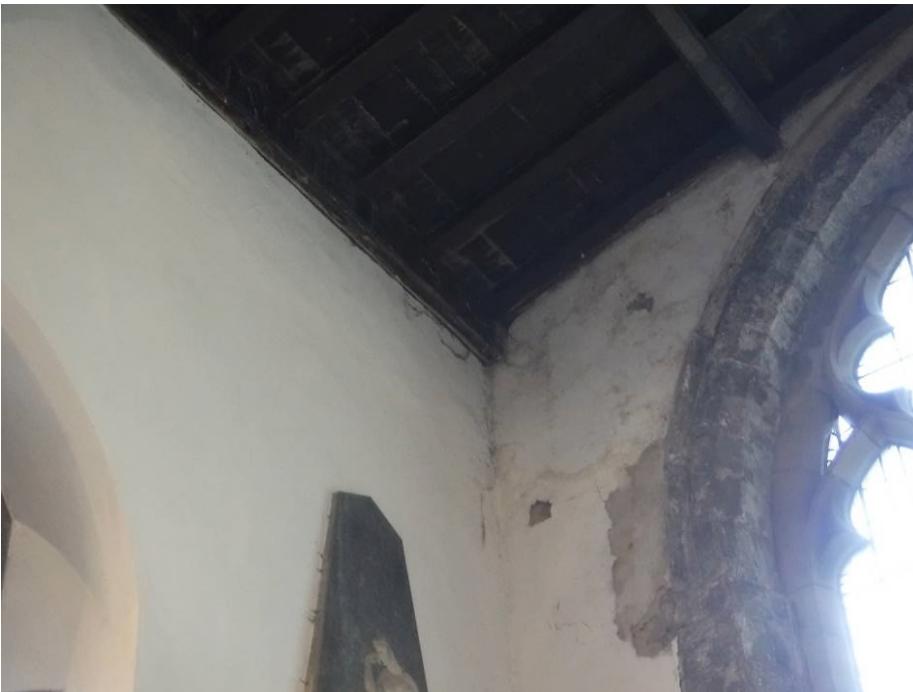
Chancel – Damage at E corner previously noted remains and though this is thought to be fairly ancient now, of greater concern is new plaster falling from the N E up at high level and there are current plans to investigate this as part of an external examination. There will be a need for future plaster reinstatement and decoration.

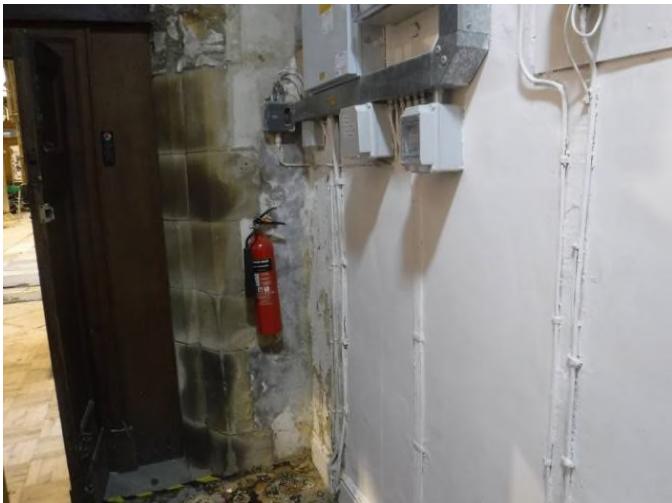
Organ Chamber – The arch into the transept on the N side shows the salts that was last reported in the QI and also the wall above the electrical distribution board is losing its lime wash coating and also at low level by the fire extinguisher, it is highly likely that this along with other damp patches are residual damp from previous water ingress and the church is in the process of drying out.

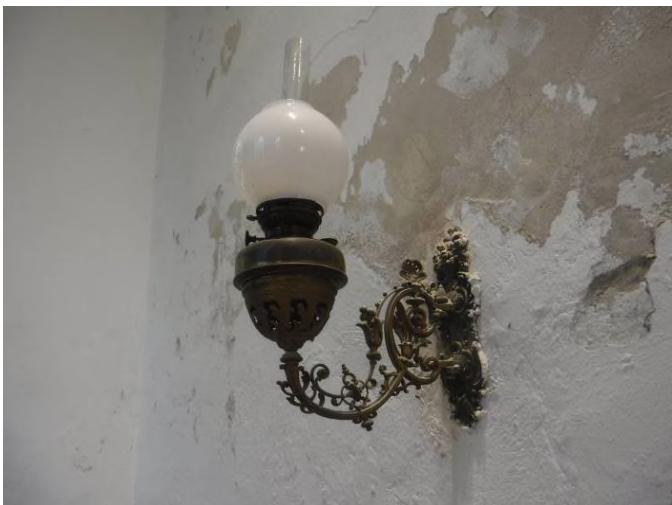
South Aisle – Has efflorescence above the newton lath remedial dado work. The N side is better. Up at the W end of the aisles where the air is often stiller there is damp showing at the S side and there obviously has been some repairs on the N side, also just at that junction by the arcade is some big bumps of masonry up at eye level, I am not sure what that it.

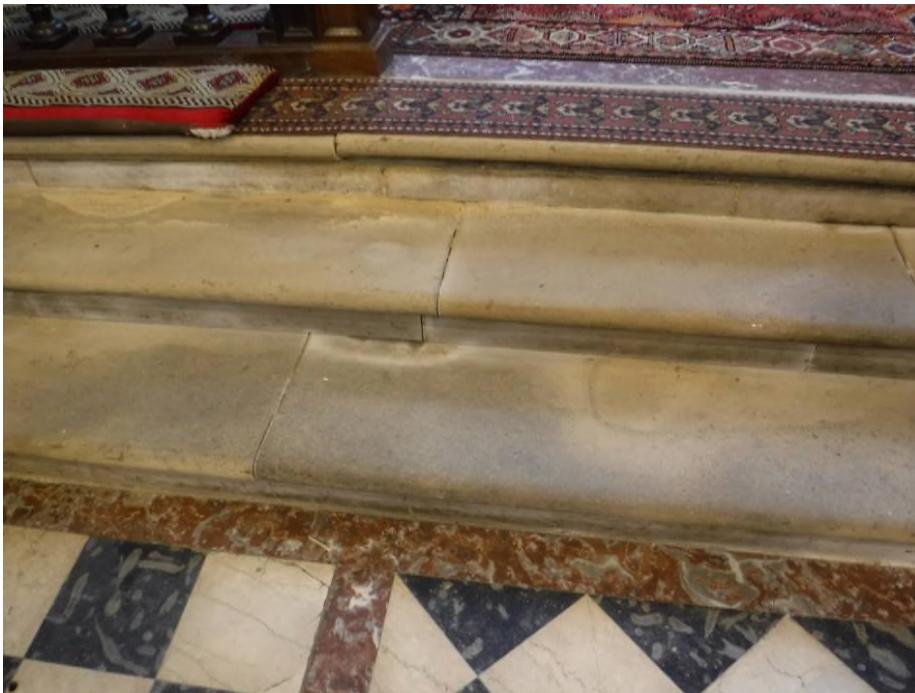
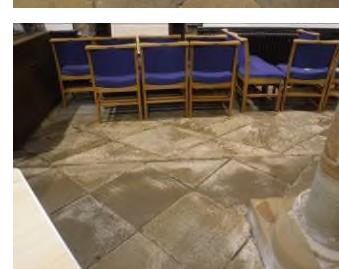
Sanctuary – White, red and black marble tiles and steps, part carpeted. Fair but parts cracked where base out of level, perhaps slight heave. Communion steps are good sandstone, parts of pointing missing.

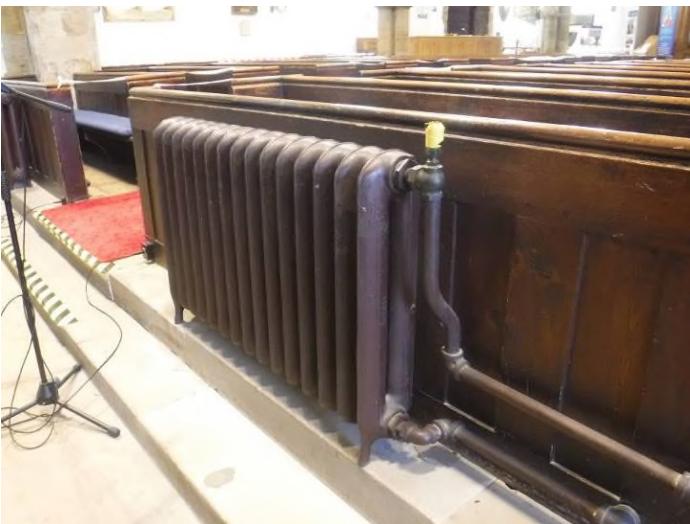
Nave and Aisles – Raised two steps above crossing level, lifted to improve gravity heating circulation but that is uncertain. Nave and Aisle passages and E and W crossings all good sandstone diaper flags. Mainly sound but some ragged edges and out of level. Decayed edge against area of lozenge shaped flags by N Aisle door. Some decay close to font is a slight risk in a busy area.
