**QUINQUENNIAL INSPECTION REPORT
OF
SEDGEFIELD, ST. EDMUND**

**INSPECTION OF CHURCHES MEASURE 1955
CARE OF CHURCHES & ECCLESIASTICAL JURISDICTION MEASURE 1991**

January 2021

Beaumont
Brown
Architects LLP

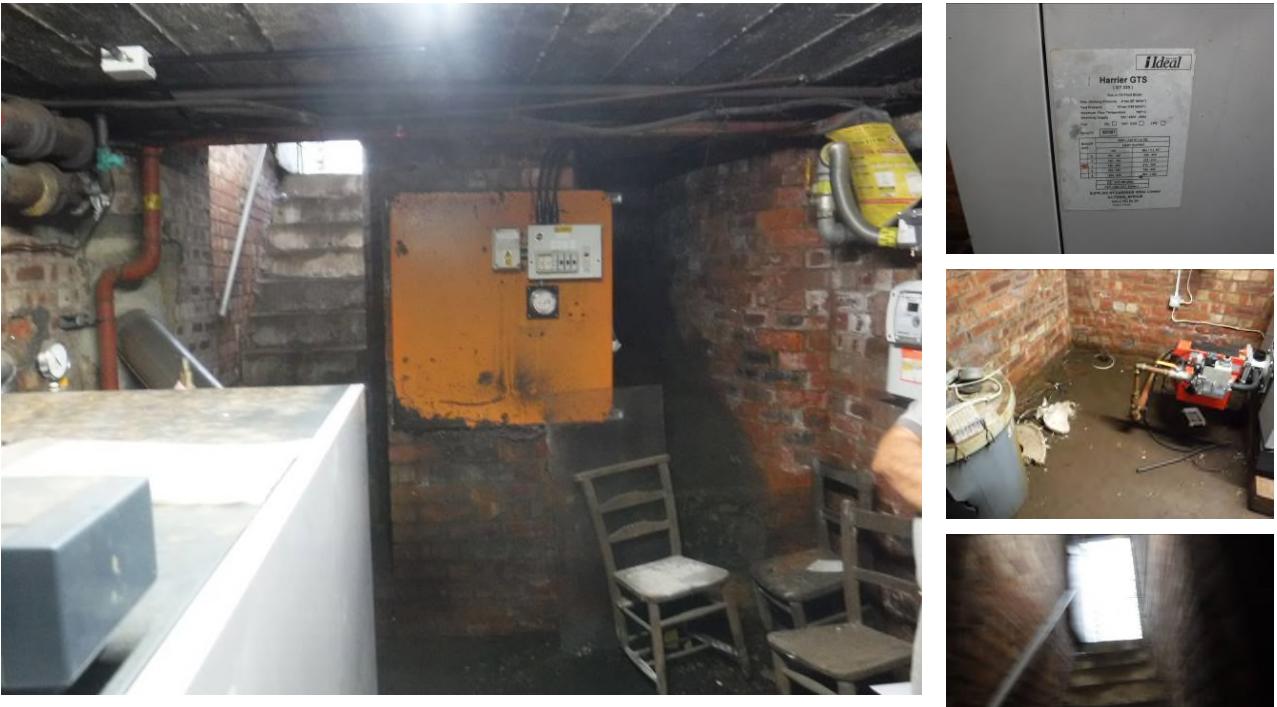
- **Ceiling** – Concrete shuttered ceiling looks ok.
- **Walls** – The walls are stock brickwork and they are damp particularly at low level on the N side, some spalling to it but they are serviceable enough.
