QUINQUENNIAL INSPECTION REPORT

St. MARY THE VIRGIN

FRONT STREET, SHERBURN VILLAGE, DURHAM, DH6 1QU

Michael Atkinson Architecture + Heritage

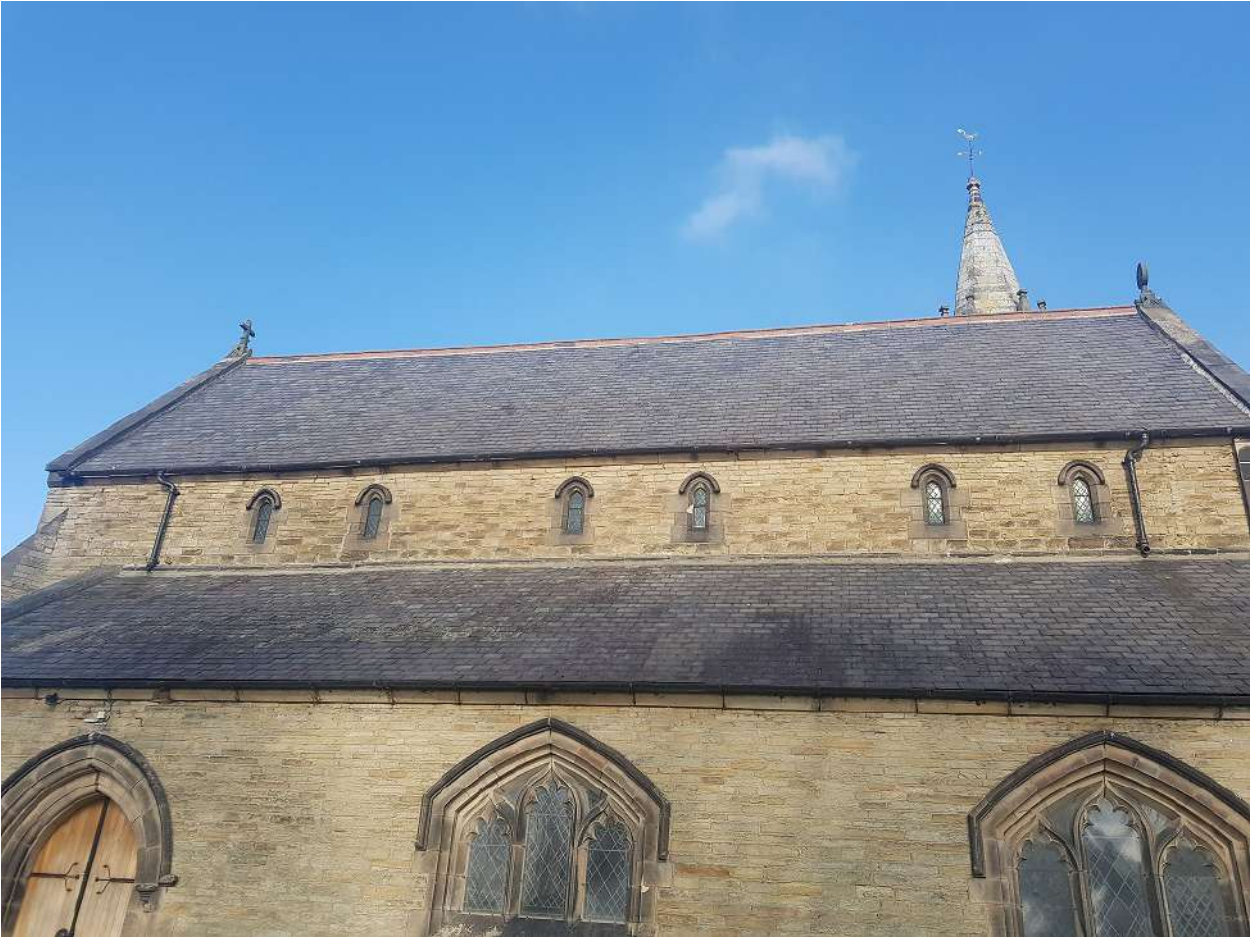
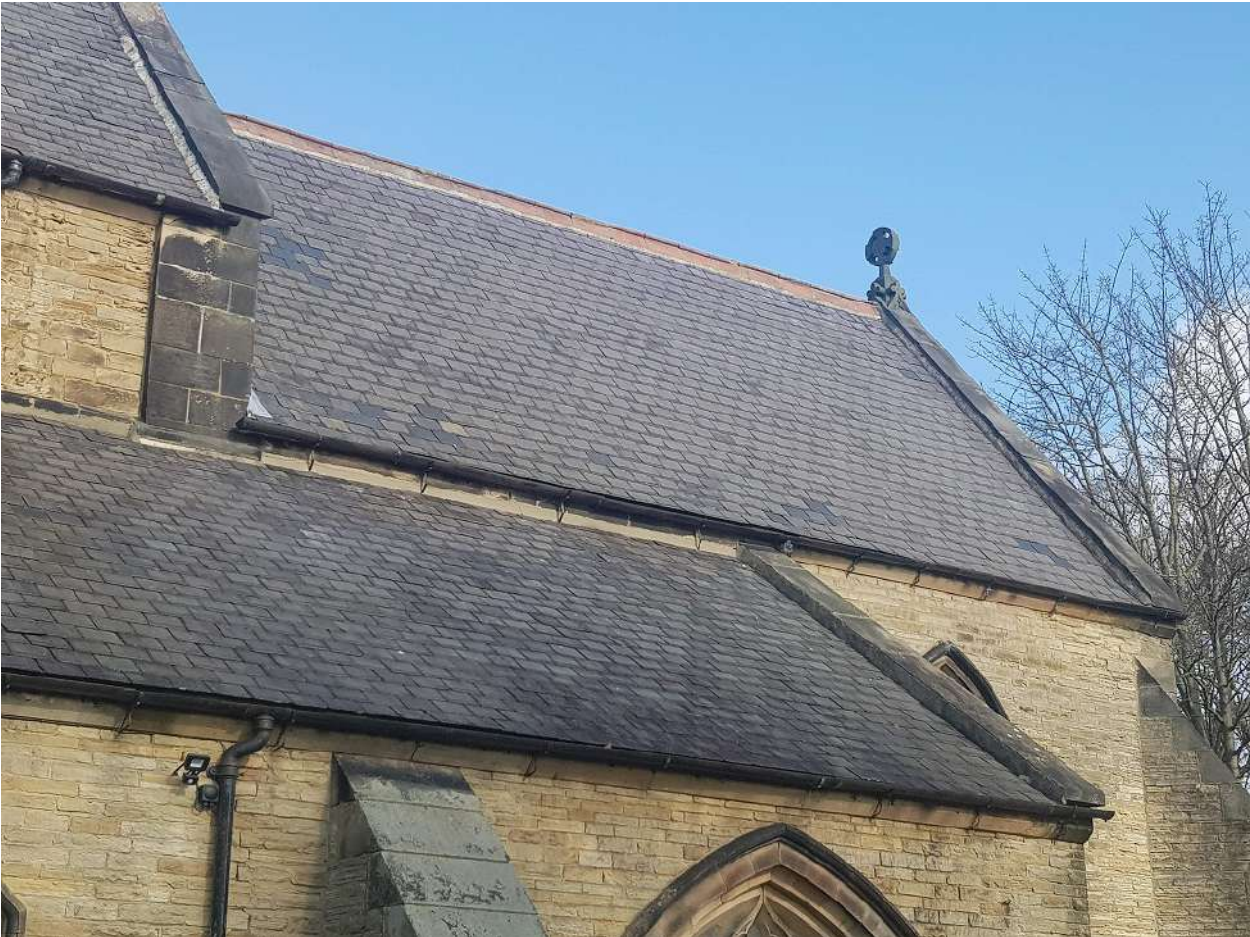
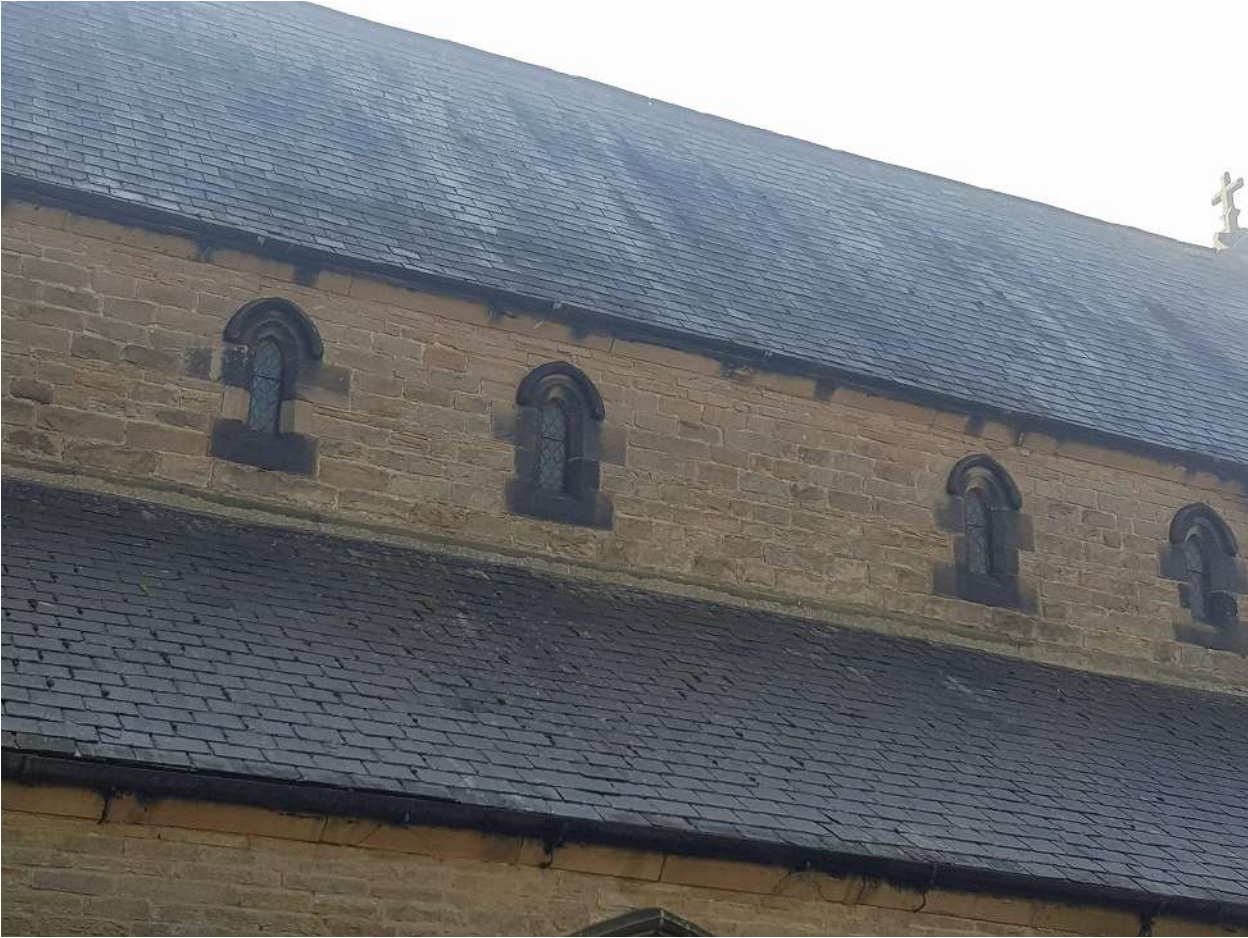
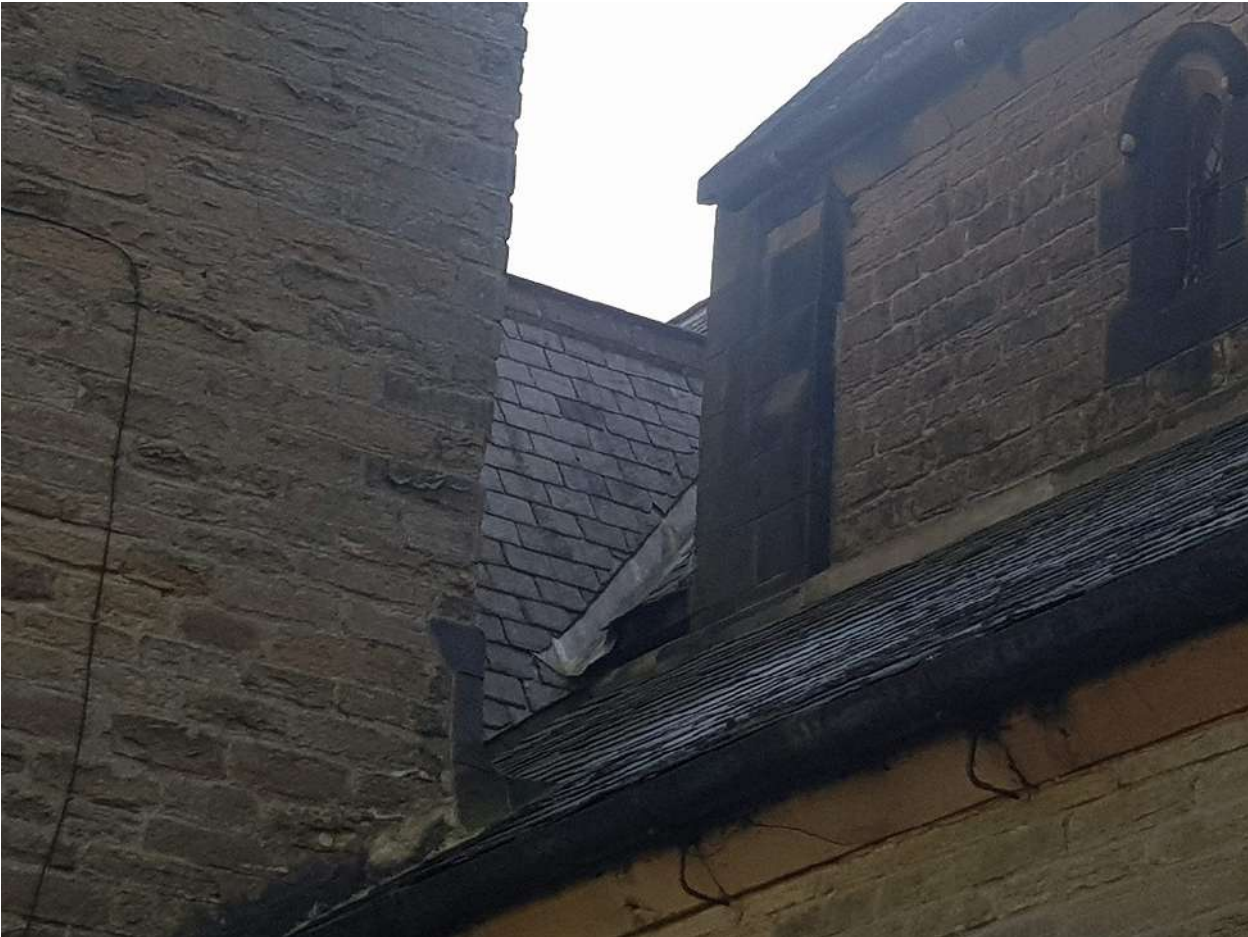
The Welsh slate roof covering appears in a fair condition as does the ridge. The abutment mortar flashing to the north gable appears sound albeit a little loose at the lower section. Lead valley with the chancel and the lead cover flashing to the south all look to be satisfactory.

Similar condition reported to this roof covering as per the Vestry – North Elevation East Slope. Slating adjacent to the lead valley is cracked and chipped in places.

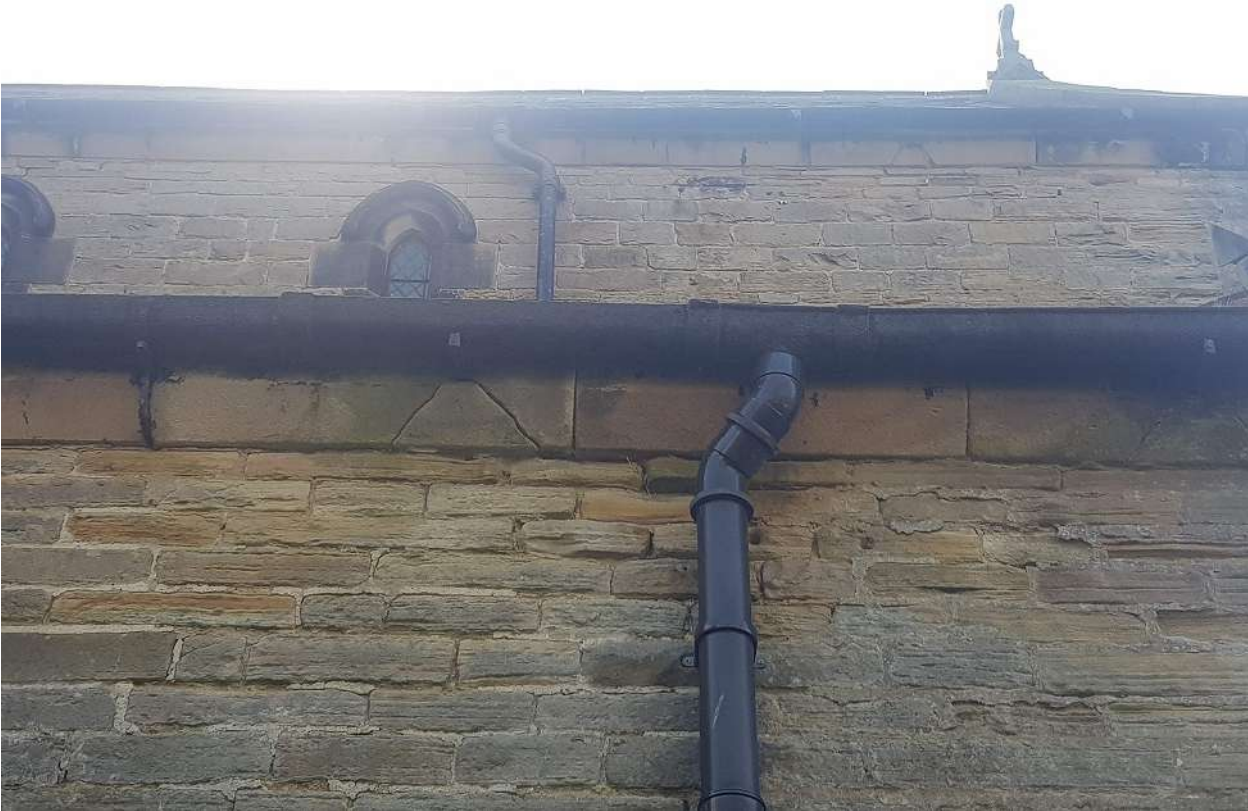
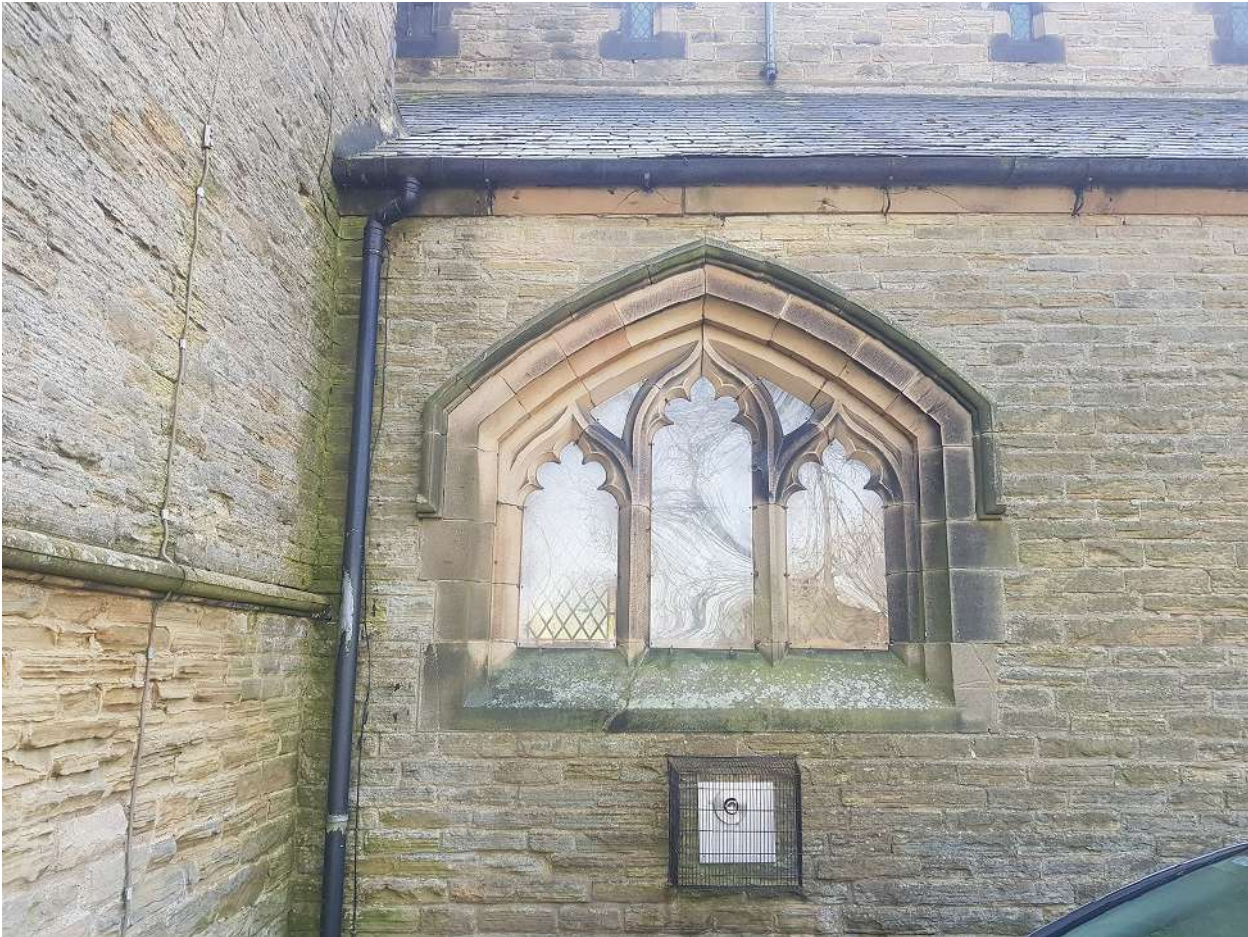
The comments made at the time of this inspection reflect those observations made in 2015. The rainwater goods are in a deteriorating condition and should recovering of the roof coverings be carried out then renewal of the rainwater goods would also be necessary.

R3 It is recommended that the rainwater goods are replaced in their entirety.

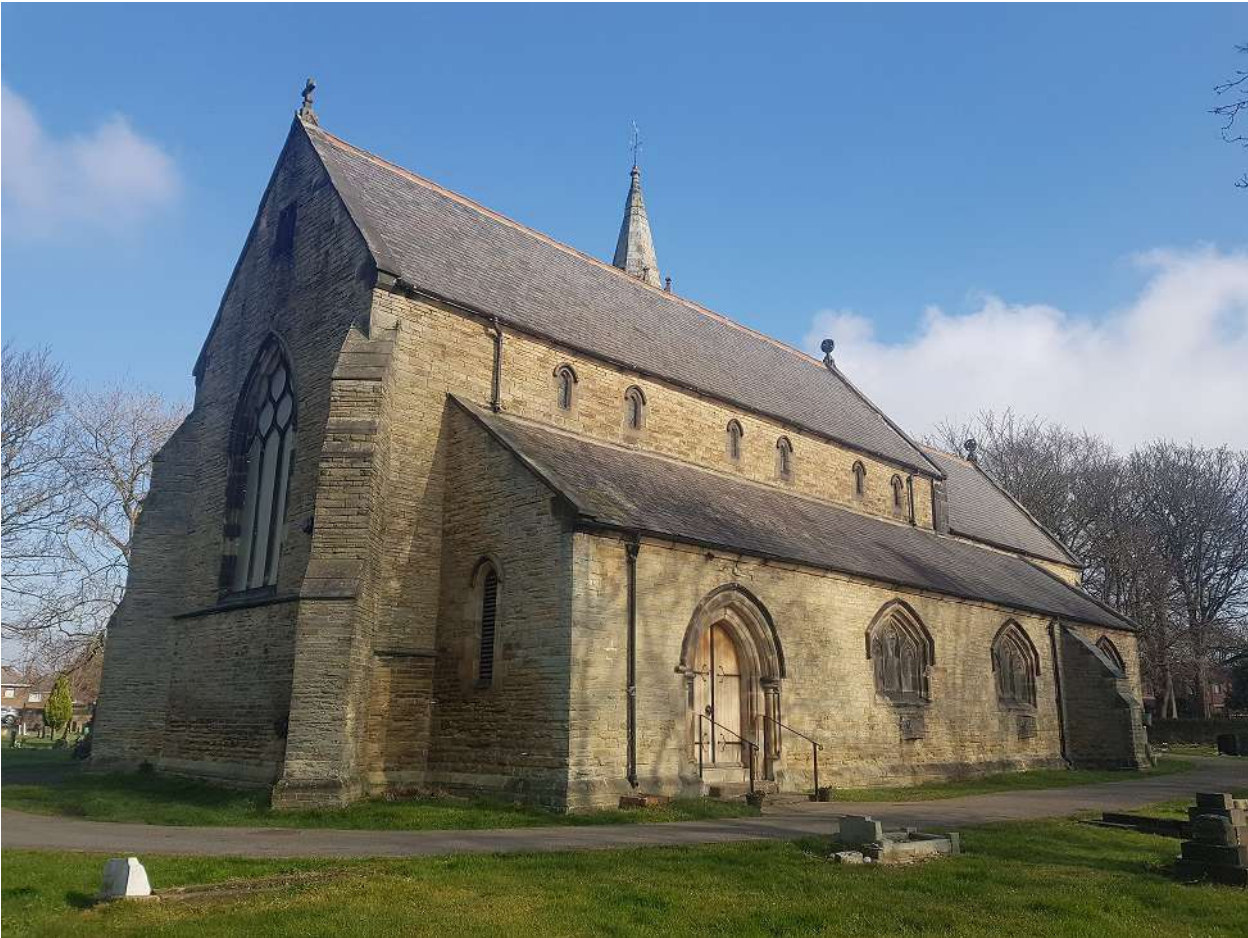
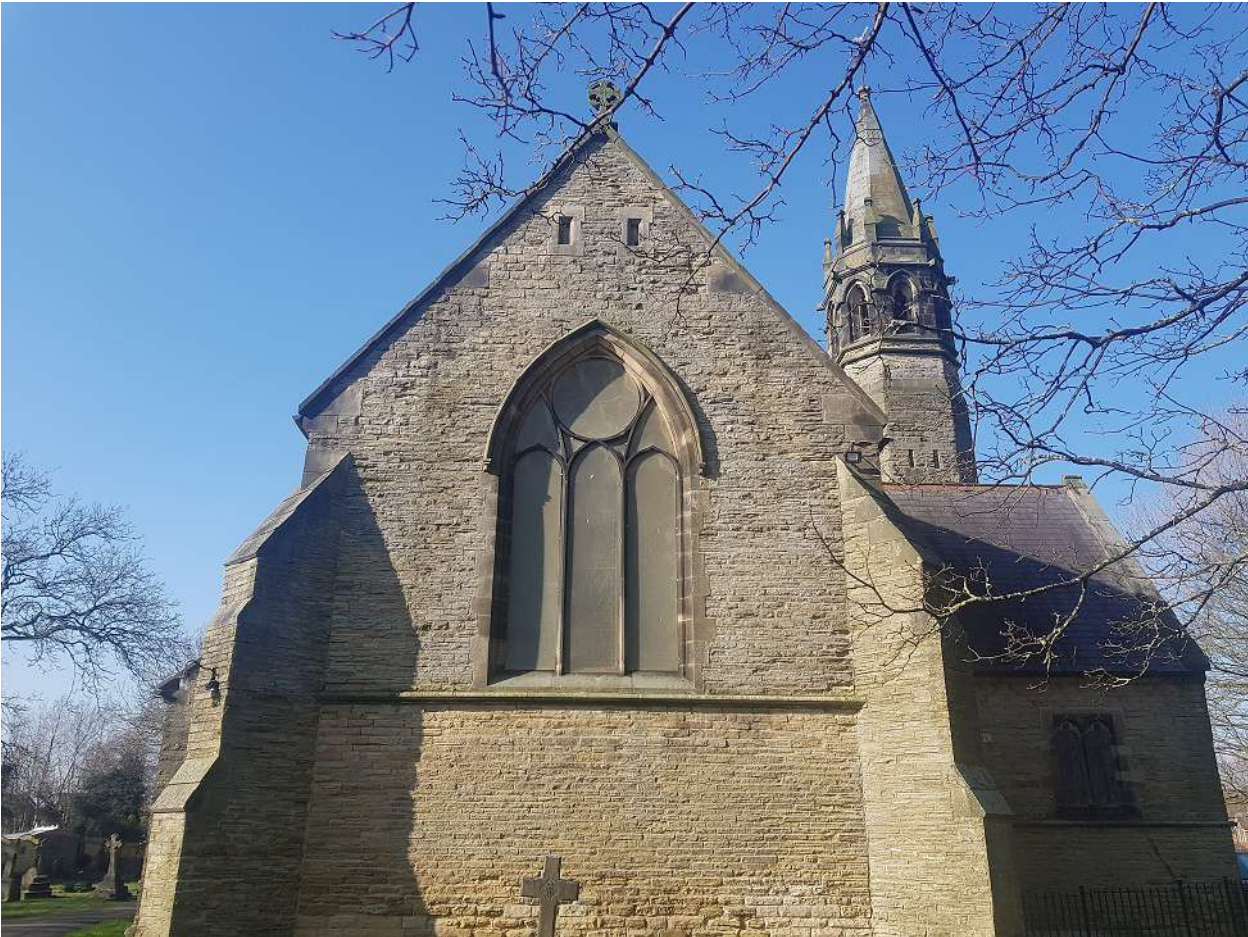
There are vertical joints open between gutter copings and require re-pointing. Minor open joint to the right hand side of the lancet window. The string course below the lancet window has open joints which will require re-pointing. Below the lancet window there is erosion to the face of the stonework, repointing required to the panel.

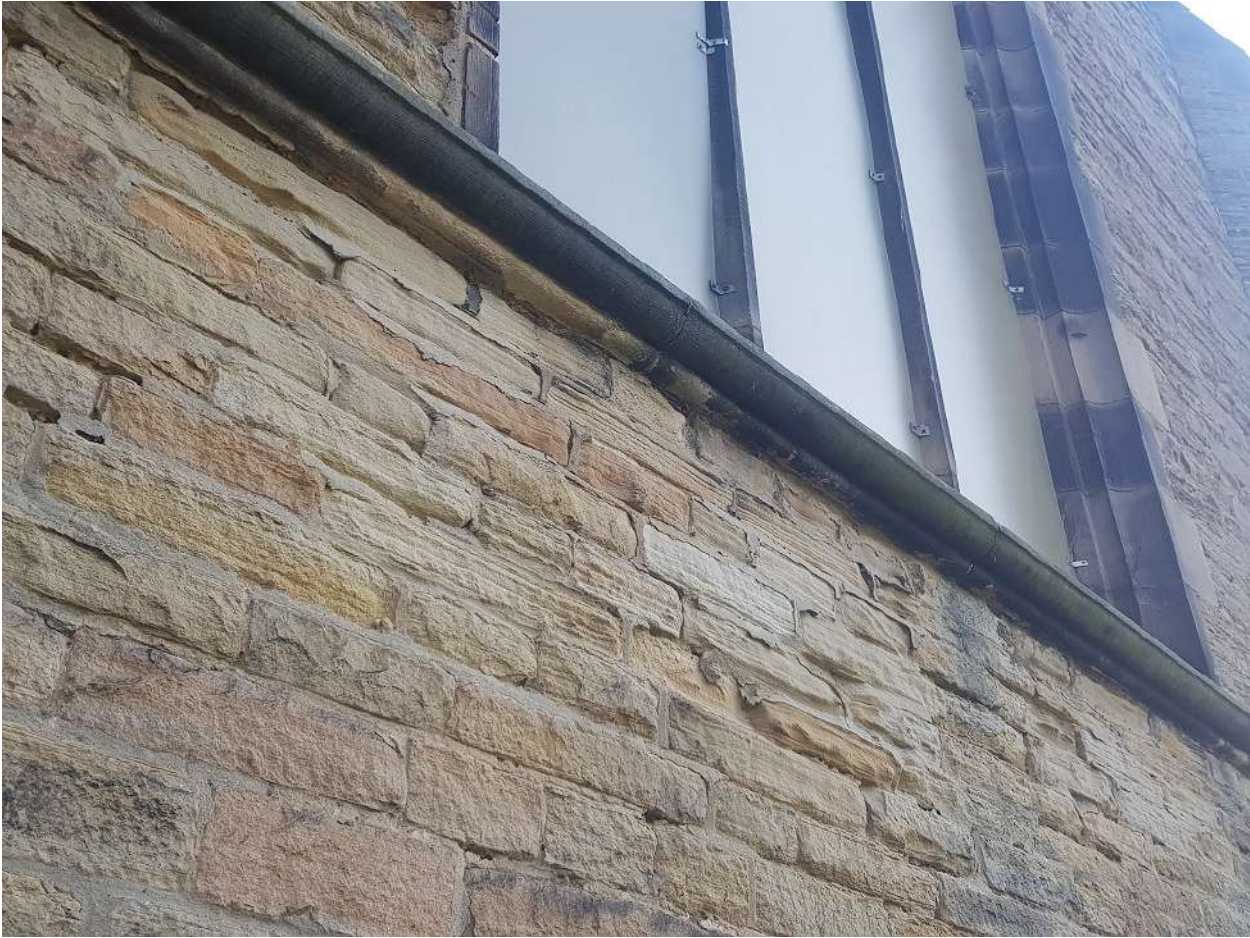
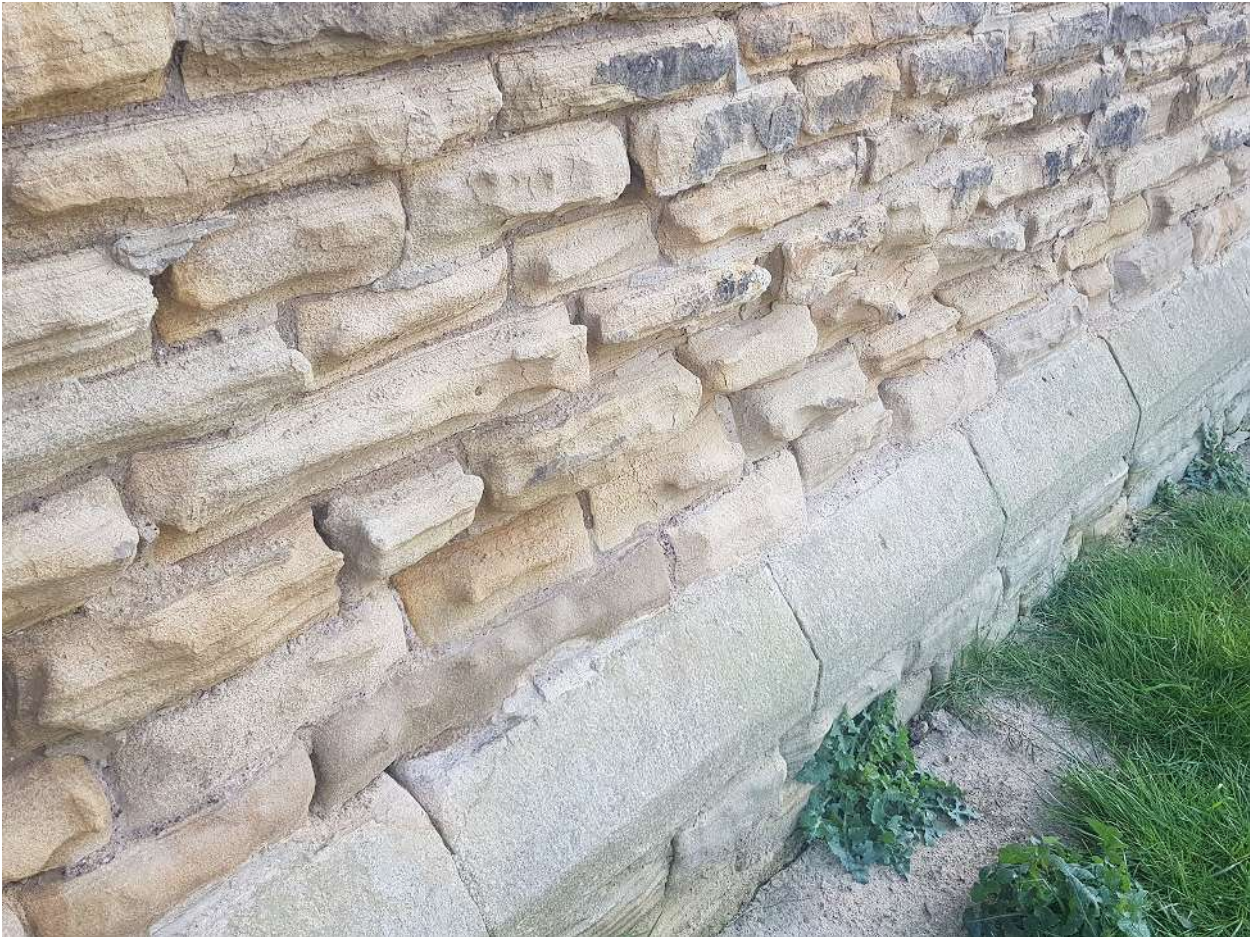
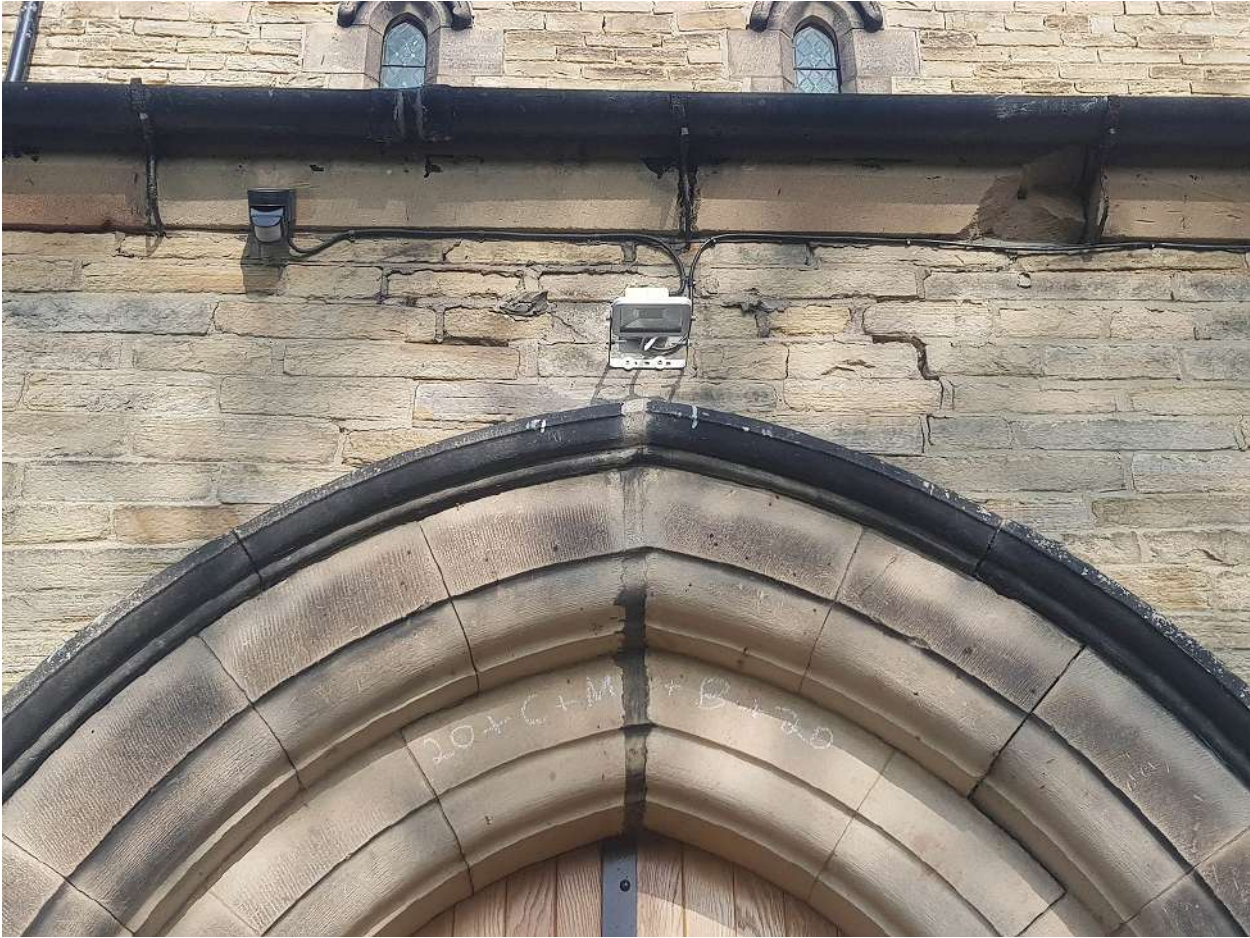
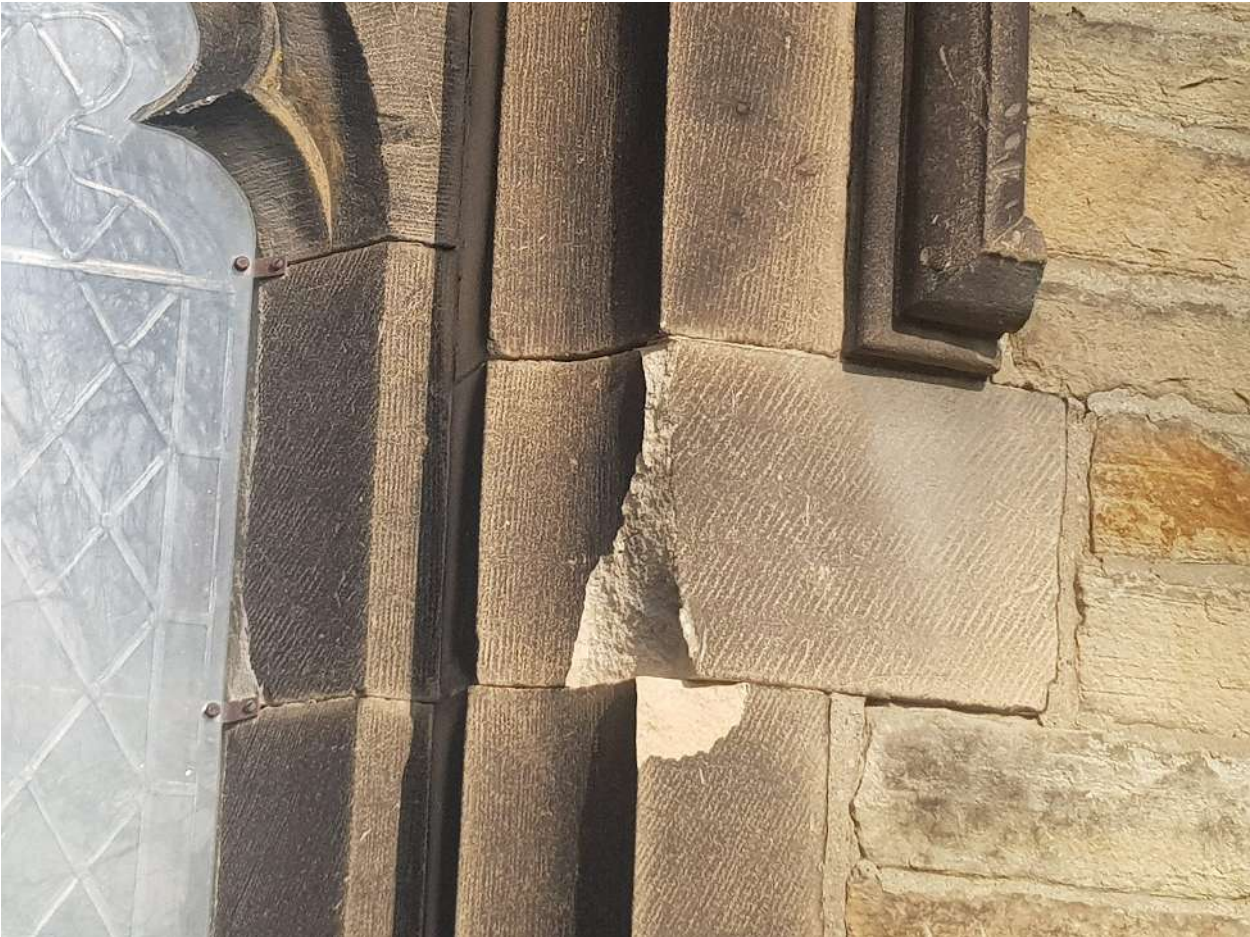
Eastern kneeler has moved in the past somewhat which has caused the water table coping stones to slip. A spalled stone exists immediately below the western kneeler due to the impact of rusting 'drive-in' gutter brackets which will require indenting with new stone.

There are open joints in the hood mould to the lancet window and string course below, all of which requires repointing. Below the lancet window there is erosion noted to the stonework and deteriorating pointing together with signs of excessive dampness which may well be linked to the split lead back box gutter to the tower located above. Open joints noted to the plinth stones which will require repointing.

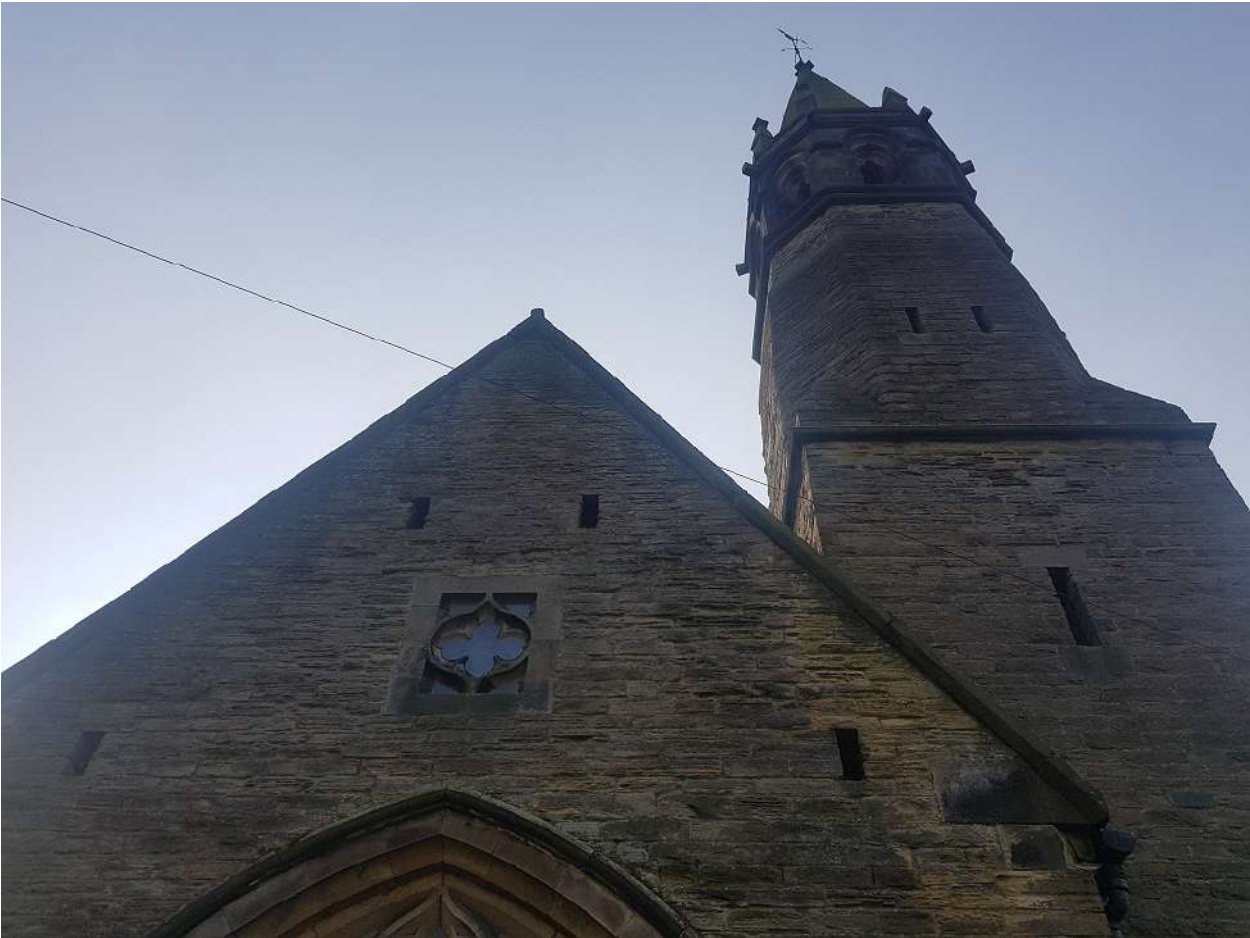
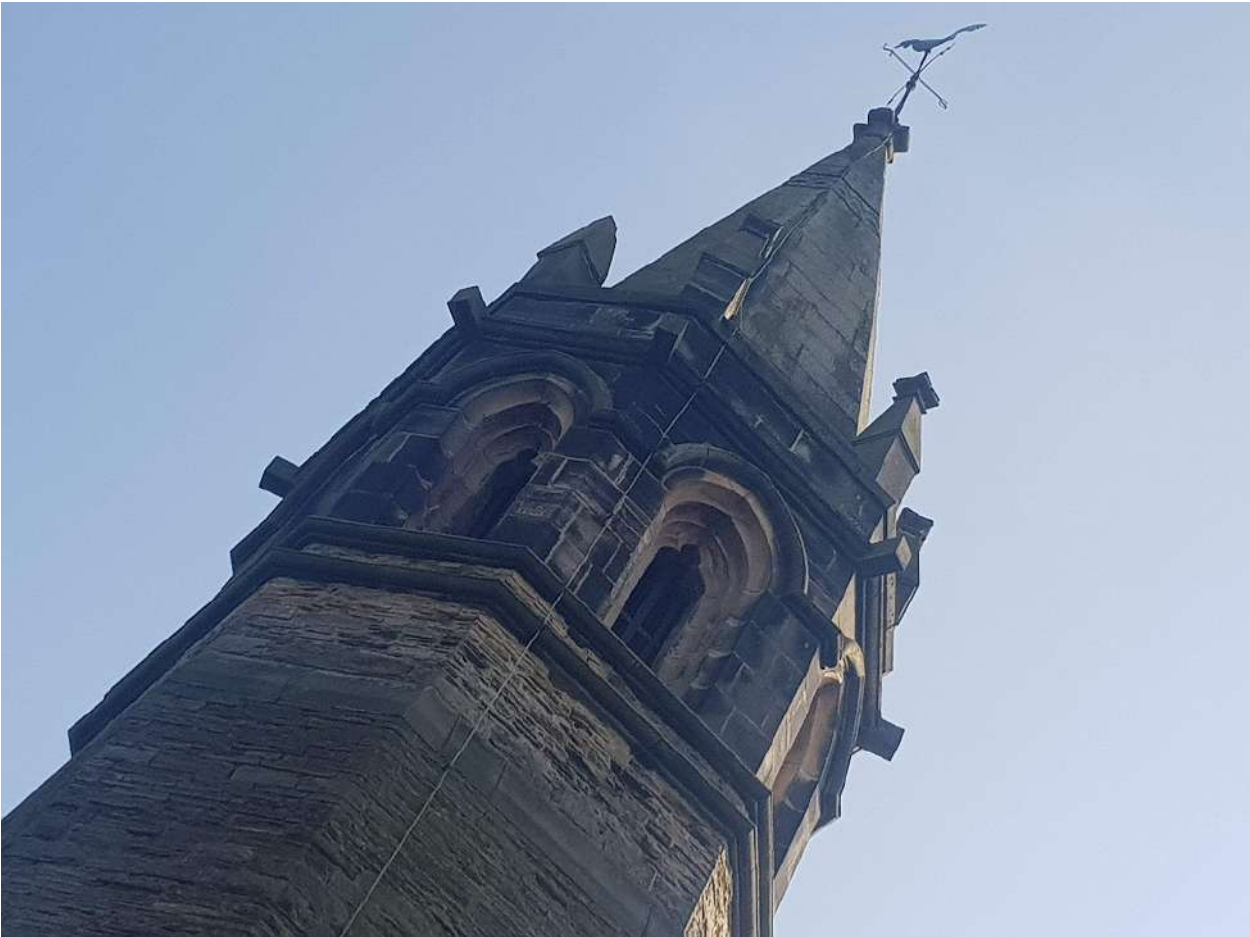
- 7.2.1 There are multiple areas of open joints to walling and ashlar stonework surrounds. Eroded stonework is also widespread which by past use of cementitious mortar has accelerated decay, compounded further through the natural effect of weathering. This has left the fabric susceptible from damp penetration, although not yet widely reflected internally through plaster and paint condition. Repointing in a lime:sand mortar is the solution combined with limited replacement/indenting of new stone where erosion has occurred to such a degree that warrants intervention. A detailed inspection and development of a repair methodology and strategy is the first step in arresting any further decay.

R1 It is highly recommended that an appropriate strategy for stone repair and/or replacement is developed.

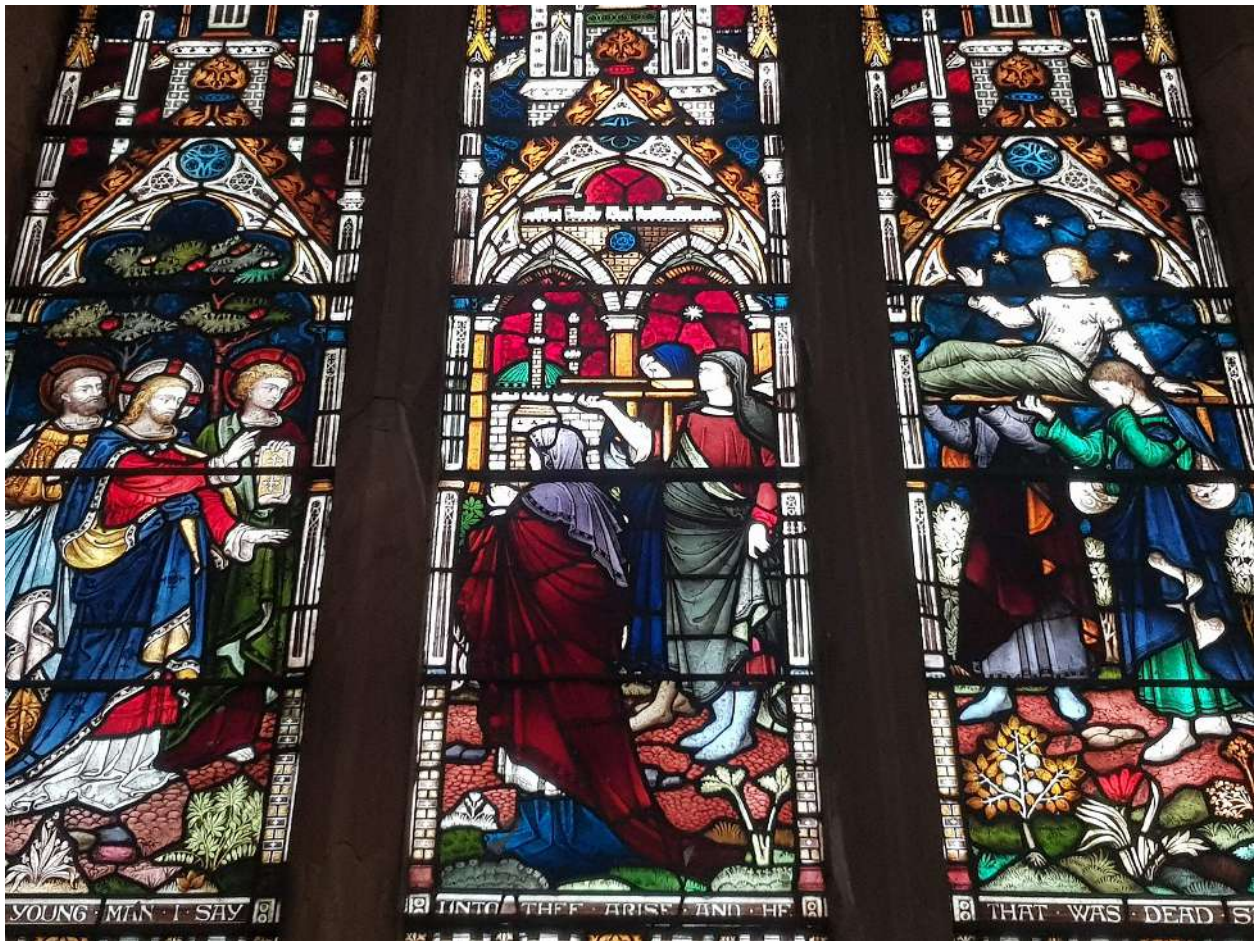
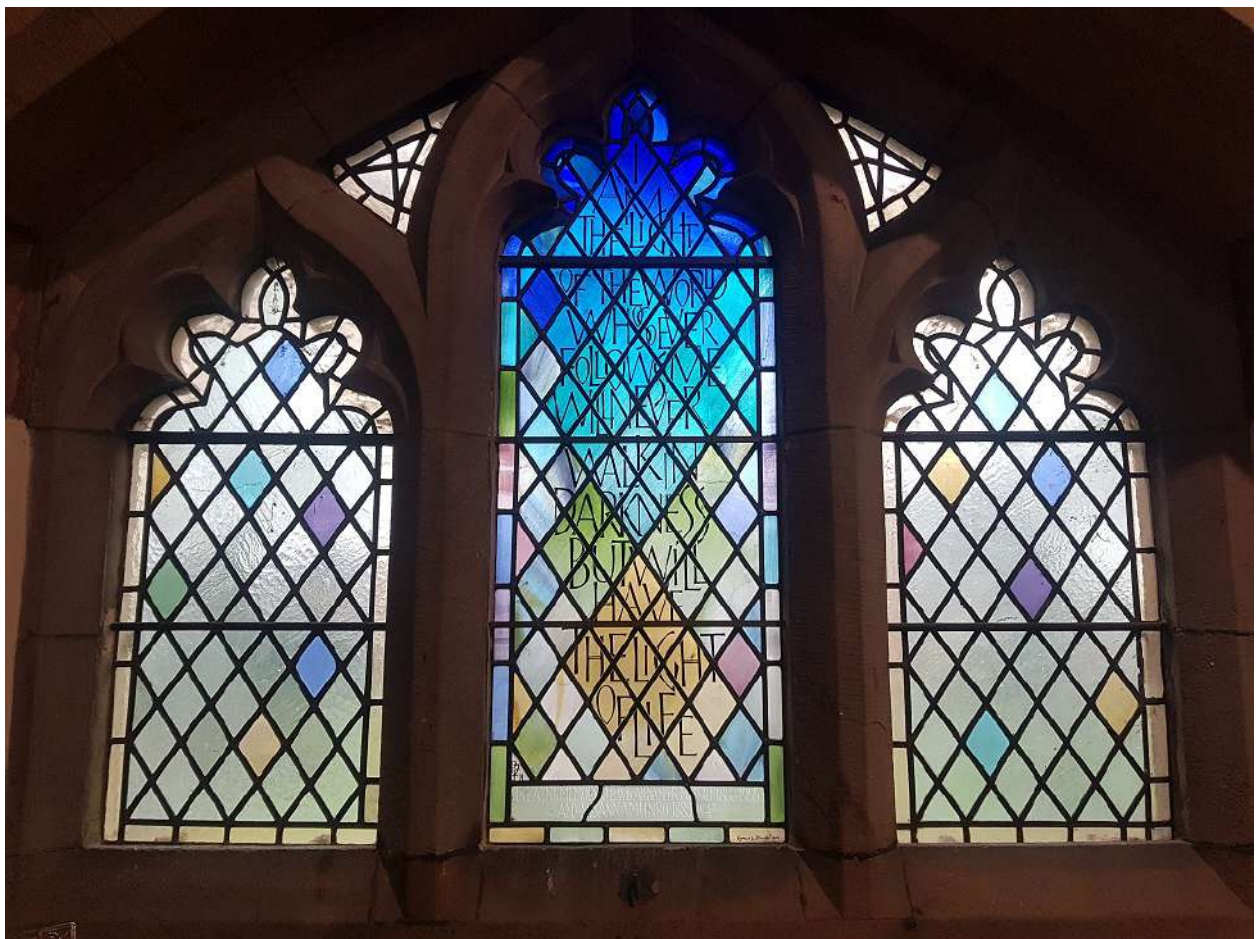
West window of illustrative stained glass (centre lancet) and diamond pattern plain leaded lights at either side. Somewhat obscured with the introduction of reordering at the west end. Two short lancet windows above of diamond pattern plain leaded lights, one with iron hopper inoperable.
