QUINQUENNIAL INSPECTION REPORT

St. MARY THE VIRGIN

FRONT STREET, SHERBURN VILLAGE, DURHAM, DH6 1QU

Michael Atkinson Architecture + Heritage

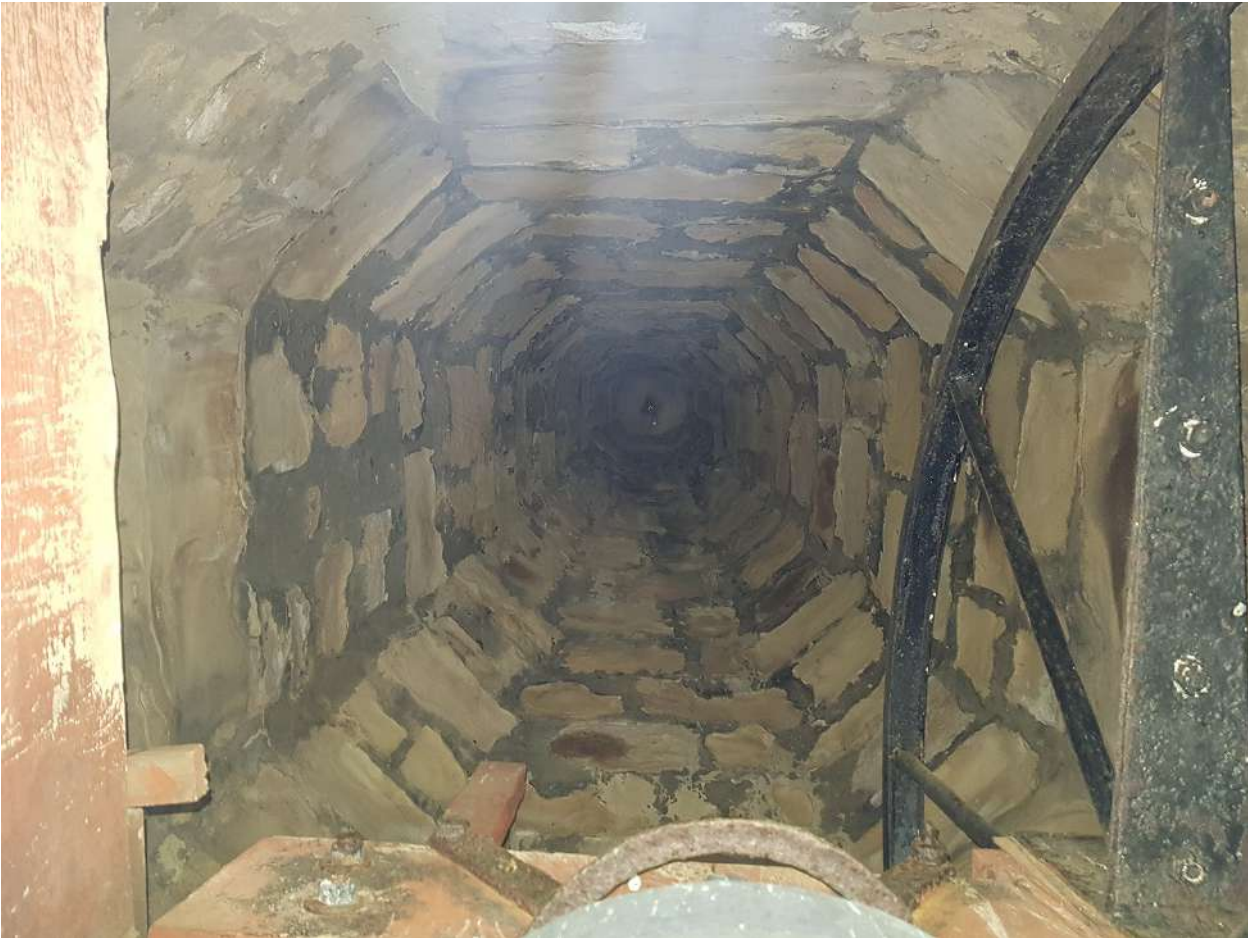
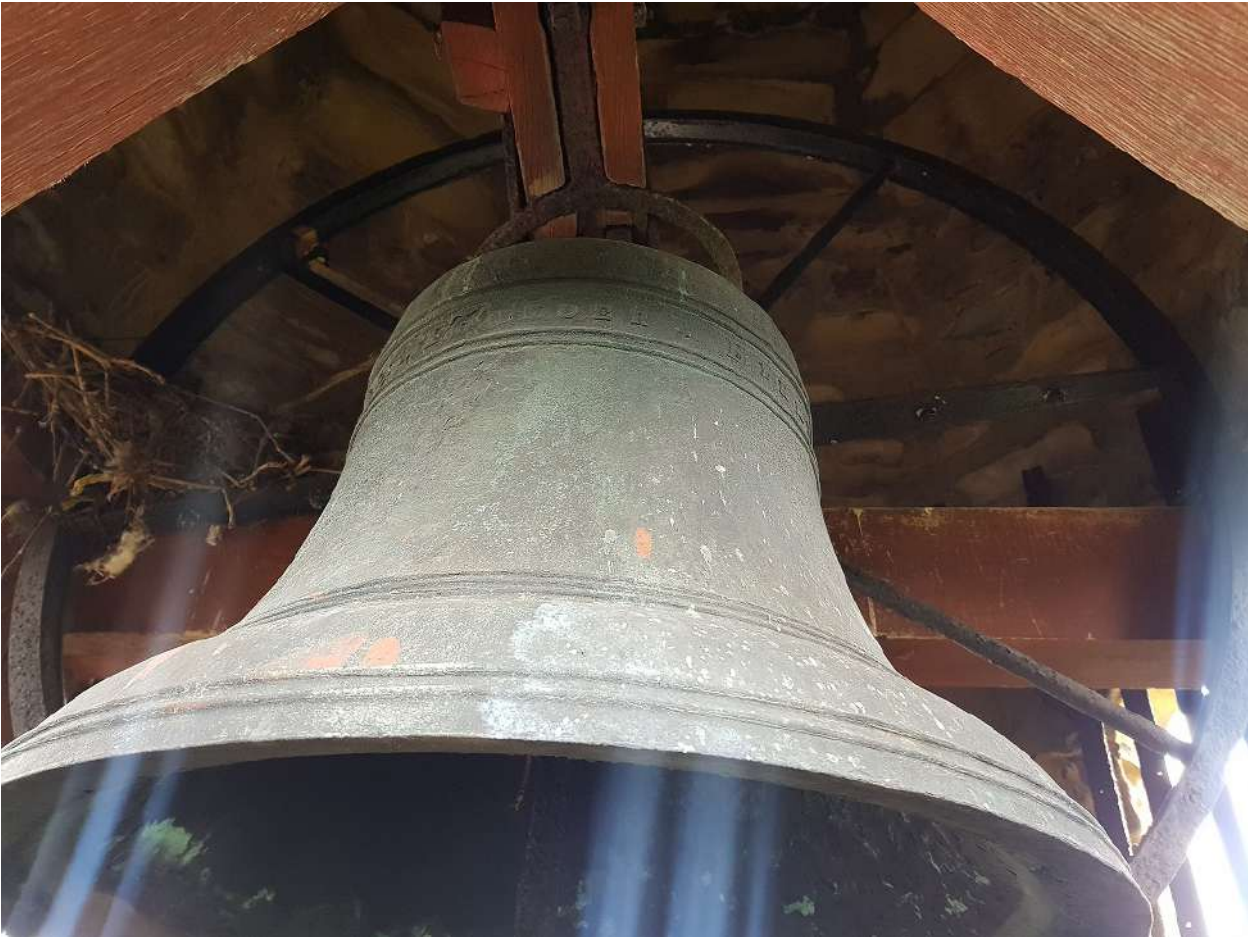
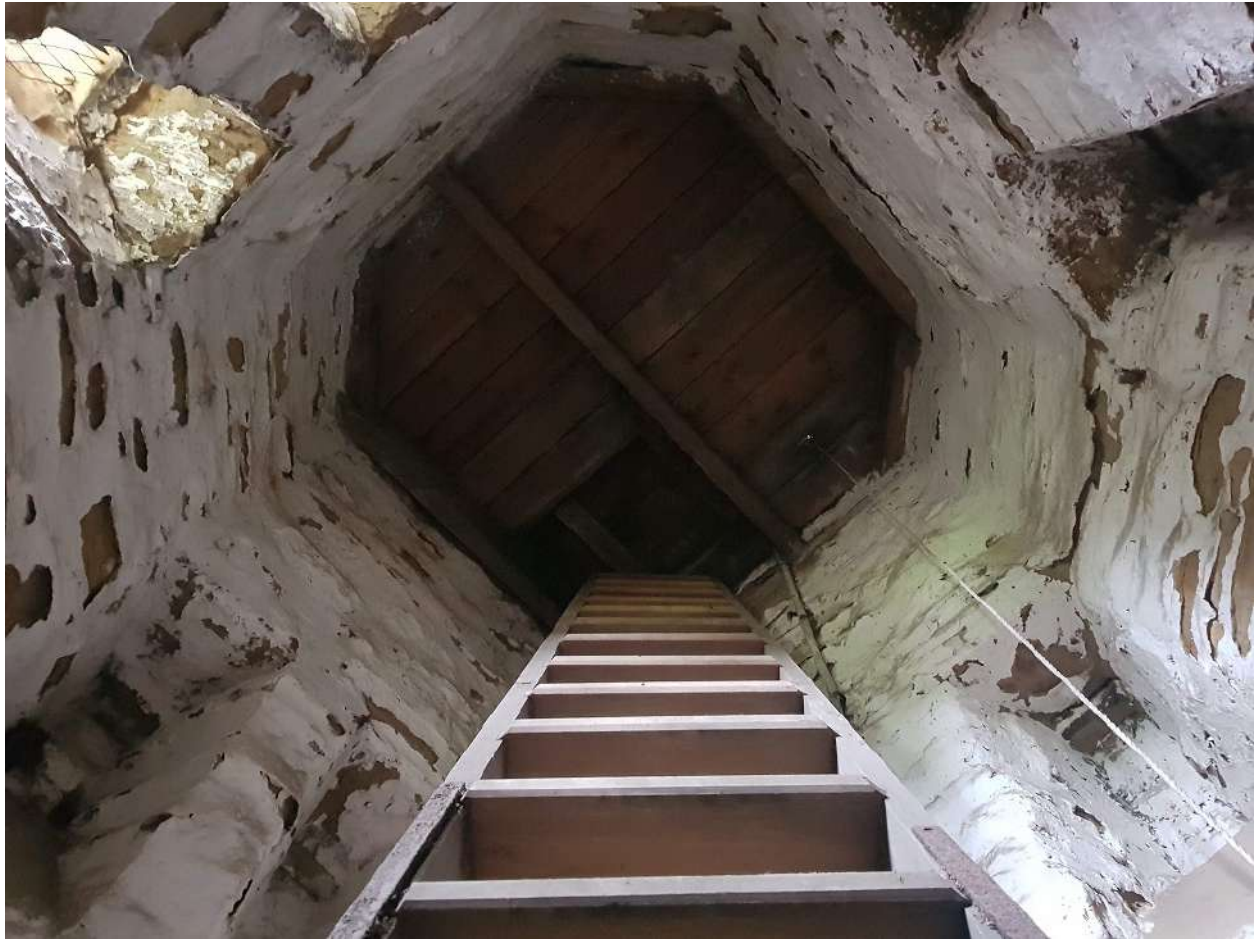
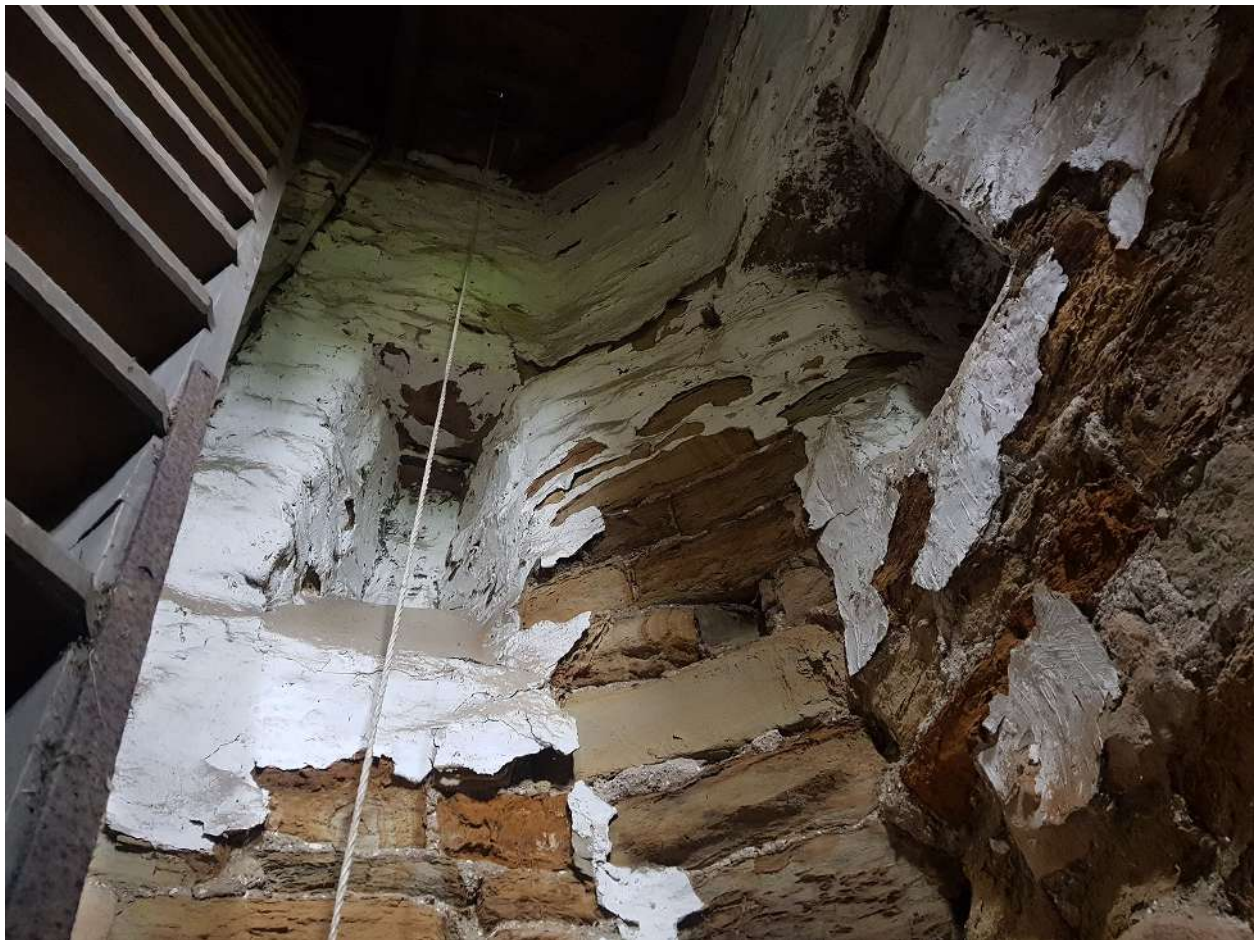
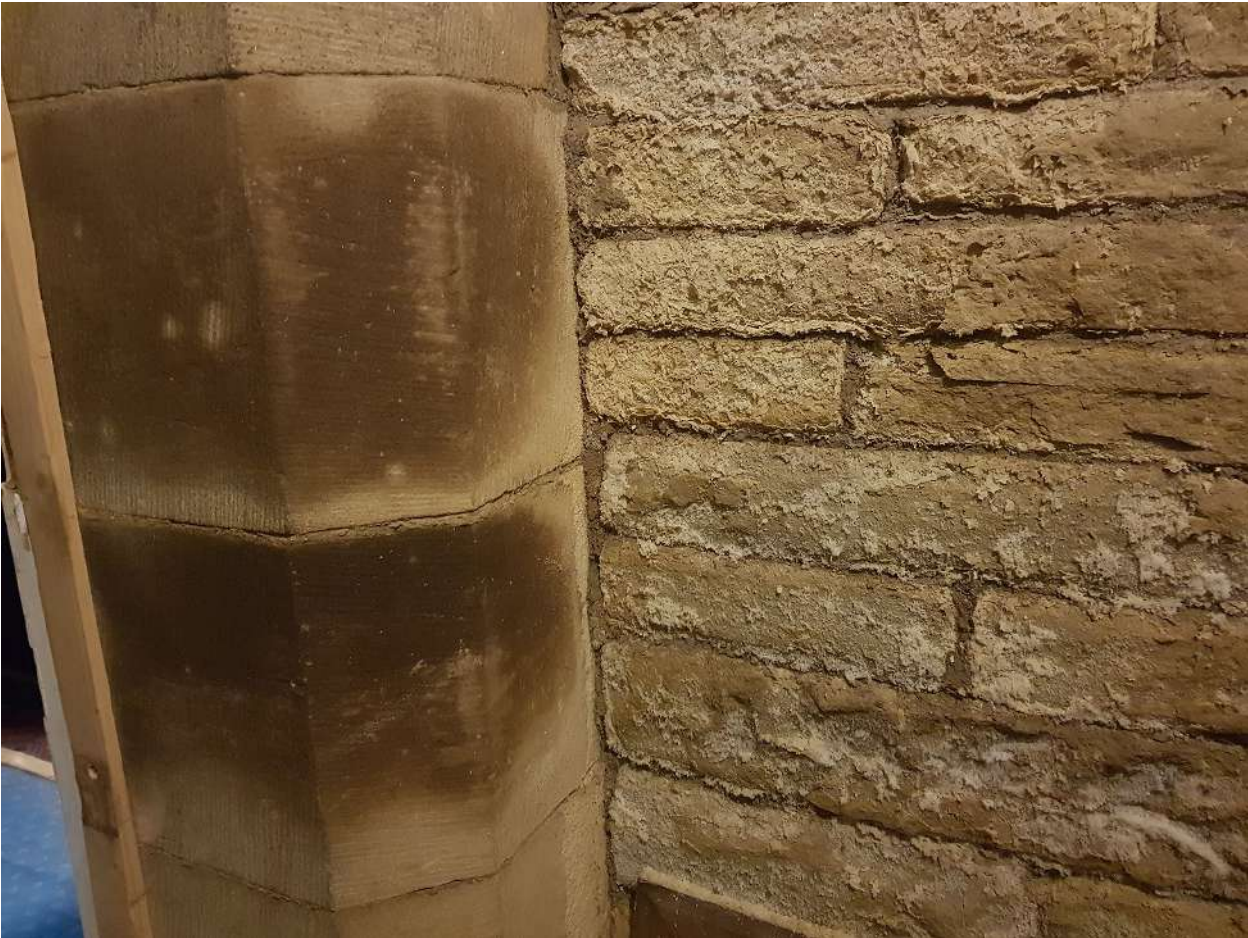
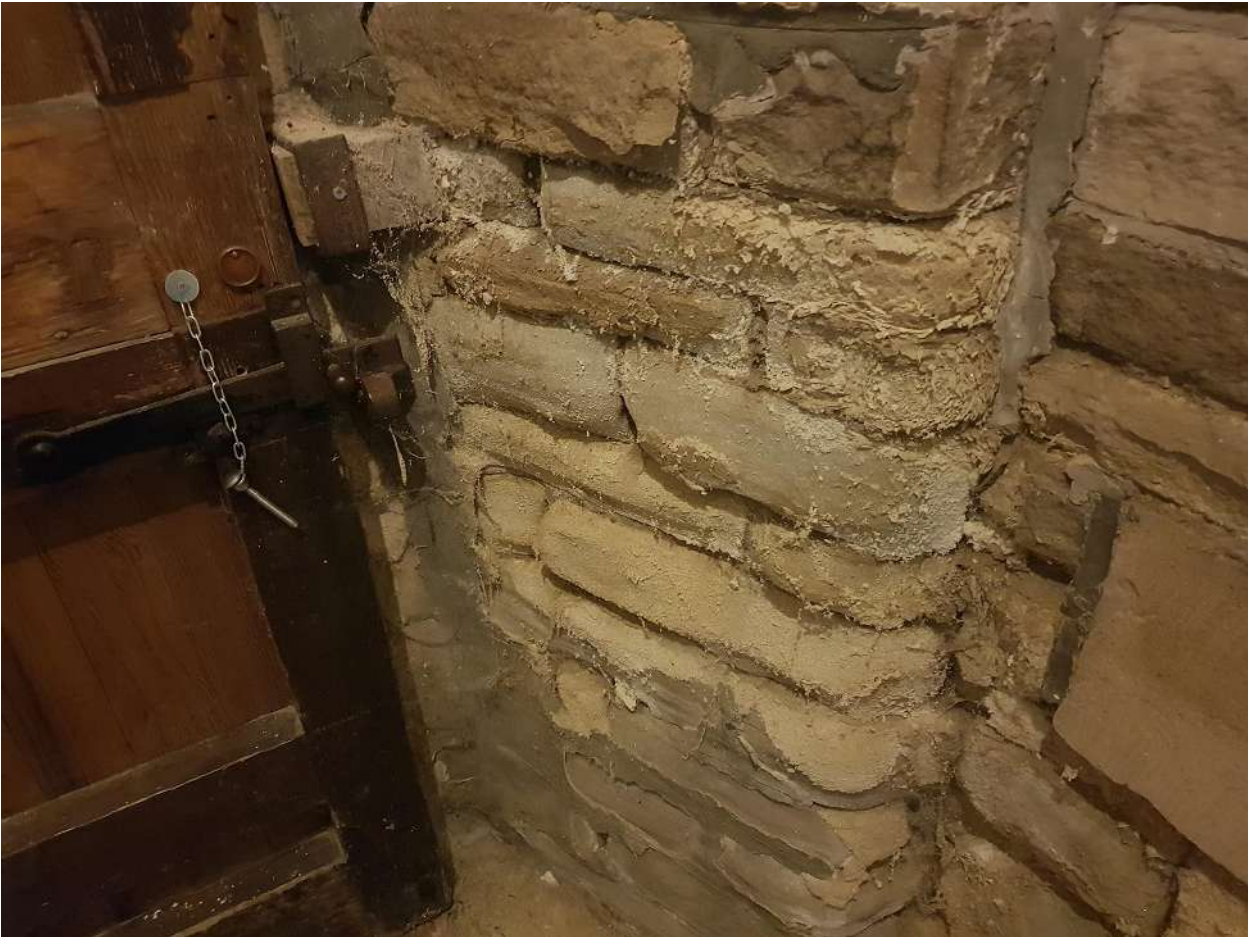
Rendered stonework with whitewashed finished. There are narrow slot window openings some of which are blocked up but two to the north side are open one of which has its mesh guarding missing. The openings are not secure to bird nesting as the floor is strewn with sticks, bird guano and leaf debris. Examination of lower stage floor not possible.

R1 It is recommended to repair existing window guarding and install new if required to prevent continuing bird nesting.

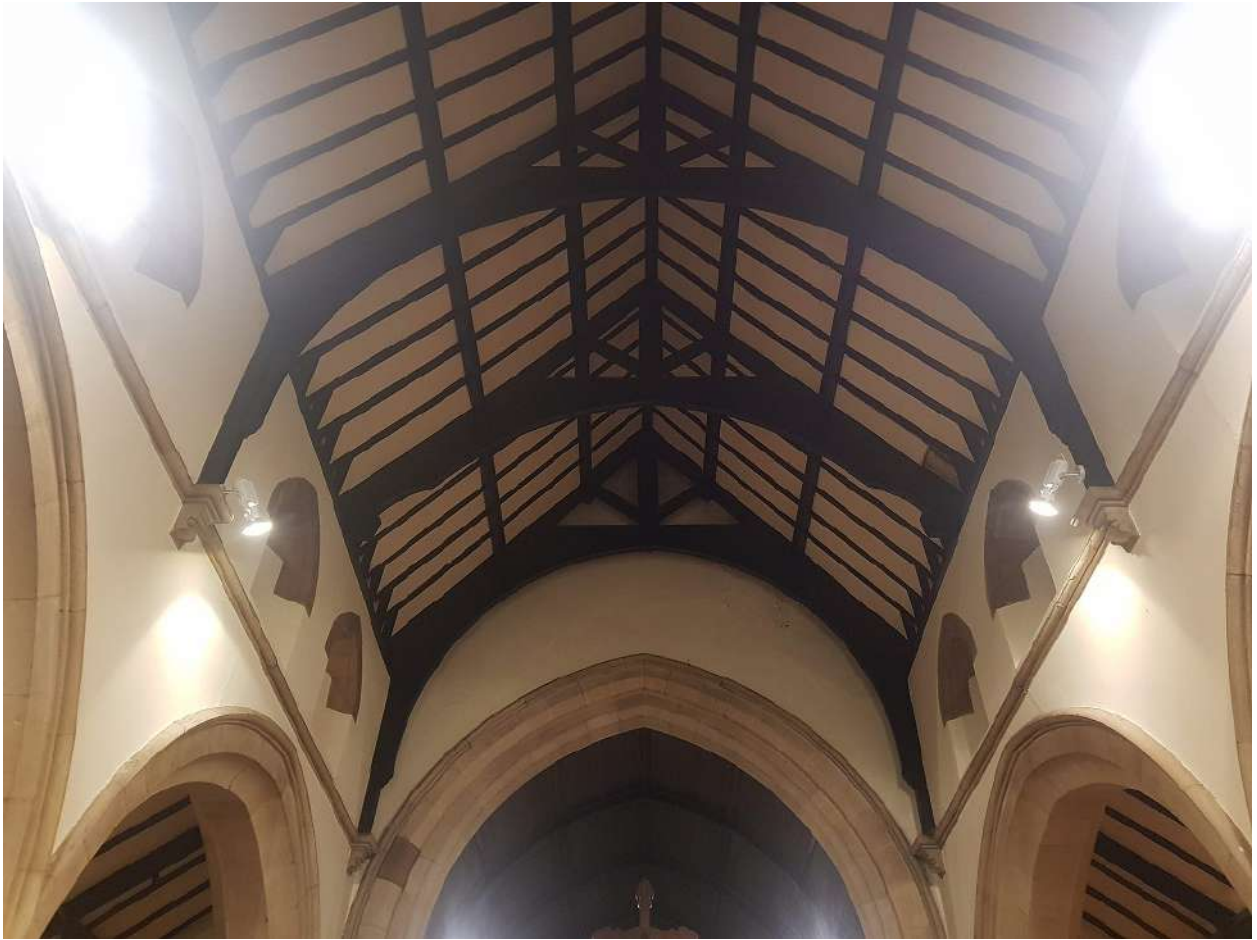
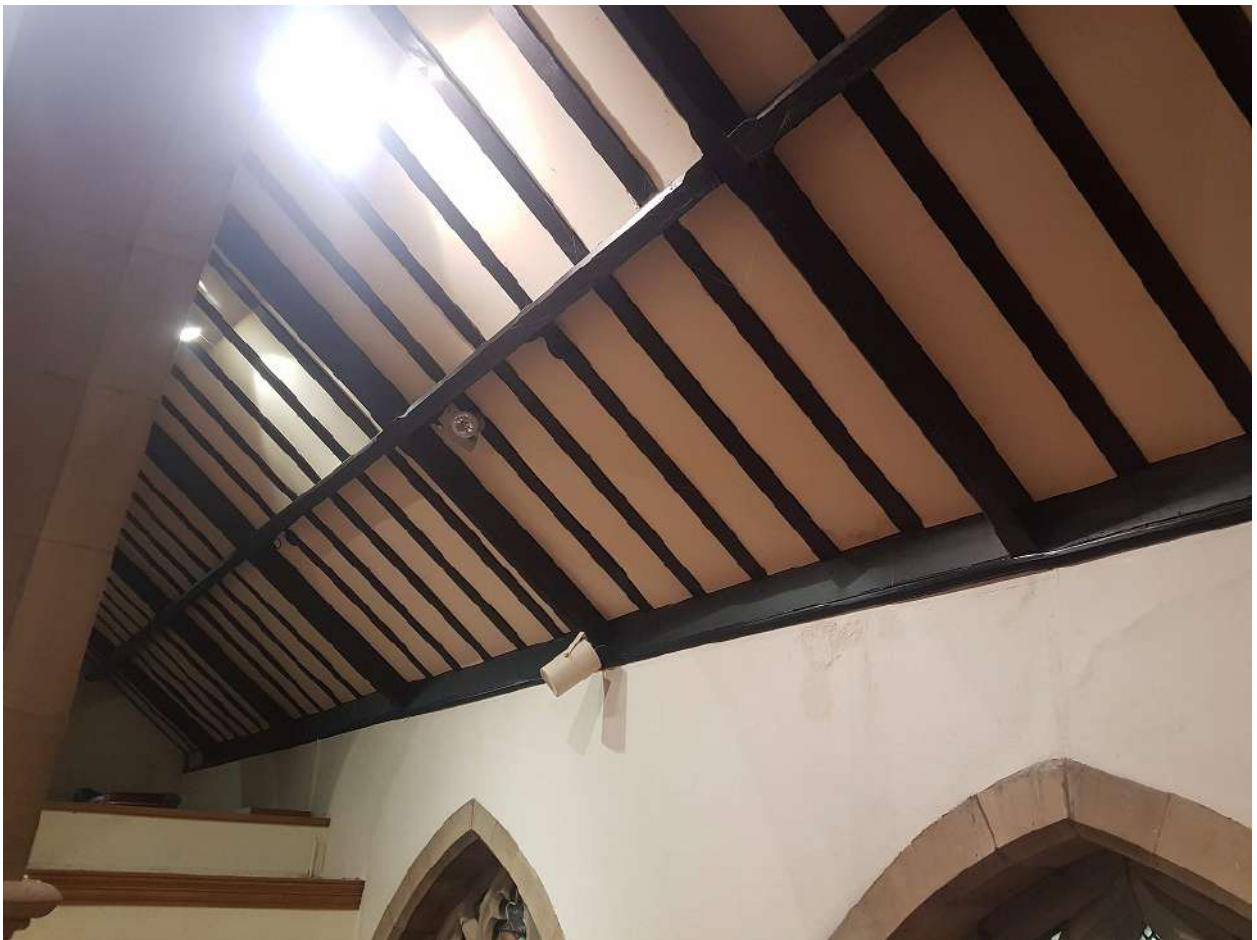
- 13.2.1 The roofing timbers appear to be in a sound condition as far as can be ascertained from floor level. As such there is no evident structural problems.

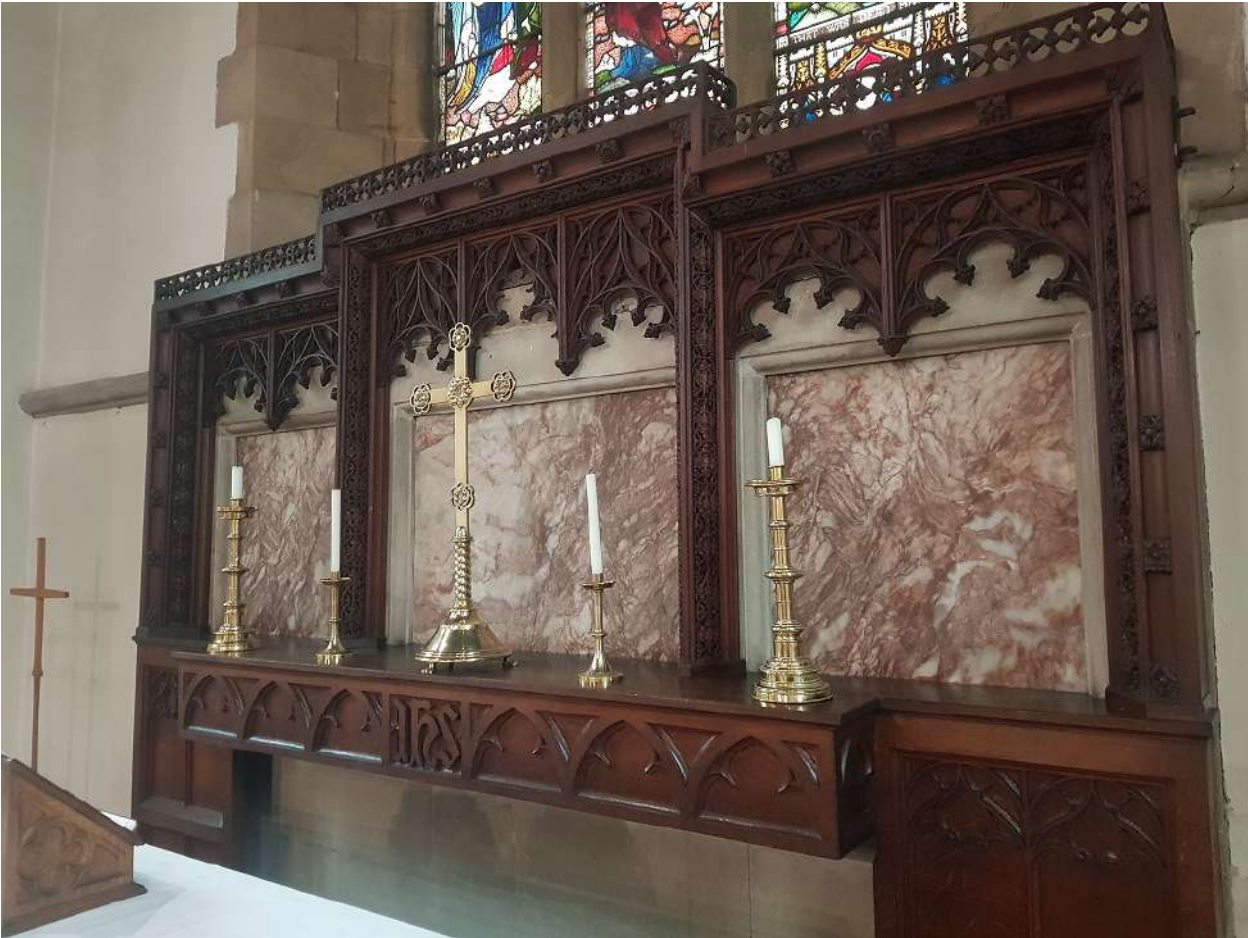
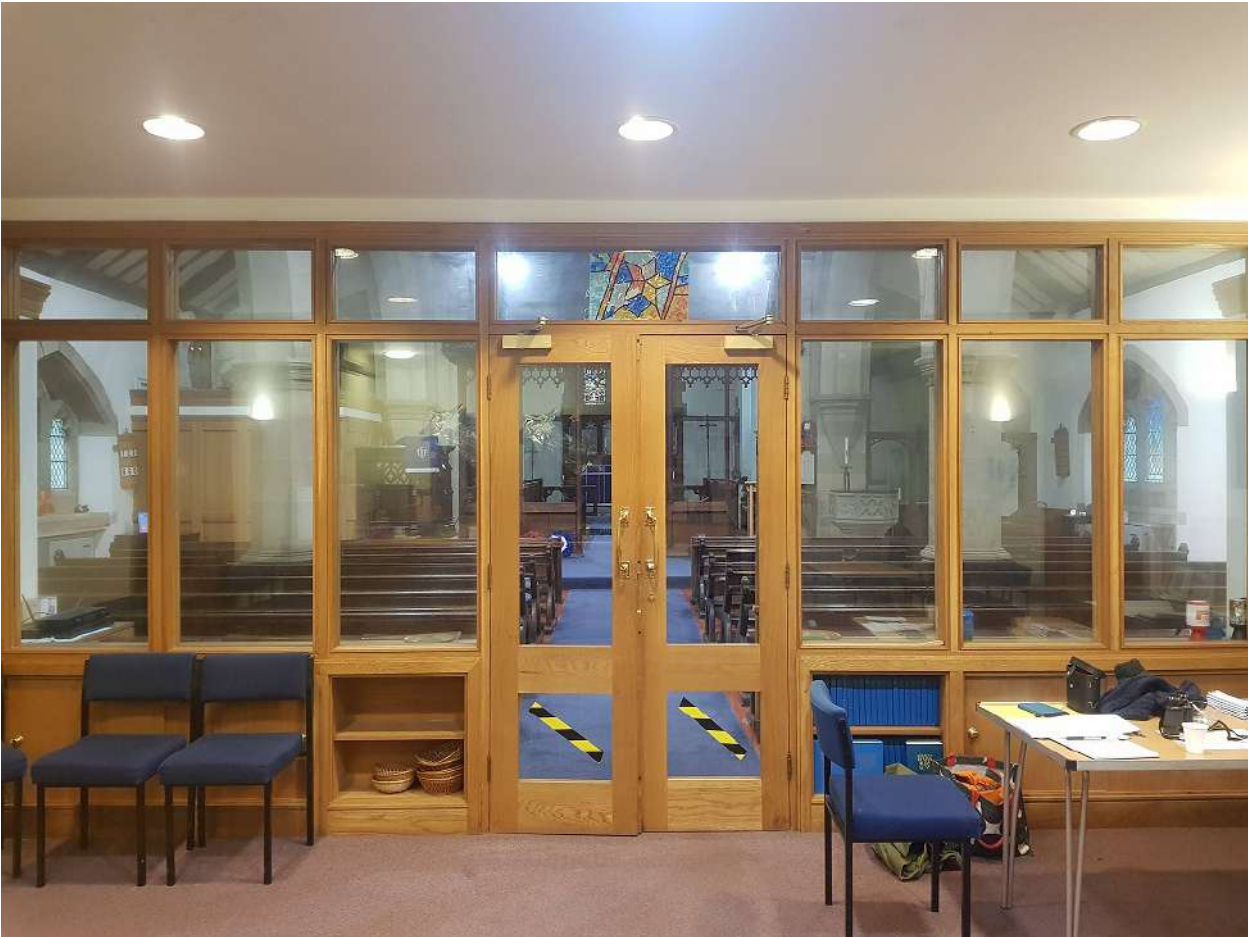
15.3.2 The timber glazed double doors to the narthex screen are binding and the overhead closer is slamming. As such some immediate attention is required to correct these issues.

RO Carry out refurbishment of narthex screen doors.

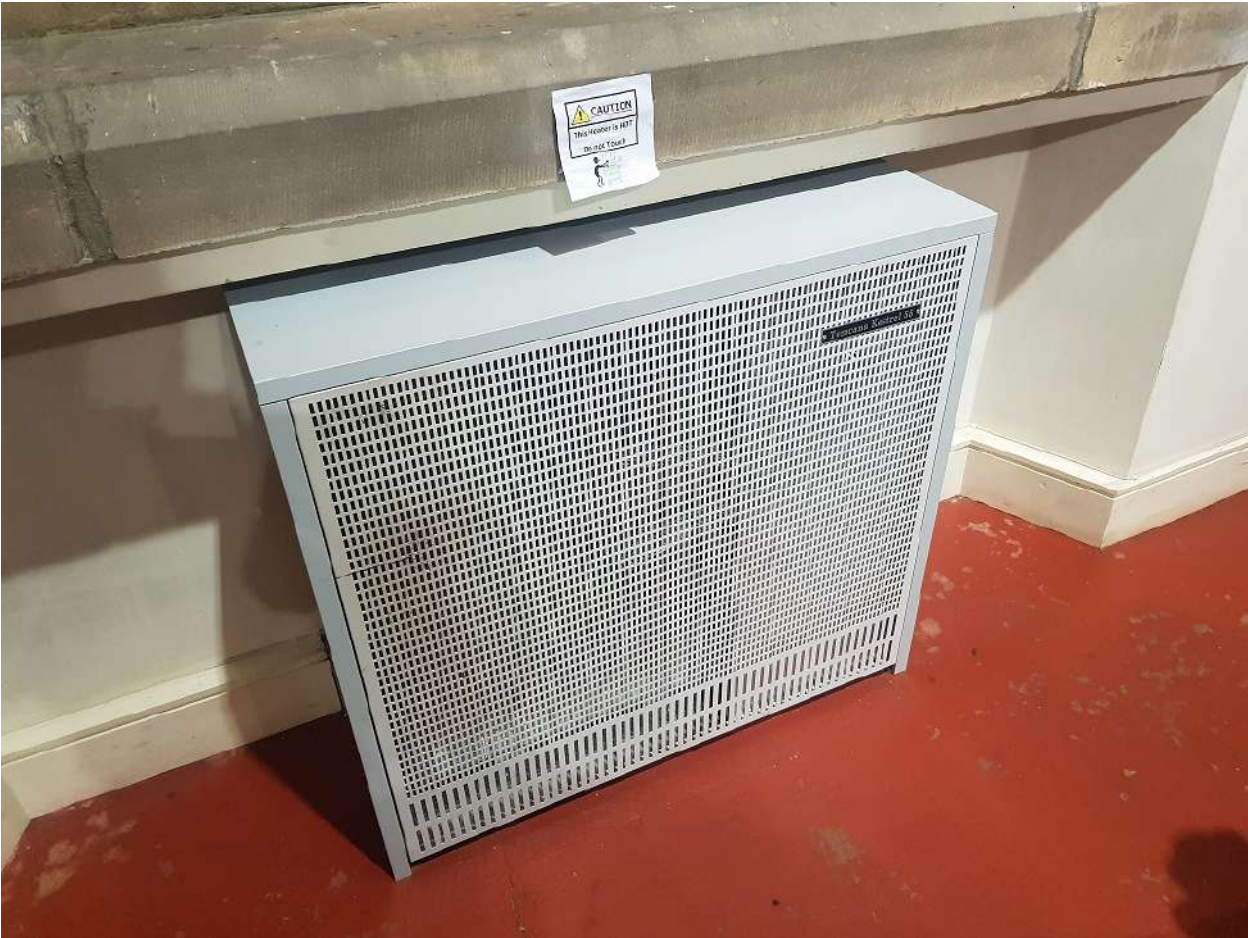
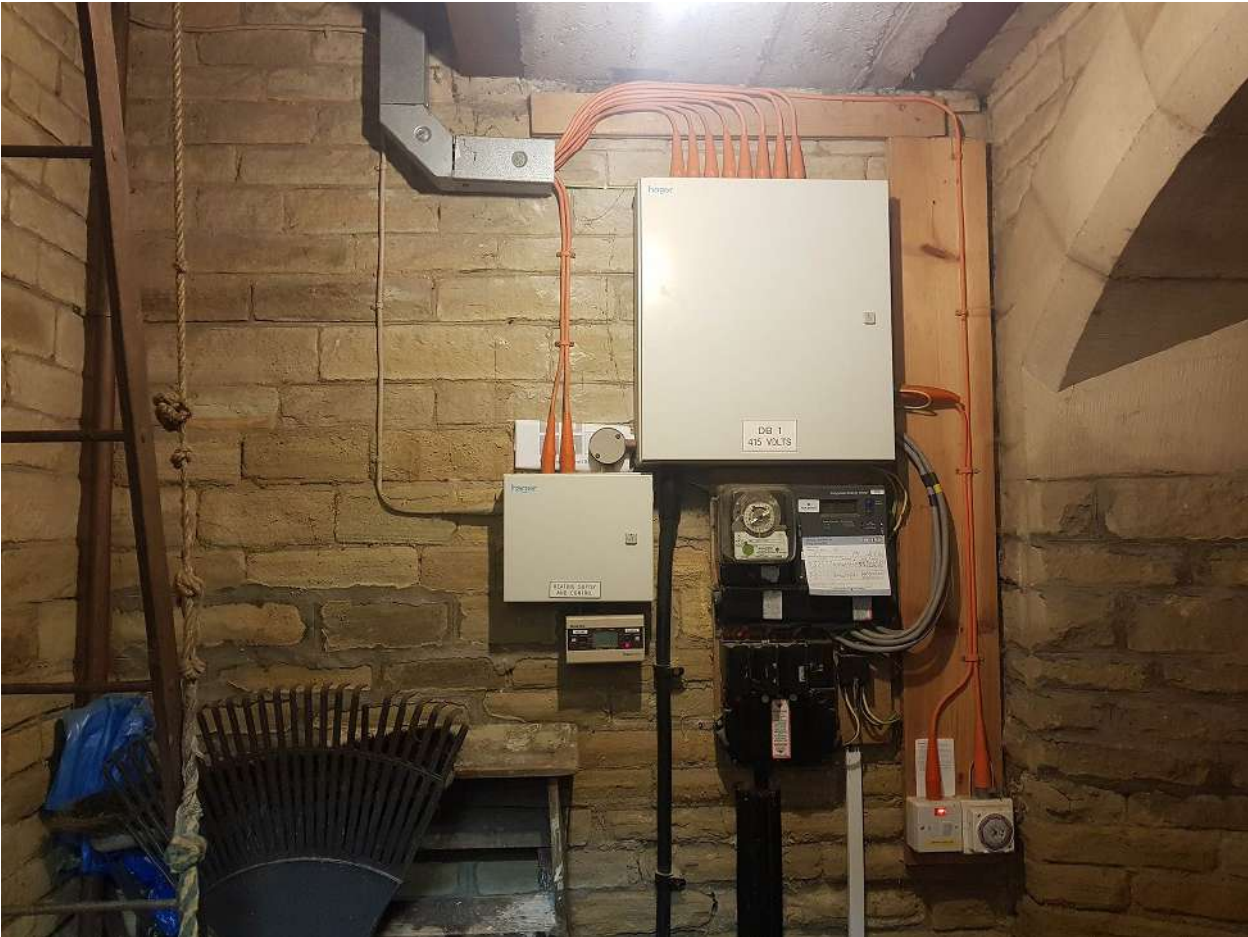
The electrical installation was completely rewired in 1993 with new distribution boards in 2011.

- 24.1.1 The last full electrical inspection and test is not known, as such checks should be made to see if the periodic 5 yearly inspection is now overdue.
