Diocese of Durham

SHOTTON
St SAVIOUR
(58)

QUINQUENNIAL REPORT
on the architect's inspection on

9 October 2017

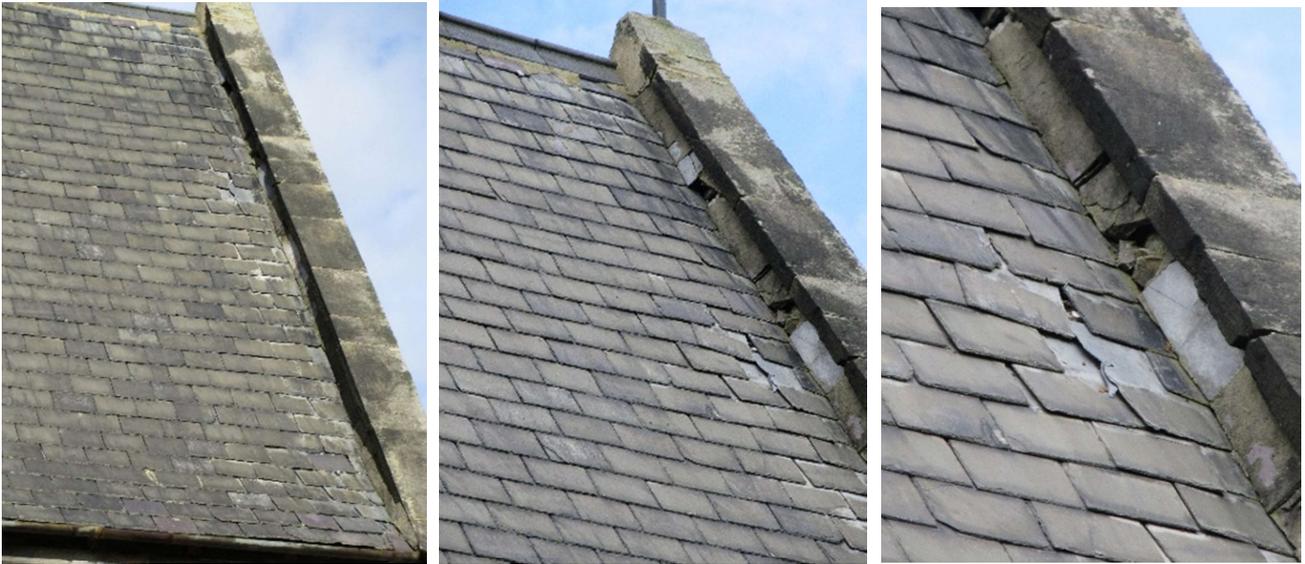
16. **Chancel** slates have lead cover flashings at the rendered Nave wall and at the E end unusual slates on edge and mortar facing under the gable watertables.
N Chancel slates good.
S Chancel much patched but fair except two slates missing against the E gable and two large holes in the slate on edge upstand, which must leak into the wall head.

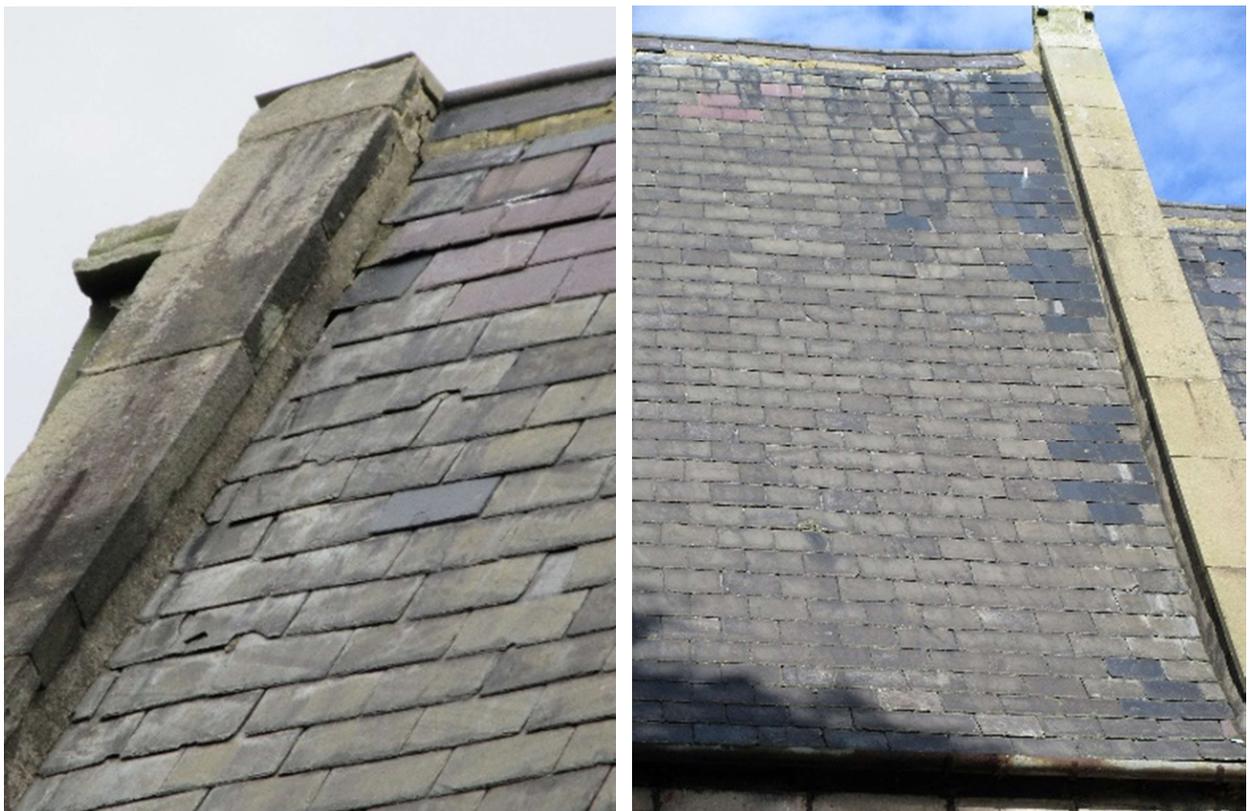
17. **Clergy Vestry** same eave height as Aisle. Slates fair, a few clipped. At E gable lead cover flashing over soakers. After lead theft the apron flashing is mixed lead and composite mineral surfaced adhesive foil.
18. **Organ chamber** gabled, several clipped E slates. Two E slates slipping nest to the gable. One slate missing and about 30% of E side ridge pointing missing. All of E and most of W valley gutters are now same foil faced substitute.
19. **S Nave** slate much patched. One slipping near eave towards E end. One slipping near E end of ridge. Some missing pointing at ridge. Mortar fillets under both gable upstands. Near top of W gable some missing narrow slates and gaps in the fillets make holes which must let water into the top of the gable wall (paras 42, 51-53).

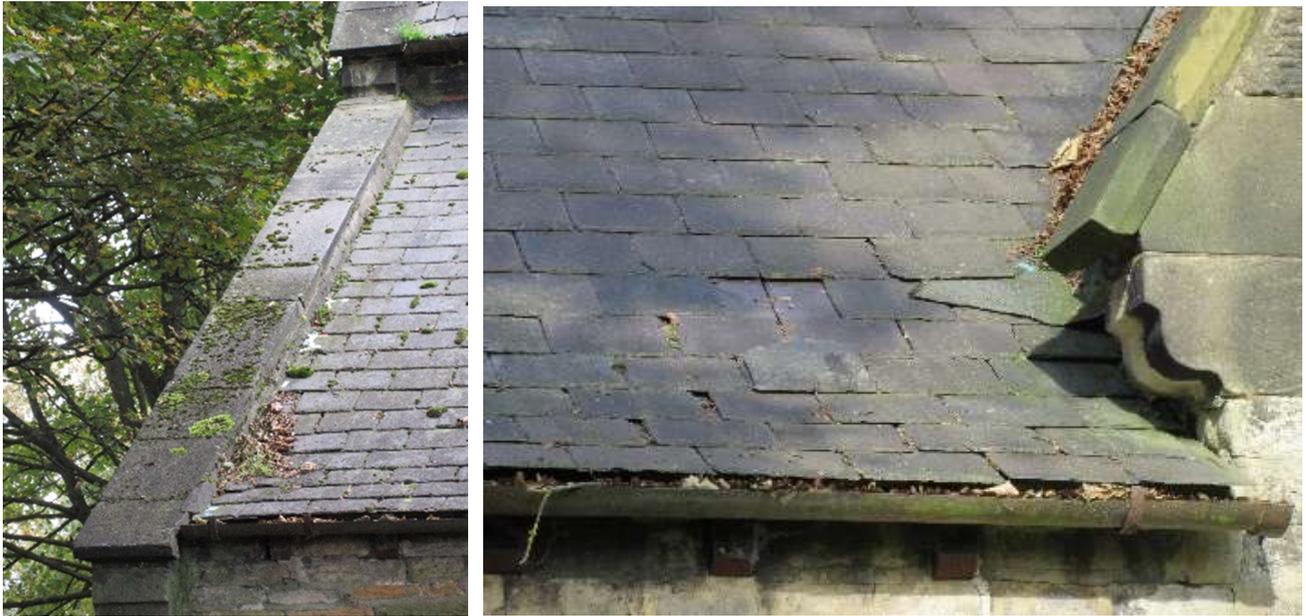
20. **S Aisle** slates mostly good. A few cracked and one slipped out at E end. Mixed lead and composite apron flashing. At the W end watertables no visible soakers in the slates under a fillet, where plants grow in cracked mortar.

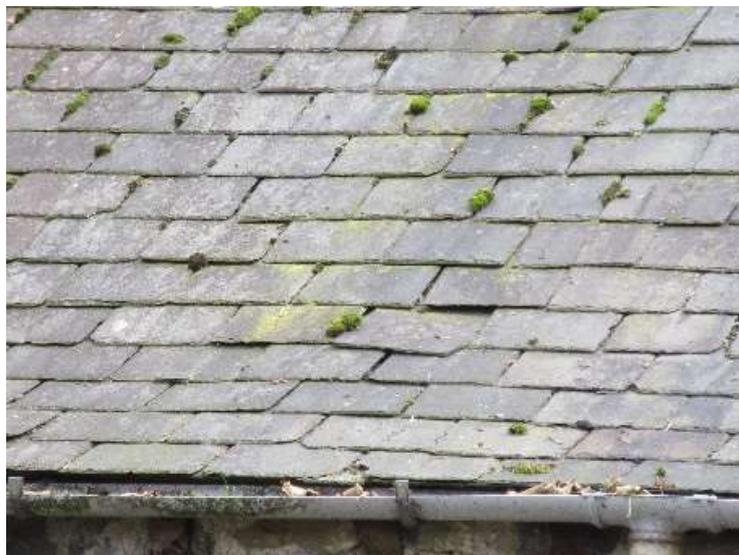
25. **N Aisle** one slipping twisted slate near eave over the wall dividing Aisle and Vestry, perhaps showing a loose batten. E of Porch plants grow between Aisle slates. The sarking boards inside have flaked paint and some surface salts showing at least occasional damp. There are no other clear slate defects at present but there must be poor laps and no felt under the slates as second line of defence.

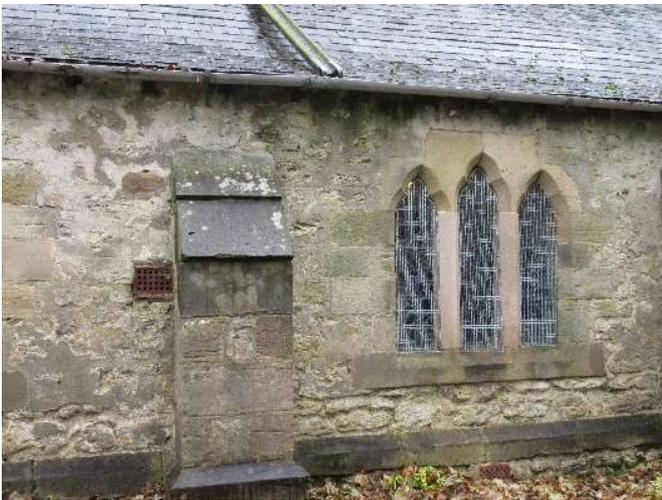
30. Gutter drips at several places due poor levels and leaf blockage especially:
At the N Aisle over the E window and the W buttress where the gutter lacks brackets
Between Chancel and chimney where the Vestry gutter falls away from its outlet, wetting the vestry and Chancel wall (plaster damaged at new boiler and in Chancel) (and para 44).

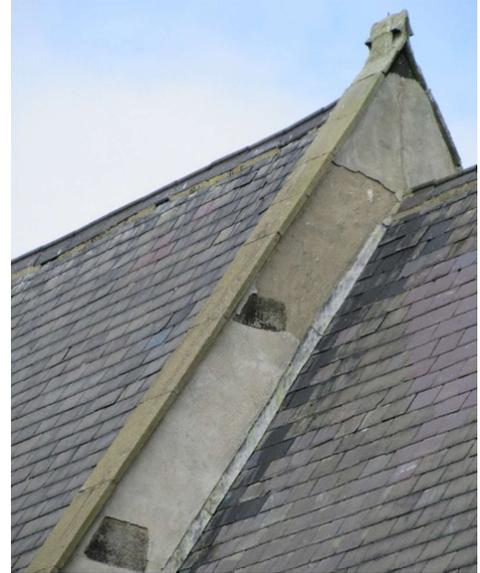
39. The **Nave E gable** is rendered, top coat part missing at the top of the S side.

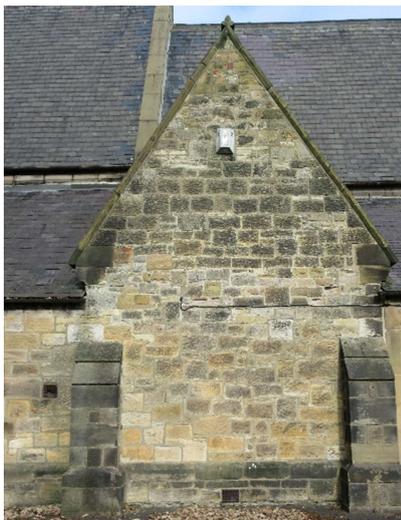
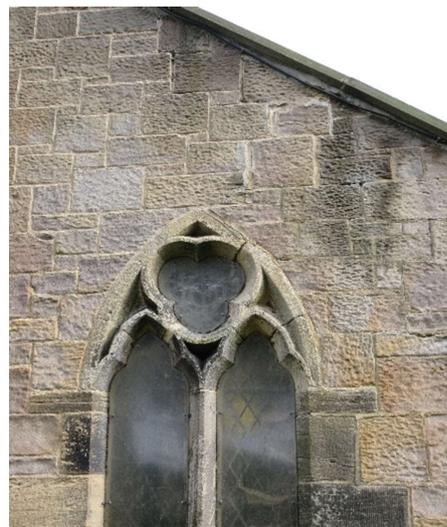
40. **Organ Chamber and S Aisle** (1903) uncoursed squared sandstone on a plinth with buttresses. A bitumen damp proof course just above ground. Struck cement pointing. In the Organ gable some stone decay at ground level and mid height.

41. At the Aisle S side L of the W window some open cracking. At the Aisle W end pointed cracks over the window and in its tracery. Both show former movement of the corner out to SW towards a medium sized sycamore 6m away. Otherwise sound.
42. **Nave W Gable** fair but strong signs (paras 19, 51 - 53) that the peak is damp due to defects at watertables and roof. Upper N watertables appear concrete, one decayed, a plant growing in another. Bottom panel repointed 2011.

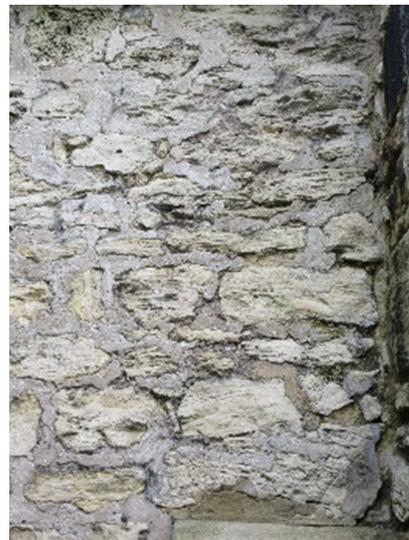
44. The **Choir Vestry** E side and Chimney are also limestone with sandstone dressings. Mixed cement over lime pointing, especially poor under the overflowing E gutter which wets the wall (para 30). The later N gable and wall over the door are squared sandstone. Stone and pointing fair except some loss of cement pointing under the cill. A timber flagpole in a steel bracket on the gable.

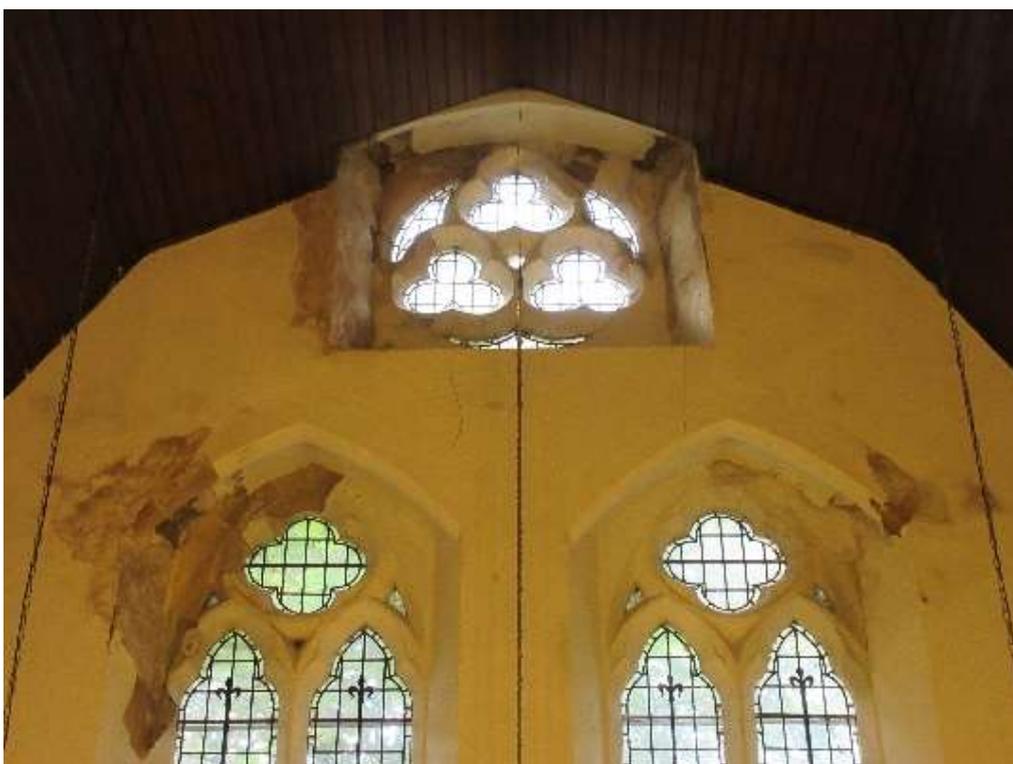
51. **W Nave** top roundel with tracery forming three trefoils. Some 80% outside stone replaced in 2010, sound. In 2010 the damaged internal reveals were replastered and repainted. The plaster is deeply damaged again, showing the gable peak remains wet.

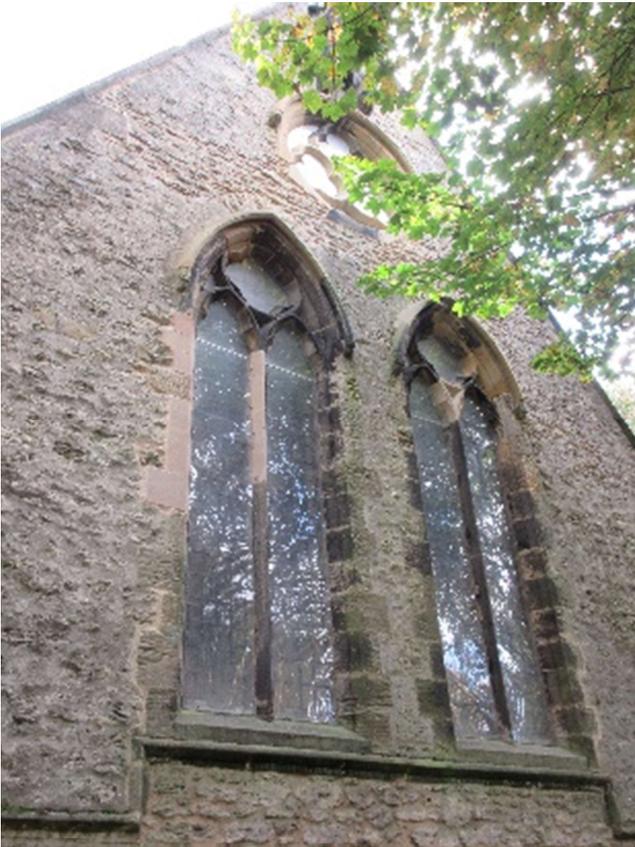
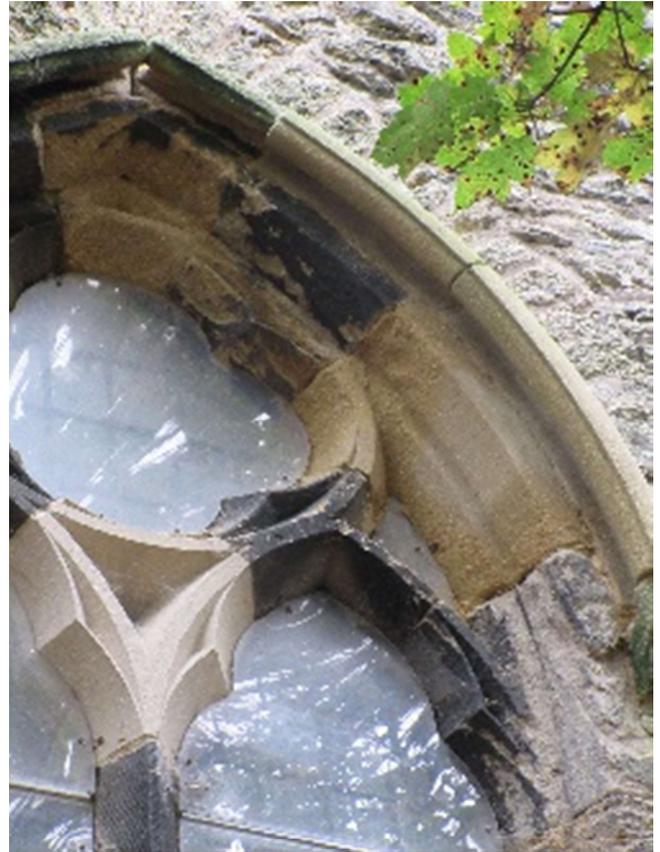
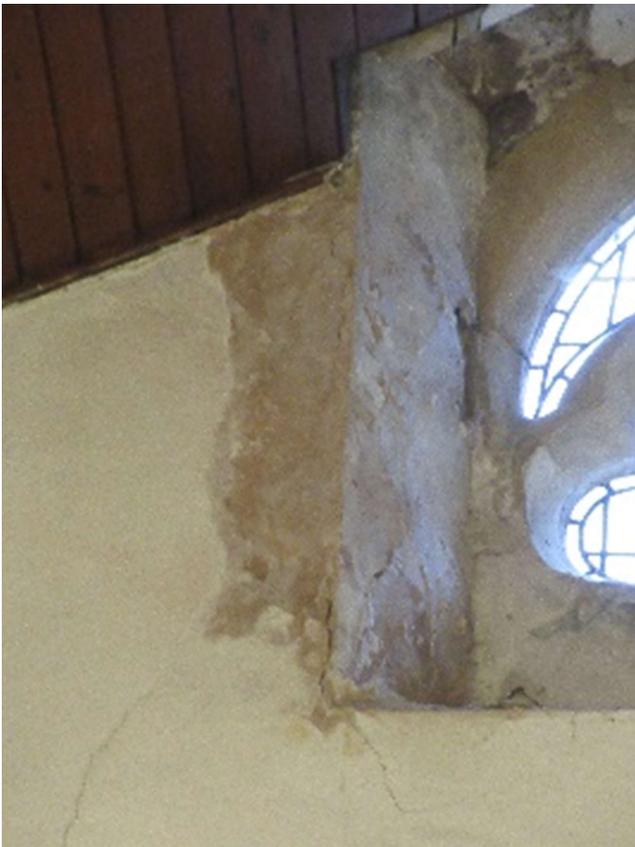
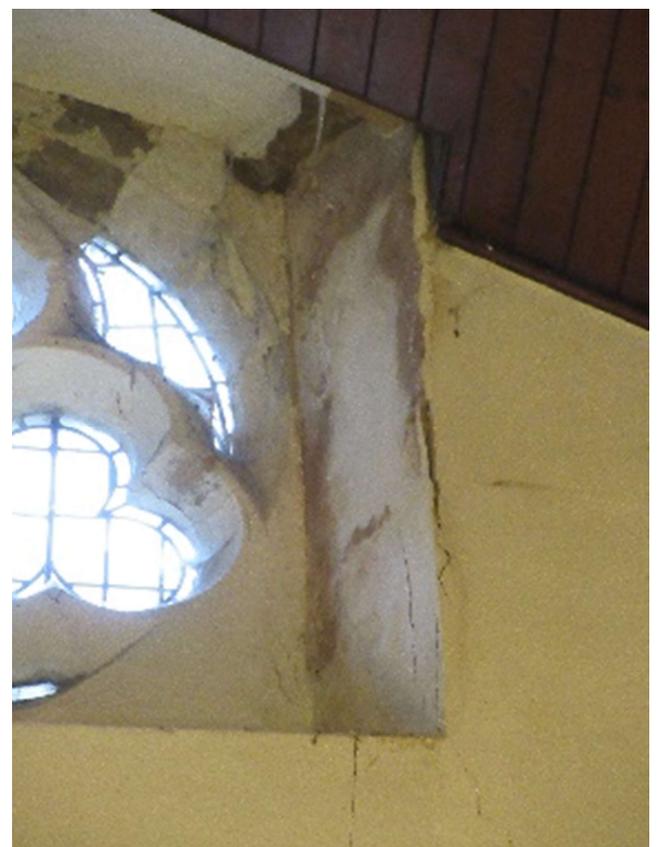
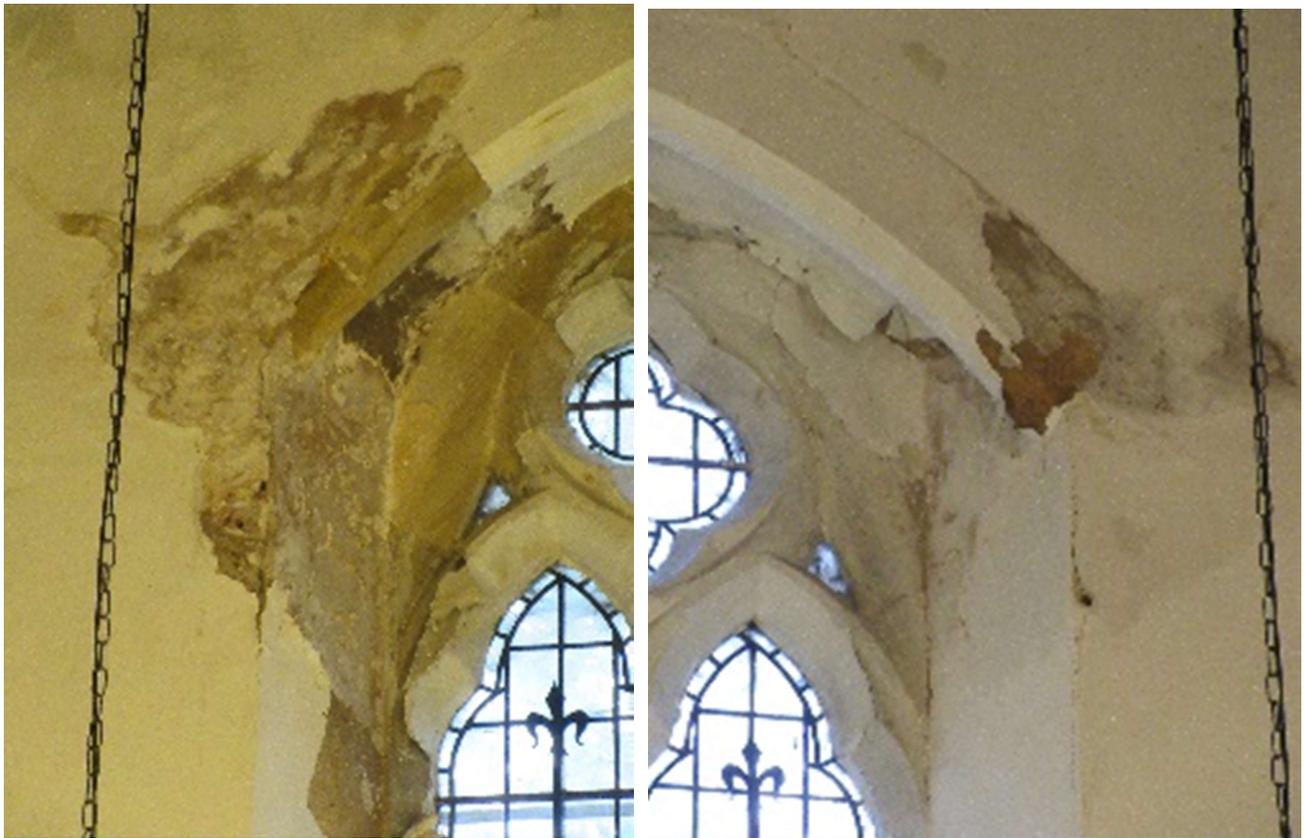
52. **W Nave** pair of tall two light windows. Hoodmoulds sound after most stones replaced in 2010 but the joint at the peak of the S hoodmould is now open and decayed back, letting water into the arch. In the S light the cusped Y tracery at the top of the mullion and one arch stone replaced in 2010. Now minor surface decay of part of the new arch stone adjoining the retained arch stones. Otherwise fair with minor decay in some soft beds.

53. Corresponding stone and plaster decay inside shows the masonry at the roundel and the tops of the two light windows, especially around the S side of the S light remains damp. Causes may include
 Lack of damp proof course under the gable water tables
 Lack of soakers in the nave slates and holes in the mortar fillet under the gable water tables (para 19)
 Open hole at top of the S hoodmould
 Open hoodmould joints

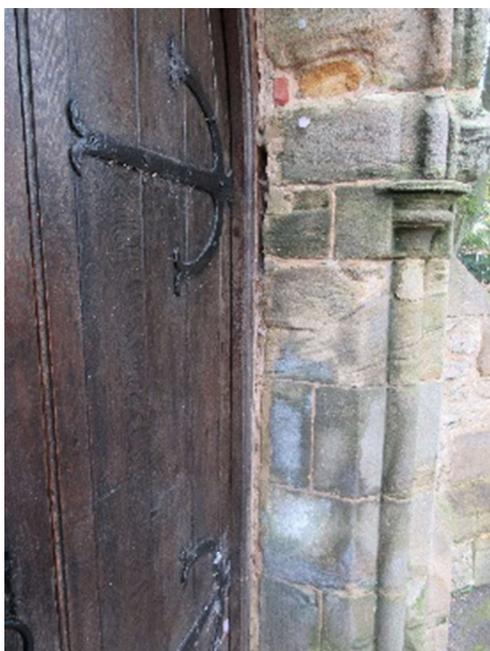
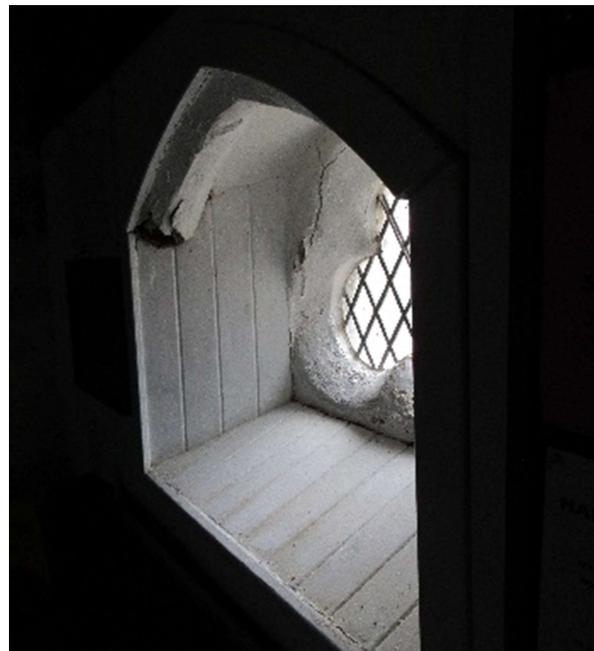
55. **Porch** small trefoil windows each sound, now pointed but stone softened inside.
 Unusually the moulded door arch and hoodmoulds are carved from magnesian limestone, now decayed back from each joint (before 2010 repointing) but structurally sound. Sound sandstone lower reveals and shaft decoration. Pointing lost between stone and door frame.

Decay inside the Porch windows and at their inner arches

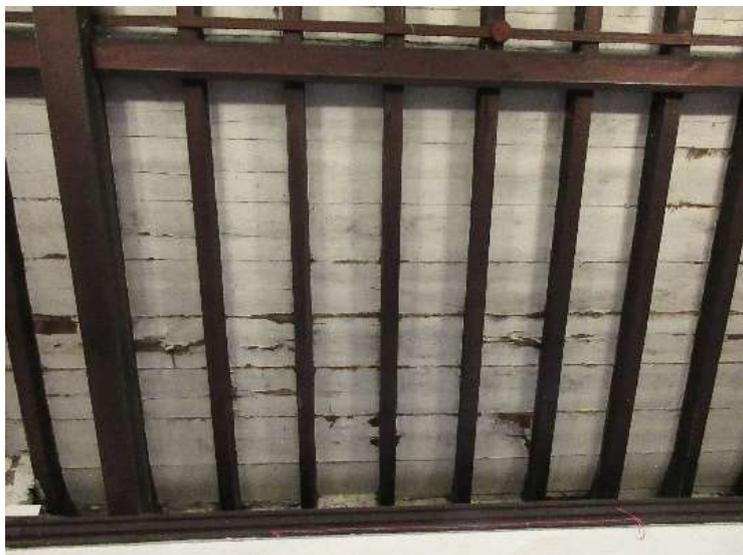
64. **Aisles** exposed sarking boards painted between rafters. Paint loss from joints in N Aisle suggests damp (para 25). **Clergy Vestry** same boards but varnished.

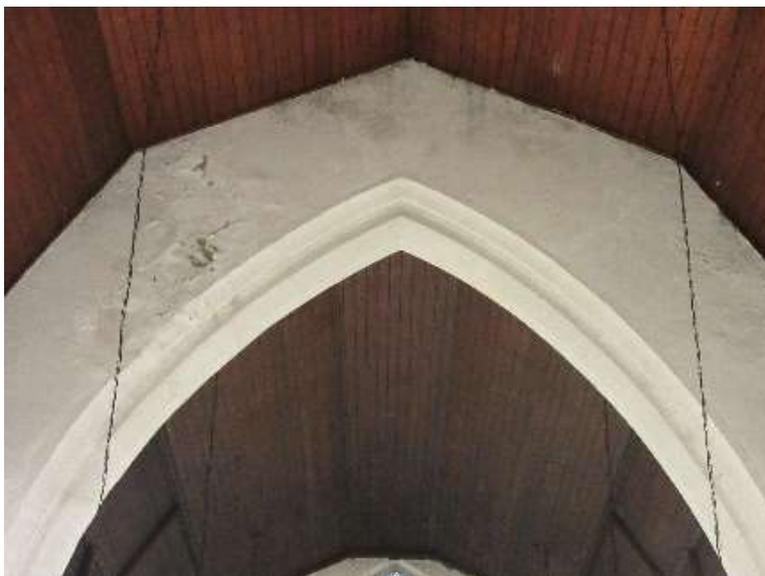
66. White eggshell paint covers the whole interior including the stone of the Chancel arch, the arcade piers and arches and the window surrounds. Paint probably disguises previous mortar repair of damp damaged stone. Unless the paint is more permeable to water vapour than it appears it will itself trap damp, leading to more damage at weak parts.
67. At least the E and W gables are plastered on split chestnut laths held off the stone walls, probably to increase resistance to driving rain. Solid rubble exposed gables are not naturally waterproof.
68. The **Chancel arch** is sound. Above it flaking paint on the Nave N side, either remaining from before repair of the external render about 5 years ago or caused by leaking watertables.

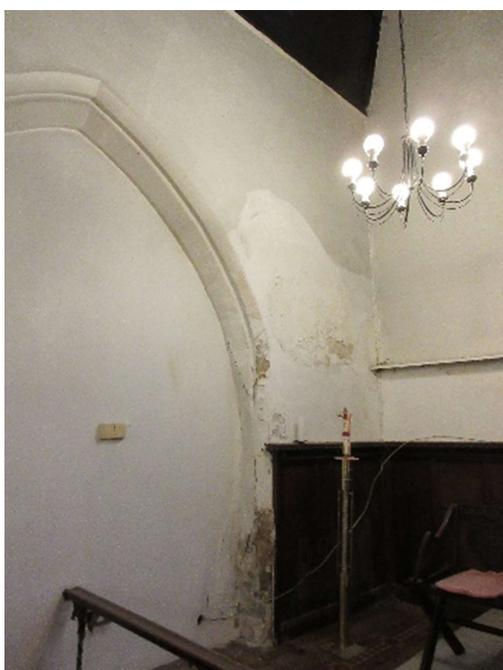
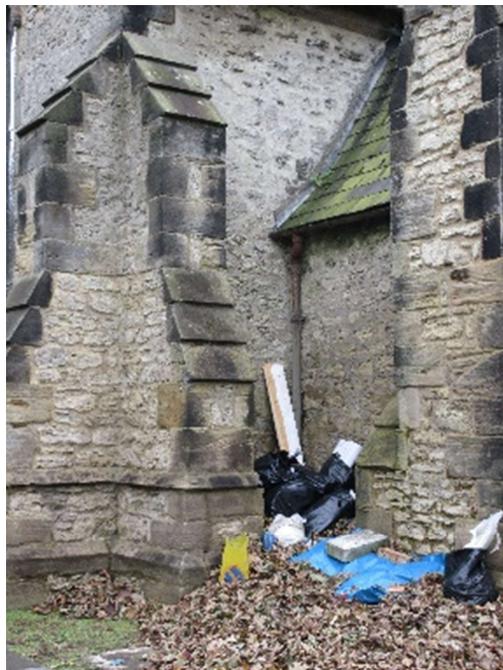
69. Chancel E gable damp damaged both sides of the window at about arch spring level, especially at the top of the N reveal, perhaps remaining after the 2010 repointing of the upper E gable.
70. The rest of the **Chancel** is fair. Recent paint on repaired plaster shows how dirty the rest of the walls are. Damaged paint and efflorescing salts at bottom of the Organ arch, hidden by a choir bench. At its E side a mortar repair is forced off by salts due to rising damp.
71. Chancel walls mainly sound but salts effloresce again in the upper part of the 2010 plaster repairs N of the altar and at low level at the reveal of the filled N arch (sources of damp the gutter falling the wrong way, possible blocked gully and heaped leaves and black bags outside – paras 30, 34)

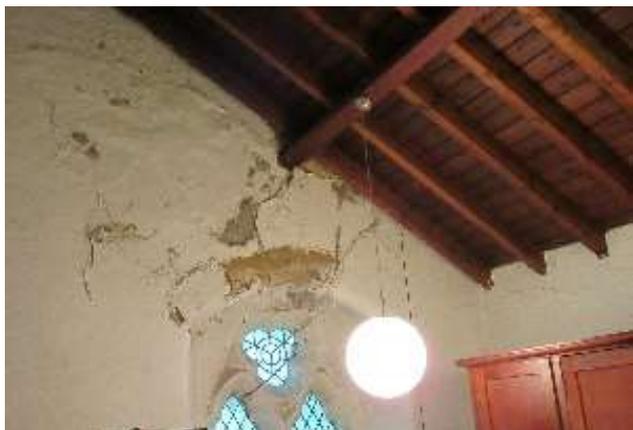
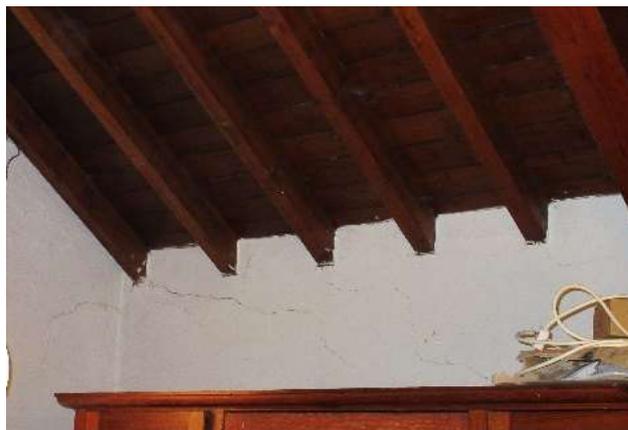
72. **Clergy Vestry** good except two movement cracks over the window and through the window tracery to the glass and high level horizontal cracks in the E end of the S wall show the corner has subsided.
Damp damage over the N side of the window worse than last inspection (open water table joints over, para 38).

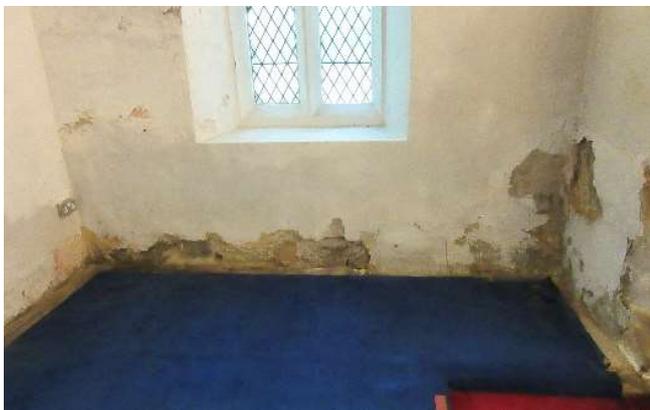
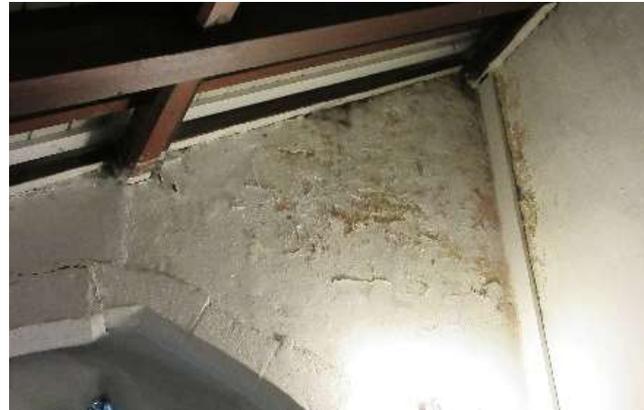
75. At S Aisle W end general damp damage of plaster especially at high level in the NW corner next to the end of the S Arcade shows present or former damp through the roof or watertable.

More damp damage at both sides of the end of the arcade (W respond) where stone is lost due to severe salt efflorescence caused by rising damp.

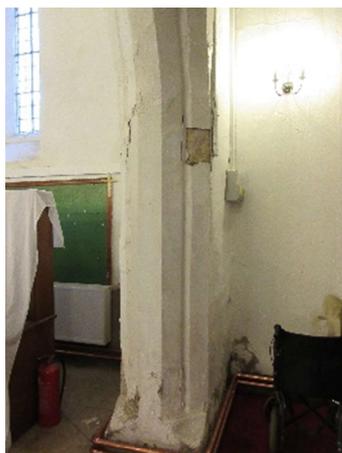
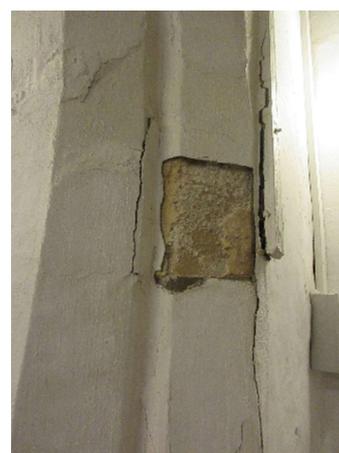
76. The **N Arcade** W end has similar but less severe rising damp and plaster damage at arch spring level both sides of the arch respond. Plaster or stone is being forced off the arch by salts in the stone.

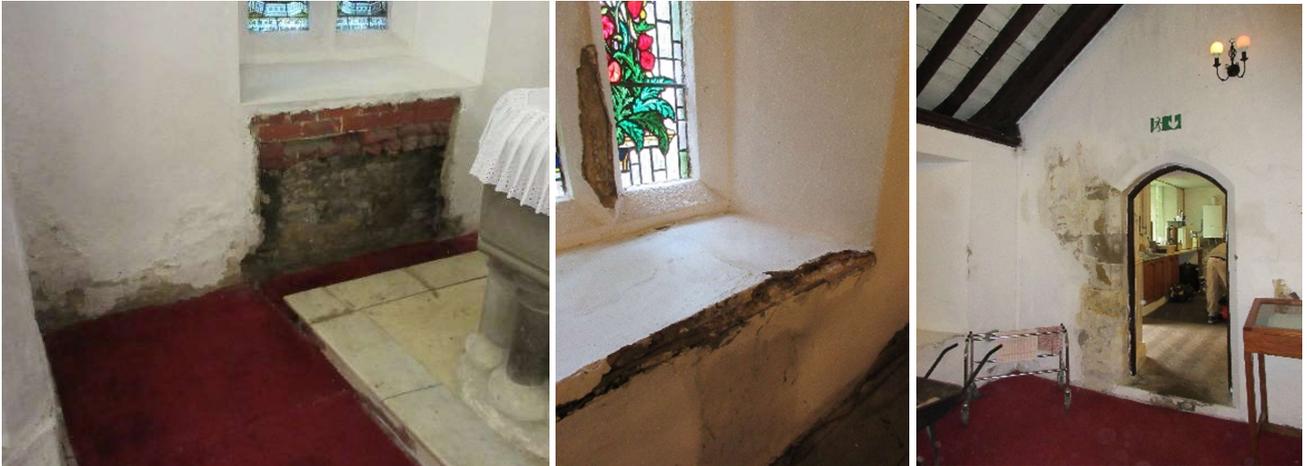
78. In the **N Aisle W** gable slight damage at high level and just replastered under the window. Note that brick inner wall face under the window found when plaster removed.

All the N window cills are cracked, worst at middle window cill where the render lifted by salts. Further rising damp each side of the door to the Vestry.

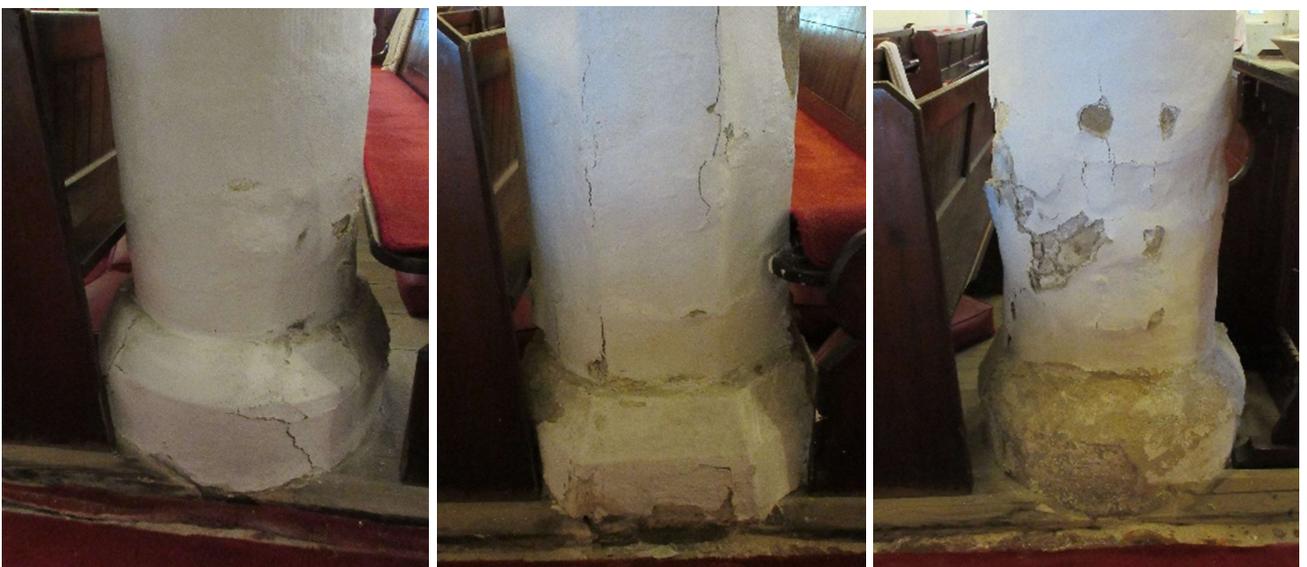
81. **N Arcade** same but the damage reaches higher in the pier shafts to above pew back level. The W pier is worst, the mortar repair of the bottom half having failed and salts bursting to top of pew level. The depth of decay is not known but could be becoming a risk to the structure.

NE pier aisle side 2017

mid N pier aisle side 2017

NW pier aisle side 2017

83. The comparison photos show rising damp continues to damage paint, mortar patching and stone. The ground around and under the building must be saturated and rising damp is not being controlled by damp proof courses or by enough subfloor ventilation. The arcade bases appear surrounded on three sides by suspended floor and on one by solid walkway floors which are damp and may themselves obstruct cross ventilation. The base of the former S Nave wall on which the S arcade may stand may itself draw up water while obstructing air flow.

As an interim measure removal of all paint from the piers and new air grills around all bases to allow low level evaporation may protect the pier shafts from further damage but appearance will remain poor.

When damp is controlled stone replacements or further mortar repair with new damp proof courses will be needed.

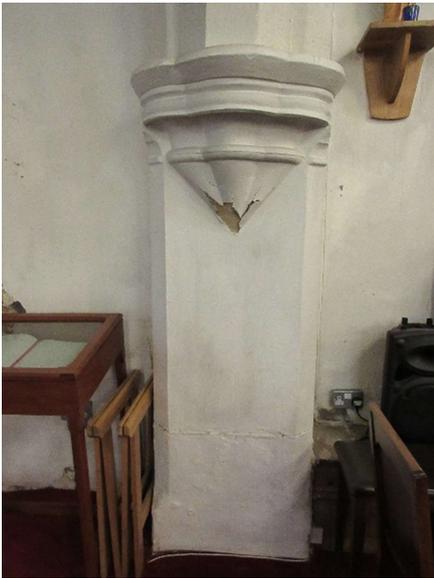
NE respond

82. In sum decay of the arcade piers gets slowly worse. Salts now show higher in the piers and in three of the four end responds with more stone and mortar decay.

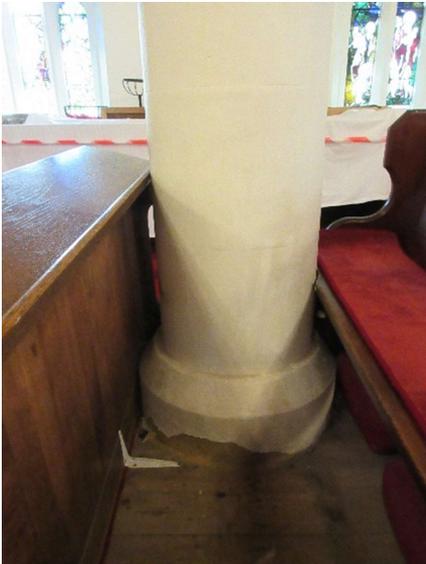
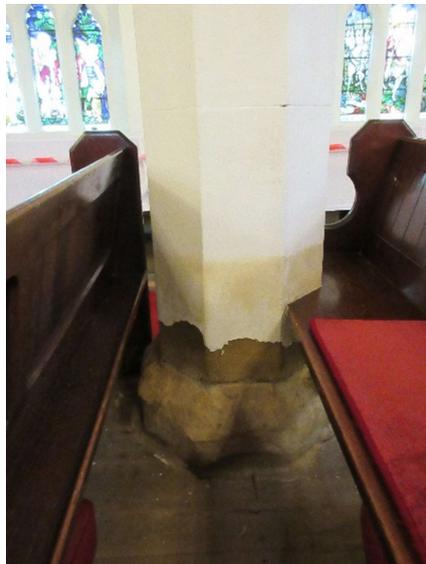
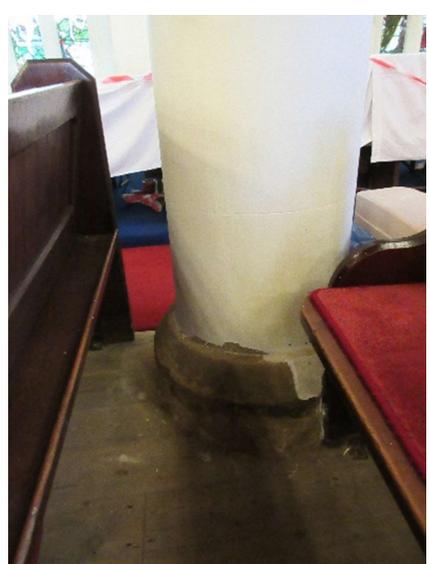
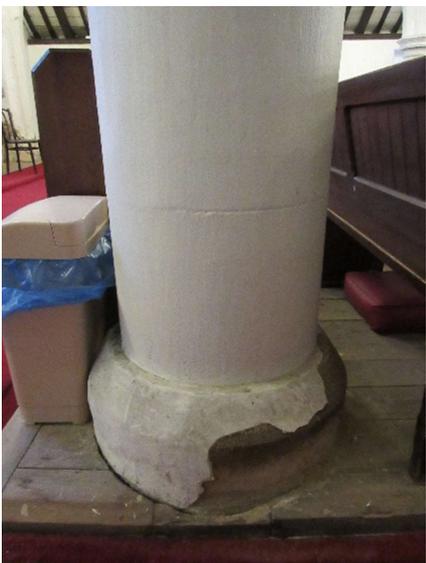
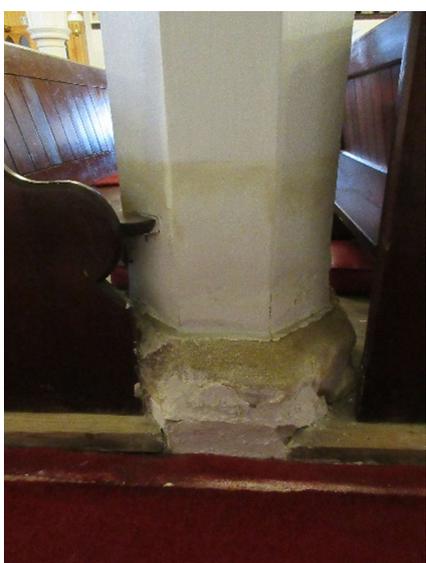
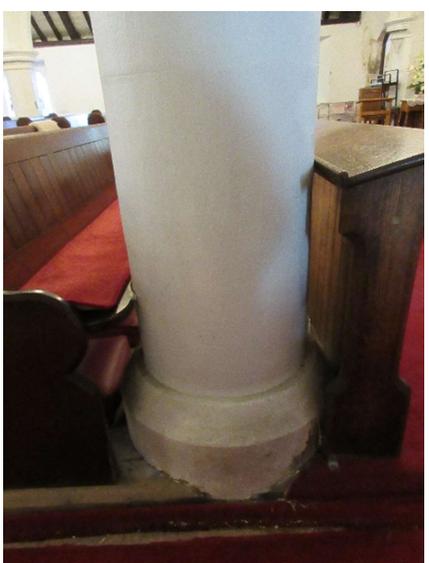
80. **S Arcade** three piers (two round, middle octagonal) seem sound except stone damage in the bases especially the middle and W pier due to salts in rising damp. The bases have been patched with mortar and painted over but are disrupted by further salt efflorescence, slightly worse than at last inspection.

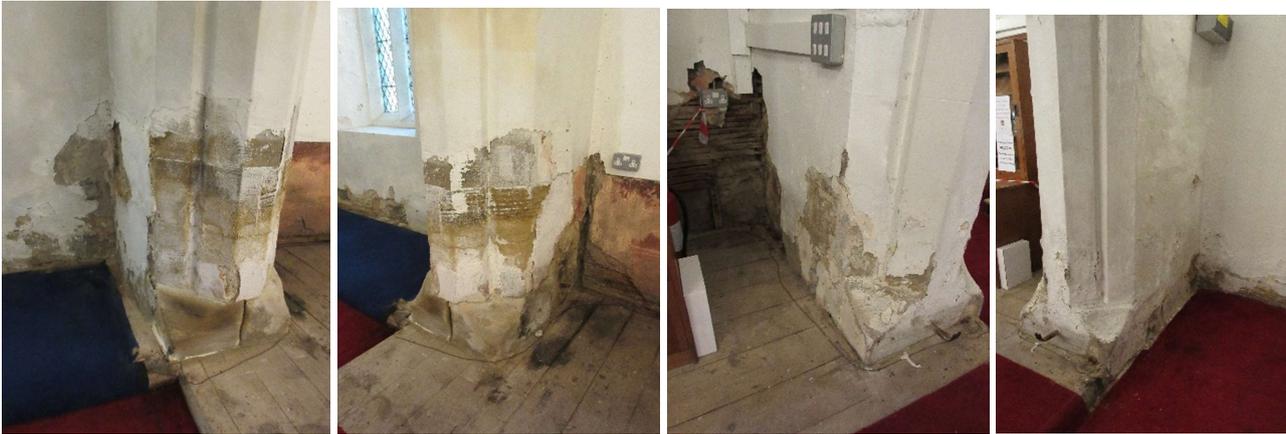
SW respond 2017

NW respond 2017

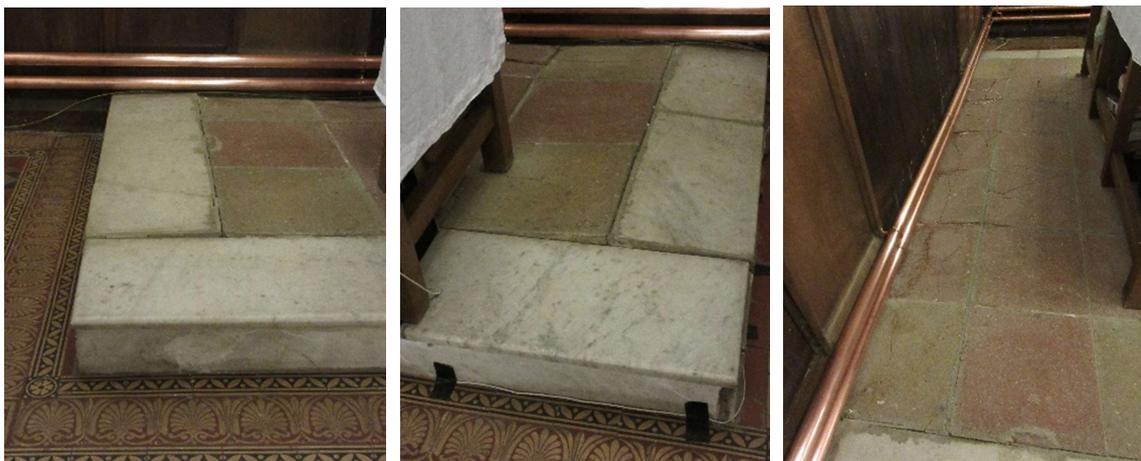
105. **Altar platform** is large plain ceramic tiles with marble step, both part lifted, uneven and about 50% broken, suggesting underlying fill has swollen as often found in Victorian churches. Simple to replace with clean fill and new tiles.

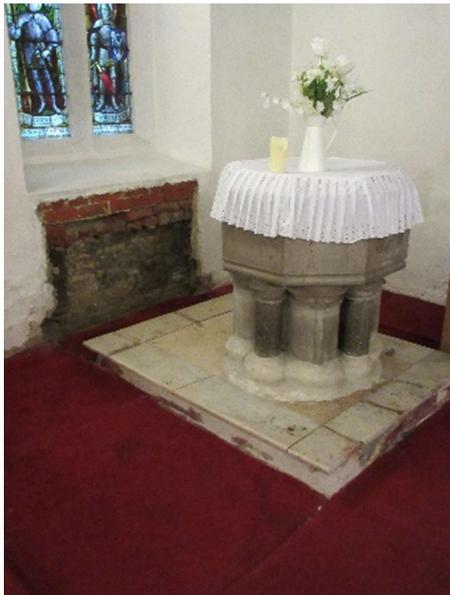
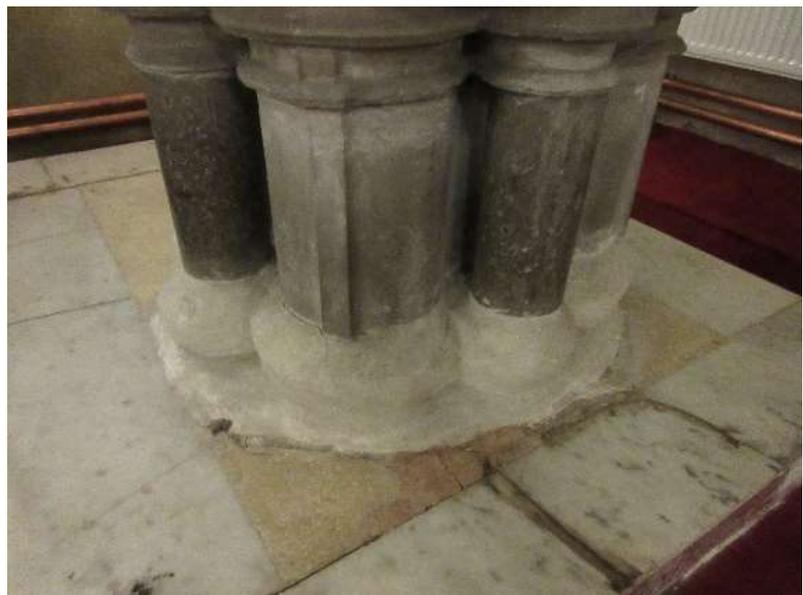
112. A solid floor walkway crosses the church from the Porch. The NW corner is solid floor under a marble font platform. Parts of the marble are loose and cracked.
Against the Nave W wall a pew platform, uneven and part patched with boards in different directions.

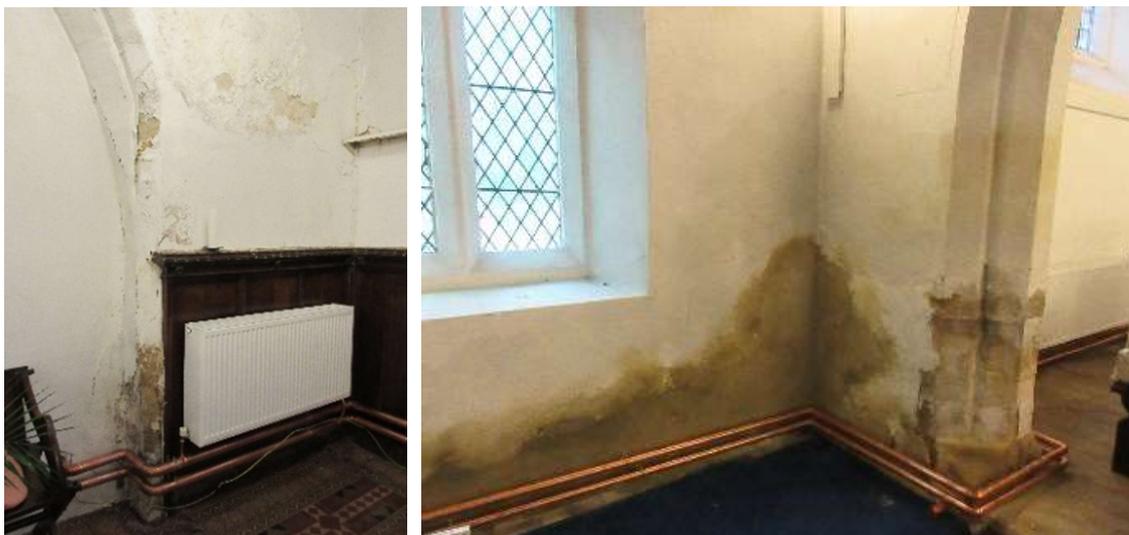
118. Large gas meter and new balanced flue boiler on E wall of Choir Vestry. New pressurised copper two pipe circulation around the church perimeter and steel panel wall radiators being installed during inspection.
