QUINQUENNIAL INSPECTION REPORT - MAY 2023

# HOLY TRINITY CHURCH

FRONT STREET, SOUTH HETTON, CO. DURHAM, DH6 2UA

Report prepared by

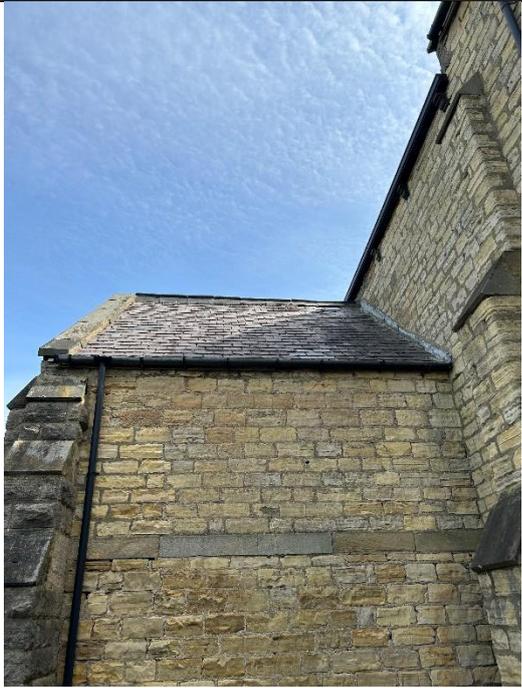
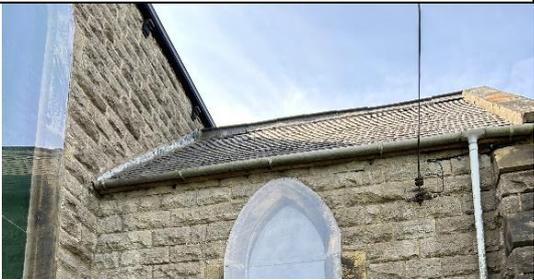
<p><b>Condition</b></p> <ul style="list-style-type: none"> <li>Ridge tiles are well bedded, but with some gaps in between.</li> <li>There are some slipped / broken slates.</li> <li>Mortar fillet to water table is sound.</li> <li>Lead flashing into Chancel wall with a mortar fillet is weathered away towards the bottom.</li> <li>Timber fascia for gutter is broken at the exposed end.</li> </ul>

<p><b>Repair Needs</b></p> <ul style="list-style-type: none"> <li>• Monitor slates and re-fix any which continue to slip, or are blown off.</li> <li>• Repoint ridge tiles and mortar fillet to lead flashing, and at same time, check that they are soundly bedded, taking remedial action as required.</li> <li>• Consider replacing timber fascia</li> </ul>	<p>M  D  E</p>
--	---	--------------------------------

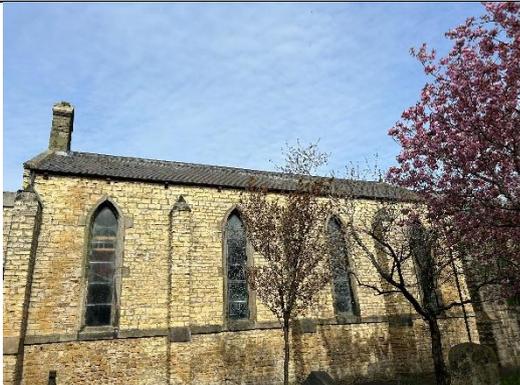
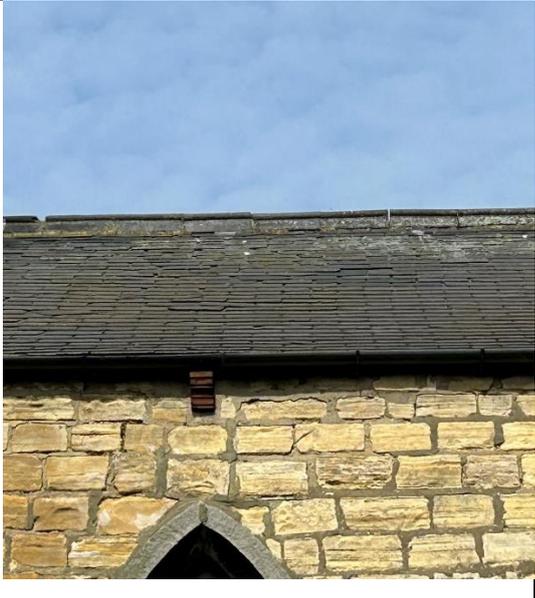
<p><b>Condition</b></p> <ul style="list-style-type: none"> <li>• There are a few slipped, and chipped slates.</li> <li>• Mortar pointing between ridge tiles has weathered out in some locations towards the western end.</li> <li>• Mortar bedding to ridge tiles is starting to break down.</li> <li>• Mortar fillet to water table appears sound.</li> </ul>	
	<p><b>Repair Needs</b></p> <ul style="list-style-type: none"> <li>• Monitor slates and re-fix any which continue to slip, or are blown off.</li> <li>• Repoint ridge tiles, and at same time, check that they are soundly bedded, taking remedial action as required.</li> </ul>	<p>M D</p>

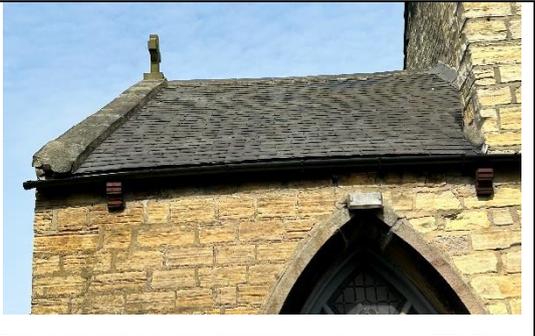
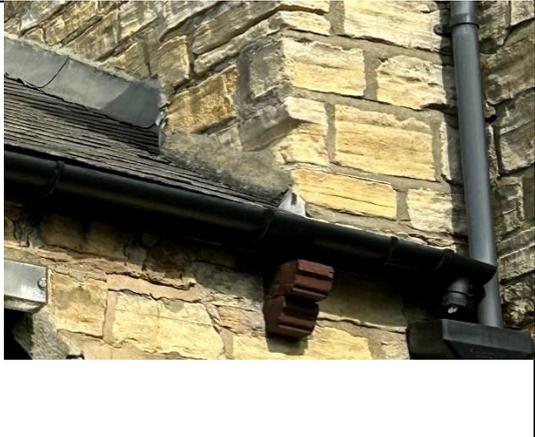
<p><b>Condition</b></p> <p><b>Roof to West Gable</b></p> <ul style="list-style-type: none"> <li>• Stone cross appears to be in good condition.</li> <li>• Bottom coping stone on south pitch is broken and appears to have moved / slipped and is exposing a steel cramp.</li> <li>• Ridge tiles appear to bow in the centre of the roof.</li> <li>• Mortar fillet to nave buttress has broken at the front.</li> </ul>

<ul style="list-style-type: none"> <li>• Flashing to Nave wall appears sound</li> <li>• Mortar fillet to water table appears sound.</li> <li>• There appears to be a few chipped slates.</li> </ul> <p><b>Roof over vestry link to extension</b></p> <ul style="list-style-type: none"> <li>• Mortar bedding and pointing to ridge tiles appear sound.</li> <li>• Flashings appear sound.</li> <li>• Slates appear sound.</li> </ul>	
	<p><b>Repair Needs</b></p> <ul style="list-style-type: none"> <li>• Mortar fillet to be repaired to prevent water ingress.</li> <li>• Consider replacing and/or re-bedding the coping stone to the west gable roof.</li> </ul>	<p>D E</p>

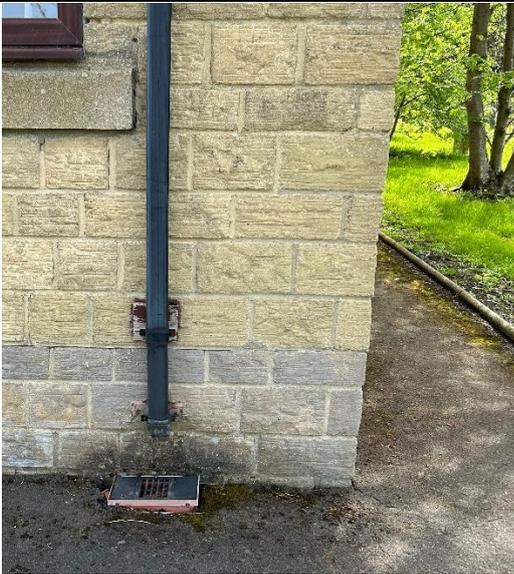
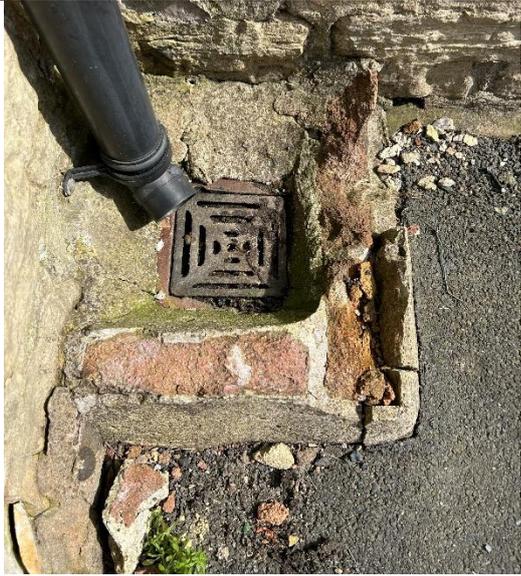
<p><b>Condition</b></p> <ul style="list-style-type: none"> <li>• Shoe of Rainwater down comer is still missing on community hall north elevation.</li> <li>• An assessment of the rainwater run off suggests that the existing gutters are only just sufficiently sized for the roof. They are also in poor condition, with numerous ad hoc repairs.</li> <li>• Downpipe adjacent to the vestry door on south elevation is discharging into a gully which appears blocked.</li> <li>• Downpipe on west elevation, next to boiler house has been replaced with a new white downpipe.</li> </ul>

<p><b>Repair Needs</b></p> <ul style="list-style-type: none"> <li>• Continue to clear gutters of debris and leaves.</li> <li>• Replace shoe of down comer to community hall, water discharging onto the pavement can cause a slip hazard in freezing weather. PCC might consider using grit and salt in freezing weather until the repair can be made and also around the Organ Chamber where the gulleys discharge onto the footpath.</li> <li>• Unblock gulley next to vestry door.</li> </ul>

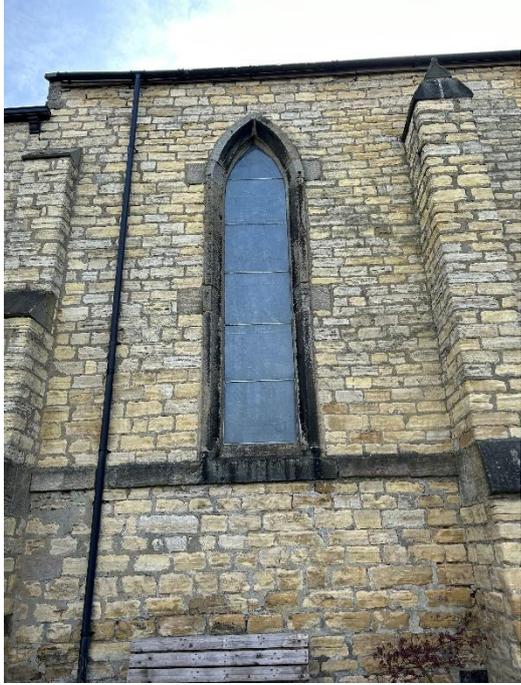
<p><b>Condition</b></p> <ul style="list-style-type: none"> <li>• Generally, sound with some individual stone weathering</li> <li>• Unsightly Cement pointing below the sill level string course.</li> <li>• Slight delamination of stones in places.</li> <li>• Pronounced weathering of buttress and coping stones</li> <li>• Some efflorescence below string course in the bay next to main entrance still present.</li> </ul>	
	<p><b>Repair Needs</b></p> <p>none</p>

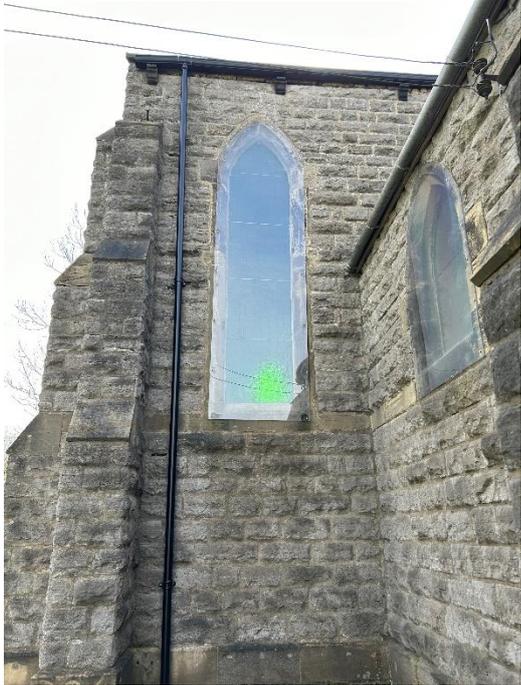
<p><b>Condition</b></p> <ul style="list-style-type: none"> <li>• The section of wall east of the Organ Chamber has some modern cement mortar however generally sound.</li> <li>• There are some open mortar joints still present at high level.</li> </ul>	
	<p><b>Repair Needs</b></p> <ul style="list-style-type: none"> <li>• Repoint open mortar joint, using a suitable lime mortar.</li> </ul>	<p>D</p>

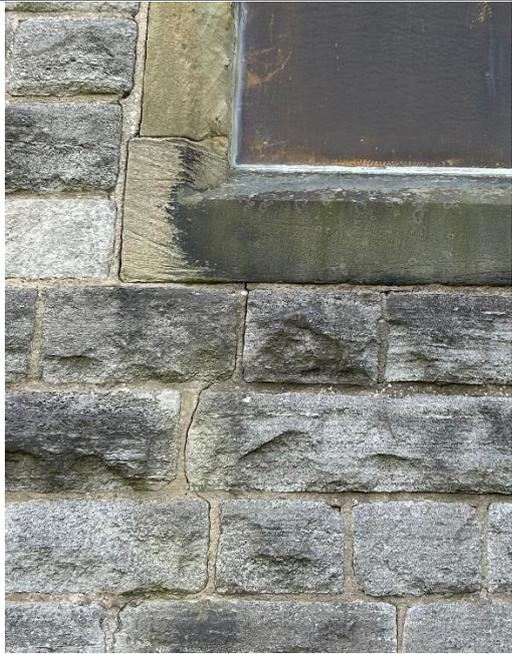
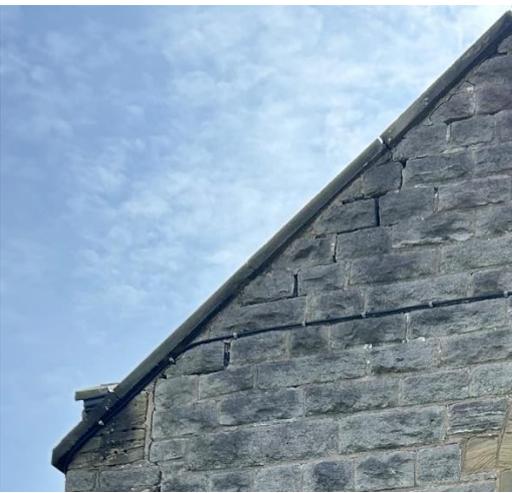
<p><b>Condition</b></p> <ul style="list-style-type: none"> <li>• Some areas of re-pointing required to vertical joints in plinth and string course stones and to stones on the east facing buttress.</li> <li>• Some stones showing weathering</li> <li>• There is a hole in the wall adjacent to the cap stone of the buttress on the west elevation.</li> <li>• There is a settlement / movement crack below the window on the east elevation to the left-hand side.</li> <li>• There are some signs of movement below the coping stones on the east roof pitch side, resulting in open vertical mortar joints present within the stone at high level on the north elevation.</li> <li>• There is a crack below the window on the north elevation to the left-hand side.</li> <li>• Mortar bedding to the coping stones is weathered.</li> </ul>

<p><b>Repair Needs</b></p> <ul style="list-style-type: none"> <li>• Some vertical mortar joints to plinth stones and string courses require re-pointing, using a suitable lime mortar.</li> <li>• Re-pointing required to vertical mortar joints below the coping stones in top left (north side)</li> <li>• Re-point mortar bed below coping stones on north side.</li> <li>• Monitor cracking below the windows on both north and east elevations. They don't appear to have worsened since last QQI.</li> </ul>	<p>D</p> <p>C</p> <p>C</p> <p>M</p>

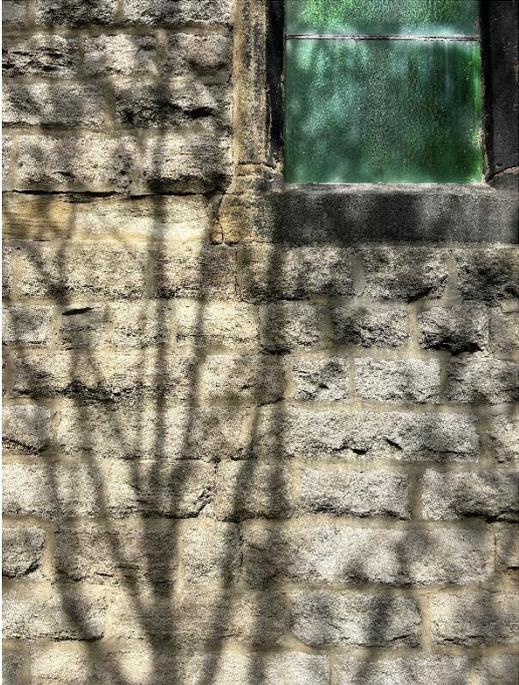
<p><b>Condition</b></p> <ul style="list-style-type: none"> <li>• Stone and pointing generally sound.</li> <li>• Movement crack along left-hand side of window W.03 are still present, to wall above and below the window and also in the quoins. They do not appear to have worsened since the last QOI.</li> </ul>	
	<p><b>Repair Needs</b></p> <ul style="list-style-type: none"> <li>• Monitor cracking to walls above and below W.03</li> </ul>	<p>M</p>

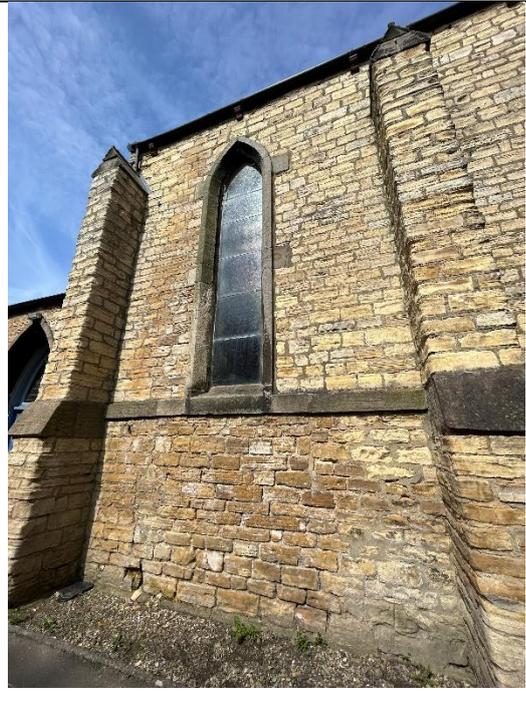
<p><b>Condition</b></p> <ul style="list-style-type: none"> <li>• Pointing is weathering out in areas, particularly below string course.</li> <li>• Stones below string course are weathering.</li> <li>• Some modern cement mortar present but has mostly come away.</li> <li>• Efflorescence present on base stones below string course, but to lesser extent to previous QQI.</li> <li>• Buttresses have weathering to stones particularly corner stones.</li> <li>• There are some holes behind the RWP which could do with filling to prevent water ingress.</li> </ul>

<p><b>Repair Needs</b></p> <ul style="list-style-type: none"> <li>• Some areas of repointing required below string course and to holes behind RWP, using a suitable lime mortar.</li> <li>• Brush off the worst of any remaining efflorescence if required</li> </ul>	<p>D  M</p>

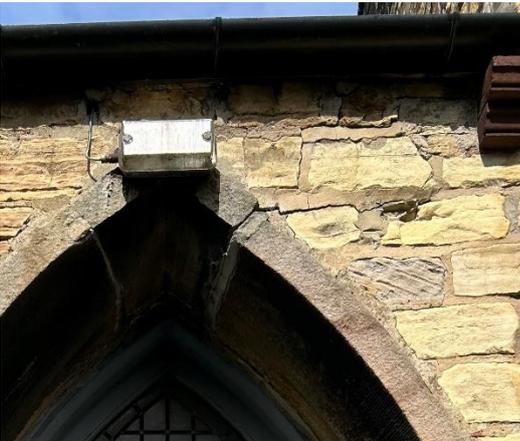
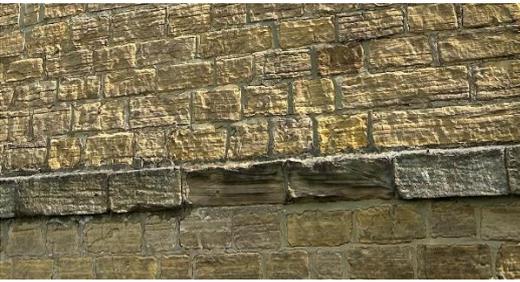
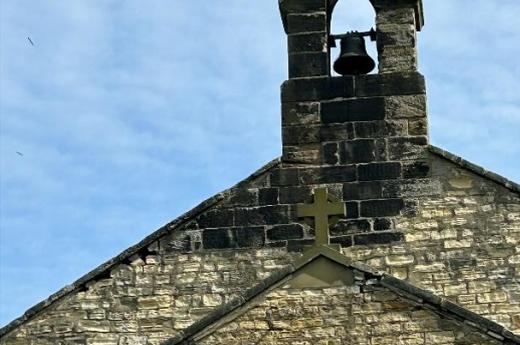
<p><b>Condition</b></p> <p><u>South Elevation of Vestry</u></p> <ul style="list-style-type: none"> <li>• Ashlar stone to right hand side of door behind the RWDP is considerably eroded.</li> <li>• There is signs of movement above the door archway (D.01), with mortar cracking visible.</li> <li>• Modern cement mortar is cracking and coming away.</li> </ul>

<p><u>West Elevation of Vestry</u></p> <ul style="list-style-type: none"> <li>• Heavily eroded stones at the base.</li> <li>• String course stones are also heavily eroded.</li> <li>• The mortar joint below the stone copings are in poor condition and largely missing. Stone pinning's are visible where mortar has weathered.</li> </ul>

<ul style="list-style-type: none"> <li>• The bottom coping stone on south side of roof appears to have moved / slipped.</li> </ul> <p><u>West Elevation of Nave (High Level)</u></p> <ul style="list-style-type: none"> <li>• There is some atmospheric staining to the stone at high level, including on the bell tower.</li> <li>• Some coping stones on north pitch appear to be broken / missing and pointing below appears to be weathering.</li> </ul>

<p><b>Repair Needs</b></p> <ul style="list-style-type: none"> <li>• Some areas of repointing required, using a suitable lime mortar.</li> <li>• Monitor cracking above Door D.01</li> <li>• Consider replacing and/or re-pointing copings stones, to nave roof.</li> </ul>	<p>D  M  E</p>
--	--	--------------------------------

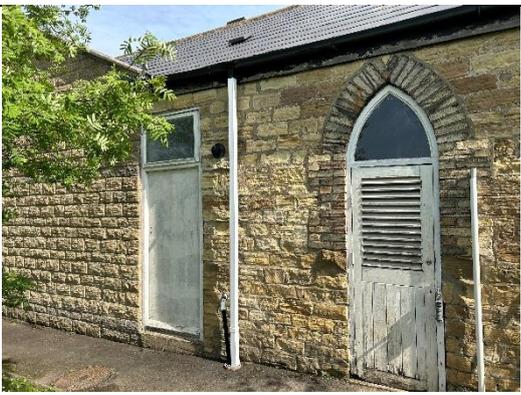
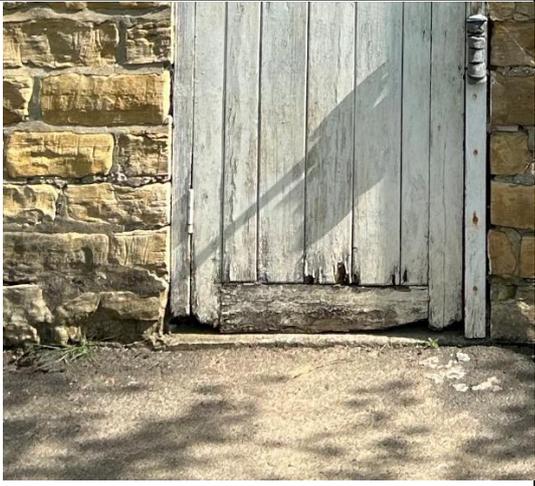
<p><b>Condition</b></p> <ul style="list-style-type: none"> <li>• D.01 is in reasonable condition, paintwork appears to have been renewed at high level since last QQI.</li> <li>• The paintwork on D.02 and D.03 has been renewed since last QQI, however could do with an additional coat.</li> <li>• The timber at the bottom of D.02 and its frame remains badly deteriorated.</li> </ul>

<p><b>Repair Needs</b></p> <ul style="list-style-type: none"> <li>• The timber frame of door D.02 requires a splice repair to the bottom, suggest 30cm of door frame to prolong its lifespan.</li> <li>• Consider an additional coat of paint to external doors to prolong lifespan</li> </ul>	<p>E</p> <p>D</p>
---	--	-------------------

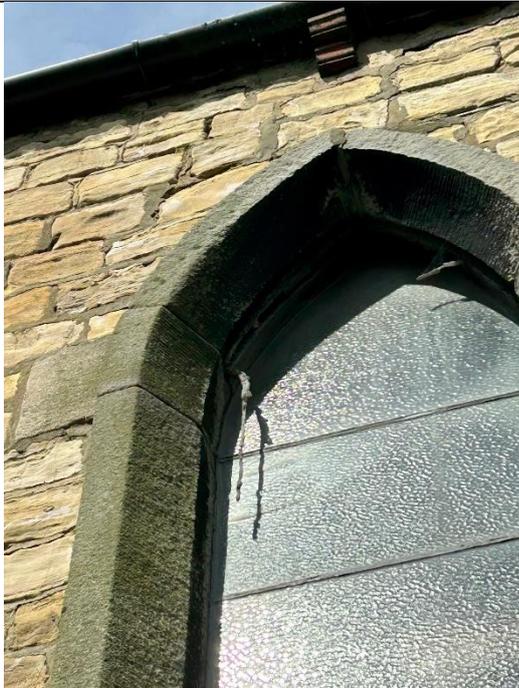
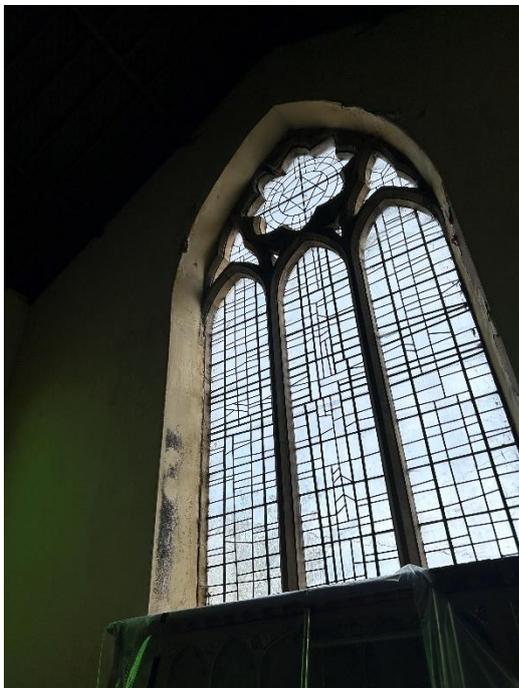
- Windows W.01 and W.13 have had replacement panes and polycarbonate covers added since last QQI.
- Generally stone surrounds (externally) are sound although some are weathering and have staining at varying degrees present.

- There is a gap at the head of window W.07 between the stone and silicone appears to be missing in places externally. Internally there is staining and blistering to plaster surround.

- The stones below the arch of W.06 appear to be out of line with the arch stones, which indicates some movement has occurred.
- W.02 appears to have had repairs and a polycarbonate cover added since last QQI.

- There is some cracking on left hand quoins to W.03 and some holes which are likely to be from previous fixings.
- There is a broken stone below the arch at W.05.

- Plaster reveals to windows internally have varying degrees of cracking and bulging of plaster / paint.
- W.05 has small pieces of stained glass broken and missing.

- W.04 some stained-glass pieces are missing and some areas appear to be bulging.
- The stained glass on W.06 appears to be bulging at the top.

<p><b>Repair Needs</b></p> <ul style="list-style-type: none"> <li>• Monitor cracking to the stone surrounds</li> <li>• PCC to consider a programme of window repairs to cracked, missing and bulging glazing panes.</li> </ul>	<p>M E</p>
--	--	----------------

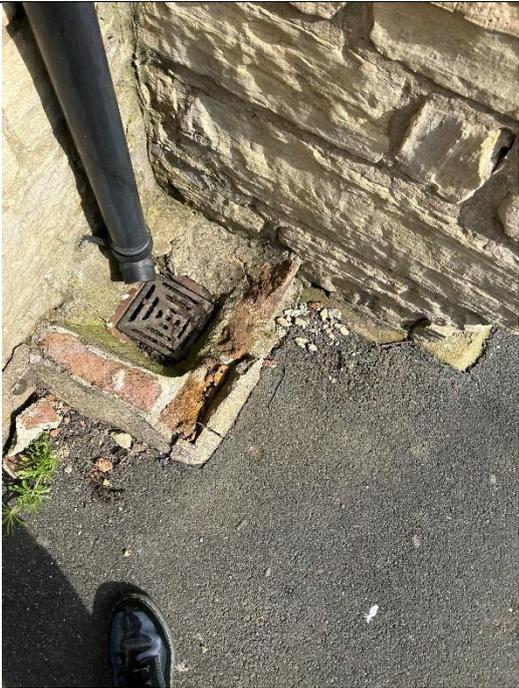
<p><b>Condition</b></p> <ul style="list-style-type: none"> <li>• Stone are damaged around the gully adjacent to the old entrance door into the vestry. The gulley also appears to be blocked and full of debris.</li> </ul>	
	<p><b>Repair Needs</b></p> <ul style="list-style-type: none"> <li>• Gully next to vestry door to be unblocked to ensure rainwater can flow clearly and not overspill onto pavement.</li> <li>• Consider replacing the stones around the gully adjacent to vestry door.</li> </ul>	<p>B E</p>

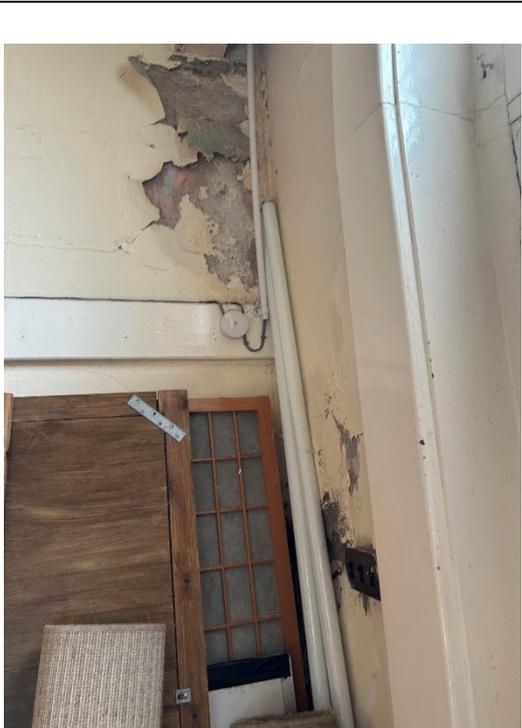
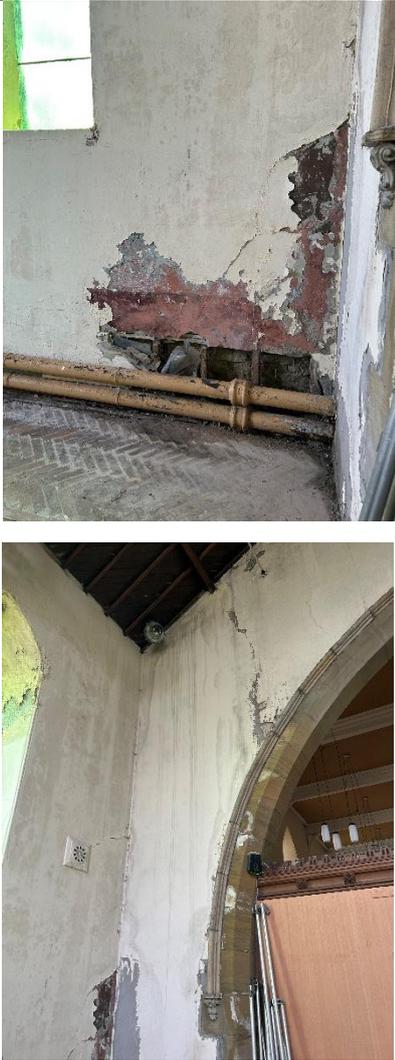
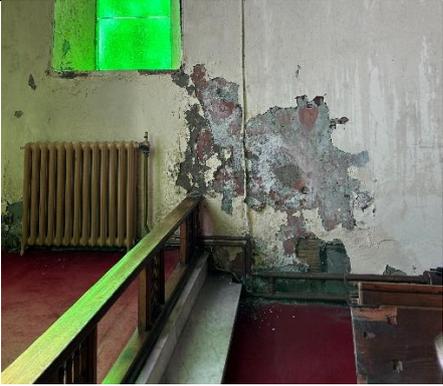
<p><b>Condition</b></p> <ul style="list-style-type: none"> <li>• The large damp patch and flaking paint on the wall next to the old entrance door (D.01) in the vestry is still present.</li> <li>• Plastered walls within the Nave are generally in good condition. Although signs of damp are present in the corner behind the pulpit, this was probably due to past water ingress between nave and chancel roofs.</li> <li>• There is some staining on the north walls which could possibly be a sign of damp.</li> <li>• Both internal stone arches are damp and some delamination of the stone face is occurring at low level. Salt Crystals and Efflorescence are also present.</li> <li>• There is extensive damp to the walls within the Chancel, particularly along the southern wall and the internal wall between chancel and nave. There is water staining visible on both walls from high level down the wall. This is likely to be caused from</li> </ul>

<p>the past water ingress issue. The re-roofing should now allow the walls to dry out and be re-decorated.</p> <ul style="list-style-type: none"> <li>• There is a patch of damp upstairs above the door through to the balcony. Paint is flaking. This indicates water ingress from the junction in the nave / vestry roof above.</li> </ul>

<p><b>Repair Needs</b></p> <ul style="list-style-type: none"> <li>• Once the walls in the Chancel have dried out it might be worth the PCC getting specialist to assess the stone and mortar to determine if any remedial plaster treatment is required.</li> <li>• Inspection of the flashing between Nave and Vestry roofs due to evidence of water ingress internally. The flashing may need replacing.</li> </ul>	<p>E</p> <p>C</p>

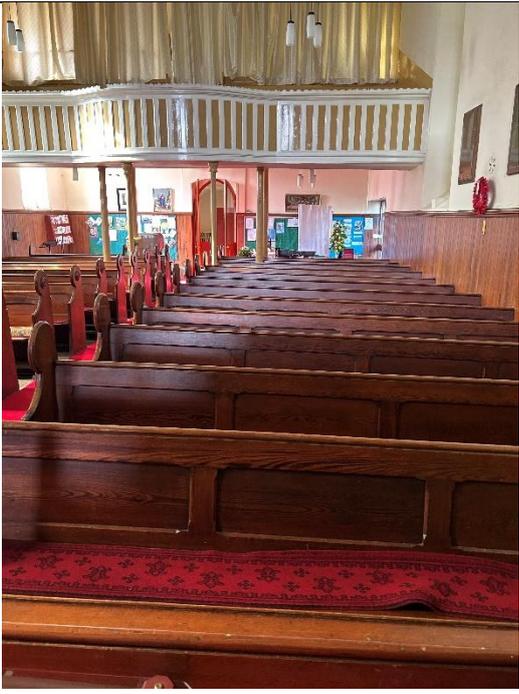
<p><b>Condition</b></p> <ul style="list-style-type: none"> <li>• Pews to balcony appear secure and sound.</li> <li>• Pews within Nave appear sound and secure with rows 3<sup>rd</sup>, 6<sup>th</sup>, 7<sup>th</sup> &amp; 10<sup>th</sup> from the back on the north side appearing a little loose.</li> <li>• Pews in the Chancel have been removed during the re-roofing works.</li> <li>• The pulpit is sound and stable.</li> <li>• The font appears in good condition.</li> </ul>

<ul style="list-style-type: none"> <li>• Consider fixing down the loose pews within the Nave.</li> </ul>	D
--	--	---

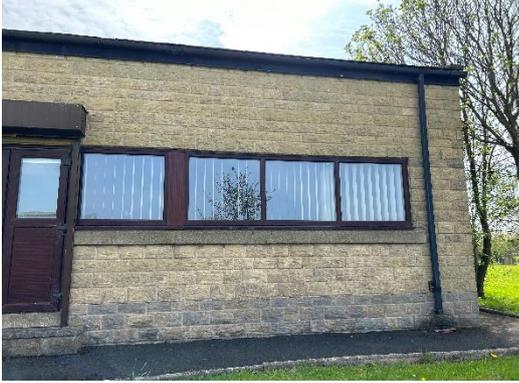
<p><b>Condition</b></p> <ul style="list-style-type: none"> <li>• The lintels above the north facing windows either side of the door appear to be bowing over the last 3 window bays, there are also vertical cracks present which indicates movement of the wall.</li> </ul>	
	<p><b>Repair Needs</b></p> <ul style="list-style-type: none"> <li>• Monitor cracking above the window lintels.</li> </ul>	<p>M</p>
