QUINQUENNIAL INSPECTION REPORT - MAY 2017

HOLY TRINITY CHURCH

FRONT STREET, SOUTH HETTON, CO. DURHAM, DH6 2UA

SAMANTHA DIXON

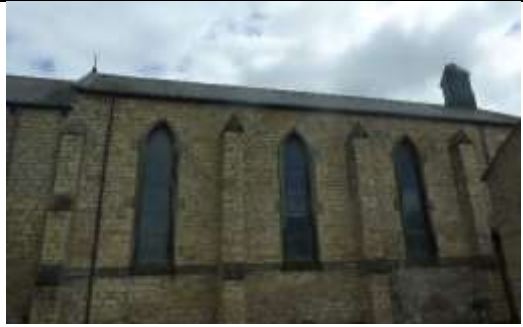
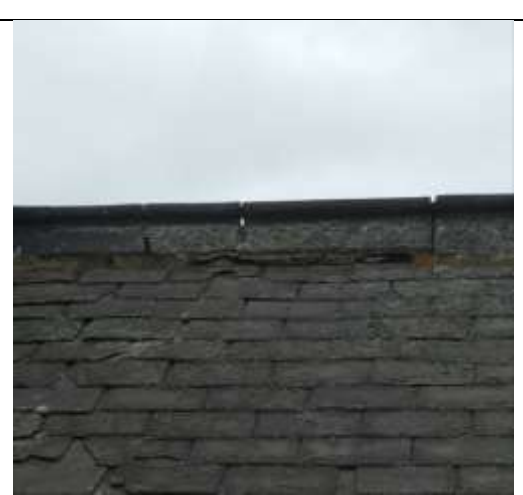
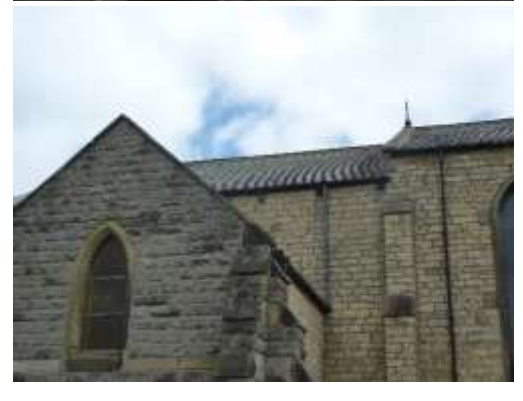
Northern Pitch of the Nave Roof

<p>Condition</p> <ul style="list-style-type: none"> • There is a slight undulation in the ridge tiles with sagging towards the east side. • The mortar bedding to the ridge tiles is weathering with bits missing in places. • Mortar pointing between ridge tiles is weathering out in some areas and missing in places. When water gets into the bedding, frost will begin to lift the ridge tiles. • There are numerous slipped or broken slates to right hand side of the roof and around the ridge. • Slates are covered in Lichen, probably due to the relatively low pitch. • Water table on eastern side adjoining chancel with concrete mortar fillet, no flashing, is weathering • A detailed inspection of the bell tower could not be carried out however the PCC advice that repair works are required.

<p>Repair Needs</p> <ul style="list-style-type: none"> • We advise that the roof to the nave be re-roofed. <ul style="list-style-type: none"> ◦ Slates should be replaced with natural slate of a matching size. Welsh slate is preferable due to its durability however good quality Spanish slate can also be used. 	<p>C</p>

<ul style="list-style-type: none"> ○ Installation of a breather membrane will give greater resilience to wind driven rain. ○ Repair or replacement of the ridge tiles. ○ Replacement of flashings at abutments. <p>Further details can be found in the 'Report on Roof inspection' document appended to this report.</p>	
--	-----------------------------------------------------------------------------------------------------------------------------------------------------------------------------------------------------------------------------------------------------------------------------------------------------------------------------------------------------------	--

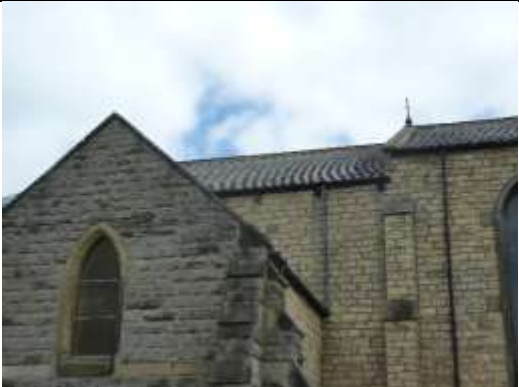
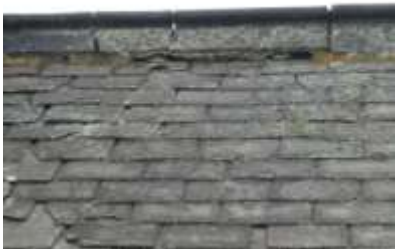
Northern Pitch of the Chancel Roof

<p>Condition</p> <ul style="list-style-type: none"> ● The ridge tile bedding is largely sound with some missing in places ● The stone cross on the left is in sound condition. ● Algae / moss growing generally. ● Flashings look sound. 	
	<p>Repair Needs</p> <ul style="list-style-type: none"> ● We advise that the roof to the chancel be re-roofed. <ul style="list-style-type: none"> ○ Slates should be replaced with natural slate of a matching size. Welsh slate is preferable due to its durability however good quality Spanish slate can also be used. ○ Installation of a breather membrane will give greater resilience to wind driven rain. ○ Repair or replacement of the ridge tiles. ○ Replacement of flashings at abutments.

Further details can be found in the 'Report on Roof inspection' document appended to this report.	
--	---------------------------------------------------------------------------------------------------	--

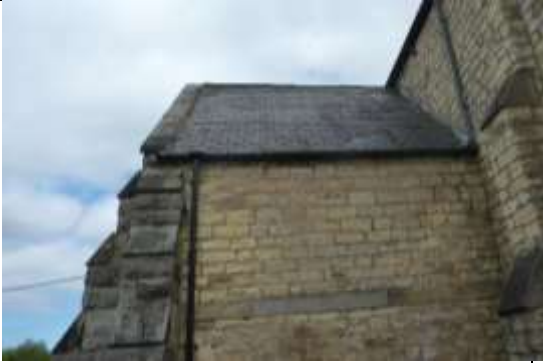
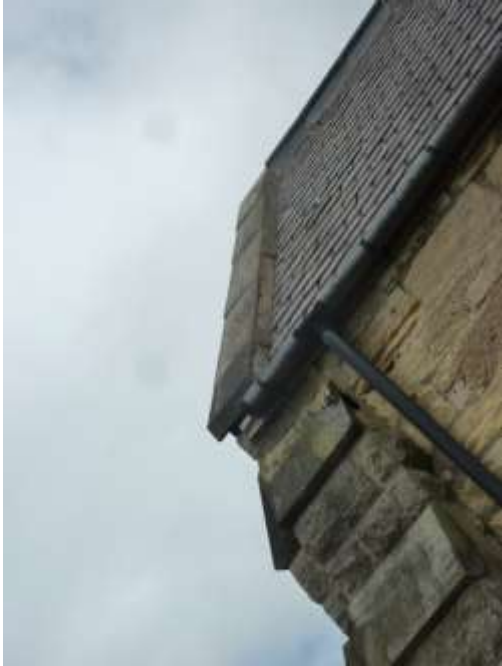
Organ Chamber Roof

<p>Condition</p> <ul style="list-style-type: none"> • Ridge tiles are well bedded, but with some gaps in between. • There are some slipped / broken slates. • Mortar fillet to water table is sound. • Lead flashing into Chancel wall with a mortar bed is sound. • Timber fascia for gutter broken at the exposed end. 	
	<p>Repair Needs</p> <ul style="list-style-type: none"> • Monitor slates and re-fix any which continue to slip, or are blown off. • Repoint ridge tiles, and at same time, check that they are soundly bedded, taking remedial action as required. 	<p>M D</p>

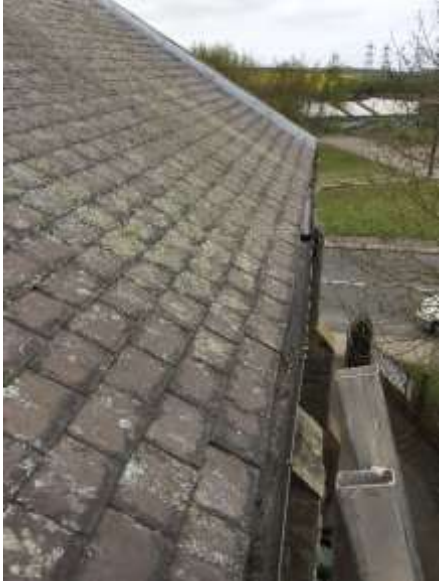
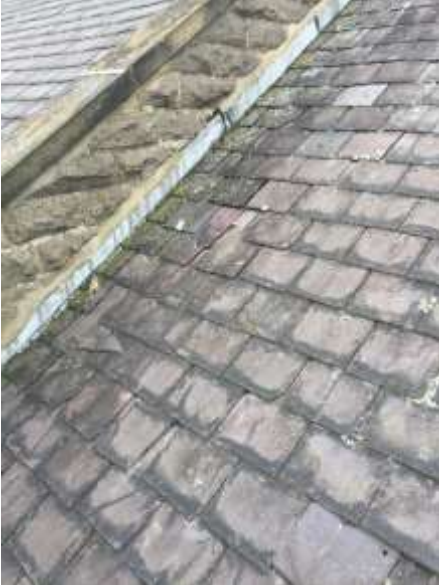
Southern Pitch of Chancel Roof

<p>Condition</p> <ul style="list-style-type: none"> • Algae / moss growing generally which is likely due to its relatively low pitch. • There are a few slipped and broken slates. • The mortar fillet above the lead flashing chased into the nave wall is breaking down and missing in places which will be allowing water to penetrate the stone wall. • Mortar bedding to the ridge tiles is starting to break down and mortar pointing between ridge tiles has weathered out in some locations. 	
	<p>Repair Needs</p> <ul style="list-style-type: none"> • We advise that the roof to the chancel be re-roofed. <ul style="list-style-type: none"> ○ Slates should be replaced with natural slate of a matching size. Welsh slate is preferable due to its durability however good quality Spanish slate can also be used. ○ Installation of a breather membrane will give greater resilience to wind driven rain. ○ Repair or replacement of the ridge tiles. ○ Replacement of flashings at abutments.

Further details can be found in the 'Report on Roof inspection' document appended to this report.	
--	---------------------------------------------------------------------------------------------------	--

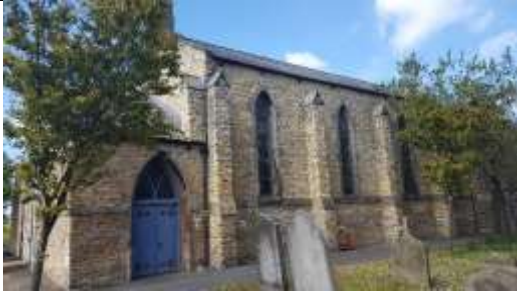
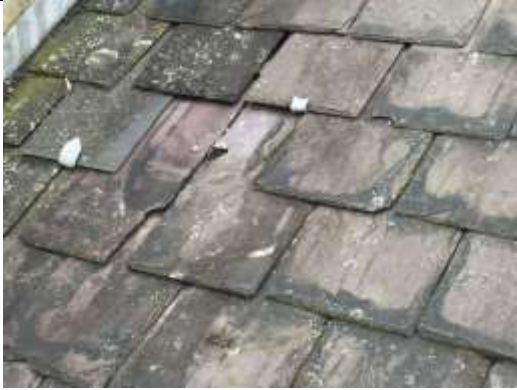
<p>Condition</p> <ul style="list-style-type: none"> • Algae / moss growing generally which is likely due to its relatively low pitch. • There are a few slipped and broken slates. • Mortar bedding to the ridge tiles is starting to break down and mortar pointing between ridge tiles has weathered out in some locations. 	
	<p>Repair Needs</p> <ul style="list-style-type: none"> • We advise that the roof to the chancel be re-roofed. <ul style="list-style-type: none"> ○ Slates should be replaced with natural slate of a matching size. Welsh slate is preferable due to its durability however good quality Spanish slate can also be used. ○ Installation of a breather membrane will give greater resilience to wind driven rain. ○ Repair or replacement of the ridge tiles. ○ Replacement of flashings at abutments. <p>Further details can be found in the 'Report on Roof inspection' document appended to this report.</p>

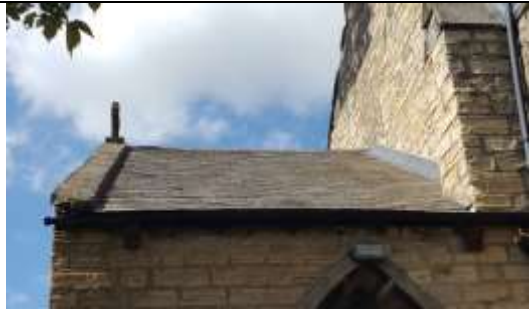
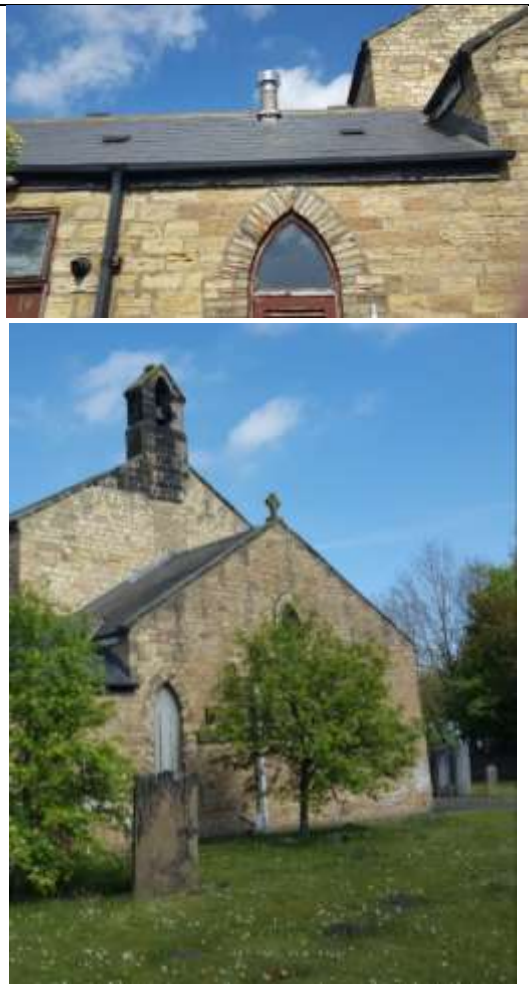
<p>Condition</p> <p>Roof to West Gable</p> <ul style="list-style-type: none"> • Stone cross appears to be in good condition, it may have been replaced in recent years. • Bottom coping stone on south pitch is broken and appears to have moved / slipped. • Ridge tiles appear to bow in the centre. • Some slipped / missing slates. • Mortar fillet to nave buttress has broken at the front. • Flashing to Nave wall appears sound • Mortar fillet to water table appears sound. <p>Roof over vestry link to extension</p> <ul style="list-style-type: none"> • Mortar bedding and pointing to ridge tiles appear sound. • Flashings appear sound. • Slates appear sound.

<p>Repair Needs</p> <ul style="list-style-type: none">• Mortar fillet to be repaired to prevent water ingress.• Monitor slates and re-fix any which continue to slip.	<p>D M</p>
-----------------------------------------------------------------------------------	-----------------------------------------------------------------------------------------------------------------------------------------------------------------------------------------------------	----------------

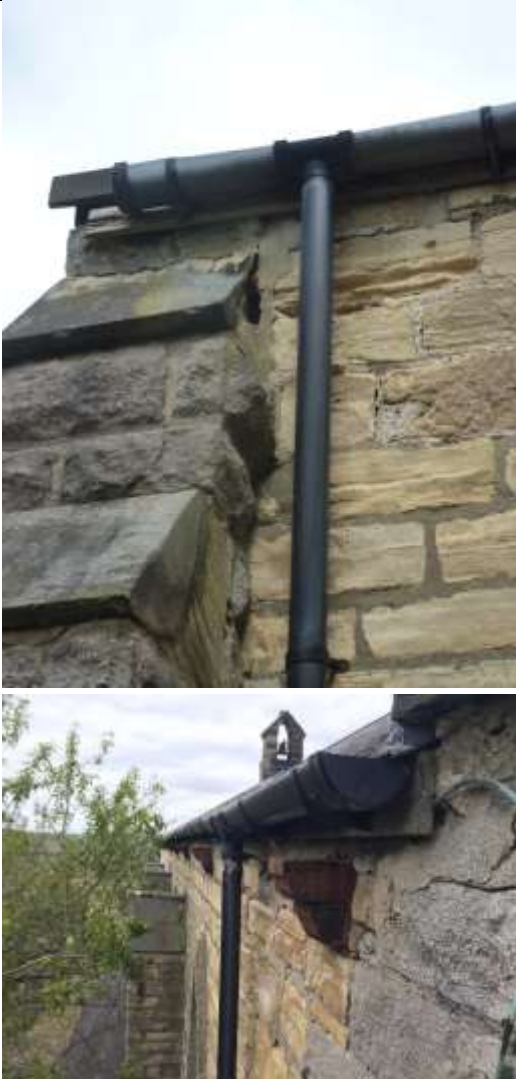
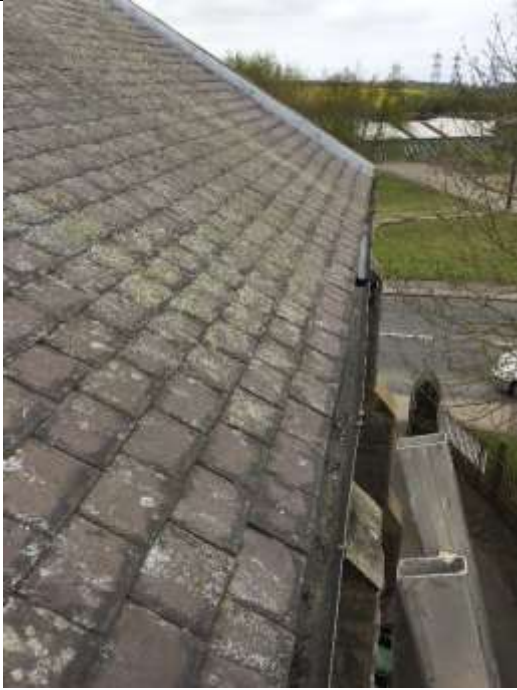
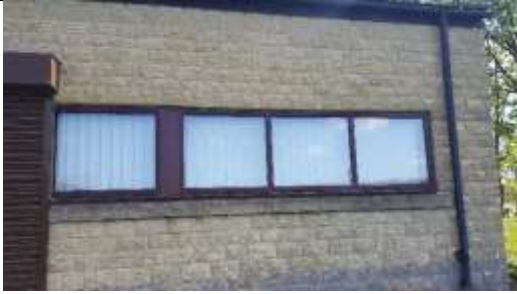
<p>Condition</p> <ul style="list-style-type: none"> • Shoe of Rainwater down comer is missing on community hall north elevation. • There is some evidence of debris/leaves in gutters. • An assessment of the rainwater run off suggests that the existing gutters are only just sufficiently sized for the roof. They are also in poor condition, with numerous ad hoc repairs.

<p>Repair Needs</p> <ul style="list-style-type: none"> • During the re-roofing works to the Nave & the Chancel the opportunity should be taken to renew the rainwater goods with a product sized appropriately for the roof and more durable. We would propose using an aluminium ogee type gutter with a matching 76mm diameter circular rainwater down pipe. Further details can be found in the 'Report on Roof Inspection' document appended to this report. • Continue to clear gutters of debris and leaves. • Replace shoe of down comer to community hall, water discharging onto the pavement can cause a slip hazard in freezing weather. PCC might consider using grit and salt in freezing weather until the repair can be made. 	<p>C</p> <p>M</p> <p>D</p>

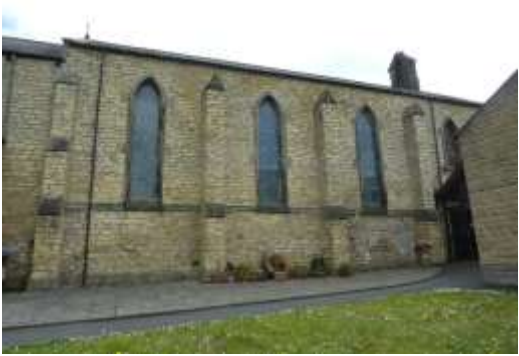
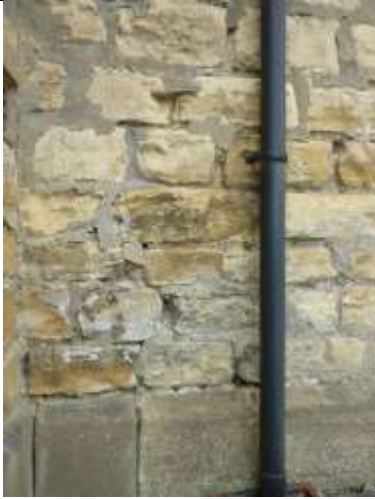
<p>Condition</p> <ul style="list-style-type: none"> • Generally sound with some individual stone weathering • Unsightly Cement pointing below the sill level string course. • Slight delamination of stones in places. • Repointing required to vertical joints in stone plinth. • Pronounced weathering of buttress and coping stones • Some efflorescence below string course in the bay next to main entrance. 	
	<p>Repair Needs</p> <ul style="list-style-type: none"> • Need for some localised re-pointing below string course. (Any re-pointing to be done with a suitable lime mortar) 	<p>D</p>

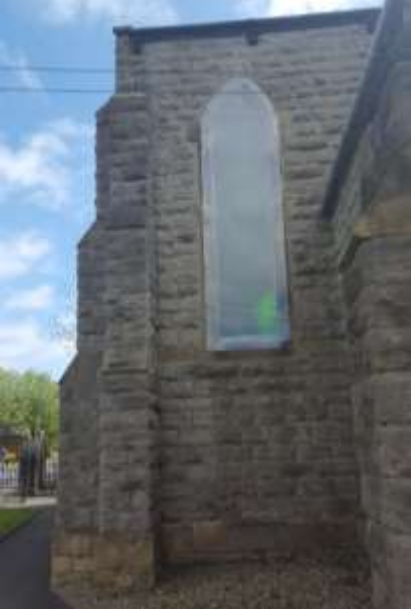
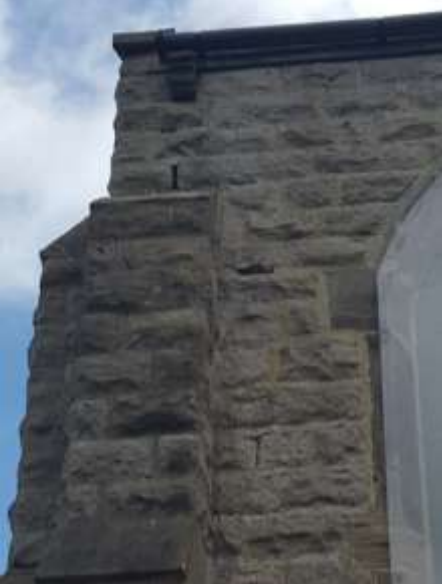
<p>Condition</p> <ul style="list-style-type: none"> • The section of wall east of the Organ Chamber has some modern cement mortar however generally sound. • There are some open mortar joints. 	
	<p>Repair Needs</p> <ul style="list-style-type: none"> • Repoint open mortar joint, using a suitable lime mortar. 	<p>D</p>

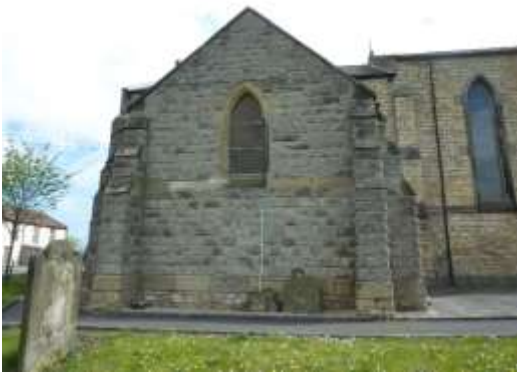
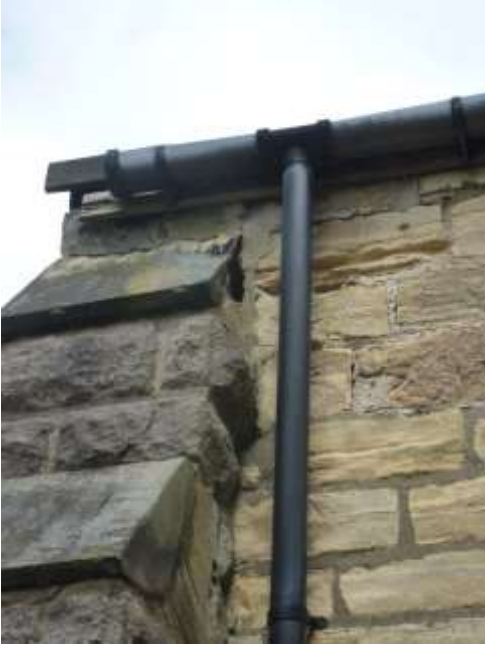
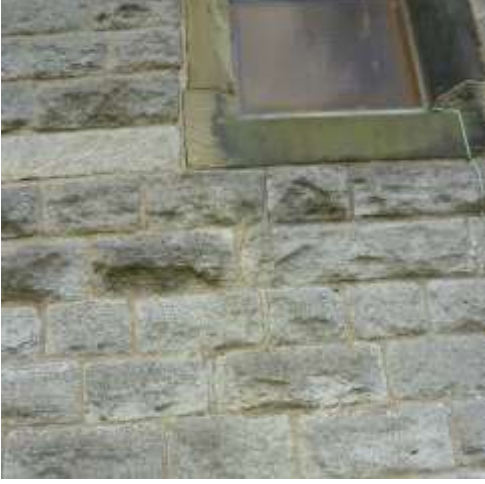
<p>Condition</p> <ul style="list-style-type: none"> • Some areas of re-pointing required • Some stones showing weathering • There is a hole in the wall adjacent to the cap stone of the buttress on the west elevation. • There is a settlement / movement crack below the window on the south elevation to the left hand side. • There are some signs of movement below the coping stones on the left hand side, resulting in open vertical mortar joints. • There is a crack below the window on the east elevation to the left hand side.

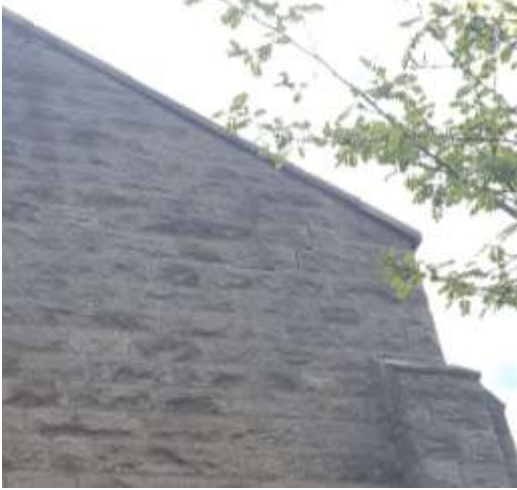
<p>Condition</p> <ul style="list-style-type: none"> • A crack below right hand side kneeler stone. • Pointing is weathering out below coping stones. • Cracks to left hand side kneeler stone and buttress. 	
	<p>Repair Needs</p> <ul style="list-style-type: none"> • Repointing below coping stones required, using a suitable lime mortar. 	<p>C</p>

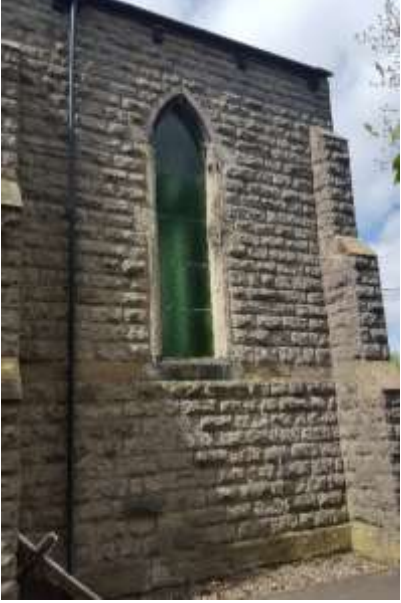
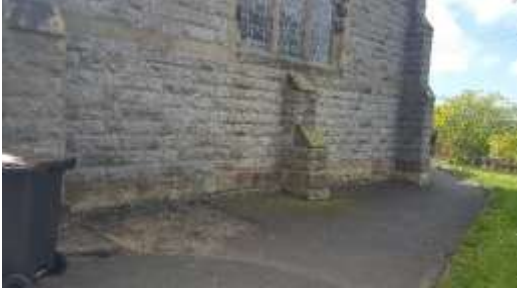
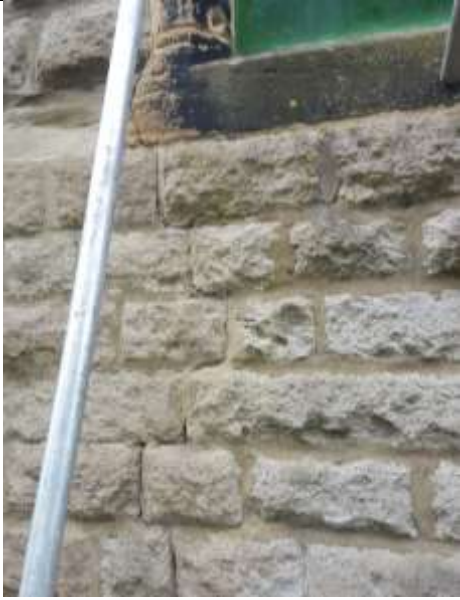
<p>Condition</p> <ul style="list-style-type: none"> • Stone and pointing generally sound. • Movement crack along left hand side of window W.03, to wall above and below the window and also in the quoin. Movement cracks appear to have already been re-pointed at head of window.

<p>Repair Needs</p> <ul style="list-style-type: none"> • Monitor cracking to walls above and below W.03 	<p>M</p>

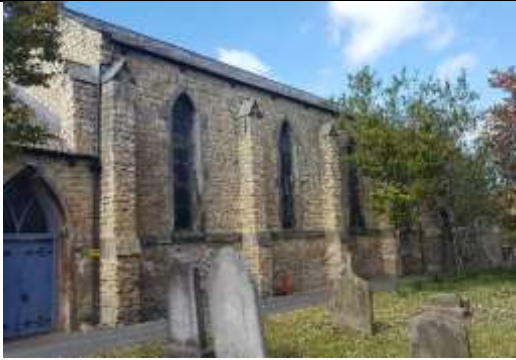
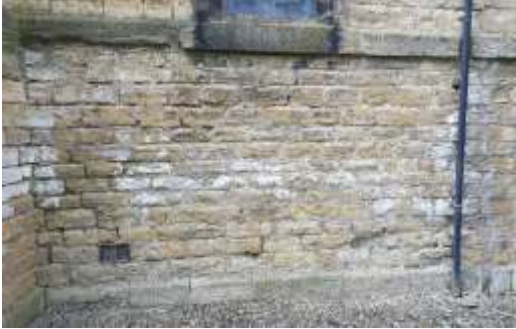
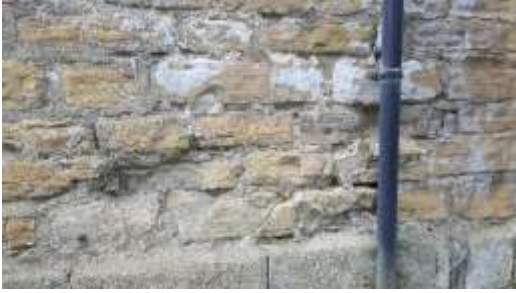
<p>Condition</p> <ul style="list-style-type: none"> • Pointing is weathering out in areas, particularly below string course. • Stones below string course are weathering. • Some modern cement mortar present but has mostly come away. • Efflorescence present on base stones below string course.

<p>Repair Needs</p> <ul style="list-style-type: none"> • Some areas of repointing required below string course, using a suitable lime mortar. • Brush off the worst of any remaining efflorescence if required 	<p>D</p> <p>M</p>

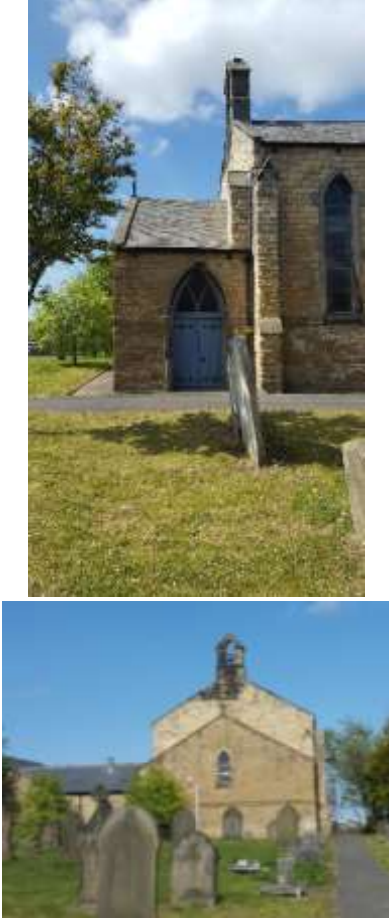
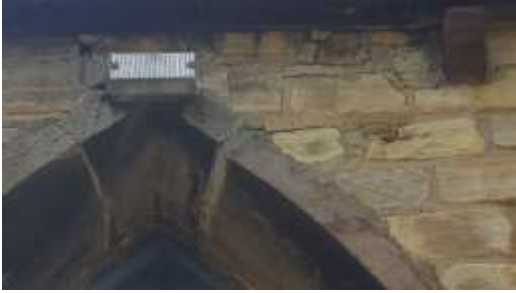
<p>Condition</p> <p><u>South Elevation of Vestry</u></p> <ul style="list-style-type: none"> • Ashlar stone to right hand side of door behind the RWDP is considerably eroded. Efflorescence is also present in this area. • There is signs of movement above the door archway (D.01), with mortar cracking visible.

<p>Repair Needs</p> <ul style="list-style-type: none"> • Some areas of repointing required, using a suitable lime mortar. • Monitor cracking above Door D.01 	<p>D</p> <p>M</p>

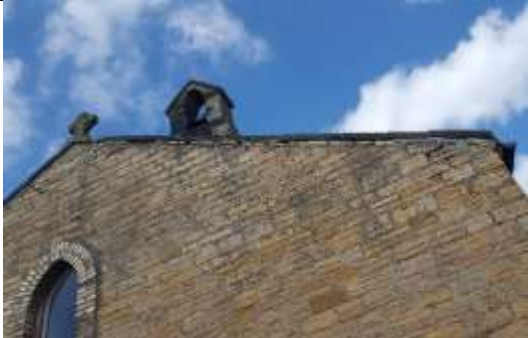
<ul style="list-style-type: none"> • Modern cement mortar is cracking and coming away.

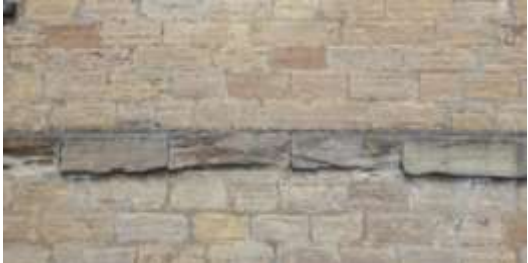
<p><u>West Elevation of Vestry</u></p> <ul style="list-style-type: none"> • Heavily eroded stones at the base. • String course stones are also heavily eroded. • Efflorescence is present at base. • The mortar joint below the stone copings are in poor condition and largely missing. Stone pinning's are visible where mortar has weathered. • The bottom coping stone on south side of roof appears to have moved / slipped.

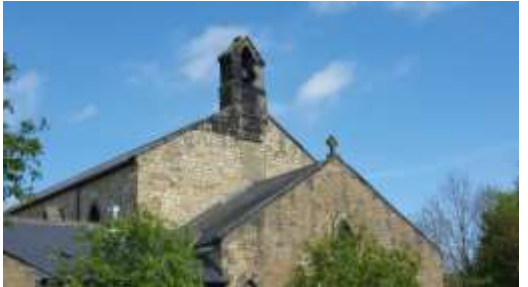
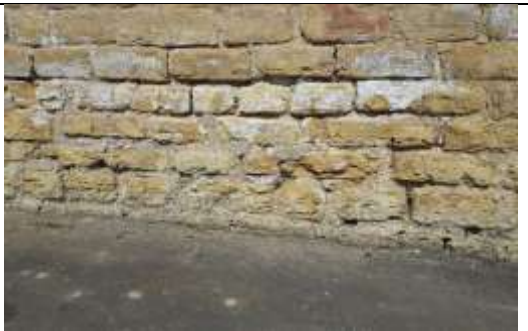
<p><u>West Elevation of Nave (High Level)</u></p> <ul style="list-style-type: none"> • There is some atmospheric staining to the stone at high level, including on the bell tower. • Some coping stones on north pitch appear to be broken / missing and pointing below appears to be weathering.

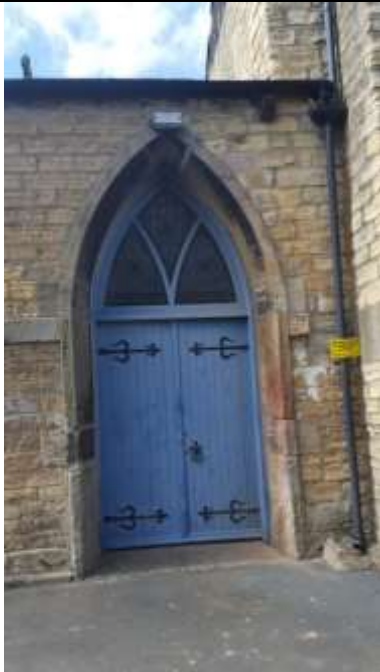
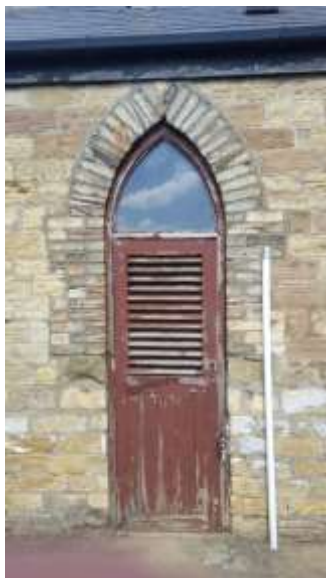
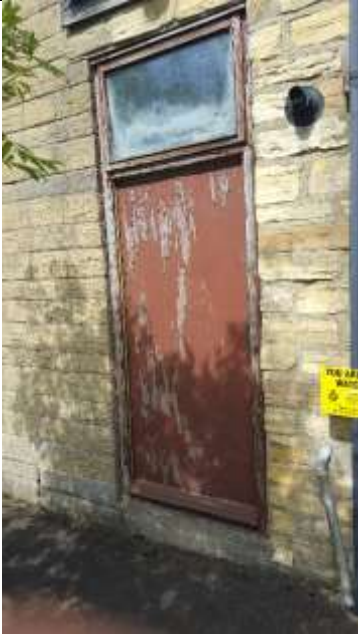
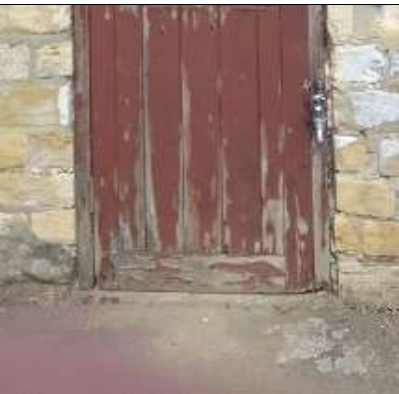
<p>Condition</p> <ul style="list-style-type: none"> • D.01 is in reasonable condition although the paintwork is deteriorating. • The paintwork on D.02 and D.03 is in poor condition and has started peeling. • The timber at the bottom of D.02 and its frame has badly deteriorated.

<p>Repair Needs</p> <ul style="list-style-type: none"> • All doors would benefit from repainting to prolong their lifespan. Flaking paint should be removed first. • The timber frame of D.02 requires a splice repair to the bottom, suggest 30cm of door frame. 	<p>B</p> <p>B</p>

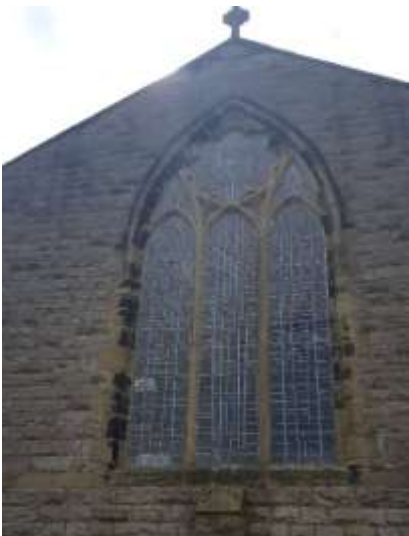
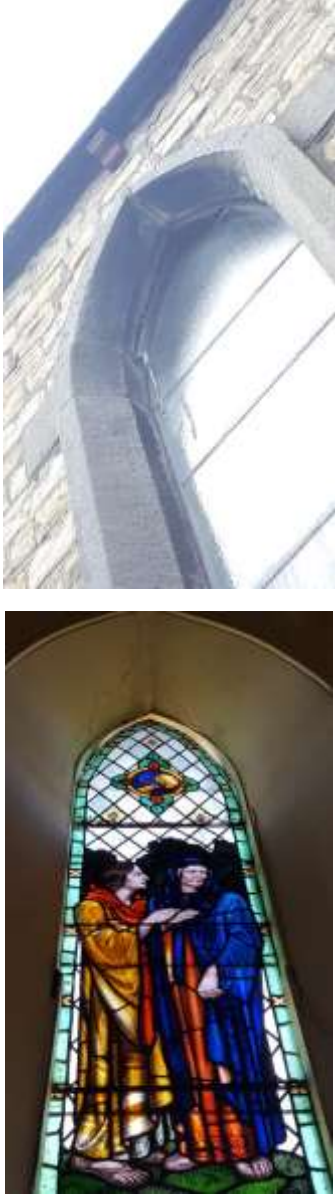
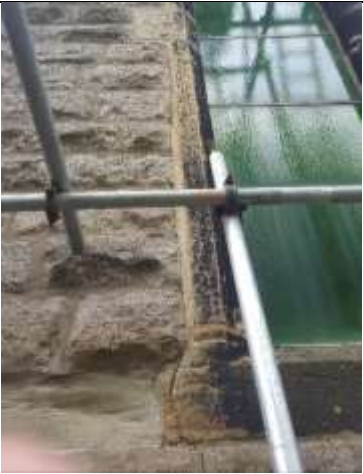
<p>Condition</p> <ul style="list-style-type: none"> • Windows W.01 & W.13 have broken glass panes. • Generally stone surrounds are sound although some are weathering and have staining at varying degrees present. • There is a gap at the head of window W.07 between the stone. • The stones below the arch of W.06 appear to be out of line with the arch stones, which indicates some movement has occurred. • The mortar fillet at W.02 is eroding at the bottom. • There is some cracking on left hand quoins to W.03 and some holes which are likely to be from previous fixings. • There is a broken stone below the arch at W.05. • Plaster reveals to windows internally have varying degrees of cracking and bulging of plaster / paint. • W.05 has small pieces of stained glass broken and missing. • W.04 some stained glass pieces are missing and some areas appear to be bulging. • The stained glass on W.06 appears to be bulging at the top. • W.01 has some damaged panes and the stone surround appears to be damaged at the top. There is a large amount of cob webs.

<p>Repair Needs</p> <ul style="list-style-type: none"> • The PCC should consider Polycarbonate protection to the windows that do not currently have it. • Monitor cracking to the stone surrounds • Repoint Mortar fillets at the bottom of window surrounds 	<p>E</p> <p>M</p> <p>C</p>

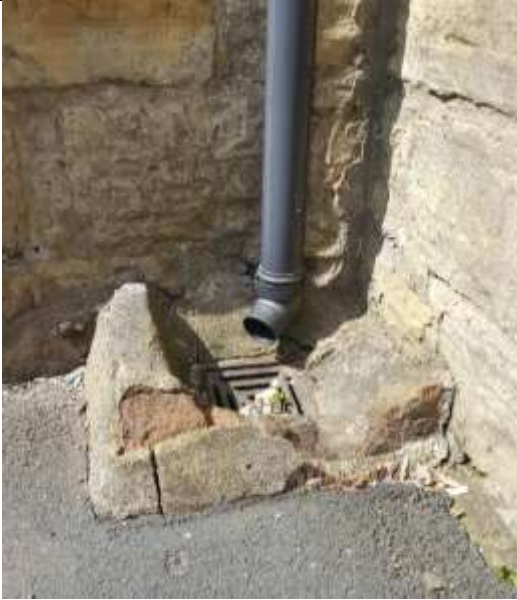
<p>Condition</p> <ul style="list-style-type: none"> Stone are damaged around the gully adjacent to the old entrance door into the vestry. 	
	<p>Repair Needs</p> <ul style="list-style-type: none"> Stones around gully could be replaced 	<p>E</p>

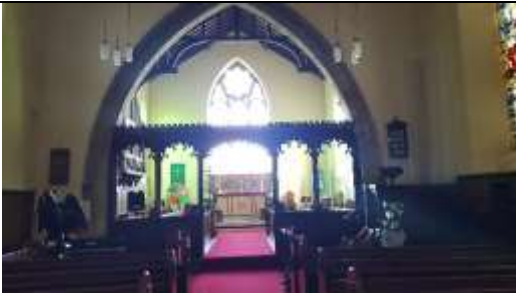
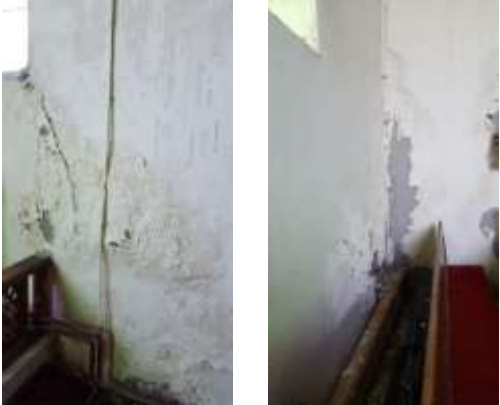
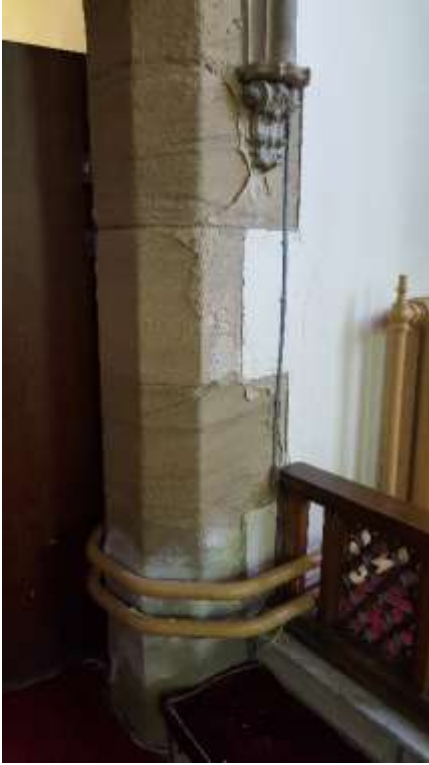
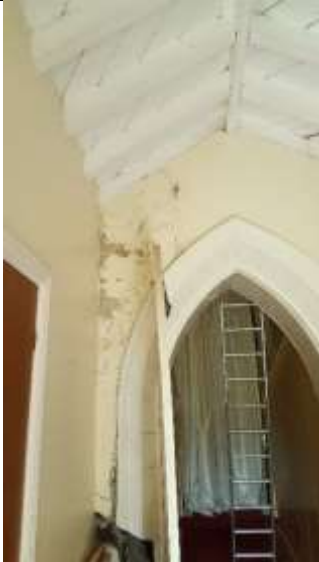
<p>Condition</p> <ul style="list-style-type: none"> • There is a large damp patch on the wall next to the old entrance door (D.01) in the vestry. • Plastered walls within the Nave are generally in good condition. Although signs of damp are present in the corner behind the pulpit. • Both stone arches are damp and some delamination of the stone face is occurring at low level. Salt Crystals and Efflorescence are also present. • There is extensive damp to the walls within the Chancel, particularly along the southern wall and the internal wall between chancel and nave. There is water staining visible on both walls from high level down the wall. • There is localised delamination of the plaster from the substrate at low level and the paint finish is peeling. • There is a patch repair with modern cement/ plaster present at low level. • There is a patch of damp upstairs above the door through to the balcony. Paint is flaking. This indicates water ingress from the junction in the nave / vestry roof above.

<p>Repair Needs</p> <ul style="list-style-type: none"> Once the roof has been replaced, brush down loose plaster / salts once the walls have dried out. Once the walls have dried out it might be worth the PCC getting specialist to assess the stone and mortar to determine if any remedial plaster treatment is required. Inspection of the flashing between Nave and Vestry roofs due to evidence of water ingress internally. The flashing may need replacing. 	<p>E</p> <p>C</p>
-----------------------------------------------------------------------------------	-----------------------------------------------------------------------------------------------------------------------------------------------------------------------------------------------------------------------------------------------------------------------------------------------------------------------------------------------------------------------------------------------------------------------------------------------------------------------------------------------------	-------------------

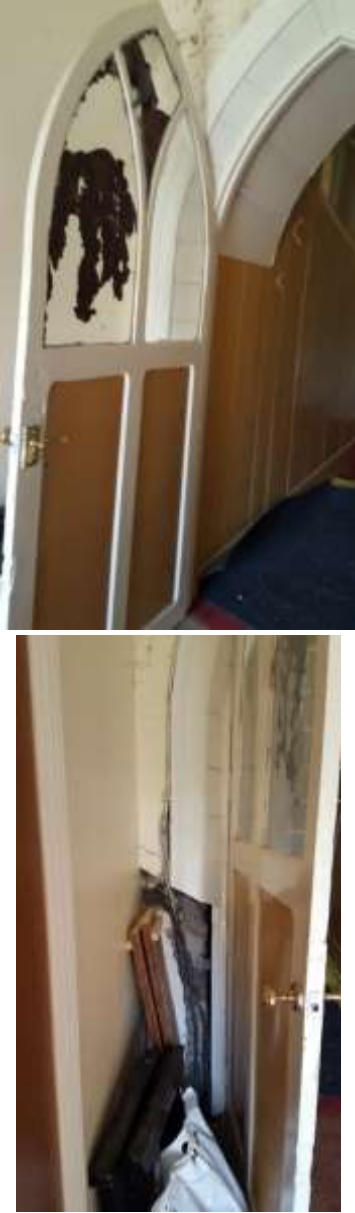
<p>Condition</p> <ul style="list-style-type: none"> • Doors on the ground floor appear to be in good condition. • Damage to the top panes of the upstairs door to the balcony. • The architrave has been cut away on the left hand side of the door at low level. 	
	<p>Repair Needs</p> <ul style="list-style-type: none"> • Redecoration of aging internal door finishes 	<p>E</p>

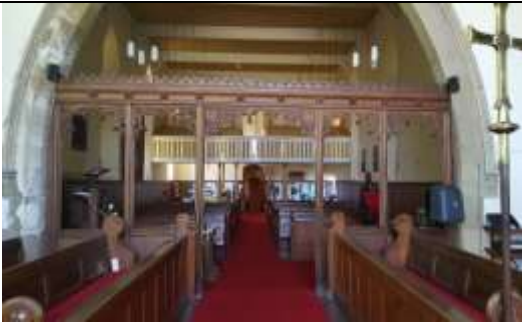
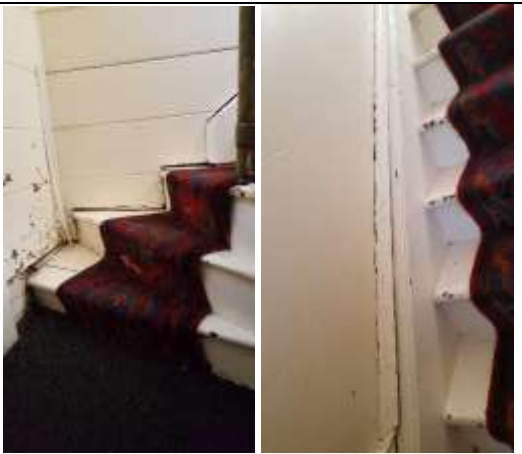
<p>Condition</p> <ul style="list-style-type: none"> • All flooring appears to be in good condition. • The bottom step of the access stair has settled to one side, otherwise staircase appears sound. This is a safety hazard. • There is a gap between stringer and wall, which is unsightly.

<p>Repair Needs</p> <ul style="list-style-type: none"> • Suggest the bottom step is taken apart and re-built level. 	<p>B</p>

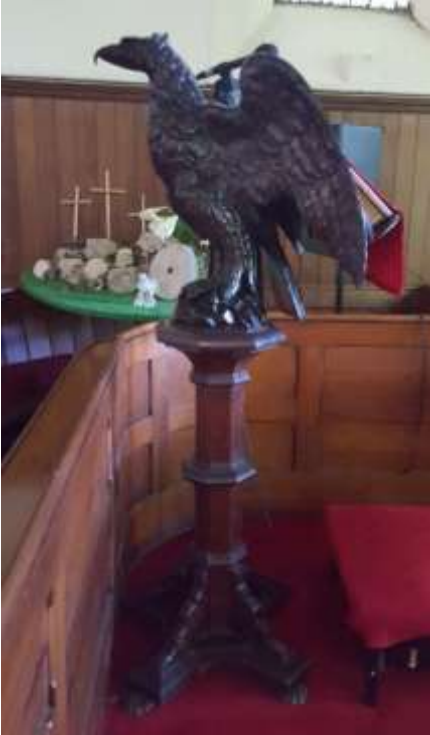
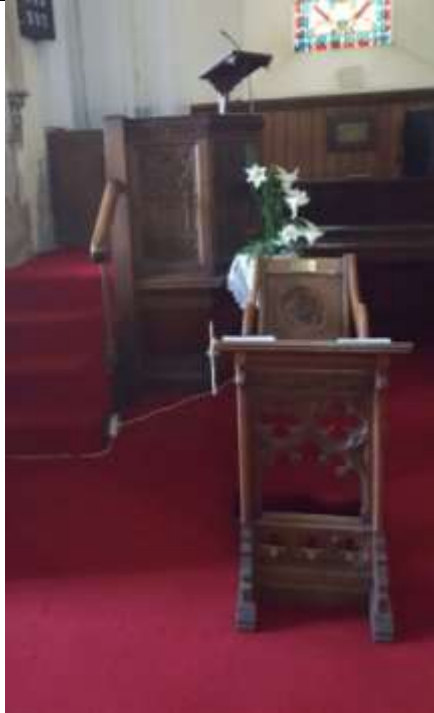
<p>Condition</p> <ul style="list-style-type: none"> • Pews to balcony appear secure and sound. • Pews within Nave appear sound and secure with rows 3rd, 6th & 7th from the back on the north side appearing a little loose. • Pews in the south side of the Chancel appear a little loose. • The pulpit is sound and stable. • The font appears in good condition. 	
	<p>Repair Needs</p> <ul style="list-style-type: none"> • None.

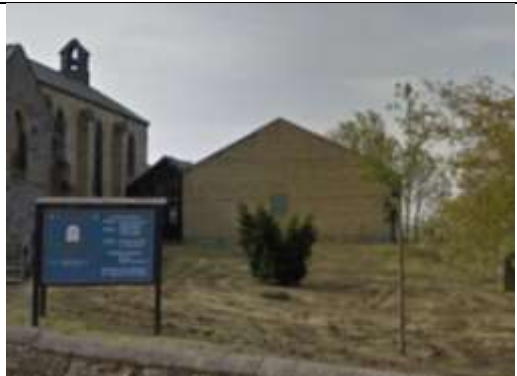
<p>Description</p> <ul style="list-style-type: none"> • Bradstone walls • Fibre Cement Slate Roofs with bedded ridge tiles • UPVC Windows 	
 	<p>Condition</p> <ul style="list-style-type: none"> • The lintels above the north facing windows either side of the door appear to be bowing over the last 3 window bays, there are also vertical cracks present which indicates movement of the wall.

<p>Repair Needs</p> <ul style="list-style-type: none"> • Monitor cracking above the window lintels. 	<p>M</p>
--	---------------------------------------------------------------------------------------------------------------------------	----------
