# ALL SAINTS SOUTH SHIELDS

**Boldon Lane West Harton  
(111)**

## QUINQUENNIAL REPORT

**26 June 2020**

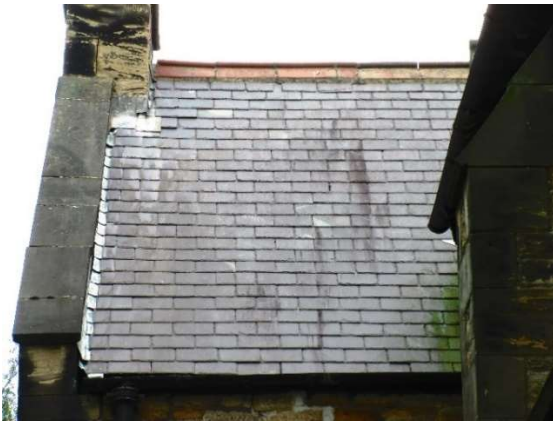
15. Organ chamber slate sound but outward movement of the W side of the gable has pulled apart the cover flashings and lead soakers, leaving a short gap where there may be some leakage, not visible inside. No visible change since last inspection.

W side of Organ Chamber – lead flashings at gable pulled apart

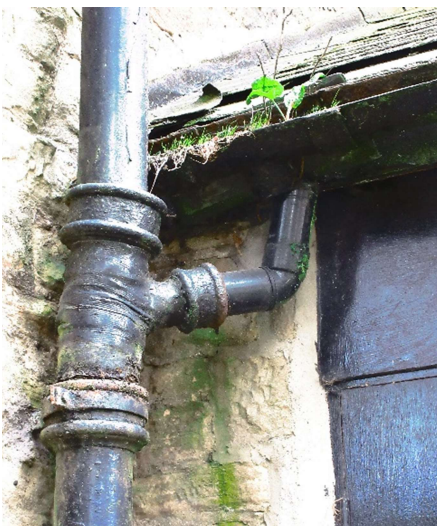
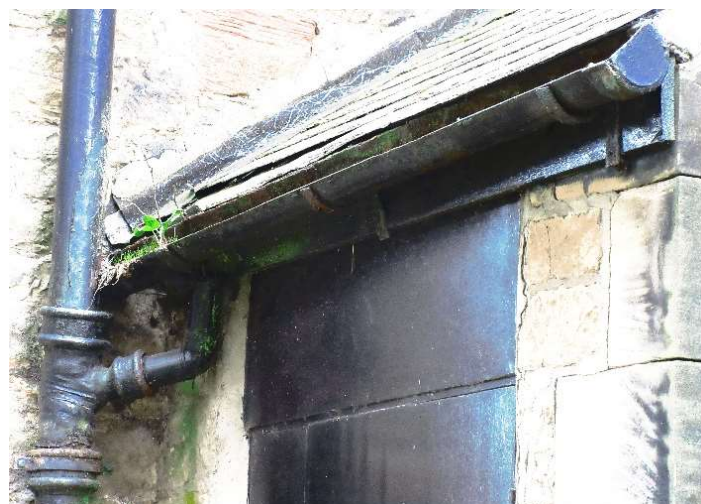
21. Church half round cast iron gutters on brackets with round pipes. Paint generally sound but rust at several open joints.
22. The S Nave gutter E end and S Chancel W end drop slightly from the outlets and are silted with plant growth. Need cleaning and releveling.
23. The Organ E gutter is decayed and tips outward. Under the W gutter green streaked stone suggests a leak
24. The N Porch gutter is choked and tipped out of its brackets. Its outlet is no longer connected so wets the wall.

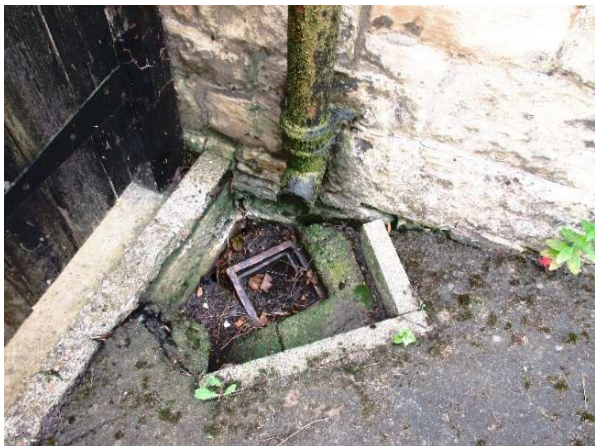
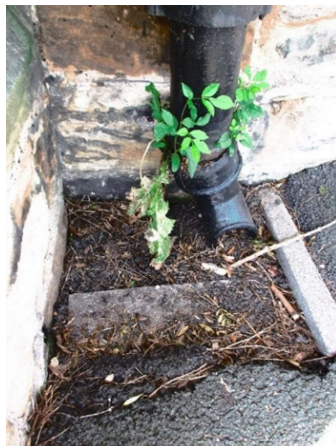
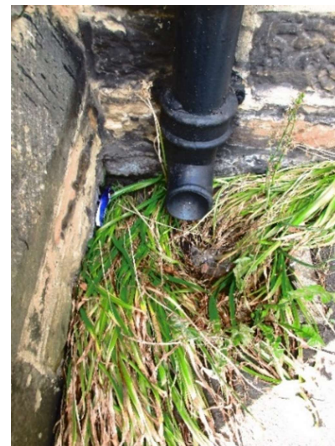
25. At W extension ogee gutters and square aluminium downpipes. The S gutter W end stop seems missing. Plastic downpipes from the W Porch.
26. The extension gullies and 100mm foul drains combine with earlier drains from the church gullies and connect to public sewer.
27. Several church gullies are choked. At least annual cleaning and flushing of drains is needed.

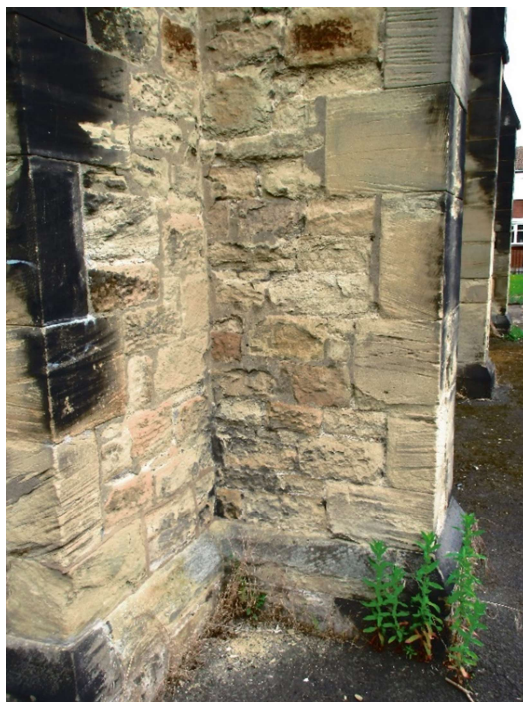
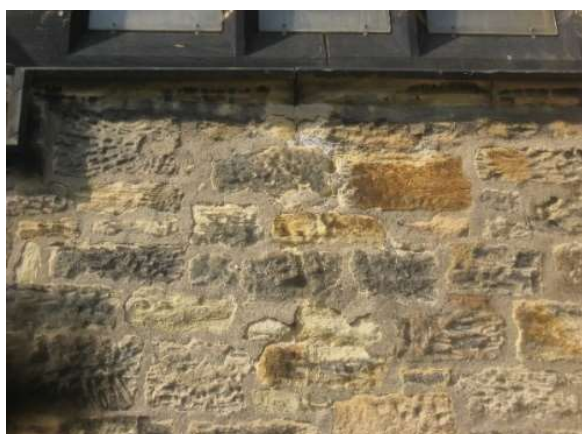
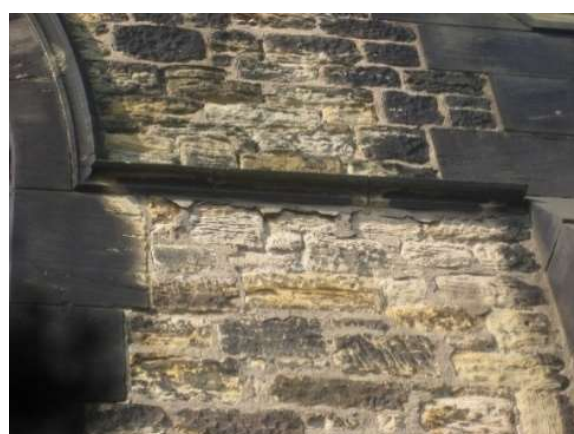
stone decay next to over-hard pointing under the window and under the string course near the N buttress

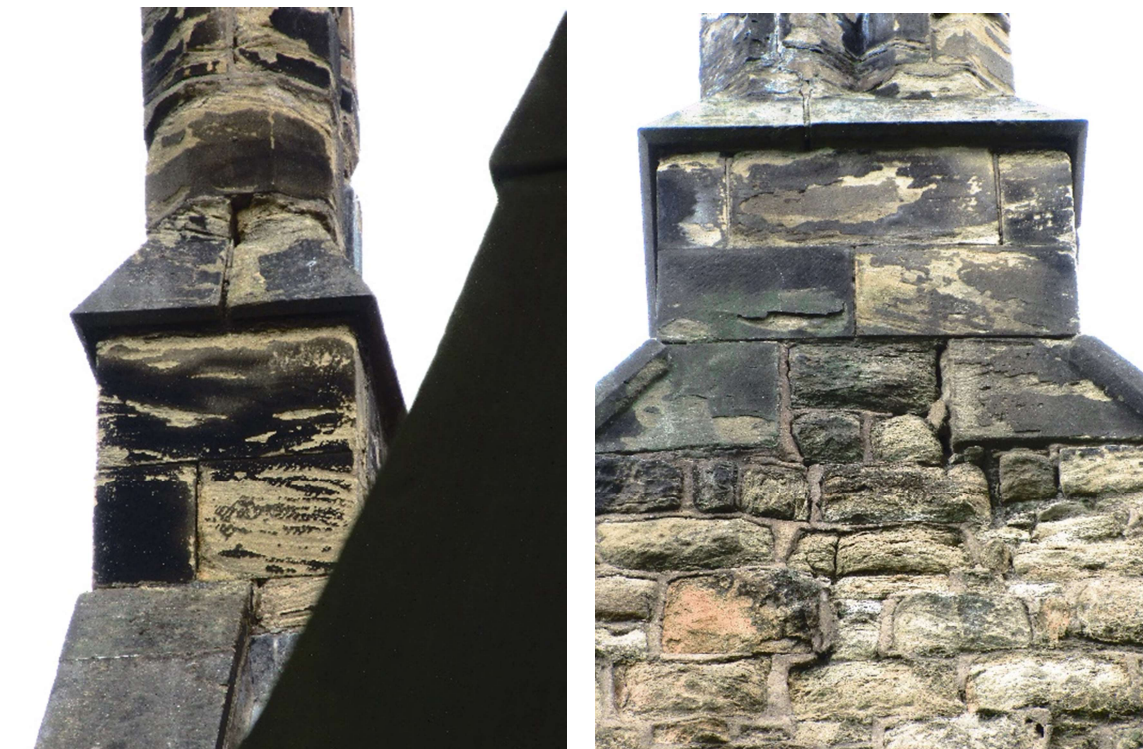
35. Linked twin octagonal chimney flues on a sloping base with drip over two courses of plain chimney. The caps and base seem sound dressed stone. The three course octagonal flues have old render repairs, are decaying from open joints but seem stable. Many joints open, especially at W where the two sloping base stones are decayed with an open hole between them. Replacements needed. No visible lean.

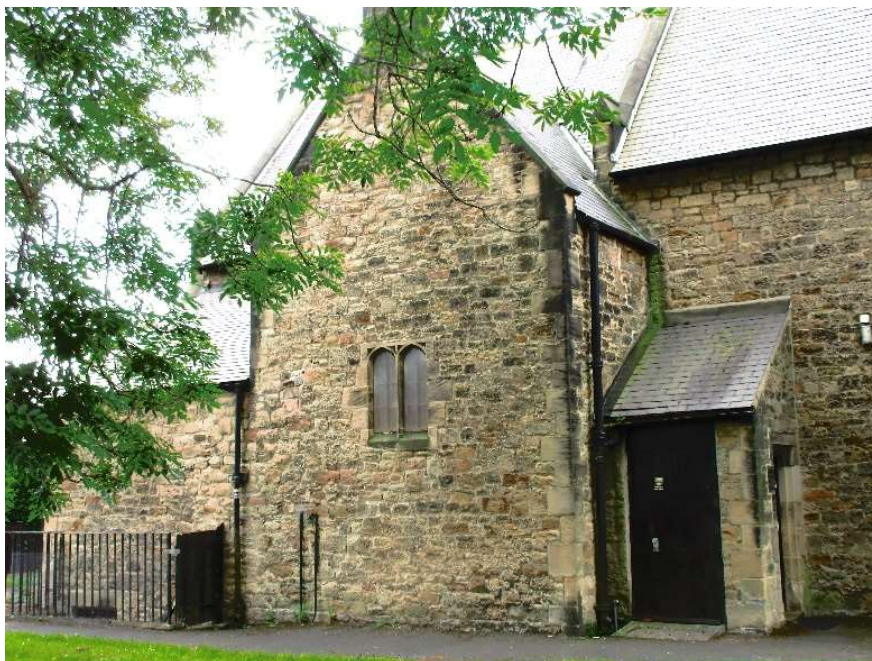
36. Under the chimney a patch of deeply weathered open joints and decayed stones are beyond repointing and need stone replacements to keep out the weather and the chimney stable.
37. The widest movement cracks were where the unbonded N Porch separated from the Nave and the very wide diagonal crack in the organ W wall. Both have been pointed in cement mortar and seem stable.

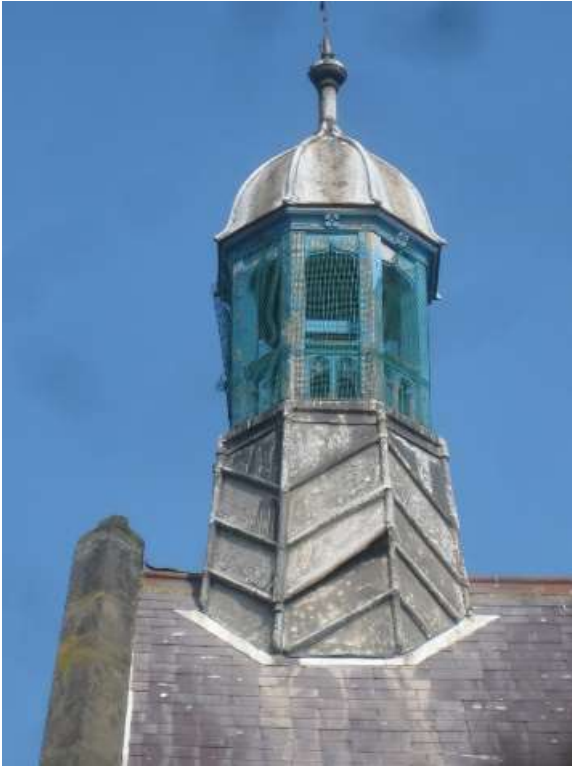
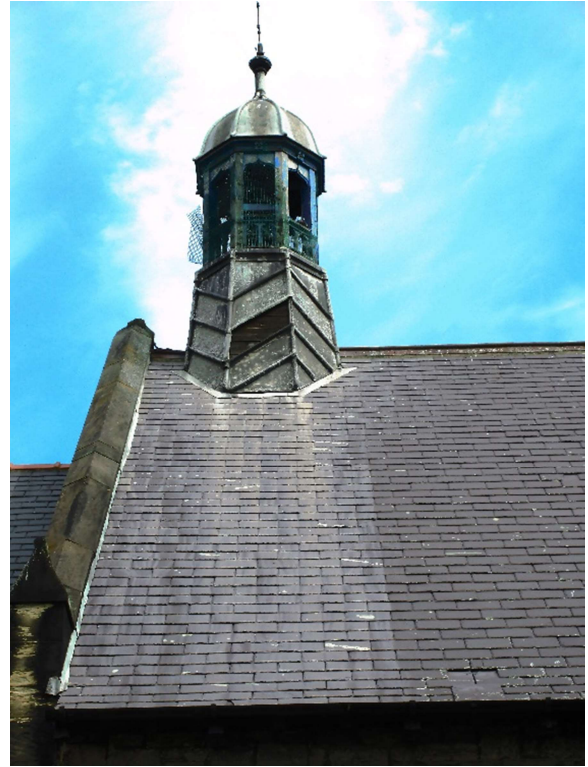
40. A graceful small octagonal turret near the W end of the Nave ridge is timber framed with lead clad dome and base and external plastic bird mesh over traceried timber openings. One S lead panel has fallen and is stored at the vicarage. Timber boards and diagonal rolls now exposed. The remaining exposed timber parts need paint. Parts of the mesh are loose. Otherwise appears sound though no close access. The exposed timber will decay if left unprotected and the time comes for general repair and painting from scaffold.

2015 lead panel coming loose      2020 lead panel missing from S side of turret and slate slipped from Nave eave

Repair slates	13, 14, 19
Clear hidden lead gutter	16
Clean and refix parts of the guttering and gullies	22 – 25, 27
From scaffold around turret assess and repair including lead	40
Wash grease from Kitchen extract fan including inside	71
Renew failed lamps at Nave and upper room	98, 99

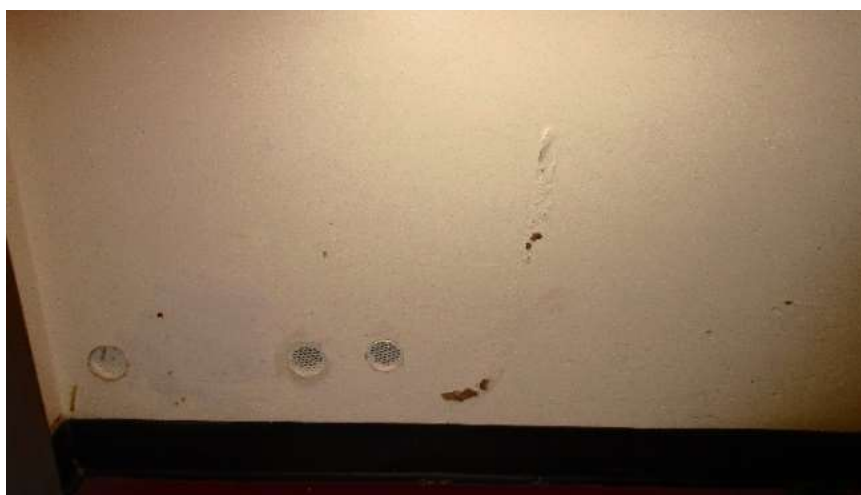
69. The extension walls are sound painted plaster. At Kitchen, coffee bar and wcs vinyl sheet splashbacks over the worktops and basins. Minor cracked plaster again in W entry lobby by inner door N frame. In Ladies lobby damage by rising damp at original W wall of Nave has been repaired with added plaster vents. Minor paint damage has appeared again.

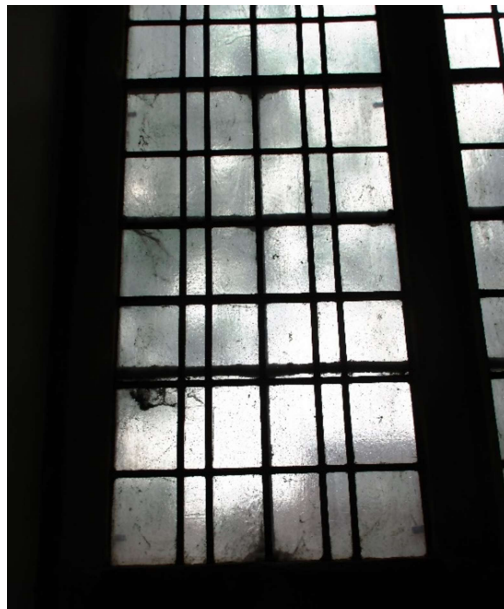
74. All windows have ventilated polycarbonate well fitted to the tracery. Clouded by sunlight or very dirty inside at E, S and W, especially at the tracery of Chancel SE window

Replace water marked ceiling tiles upstairs	56
Clean between glass and protection	74, 75

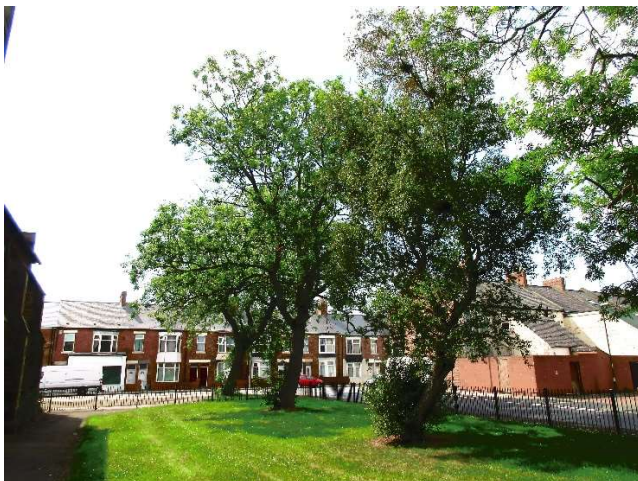
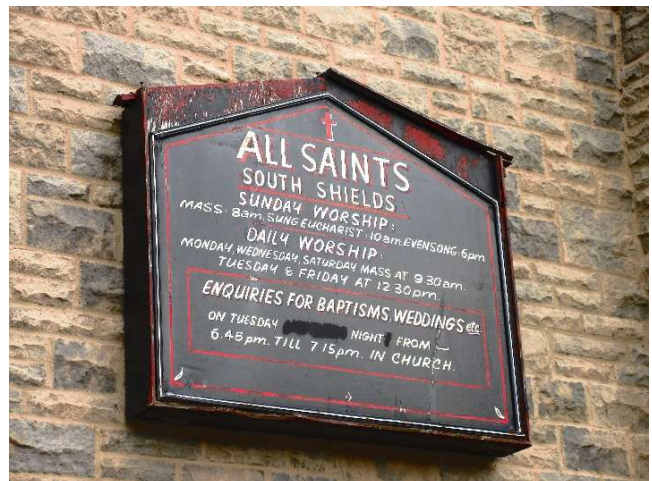
113. Small flat grounds maintained by the local authority. The remaining mature ash trees (three at N, one at S with single silver birches each side) are important in the townscape. The grassed site has steel railings and gates, where rust has begun in places.

114. A painted wooden sign on the church W wall has lost part of its cap and deteriorates.
