**Quinquennial Inspection Report
The Church of St Stephen's, South Shields
Archdeaconry of Sunderland
Deanery of Jarrow
Diocese of Durham**

David Jowett - Architect, BA, DipArch, RIBA
25 Roseworth Avenue
Gosforth
Newcastle upon Tyne
NE3 1NB
Tel: 07788 710 204
email: david@davidjowett-architect.co.uk

18 December 2024

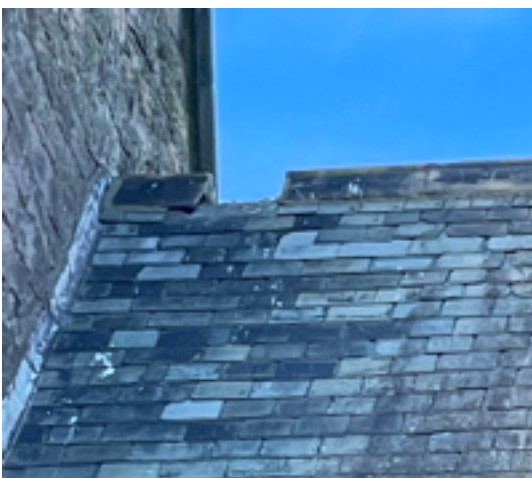
Overall the slating appears in reasonable condition, as are the flashings and most of the ridges. A missing ridge tile to the Chancel should be replaced immediately. There are a few slipped, broken and incorrectly sized slates, notable a broken slate to the nave west end south elevation; an incorrectly sized slate to the Porch west elevation; broken and missing slates to the chancel south elevation; a chipped slate to the organ north elevation. There have been slate repairs in non-matching slates that would be better replaced with Westmorland slate. There was no access to view the flat roof to the meeting room or the hidden lead lined gutters.

Missing Chancel Ridge Tile

Replace missing ridge tile. Cost Band 1– £0.00-£1,999.

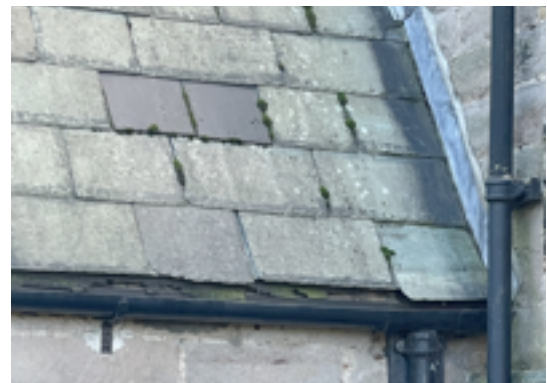
Non-Matching Repairs to Porch

Replace none matching slates with Westmorland slates. Cost Band 2– £2,000.00-£9,999.

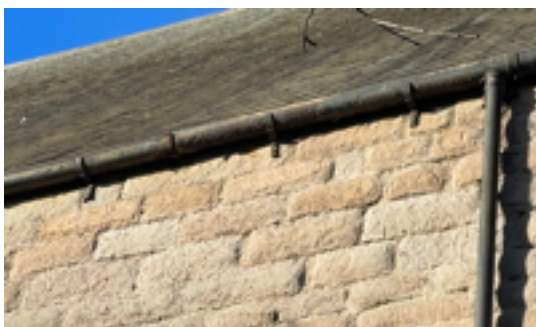
Rainwater goods to the church, both gutters and rainwater pipes, are in urgent need of decoration. Some joints require resealing and wooden blocks behind fittings are, in some cases, rotten and require replacement.

Rusting Gutters South Elevation

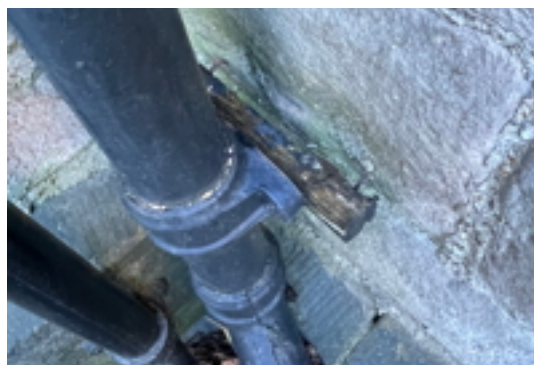
Rotten Wood Block South Elevation

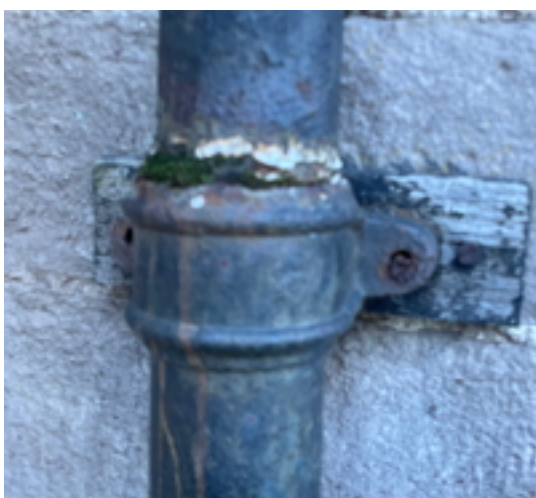
Decayed Joint

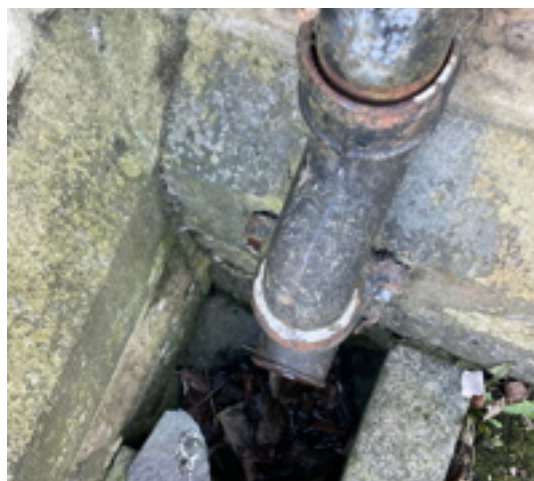
Rusting Rainwater Pipe North Porch

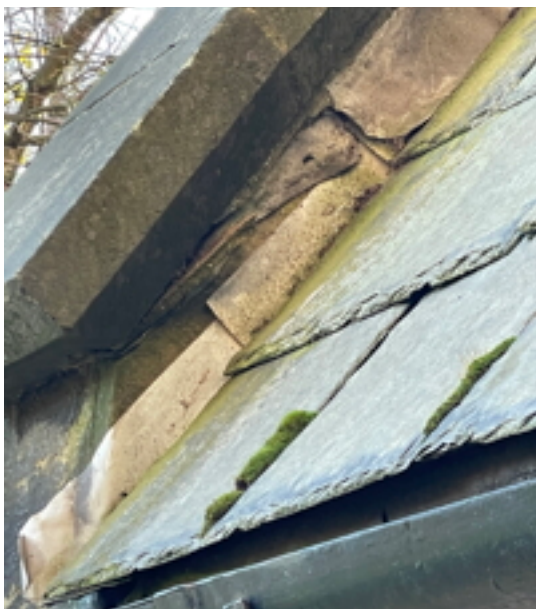
Missing lead flashing to south porch east and west elevations. Misaligned coping and leadwork to nave south elevation east end. A vestry chimney has been reduced to a stepped return parapet in stone and brick with concrete tables. West end north gable coping stone displaced near peak.

Porch Missing Flashing East Elevation

Replace missing flashings to south porch. Reform lead flashing to nave east end south elevation to fully cover soakers and secure copings. Cost Band 2– £2,000.00-£9,999.

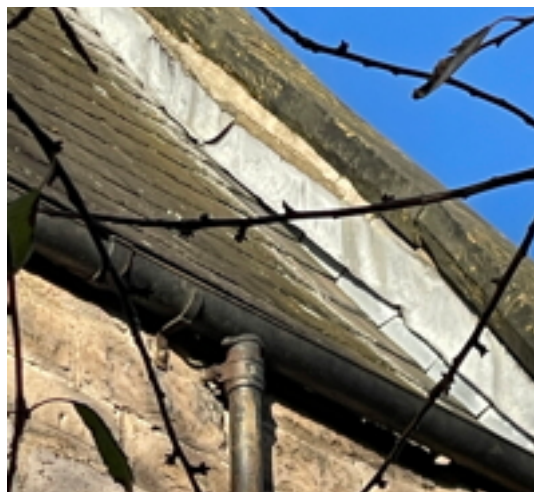
Missing Aligned Copings and Flashing Nave East End South Elevation

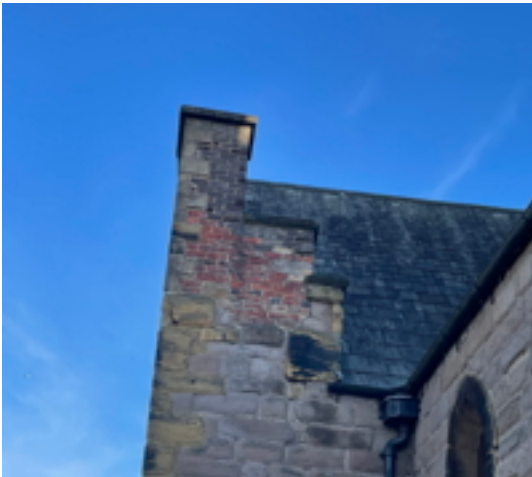
Vestry Chimney West Elevation

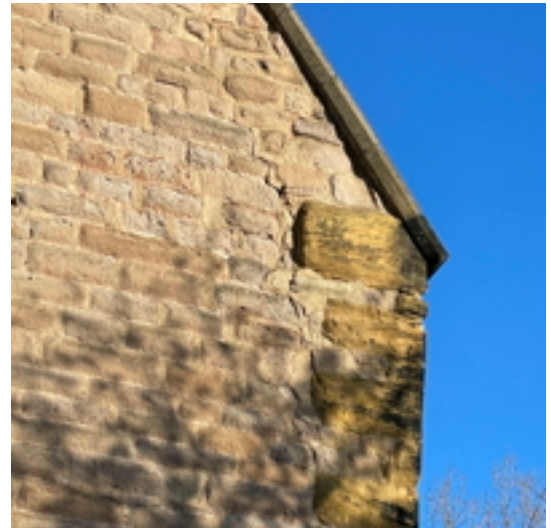
West Gable South Side Cracking

There is an open joint in the tower west elevation. There is cracking at the foot of the west gable south side.

Monitor existing areas of stone decay and any slightly open joints. Delaminating stones should be brushed down and washed with clean water as loose and friable stone holds water that can freeze in cold weather accelerating the de-lamination. Cost Band 1– £0.00-£1,999.

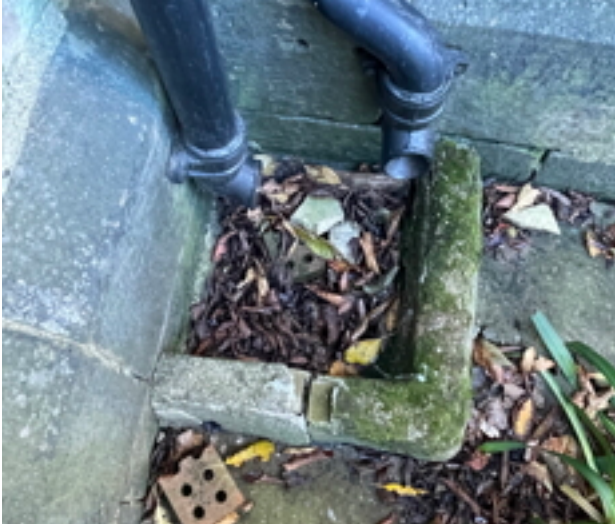
Gullies generally blocked with leaves. Gully surround at chancel south elevation west end needs to be remade. Missing grating south porch west elevation.

Blocked Gully

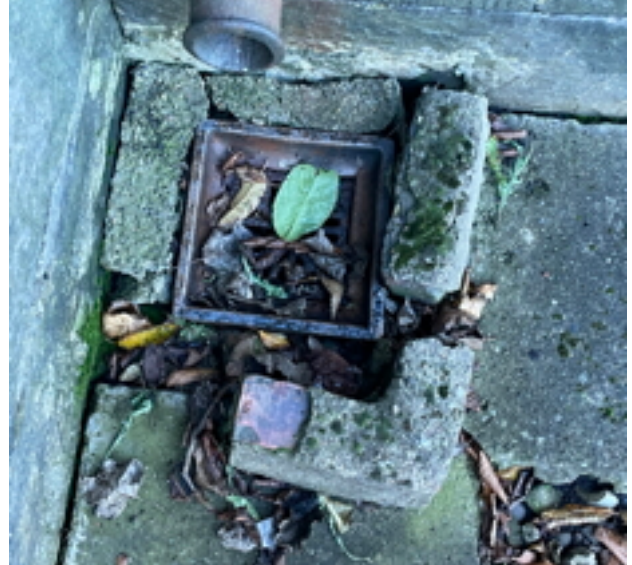
Broken Gully Surround

Replace missing gully cover and remake gully surround. Cost Band 1– £0.00-£1,999.

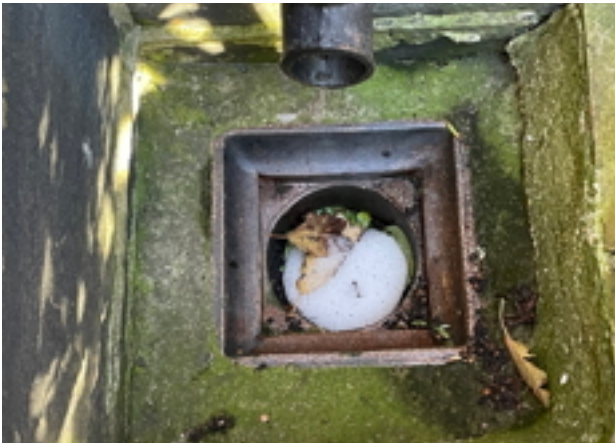
Missing Gully Grating

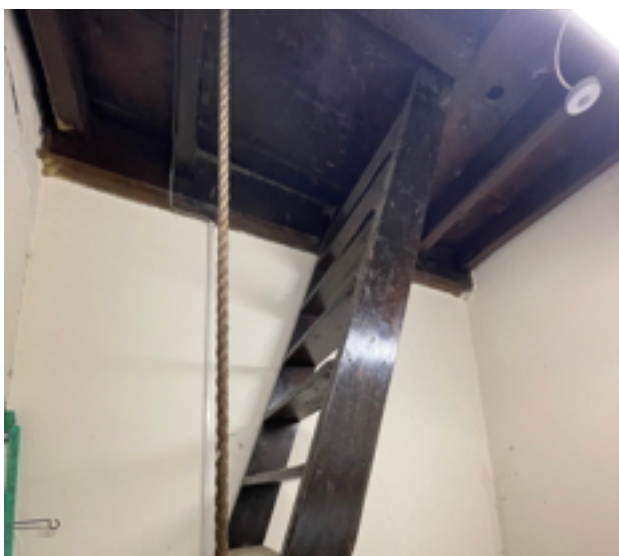
The hatch was difficult to close due to debris around the edges. The tower was generally very cluttered.

Ladder and Hatch Over

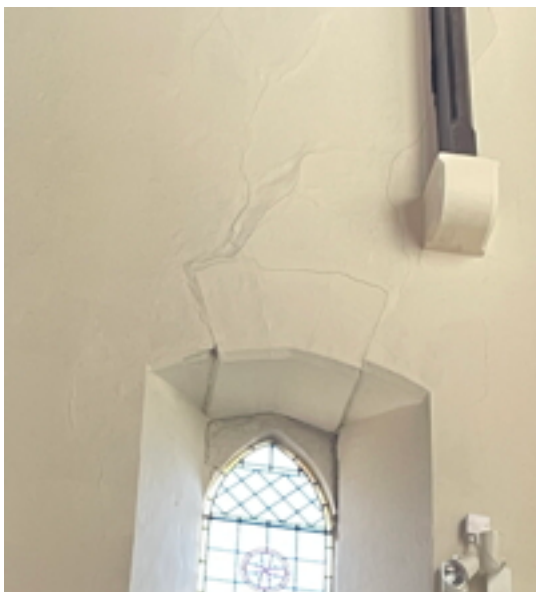
There is crack above the south wall west end window. Slight damage by rising damp at the door to the south porch east end.

South Wall Cracking Over Window

Monitor crack and damp to south wall. Cost Band 1– £0.00-£1,999.

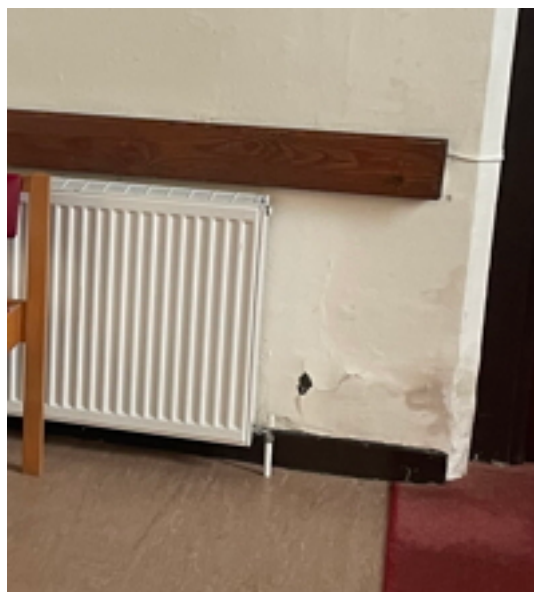
South Wall Rising Damp at South Porch Doorway

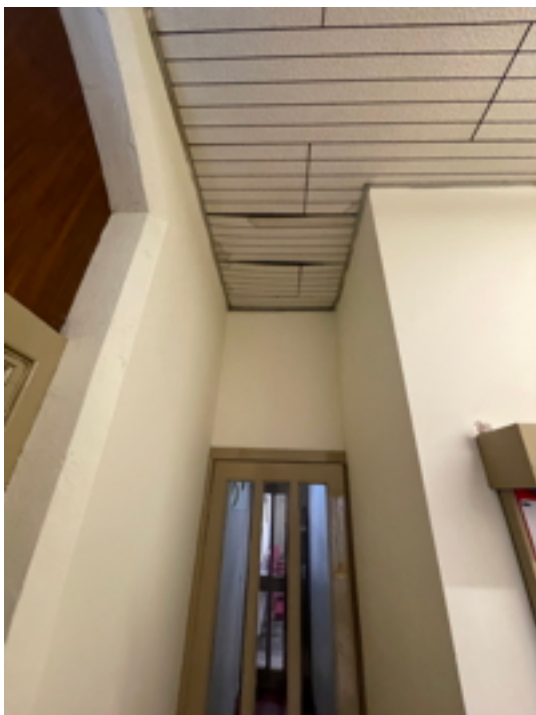
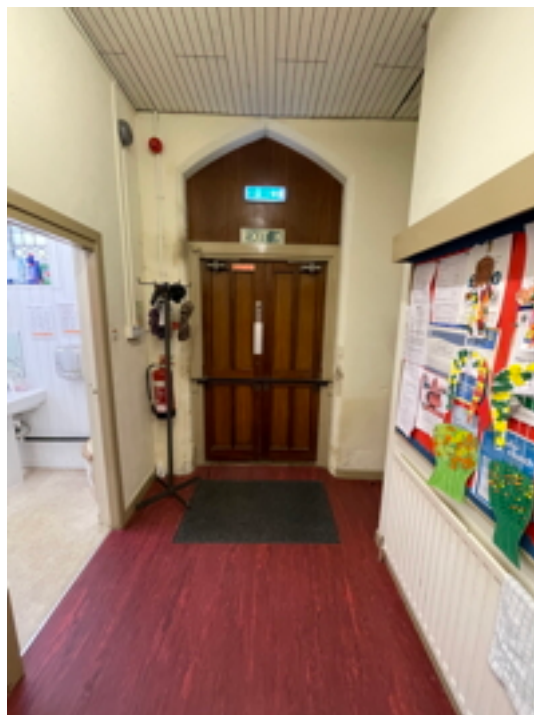
There are signs of damp around the external door. The suspended ceiling tiles are distorted and stained leading towards the lounge.

Monitor damp around the kitchen lobby external door and ensure roof is watertight above and replace damaged and missing ceiling tiles including those to Store and Tower Passageway. Cost Band 1– £0.00-£1,999.

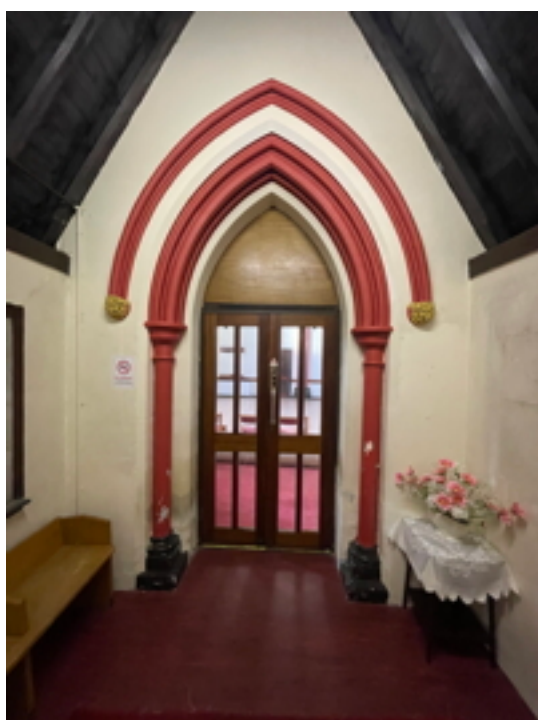
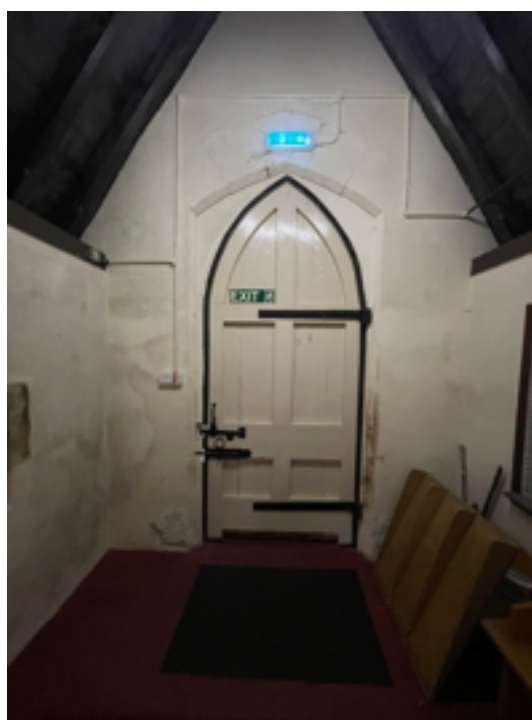
There are signs of damp on the south wall and the paint is generally discoloured indicating damp.

Consider scheme to improve ventilation. Consider whether modern paint is trapping moisture within the walls. Check external gullies are all in full working order. Check rainwater goods and roof are all in full working order. Cost Band 1– £0.00-£1,999.

In South porch consider scheme to improve ventilation. Consider whether modern paint is trapping moisture within the walls. Check external gullies are all in full working order. Check rainwater goods and roof are all in full working order. Cost Band 1– £0.00-£1,999.
