PARISH CHURCH OF
ST JOHN THE BAPTIST
St John's Chapel Weardale

QUINQUENNIAL INSPECTION REPORT
DECEMBER 2022

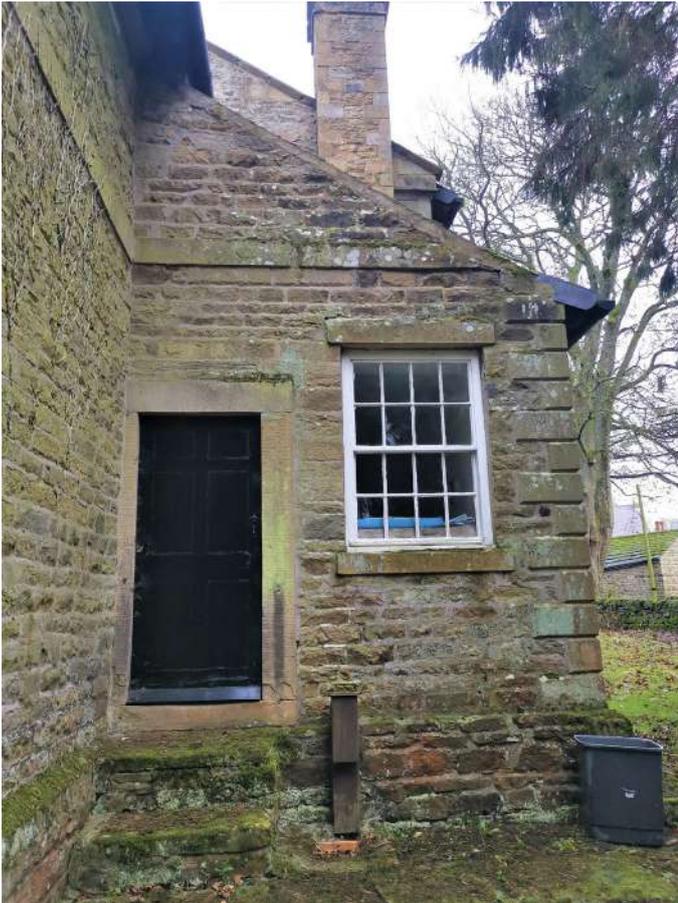
The roof of the vestry to the north of the chancel was also re-roofed with new lead work as elsewhere - no visible broken slates, but very heavy moss build up. The verge to the east has no overhang and the slates appear slightly set back onto the wallhead requiring heavy cement flaunching. This leaves the top of the wallhead appears vulnerable and would benefit from better consolidation.

Verge to vestry not shedding water adequately

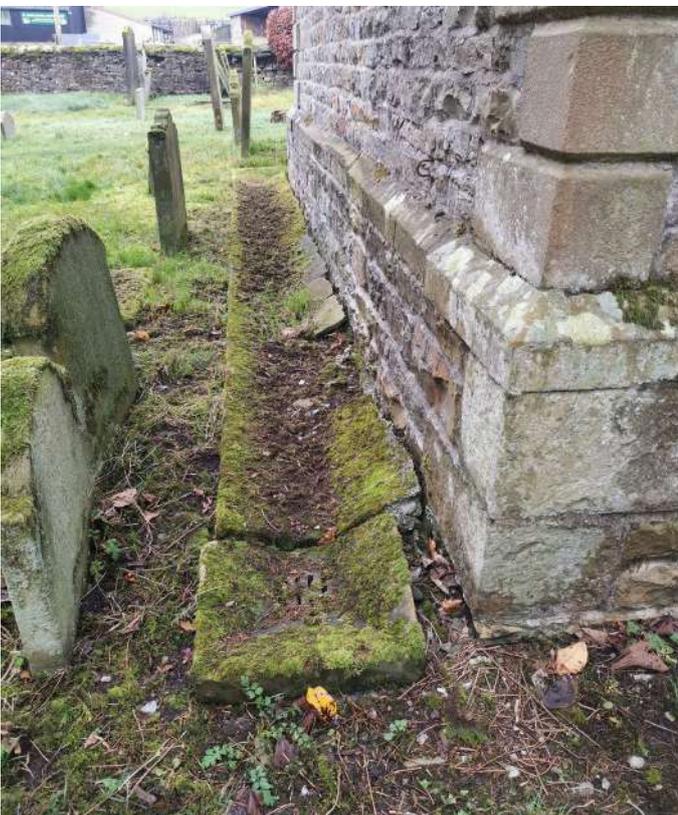
In many areas the concrete channel is breaking up and in an ideal world these should actually be removed and a gravel filled trench added, or as a minimum left bare to the earth. To the west of the Nave and around the tower there is already a gravel strip around the base of the wall which is ideal for maintaining dry foundations and dry walls. The concrete channel to the north elevation of the Nave appears in the worst condition with more areas broken up and potentially holding water - this length should be lifted as a matter of priority.

Remove concrete channel and leave exposed to earth. Clear gullies.

a)	Inspect drainage below ground for cracks and leaks in pipework using camera	£2,000
b)	Remove concrete/stone channel at base of wall around perimeter – leave as open soil/earth initially to help dry out wall – full perimeter.	DIY / £500

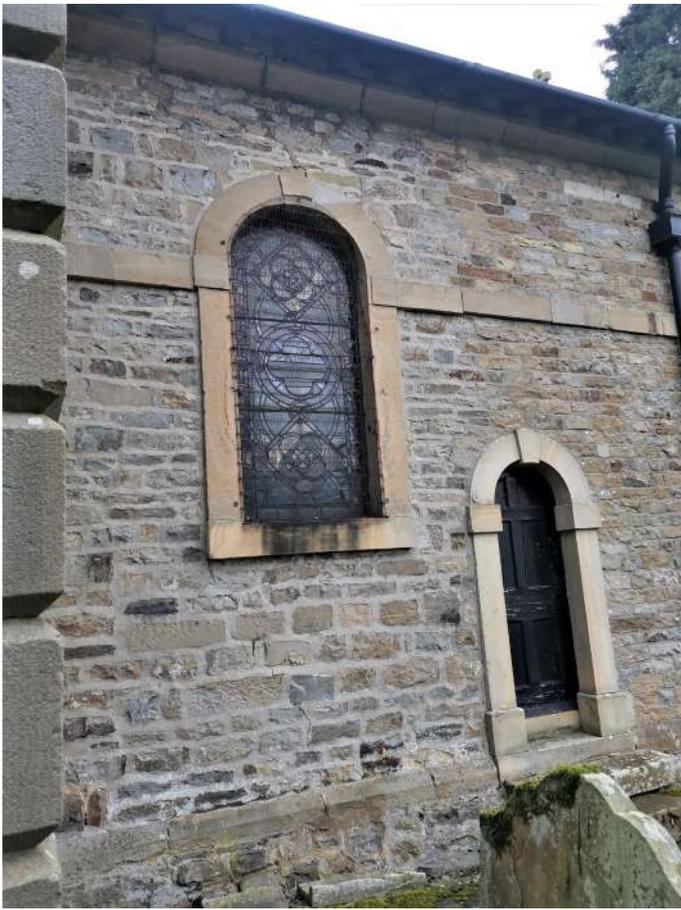
Cracks through masonry and bulge over window

There are cracks noticeable running between upper and lower windows in most window bays, but more noticeable on the south elevation. The western most windows on the south elevation appear to be the most severe, with a crack through the lintel of the ground floor window and crack through the string course above and into the upper window. Other cracks between upper and lower windows on the rest of the south elevation and on the north elevation appear to be through joints. There is a reasonably large open joint to the west of the stone sill of the upper eastern-most south nave window, and below that a stone within the string course appears to have been dislodged. *NO CHANGE since the last QI.*

This movement in the structure is possibly being caused by soft ground conditions, (caused by poor or leaking drainage), disturbed ground, or movement due to proximity of trees on the south elevation.

The wallhead in this area (south chancel) appears to be bulging out, possibly indicating roof spread.

g)	Monitor cracks. Ask engineer to re-visit to check on tell-tale markers and review other cracks. Inspect bulging at wallhead of south chancel and possibility of roof spread.	DIY

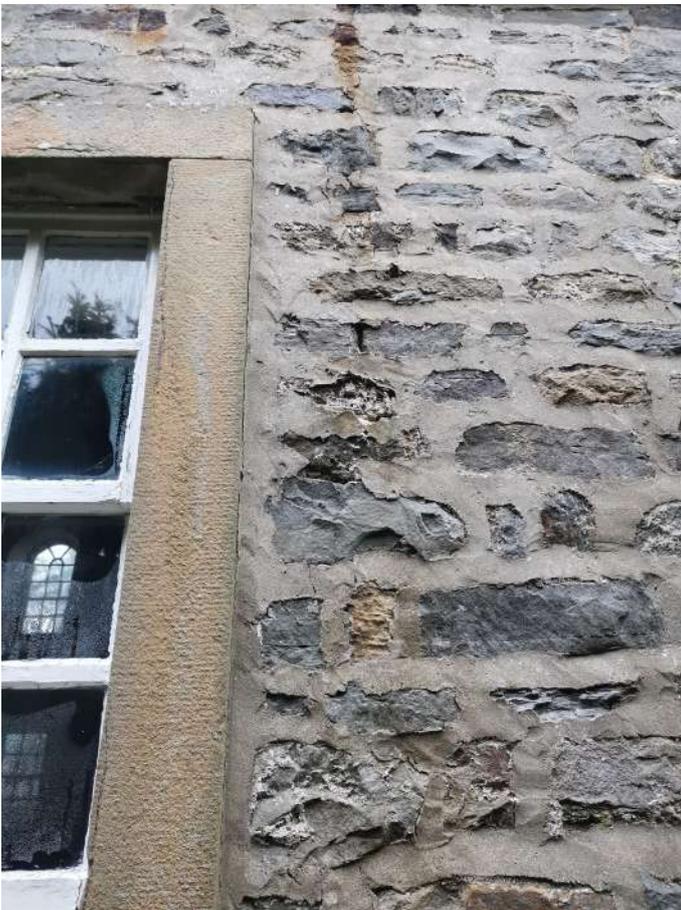
Heavy cementitious pointing will retain water

There is delaminating masonry to the south elevation of the tower, exacerbated/caused by cementitious pointing and/or mortar repairs.

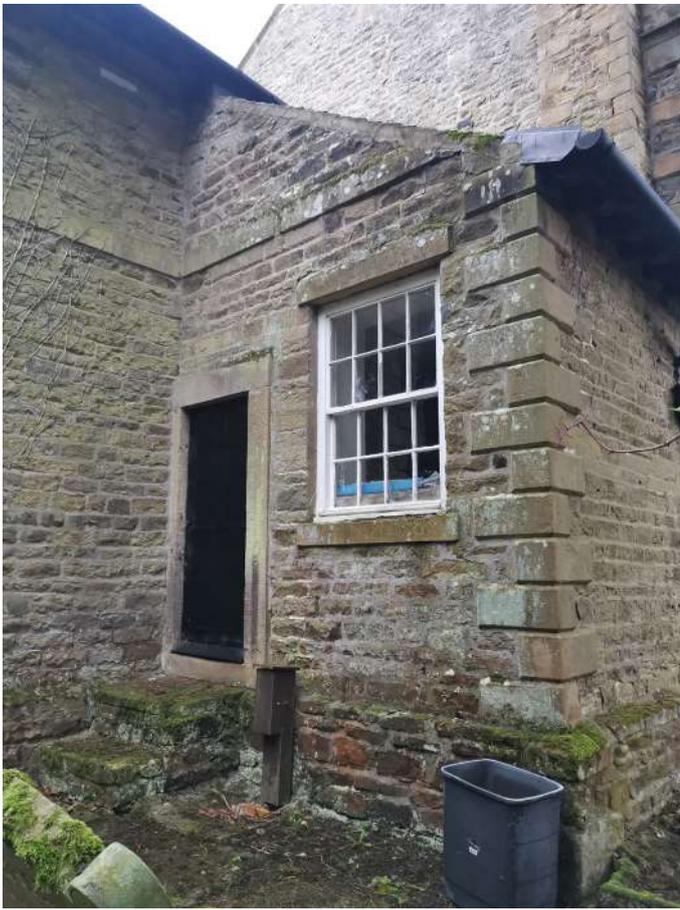
The plinth masonry particularly on the north elevation has quite a number of open joints where splash-back from the concrete channel is washing out the mortar. The stonework is heavily covered in algae and moss on the north and east.

Heavy moss, damp plinth, cementitious pointing - may have caused timber rot to floor internally

The plinth to the vestry was noted as being particularly damp and may correspond with rotten joists to the floor void - to be inspected.

h)	Rake out and re-point plinth to vestry. Inspect floor joists below floorboards and allow for repair to rotten joists.	£1,800
i)	Fix back small section of loose moulding from leading edge of internal porch door. Fix-back/seal the weatherboard to main west door and redecorate. Redecorate all external doors to ensure protection and longevity.	£1,500

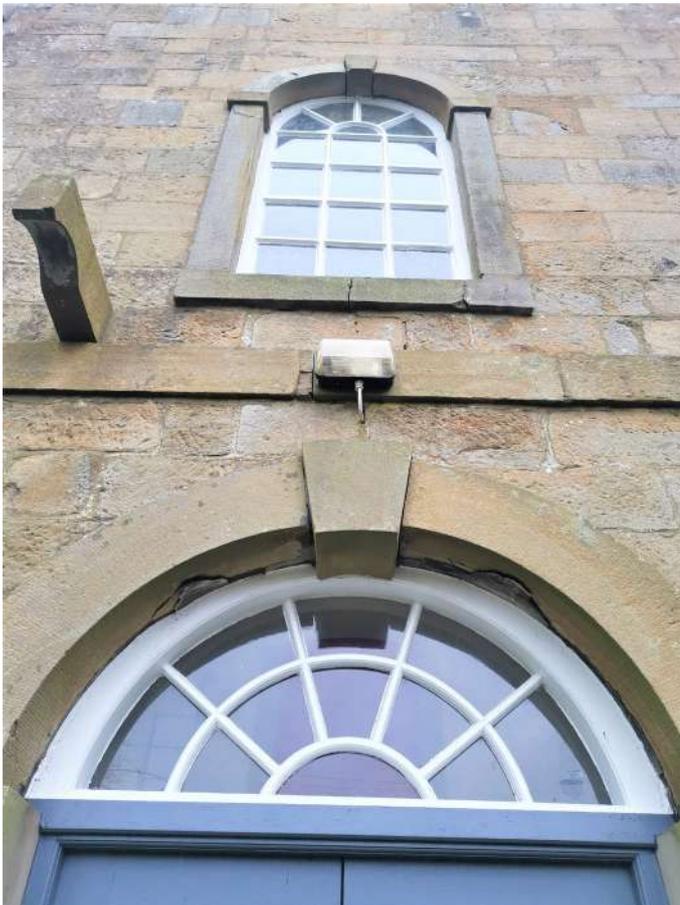
Lose masonry to reveal over fanlight. Crack through jamb to window above

To the main westerly front door there is cementitious patching to the jambs and to the half round heads, which is now detaching and the stone behind is becoming friable. To the northern quadrant over the door there is still a portion of stone which is loose - *this was picked up in the last QI and should be removed and repaired with mortar.* The joints also still are open around the keystone.

The round headed window above has a crack through its sill but this is most probably due to an old rusted fixing right through the centre of the sill. There are minor signs of vertical splits at the joint of jamb to sill. *NO CHANGE since the last QI.*

ITEM	RECOMMENDED WORKS AND URGENCY	APPROX. £s
2.01	Urgent works requiring immediate attention	
a)	Remove loose stone/cement from over main west door, inside arched head of fanlight	DIY

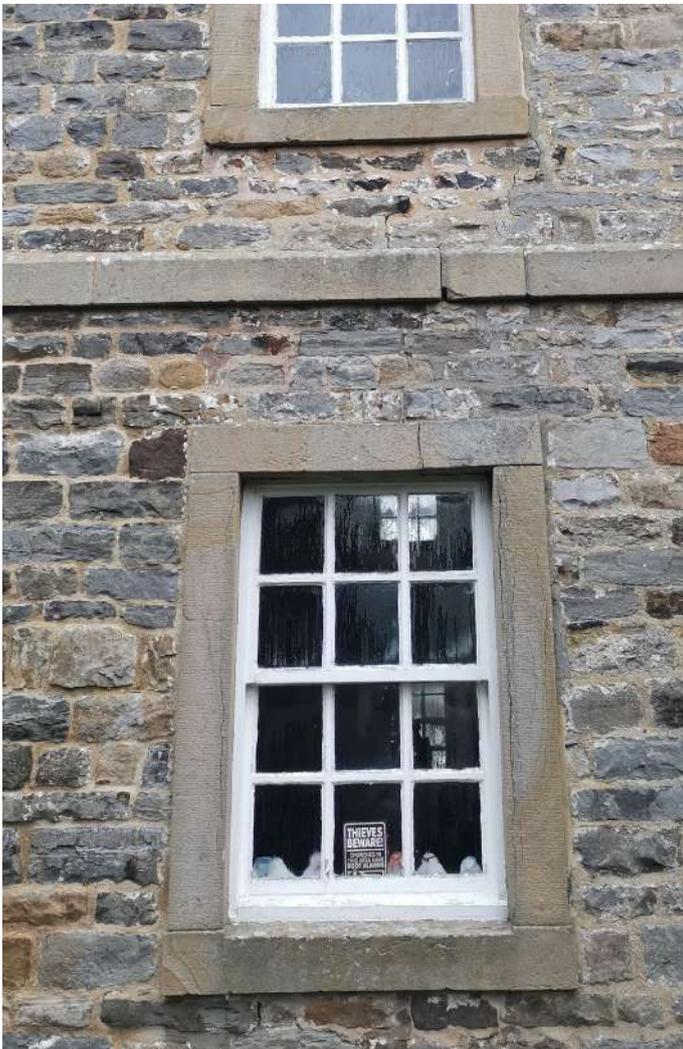
There is some deterioration to many of the window and door dressings, including vertical splitting of the stone jambs, indicating vertical bedding, (strata of the stone in a vertical plane, rather than horizontal, causing stone to split under pressure). *NO CHANGE since the last QI.*

There is a partial crack in the lintel to the western-most window of the north aisle on the ground floor and corresponding full crack through the whole lintel of the western most ground floor window on the south elevation as previously noted. *NO CHANGE since the last QI.*

Splits down vertical window jambs. Cracks through head lintel and stringcourse above.

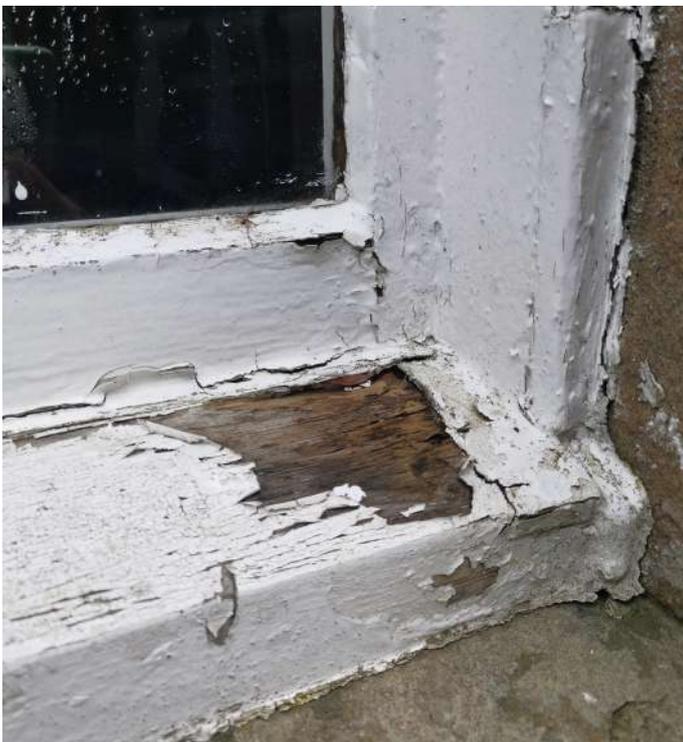
The windows themselves have deteriorated since the last inspection, with some cills or bottom rails rotten as a result of paint deterioration. All timber windows now require comprehensive refurbishment, including stripping back of paintwork, repair of rotten cills, bottom rails and the base of some side jambs, full preparation with primer and redecoration using a high-quality paint system such as Sadolin SuperDec. Proper timber repairs should be carried out rather than relying on filler, which in some instances has caused current issues.

Rotten window cills that now require repair

c)	Joinery repairs to timber sash windows inc new cills and splice repair of jambs where necessary. Full preparation, primer and redecoration in Sadolin SuperDec to all windows following repairs.	£5,500

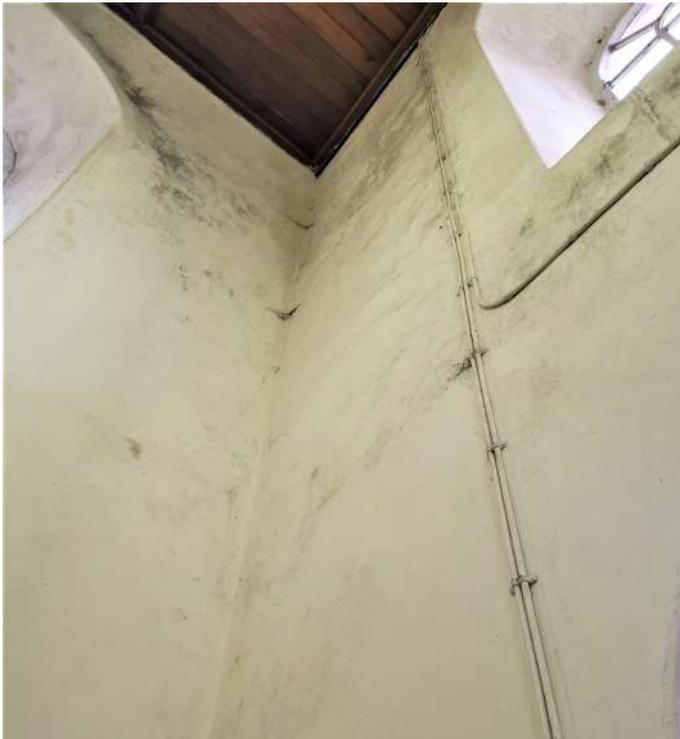
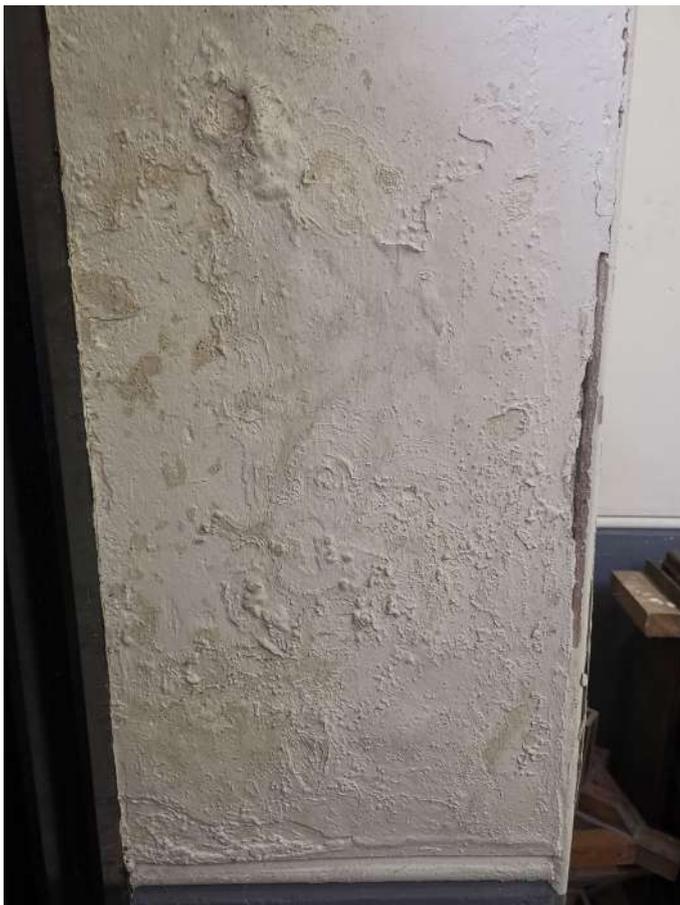
Internal walls of tower worsened - non-breathable paint making issues worse

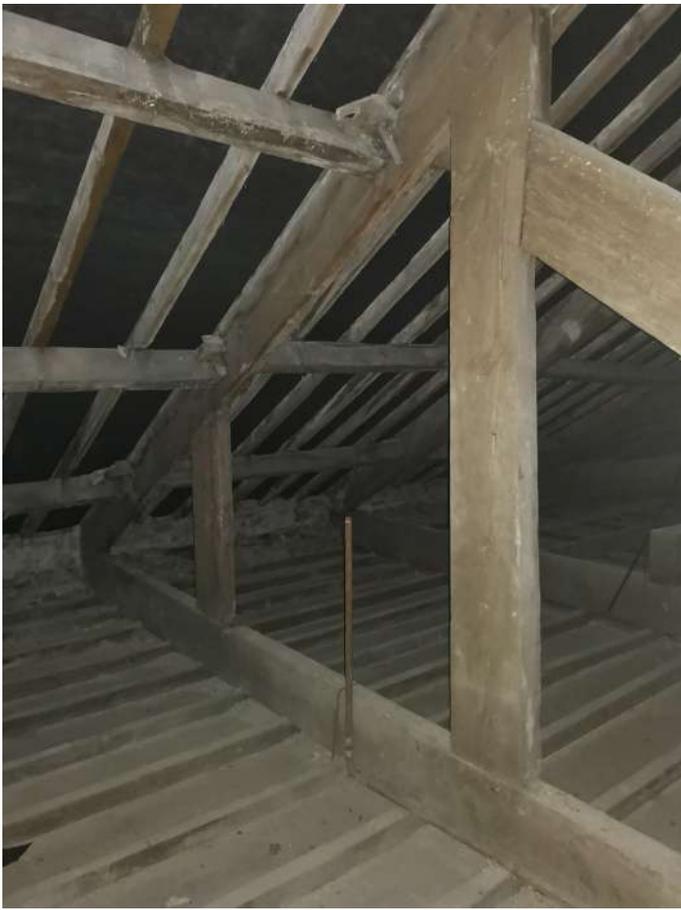
Roof void appears to be dry and sound

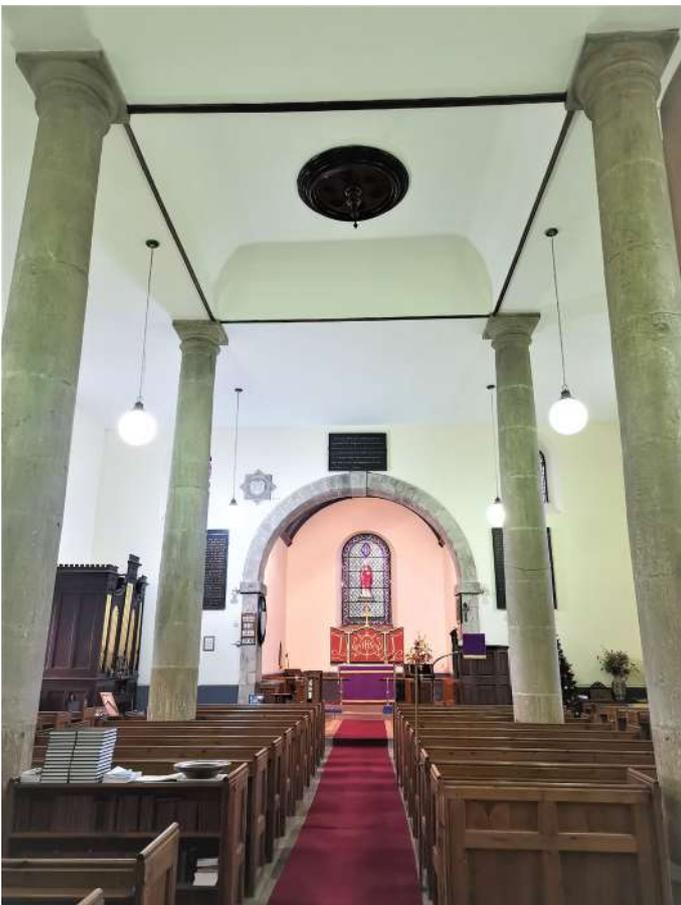
Ceiling plasterboarded and skimmed - some movement joints/cracks showing through at west end

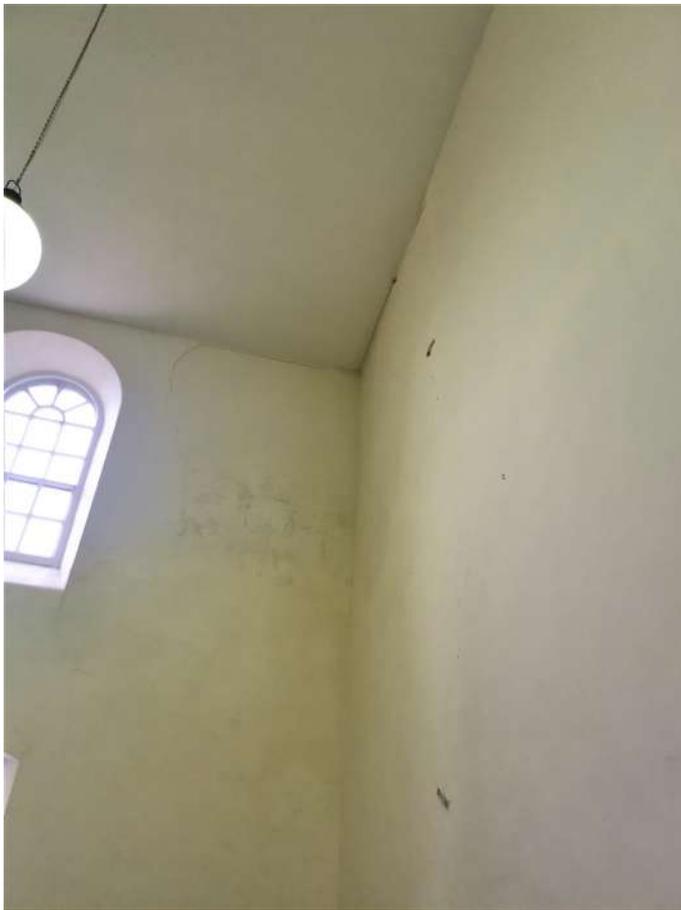
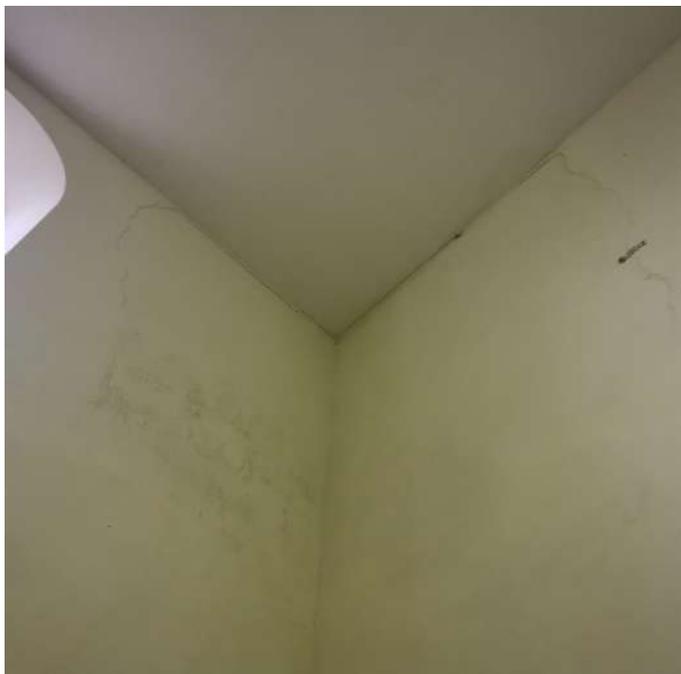
New crack in plaster to west of western window, damp damaged finishes. Tell-tale to western wall

There are several cracks in the plaster work, mostly associated with cracks in the masonry externally. Cracks noticeable in the bays of most windows between the upper and lower opening, and there are large cracks almost full height at the west end of the Nave gable at roughly the junction of the tower.

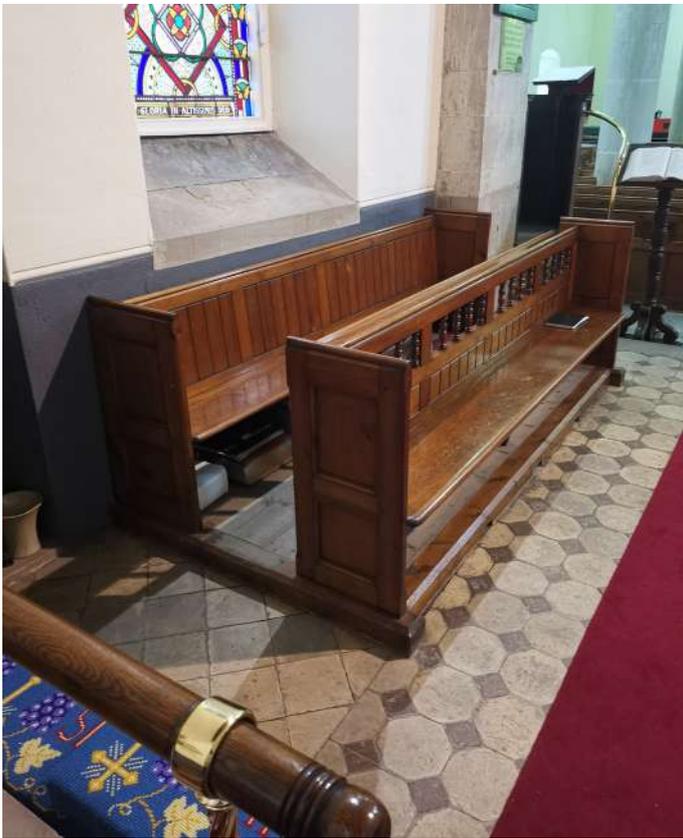
Tiles in chancel and sanctuary in good condition except some loose individual ones. Should not be sealed

The encaustic tiles of the sanctuary appear in reasonable condition although again the glaze is being worn off in some areas. A small number of loose tiles were noted in the sanctuary and would benefit from securing.

i)	Secure loose floor tiles in chancel and sanctuary.	£500
j)	Carry out recommendations from electrical inspection – improvement recommended to sockets circuit	£1,200

Attempts should not be made to re-glaze in any modern applied material. If sheen is required only beeswax should be used to polish.

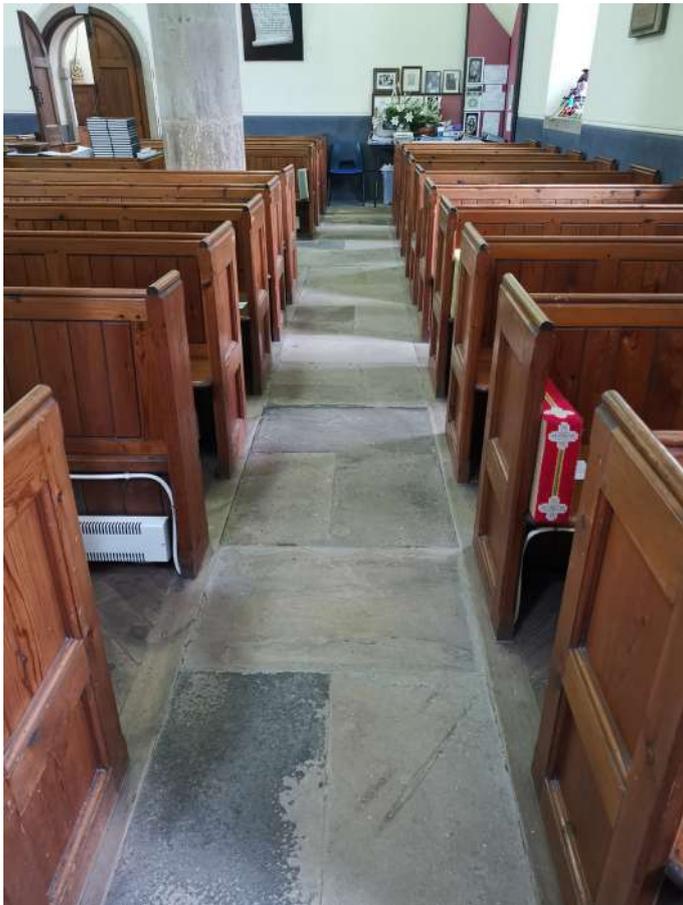
Stone flags in good condition - should not be sealed

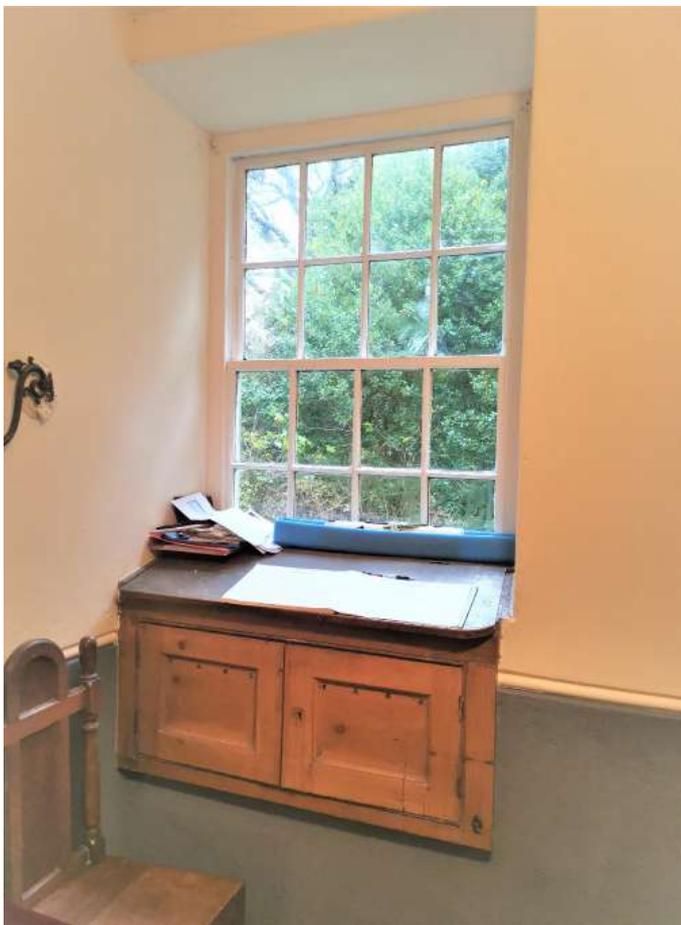
Base of window behind desk is rotten externally

There is an eight over eight Georgian sash window, with Crown glass as elsewhere. This has deteriorated since the last inspection, and the cill externally is completely rotten - requires repair and refurbishment.

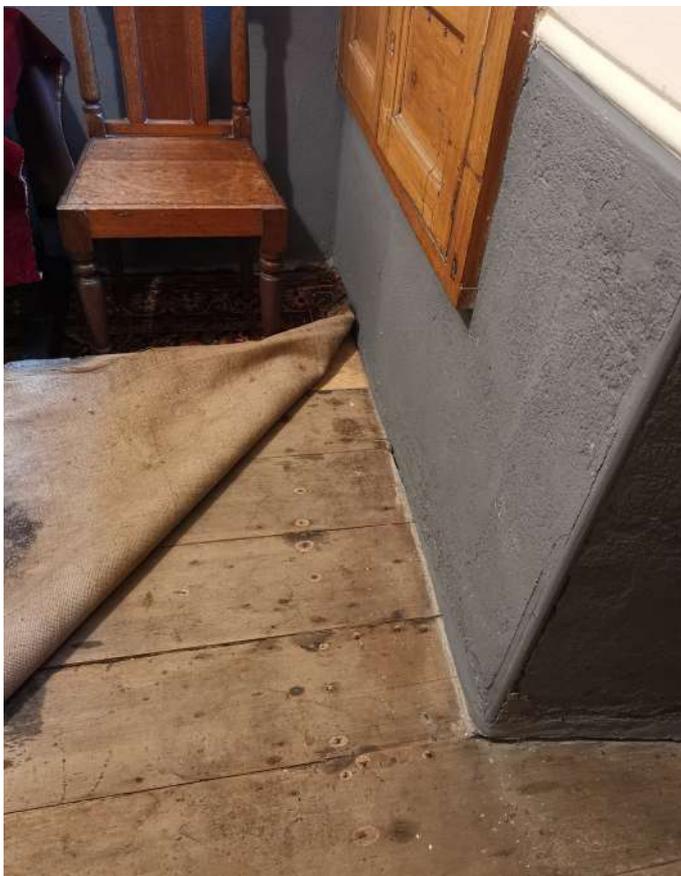
Area of floor to east vestry wall is spongy underfoot indicating lack of support, possibly rotten joists

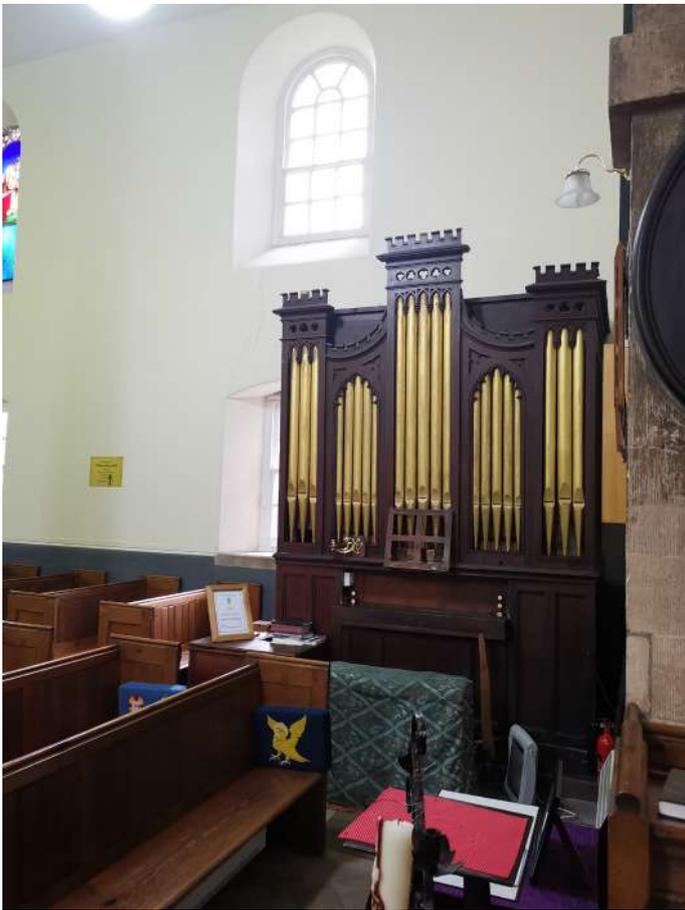
Grade I listed organ, in excellent condition

Its style is Georgian, vertical piped with good quality timber frame stained dark, with gold pipes. All appears in excellent condition and it is understood it is in good working order and is serviced regularly. There is also a small piano positioned at the front of the south aisle but it does not appear to be in use. *NO CHANGE since the last QI.*

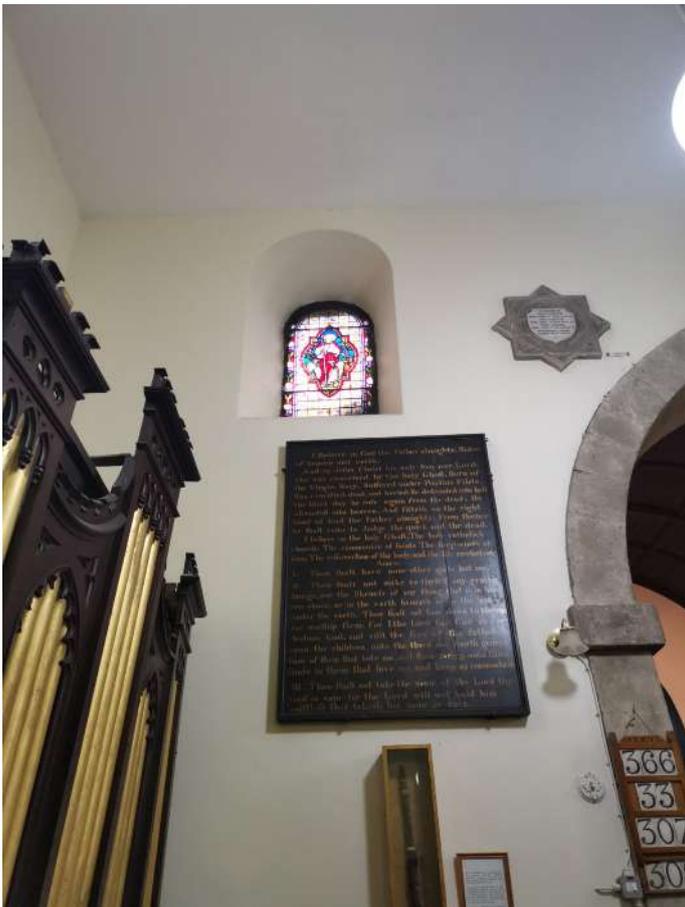
Boarded verse contemporary with church - good condition

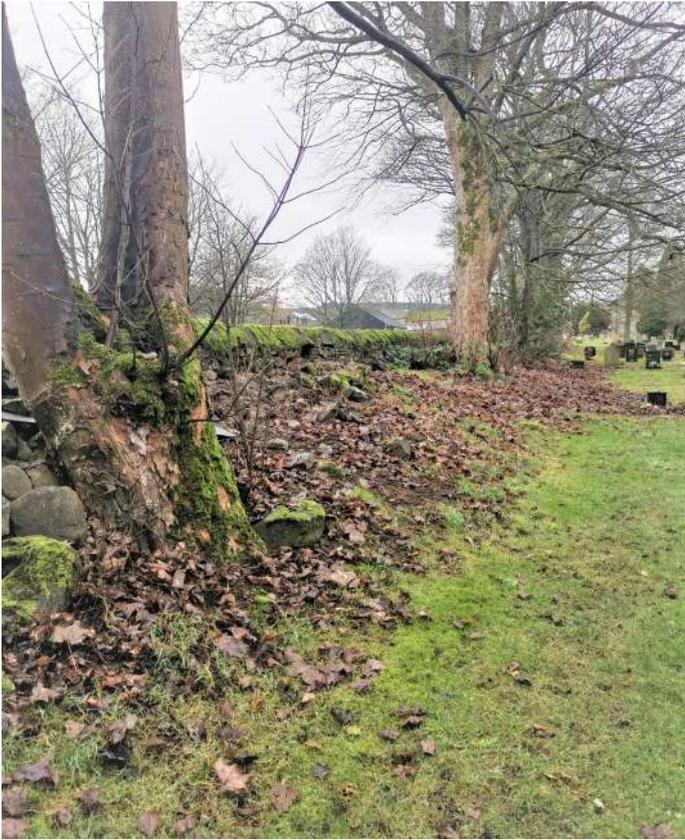
Garden waste against wall will be adding pressure to wall and maintaining a damp wall that could lead to mortar washout and de-stabilisation

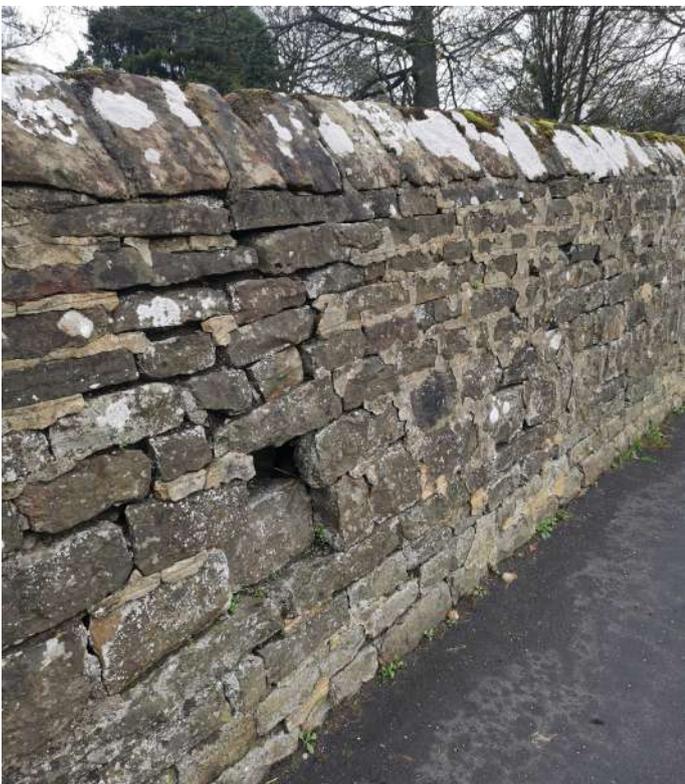
The boundary wall to the south bounds the road and is heavily mossed. The internal face is suffering in several areas where the stones have loosened and fallen away, leaving the remaining wall structure weakened and vulnerable. The added build-up of fallen stones and gardening waste may also be

Boundary wall to road in poor condition

adding undue pressure. Destabilisation, particularly beside the trees, is evident. To the road side, the wall has been heavily pointed in a weak cementitious mortar, most of which is failing. This would benefit from re-pointing in a lime mortar.

f)	Re-point boundary walls to west and south, including road elevation where heavily deteriorating – phased approach – tackle worst areas first	£25,000 (or phased)

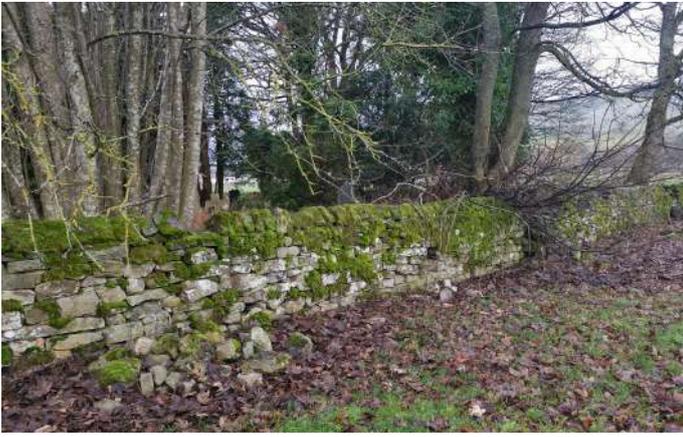
The eastern boundary wall is collapsed in two sections and requires re-building.

Eastern boundary wall - areas of collapse

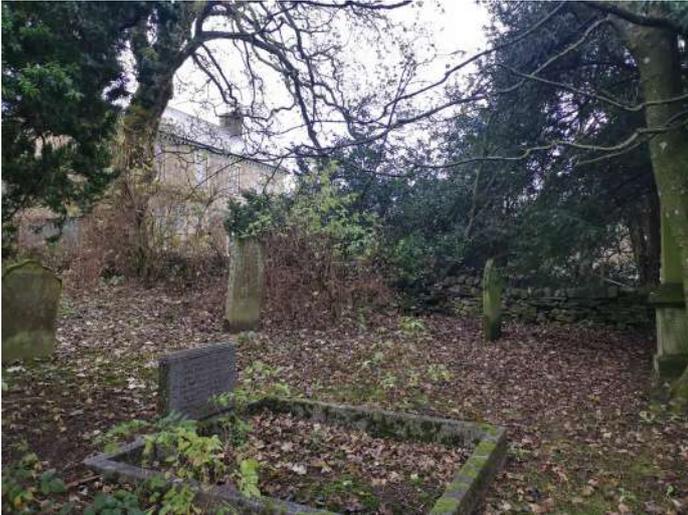
Northern boundary areas of collapse and trees/shrubbery growing on/through wall in a number of locations

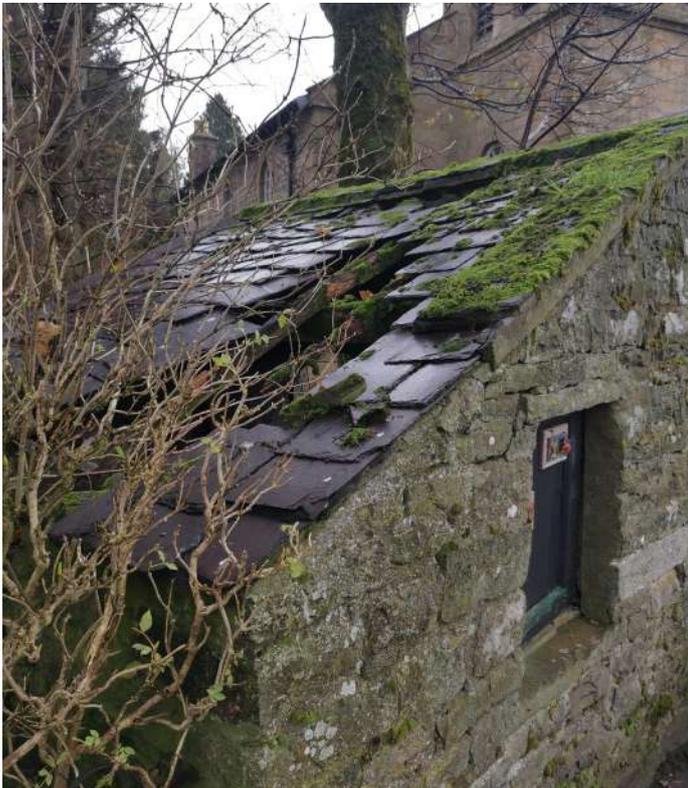
Garden shed roof collapsed - dangerous. Northern wall of shed/boundary wall also collapsed at eastern corner

f)	Repair external shed in north west corner of churchyard – now a hazard. Ensure any repair/rebuilding is carried out in lime mortar. Also now includes roof.	£12,000

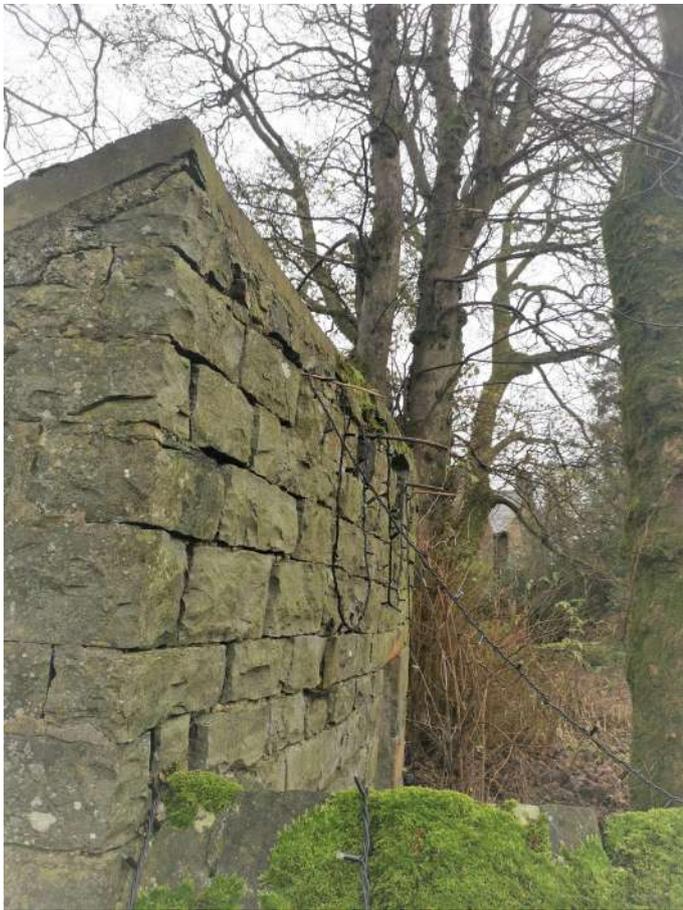
Front of garden shed leaning out and masonry unstable - dangerous - the area in front should be fenced off
