The Parish Church of St. Mary the Virgin
Staindrop, Co. Durham

Coloured Plan showing Phases of Construction of the Church – on display within the church

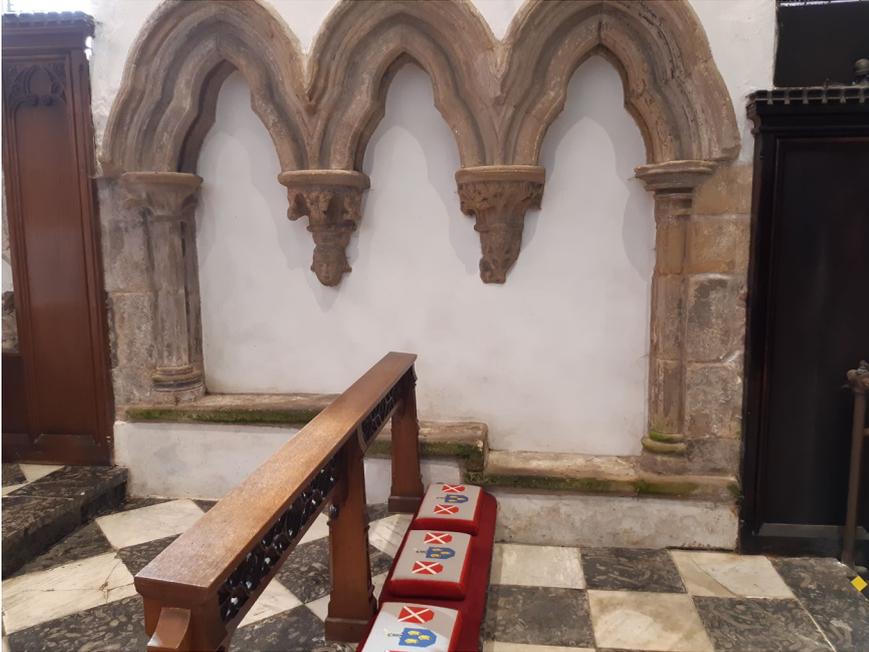
The sedilia, with low level damp mould.

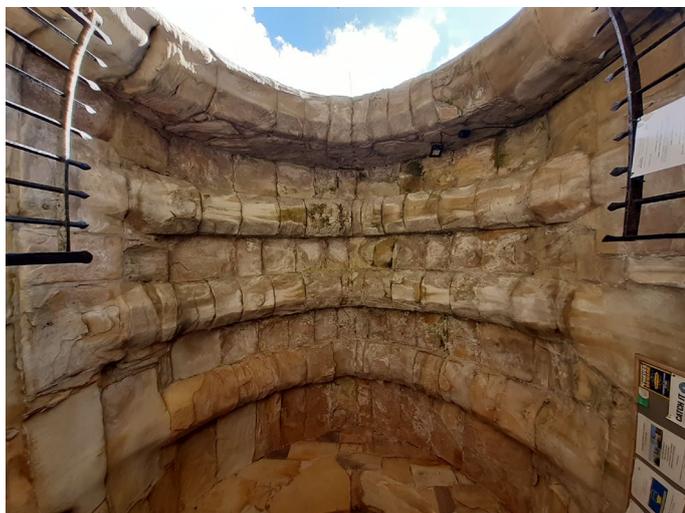
Inside the South Porch, showing damaged stonework to the vault.

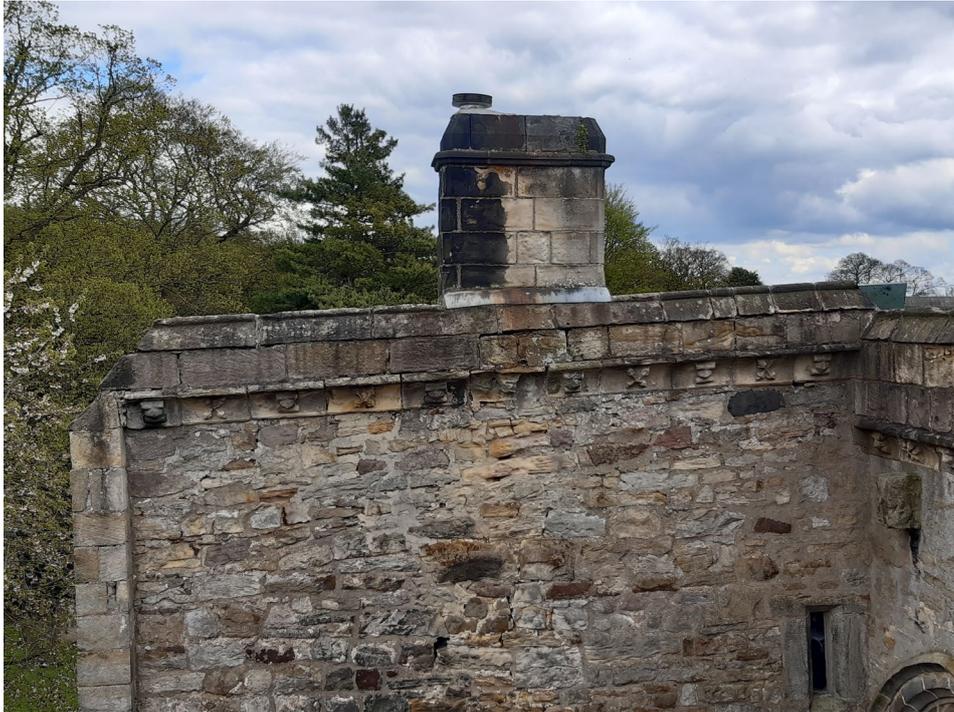
North Vestry, west facing wall showing extensive erosion and missing mortar.

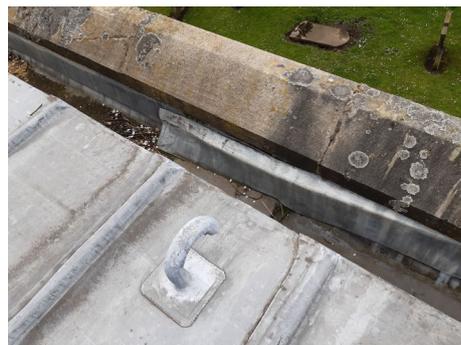
North Aisle, loose lead flashing

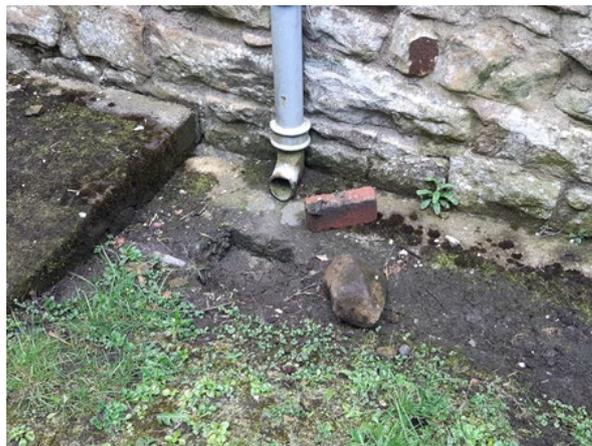
As noted in previous quinquennial inspection reports, concrete aprons extend around most of the church except on the south side of the chancel, and these are cracked in places. They encourage rather than prevent rising damp and when the opportunity occurs they should be progressively removed and replaced with a French drain as on the south side of the chancel.

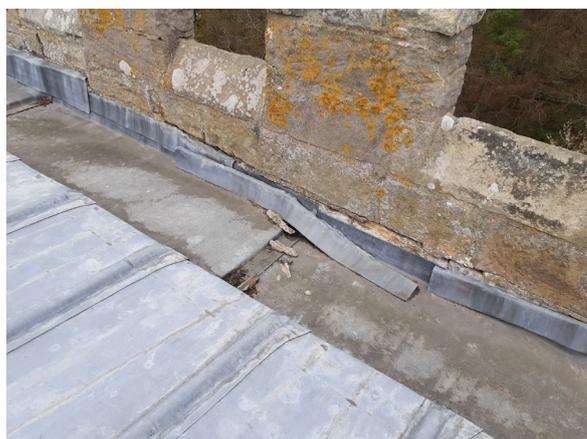
The roof coverings were renewed in 2003, in new lead, which remains sound, Four flashings need refixing to the north side and at the northeast corner. This was reported as requiring re-pointing in 2016, so the speed of deterioration in an exposed location can readily be seen. The steel bracket supporting the GRP flagpole is rusting. The hinges to the roof hatch are very rusty
