Diocese of Durham

**St CHAD STOCKTON on TEES**  
**ROSEWORTH**  
(291)

**QUINQUENNIAL REPORT**  
on the architect's inspection on

**9 May 2018**

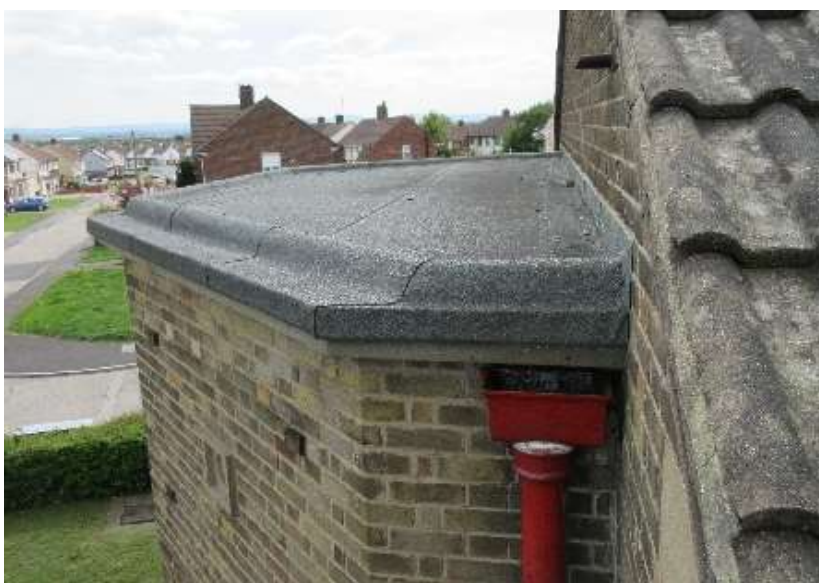
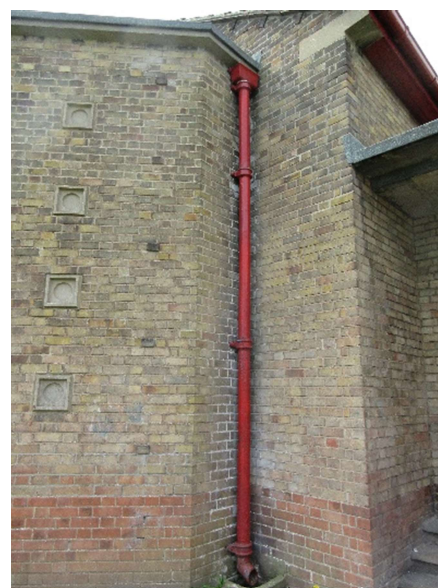
13. **Apse** flat felt with upstand drip edge and single felt outlet at N corner. A felt upstand is dressed into a brick joint and all appears sound but no close access. The small outlet (and hopper) need to be kept clear (plaster inside damaged by damp, paras 40, 46). Refelting sometimes leaves internal outlets like this too small to drain heavy rain. To be checked at next hopper clearance.

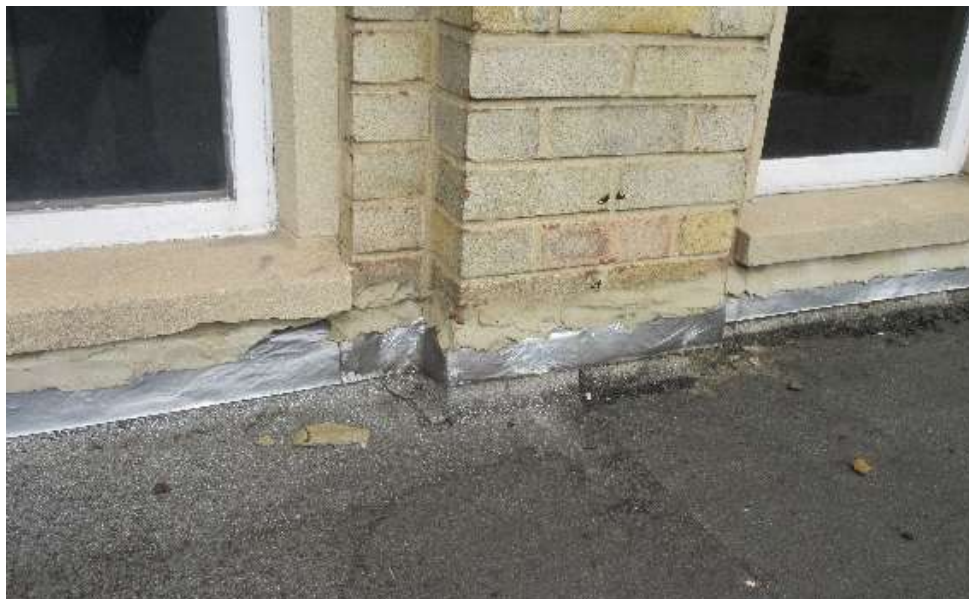
15. Under the S Clerestorey windows the felt upstands have cover flashings of mixed alloy, flashband and a little lead. They seem complete though roughly pointed into the joints and materials not most durable.

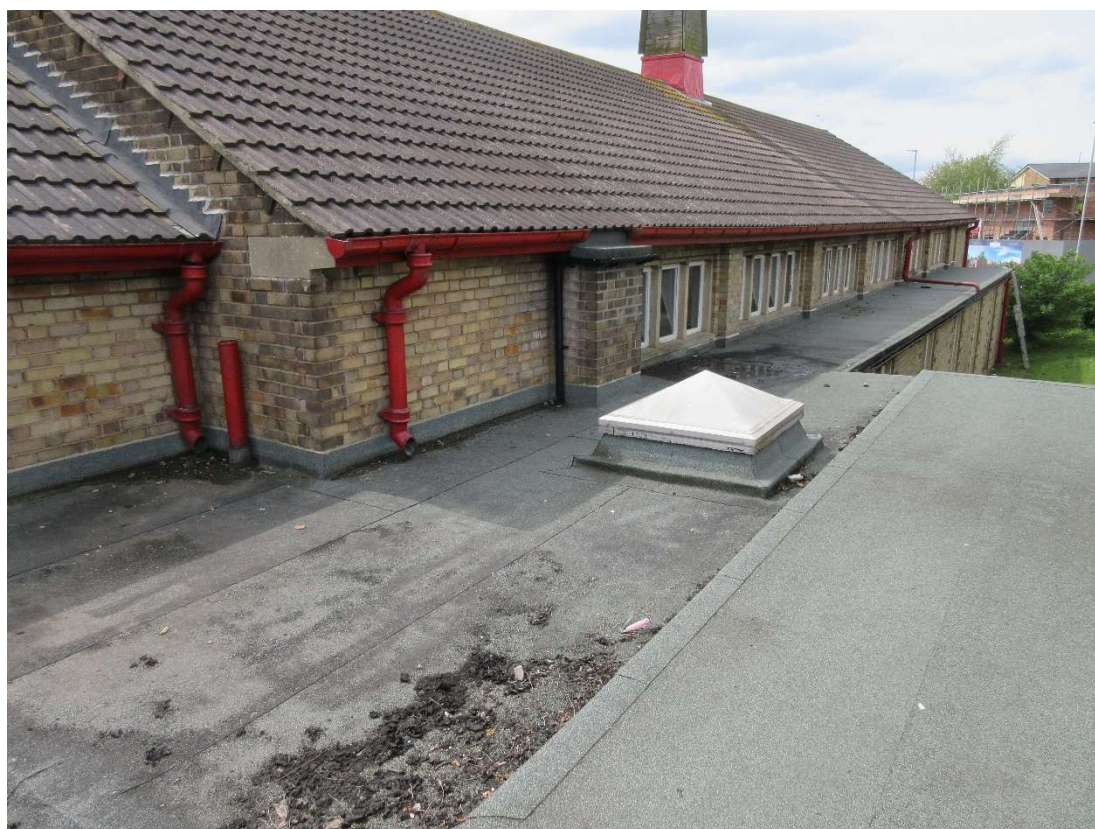
16. N Aisle and Lobby similar. Refelted since last inspection with good upstands but no insulation. A small pond just W of the former chimney.

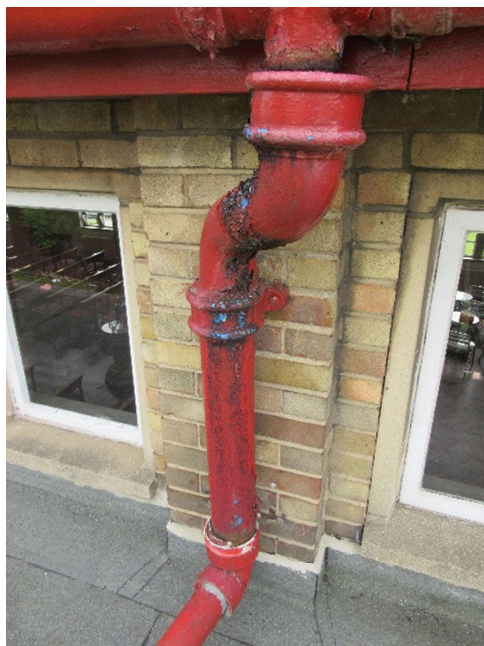
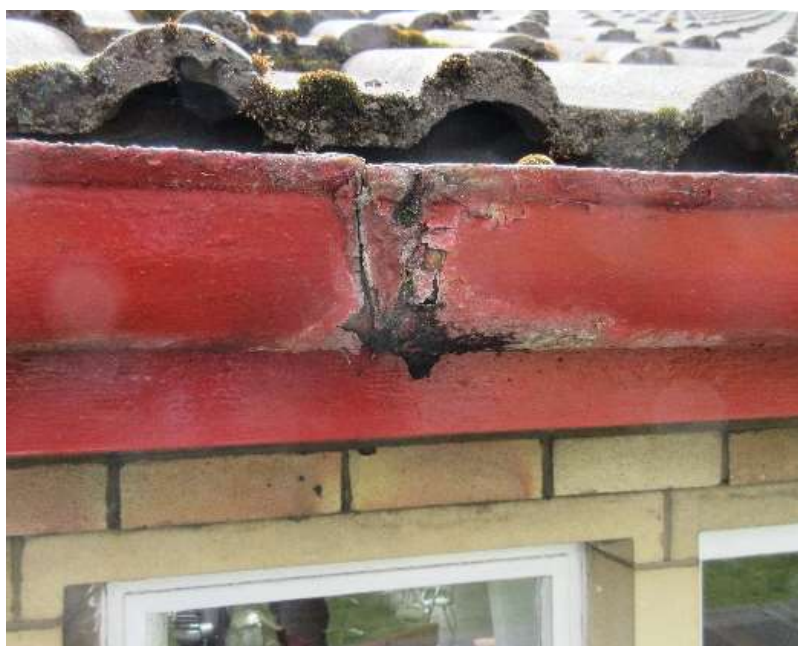
The S mid pipe bottom shoe remains missing and water may blow into the brickwork from the open end.

The N mid pipe turns across the Aisle in plastic on a timber block, now loose and damaging the recent felt.

The Choir N pipe discharges onto the lobby roof.

The Apse hopper and pipe fall over a gully. Salts all down the bricks behind the pipe and plaster damage inside suggests the hopper or pipe is or has been blocked and need regular checking (para 13).

Perhaps the plastic would be better removed and an iron shoe fitted over the felt.

Add cast iron shoe at bottom of mid S nave pipe over Aisle	21
Clean, derust, prime and paint all gutters and pipes, eave fascias and soffits	21, 23, 24, 31
Fit a painted steel pipe at the missing Kitchen waste	26
Repair broken glass at Choir and Chapel, refit film	54

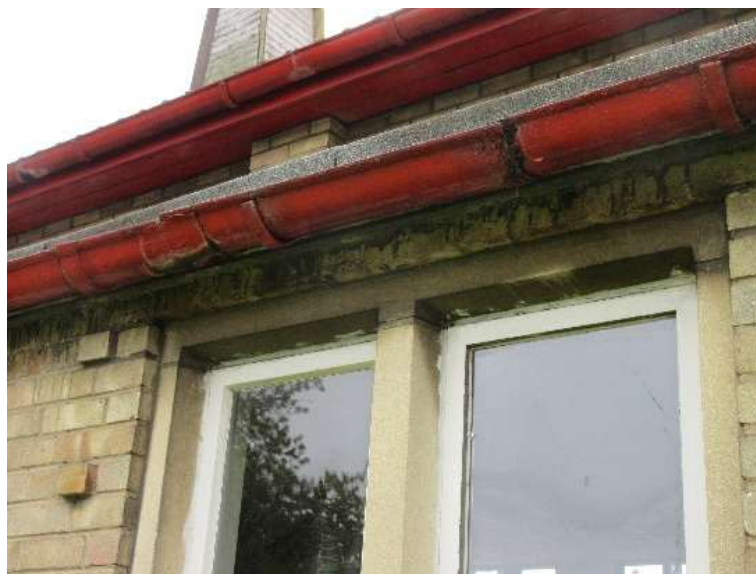
22. The W end of the S Aisle gutter was replaced but the cracked top of its downpipe remains bandaged. The N Aisle gutter is patched with flashband over the W window.

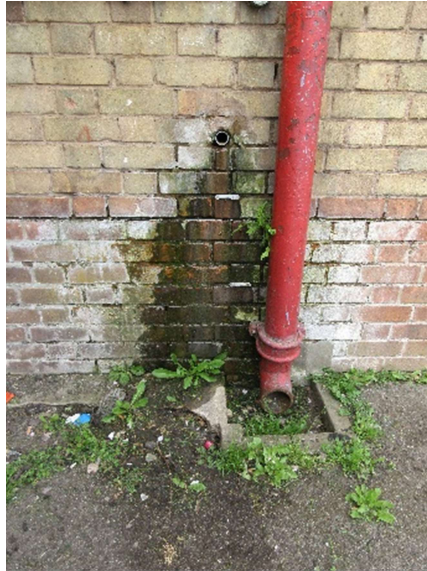
25. Yellow facing brick on red brick below floor level, flemish bond with some decorative projecting headers. Either brick and a half solid or thick leaf cavity. 'Bucket handle' pointing. Some projecting patterning at W end and openings. At the W end a large brick relief of St Chad in red brick with neat lead cloaks on the exposed top surfaces. Contrasting blue black brick in panels in the Porch and infilling its former E window.
26. The brickwork is in good condition except at the N Aisle junction of original to extension where the wall is very slightly diagonally cracked. No action is required.  
Under the missing Kitchen waste pipe the brickwork is saturated with growing plants.

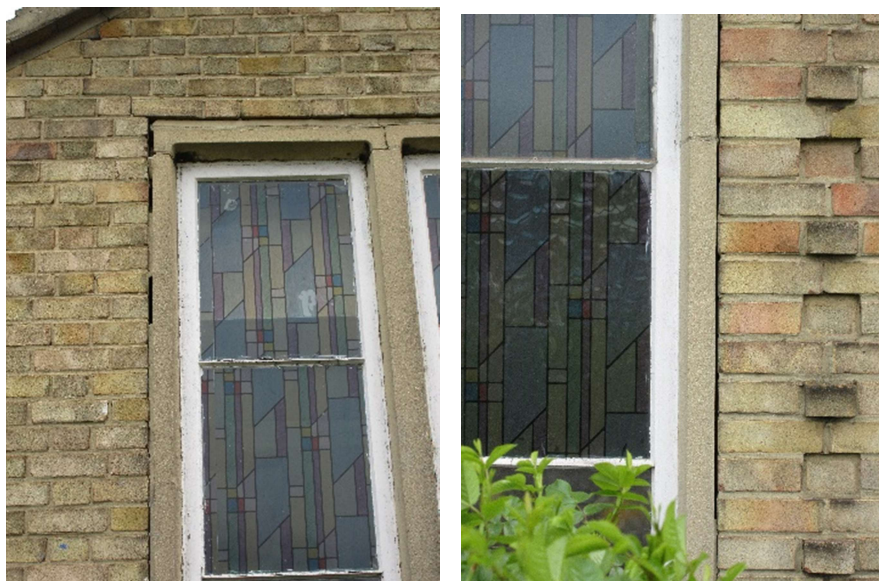
29. The windows are framed in cast stone with cast stone relief panelling under the windows. Sound but slight loss of pointing at top of the W gable N window and down its S side.

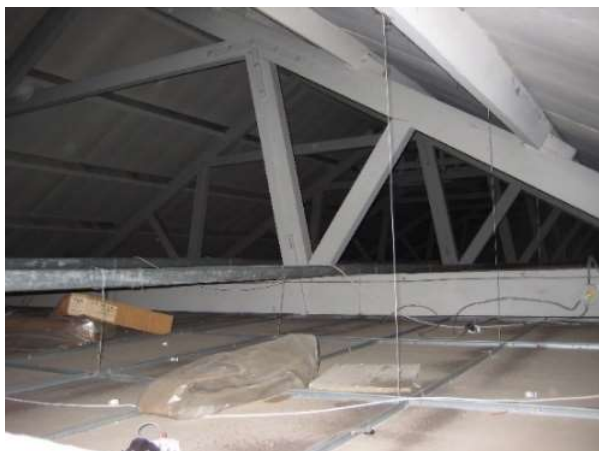
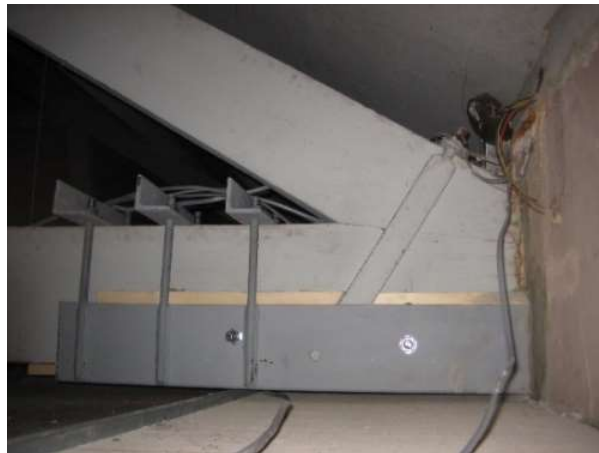
2013 pictures

37. The NE truss end (over the pulpit) was spliced with bolted steel angles and jacked up when its end softened and dropped where the wall was saturated by roof damage at the former chimney, now roofed over and dry.

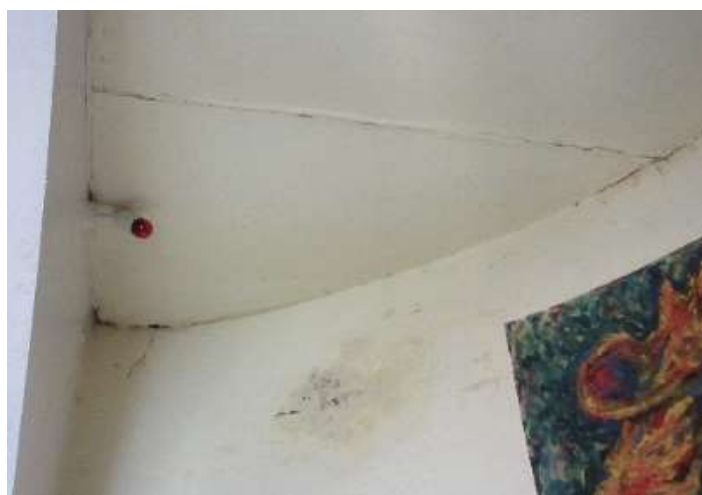
40. In the Sanctuary **apse** painted softboard with taped joints, some water marks and cracks at the curved E edge and board joints.

Repaint back door and at least the damaged parts of the plaster ceilings	35, 44
Repair and paint ceiling at Apse	40
Derust angle beads, repair damaged wall plaster and paint	46 - 48

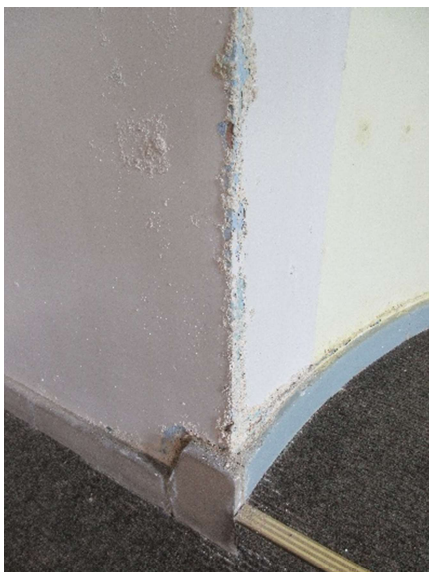
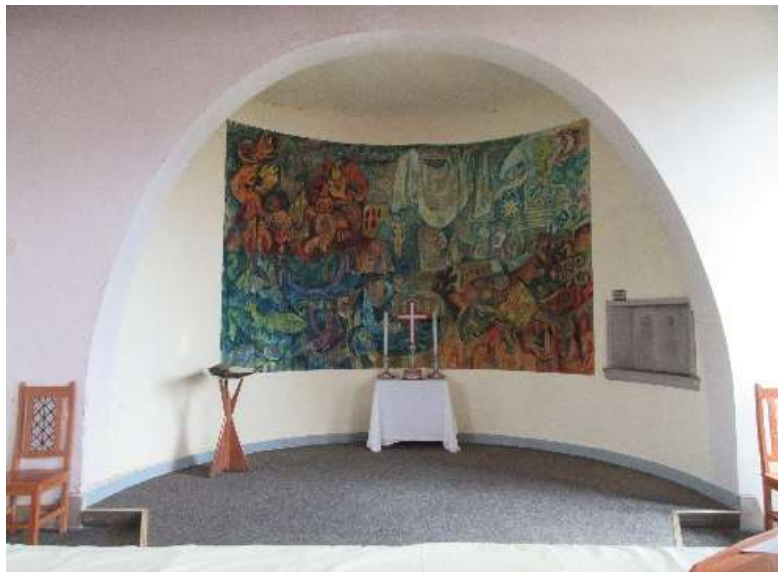
46. The interior is plain painted solid plaster with a distinctive parabolic sanctuary arch. No insulation. Plaster mainly good.  
At the arch N side (close to the rainwater pipe) plaster and paint damage with rusty angle bead especially at top and bottom.

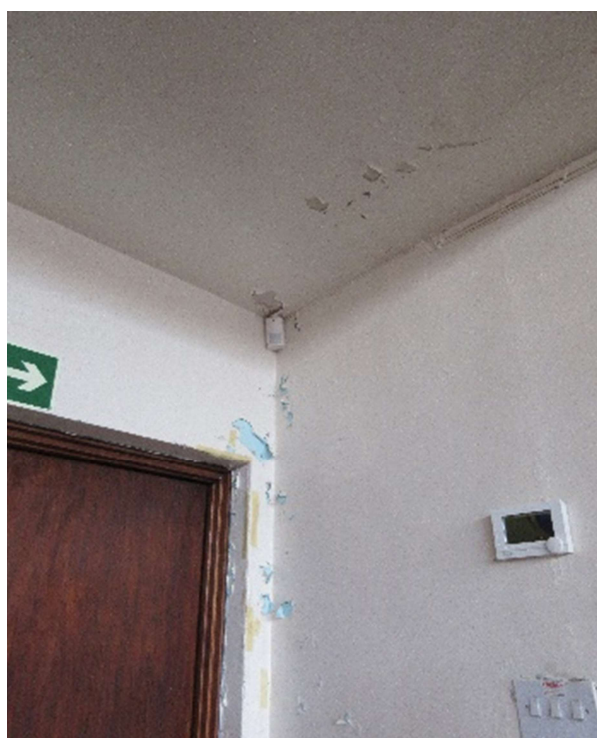
Flaking at N Aisle E end and at the NE door

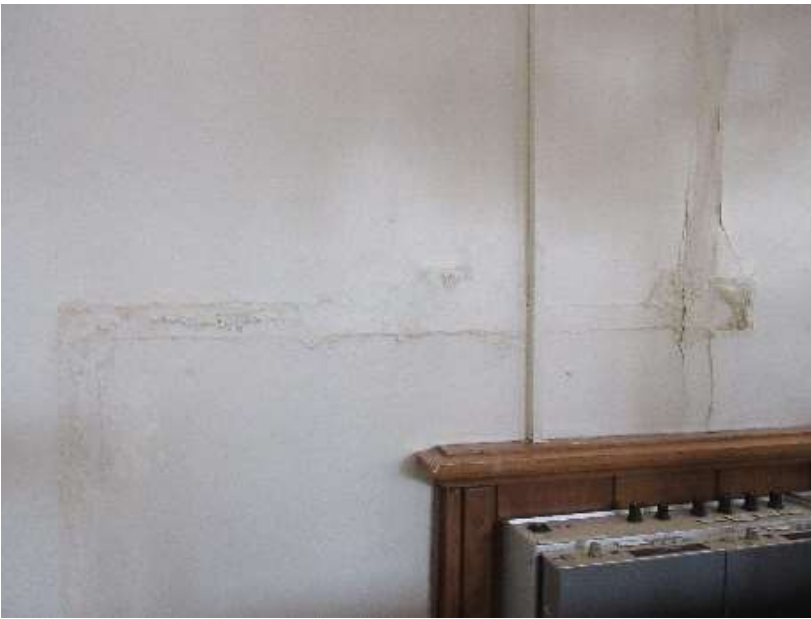
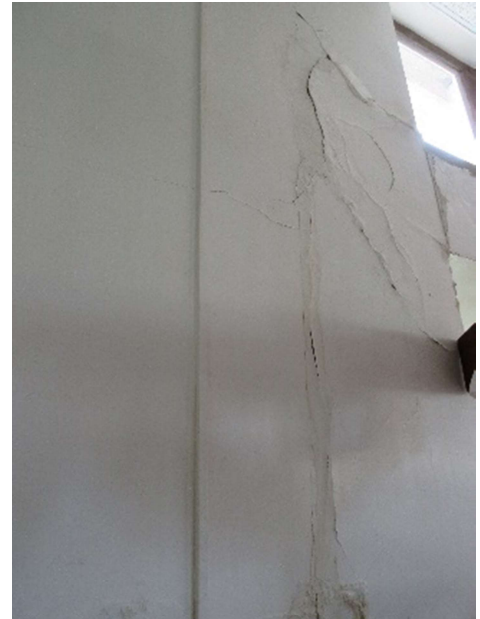
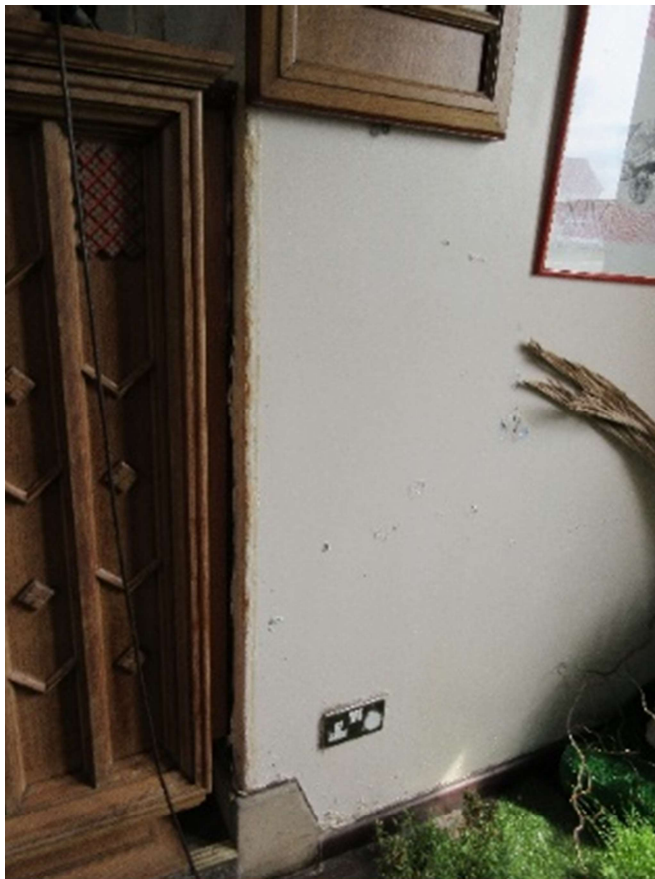
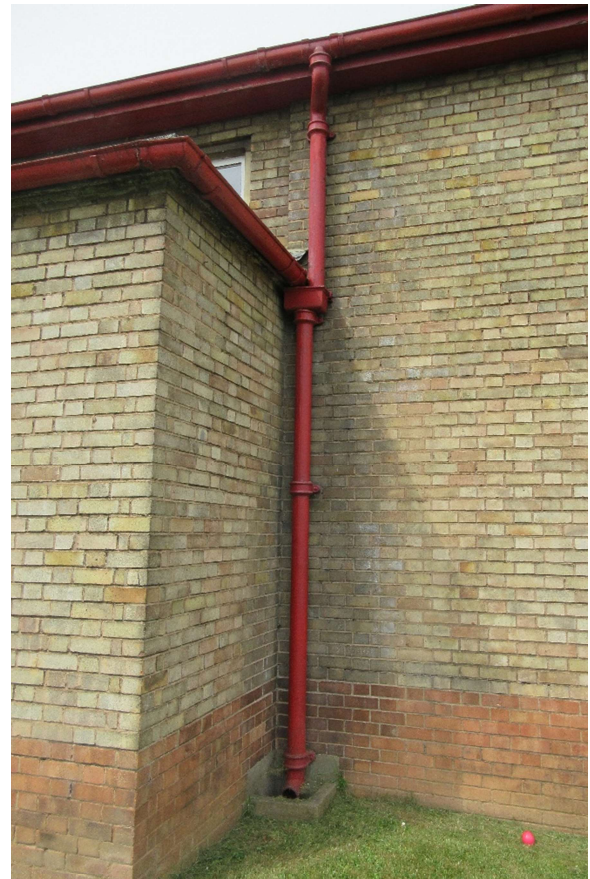
Minor damage at E wall of Choir close to the damaged arch  
Damage full height of the S wall of the Choir (especially at the concealed wiring ducts now visible) and the adjacent E end of the S Aisle (hopper and downpipe outside)

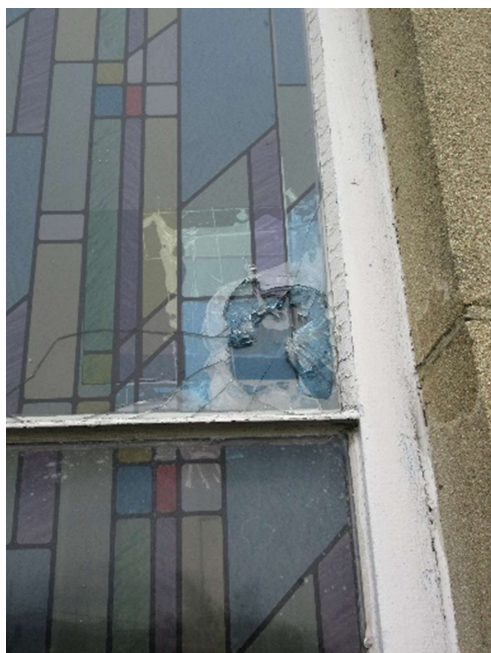
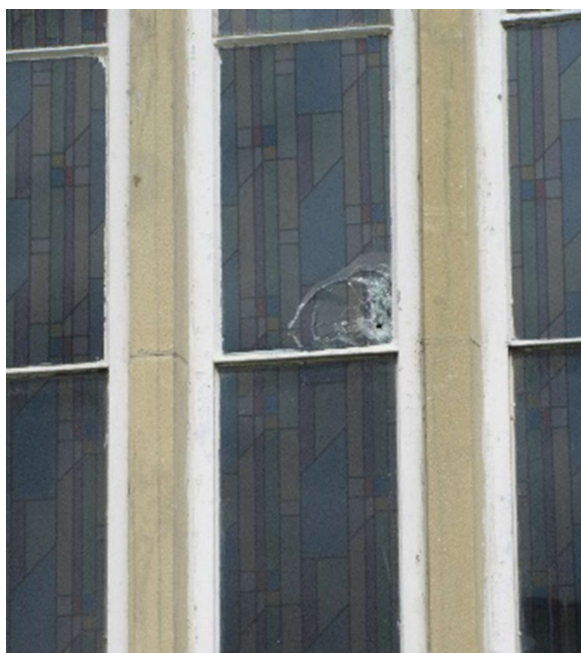
54. The pleasantly light church is single clear glazed in putty throughout.  
Added coloured film in the Sanctuary and W windows. Broken panes at the Choir and Chapel are hard to see inside due to the film but look poor outside.
