Parish Church of All Saints  
Stranton

Diocese of Durham  
Archdeaconry of Durham  
Deanery of Hartlepool

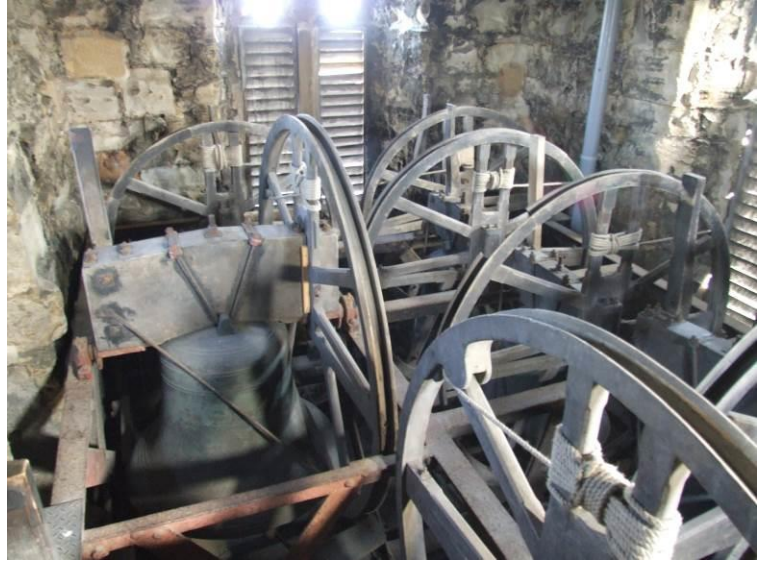
Fig 3. Corrosion to bell frame

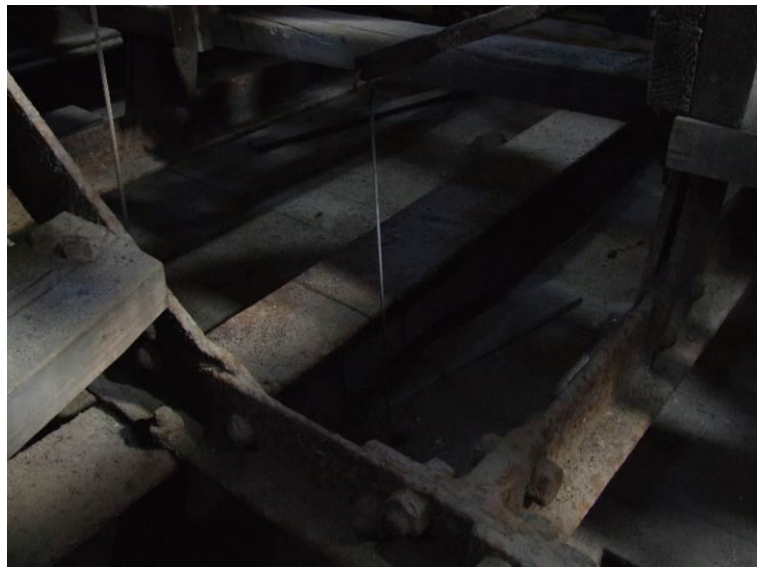
Fig 4. Corrosion to bell frame

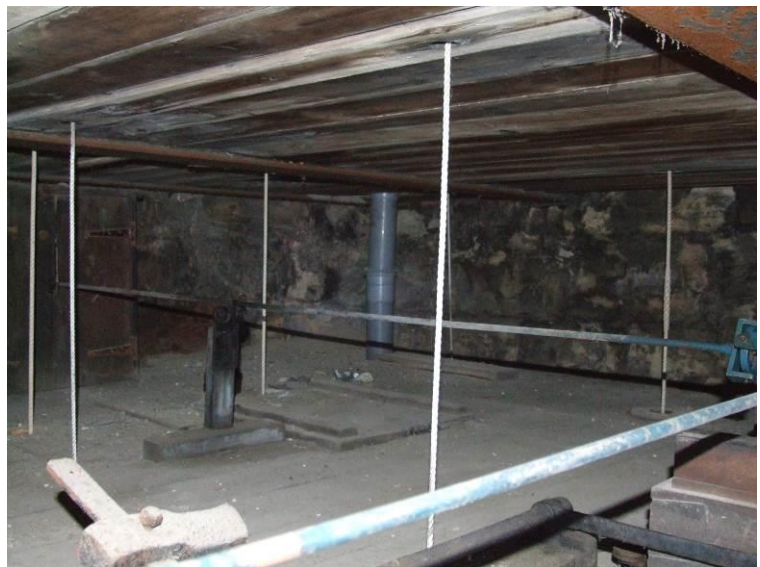
Fig 5. Steelwork,  
Belfry floor void

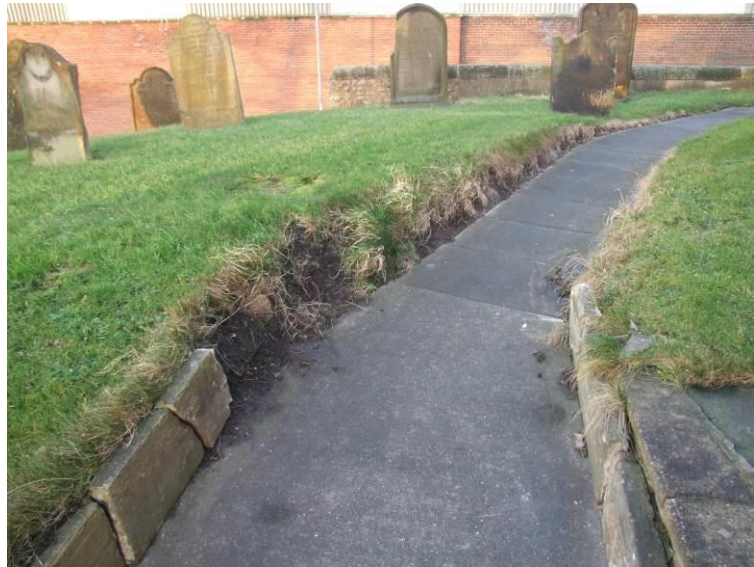
Fig 16. Missing kerb access to pathway

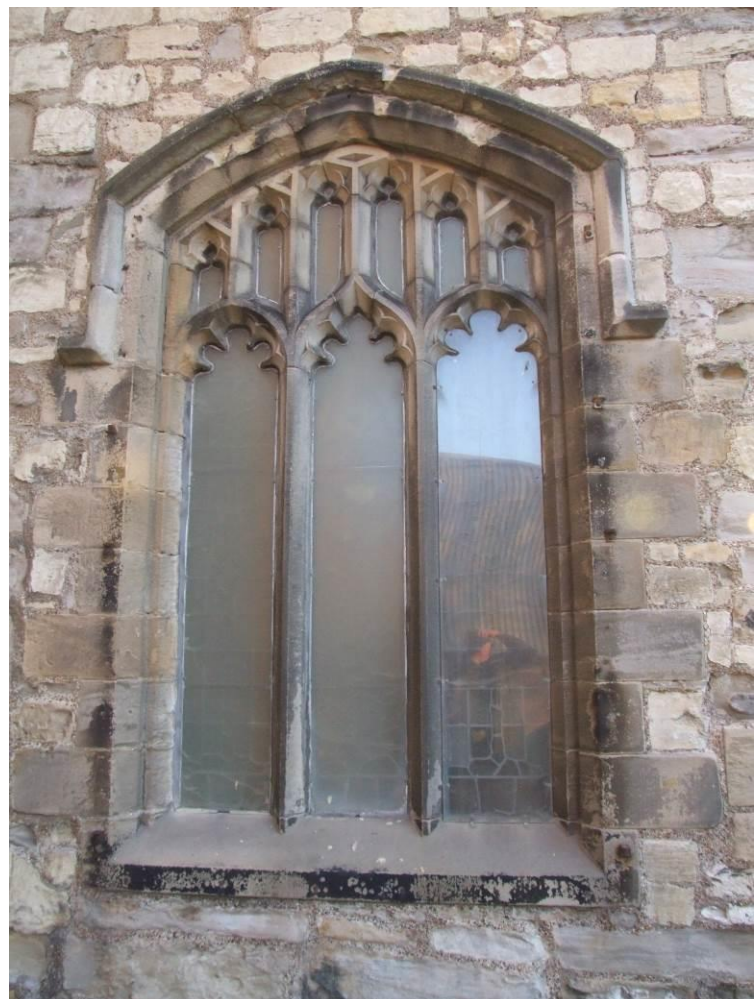
Fig 17. Stained glass protection, some tightly pointed in, latter with recommended air gap to perimeter

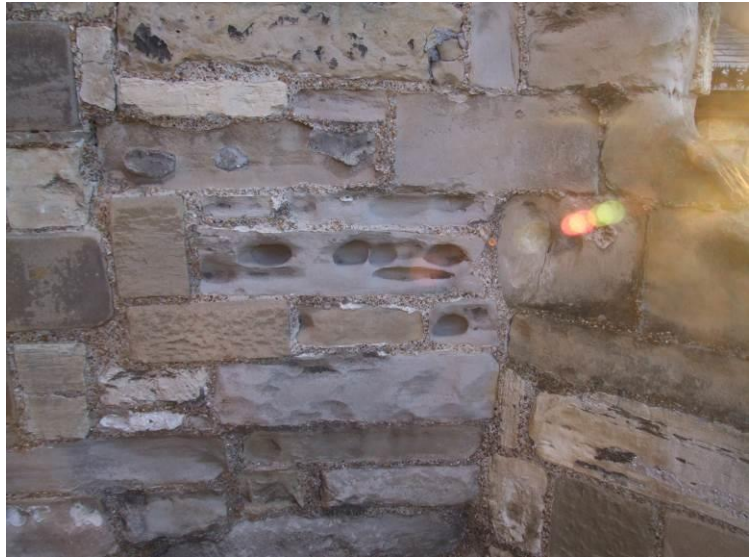
Fig 18. Localised area of extreme erosion to Tower

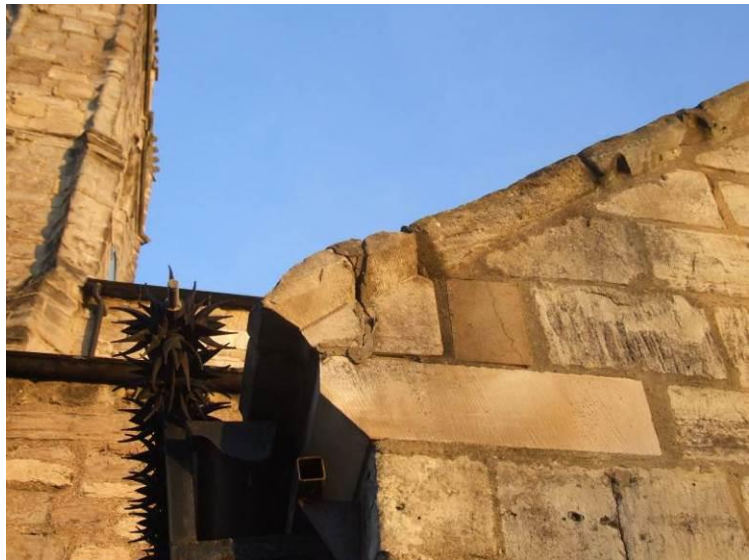
Fig 19. Repair required to termination of water tabling

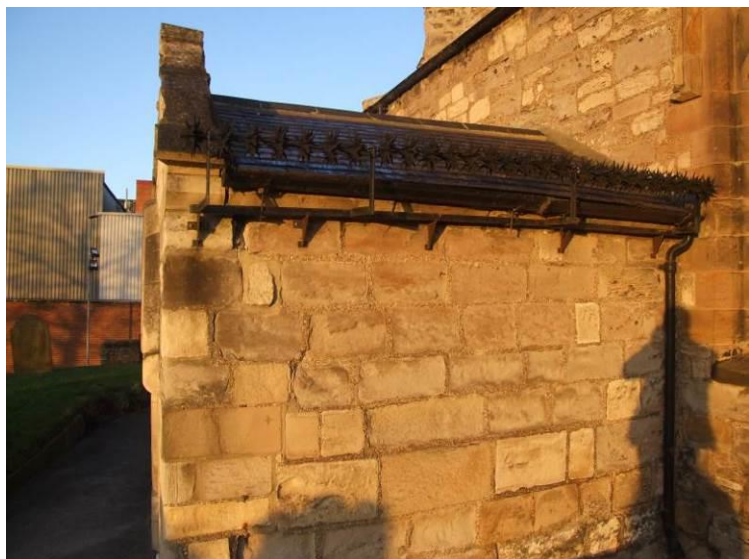
Fig 20. Localised cracking to Porch east gable

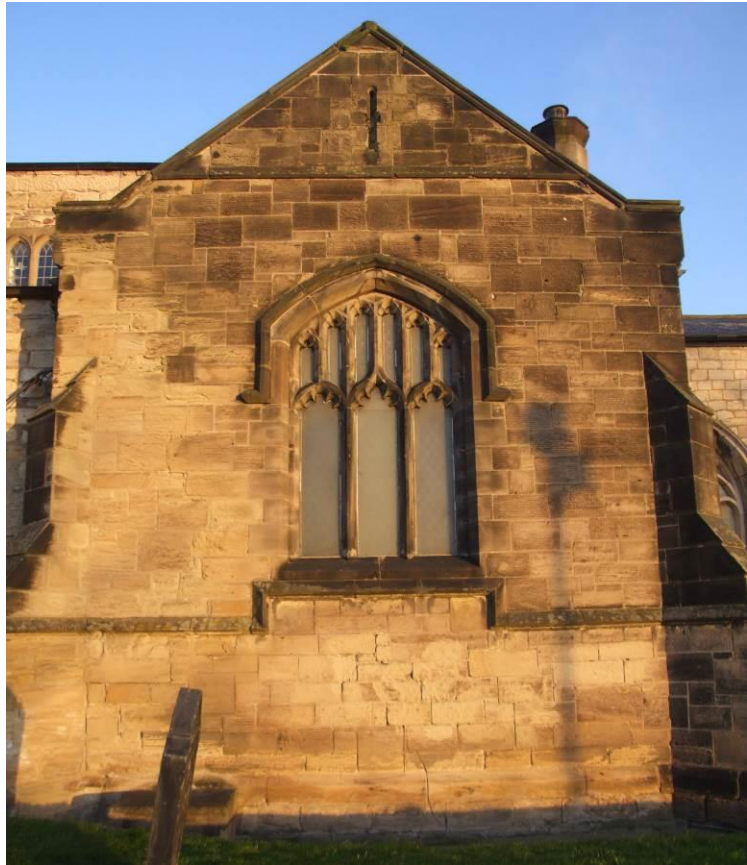
Fig 21. Central vertical cracking  
below Organ Chamber,  
south window

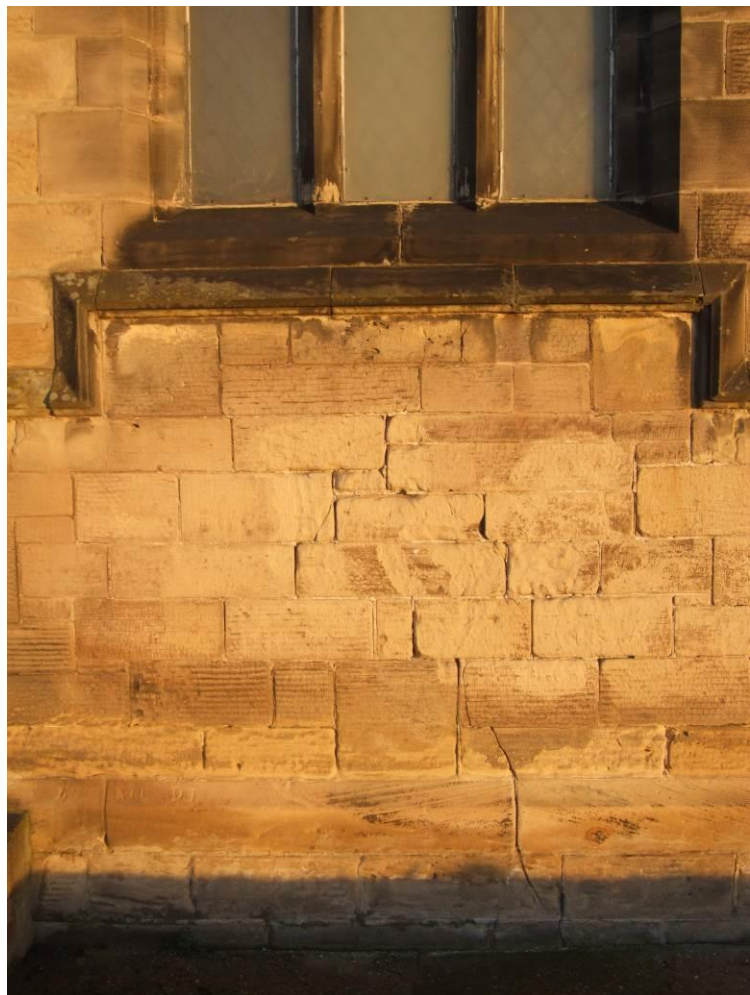
Fig 22. Detail of above

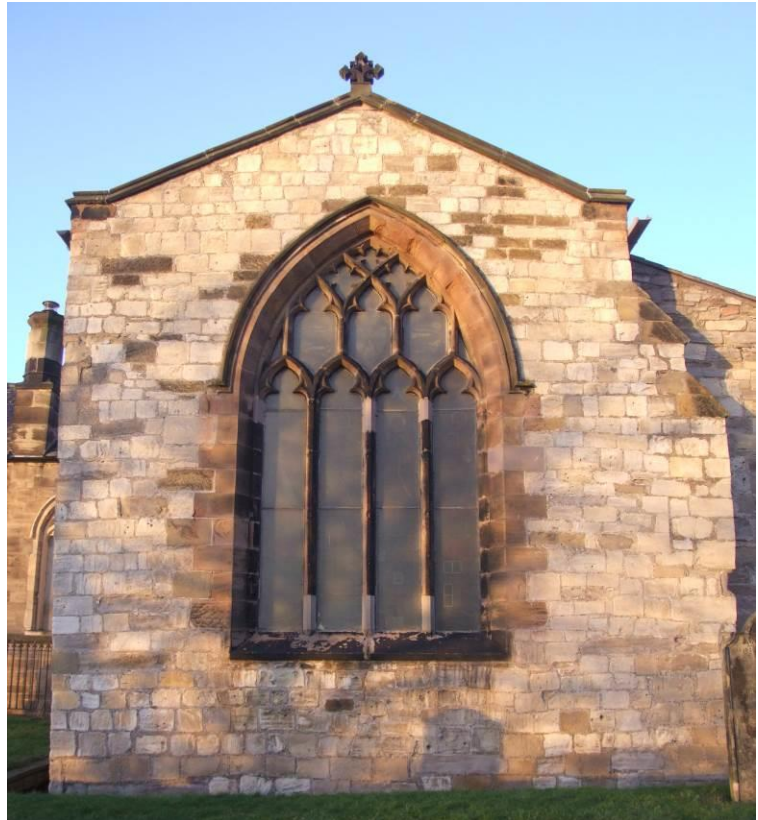
Fig 23. Central vertical cracking below east chancel window

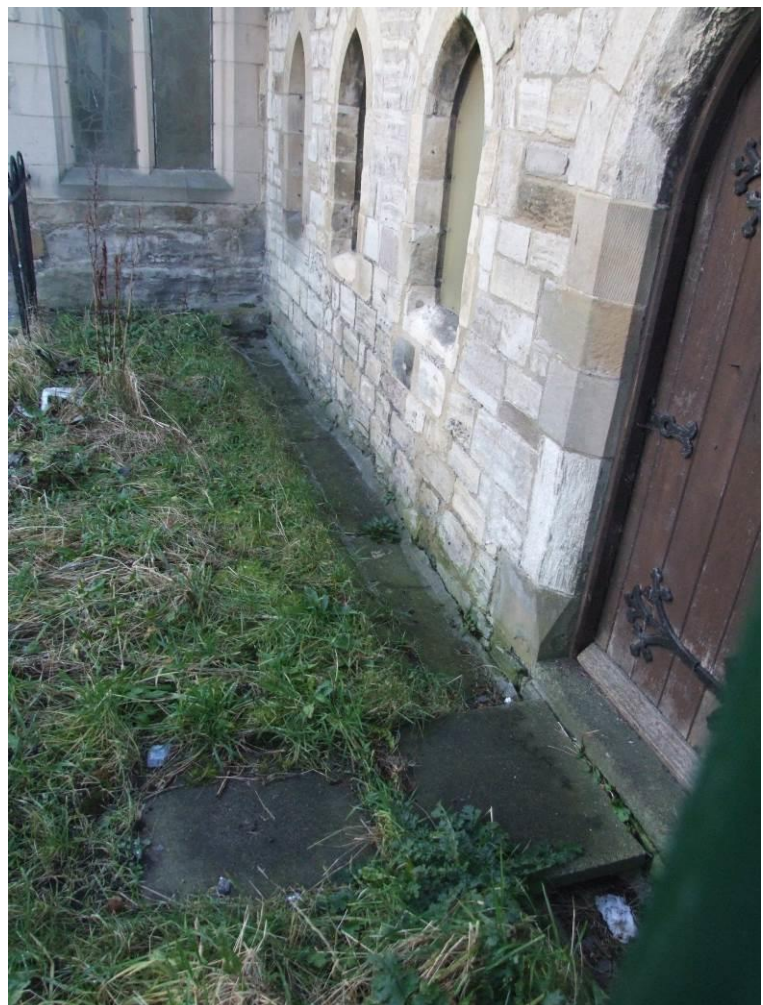
Fig 24. Perimeter channel below Clergy Vestry, east elevation

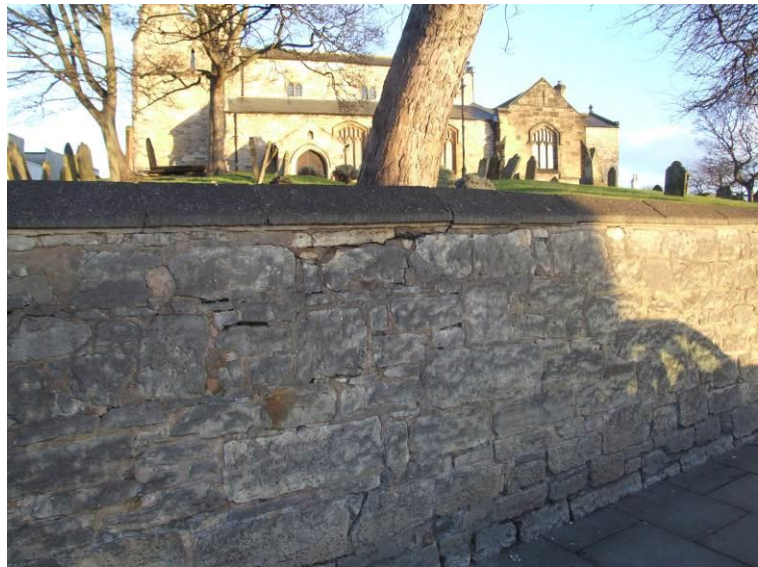
Fig 29. Tree growth, potentially compromising wall condition
