Care of Churches and Ecclesiastical Jurisdiction Measure 1991 – Quinquennial Inspection  
**ST CHADS, SUNDERLAND**

Diocese: Durham  
Archdeaconry: Sunderland  
Church Code: 613 181

Date of Inspection: 05<sup>th</sup> May 2022  
Inspection undertaken by: Jamie Holden BA (Hons) RIBA RIAS  
Previously Inspection: July 2015 by Lucy Stewart

**Studio Tamacoco Architects**

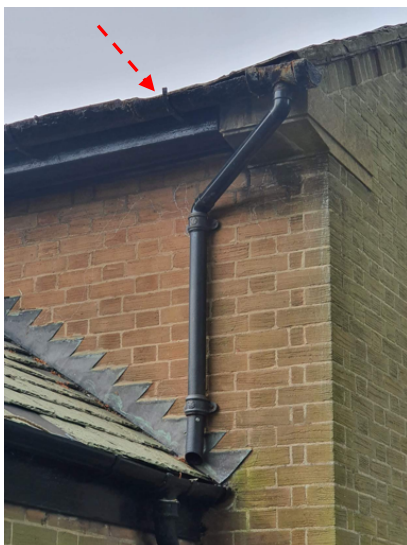
2.2.7

- 2.2.3 There is some shrinkage and minor cracking to the pointed ridge to the organ loft. **O**
- 2.2.4 The cast iron guttering at the west end, directly above the Porch, is quite badly corroded although does not appear to be leaking. This section of guttering ought to be replaced within this quinquennium. **4**

a) Cast iron gutter to be repaired

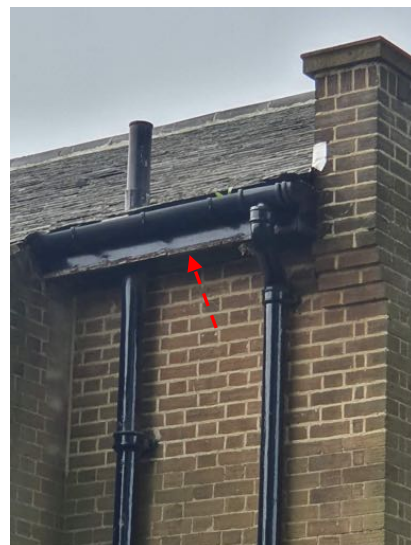
b) Fascia board required decoration.

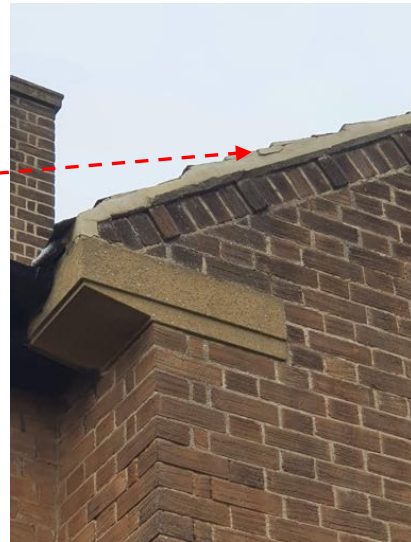
b) Minor cracking to verge pointing.

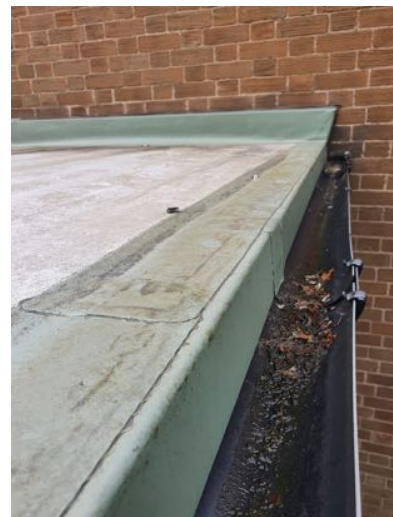
2.3.1 This section of flat roof forms a covered walkway between the Church and the Hall. It is understood that the roof was originally covered with copper sheet which has since been replaced with a single ply membrane. The membrane has abutment flashings chased into the brickwork and is all in good order.

*b) Single ply membrane has replaced a copper roof covering. The membrane is chased into the brickwork*

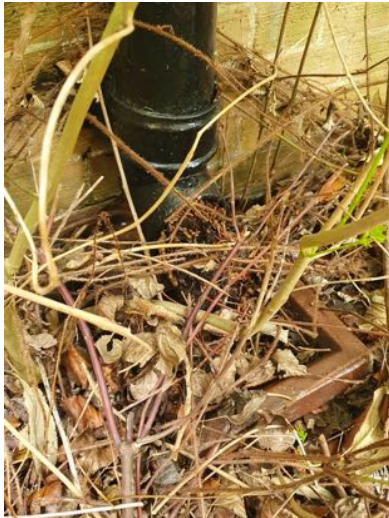
2.5.4

2.5.3 A number of the gullies are very difficult to inspect due to vegetation. It is important to keep the area around downpipes free of planting to enable easy and regular maintenance. It is advised that the drains are tested to ensure they are running freely if this has not been done in the last 5 years. If any blockages are found they must be cleared. **2**

a) Downpipe is blocked with debris that has been washed down from the gutter.

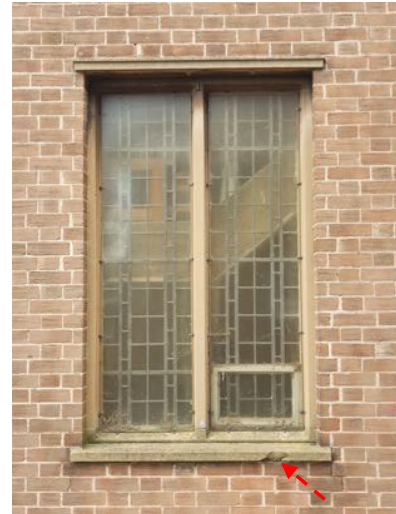
- 3.2.4 The reconstituted stone cill to the stairwell is damaged and ought to be repaired. In isolation this is not particularly urgent, however, there are similar high priority repairs recommend on the west elevation and it would be sensible to repair this window at the same time. **2**

b) Damaged cill to stairwell window.

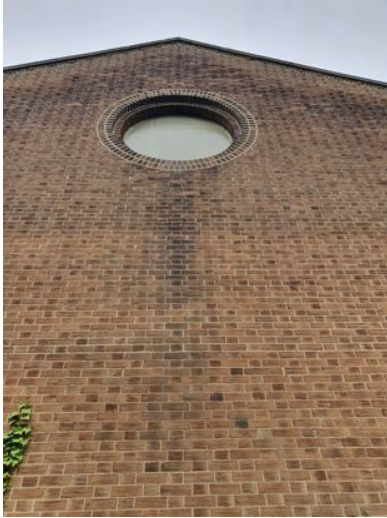
3.3.4

3.3.2 There is some staining below the circular window but overall the masonry is in reasonable condition. The area directly below the parapet was repointed in 2020.

a) Staining below circular window

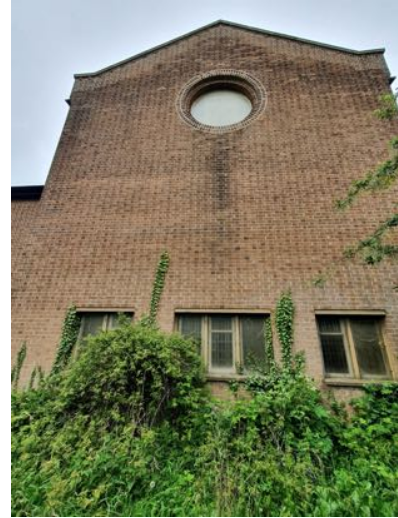
3.3.3 The base of the wall cannot be inspected due to the overgrown vegetation.

b) Overgrown vegetation obscures the base of the wall and is encroaching on the lower windows.

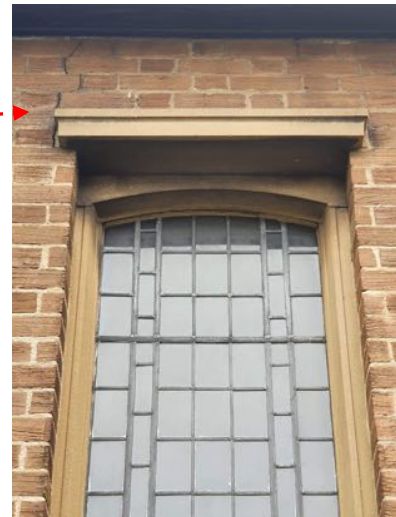
- 3.4.3 There are cracked joints at the head of the first window from the west. The internal plaster finish is also cracked in the corresponding location. This suggests structural movement/ settlement which is likely to have occurred many years ago and might now be static. There are similar cracks to some of the other windows that appear to have been repointed previously.

b) Minor settlement crack is reflected in the internal plaster finishes

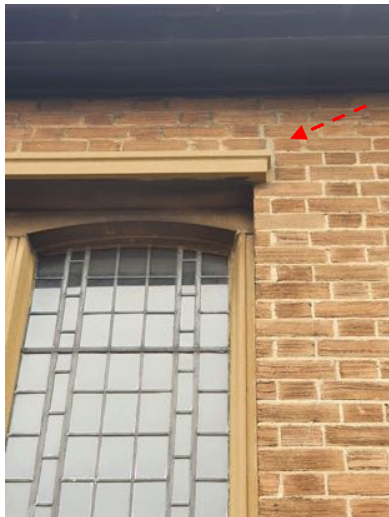
3.4.9

a) Settlement crack previously repointed.

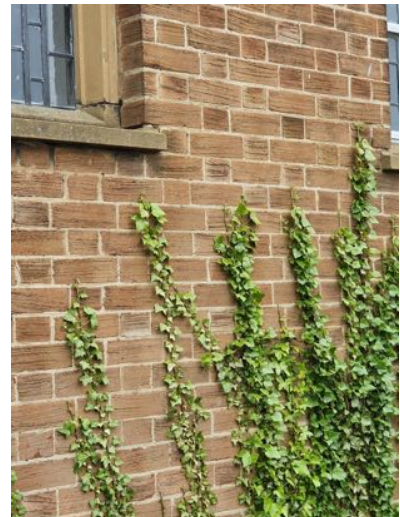
b) Ivy needs to be removed from the base of the walls.

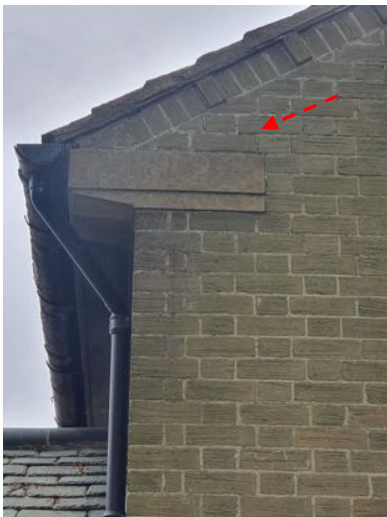
- 3.5.1 There is a very minor crack in the brickwork above the kneeler stone in the west elevation of the North Aisle. This should be monitored and if the crack develops it should be reported to the Architect. 0

a) Minor crack above kneeler

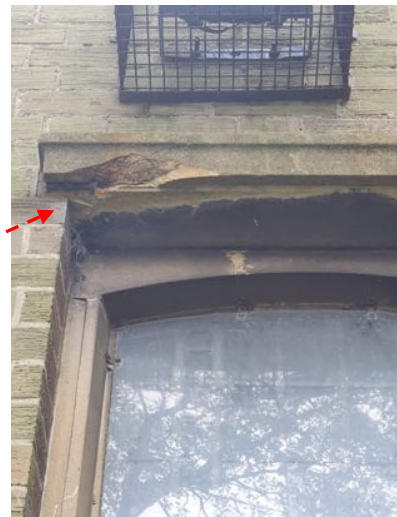
- 3.5.2 The reconstituted stone lintel above the window in the North Aisle is spalling and has revealed corroded reinforcement bars. Once imbedded metalwork has started to corrode in this manner it is likely to worsen over time and cause further damage. To remove the corroded metal work would be a rather disruptive and costly exercise, therefore, in the first instance it is recommended that the metalwork is treated with a suitable rust inhibitor and the damage stone repaired. This will be a relatively cheap repair and, with any luck, might hold for many years. 2

b) North Aisle window to be repaired.

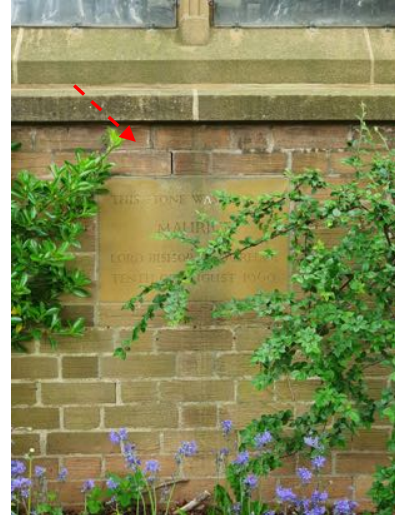
- 3.5.4 There is an open joint directly above the foundation stone which is located centrally below the cill of the west window. To be repointed with the North Aisle window repair. 2

b) Open joint above foundation stone

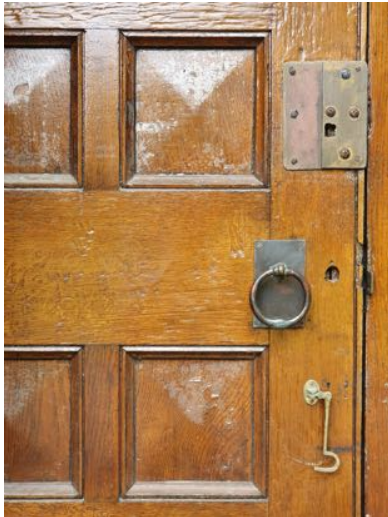
4.1.6

a) Lacquered finish starting to flake

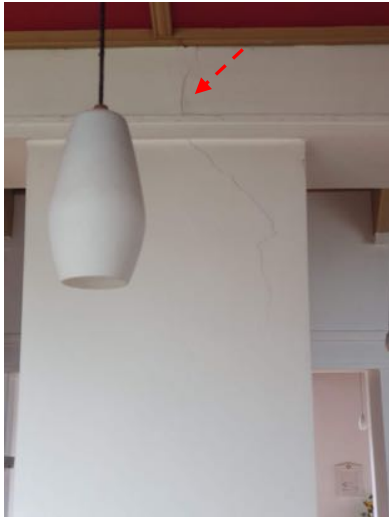
- 4.2.2 All walls and columns are plastered and painted. There are a number of cracks on the arcade around the top of the columns. It is likely that these have been there for some time and are the result of settlement. The cracks ought to be filled when the interior is next decorated but do not, when considered in isolation, justify remedial/ redecoration at this stage. Cracks to be kept under observation and any significant changes reported to the Architect. **0**

a) Cracked plaster finishes – to be monitored.

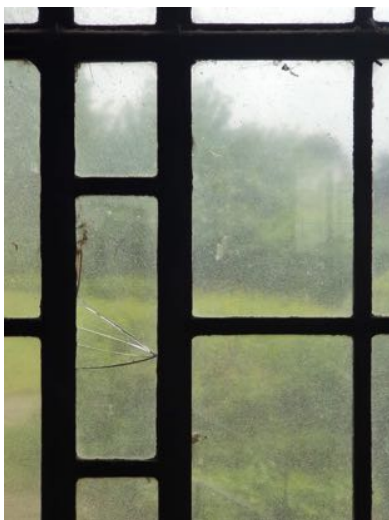
a) Minor cracks

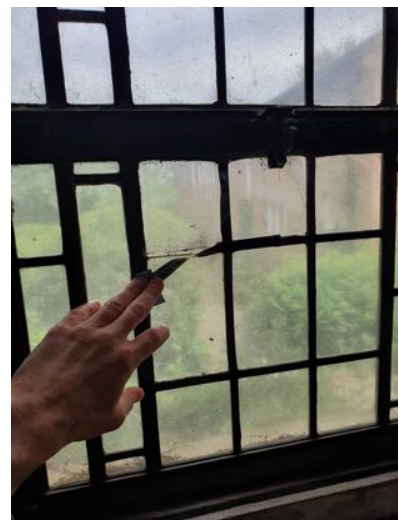
- 4.2.3 Windows have clear rectangular leaded glass, each window has a ventilation hopper. There are several cracked panes which appear to remain weathertight and a short section of lead has dropped out on one of the windows. The lead should be repaired, it is currently taped over. **2**

b) Missing section of lead came to be replaced.

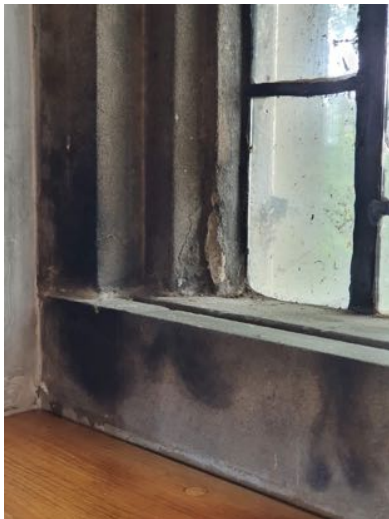
a) Minor decay to the stone window surrounds

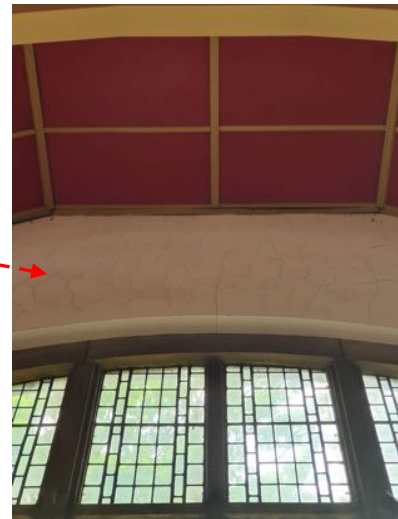
- 4.3.2 The west wall is disfigured by a 'crazed' pattern of cracking. The plaster sounds hollow in some areas which would indicate that it has de-bonded from the substrate in places. At present there are no signs of it breaking up and no significant risk of plaster debris falling although the area should be kept under observation.

- 4.3.3 The cause of this crazed effect is probably a result of sub-optimal conditions/ preparation during installation resulting in the plaster drying out too quickly and cracking. These very fine cracks are then revealed as dust and other impurities collect in them over time. Sanding and filling/ skimming the wall would probably resolve this issue which is a cosmetic rather than structural defect. However, overall the interior remains attractive therefore no remedial action is specified at this stage.

b) Crazed cracked plaster above west window

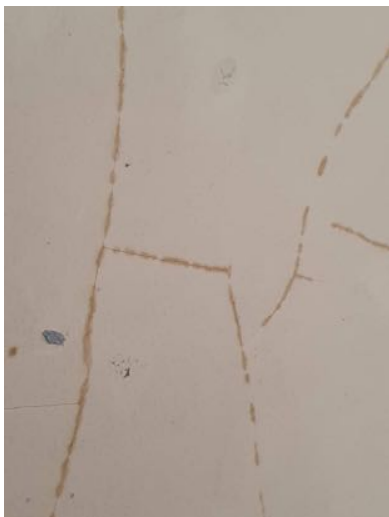
a) Detail of impurities gathered and trapped in the plaster cracks

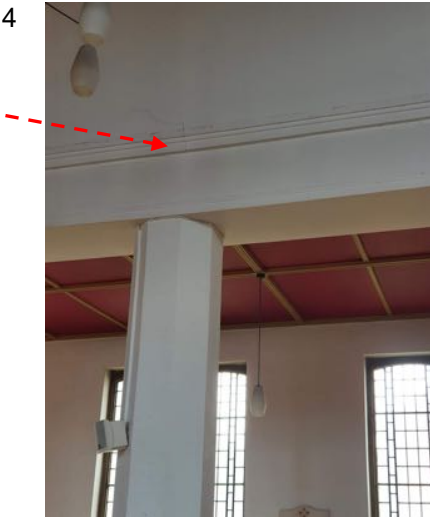
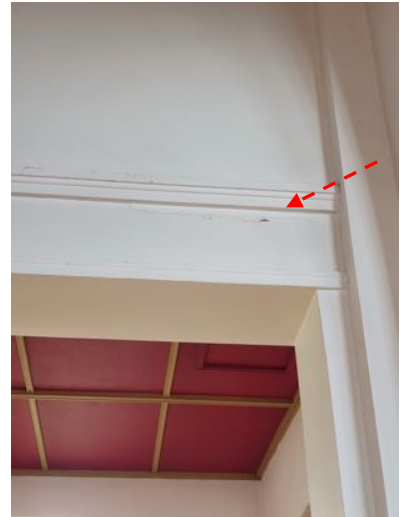
4.3.14

- 4.3.1 Open arcades to the north and south and rounded Chancel arch to the east. The west elevation has a large shallow arched window. All walls plastered and painted white. The general condition of the walls is reasonable, however similar cracks to those described in the North Aisle arcade also occur on the Nave-side which should be monitored. ○

a) Probable settlement cracks to be monitored

b) Probable settlement cracks to be monitored

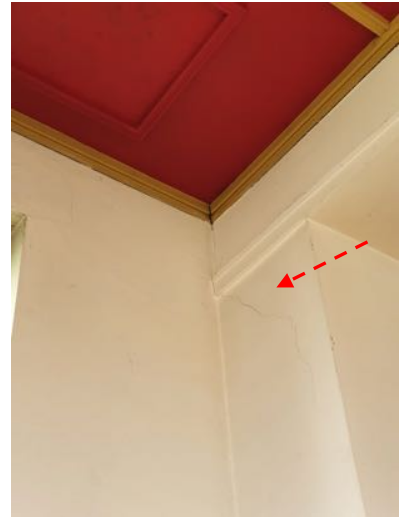
b) Settlement crack and note ceiling hatch.

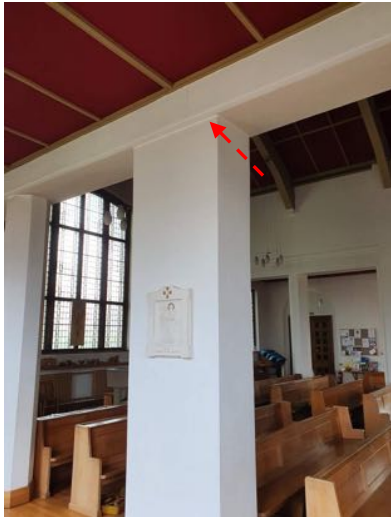
a) Settlement crack

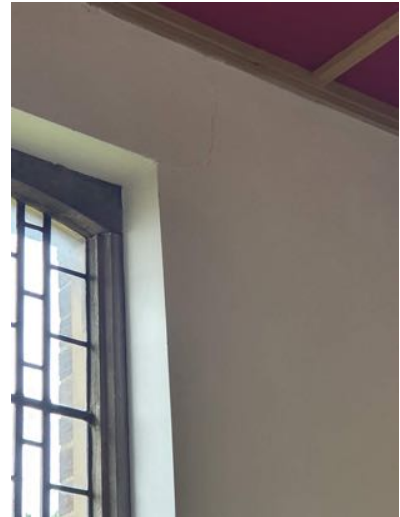
- 4.4.1 The South Aisle mirrors to north expect that the south wall has no doorway, instead there is a window. At the east end an open arch leads to the Lady Chapel. The walls are in reasonable condition with the same settlement cracks as noted elsewhere that should be monitored. At the head of the first window from the west there is a crack that is noted in the same location externally.

b) Crack at the window head corresponds with fractured masonry externally.

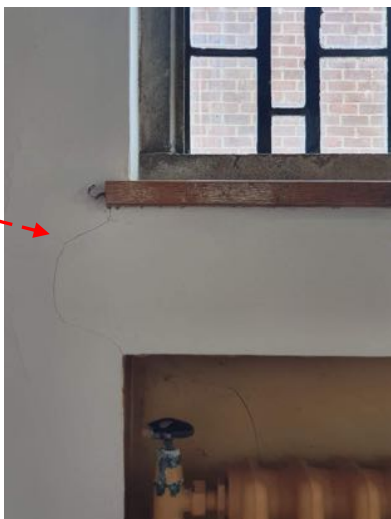
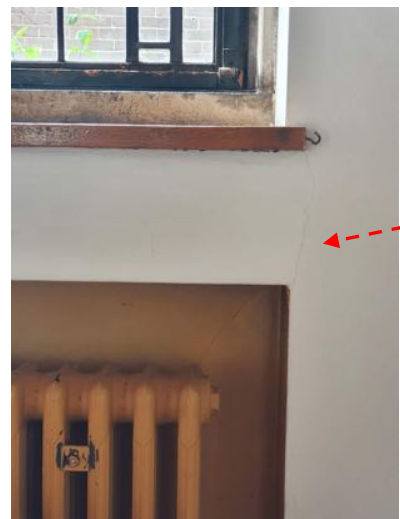
4.4.10

a) Minor plaster cracks

b) Minor plaster cracks

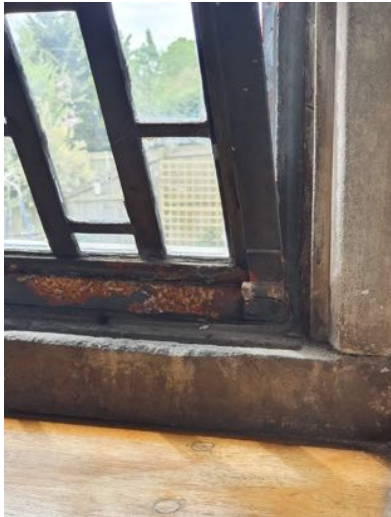
- 4.4.3 Although the hoppers are all in working order they are also all corroding and the previous finish is flaking. They should all be brushed down and repainted. A couple of hinges might need to be replaced on one or two. Decoration needs to be carried out by an experienced contractor because far too often when these type of windows are decorated they get painted shut and never open again! The contractor and specification for decoration/ refurb must be approved by the Architect. **4**

*a) Ventilation hoppers have corroded*

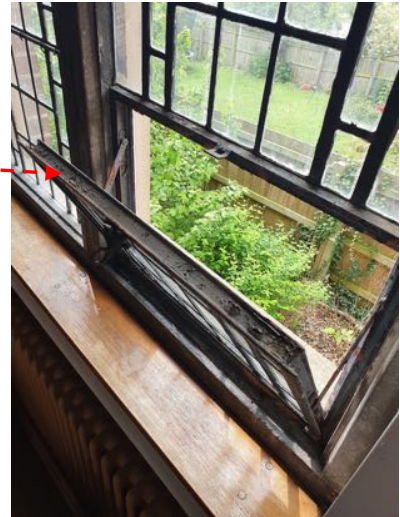
*b) Previous decorative coating is breaking down.*

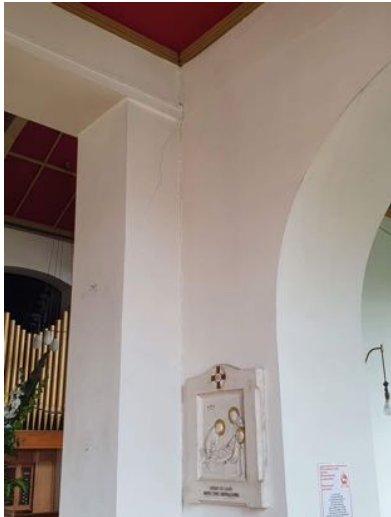
*a) Settlement cracks to be monitored.*

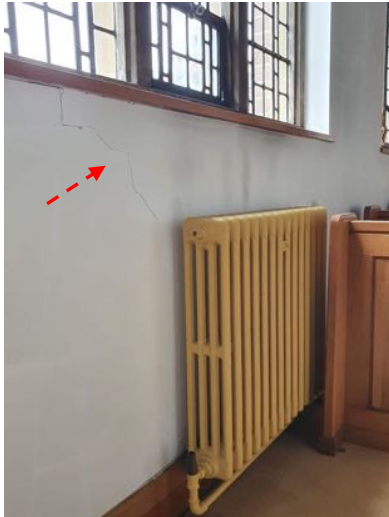
a) Cracked plaster below cill.

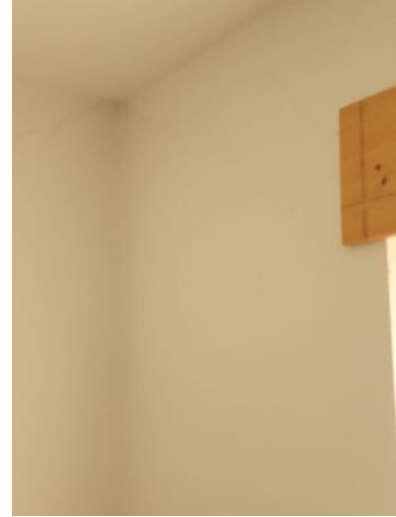
4.8.1 A very small room with fitted units and painted plaster walls and ceilings. There are minor cracks in the NW corner but all in reasonable order.

b) Minor cracks

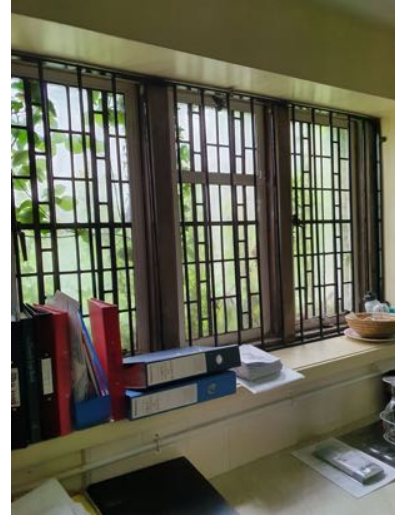
b) Vegetation can be seen growing over the east window fitted with internal security bars.

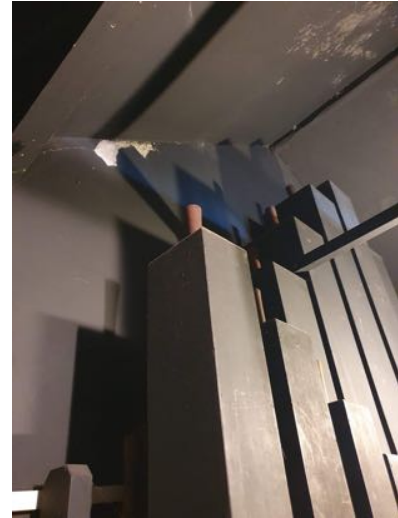
b) Some plaster damage on the gable at high level.

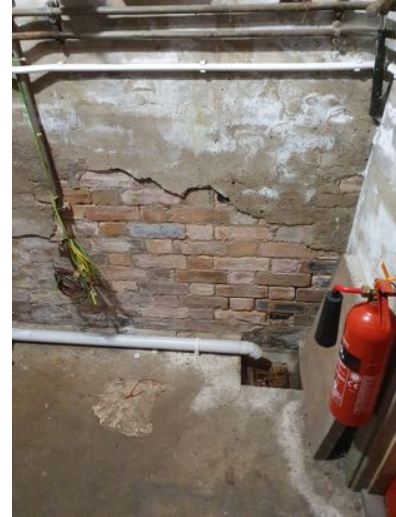
b) Missing render from the lower section of wall and drainage outlet.

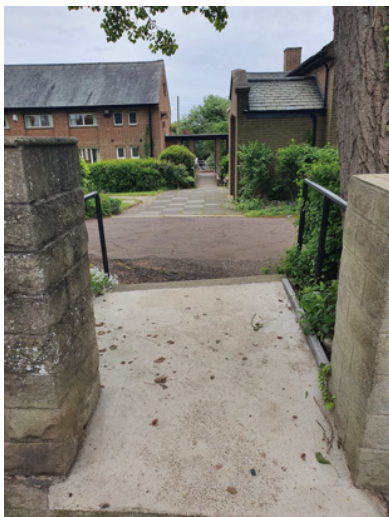
*a) Concrete shuttering to replace displaced flagstones*

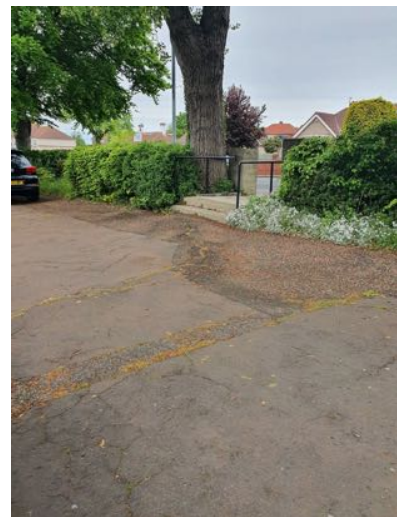
*b) Tarmac drive undulates due to tree roots*

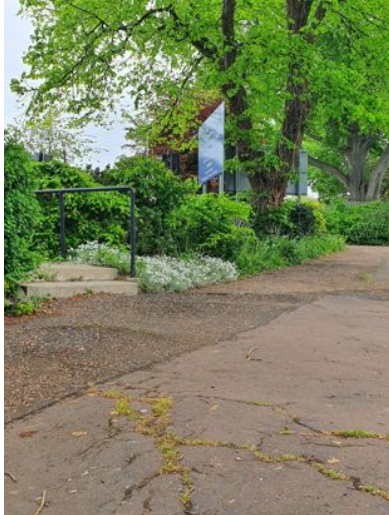
a) Weeds are taking hold in cracks caused by tree roots

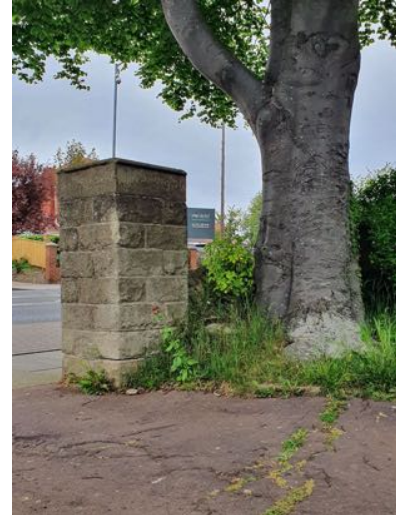
b) Defective tarmac and washed out pointing to the base of the pier.

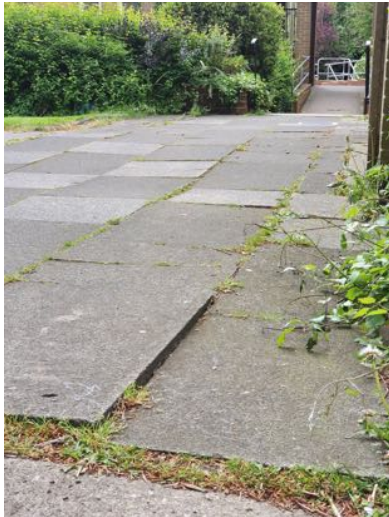
a) Uneven flagstones could present a trip hazard.

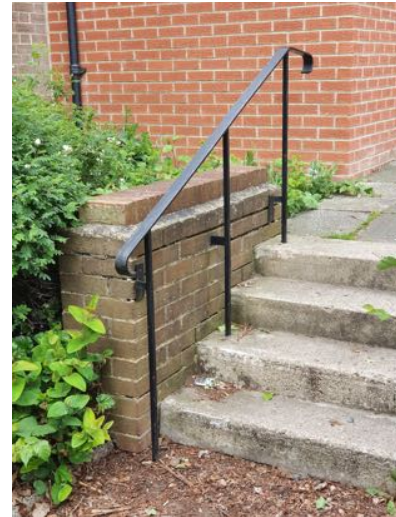
b) Resecure handrail

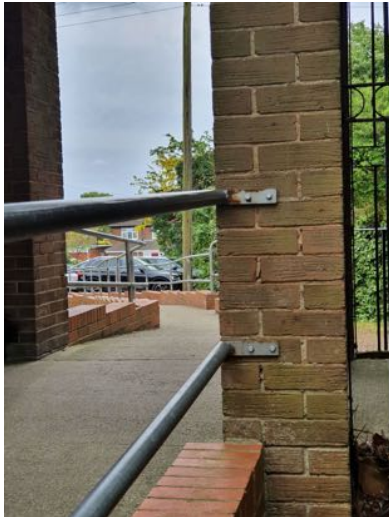
*a) Galvanised tubular handrails showing some signs of corrosion.*

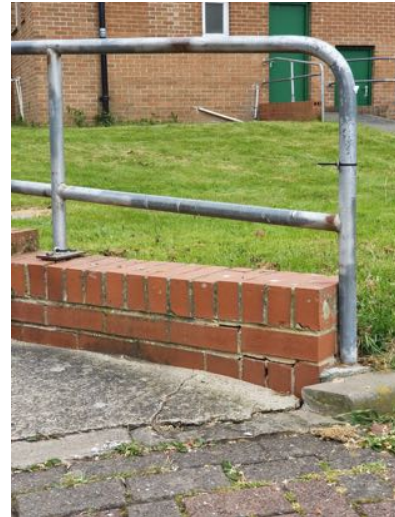
*b) Low-level wall fractured.*

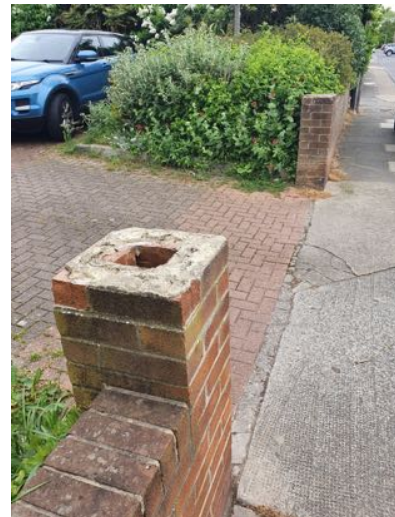
- 5.1.7 A brick built wall forms the east boundary and allows vehicle access to a parking area. There are two gate posts with capping stones missing.

*b) Caps missing from gate posts*

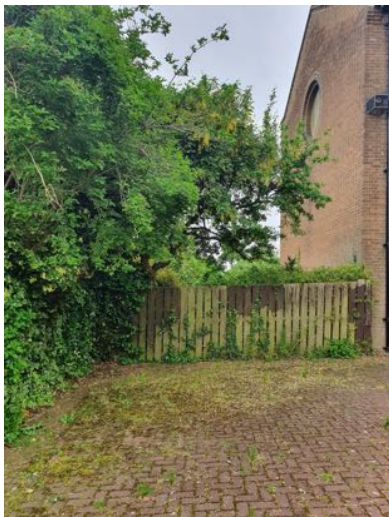
*a) Gateway in fencing to be refurbished and made operational*
