Church of St. Philip and St. James, Tow Law

Diocese of Durham
Archdeaconry of Auckland
Deanery of Stanhope

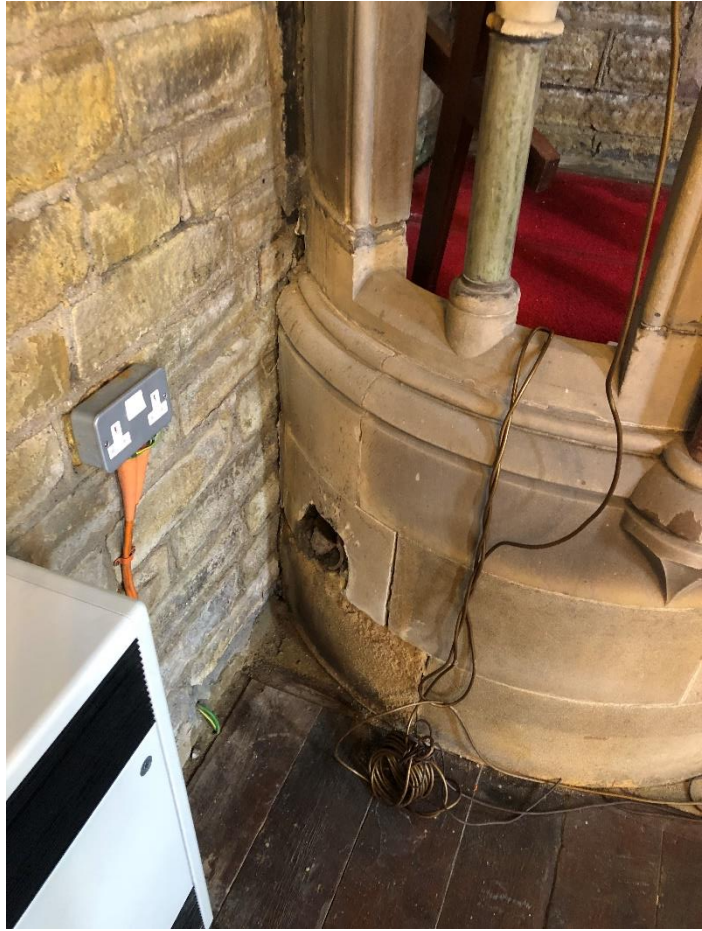
P6 (4801):
Vestry (organ loft external
downpipe leakage)

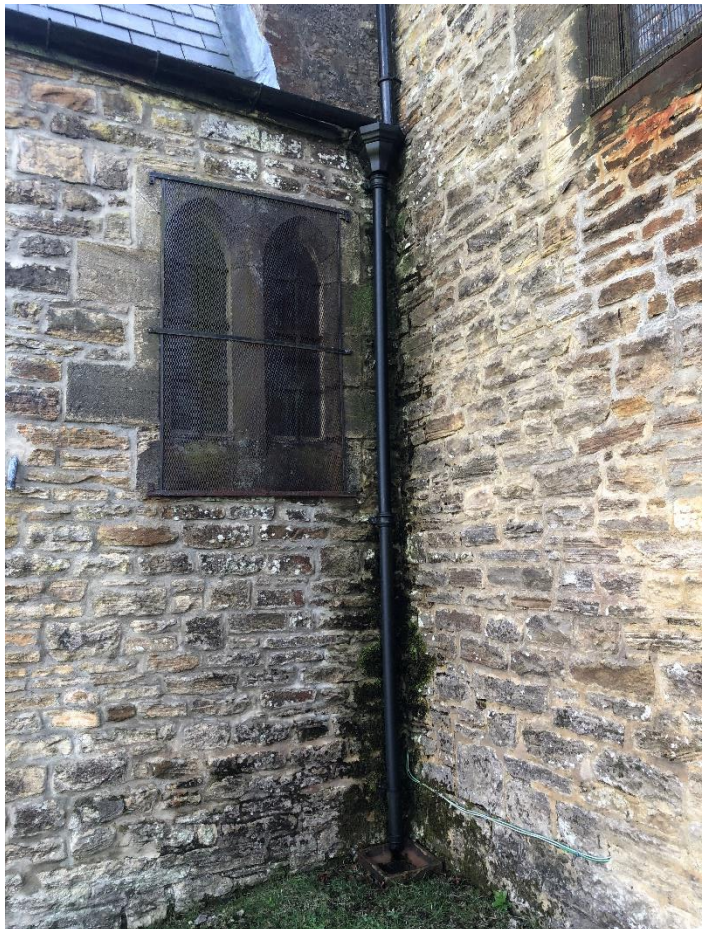
P7 (4793):
Chancel south wall, water seepage

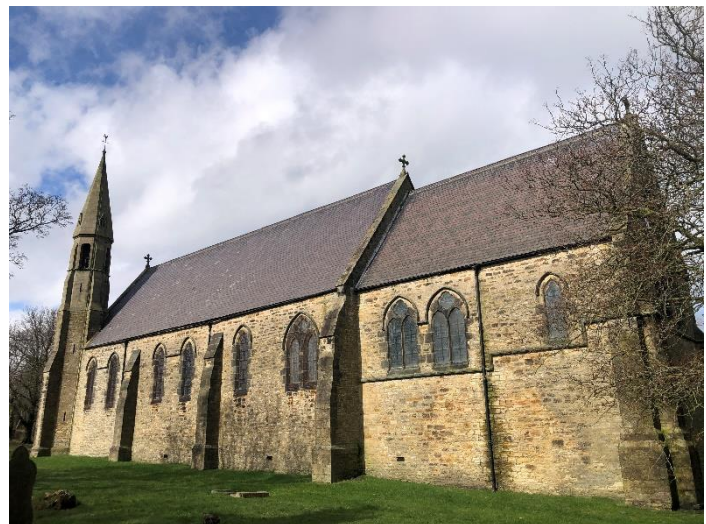
P10 (4622):
South elevation, varieties of pointing

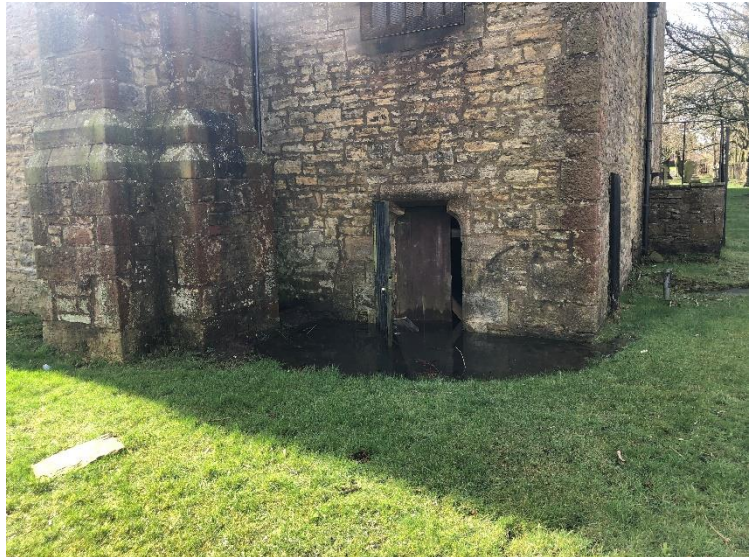
P12 (4628):
Flooded basement/
damaged door (side view)

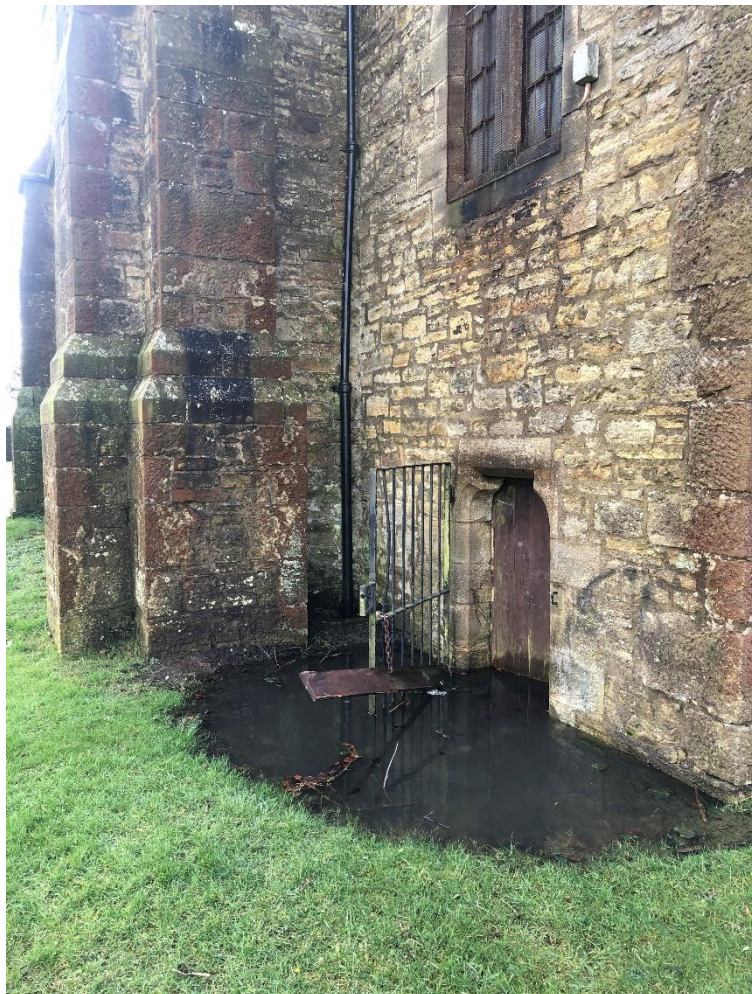
APPENDIX C: Listing Document
