HOLY TRINITY USWORTH
Washington
(19)

QUINQUENNIAL REPORT
on the architect's inspection on

20 March 2017

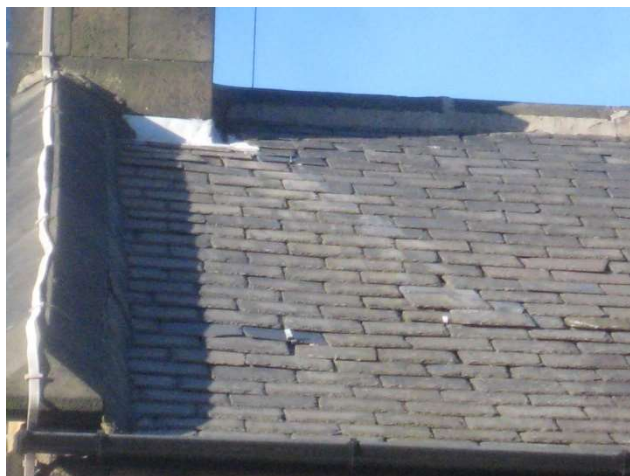
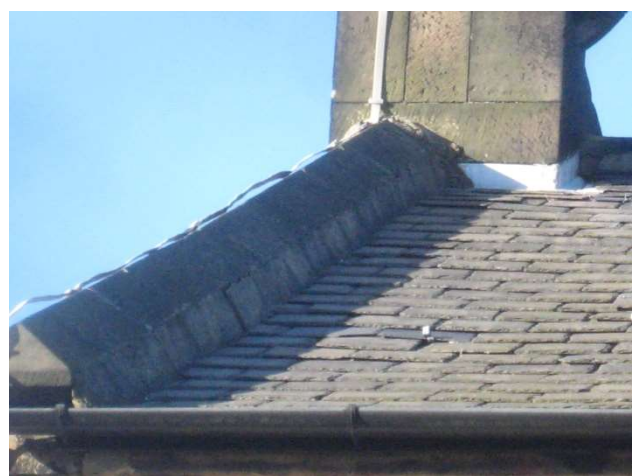
Nave SW

16. **Nave** similar but shallower and unfelted with mortar torching of the slates to the battens. Decaying boards under the eave courses. Ridged watertables with high mortar fillets covering the slates.
SW mortar fillet cracked and part loose. SE fillet breaking down with debris on the slates. NE fillet replaced and fair. NW fillet breaking down and plants growing in the cracks have been removed.
The N slates are very uneven all down the W end and around the bellcote with some slates missing. Uneven all along the ridge. A large patch at the top E end is disrupted and a slate is slipped out mid slope near the E end.
The S slates better but uneven around the bellcote where past patching has been with lead and wire clips. Two have slipped out mid height close to the W end, with daylight inside.

19. Reslating the whole building (with improved slates at the Hall), non-ferrous nails, felt, secret gutters and better flashings is justified.

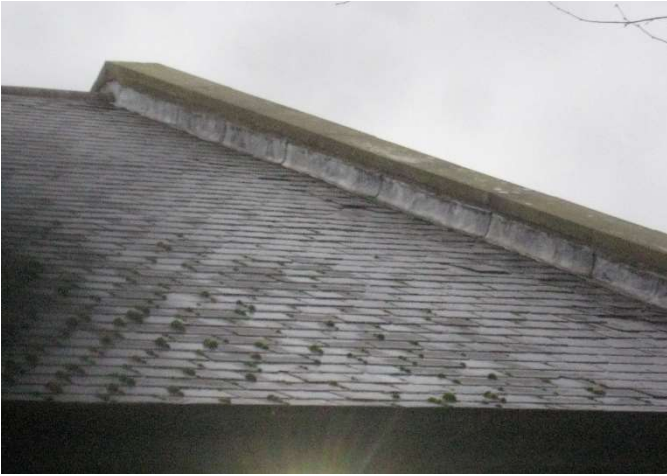
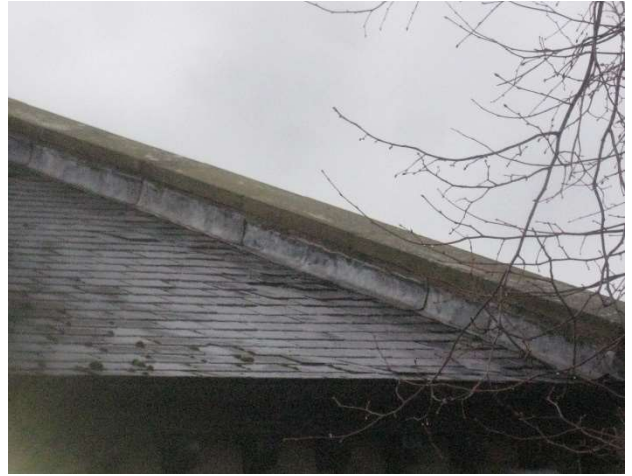
Hall NW

18. At S side Hall broken and missing slates by bell turret, all up the W gable and SW eave. A slate formerly patched in with adhesive lies broken on the ground. The N side better but three slates missing and others slipping near the W upstand.

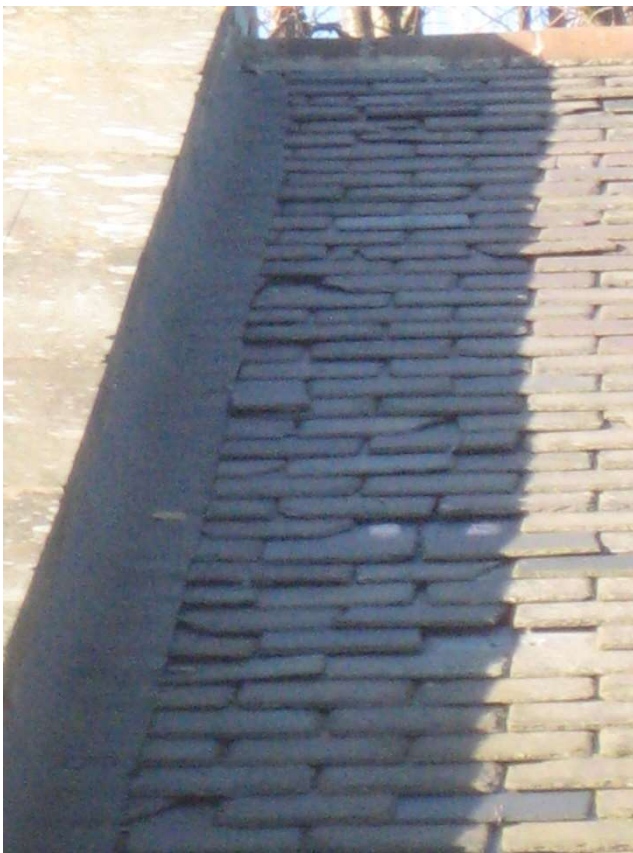
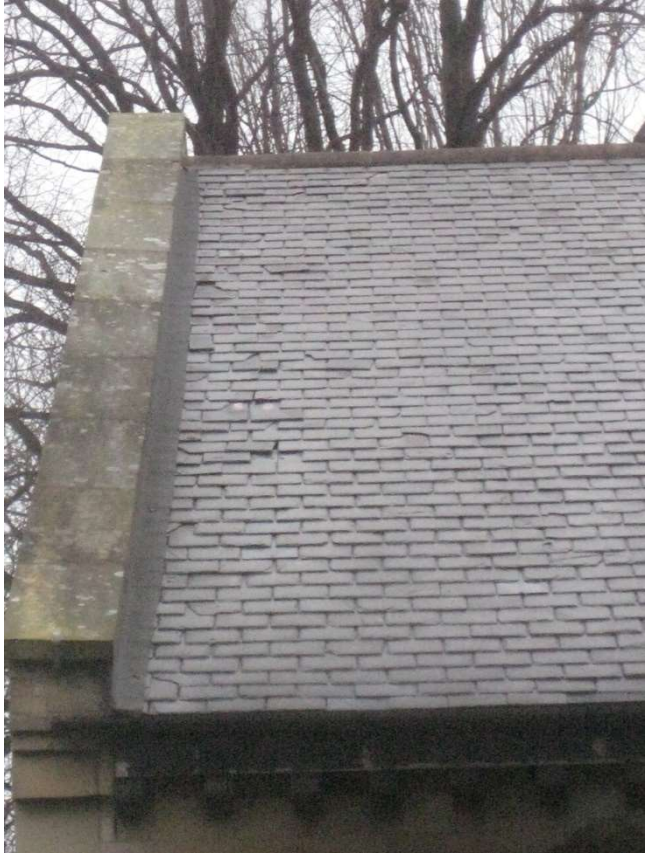
Hall SW and adhered slate on ground

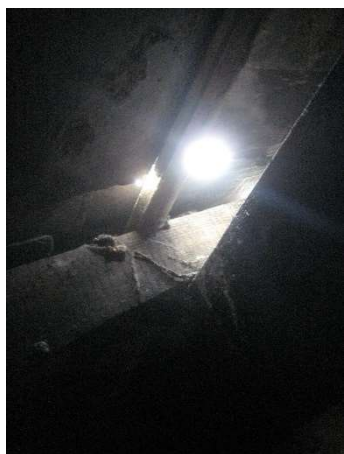
Daylight at missing slate Nave SW

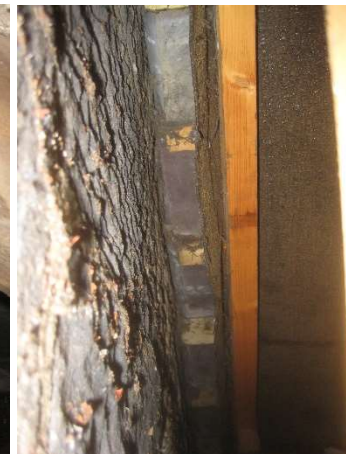
Hall felt not reaching the Nave wall

17. The **Hall** has welsh slate on felt mostly in fair condition with timber corbels at the eaves to echo the stone corbels at the Nave. Two vents in the clay ridge. No lead soakers in the slates at the W upstand but instead cover flashings are dressed over the slates, a weak detail. The former lead flashings appear to have been changed to Nuralite or similar composite material. Parts of the remaining E lead flashings are coming loose. The felt does not reach the Church wall so any leak through the flashings runs down the wall (photo below and para 53).

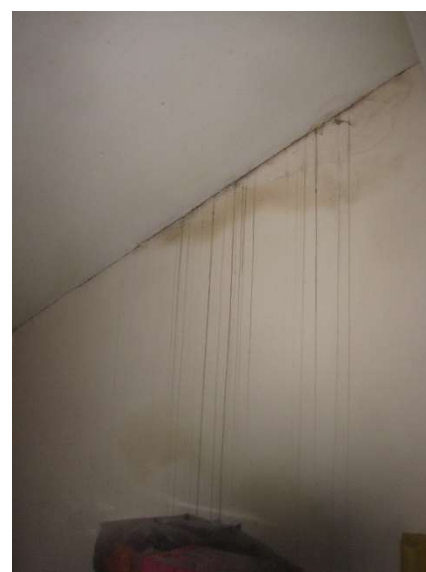
upper store wall where Hall felt does not reach the Nave wall

53. The extension walls are painted cream. Minor cracks between upper Office walls and ceiling. In the small upper Store water marks down the wall abutting the Church (para 17). Holes left from a phone on the stair should be filled.

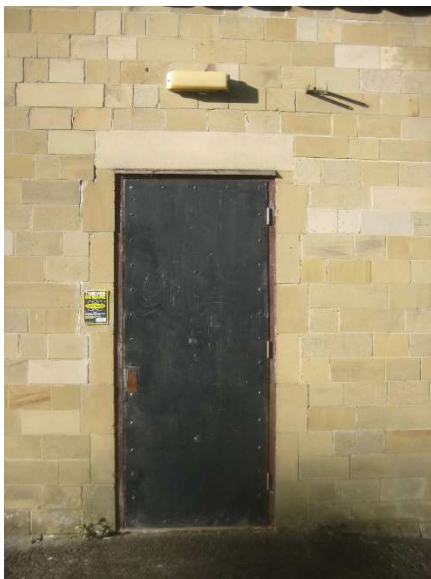
Wall by S door (para 27)

27. Some cladding joints remain cracked and open L of the S escape door.

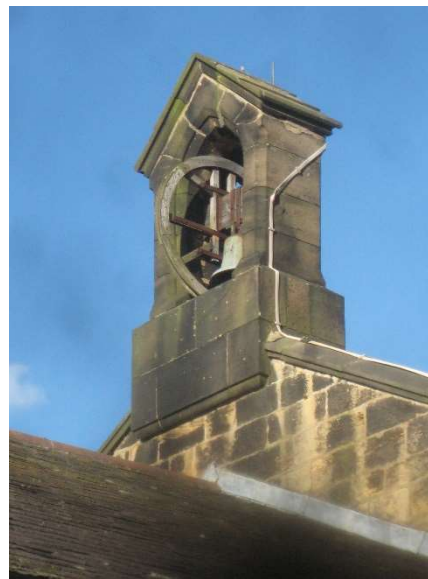
Bellcote

28. The small bellcote was rebuilt when the Hall was added and appears sound. The single bell, oak beam and wheel and the rope through the ridge seem sound. Behind the organ the Nave ceiling is watermarked where water drips through a wide iron pipe sleeve mortared into the ridge for the bell rope.

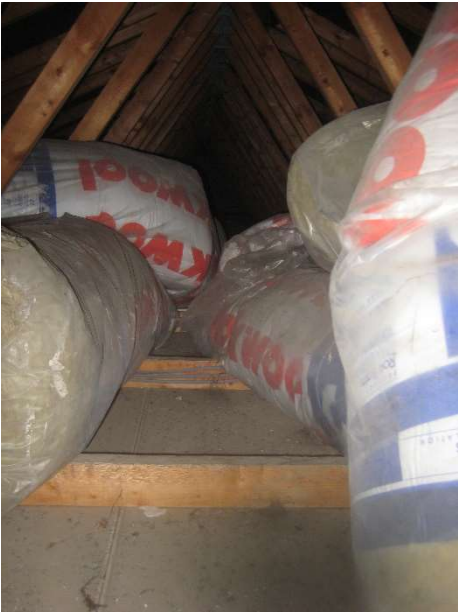
39. The Hall and new rooms have plasterboard, sound but with minor movement cracks at the walls.
40. The plasterboard is part insulated with mineral wool and more unused rolls lie in the lofts. Over the S rooms quilt has been disturbed and not fully relaid. The N rooms are about 90% covered and a roll of unused quilt stands in the void. Parts only of the lower and upper parts of the Hall are covered. No insulation is laid over the upper office although again many rolls stand there unused, doing nothing useful. As well as laying the existing rolls it would be better to double the thickness throughout to bring it closer to current standard.

over centre of hall - mostly uninsulated despite unused rolls lying in the void

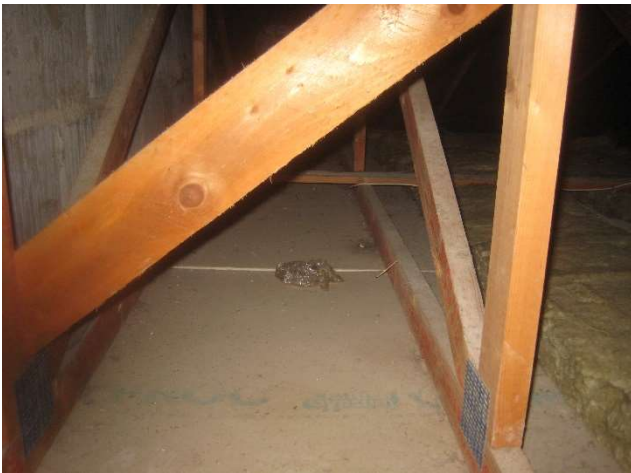
over N side of Hall – mostly uninsulated despite unused rolls lying in the void

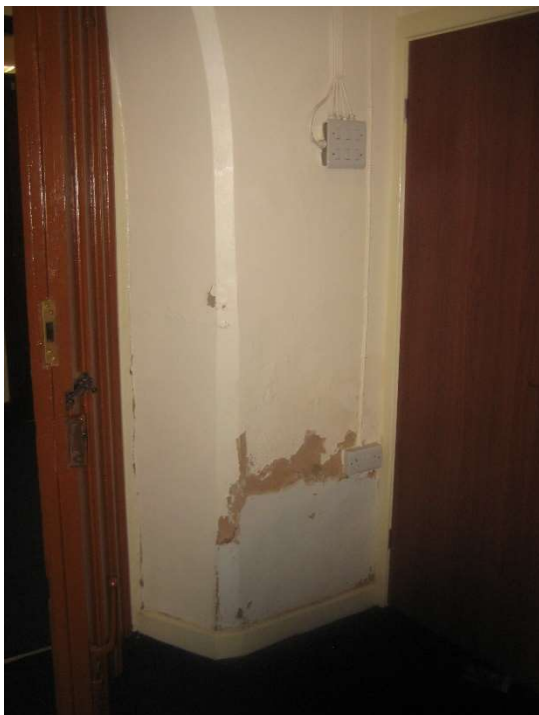
49. Rising damp at the original Church W external walls now internal is concealed in the Kitchen by half tiling and elsewhere was controlled with apparent waterproof render to about 1m high. Visible damp has become more extensive and now damages the plaster and paint:

- In the foyer showing as mould in the fitted cupboards and as stains on the former buttresses outside the ladies door
- At doors into the Nave – especially at the Church face N side which has been patched next to a surface plastic socket, lesser on the foyer side
- In the ladies behind the radiator and at the bottom of modern masonry infilling a church window (plaster now stripped)
- At gents slight above render level, which is itself poor behind the wc

Church side of Nave doors

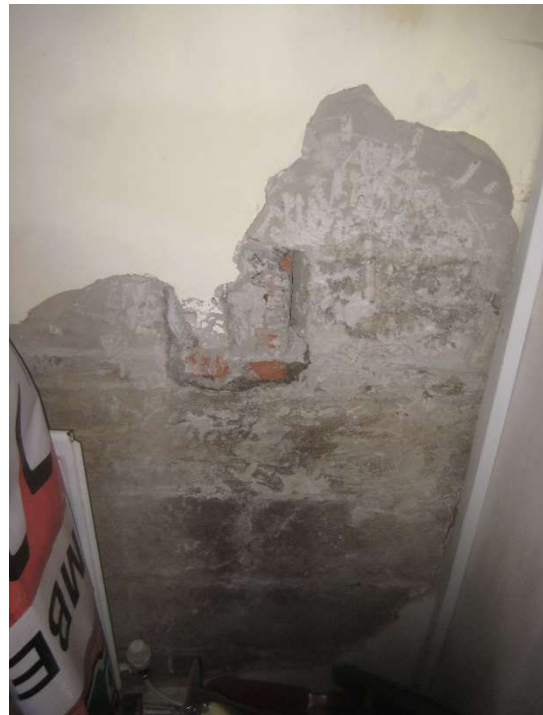
ladies wc after removal of damaged plaster

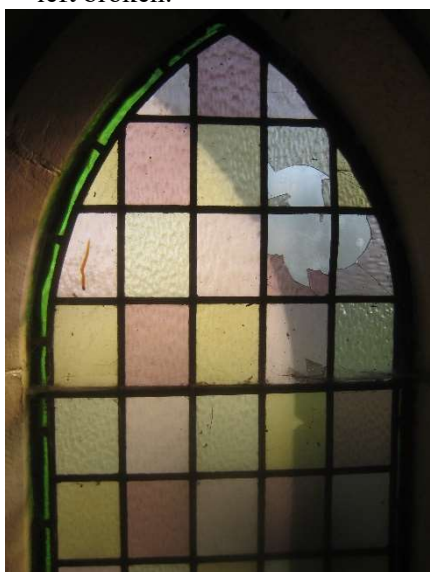
lean-to para 55

55. N Chancel and lean-to – two lancets in each have coloured cast quarries with one hopper each side (clear sheet glass on N side) in good condition but dirty. S hopper permanently slightly open. The SW window has four broken pieces at top (making a hole open to the back of the unventilated protection) and two cracked at the bottom. The flexible protection is too close to the glass. Cast wired glass in the lower Meeting room.

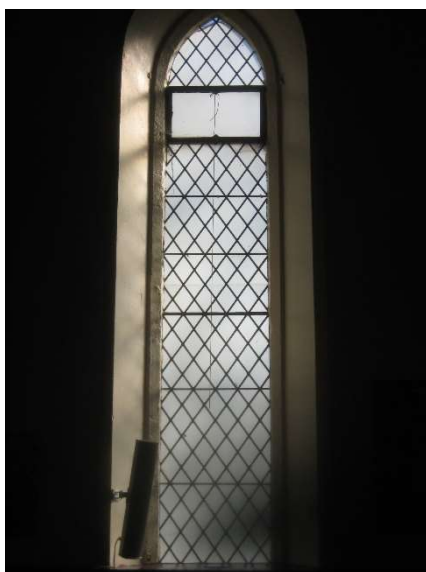
typical nave lancets para 56

56. Six of the eight Nave lancets have well leaded clear diaper quarries in fair condition though the glass is dirty both sides and cannot be properly cleaned without removing the protection. Four hoppers, two of them reglazed in unleaded float glass. The lancet by the pulpit has opal glass (and some clear replacements) with yellow border in good condition. One of the S lancets is another Coxon 1875 memorial stained glass with minor repairs including overglazing and some bowing due to weak lead pattern.

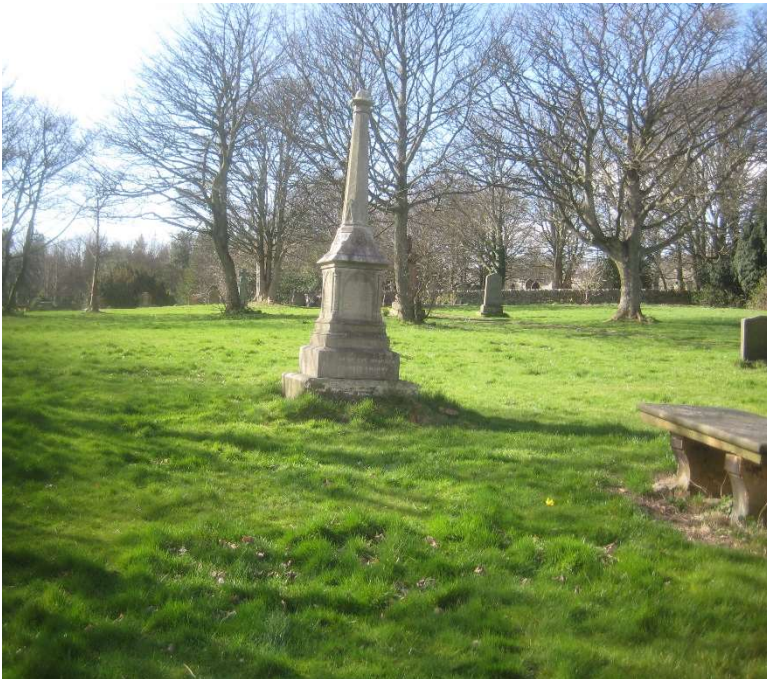
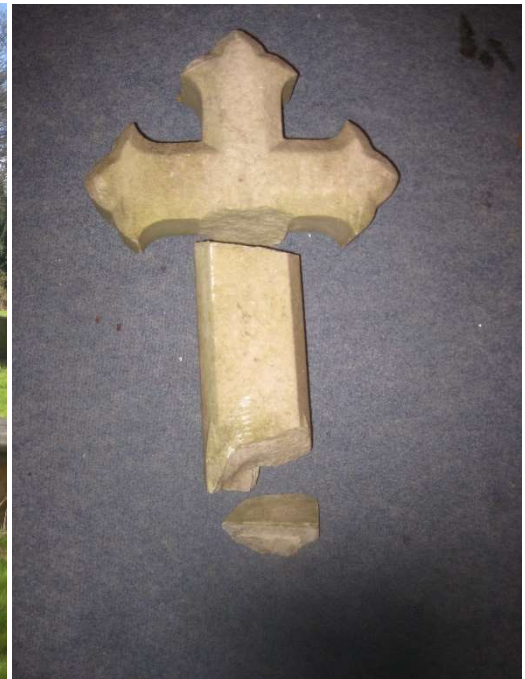
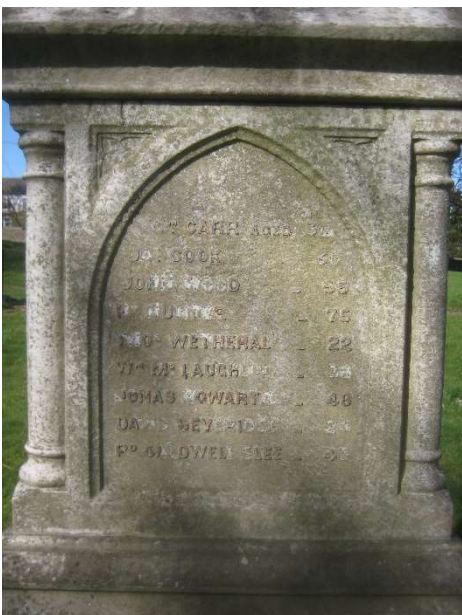
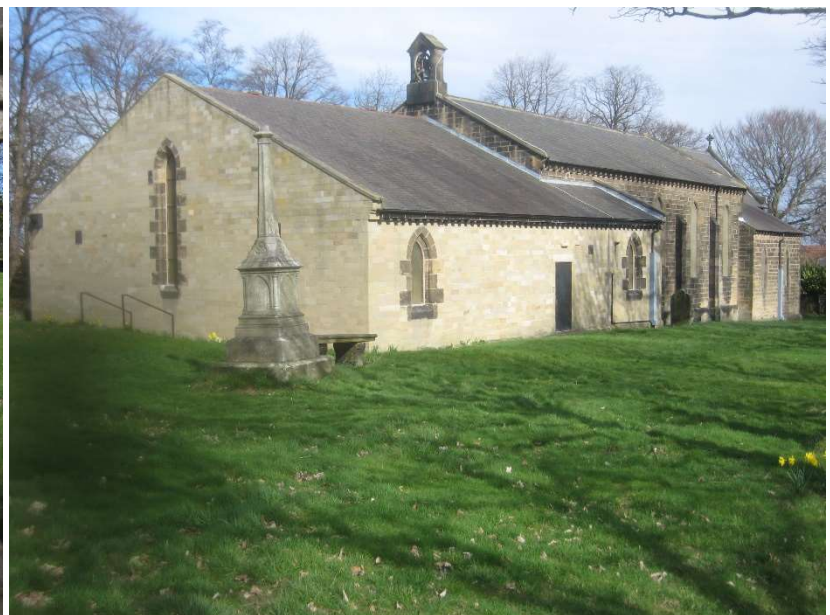
1885 monument

- 93. Since the last report a brown marble obelisk has been re-erected.
- 94. The 1885 colliery accident monument SW of the church is separately listed grade II. Its weathered painted stone is in fair condition but it leans and most of its broken cross finial is in the upper office. About 40% of the individual lead lettering is missing.

- 95. A photograph shows it was once surrounded by grave markers in a low fence, all now removed. Little remains of a modern brick kerb. In 2006 an application for faculty for a new chain surround was refused. A listed monument ought to be kept in good repair so it appears time to raise funds and reopen discussion with the authorities on repairing the finial and lettering and on releveling the monument on a new foundation, without attempt to reinstate the named graves.

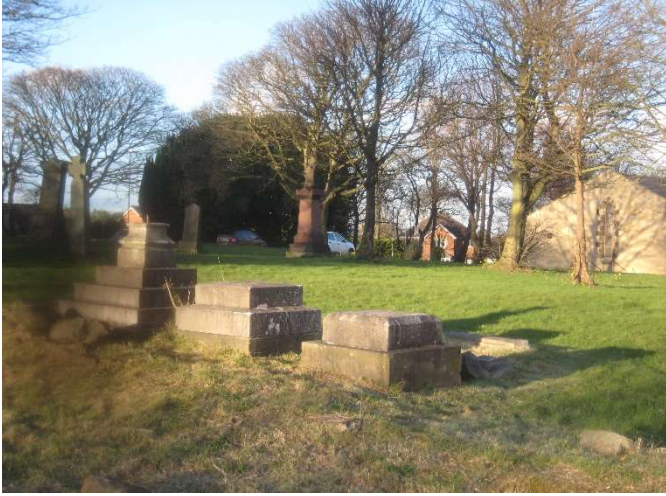
W edge of the E churchyard

A Fowler grey granite obelisk near the S wall is sound but its large kerbed grave is covered by rhododendron, not maintained and some kerbs lie flat. Another group by the E wall lies flat or lacks parts. The owners or local authority should be pressed to re-erect the flat stones safely and to record and remove the broken monuments.

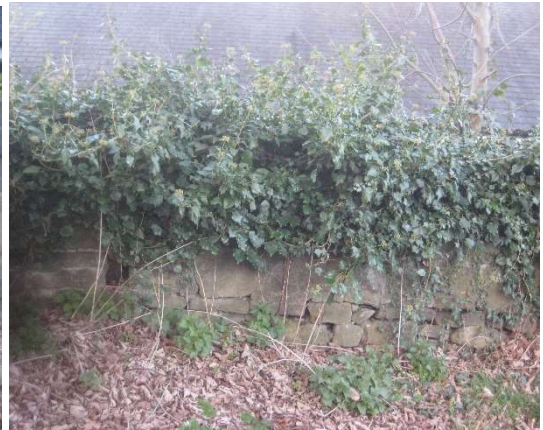
part of the E wall

99. At E the boundary wall retains the churchyard high above adjoining house gardens. A small gated opening has been formed through the E wall to a neighbour's garden. Many self seed saplings along the church side of the wall need to be removed before they become large enough to damage the wall. Much of the E wall is overgrown and needs to be raked and pointed. The S wall is too overgrown to judge its condition.
