Diocese of Durham

**HOLY TRINITY USWORTH**  
**Washington**  
(19)

**QUINQUENNIAL REPORT**  
on the architect's inspection on

**20 May 2022**

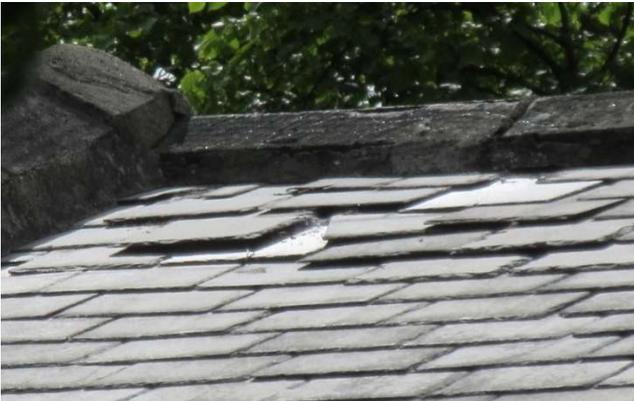
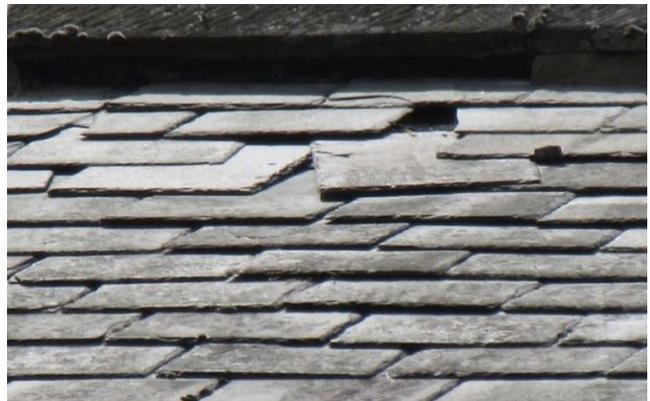
Nave N side E end

15. The N Nave slates are very uneven all down the W end and around the bellcote with some slates missing. Uneven along half the ridge length. A large patch at the top E end is disrupted. The S slates better but uneven around the bellcote where past patching has been with lead and wire clips. One slipped out of its lead clip close to the SW corner is missing, showing daylight inside.

Reslate Nave – including probable timber repairs	10, 11, 13 – 17, 110
--	----------------------

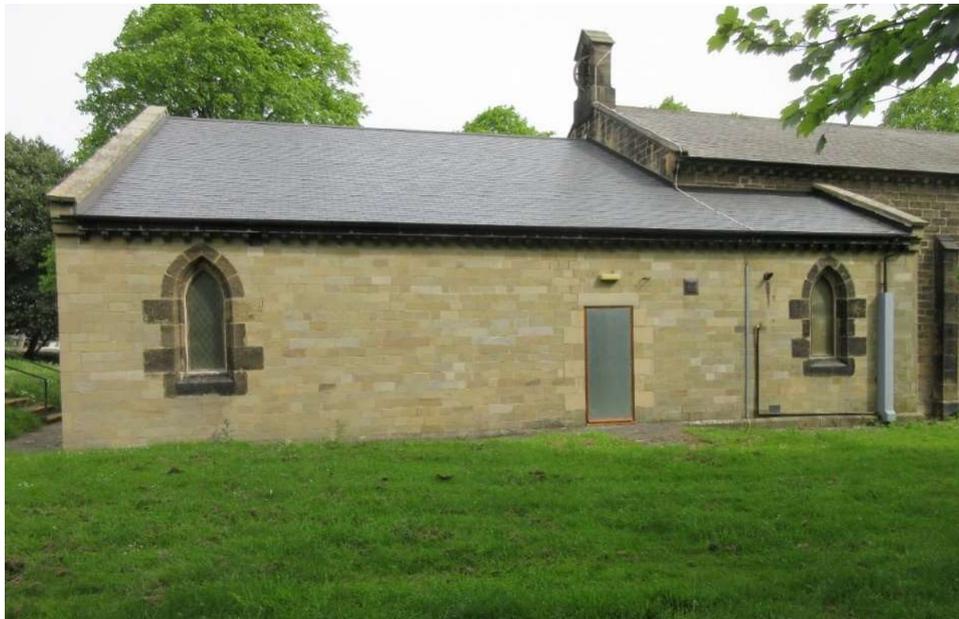
16. SW mortar fillet cracked and part loose. SE fillet breaking down with debris on the slates.  
NW fillet breaking down and former plants growing in cracks have been removed.  
NE fillet replaced, fair.
17. The Nave needs to be reslated with timber repairs, felt, non-ferrous nails, secret gutters and better flashings is needed, including new large slates and wide laps to suit the low pitch.
18. The attached Hall was added as cheaply as possible in about 1990.
19. The **Hall** now has new (Spanish?) slate and felt in good condition with timber corbels at the eaves to echo the stone corbels at the Nave. Dry ridge tiles.  
At the W upstands cover flashings are dressed over the slates, a weak detail if without lead soakers in the slates - none visible.  
The former lead flashings at N retained. NE lead flashings good.  
At S both end flashings are Nuralite or similar composite material.

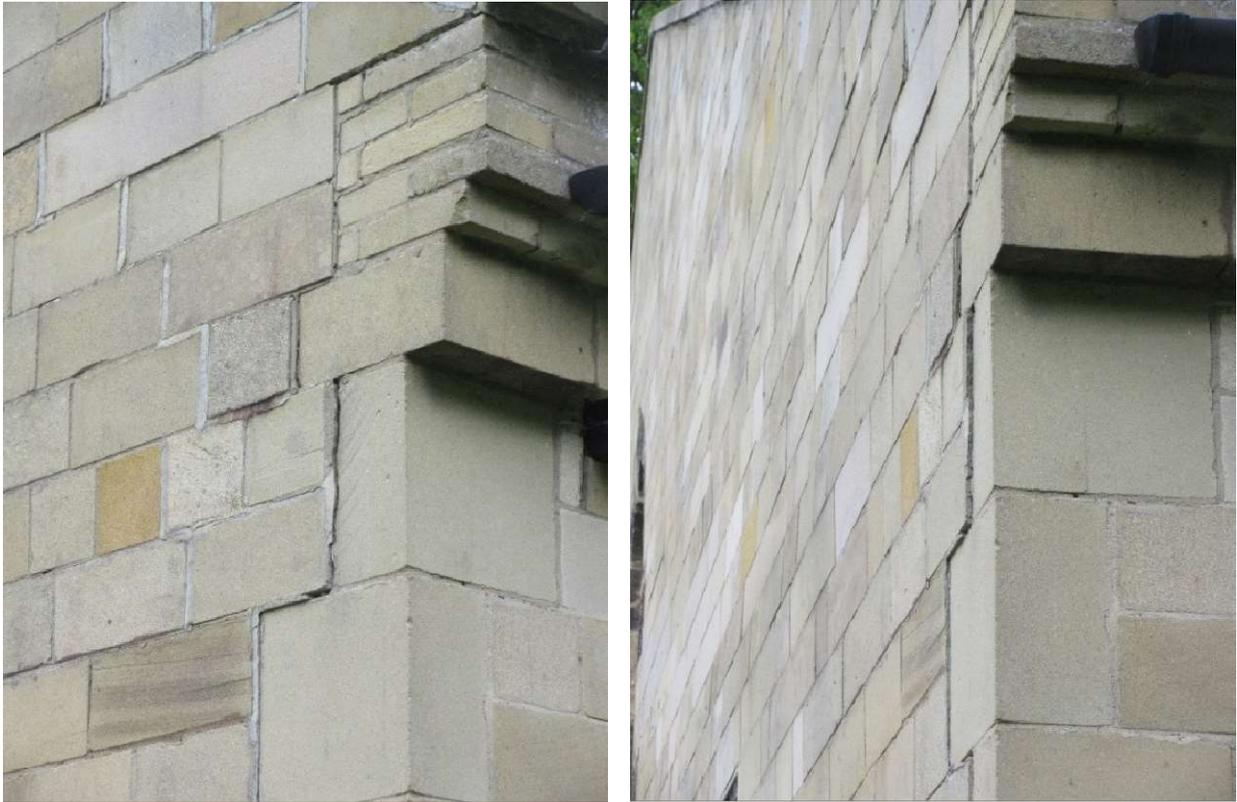
Paragraph 30 – signs of separation of stone cladding at the SW corner

30. Now there is slight bellying at the S end of the gable and separation between the cladding and the quoins, not seen previously. This may be a repeat of the same defect and needs to be kept under observation in case the belly increases.

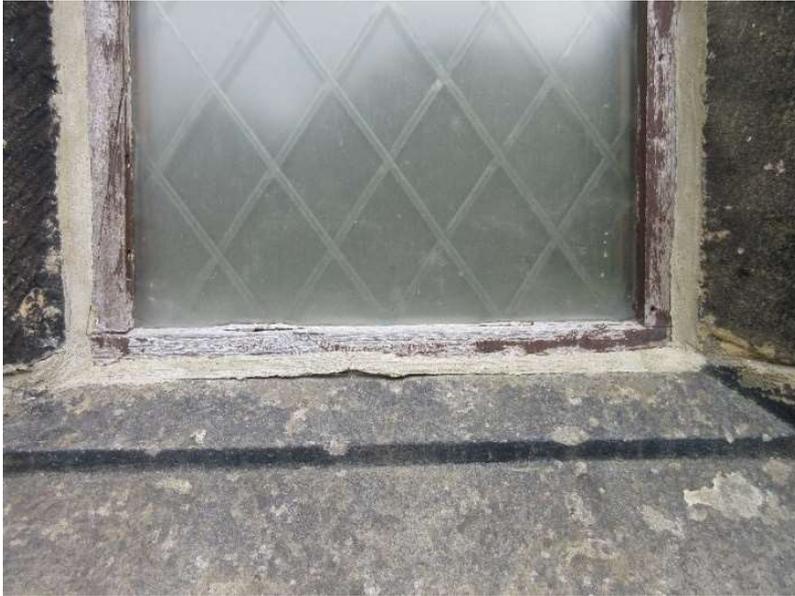
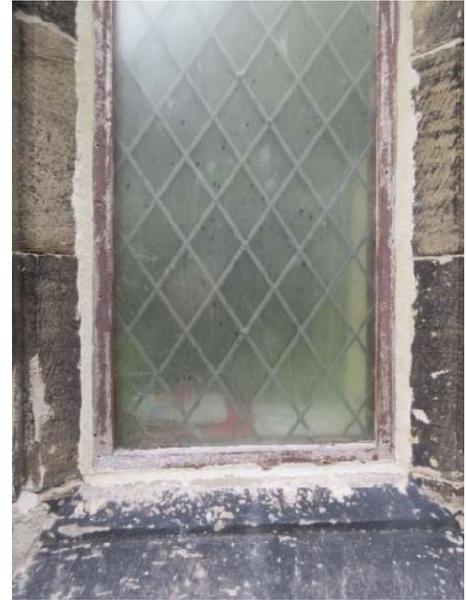
36. The arched wooden framed Hall windows remain sound though their stain is perished away with missing or cracked putty and exterior mortar fillets.

Point E gable watertable joints, courses below and under Nave windows	25, 26
As a minimum restrain and repoint Hall windows (see below)	36
Repaint Hall gutter fascias	37
Renew Church glass protection with glass cleaning and repair of broken glass in lean-to	58 - 62, 111
Check liability for repair of retaining walls, ensure repairs are done	101, 103, 104
Destroy the saplings along the E boundary wall	104
Derust and paint handrails at steps	105

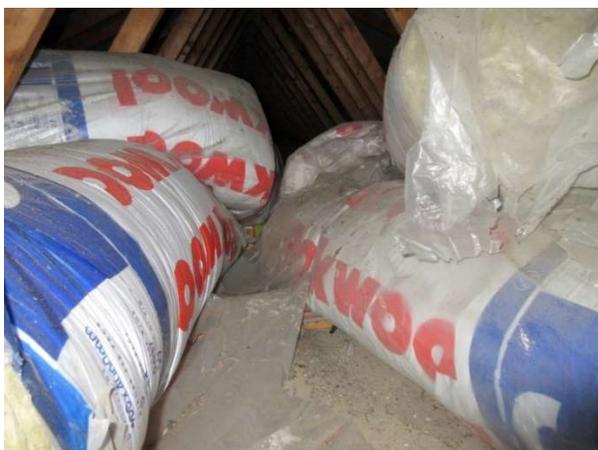
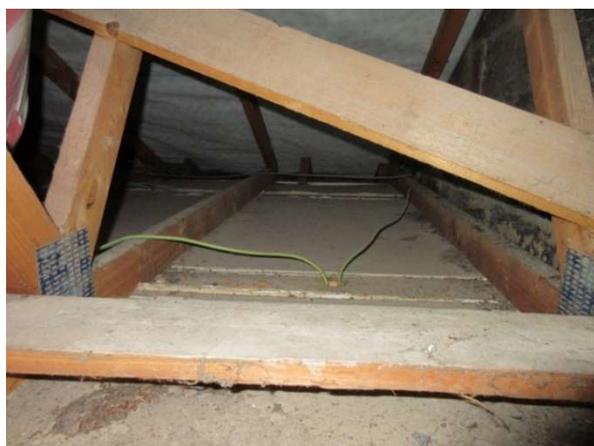
Parts only of the lower and upper parts of the Hall are covered. No insulation is laid over the upper Office although now *additional* rolls stand there unused, doing nothing useful. As well as laying the existing rolls it would be better to double the thickness throughout to bring it closer to current standard.

Over the Hall – unused rolls of insulation (more than previously?) but parts of the ceilings remain uninsulated

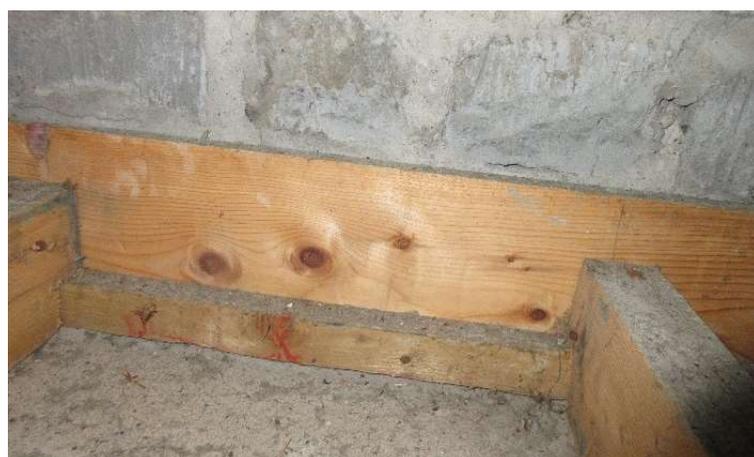
Missing insulation over Ladies

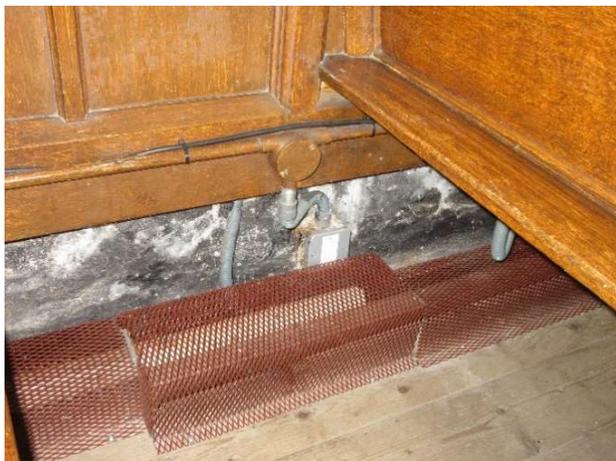
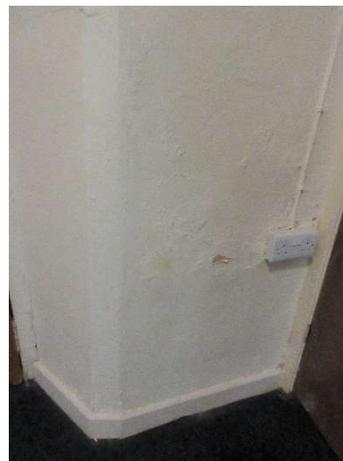
paragraph 52

52. Rising damp at the original Church W external walls now internal is concealed in the Kitchen by half tiling and elsewhere was controlled with apparent waterproof render to about 1m high.  
Visible damp (less than previously) damages the plaster and paint:

- In the foyer showing as very slight mould in the fitted cupboards and as stains on the former buttresses outside the Gents door
  - At doors into the Nave – at the Church face N side which has been patched next to a surface plastic socket, less on the Foyer side

- In the Gents right of the radiator (where plaster repaired after damp treatment)
  - At Ladies slight above render level, which is itself poor behind the wc

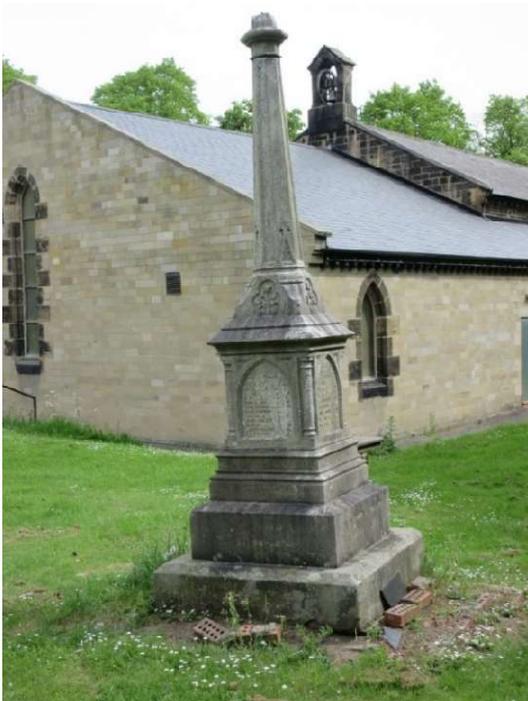
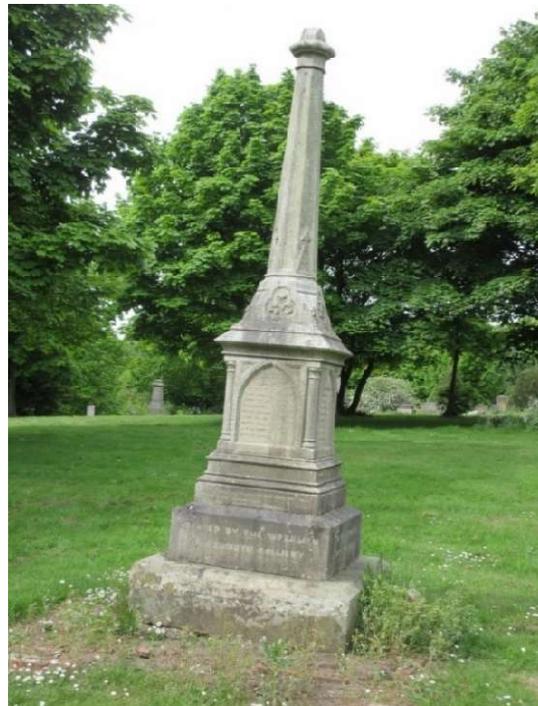
95. The churchyard is divided into E and W by a low stone wall whose S half long ago collapsed and is just an overgrown hump. Both parts are maintained by Sunderland Council.  
In 2002 a small planted Garden of Remembrance was formed with sandstone kerbs against the E side of the standing wall.
96. A brown marble obelisk has been re-erected.
97. The 1885 colliery accident monument SW of the church is separately listed grade II. Its weathered painted stone is in fair condition but it leans and most of its broken cross finial is in the upper Office. About 40% of the individual lead lettering is missing.

98. A photograph shows it was once surrounded by grave markers in a low fence, all now removed. A modern brick kerb is now just unsightly loose bricks. In 2006 an application for faculty for a new chain surround was refused.  
A listed monument ought to be in good repair so it is time to raise funds and reopen discussion with the authorities on repairing the finial and lettering and on releveling the monument on a new foundation, without reinstating the named graves.

112. Thorough repair of the 1885 listed monument is overdue.

Finish the plaster and cover moulds around the upper doors and redecorate whole upstairs	48, 56
Paint basement door and door at foot of Hall stair	49, 50
Replace extension glazing and protection as sealed units without timber	63
Change carpet colour at ramp in Nave	67
Seek funding for full repair and relevelling of the listed 1885 monument including refitting or replacement of the fallen cross	97, 98, 112

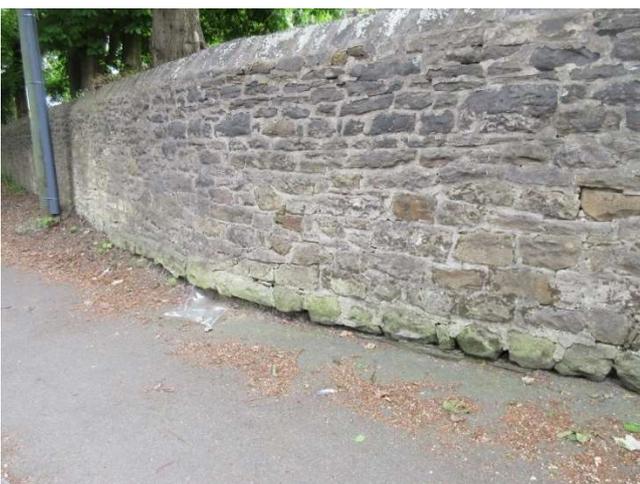
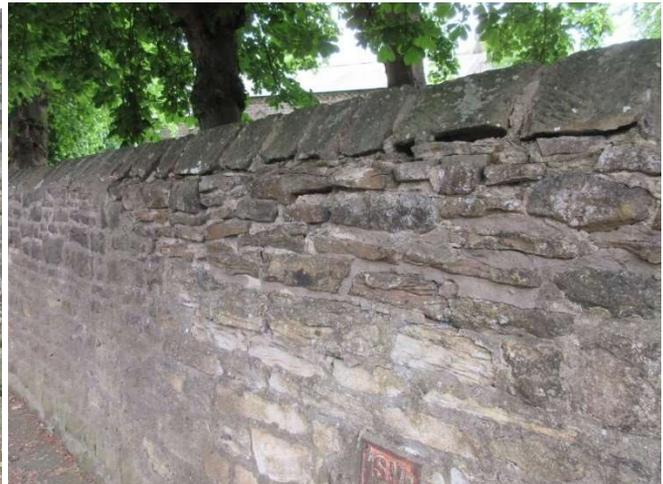
101. At the road a stone wall some 2m high retains the churchyard at NE. Parts lack pointing and are loose where pushed by a tree. It bulges opposite the road 'Beechcroft' some 6m long between two utility poles, where the wall seems pushed off its foundation, perhaps by the extra weight of a very close tree. Advice is needed on who is liable to maintain the retaining wall (parish or Council) and what steps are needed at the part which seems bulged.
