St MICHAEL SULGRAVE

Washington

QUINQUENNIAL REPORT

3 August 2023

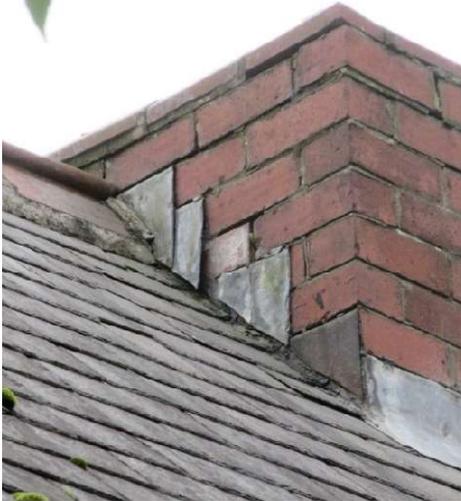
not in a conservation area

Lead cover flashing missing from NW of chimney

Decide whether to repair or demolish chimney and act	11, 22
At NW manhole rebuild or at least rake and point brickwork	16
Prepare and paint window frames at S and W Nave including cut out and repair rot at one W cill	30

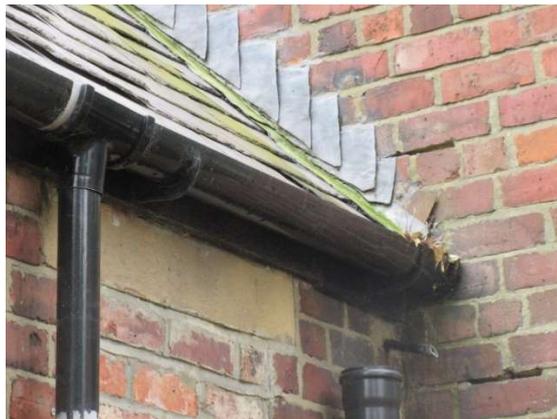
Incumbent Revd Julie Wing

W side of offshoot

Continue to monitor cracks and beam for signs of movement	8
Clear gutters at least once a year	12

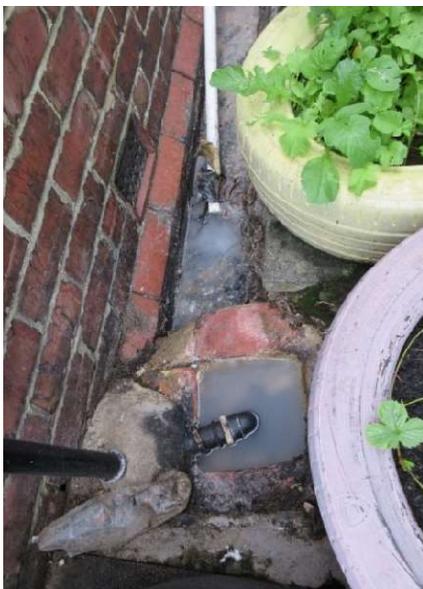
Overflowing gullies at Kitchen

Repair S Nave slates	10
Clear gullies and manhole outside Kitchen	13, 16
Act on any significant recommendation in the expected Electrical Test Report	62
Renew ceiling light at Lobby	64

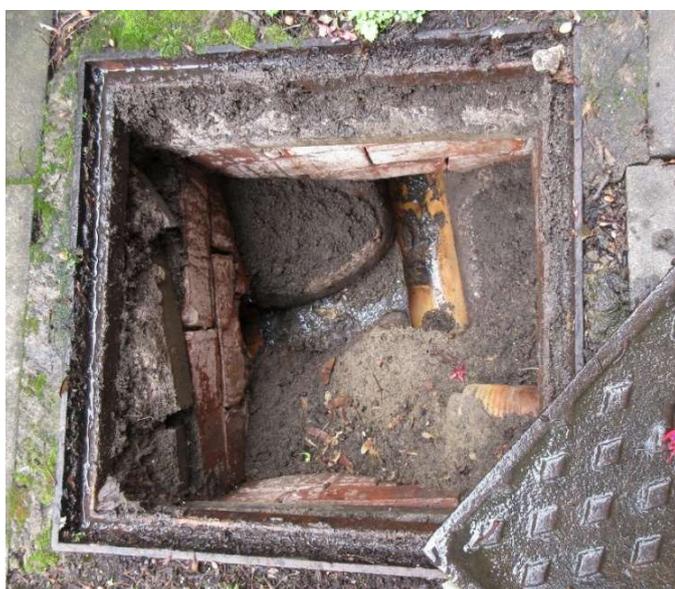
Loose brickwork and soil blocking kitchen branch at NW manhole

14. Earthenware drains with shallow brick manholes around most of the building. The drains pick up the rainwater gullies, the Kitchen waste gully, the wc and a former wc in the now bricked up lean-to against the Chancel S wall. One branch goes E around the Chancel to the S side. The other begins at the Kitchen gully and passes the W end. They join at the middle of the S side and pass out S to a sewer.
15. Past blockage by tree roots is recorded but no present sign of trouble.
16. The sample NW manhole was opened again. The brick joints remain open letting soil build up in the manhole, part blocking the kitchen gully branch, perhaps explaining the overflows there (para 13). Clearance, rebuilding or at least internal repointing is needed. Other manholes may be similar.

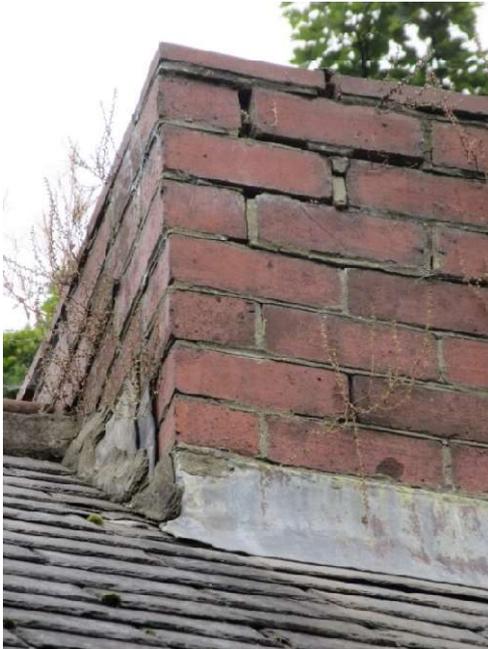
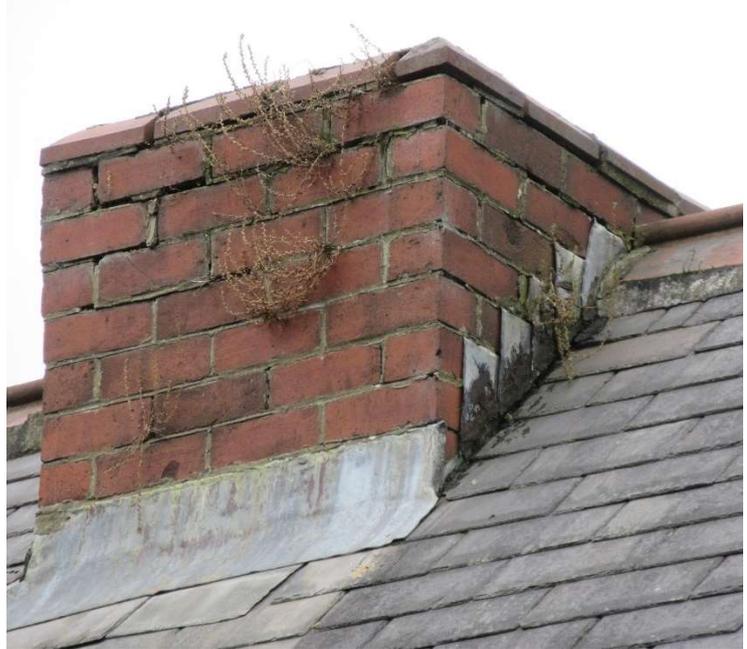
E side of Chimney – upper bricks coming apart with plants in open joints

22. At the disused chimney two former pots and a top brick course have been removed. Top not visible but no sign of any capping so the brick stack seems fully exposed to the weather. If so it is natural that brick joints at the upper E side are open with plants growing. This will progress.
Given both flues are now disused and the chimney needs repair the alternative of removing the chimney down to slate level and slating over should be considered.

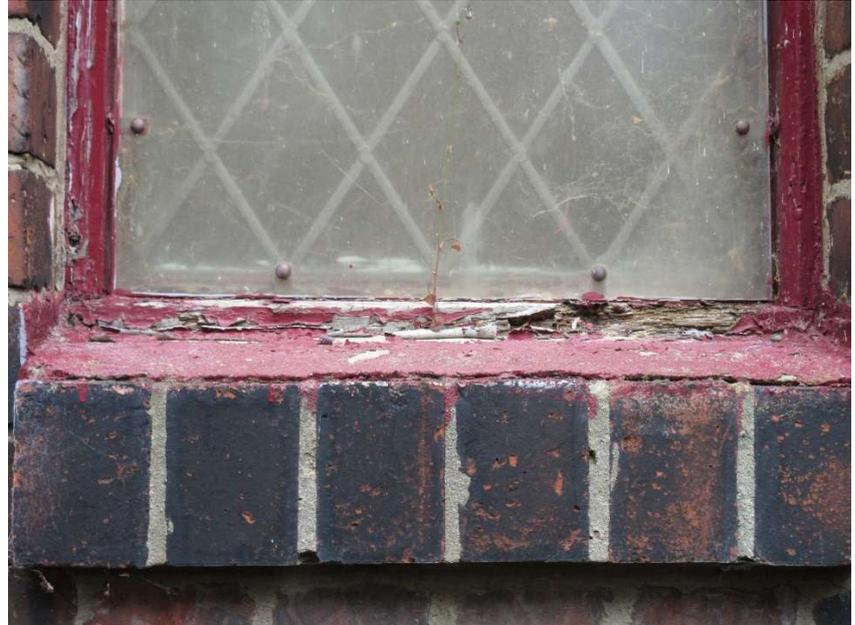
27. Slow corrosion of a small iron cross at the E end of the ridge continues and cannot practically be stopped. It leans slightly to N. If it falls it should be replaced in stainless steel.
28. Painted gable bargeboards and eave fascias good.
29. The only doors are the pair at the offshot. They are sound raised panel doors with steel sheets outside. Paint sound. The offshot windows are painted vertical sliding sashes in rebates and apparently sound though fixed shut.
30. The church window frames are painted timber in brick rebates. Generally fair but paint breaks down at S and W sides. Rot at one W end cill. The windows cannot be fully painted without removing the protection.

decay in a Nave W sill

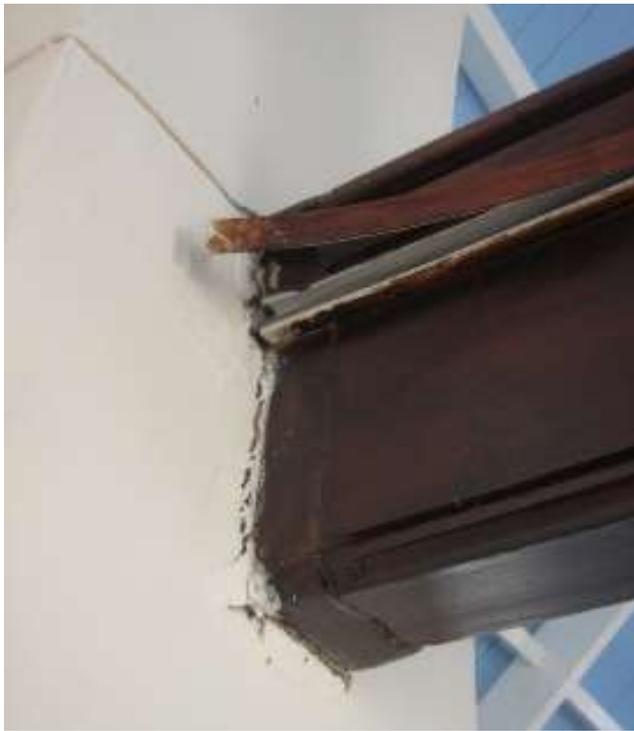
2012

36. A plain round Chancel plastered brick arch without embellishment. Below the springs a timber rood beam with dressed mouldings and cross is built into the opening. In the past its S end pulled out of the plaster and a 43mm long infill of the moulding was inserted. In 1997 the infill was found further pulled 4mm out of the plaster. The gap is now very slightly wider which may be no more than seasonal movement or the Chancel arch may continue very slight spread.

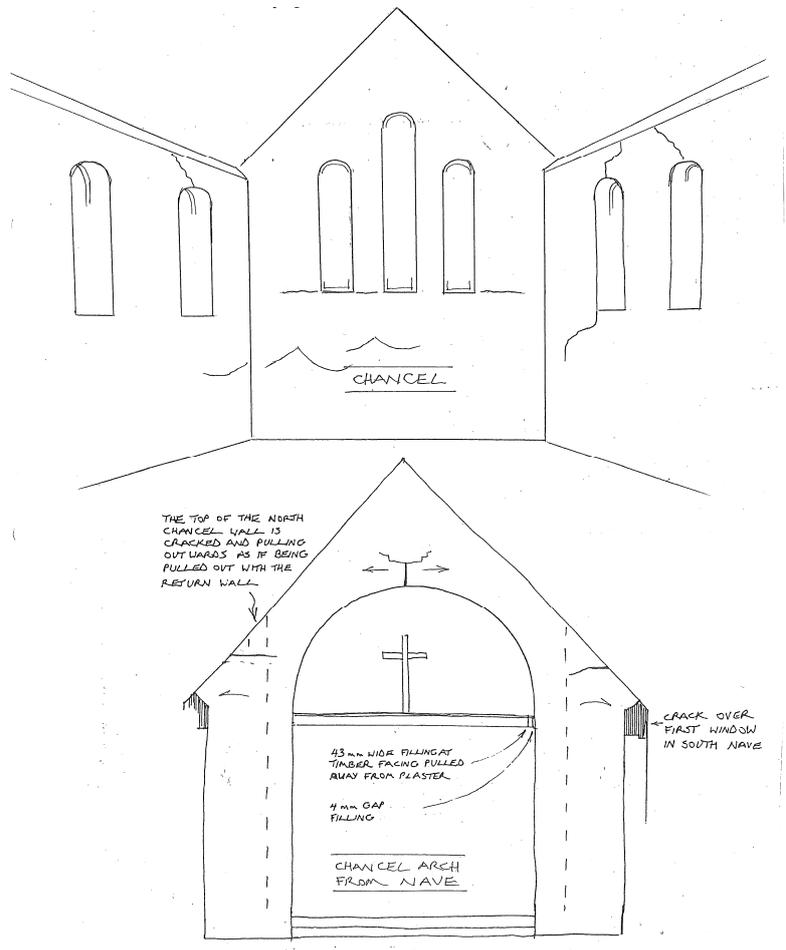
37. Plaster cracks at the Chancel arch and Chancel windows and walls were recorded in past reports and have appeared stable since at least 1992. The whole interior was filled and decorated in 2011. Most cracks previously noted are again visible, suggesting the building is essentially stable but that some parts flex slightly with the seasons.

38. As an aid to future inspections a 2007 record sketch is repeated below. No material change.

CHANCEL MOVEMENT CRACKS 2023 (very similar to 2007)
