**QUINQUENNIAL INSPECTION REPORT
OF
WASHINGTON, HOLY TRINITY**

**DIOCESE OF DURHAM
ARCHDEACONRY OF SUNDERLAND
DEANERY OF CHESTER-LE-STREET AND HAUGHTON –LE-SKERNE**

**INSPECTION OF CHURCHES MEASURE 1955
CARE OF CHURCHES & ECCLESIASTICAL JURISDICTION MEASURE 1991
March 2022**

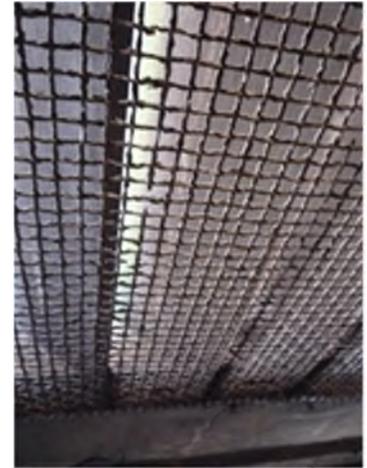
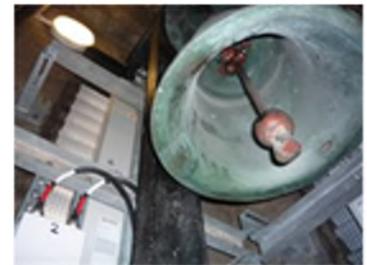
New glass fibre louvres and cord bird screening on all elevations except the West. The West has its original timber and rusting guarding which has now got gaps in it. Contains two bells in a steel frame that has been painted black. Appears to be okay, although the access is restricted now by telecom equipment.

Recommendation: repair west louvre guarding

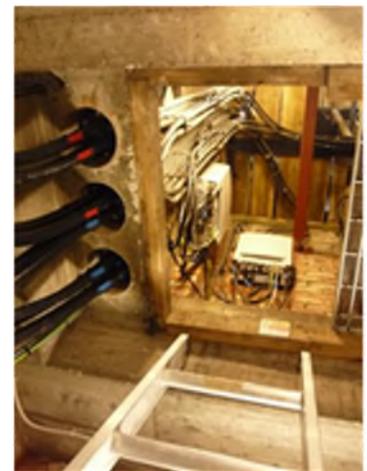
M **Belfry concrete walls.** Some water penetration showing on the downpipe looks historic. Generally sound condition structurally. Has timber planking for a floor.

C **Belfry lower stage:** This has brick walling and a two stage concrete floor. New telecom equipment in it. At this stage there is a crack on the Eastern side step of approximately 3mm. Modern beam bolted in midway up on the East-West access. The floor has three new hole penetrations cut into them for power cables but doesn't look to be affecting its structural stability. A concrete structure of legs in this room which is fairly substantial and in good condition. The room contains four sizeable cabinets for the telecoms equipment. There is a suspended metal grid floor.

The access hatch from the gallery is near impossible to operate over-arm and needs a grab handrail. There was no safety harness

Recommendation: Fix grab rail at head of ladder and ensure harness equipment is on site.

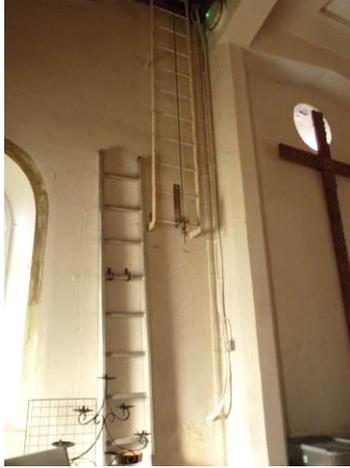
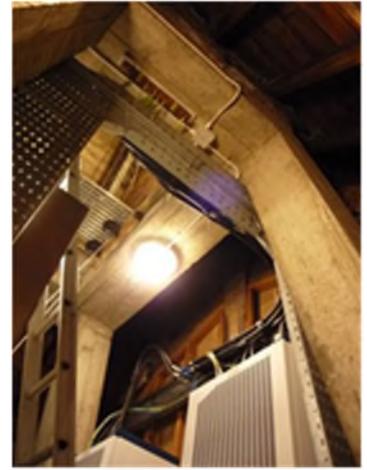
C The general installation of the electrical cabinets, which appear to be for both Vodafone and BT, appears okay. The incoming service cable infill is poor and letting in a draught.

Recommendation: Fill gap around incoming service cable.

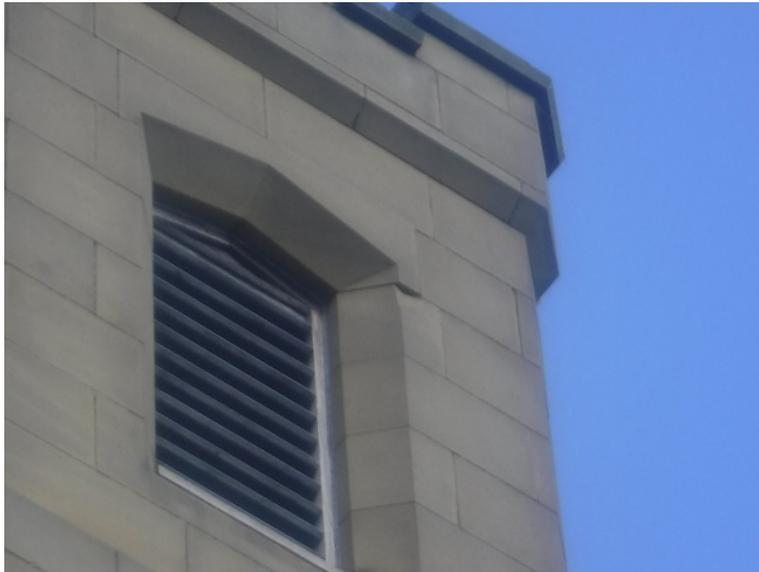
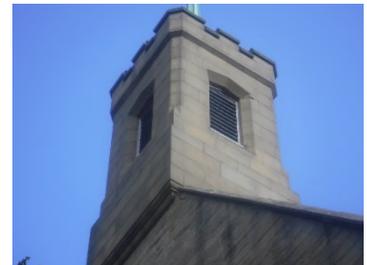
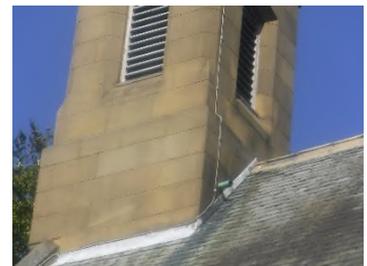
M Same cracking on the S E side as seen on the previous QI but no change.

The N W corner is doing the same, (not reported in last QI- was it missed?). Minor erosion to the pointing as before. Spire copper looks ok and the bent E symbol of the weathervane remains bent. It is quite windy today and the weathervane itself isn't rotating. When the lightning conductor people visit they should have a look in the base of the spire and also the roof arrangement of the belfry.

Recommendation: steeplejack to look at spire weathervane and inside spire structure.

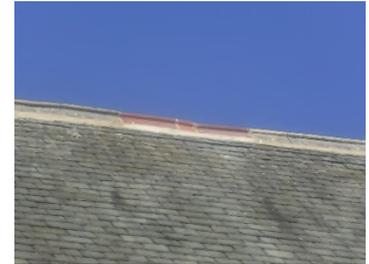
South side – Part of the ridge has been rebbeded by Wensley Roofing, some non matching replacements and uneven. The Westmoreland slating is diminishing and variable width. It has had some repairs in the past and there are a few tingles showing it all appears to be ok. Abutment flashings are mortar covered lead to watertables that seems ok and the angled watertables are alright and the apex cross looks ok.

North side – Some areas of moss and one slate missing by the belfry. Abutment flashings all look ok, same as the other side and there are also tingles as well.

Recommendation: remove moss

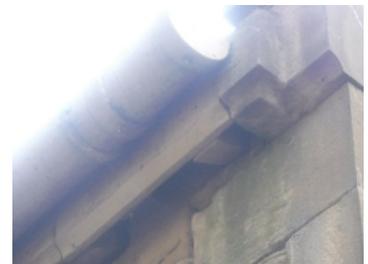
Painted cast-iron half round gutters on fascia brackets timber fascias to circular downpipes with collars to open directional shoes to gulleys. The following review around the church picks up any particular defects. The decoration is breaking down and there is quite a bit of leaf build-up in the gutters as the tree is quite heavily wooded and it is Autumn.

Recommendation: replace plastic with cast iron, redecorate. Unblock gullies, repair broken fittings, adjust outlets to drain into gullies, clear blocked downpipes, improve leaf guarding at gullies

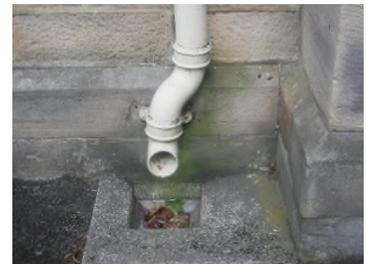
North side – Gutter looks ok, single downpipe like the S side, downpipe is cracked and there are large rust marks on it and the directional shoe really should be turned to the gully which looks blocked.

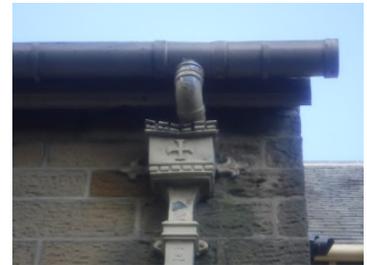
The swan neck outlet of the gutter is actually grey plastic and the paint is coming away from it and it has rather squashed the top of the hopper and the decoration is breaking down on that. This has a square downpipe. Gully looks ok.

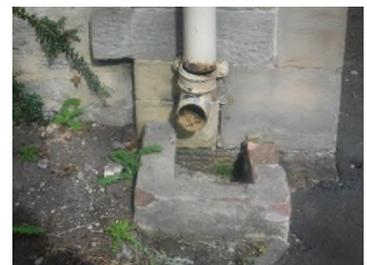
Downpipe running outlet shoe disconnected from the pipe and the gully terracotta surround is broken up but repaired in cement it will do.

North side – Downpipe is loose, might be blocked because there are leaves at the bottom of it.

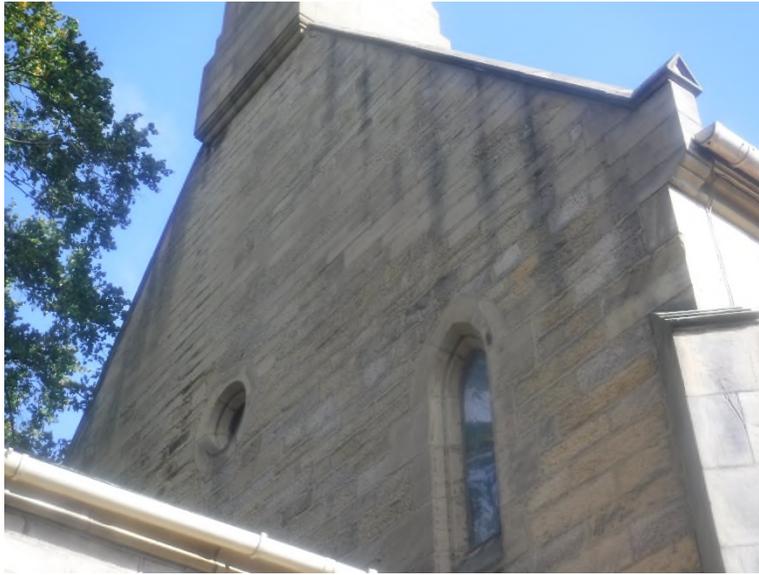
Looks as if it has had quite a bit of a rebuild probably when they put the belfry in, there is a slight crack just at the foot of the belfry on the SW corner as it sat on the top of it. Walling generally sound, slight erosion to the N of the circular window and there is a bit of a crack running down it which has been repaired in the past rather heavily in cement, the base of the wall on the N side is a bit scarred by some lean-to addition in the past perhaps a meter cupboard of some kind but it is ok.

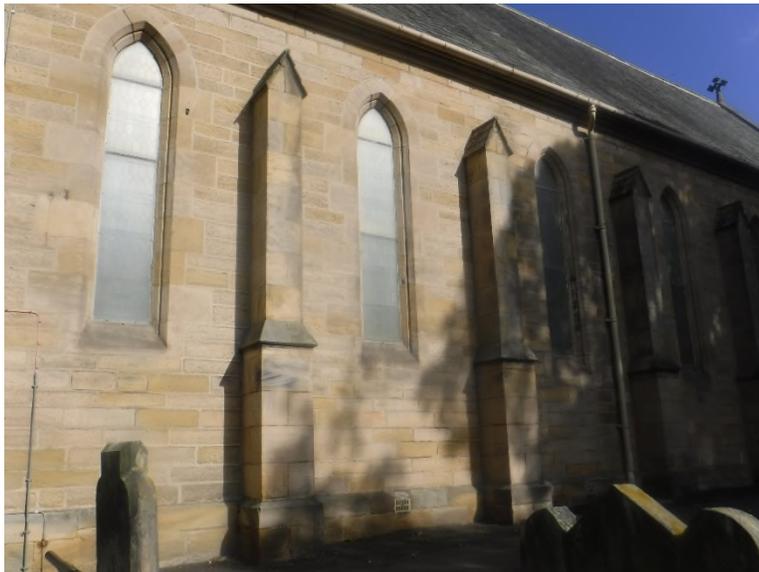
South side – Eaves cornice ok, walling is sound repointed rather heavy strap pointing but it is ok. Buttresses have little apex roofs and whilst they have got some minor open joints they are ok.

East side – Only a small amount visible as it abuts the chancel, watertable is ok and walling looks sound. At the kneeler on the N side very large bolt head and plate rusting showing, what is that doing there?

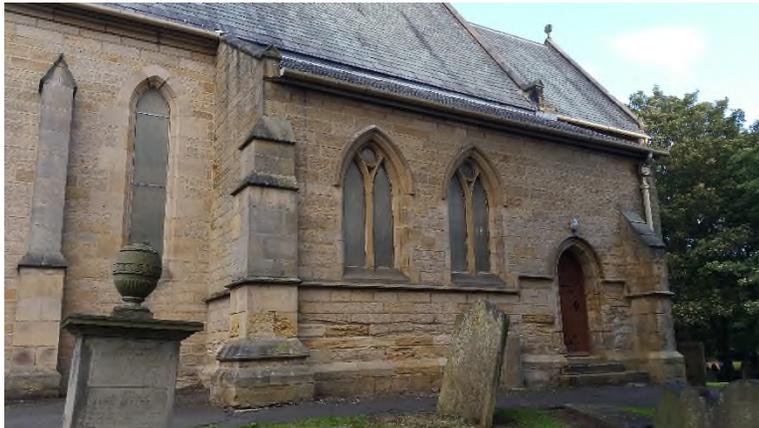
West side – Repoint same as the S nave, watertable has had water markings in the past running down but they are old, walling is generally sound with a bit of erosion above the plinth and this is evident right around the building. Clasp corner buttress with erosion to its lower stage.

South side – Continuation of the erosion seen on the W side above the plinth and to the side of the doorway. Attached buttress a bit worn but ok, to the right the wall is a bit green so is that historic damp or damp from a problem at the box gutter the one with the squashed in top?

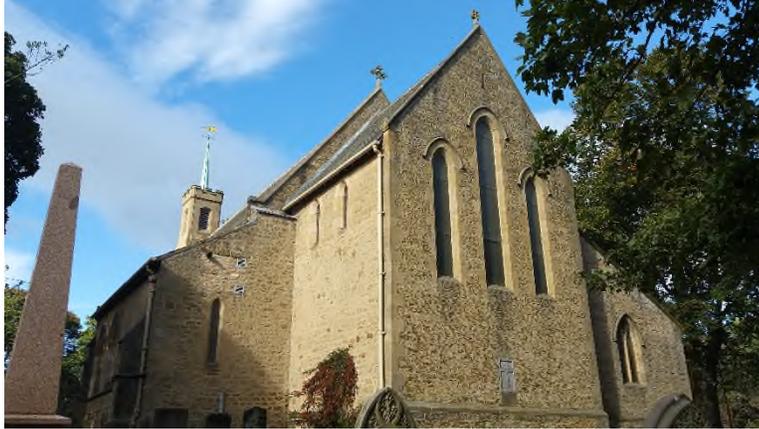
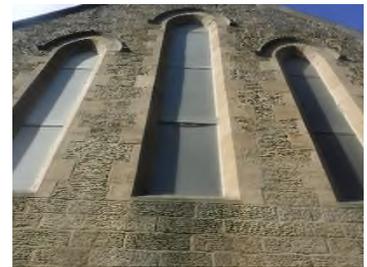
South side – Upper part matches the nave but the majority of the wall is in random rubble and badly smeared with pointing and a couple of eroded stones at the bottom but generally sound. Cotoneaster up against this so can't see behind that very well, there is some erosion I think.

East side – Perhaps open joint to the watertable on the S slope maybe the same on the N mirrored. Slight open joint underneath the apex of the watertable, walling is all sound with some minor open joints below the plinth but don't need attention.

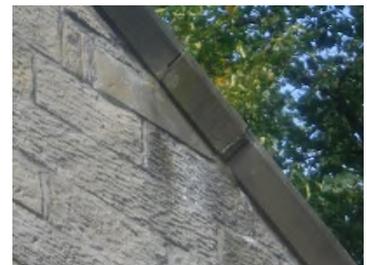
East side – Water getting through one of the watertable joints there certainly looks to be some damp up there, slight open joints at the kneeler though it is not really moving, the walling itself is sound it looks like it has got the original water here which is to be valued and some open joints just below the plinth and also hand fistedly bodged in cement at one point.

North side – Has had a patched in crack at the junction almost at the junction to the organ loft, walling itself is generally ok.

Recommendation: repoint watertable joints

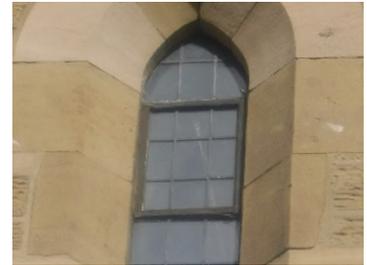
South side – Five single lancets all have got some slight movement to the apexes in the past but I think that is all historic, the polycarbonate has been pointed in and that pointing is coming away and the junctions of the various sheets are also coming apart and I think it is time for a repair now on that.

North side – Five single lancets, masonry is all ok, the movement if any is more on the S side than the N side. Polycarbonate not so grey and dull but the joints are breaking up and this polycarbonate has been pointed in like it has on the S side.

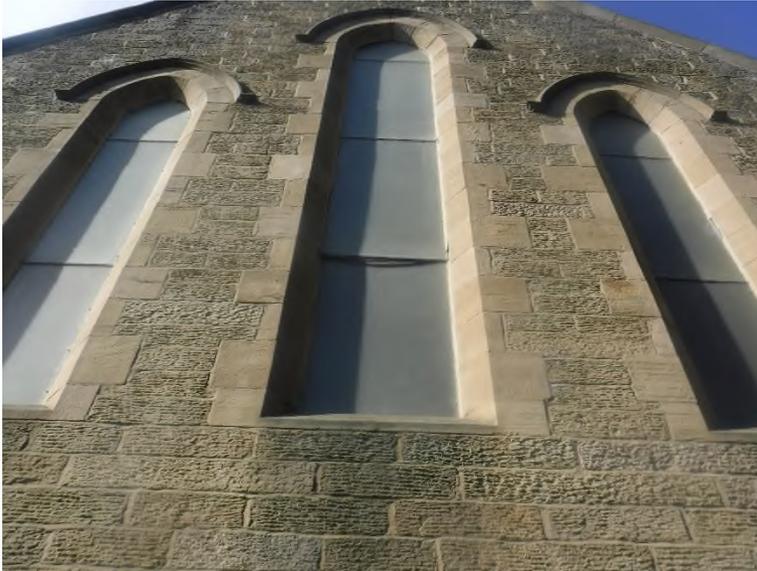
South side – Two single lancets has seen movement at the western arch top but ok, within are unprotected clear glazed lead quarries with rusted ventilators.

East side – Commanding three light single lancets central taller than its neighbours, masonry looks fine but the polycarbonate has dulled, pointed in like the nave and the sheets are splitting to the centre.

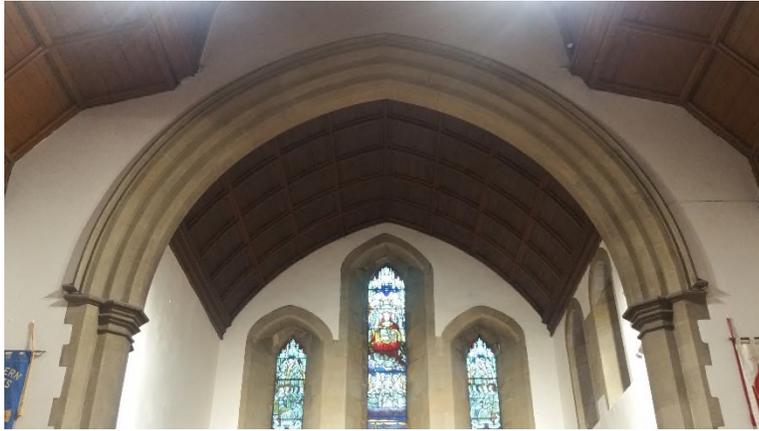
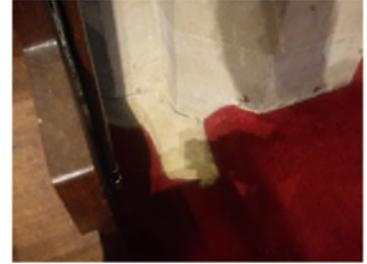
Fractional movement at the arch at the apex but this is historic, it is all in good condition apart from a little bit of damp at the bottom of the arch which is subsumed by the sanctuary step.

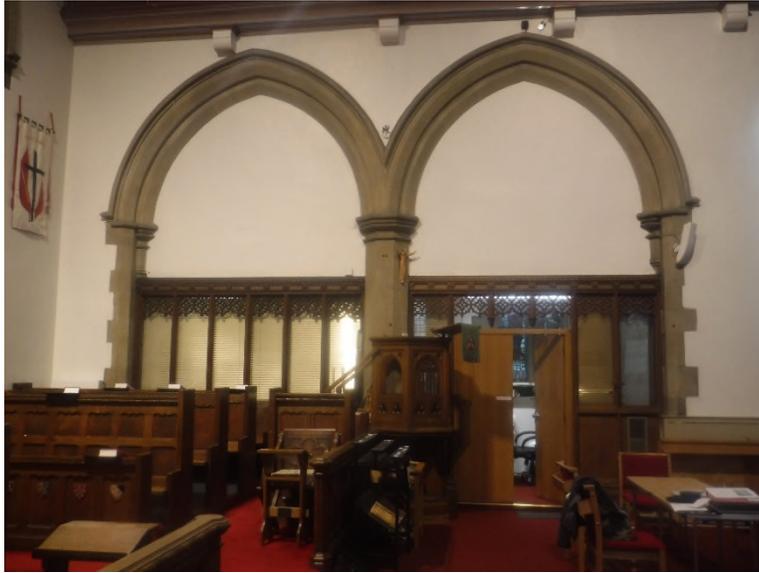
S arcade to the office

Slight fracture to the arch stone closest to the E but hairline is just an easing, the other arch is ok, and down to the ground the arches look sound.

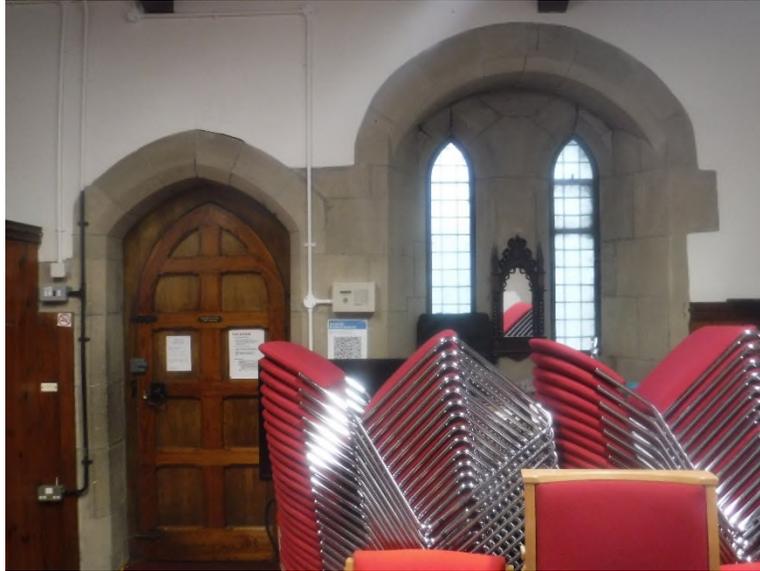
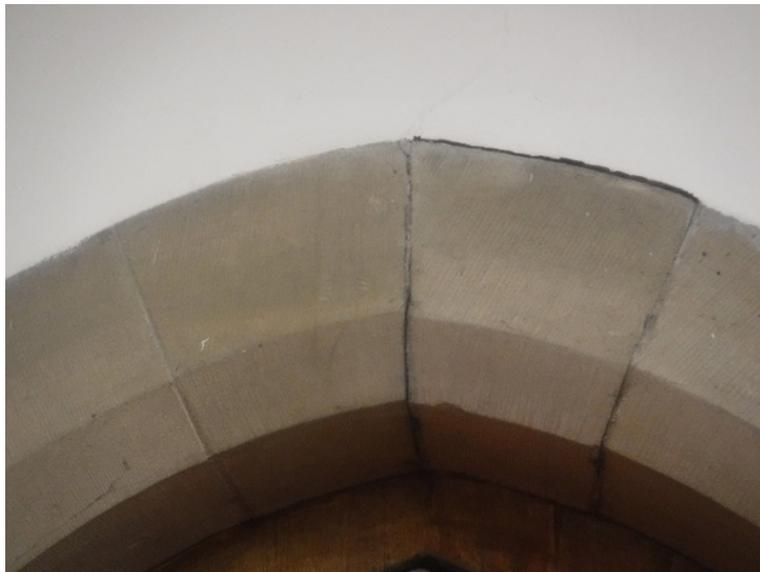
Clergy Arch from the chancel – This has opened up approximately 2mm and there is a bit of a hairline crack running up it but I think this again is ancient.

Recommendation: N organ loft W window- keystone dropped in two stages. Point up the gap in the wall and keep monitored.

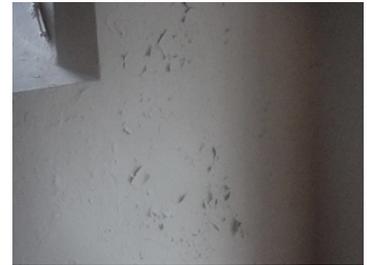
Organ Loft – Decoration breaking down on the N wall and the W and also within the room itself particularly on the E wall and at high level where we know on the other side there is a bit of poor render.

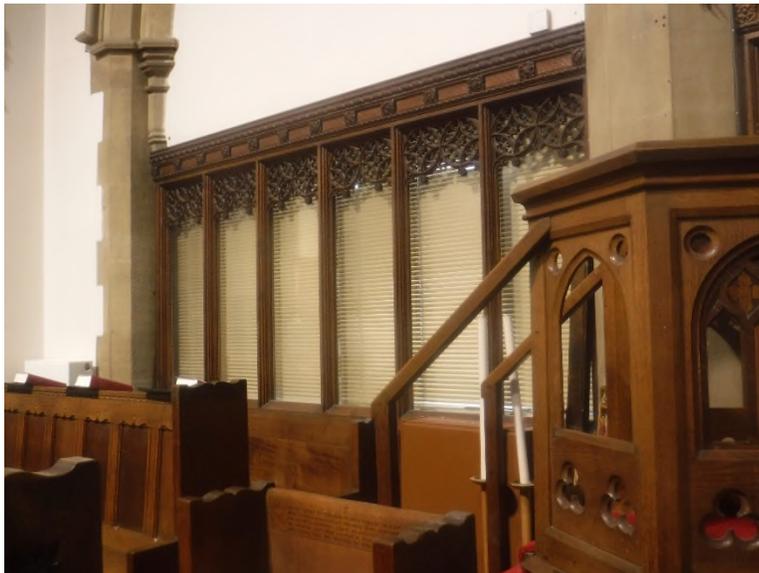
Oak partition screen with fine fret work, fine fret work, good cornice, retro glazed in good condition, it has had a rather poor looking door inserted into it, it is just a flush door and rather beaten up. The inside of the panelling is less decorated but ok.

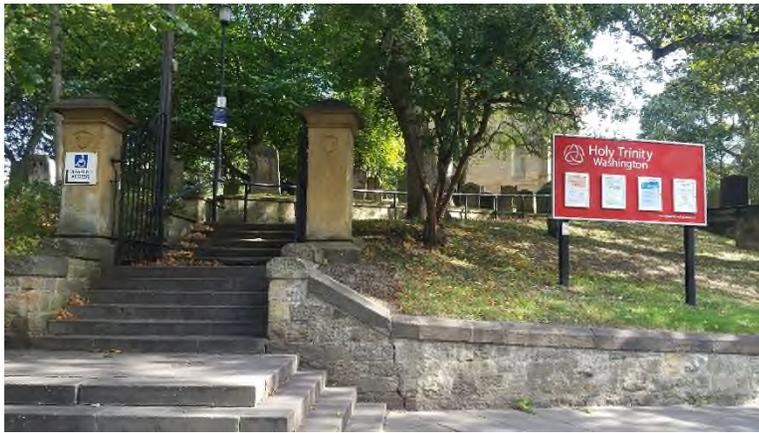
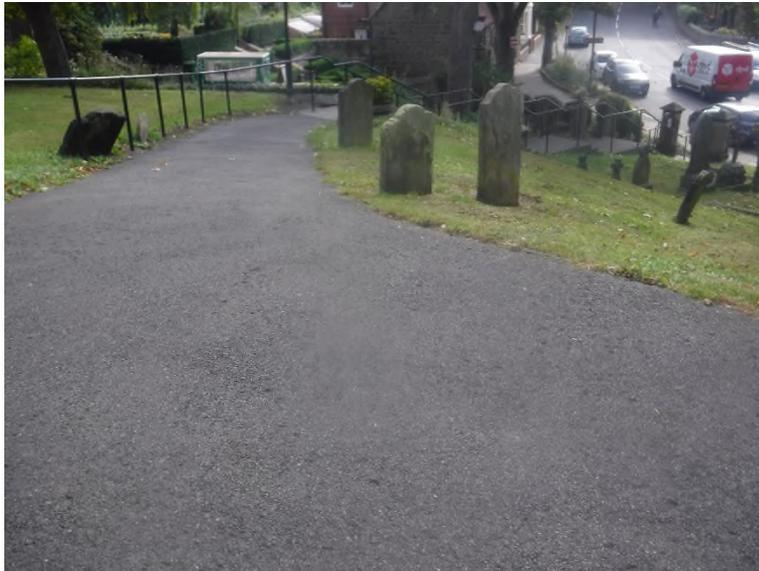
Comprises burial ground, multiple headstones and mature trees. Steep path to the W, S and E. They are tarmacked and have hand railing which is sound. The entrance area has paving and handrails with open joints to the stonework which was due to ground movement from the installation works and now is being caused by tree root movement.

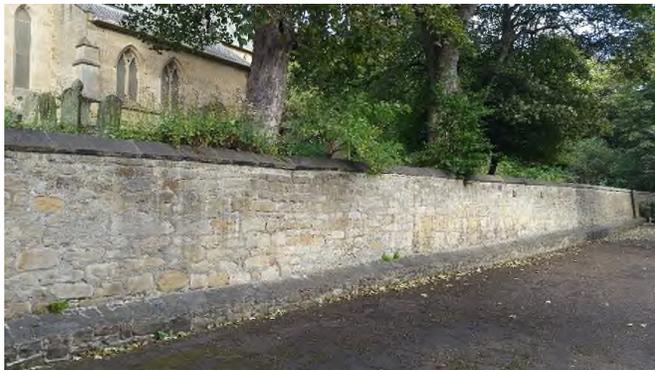
S side

Retaining wall to the old hall the adjoining National Trust property that wall itself is in good condition and is believed to be in the ownership of the National Trust. The PCC have been thinking of putting some shrubbery on that border at high level. The trees that are quite close to it do tower rather over the wall and the wall has been built out in places to accommodate its growth where it has buckled slightly.

Recommendation: Point open joints in steps. reduce trees on S boundary

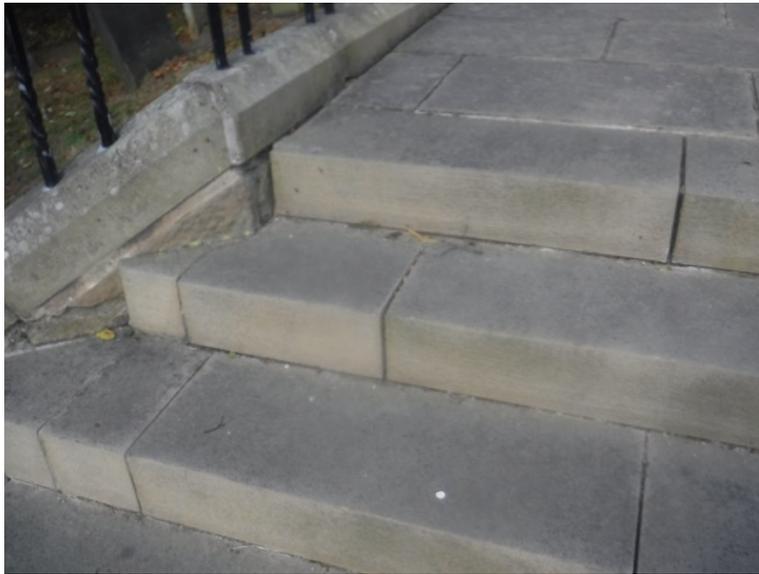
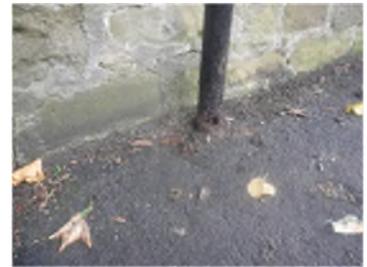
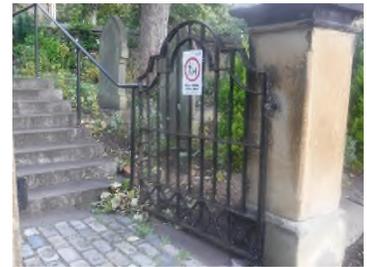
Steps continue to be buckled a little at the lower stage and there are open joints. The gates don't open as they are rusted up. To the N side of this the low wall is cracking in a couple of places.

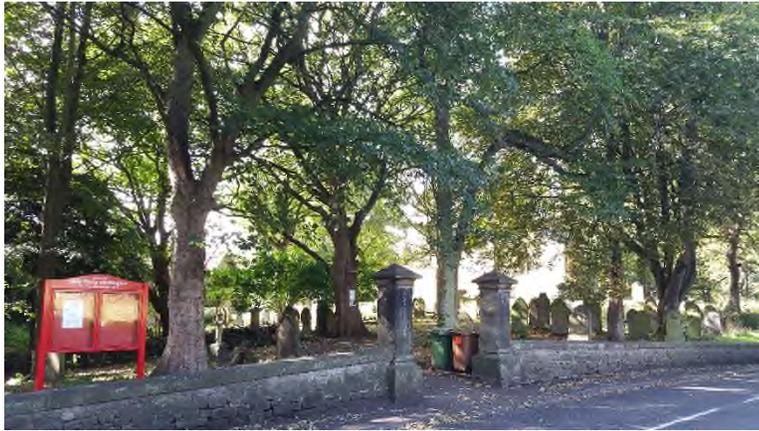
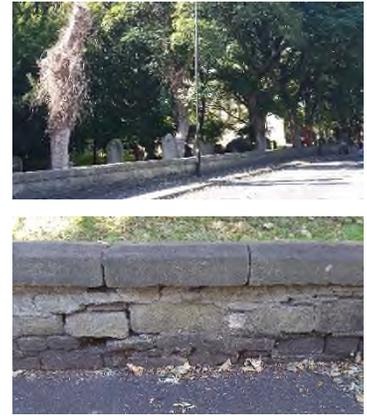
Low wall retaining the sloping churchyard and there are many open joints to it at low level. To the NE end is a pillared entrance without gates. Paths are tarmac and ok.
