Diocese of Durham  
**All Saints Church, Wheatley Hill**

**Quinquennial Report**  
On the architect's inspection of

**14<sup>th</sup> July 2023**

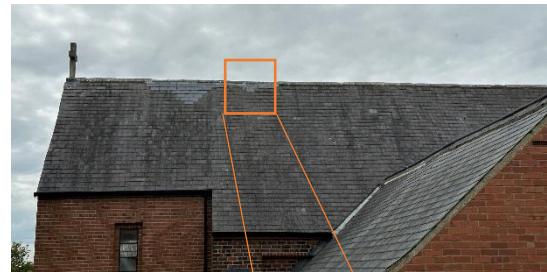
Figure 4- North ridge tiles

6.1 **North** – One large roof over the sanctuary, chancel and nave. A grey teracotta ridge for the most, with some red coloured inserts which have badly weathered. There is an area to the east which has been filled with very small pieces and looks to have gaps. The slating is showing its age. There are some large areas of slate replacements that don't match, one has slipped and there is a loose slate in the meeting room valley. The roof also looks to be dipping slightly at the changes of structure from the chancel. There are 4/5 areas of loose or broken slating across this pitch.

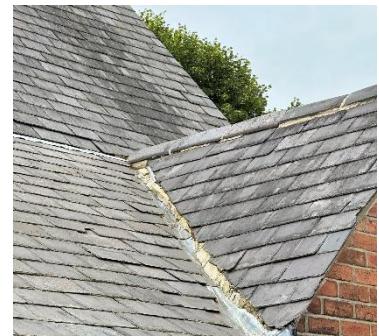
Figure 5- Porch NE valley

6.1.2 **Valleys** to the meeting room and porch are lead flashings. To the east of the porch there is some valley pointing which has fallen out and sits in the valley. Some areas have been silicone pointed in the past.

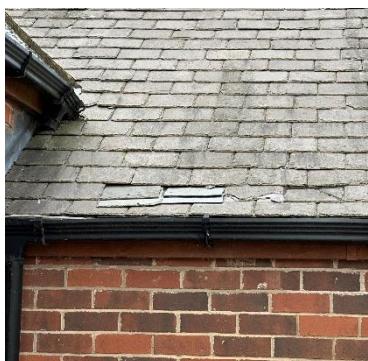
Figure 6- North area of patching

6.1.3 **North Aisle** roof is a continuation of the nave, with a different pitch. At the change in pitch there is a lead flashing that has a patch towards the east. Internally there is a corresponding area of damp noted at item 13.6.1. The roof has many patched repairs which are just about holding up, one in particular near the meeting room entrance is poor.

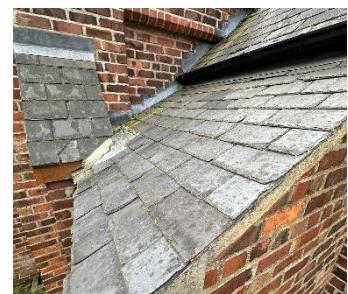
Figure 7- Blower room roof

6.3 **Blower Room & Butress** to the NE has a lean to roof of slating that appears ok. It forms a little box gutter against the side of the buttress in lead, the pointing has come loose here and a large loose part was removed at the inspection to avoid it falling. Verge pointing ok. Stepped lead flashing to chancel ok. One cracked slate to buttress.

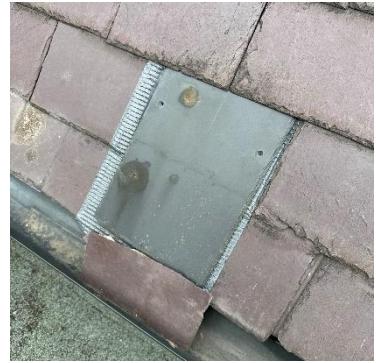
Figure 8- Poor tile replacement

6.5 **South** – ridge in grey terracotta as per north, six tiles are laminating from this side. There is an area of bedding which is slightly raised near the bellcote. Slate roof with large areas of past replacement. The area over the Chancel is recognisably different from elsewhere. The slate is slightly greyer, rather than the blue/purple elsewhere. There are a few areas which are loose at this junction. There is a slate cracked over the Chancel at low level and a very badly fixed patch at midpoint above the south aisle.

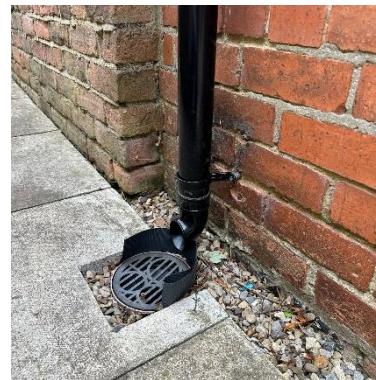
Figure 9 – DPC behind gully

- 7.3.1 East elevation gutter leads to a downpipe that goes down to the gully but misses it and the running shoe outlet is still broken. This needs extending to discharge to the gully.
- 7.3.2 On the west side, the running outlet needs a rainwater pipe with directional shoe as no gutter is fixed to the outlet. This takes the water from the entire west meeting room roof.
- 7.3.3 The gullies on this elevation are a mixture of salt glazed and modern plastic which are satisfactory.
- 7.3.4 There is no gutter to the eaves of the boiler room, this may have led to the damp at the base of the door as per item 9.7.

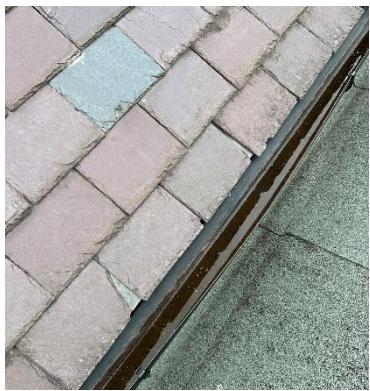
Figure 10 – Pooling in gutter above south aisle

- 7.5 **South elevation**  
7.5.1 **Nave** – old plastic half round guttering with downpipes discharging onto the flat roof. One area of pooling shows that the fall to the outlet in this location is inadequate. The fascia is timber and needs decorating.  
7.5.2 **Chancel** – ogee gutter with round downpipe leading to the south aisle east gutter.  
7.5.3 **Sanctuary** – plastic guttering, as per the north elevation – unclear if this side suffers from the same issue as item 6.4. The joint of the gutter to the downpipe doesn't look square but may be ok, check when in use.

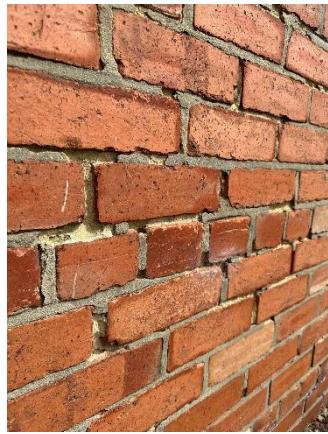
Figure 14- S.Aisle brickwork

- 8.3.1 **Nave:** a strip of brickwork under the gutter not able to be inspected due to the south aisle, abutment to S.Aisle looks ok.
- 8.3.2 **Aisle:** The damp proof course is beginning to bleed, open joints and heavy cement over pointing on the surface now has significant erosion to the softer pointing behind. One brick broken to the west corner. Open joints prevail at window reveals.

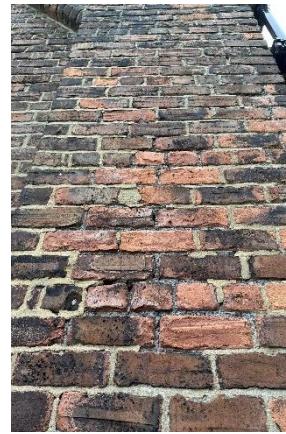
Figure 15- Chancel Brickwork

- 8.3.3 **Chancel:** original lime pointing wearing away to the extent that re-pointing is now required. Erosion particularly at lower level and brickwork is spalling. Some efflorescence at low level. The buttress has spalling brickwork and fewer open joints, with a small crack to the top. Keep crack and spalling under review.

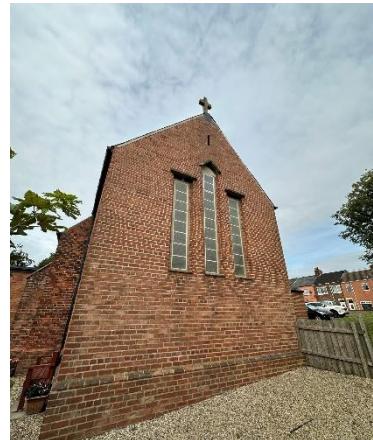
Figure 16 – East elevation

8.4 EAST ELEVATION- Recently re-pointed in Portland cement. At the apex, the cross has reportedly been replaced and has new lead flashings.

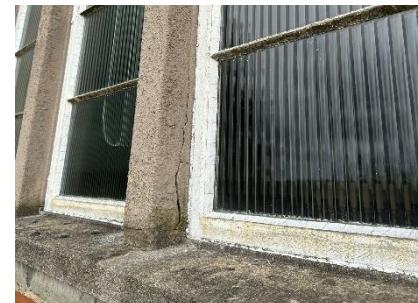
Figure 17 – South aisle windows

- 9.2.1 **Sanctuary:** rust showing to the horizontal bars and also beginning to show on the frame.
- 9.2.2 **Chancel:** some slight rusting to the fixings of the polycarbonate which is covering the diamond pattern. Some fixings have lost their seating, and some have silicone over. There is dirt trapped behind these.
- 9.2.3 **South aisle:** this features the metal windows whose putty pointing is continuing to shrink and the decoration continues to break down on the putty side. The decoration to the windows has deteriorated. The three large windows in the aisle have concrete frames which have been partially repaired in the past. These frames have been decorated with a rough finish. Little change is evident from the last report. A plant grows from the eastern most sill.

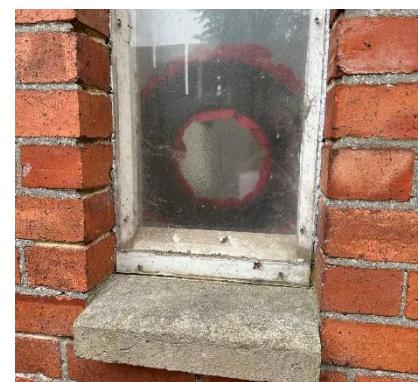
Figure 18 – south aisle as 9.3.1

- 9.3.1 South aisle: the timber is eroding at the sill where the polycarbonate has been screwed directly to the face. This looks to have been painted since the last inspection, screws look to have been replaced with stainless steel torx head. Still catches dirt.
- 9.3.2 Nave: three light windows with polycarbonate glazing and this is trapping a lot of dust. It would benefit from a more modern clear polycarbonate.
- 9.3.3 Porch: metal window which has a broken sill, rusting lintel and it is losing its decoration.

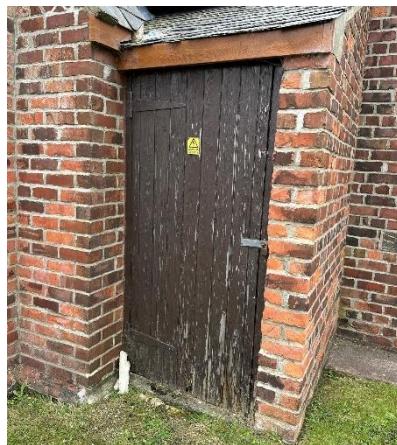
Figure 20 – blower room door

9.7 **Blower room** door is rotten at the bottom edge and needs replacing.

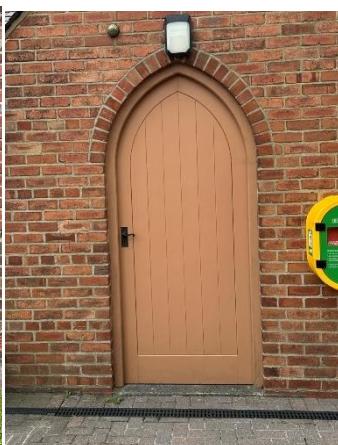
Figure 21 – main porch door

9.5 **Main porch doors** – Arched head timber painted door in good condition, lever handle.

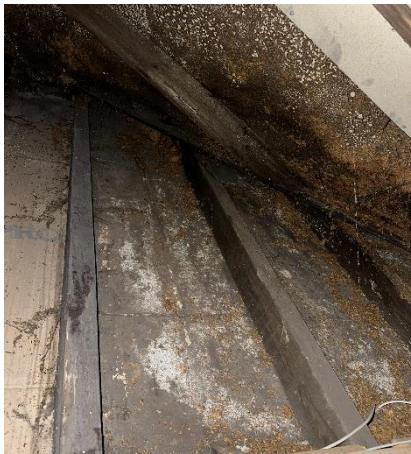
Figure 23 – porch as item 11.1

- 11.1 Over the **Porch** there are rafters and a valley board to the east. This area was inspected from a hatch in the WC. The valley board is completely rotten and should be replaced in its entirety alongside any timbers with damp issues when the area is opened up.

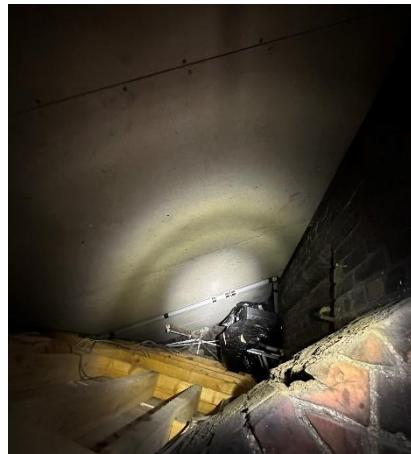
Figure 24 – Remainder of void at 11.2

- 11.2 **Vestry /WC/ Kitchen** – rafters are covered with boarding so condition cannot be checked. Boarding could be asbestos.
- 11.3 **Nave** – Scissor trusses and purlins, assumed rafters beneath boarding.

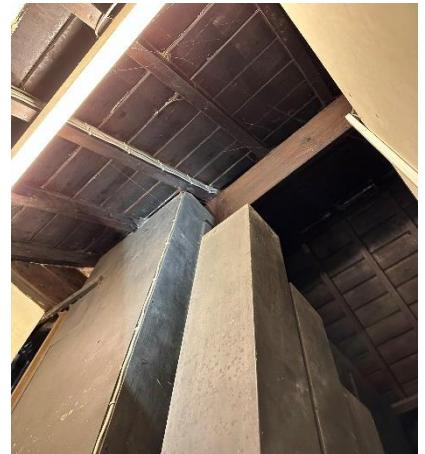
Figure 25 – organ loft

- 11.5 **Organ loft** – open boarded rafters, some slight staining would appear historic, but should be monitored in future surveys, no former pictures available.

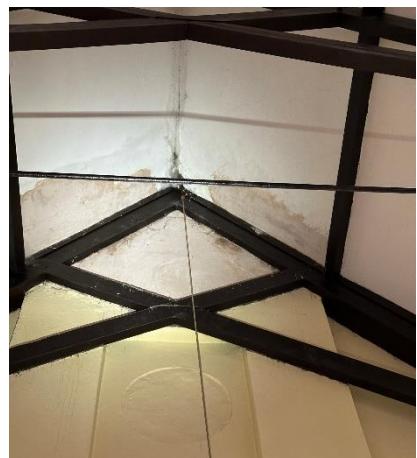
Figure 26 – Nave west

which requires decoration, the churchwarden noted that this is an area that still causes issues where the bell rope penetrates the roof. A long-term fix to prevent damp would be advisable at this stage.

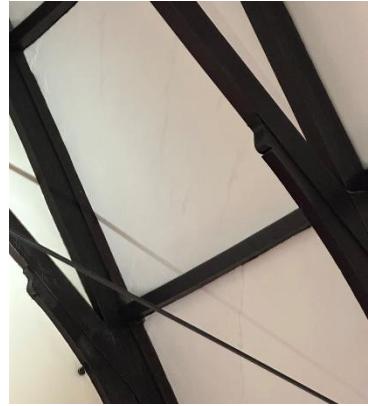
Figure 27 –cracking as item 12.5.1

12.5.1 There are several hairline cracks to the plaster at the mid-points between the trusses. At the first southern bay from the chancel arch, diagonal cracks to the panel in several locations look to suggest some movement, however this could be historic as appears to have been painted over. This should be monitored closely as no photographs are available from the previous inspection.

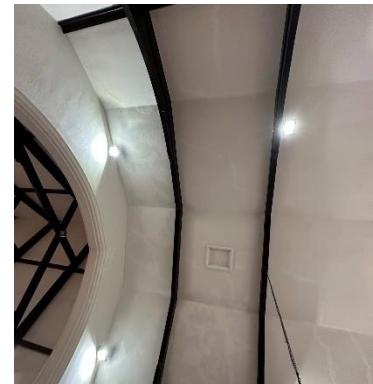
Figure 28 chancel ceiling

12.6 **Chancel** – some historic cracking, water staining noted in the last report has been decorated and not re-occurred. Some additional cracking to joints. The ceiling is now heavily patched with paint of varying ages and types, and it would benefit from re-decoration in its entirety. This would also help identify if there is any current movement.

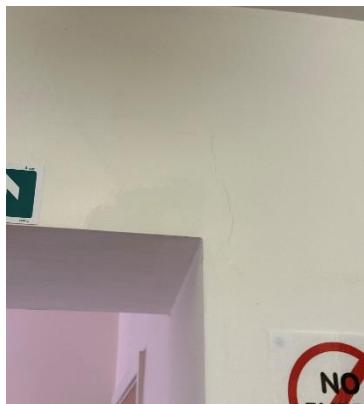
Figure 29 –cracking as item 13.4

13.4 **Kitchen, circulation space and meeting room** - Walls – Plastered and ok apart from a small area of damp to the base of the wall near cabinets on external wall at both ends. There is also a hairline crack above the opening to the meeting room. In addition, small cracks to the left hand side of the entrance door should be monitored.

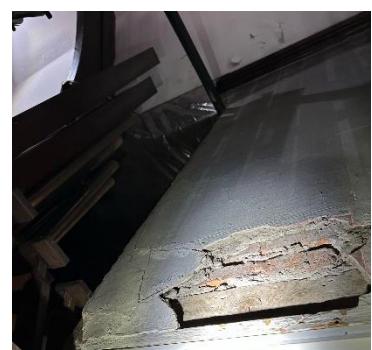
Figure 30 –prick pier as item 13.5.1

13.5.1 Above the passageway from the meeting room to the chancel there is a brick pier which overhangs the walkway. This appears to be supported by a single timber post and timber lintels, the plaster on the

brickwork is spawling from the face, no cracks are evident at high level suggesting there is no significant movement here from the failure of the support, however, this should be checked for adequacy and stability by a suitably qualified engineer. The base of the timber post could not be inspected to check its condition.

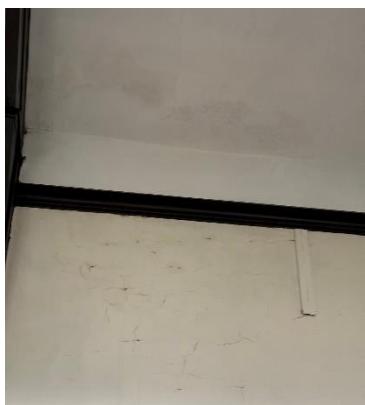
Figure 31 –cracking as item 13.6.1

13.6.1 **North** – plastered walls are showing cracking from the past. There is a large area of historic damp in the middle of the wall. The paint has flaked a little more from the previous report, this may be a sign that the paint is vapour impermeable, this could be removed and replaced with a breathable paint. A raised area of plaster above the door from the kitchen appears historic and decoration is holding up well.

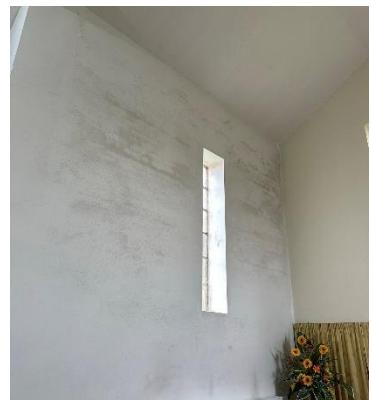
Figure 32 –damp as item 13.7.1

13.7.1 The north wall of the sanctuary shows damp staining to the top, this is likely linked to item 6.4. and has reportedly been remedied. Monitor for drying, the non-breathable paint may make this take longer. At low level, the wall is screened by curtain and its ok behind it.

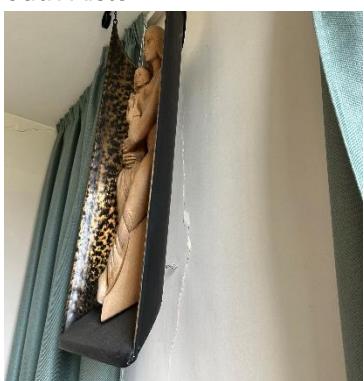
Figure 33 –cracking as item 13.8.3

13.8.3 **East** – Curtained at the Lady Chapel and there is a vertical crack behind the Madonna and Child, approximately

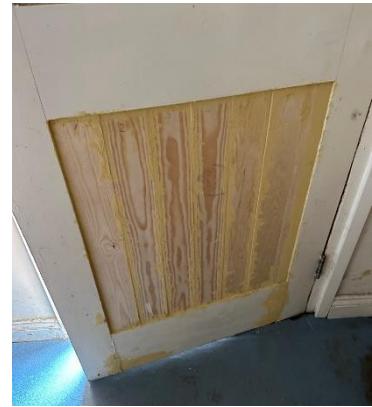
Figure 34 – meeting room door

14.3 External meeting room door – single faced paneled door with a sprung arched head. has been poorly repaired, using a brace on the face to support the bottom rail and to the internal face T&G boarding has been added into the rebate. This door will need replacing within 12 months.
