Whitworth Church, Whitworth

Diocese of Durham  
Archdeaconry of Sunderland  
Deanery of Auckland

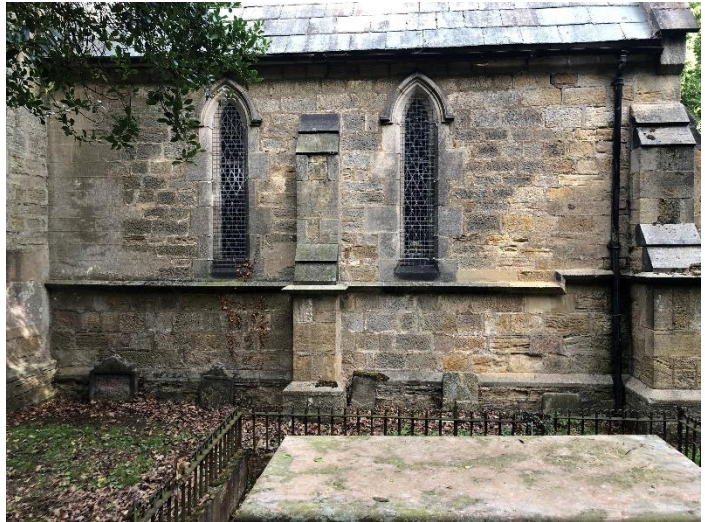
Fig. 3 (IMG 8299)  
Pattern cracking/face erosion from eaves  
to drip course

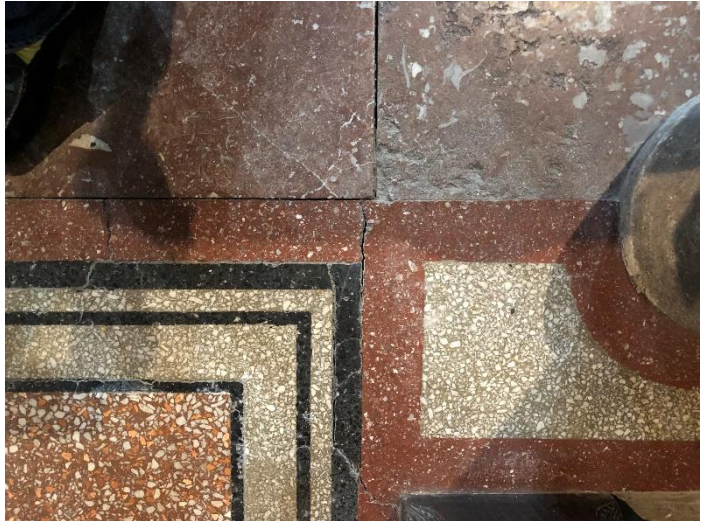
Fig. 4 (IMG 8275)  
Slight cracking of terrazzo flooring

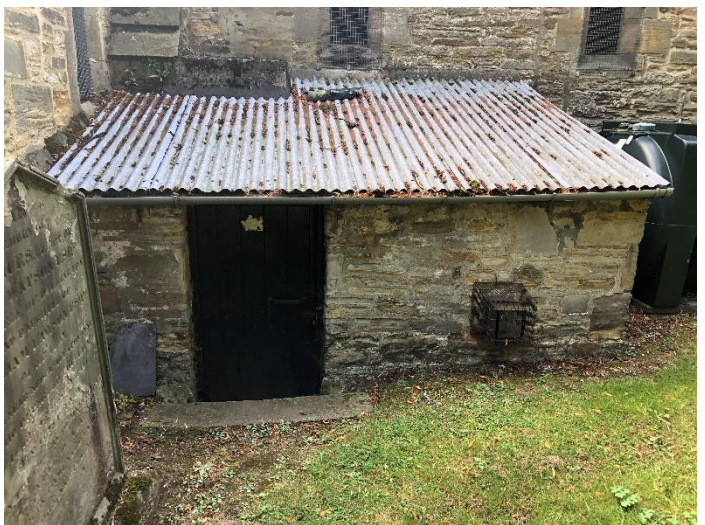
Fig. 5 (IMG 8321)  
Boiler house lean-to

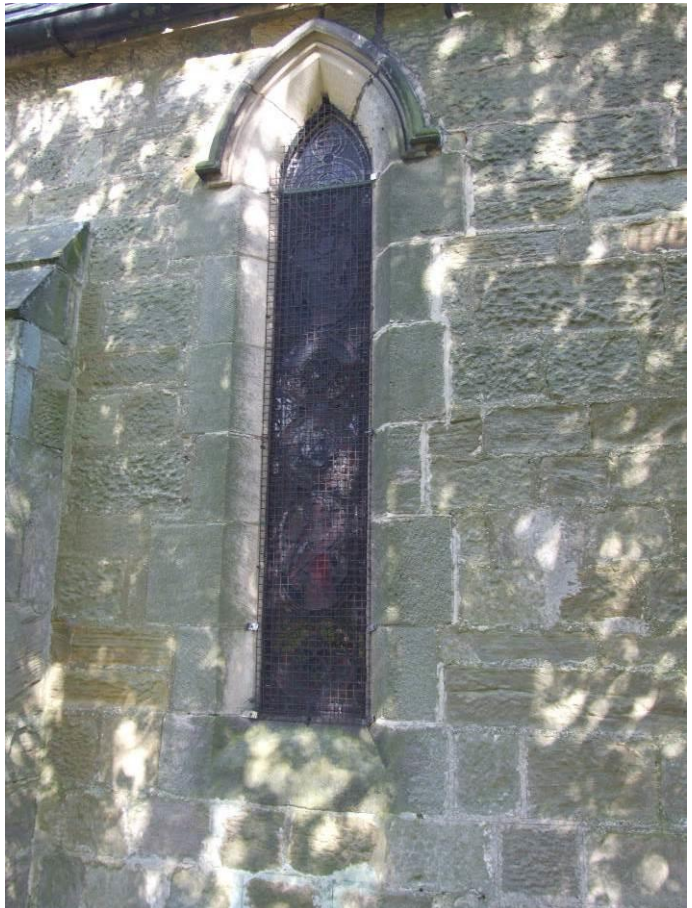
Fig. 7 (IMG 1304)  
Corroding but not yet pattern  
staining window guards

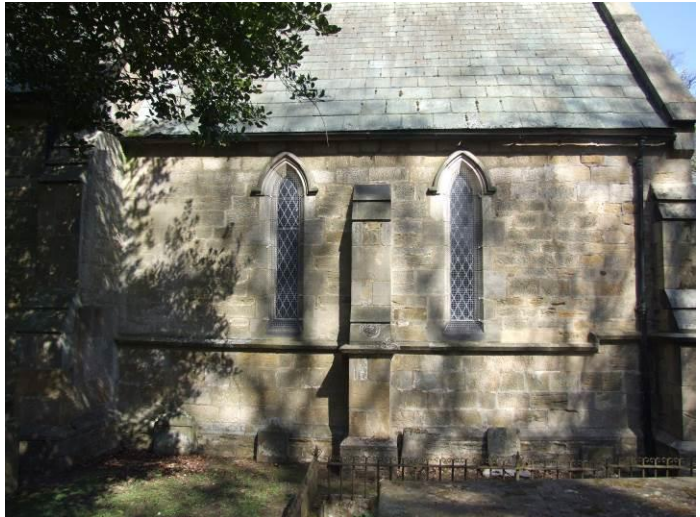
Fig. 8 (IMG 1307)  
Note some stone face erosion to left hand side of eastern buttress, may relate to gutter overflow

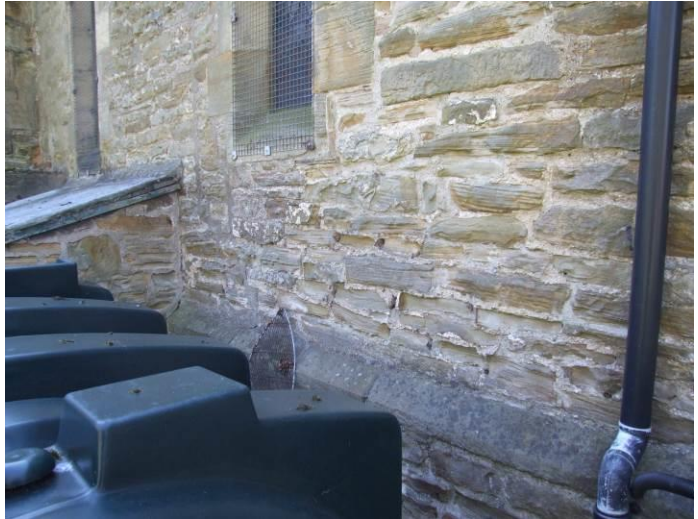
Fig. 13 (IMG 1322)  
Figure with roof protection and new  
stone column (west end of Church):  
some slate damage

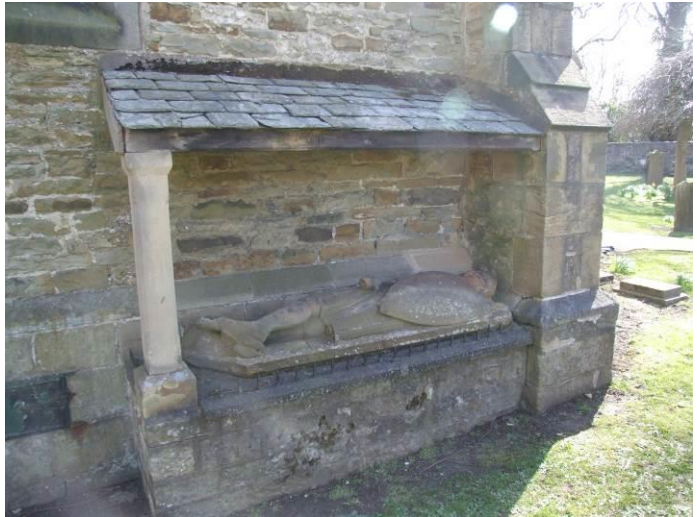
Fig. 14 (IMG 1323)  
Figure with roof protection and new  
stone column (west end of Church):  
some slate damage

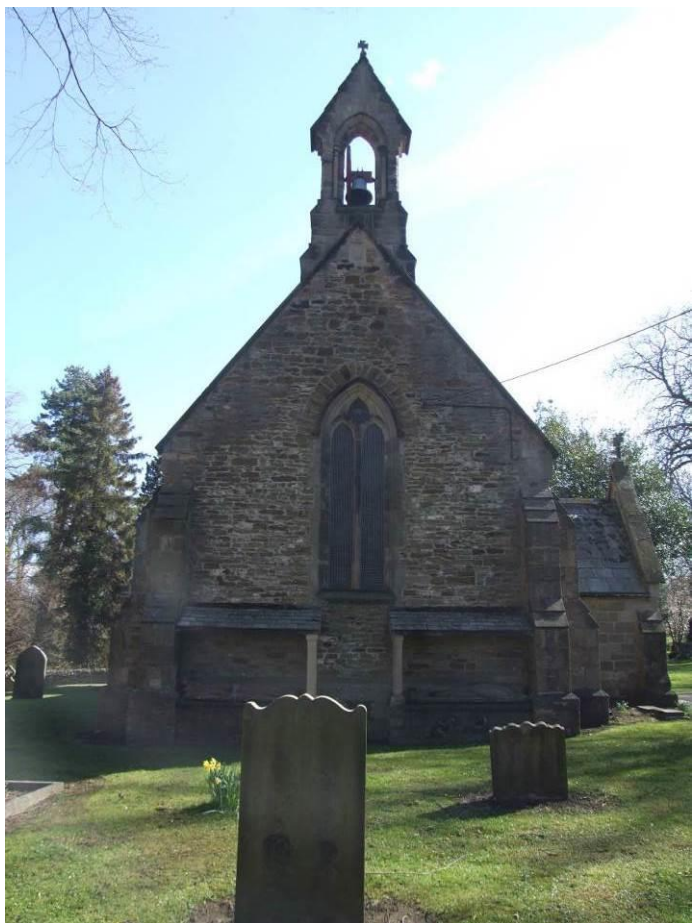
Fig. 15 (IMG 1321)  
General view of west end
