QUINQUENNIAL INSPECTION REPORT - APRIL 2023

HOLY TRINITY CHURCH

FRONT STREET, WINGATE, CO. DURHAM, TS28 5AN

Report prepared by

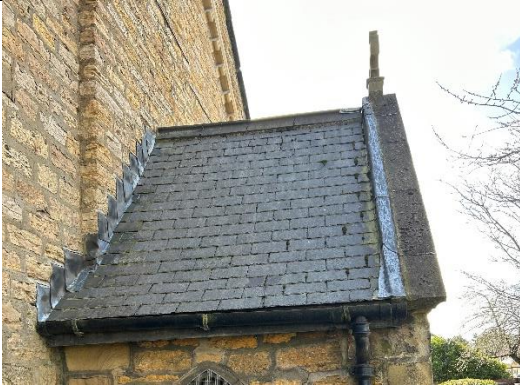
Northern Pitch of the Porch Roof

<p>Description</p> <ul style="list-style-type: none"> • Natural Blue Welsh Slates • Profiled terracotta ridge tiles • Water table to outer edge • Stone cross on water table • Non-Lead flashing to junction with Nave Wall. 	
	<p>Condition</p> <ul style="list-style-type: none"> • The roof appears generally sound, there are a few chipped slates. • Ridge tiles appear sound and well bedded. • The start of some moss growth in gaps between slates closest to the water table. 	
	<p>Repair Needs</p> <ul style="list-style-type: none"> • Monitor moss growth and remove with a wire brush if it starts to get excessive. 	M

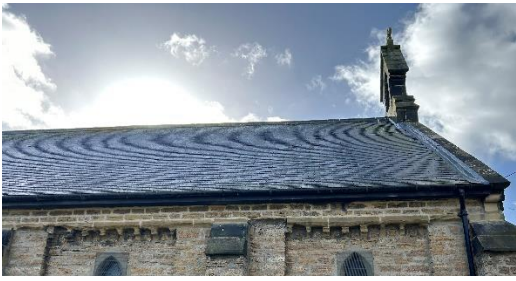
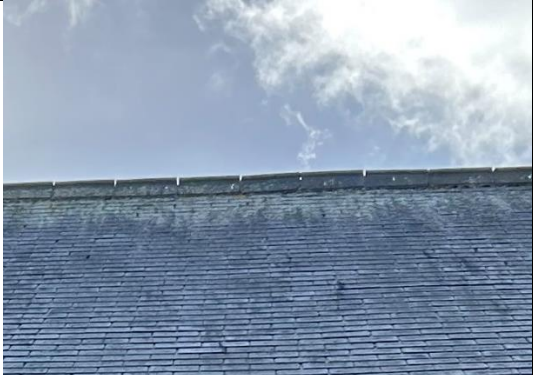
Northern Pitch of the Nave Roof

<p>Description</p> <ul style="list-style-type: none"> • Natural Slates • Profiled terracotta ridge tiles • Water tables to both sides. • Flashings have been replaced recently with a non-lead alternative product Master Form, to water tables. 	
---	---	--

<p>Condition</p> <ul style="list-style-type: none"> • The roof appears generally sound. • There are areas on the western side of the roof that appear to have been replaced with thicker slates than the original. • Ridge tiles appear well bedded, but some joints still appear open. 	
	<p>Repair Needs</p> <ul style="list-style-type: none"> • Re-point vertical open joints to ridge tiles. Initially check with Stones Technical Services to ascertain whether this should have been done within their roof works in 2022. 	D

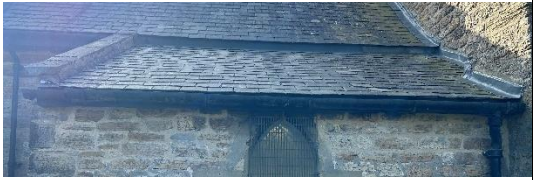
Vestry Roof

<p>Description</p> <ul style="list-style-type: none"> • Natural Slates • Water table to East gable. • Flashed upstand at ridge to the Chancel Eaves 	
	<p>Condition</p> <ul style="list-style-type: none"> • Roof appears to be in reasonable condition. • Flashings have been replaced since last QQI with a MasterForm flashing to water table into Nave Wall. • Slipped slates have been refixed since last QQI. • There are a few slates with chipped corners. 	
	<p>Repair Needs</p> <p>None</p>

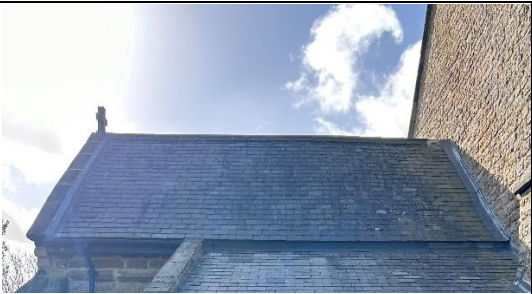
Northern Pitch of Chancel Roof

<p>Description</p> <ul style="list-style-type: none"> • Natural Slates • Profiled terracotta ridge tiles • A stone cross is located on the Eastern side of the Chancel roof on the water table. 	
	<p>Condition</p> <ul style="list-style-type: none"> • Roof is generally sound. • Slipped slates have been refixed since last QOI. • Flashings have been replaced with a non-lead alternative product Master Form, to water table on east, since the last QOI. • Flashing chased into stone on Nave wall to the west has been replaced with a non-lead alternative product Master Form, since the last QOI. • There is some moss growth developing. 	
	<p>Repair Needs</p> <p>Monitor moss growth and if it gets excessive, remove with a wire brush.</p>	M

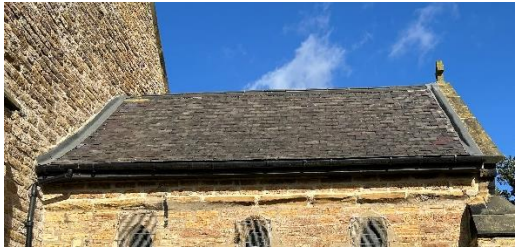
Southern Pitch of Chancel Roof

<p>Description</p> <ul style="list-style-type: none"> • Natural Slates • Profiled terracotta ridge tiles • Water table to east gable. • Non-lead Masterform flashings to water table at East and chased into Nave wall on the West side. 	
	<p>Condition</p> <ul style="list-style-type: none"> • Roof appears in good condition

<ul style="list-style-type: none"> • Previously slipped slates appears to have been re-fixed since last QQI and are now sound. • Self-adhesive flashing tape to water table at East and chased into Nave wall on West side have been replaced with new Master Form non-lead flashing, since last QQI. • New flashings and mortar fillets appear sound. • There are a few slates with chipped corners. 	
	<p>Repair Needs</p> <p>None</p>

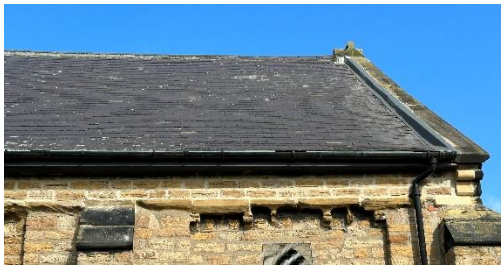
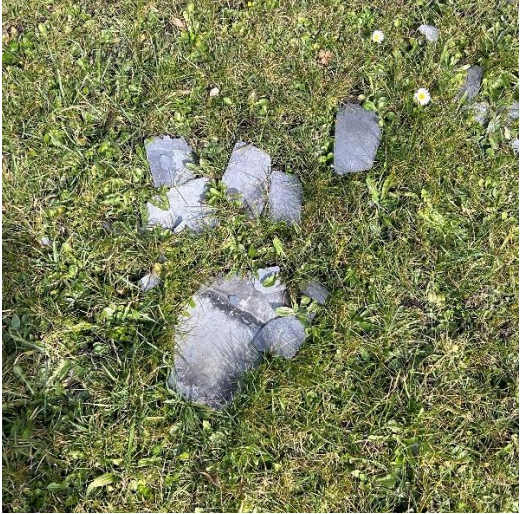
Southern Pitch of Nave Roof

<p>Description</p> <ul style="list-style-type: none"> • Natural slates • Profiled terracotta ridge tiles • Water table to both gables. • Bell Tower on top of Water table to West side.

<p>Condition</p> <ul style="list-style-type: none"> • Roof appears to be generally sound. • A fallen slate on the grass, although it was not obvious where it had fallen from. • The flashing tape to both water tables has been replaced with Master Form non-lead flashing, since the last QQI. • There are a few slates with chipped corners. 	
	<p>Repair Need</p> <p>None</p>

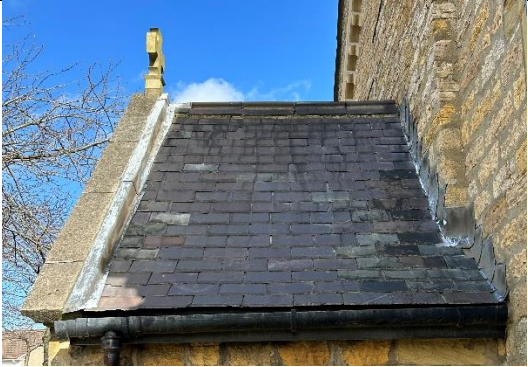
Southern Pitch of Porch Roof

<p>Description</p> <ul style="list-style-type: none"> • Natural slates • Profiled terracotta ridge tiles • Water table to west gable. • Stone cross on water table. • Lead flashing to water table and cut into Nave Wall. 	
	<p>Condition</p> <ul style="list-style-type: none"> • The roof appears generally sound, with some chipped slates. • Slipped tiles have been re-fixed since the last QQI. • Ridge tiles appear sound and well bedded. 	
	<p>Repair Needs</p> <p>None</p>

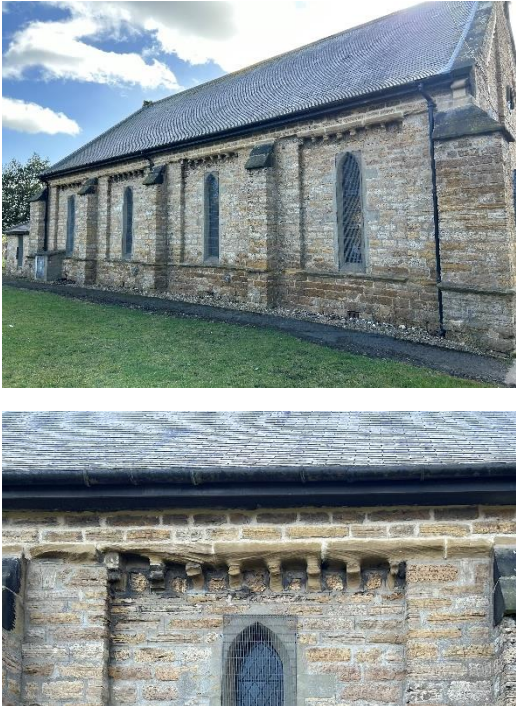
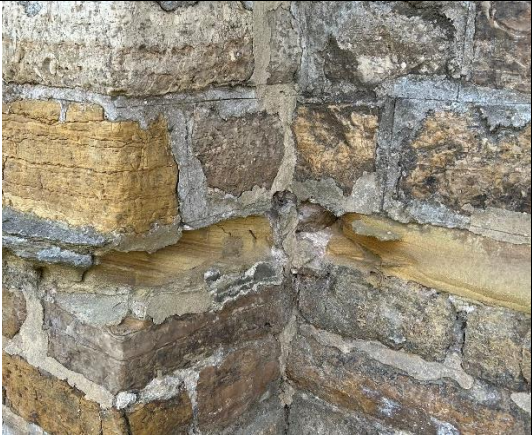
North Elevation of the Nave

<p>Description</p> <ul style="list-style-type: none"> • Coursed random rubble magnesium limestone with sandstone detailing to string & corbel courses, window surrounds • Sandstone window surrounds have been previously rendered over. • Some sandstone elements have been replaced previously. • Pointing has been renewed at some point in the past with what appears to be cement rich mortar and in places has been taken over the stone face. • The pointing at high level around the eaves has been renewed since the last QOI with what looks like a compatible lime-based mortar. 	
	<p>Condition</p> <ul style="list-style-type: none"> • The decorative corbel courses above the window bays are heavily eroded, but does not seem to have significantly changed since the last QOI. • The sandstone string course is also heavily eroded, with some sections completely eroded back to the face of the wall. And in some instances, have begun to erode into the wall, but does not

<p>seem to have significantly changed since the last QOI.</p> <ul style="list-style-type: none"> • The window surrounds have been thinly pointed over in the past, on the whole appears sound with some areas at the bottom starting to crack. • There are a number of stones across the elevation that have a crazed surface, which are vulnerable to moisture penetration. • Pointing generally remains sound. 	
	<p>Repair Needs</p> <ul style="list-style-type: none"> • Suggest PCC to consider a programme of spot stone replacement to corbels, dentils, string course etc along the lines of the replacement previously undertaken to the west gable. • PCC should also monitor stonework for further degradation – any stones at high level at risk of falling should be immediately attended too. • It is not clear whether corbels are relying in dentils for support. We suggest a structural engineer has a look at this. 	<p>E</p> <p>M</p> <p>D</p>

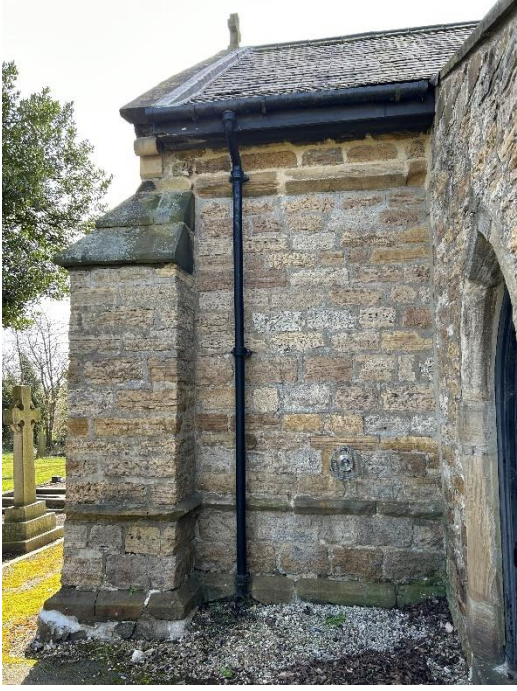
North Elevation of Chancel

<p>Description</p> <ul style="list-style-type: none"> • Coursed random rubble magnesium limestone with sandstone detailing to string, plinth & corbel courses, window surrounds • The sandstone corbel stone has been replaced below the water table. • Pointing has been replaced in the past with what appears to be cement rich mortar and in places has been taken over the stone face. • Pointing at high level has been renewed since the last QQI with what looks like a compatible lime-based mortar. 	
	<p>Condition</p> <ul style="list-style-type: none"> • Generally pointing appears sound. • Re-pointing of open joints to the plinth course has taken place since the last QQI. • There are some crazed and cracked stones particularly on the buttress, which are vulnerable to moisture penetration. 	
	<p>Repair Needs</p> <p>None</p>

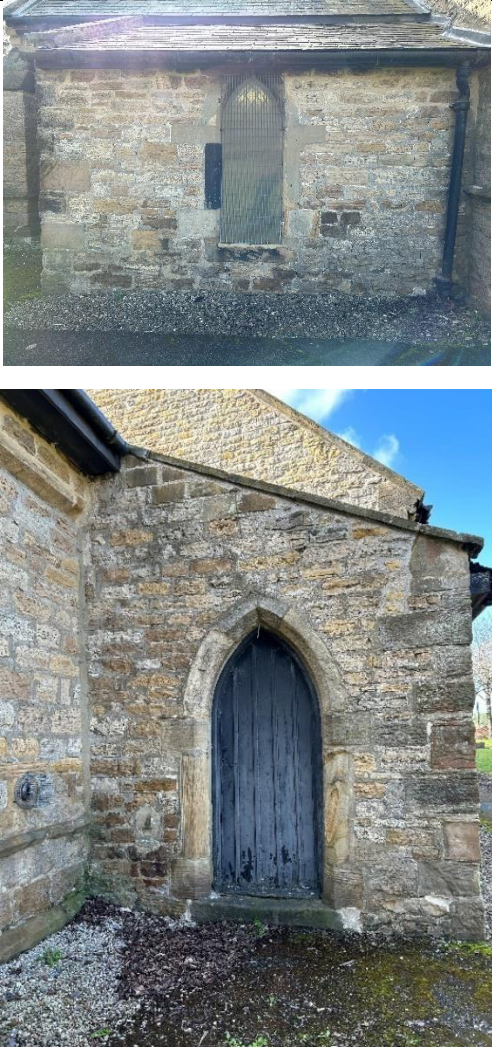
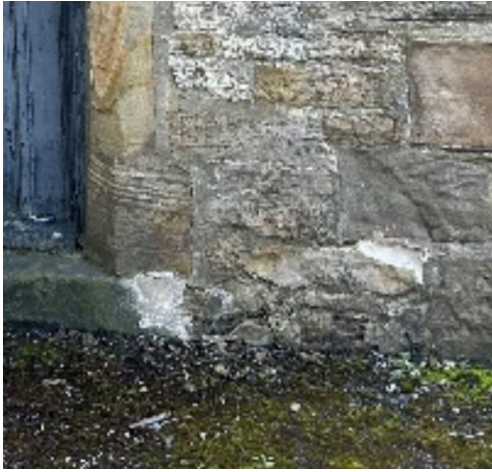
Vestry

<p>Description</p> <ul style="list-style-type: none"> • Coursed random rubble magnesium limestone with sandstone detailing to window & door surround. • The sandstone window surround has been thinly pointed over. 	
--	--	--

<p>Condition</p> <ul style="list-style-type: none"> • Walls and pointing are generally sound. • It is noted that some small areas of pointing have been done since the last QQI where it was identified that pointing was missing. • Sandstone door surround has eroded particularly on the northern edge, and pointing is now sitting proud in some areas. This doesn't appear to have significantly deteriorated since the last QQI. • The cement render over the sandstone window surround has weathered and is missing / cracked in places and looks unsightly. 	
	<p>Repair Needs</p>

<ul style="list-style-type: none"> Any delaminated render to window surrounds should be knocked off. 	M
--	---	---

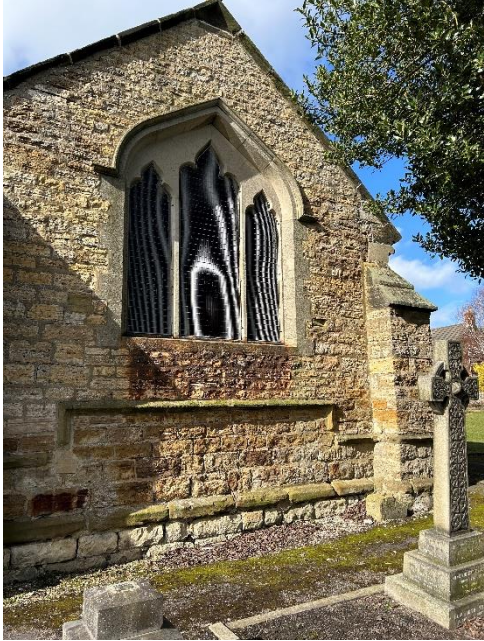
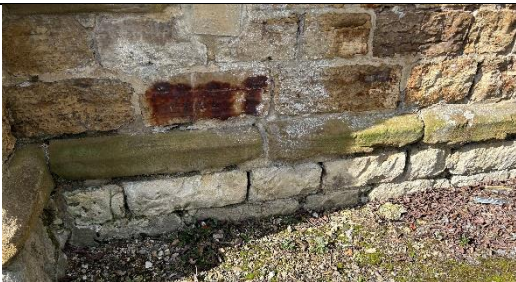
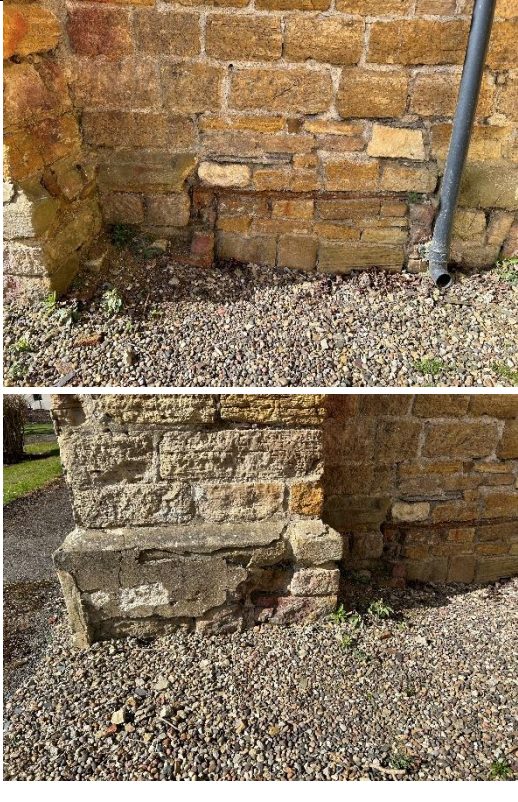
Chancel Gable / Nave East Elevation,

<p>Description</p> <ul style="list-style-type: none"> Coursed random rubble magnesium limestone with sandstone detailing to window surround, plinth and string course. Sandstone window surround has been previously replaced with concrete surround.

<p>Condition</p> <p><u>Chancel Gable</u></p> <ul style="list-style-type: none"> There is severe staining below the chancel window. Pointing is generally sound but has weathered out in some locations at low level, below the string course. There are a number of crazed stones, particularly at high level which are vulnerable to moisture penetration. <p><u>Nave Gable</u></p> <ul style="list-style-type: none"> Stone and pointing appears sound. Sandstone string course is heavily eroded, with some sections eroded back to the face of the wall. Some areas of pointing have weathered out at low level, which has exposed some rusted steel.

<ul style="list-style-type: none"> The buttress plinth has been rendered over previously which has now weathered and eroded with a broken stone. 	
	<p>Repair Needs</p> <ul style="list-style-type: none"> Repoint at low level. Using suitable lime mortar. Suggest PCC consider a programme of spot stone replacement to string course and buttress plinth. 	<p>D E</p>

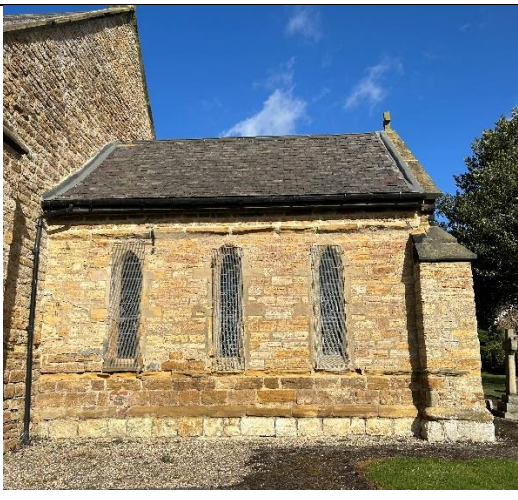
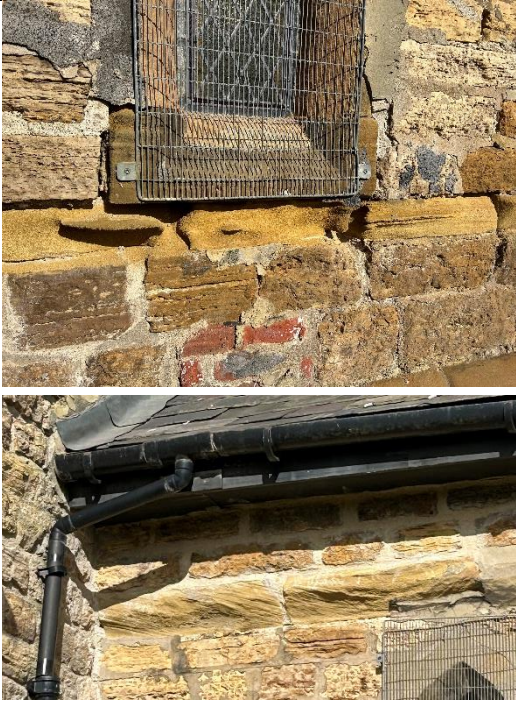
South Elevation of Chancel

<p>Description</p> <ul style="list-style-type: none"> Coursed random rubble magnesium limestone with sandstone detailing to plinth and string courses and window surrounds. The sandstone window surrounds have been thinly pointed over. Pointing at high level has been renewed since the last QQI with what looks like a compatible lime-based mortar. 	
---	---	--

<p>Condition</p> <ul style="list-style-type: none"> • The sandstone string & corbel courses above and below the windows are heavily eroded, mostly back to the face of the wall. There does not appear to be any significant change to the deterioration since the last QOI. • Unsightly pointing which appears to be modern cement mortar is present, however appears sound above string course. • Missing or damaged stone has previously had a patch repair below window W10, with red brick. The pointing has been renewed since the last QOI. • The cement render over the sandstone window surrounds have weathered and is missing / cracked in places and looks unsightly. 	
	<p>Repair Needs</p> <ul style="list-style-type: none"> • Suggest PCC consider a programme of spot stone replacement to string courses along the lines of the replacement previously undertaken to the west gable. • Any delaminated render to window surrounds should be knocked off. 	<p>E</p> <p>M</p>

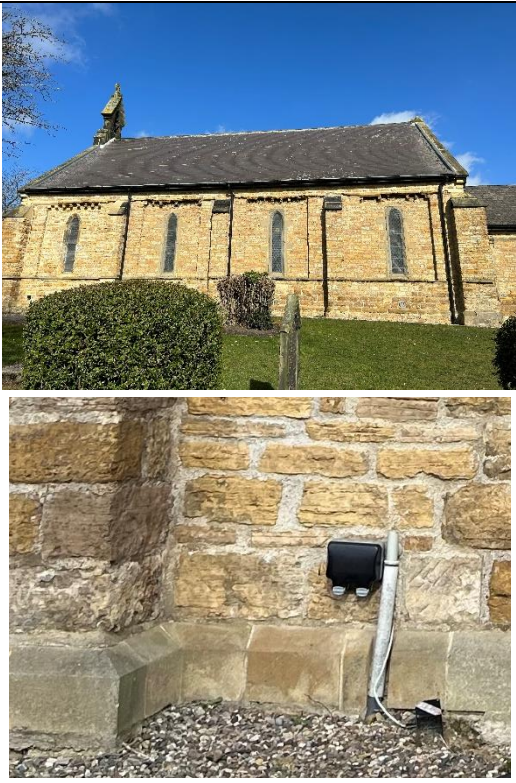
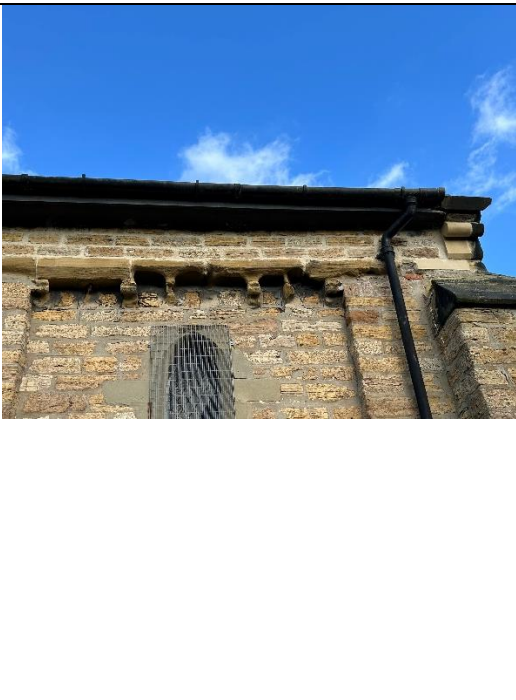
South Elevation of the Nave

<p>Description</p> <ul style="list-style-type: none"> • Coursed random rubble magnesium limestone with sandstone detailing to plinth and string courses and window surrounds. • The sandstone window surrounds have been thinly pointed over. • Pointing at high level has been renewed since the last QQI with what looks like a compatible lime-based mortar. • An outdoor double socket has been installed adjacent to the west buttress since the last QQI.

<p>Condition</p> <ul style="list-style-type: none"> • Stone and pointing appear sound generally. • Both stone kneelers (east and west) and part of the stone corbel course to the west of the elevation has been replaced previously. • The remaining corbel courses above the window bays are extremely eroded. There does not appear to be any significant further deterioration since the last QQI. • The string course below the windows are also eroded to varying degrees across the elevation. There does not appear to be any significant further deterioration since the last QQI.

<p>Repair Needs</p> <p>Suggest PCC consider a programme of spot stone replacement to corbels, dentils, string course etc along the lines of the replacement previously undertaken to the west gable.</p>	<p>E</p>

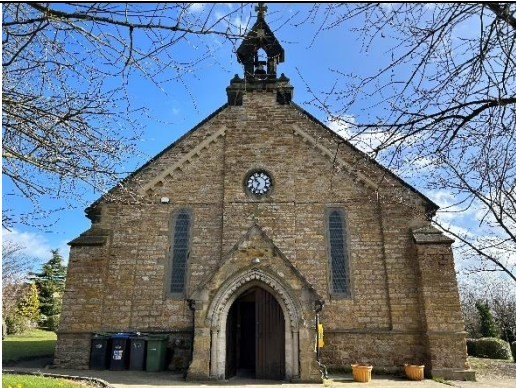
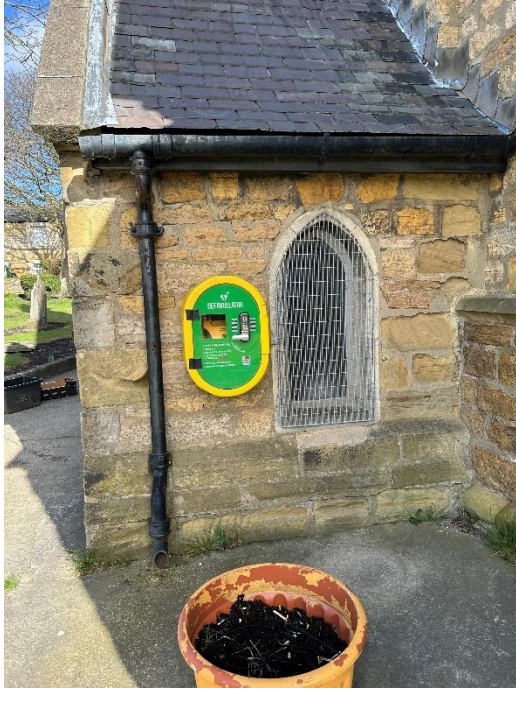
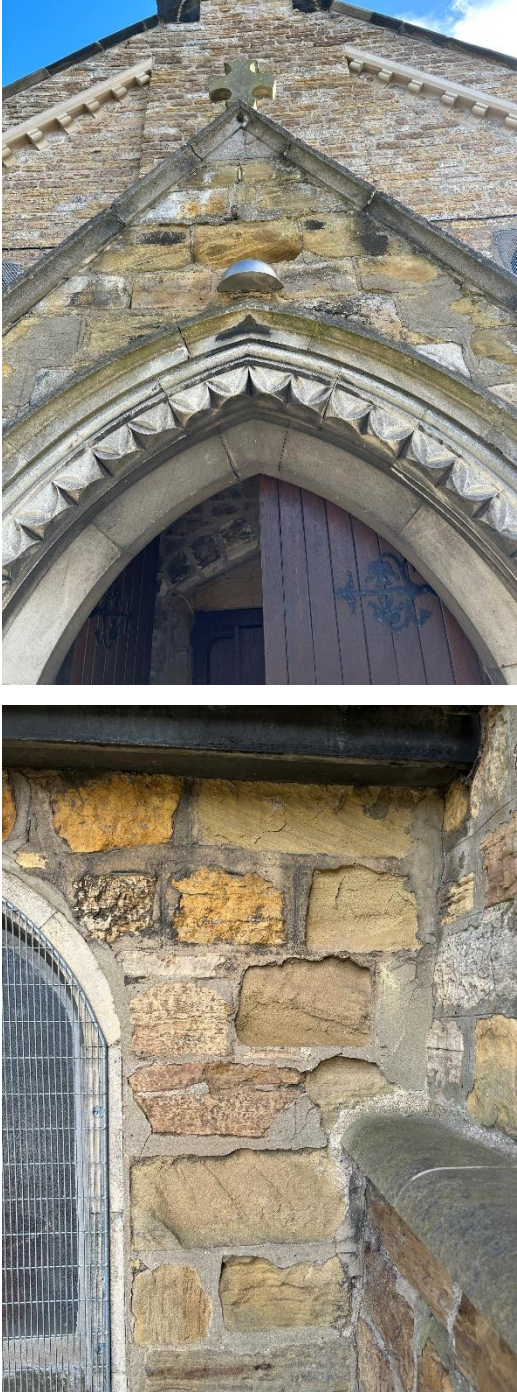
Porch / West Elevation

<p><u>West Elevation</u></p> <ul style="list-style-type: none"> • Coursed random rubble magnesium limestone with sandstone detailing to plinth and string courses and window surrounds. • The sandstone window surrounds have been thinly pointed over. <p><u>The Entrance Porch</u></p> <ul style="list-style-type: none"> • The porch is constructed of sandstone with artificial stone door and window surrounds. • A defibrillator has been installed onto the south elevation of the porch, since the last QQI. • A new light fitting above porch entrance door has been installed since the last QQI. 	
	<p>Condition</p> <p><u>West Elevation</u></p> <ul style="list-style-type: none"> • Walls and pointing appear sound. • The pointing over the stone window surrounds has weathered off in sections and is cracked. • Gable coping stones appear well bedded & pointed. • The logbook indicates the clock was serviced in July 2022 but is displaying a slight delay in time. • The sandstone apex belfry is heavily stained black, but appears sound.

<p><u>Porch</u></p> <ul style="list-style-type: none"> • The door surround has some blackened staining and movement cracks present on the northern side and at the top. • There is some delamination of the face of stone particularly on the southern elevation of the porch. This does not appear to have significantly deteriorated since the last QQI. • There is a particularly weathered stone behind the security light above the door arch. • Pointing to the porch gable coping stones has weathering out in places and cracked. 	
	<p>Repair Needs</p> <ul style="list-style-type: none"> • Monitor cracking to arched door surround. • Repointing to porch gable coping stones required and open joint at top of arch surround, using a suitable lime mortar. • Any delaminated render to window surrounds should be knocked off. 	<p>M</p> <p>D</p> <p>M</p>

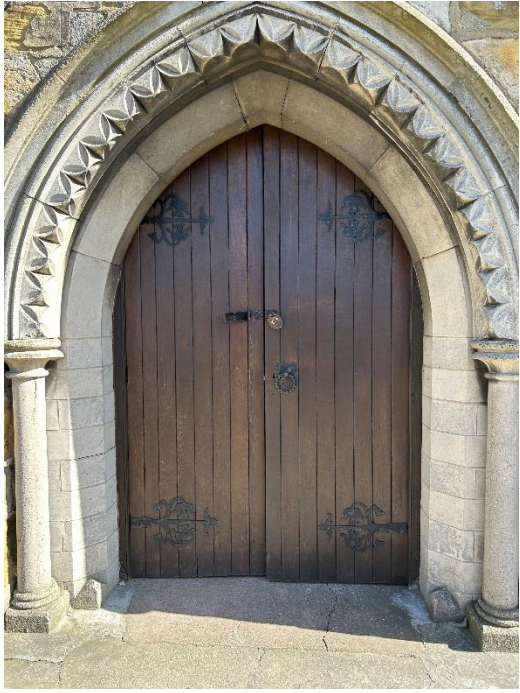
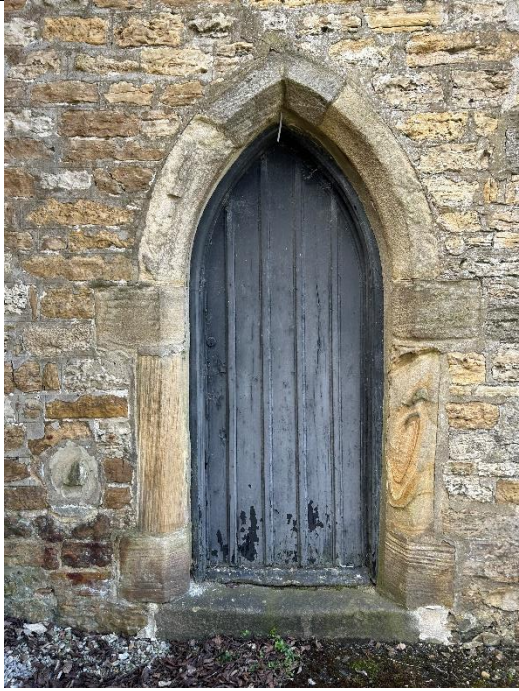
Exterior Doors

<p>Description</p> <ul style="list-style-type: none"> The Main Entrance door (D1) is a varnished oak boarded double door with arched head. The door into the Vestry has been blocked up on the inside but the original door remains externally. 	
--	--	--

<p>Condition</p> <ul style="list-style-type: none"> • The Main entrance door (D1) is in good condition. • The Vestry door (D2) is in reasonable condition; however, the paint is beginning to deteriorate at low level. 	
	<p>Repair Needs</p> <ul style="list-style-type: none"> • The vestry door would benefit from repainting to prolong its lifespan and prevent water ingress, particularly as the door is blocked up internally. Any flaking paint should be removed first. 	<p>C</p>

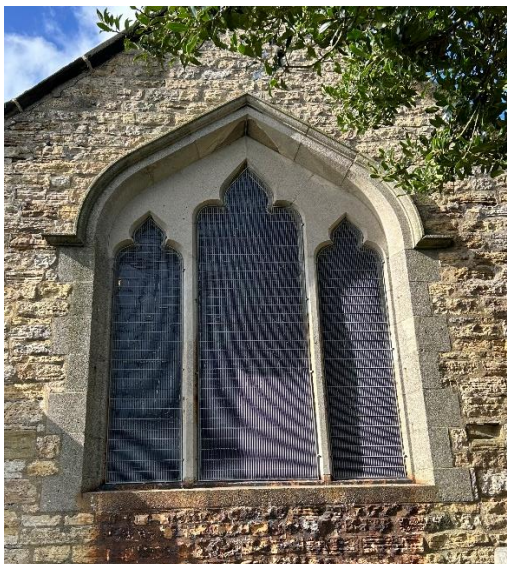
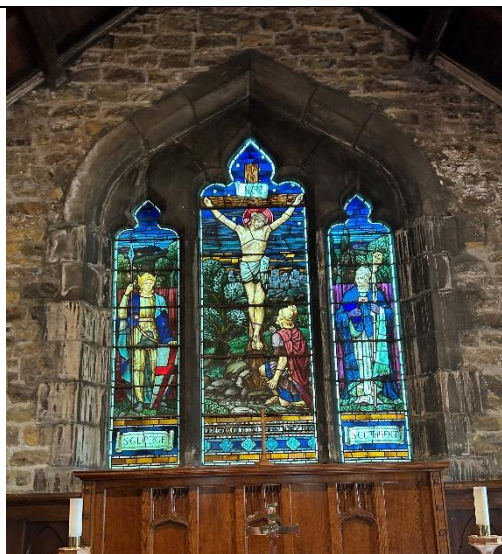
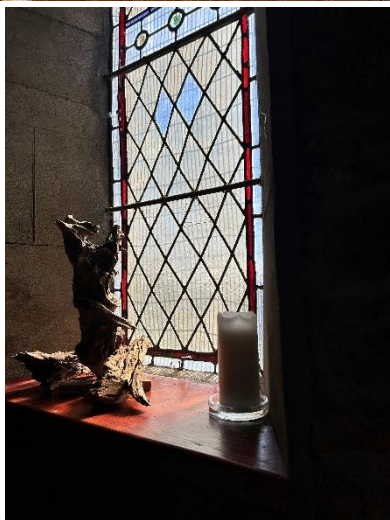
<p>Description</p> <ul style="list-style-type: none"> • All windows are arched with leaded glass. Some with stained glass elements. • All windows are set into sandstone or imitation stone surrounds, with the majority rendered over with a thin mortar layer. 	
--	---	--

- All windows have galvanised wire guards installed, and the vestry window also has polycarbonate protection behind the wire guard.

- Generally stone surrounds are sound although the rendered finish externally is weathering in places.
- W7 on east elevation is in good condition, however the window surround has water staining internally. Staining does not appear to have deteriorated any further since the last QI.
- W2, W3, W5, W9, W11 & W13 appear to have some bulging of the glass panes in areas.
- W4 & W12 appear to have been replaced with plain leaded glass.
- Windows W2, W3, W8, W9, W10, W11, W13 all appear to have had some replacement panes.
- Windows W8, W9, W11, W15 appear to have fractured panes.
- Window W6 was inaccessible internally as it is covered by the organ.
- Window 14 was also inaccessible internally as it sits above the WC/Flower room.
- The window in the vestry appears to be new leaded glass.

<p>Repair Needs</p> <p>Monitor staining to the East Gable window internally.</p> <p>PCC to consider programme of window repairs to windows with bulging panes or fractured glass.</p>	<p>M</p> <p>E</p>
--	--	-------------------

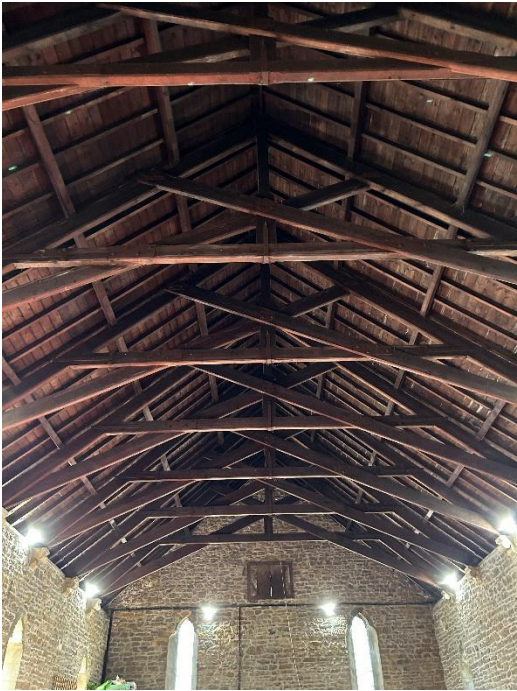
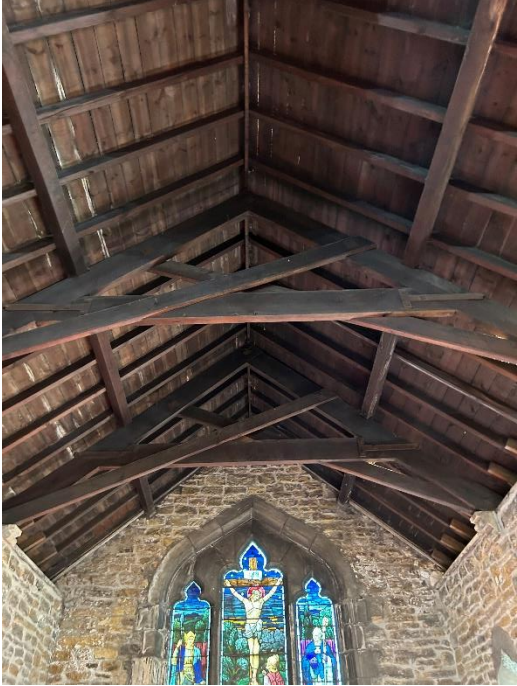
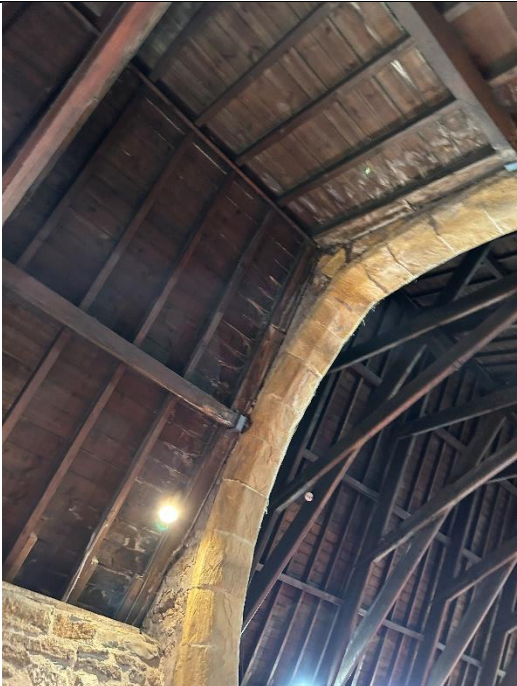
11.2 ROOF STRUCTURES AND CEILINGS

<p>Description</p> <ul style="list-style-type: none"> • The nave consists of 7 heavy timber scissor trusses with 3 sets of timber purlins to each side. The ceiling is formed by the underside of the timber sarking boards. • The chancel consists of 2 timber trusses of similar construction to the nave, with single purlins to each side. The ceiling is formed by the underside of the timber sarking boards. • The entrance porch also consists of a timber ceiling. • There is a lathe and plaster ceiling in the Vestry • There is a plasterboard ceiling to the WC and flower room.

<p>Condition</p> <ul style="list-style-type: none"> • The timber sarking boards forming the ceilings in the chancel and nave appear sound, with some old water staining near the arch in the chancel. This does not appear to have deteriorated since the last QQI. The replacement of the flashings has hopefully resolved the water ingress issue. • The lathe and plaster ceiling in the vestry appears sound, although uneven. • Plasterboard ceilings are in good condition. 	
	<p>Repair Needs</p> <ul style="list-style-type: none"> • Continue to monitor staining around the arch junction between Chancel & Nave. 	M

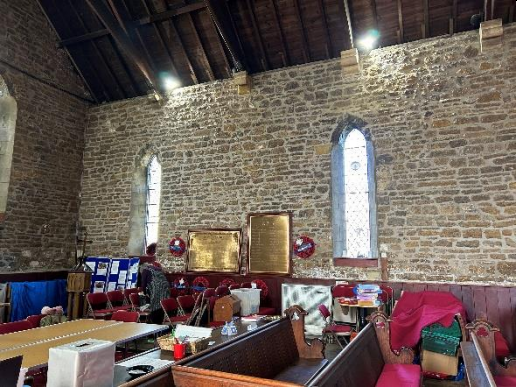
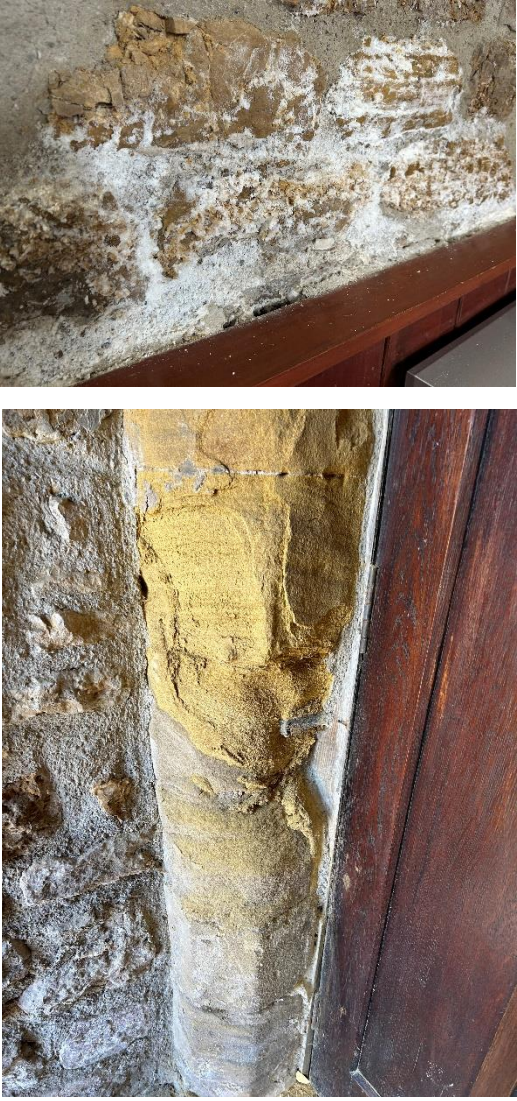
11.3 INTERNAL WALLS

<p>Description</p> <ul style="list-style-type: none"> • Mainly exposed limestone with dado panelling at low level. The 2013 QQI report by John Niven suggests the walls were fully repointed in 2008. • The vestry walls are lime washed with the external door blocked up internally with concrete blocks and lime washed over. 	
---	---	--

<p>Condition</p> <ul style="list-style-type: none"> • The internal stone walls generally appear to be in good condition. • The stone surround to the inner door in the porch has eroded and delaminated in places, due to past moisture ingress. It does not appear to have deteriorated significantly since the last QQI. • The efflorescence noted in the last QQI report is still present on the lower parts of the north wall in the Nave, above the timber panelling. However, it does appear to be slightly better. • There is efflorescence present on the stone at high level above the Chancel / Nave arch. • There is efflorescence present to the east wall of the Chancel. • The stone arch between the chancel and the nave appears to be in reasonable condition. 	
	<p>Repair Needs</p> <ul style="list-style-type: none"> • Continue to brush off the worst of the efflorescence and monitor the area for reappearance. 	<p>M</p>

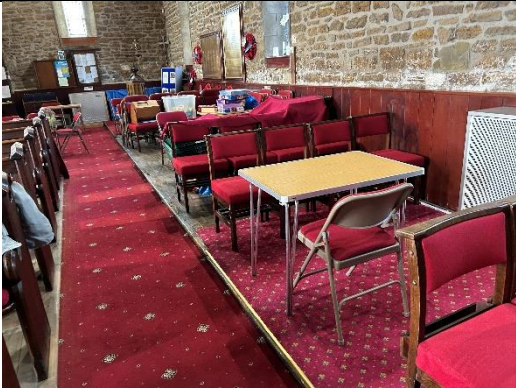
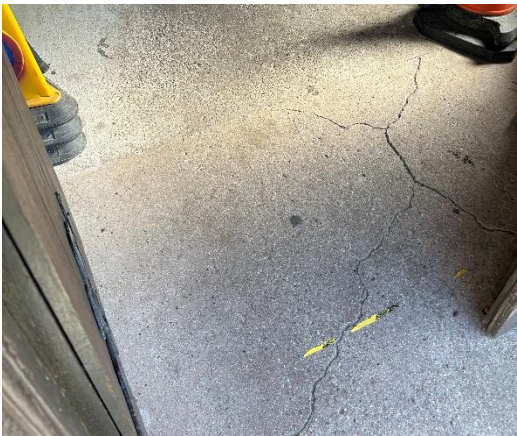
11.5 FLOORS AND PLATFORMS

<p>Description</p> <p><u>Nave</u></p> <ul style="list-style-type: none"> • Solid wood black floors to walkways, with newer concrete to west end, all now carpeted. • Raised T&G timber floors to the pewed areas. • Concrete floors to the new WC block with vinyl finish. <p><u>Chancel</u></p> <ul style="list-style-type: none"> • Suspended timber walkways, carpeted. • Raised T&G timber floors to choir stalls. • Terrazzo step to sanctuary, now carpeted. <p><u>Vestry</u></p> <ul style="list-style-type: none"> • Concrete floor with carpet finish. <p><u>Porch</u></p> <ul style="list-style-type: none"> • Exposed concrete. 	
---	---	--

<p>Condition</p> <ul style="list-style-type: none"> Floors generally appear sound throughout the Nave & Chancel Concrete floor to the entrance porch is cracked and slightly uneven. Floor finishes are in good condition. 	
	<p>Repair Needs</p> <ul style="list-style-type: none"> The cracked and uneven floor to the porch could be considered as part of the external resurfacing works, if necessary. 	<p>E</p>

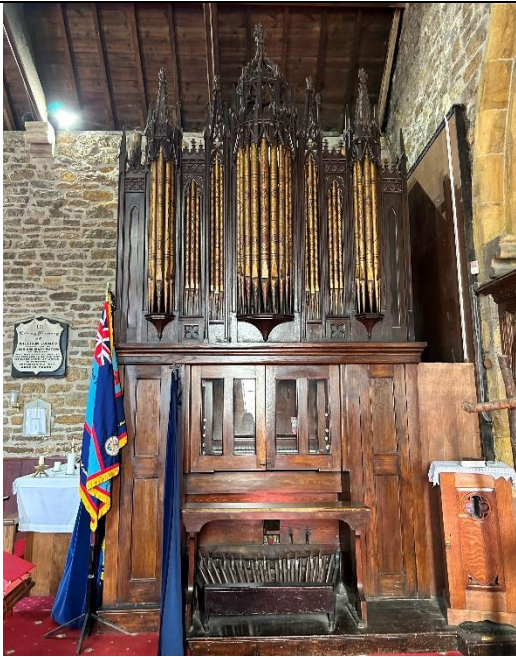
11.8 ORGAN

<p>Description</p> <p>The organ, is a 2 manual 15 stop pipe instrument built by Nelson & Co. Durham, and is located in the north east corner of the Nave.</p> <p>Condition</p> <p>The logbook indicates the Organ was last serviced / tuned in October 2022.</p> <p>Repair Needs</p> <p>Continue regular tuning and servicing by a specialist.</p>	<p>M</p>
---	---	----------

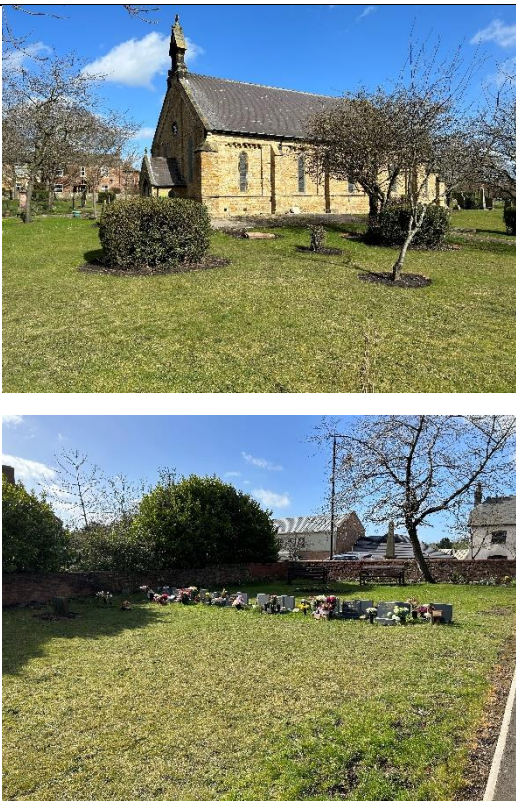
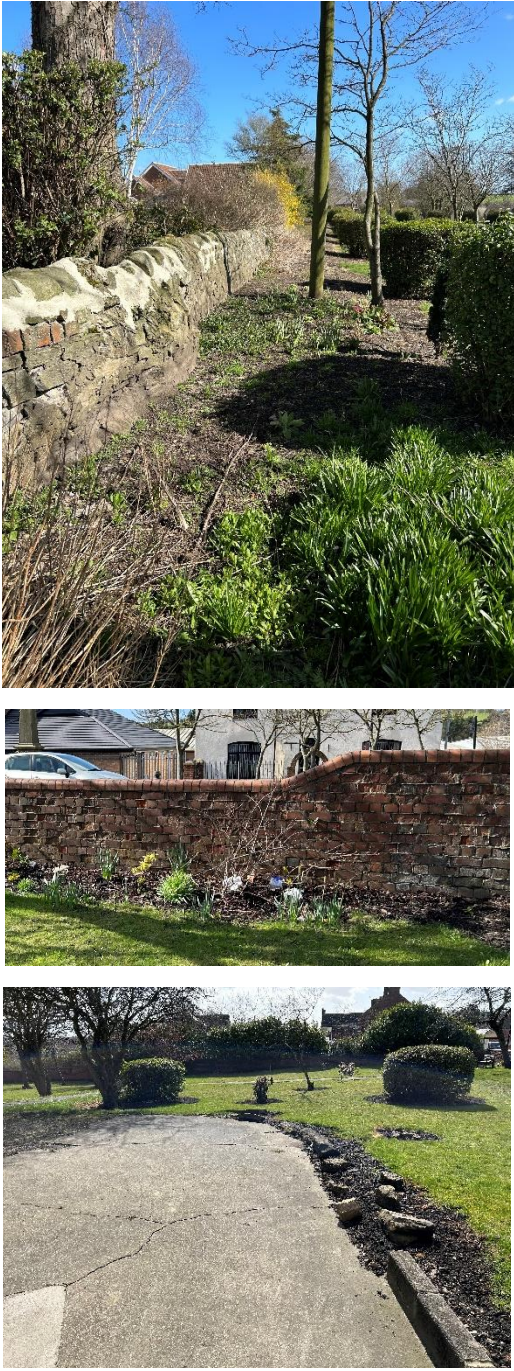
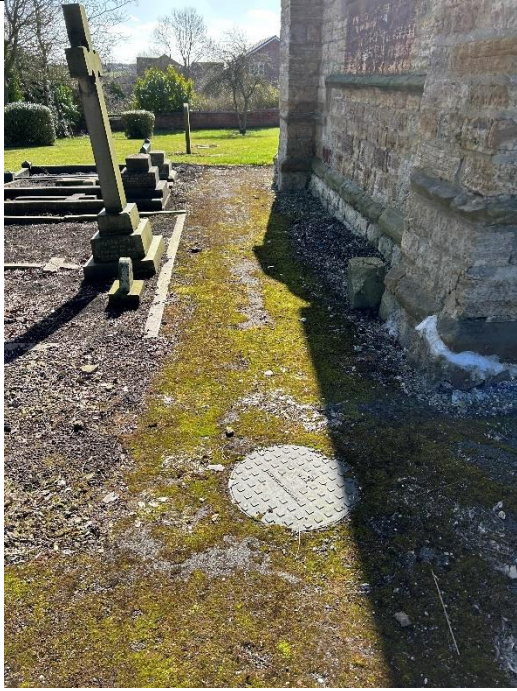
12. CHURCHYARD AND ENVIRONS

<p>Description</p> <ul style="list-style-type: none"> • There is a large churchyard with the majority situated to the east of the church. The church yard is closed and maintained by the Local Authority. • The perimeter boundary to the west is a solid brick wall. • The northern boundary consists of a mix of brick wall, stone wall and timber fencing. • The eastern boundary consists of timber fencing to neighbouring houses. • The southern boundary with the neighbouring school consists of a low brick wall to the church side and a high metal fence on the school side with planting in between. Further east the boundary changes to timber fencing when bordering houses. • Footpaths around the church are tarmac. • There are gravel margins around the church walls up to the footpath. 	
---	---	--

<ul style="list-style-type: none"> • There is a concrete entrance driveway into the church grounds with concrete kerb edging, an area of hardstanding for a couple of cars to park which consists of a mix of concrete and gravelled areas. • A new memorial garden has been created since the last QQI and a new tarmac path to this has been installed by the Local Authority.

<p>Condition</p> <ul style="list-style-type: none"> • The concrete drive is in poor condition, there are numerous cracks and damaged patches. • Tarmac paths do not have pin kerb edges which has resulted in the grass creeping onto path • Paths are uneven, loose and have moss growth on them. • Face of brickwork boundary wall (west), is delaminating on the churchyard side of the wall. • Stone boundary wall to the north is leaning slightly outwards wards. • Stone boundary wall (south) is leaning slightly inwards. • Timber fences appear sound. • The local authority has repaired the concrete pin kerbs around the entrance to the church yard and opposite the porch since the last QQI, but the remaining drive further to the south remains un edged.

<p>Repair Needs</p> <ul style="list-style-type: none"> • Monitor the delamination of the brick face to the western boundary wall. • Monitor the north and south boundary walls for any further movement. • Consider removing moss growth on footpaths to prevent slips. • PCC to consider resurfacing driveway and footpaths, as per separate report issued in December 2018. 	<p>M</p> <p>M</p> <p>M</p> <p>E</p>
---	--	-------------------------------------
