QUINQUENNIAL INSPECTION REPORT - APRIL 2018

# HOLY TRINITY CHURCH

FRONT STREET, WINGATE, CO. DURHAM, TS28 5AN

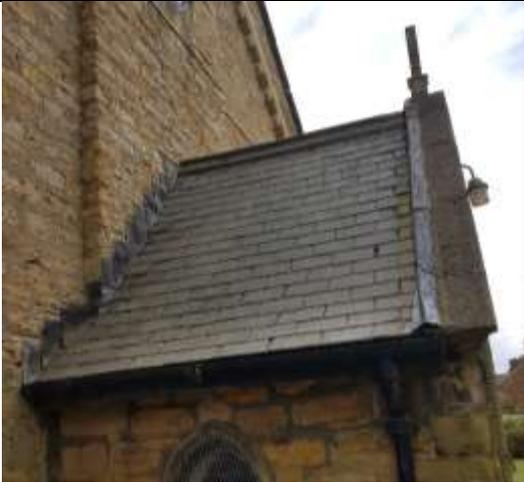
Northern Pitch of the Porch Roof

<p><b>Description</b></p> <ul style="list-style-type: none"> <li>• Natural Blue Welsh Slates</li> <li>• Profiled terracotta ridge tiles</li> <li>• Water table to outer edge</li> <li>• Stone cross on water table</li> <li>• Non-Lead flashing to junction with Nave Wall.</li> </ul>	
	<p><b>Condition</b></p> <ul style="list-style-type: none"> <li>• The roof appears generally sound, there are a few chipped / slipped slates.</li> <li>• Ridge tiles appear sound and well bedded.</li> </ul>	
	<p><b>Repair Needs</b></p> <ul style="list-style-type: none"> <li>• Monitor slates and refix any which continue to slip, or are blown off.</li> </ul>	<p>M</p>

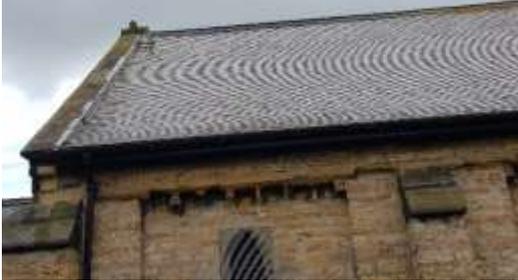
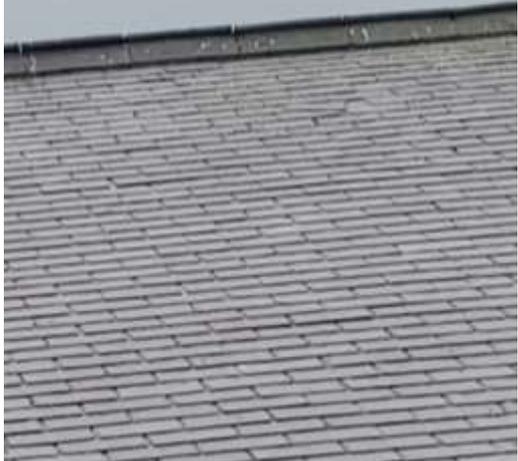
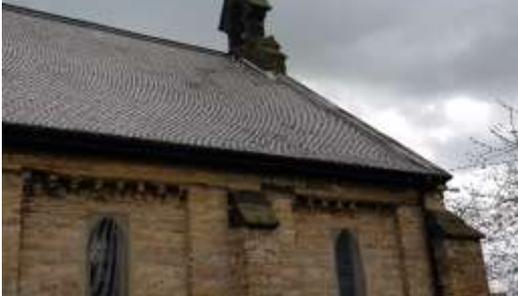
<p><b>Condition</b></p> <ul style="list-style-type: none"> <li>• The roof appears generally sound.</li> <li>• There are a few slipped slates.</li> <li>• There are areas on the western side of the roof that appear to have been replaced with thicker slates than the original.</li> <li>• The ridge tiles appear sound and well bedded, although some have open vertical joints at the top.</li> </ul>

<p><b>Repair Needs</b></p> <ul style="list-style-type: none"> <li>• Monitor slates and refix any which continue to slip, or are blown off.</li> <li>• Repoint vertical joints in ridge tiles, and at the same time, check that they are soundly bedded, and taking remedial action as required.</li> </ul>	<p>M</p> <p>D</p>

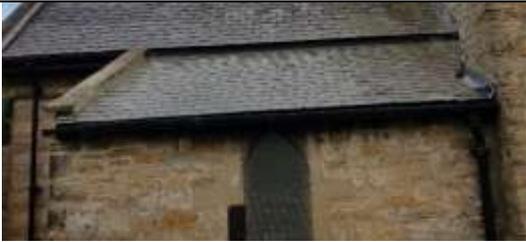
**Vestry Roof**

<p><b>Description</b></p> <ul style="list-style-type: none"> <li>• Natural Slates</li> <li>• Water table to East gable.</li> <li>• Lead flashings have been covered over with self-adhesive Flashband to water table into Nave Wall</li> <li>• Flashed upstand at ridge to the Chancel Eaves</li> </ul>	
	<p><b>Condition</b></p> <ul style="list-style-type: none"> <li>• Roof appears to be in reasonable condition.</li> <li>• There are a few slipped / chipped slates.</li> </ul>	
	<p><b>Repair Needs</b></p> <ul style="list-style-type: none"> <li>• Monitor slates and refix any which continue to slip, or are blown off.</li> </ul>	M

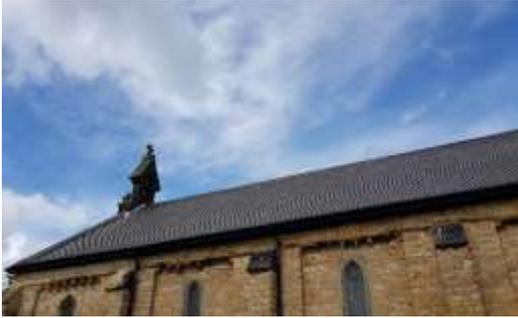
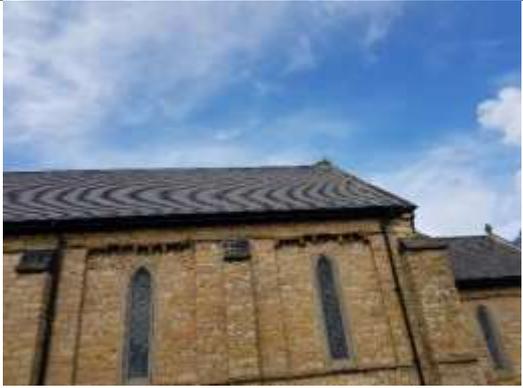
<p><b>Condition</b></p> <ul style="list-style-type: none"> <li>• The roof appears generally sound.</li> <li>• There are a few slipped / chipped slates.</li> <li>• The ridge tiles appear sound and well bedded, although some have open vertical joints at the top.</li> </ul>	
	<p><b>Repair Needs</b></p> <ul style="list-style-type: none"> <li>• Monitor slates and refix any which continue to slip, or are blown off.</li> <li>• Repoint vertical joints in ridge tiles, and at the same time, check that they are soundly bedded, and taking remedial action as required.</li> </ul>	<p>M</p> <p>D</p>

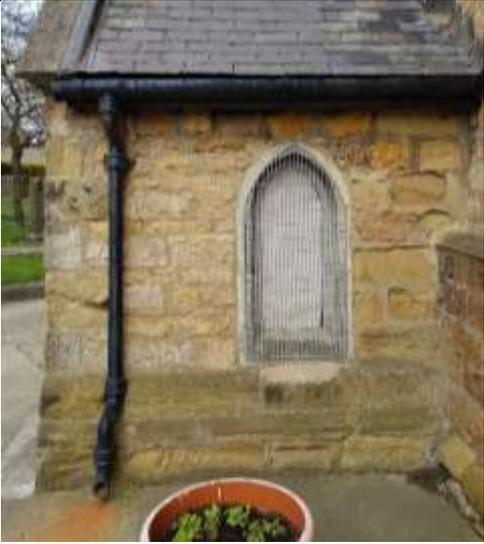
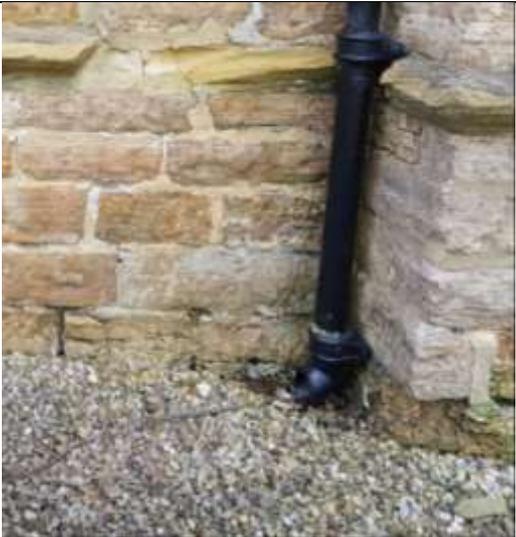
<p><b>Condition</b></p> <ul style="list-style-type: none"> <li>• Gulleys at ground level appear to be clear and free from debris.</li> <li>• The downpipe to the North West corner of the Nave does not appear to be discharging into a gully, has the gully been covered over with gravel / debris?</li> <li>• Rainwater goods appear to be in good condition, last re-decorated in 2008 as stated in the last QQ report.</li> <li>• Paint is beginning to peel in small areas on the downpipes to the porch and rust is showing.</li> </ul>

<p><b>Repair Needs</b></p> <ul style="list-style-type: none"> <li>• Investigate the gully to the North West corner of the Nave and clear out gravel / debris.</li> <li>• Consider re-painting downpipes</li> </ul>	<p>M D</p>
--	--	----------------

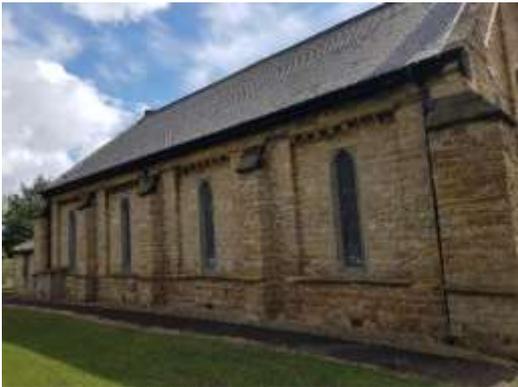
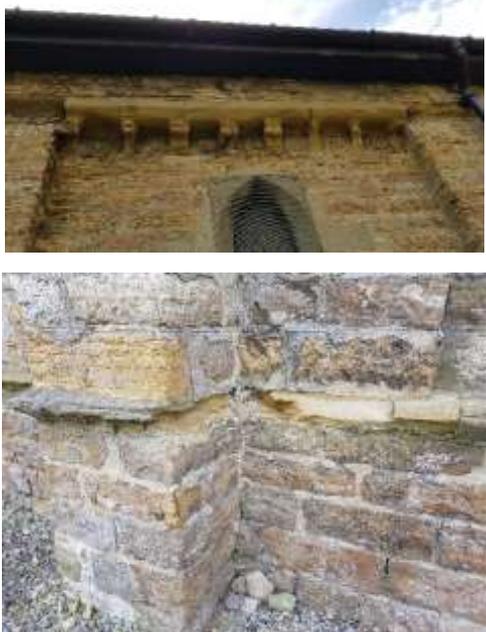
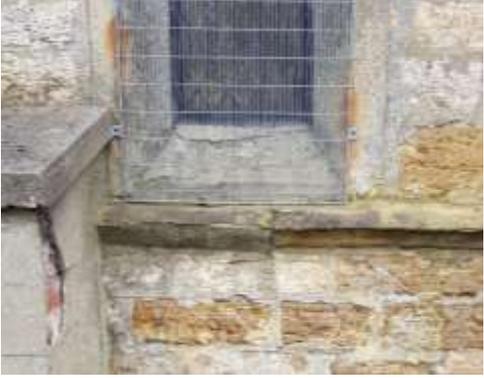
<p><b>Condition</b></p> <ul style="list-style-type: none"> <li>• The decorative sandstone corbel courses above the window bays are heavily eroded.</li> <li>• The sandstone string course is also heavily eroded, with some sections completely eroded back to the face of the wall.</li> <li>• The window surrounds have been thinly pointed over in the past, on the whole appears sound with some areas at the bottom starting to crack.</li> <li>• There are a number of stones across the elevation that have a crazed surface, which are vulnerable to moisture penetration.</li> <li>• Pointing generally appears sound.</li> </ul>

<p><b>Repair Needs</b></p> <ul style="list-style-type: none"> <li>• Suggest PPC to consider a programme of spot stone replacement to corbels, dentils, string course etc along the lines of the replacement previously undertaken to the west gable.</li> <li>• PCC should also monitor stonework for further degradation – any stones at high level at risk of falling should be immediately attended too.</li> <li>• It is not clear whether corbels are relying in dentils for support. We suggest a structural engineer has a look at this.</li> </ul>	<p>E</p> <p>M</p>

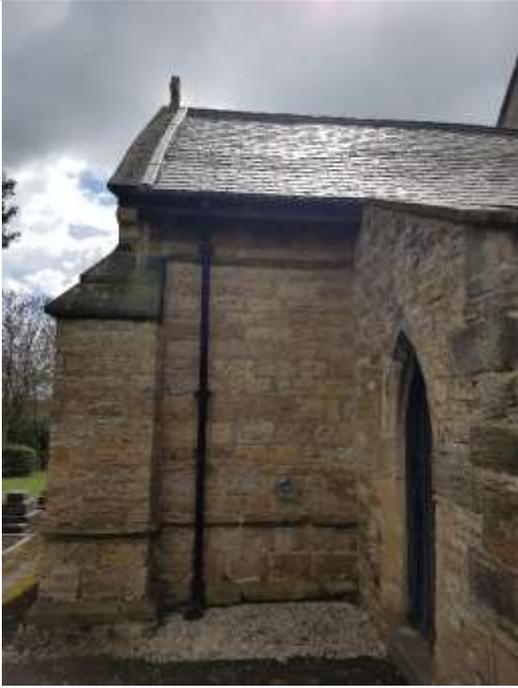
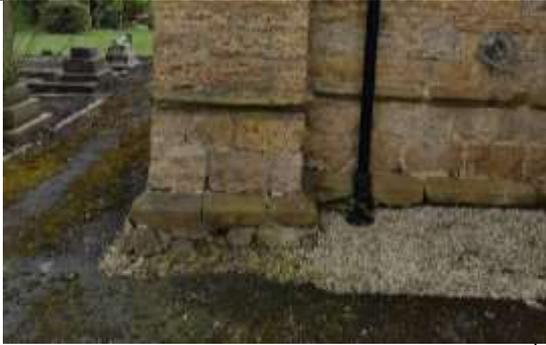
<p><b>Condition</b></p> <ul style="list-style-type: none"> <li>• Generally pointing appears sound.</li> <li>• The plinth course and course above has open joints where pointing has weathered away.</li> <li>• There are some crazed and cracked stones particularly on the buttress, which are vulnerable to moisture penetration.</li> </ul>	
	<p><b>Repair Needs</b></p> <ul style="list-style-type: none"> <li>• Repoint open joints to plinth course and course above, with suitable lime mortar.</li> </ul>	<p>D</p>

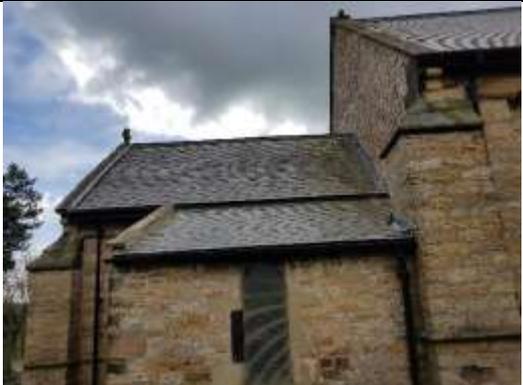
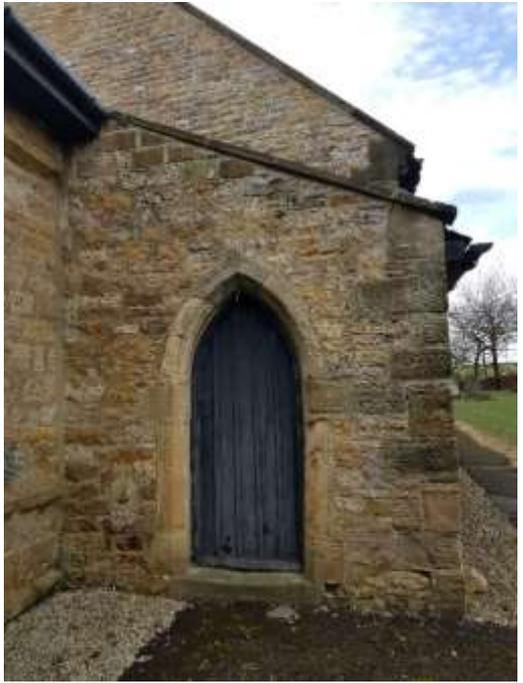
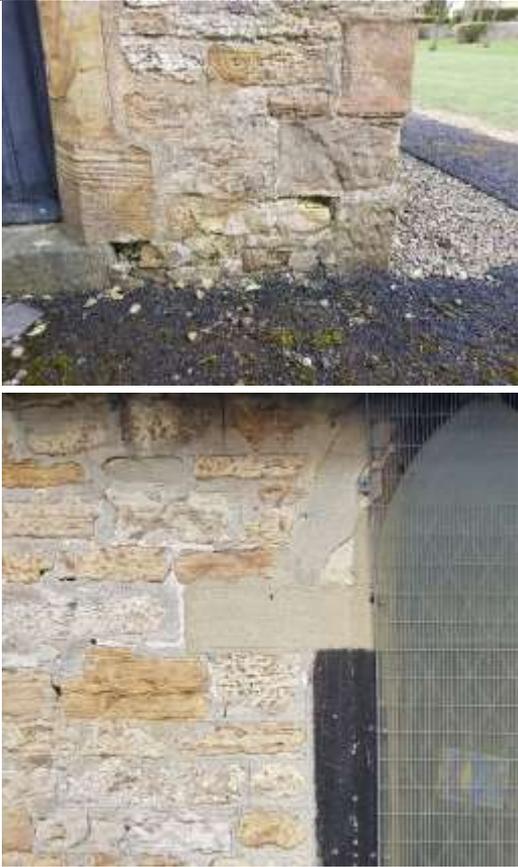
<p><b>Condition</b></p> <ul style="list-style-type: none"> <li>• Walls and pointing are generally sound, with some cracks or holes of missing pointing.</li> <li>• Some cracked/broken stones at low level.</li> <li>• Sandstone door surround has eroded particularly on the northern edge, and pointing is now sitting proud in some areas.</li> <li>• The cement render over the sandstone window surround has weathered and is missing / cracked in places and looks unsightly.</li> </ul>	
	<p><b>Repair Needs</b></p> <ul style="list-style-type: none"> <li>• Any broken stones or holes that are compromising the walls ability to shed water, such as adjacent to the vestry door, should be pointed with lime mortar – longer term PPC should consider stone replacement.</li> <li>• Any delaminated render to window surrounds should be knocked off.</li> </ul>	<p>C</p> <p>M</p>

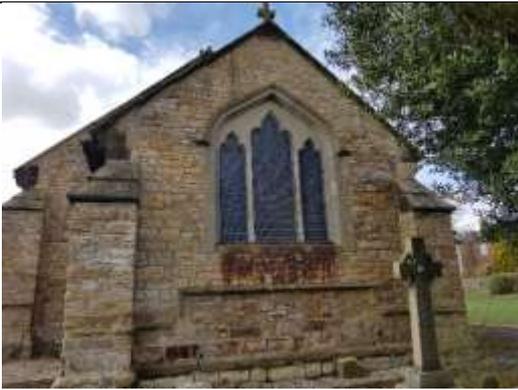
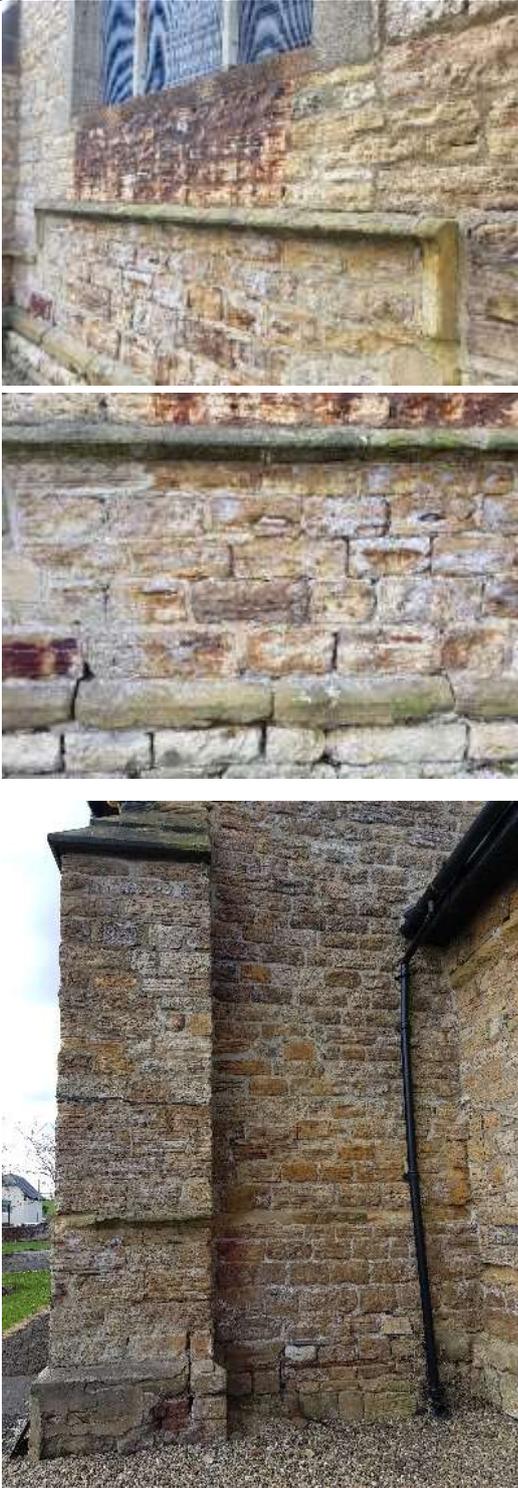
<p><b>Condition</b></p> <p><u>Chancel Gable</u></p> <ul style="list-style-type: none"> <li>• There is severe staining below the chancel window.</li> <li>• Pointing has weathered out in some locations at low level, below the string course.</li> <li>• There are a number of crazed stones, particularly at high level which are vulnerable to moisture penetration.</li> <li>• Some efflorescence present below string course.</li> </ul> <p><u>Nave Gable</u></p> <ul style="list-style-type: none"> <li>• Stone and pointing appears sound.</li> <li>• Sandstone string course is heavily eroded, with some sections eroded back to the face of the wall.</li> <li>• Some areas of pointing has weathered out at low level.</li> <li>• The buttress plinth has been rendered over previously which has now weathered and eroded with a broken stone.</li> </ul>	
	<p><b>Repair Needs</b></p> <ul style="list-style-type: none"> <li>• Repoint at low level. Using suitable lime mortar.</li> <li>• Suggest PPC consider a programme of spot stone replacement to corbels, dentils, string course etc along the lines of the replacement previously undertaken to the west gable.</li> </ul>	<p>D</p> <p>E</p>

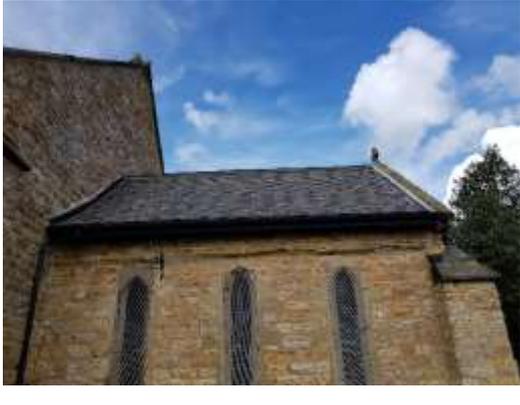
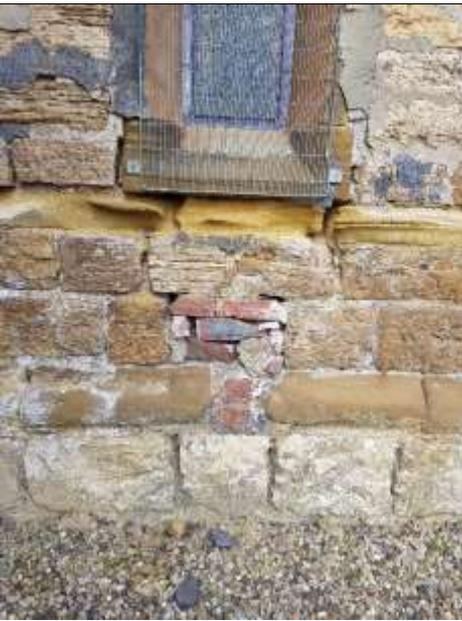
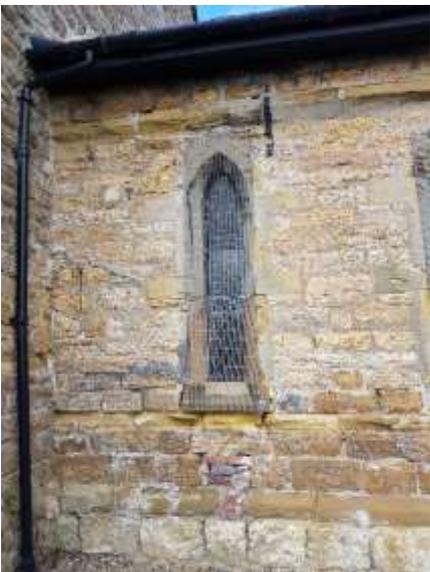
<p><b>Condition</b></p> <ul style="list-style-type: none"> <li>• The sandstone string &amp; corbel courses above and below the windows are heavily eroded, mostly back to the face of the wall.</li> <li>• Unsightly pointing which appears to be modern cement mortar is present, however appears sound above string course.</li> <li>• Missing or damaged stone has previously had a patch repair below window W10, with red brick. The pointing has now weathered out.</li> <li>• The cement render over the sandstone window surrounds have weathered and is missing / cracked in places and looks unsightly.</li> </ul>	
	<p><b>Repair Needs</b></p>

<ul style="list-style-type: none"> <li>• Suggest PPC consider a programme of spot stone replacement to corbels, dentils, string course etc along the lines of the replacement previously undertaken to the west gable.</li> <li>• Repoint at low level. Using suitable lime mortar.</li> <li>• Any delaminated render to window surrounds should be knocked off.</li> </ul>	<p>E</p> <p>D</p> <p>M</p>
--	---	----------------------------

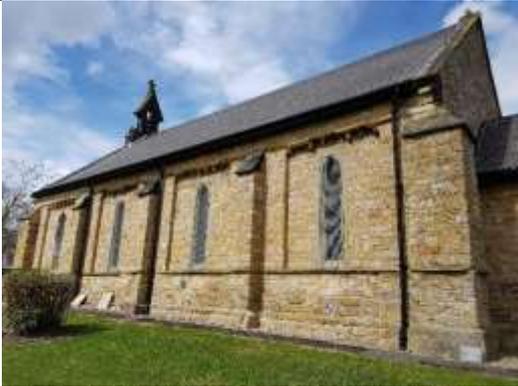
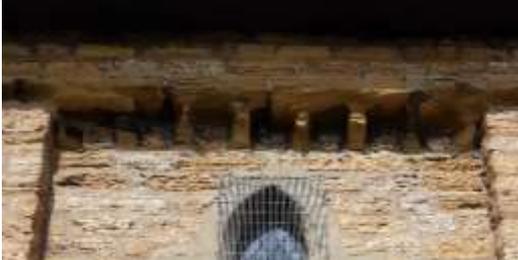
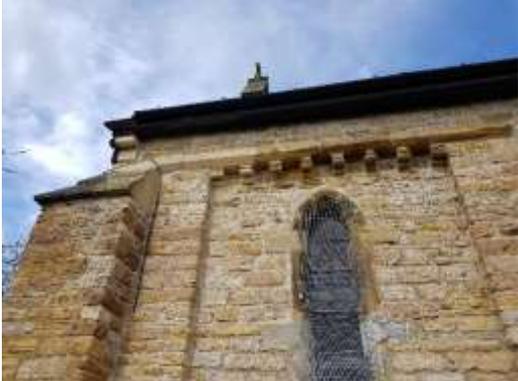
<p><b>Condition</b></p> <ul style="list-style-type: none"> <li>• Stone and pointing appear sound generally.</li> <li>• Both stone kneelers (east and west) and part of the stone corbel course to the west of the elevation has been replaced previously.</li> <li>• The remaining corbel courses above the window bays are extremely eroded.</li> <li>• The string course below the windows are also eroded to varying degrees across the elevation.</li> </ul>	
	<p><b>Repair Needs</b></p> <ul style="list-style-type: none"> <li>• Suggest PPC consider a programme of spot stone replacement to corbels, dentils, string course etc along the lines of the replacement previously undertaken to the west gable.</li> </ul>	<p>E</p>

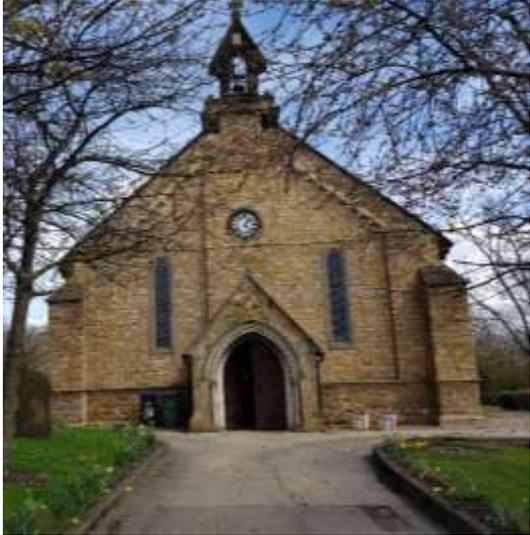
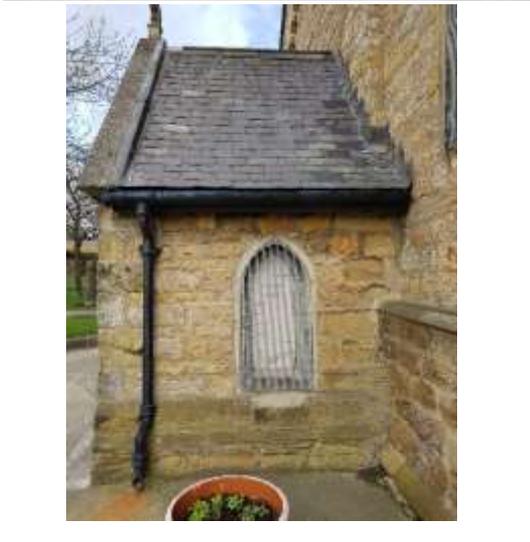
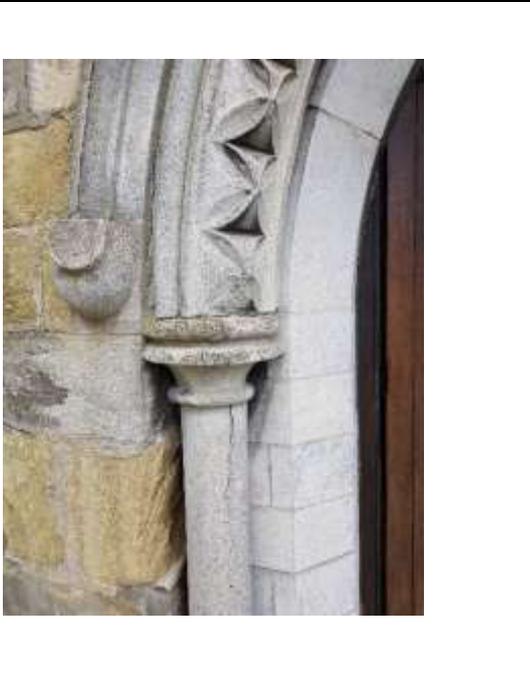
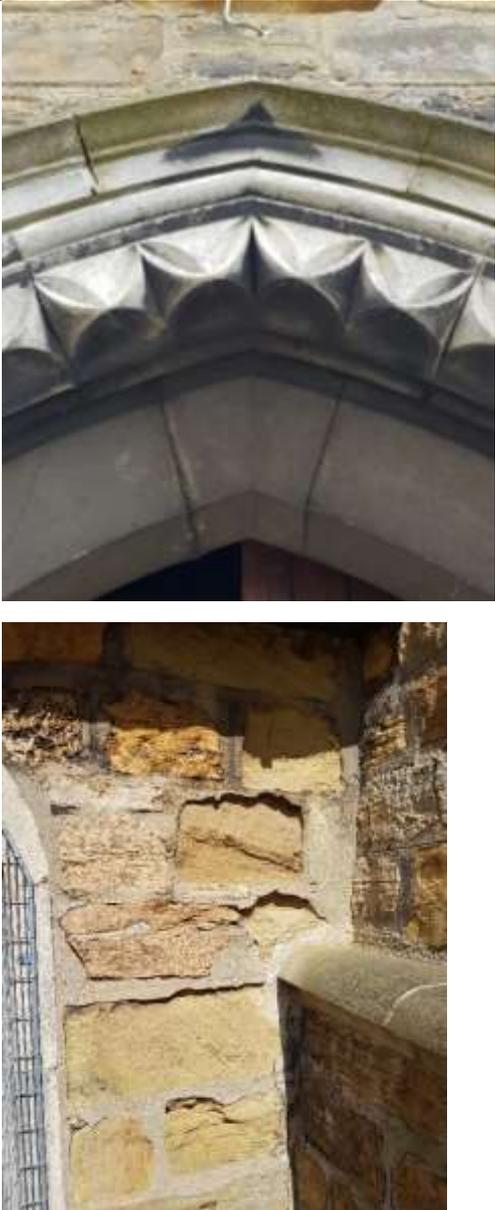
<p><b>Condition</b></p> <p><u>West Elevation</u></p> <ul style="list-style-type: none"> <li>• Walls and pointing appear sound.</li> <li>• The pointing over the stone window surrounds has weathered off in sections and is cracked.</li> <li>• Gable coping stones appear well bedded &amp; pointed.</li> <li>• The logbook indicates the clock was serviced in June 2017 and is displaying the correct time.</li> <li>• The sandstone apex belfry is heavily stained black, but appears sound. The last QQ report suggests there was repairs and repointing done in 2008.</li> </ul>

<p><u>Porch</u></p> <ul style="list-style-type: none"> <li>• The door surround has some blackened staining and movement cracks present on the northern side and at the top.</li> <li>• There is some delamination of the face of stone particularly on the southern elevation of the porch.</li> <li>• There is a particularly weathered stone behind the security light above the door arch.</li> <li>• Pointing to the porch gable coping stones has weathering out in places and cracked.</li> </ul>	
	<p><b>Repair Needs</b></p> <ul style="list-style-type: none"> <li>• Monitor cracking to arched door surround.</li> <li>• Repointing to porch gable corbel stones required and open joint at top of arch surround, using a suitable lime mortar.</li> <li>• Any delaminated render to window surrounds should be knocked off.</li> <li>• Consider pointing the hole in the stone behind the light fitting to the porch to avoid water ingress.</li> </ul>	<p>M D M D</p>

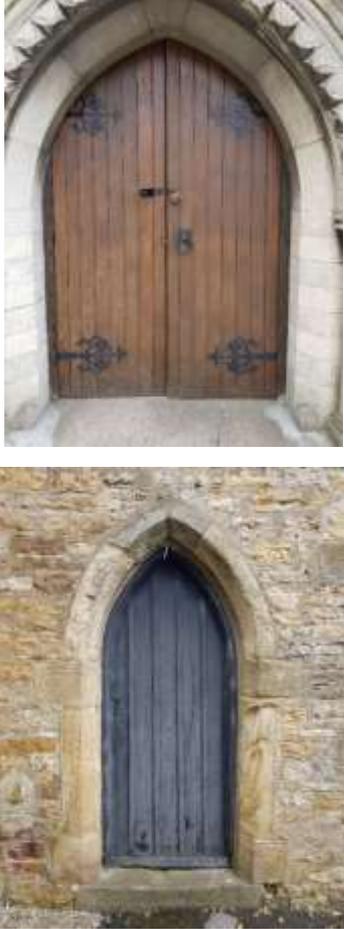
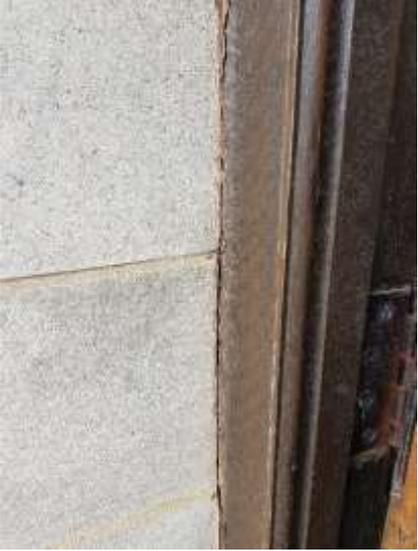
<p><b>Condition</b></p> <ul style="list-style-type: none"> <li>• The Main entrance door (D1) is in good condition.</li> <li>• The silicone sealant between the door frame and the stone surround has deteriorated.</li> <li>• The Vestry door (D2) is in reasonable condition, however the paint is beginning to deteriorate at low level.</li> </ul>

<p><b>Repair Needs</b></p> <ul style="list-style-type: none"> <li>• The vestry door would benefit from repainting to prolong its lifespan and prevent water ingress, particularly as the door is blocked up internally. Any flaking paint should be removed first.</li> <li>• Silicone sealant around door frame to be replaced</li> </ul>	<p>D</p> <p>D</p>
--	--	-------------------

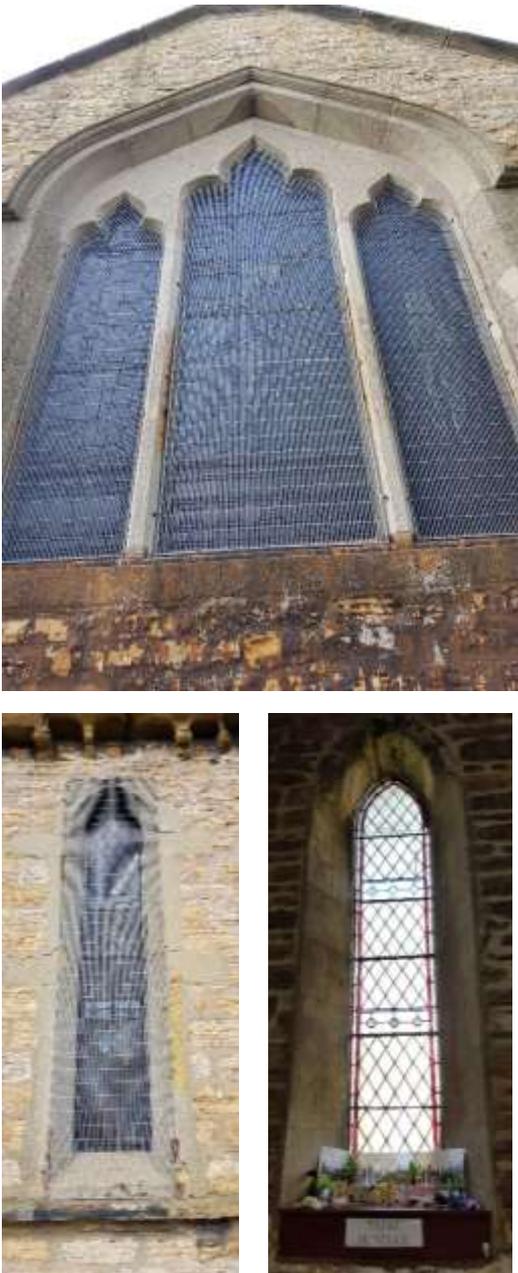
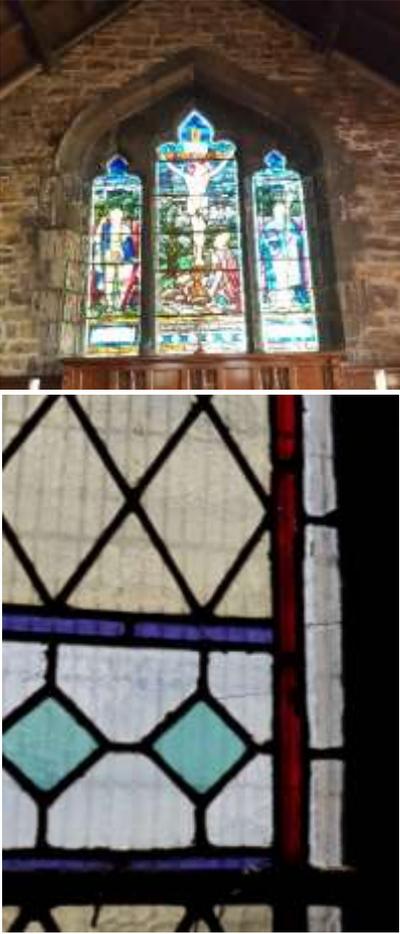
<p><b>Condition</b></p> <ul style="list-style-type: none"> <li>• Generally stone surrounds are sound although the rendered finish externally is weathering in places.</li> <li>• W7 on east elevation is in good condition, however the window surround has water staining internally.</li> <li>• W2, W3, W5, W9, W11 &amp; W13 appear to have some bulging of the glass panes in areas.</li> <li>• W4 &amp; W12 appear to have been replaced with plain leaded glass.</li> <li>• Windows W2, W3, W8, W9, W10, W11, W13 all appear to have had some replacement panes.</li> <li>• Windows W8, W9, W11, W15 appear to have fractured panes.</li> <li>• Window W6 was inaccessible internally as it is covered by the organ.</li> <li>• Window 14 was also inaccessible internally as it sits above the WC/Flower room.</li> <li>• The window in the vestry appears to be new leaded glass.</li> </ul>	
	<p><b>Repair Needs</b></p> <ul style="list-style-type: none"> <li>• Monitor staining to the East Gable window internally.</li> </ul>	<p>M</p>

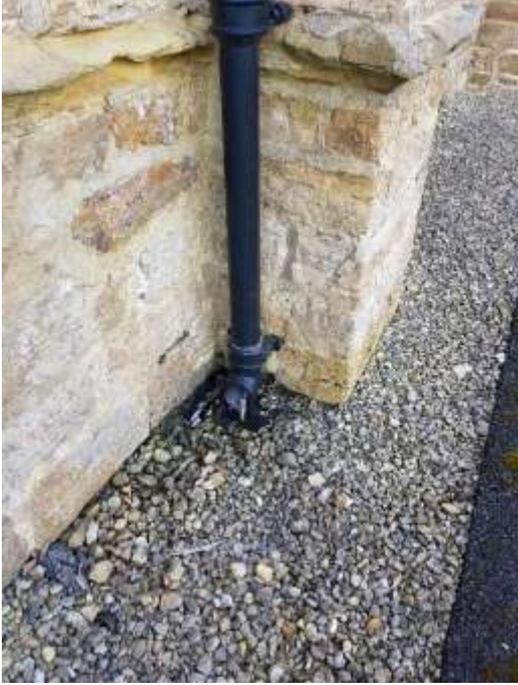
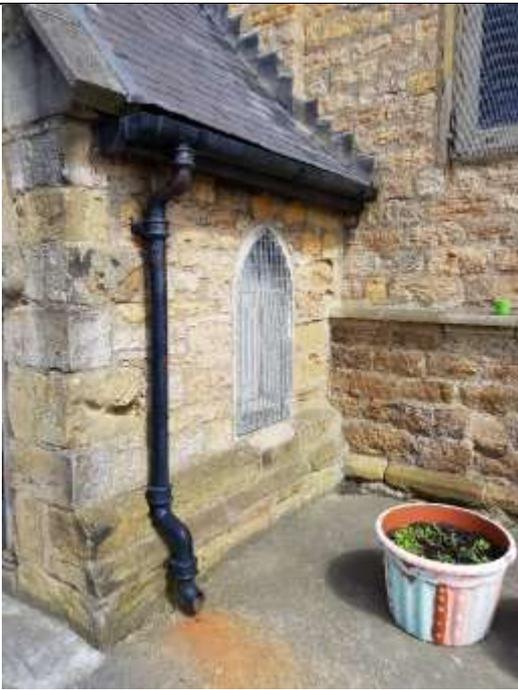
<p><b>Condition</b></p> <ul style="list-style-type: none"> <li>An inspection of the underground drainage was not carried out at this time, however appears to be operating effectively.</li> <li>Gulleys at ground level appear to be clear and free from debris.</li> <li>The downpipe to the North West corner of the Nave does not appear to be discharging into a gully, has the gully been covered over with gravel / debris?</li> <li>Downpipes to entrance porch are discharging directly onto concrete pavement, causing staining to pavement. Water discharging onto the pavement can cause a slip hazard in freezing weather</li> </ul>

<p><b>Repair Needs</b></p> <ul style="list-style-type: none"> <li>Investigate the gully to the North West corner of the Nave and clear out gravel / debris.</li> <li>PCC to ensure use of grit to areas around porch in freezing weather to reduce slip hazard.</li> </ul>	<p>M</p> <p>M</p>

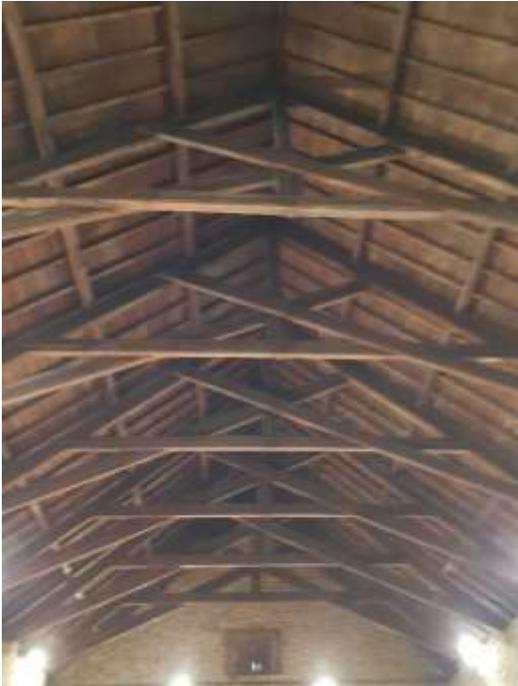
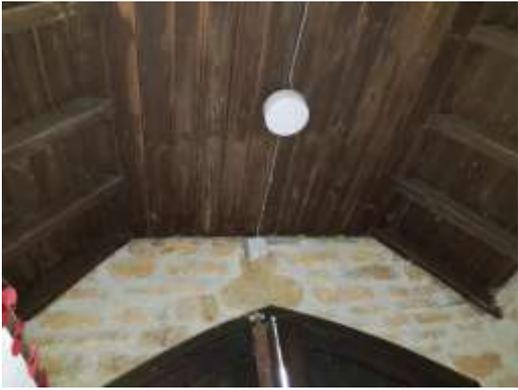
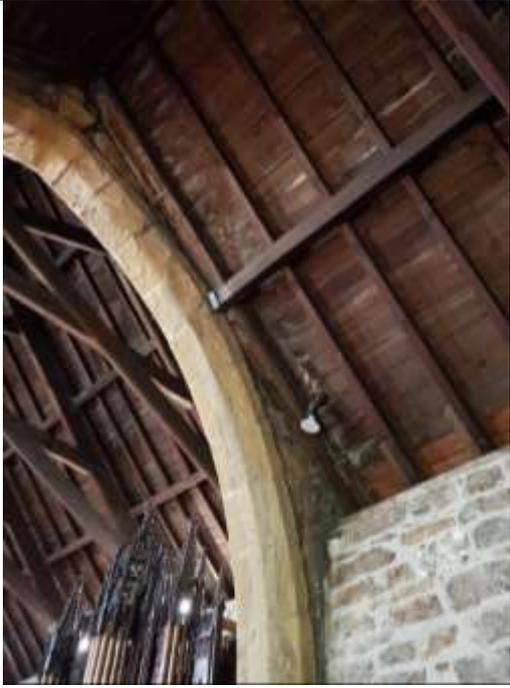
<p><b>Condition</b></p> <ul style="list-style-type: none"> <li>• The timber sarking boards forming the ceilings in the chancel and nave appear sound, with some old water staining near the arch in the chancel.</li> <li>• The lathe and plaster ceiling in the vestry appears sound, although uneven.</li> <li>• Plasterboard ceilings are in good condition.</li> </ul>	
	<p><b>Repair Needs</b></p> <ul style="list-style-type: none"> <li>• Monitor staining around the arch junction between Chancel &amp; Nave.</li> </ul>	<p>M</p>

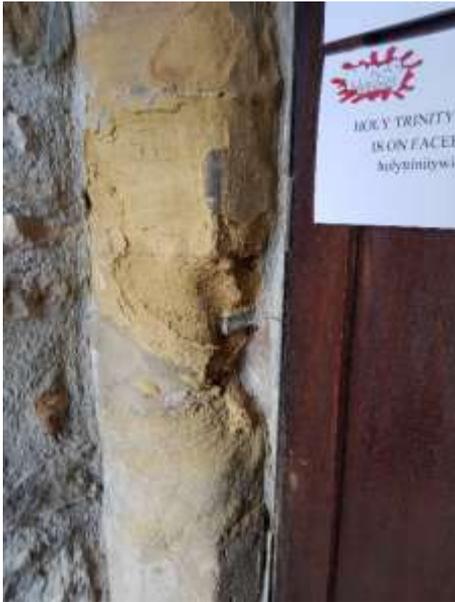
Porch

- The internal stone walls generally appear to be in good condition.
- The stone surround to the inner door in the porch is damp and decayed in places.
- There is efflorescence present on the lower parts of the north wall in the Nave, particularly thick above the timber panelling.
- The stone arch between the chancel and the nave appears to be in reasonable condition at high level, with efflorescence and some delamination of the stone present at low level.
- There is efflorescence present on the stone at high level above the Chancel / Nave arch.
- There is efflorescence present to the east wall of the Chancel.

<p><b>Repair Needs</b></p> <ul style="list-style-type: none"> <li>• Brush off the worst of the efflorescence and monitor the area for reappearance.</li> </ul>	<p>M</p>
--	--	----------

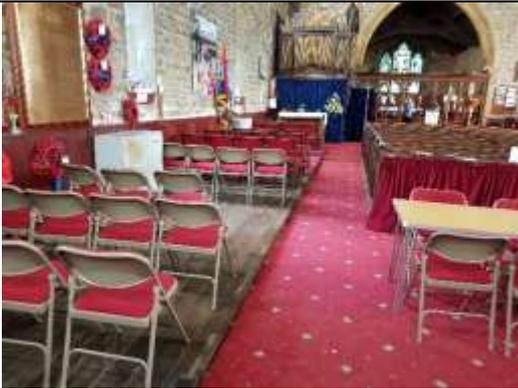
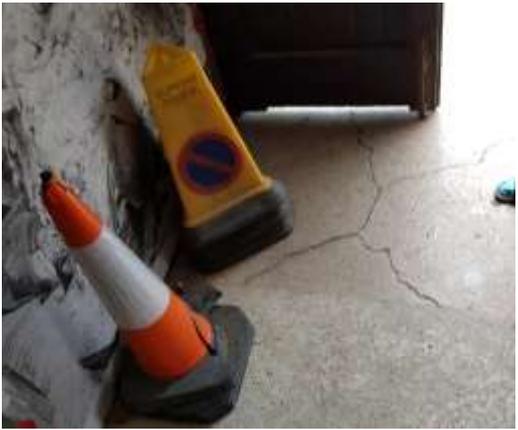
<p><b>Condition</b></p> <ul style="list-style-type: none"> <li>• Floors generally appear sound throughout the Nave &amp; Chancel</li> <li>• Concrete floor to the entrance porch is cracked and slightly uneven.</li> <li>• Floor finishes are in good condition.</li> </ul>

<p><b>Repair Needs</b></p> <ul style="list-style-type: none"> <li>• The cracked and uneven floor to the porch could be considered as part of the external resurfacing works, if necessary.</li> </ul>

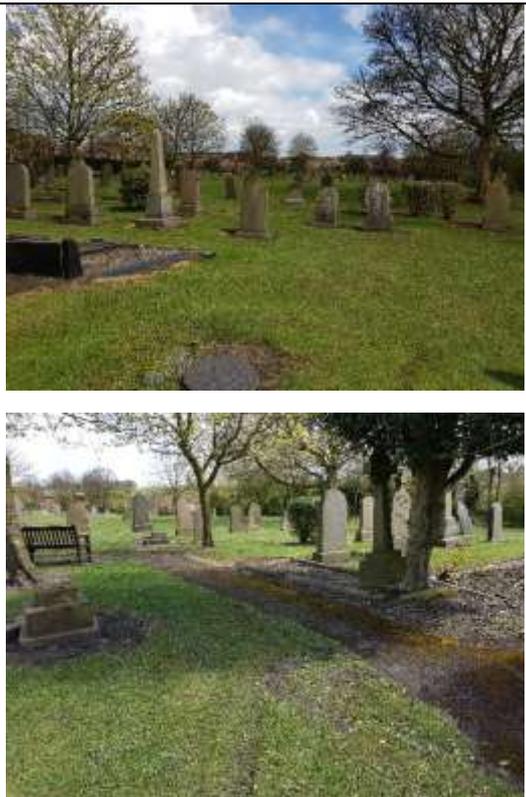
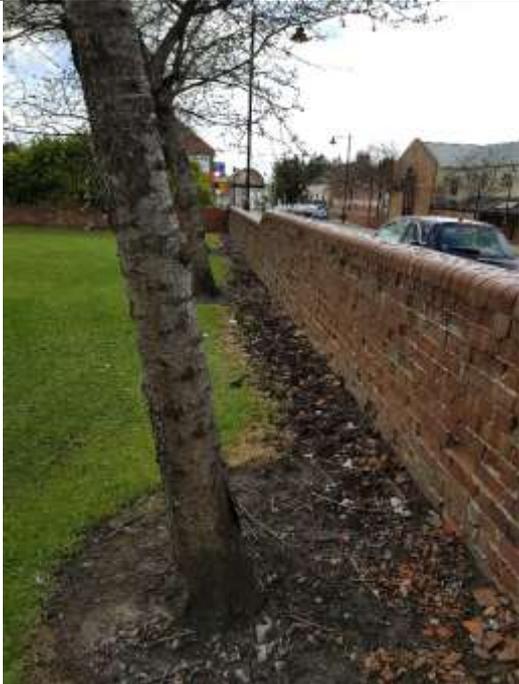
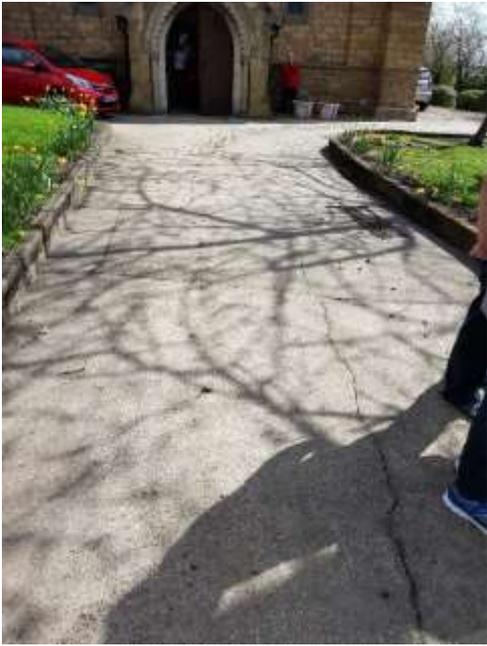
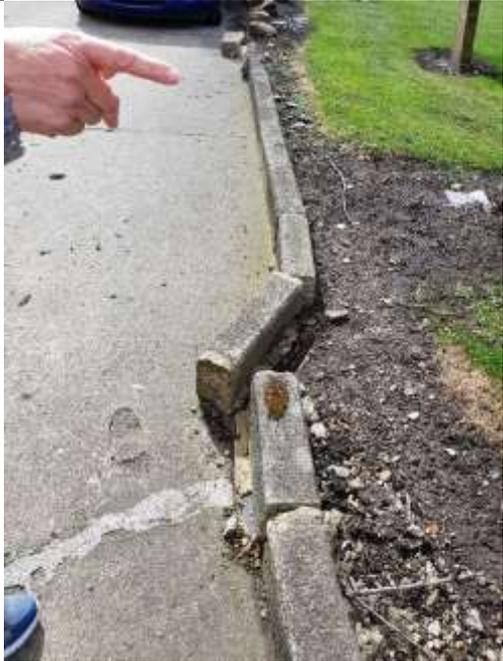
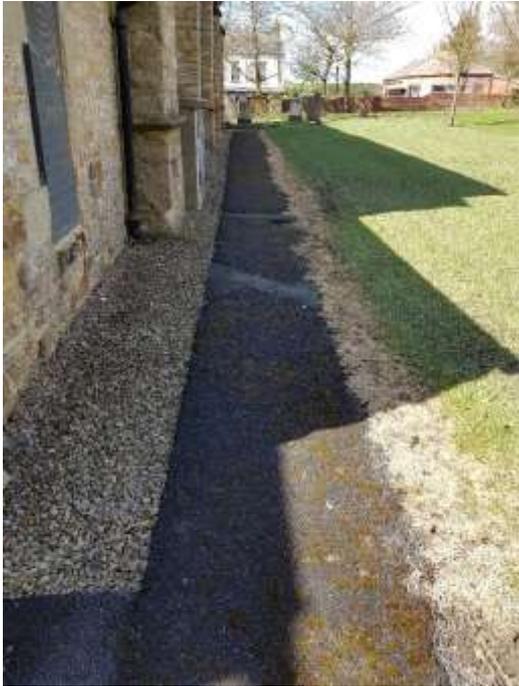
<p><b>Condition</b></p> <ul style="list-style-type: none"> <li>• The concrete drive is in poor condition, there are numerous cracks and damaged patches.</li> <li>• The concrete kerbs along the drive are damaged and have been knocked out of place in areas.</li> <li>• Tarmac paths do not have pin kerb edges which has resulted in the grass creeping onto path</li> <li>• Paths are uneven, loose and have moss growth on them.</li> <li>• Face of brickwork boundary wall (west), is delaminating on the churchyard side of the wall.</li> <li>• Stone boundary wall (south) is leaning slightly inwards.</li> <li>• Timber fences appear sound.</li> </ul>

<p><b>Repair Needs</b></p> <ul style="list-style-type: none"> <li>• A separate report will be produced for the hand standing.</li> <li>• Monitor the delamination of the brick face to the west boundary wall.</li> <li>• Monitor the southern stone boundary wall for any further movement.</li> </ul>	<p>M</p> <p>M</p>
