**QUINQUENNIAL INSPECTION REPORT
OF
WINSTON, ST. ANDREW**

**DIOCESE OF DURHAM
ARCHDEACONRY OF AUCKLAND
DEANERY OF BARNARD CASTLE**

QUINQUENNIAL INSPECTION AND REPORT

August 2023 Rev A

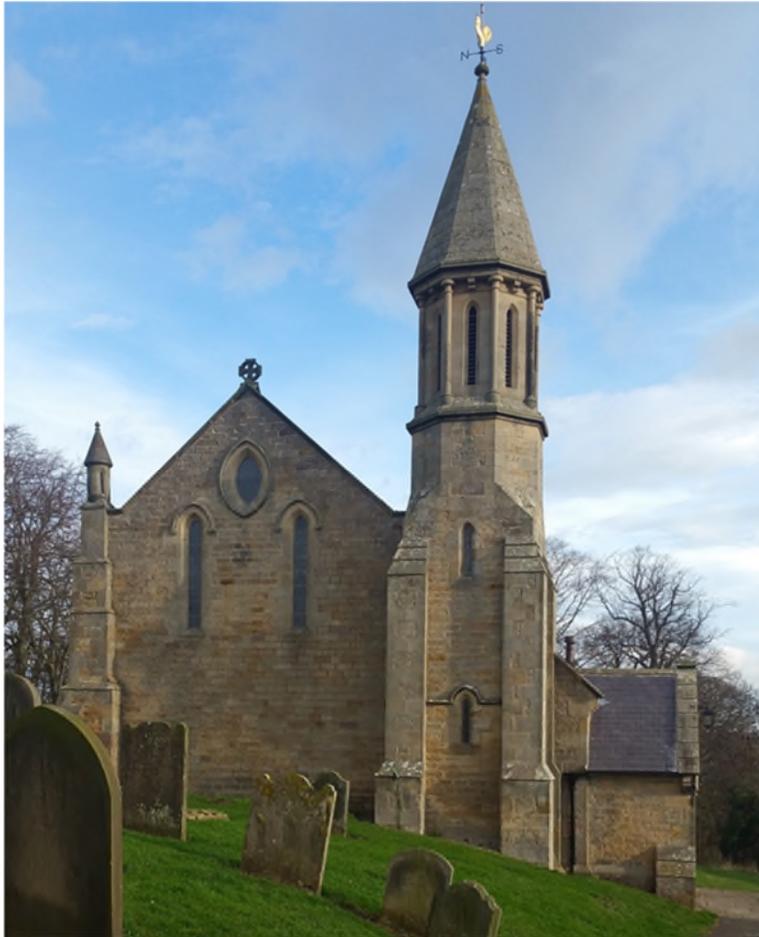
The tower is made up of three elements its roof, belfry, and the body of the tower.

Octagonal ashlar stonework topped with a button finial and cockerel and weathervane. Slight open joints at the sloping corners of the stones. Below that, octagonal belfry with circular columns at the corners and it looks like there may have been replacement shaft elements in the past, but it all looks sound now, the walling of the belfry is rather big units and there are few joints on it that looks ok and within the openings are slate louvres that look ok. At the base of the columns is a sloping stringcourse running round and I suspect open joints on the sky facing surface.

Recommendation: monitor

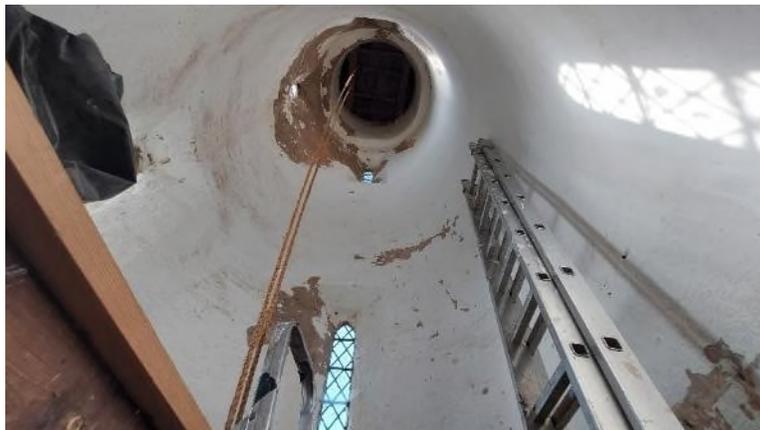
Circular tower inside, limewash painted, coming away, was plastered as well, looks like there is quite a bit of a breakdown on the south side upper window, pair of ropes leading to how many bells, just the one? And there is a deck below that, it is very difficult almost impossible to gain access up there, the ladder is just too vertical to try and get up. And the bottom of the tower is a collection of bits and bobs fouling positioning the ladder.

The tower has bead boarded battened door which is all ok.

Recommendation: tidy up base of tower. Have the top inspected by steeplejack (perhaps same time as lightning conductor inspection?)

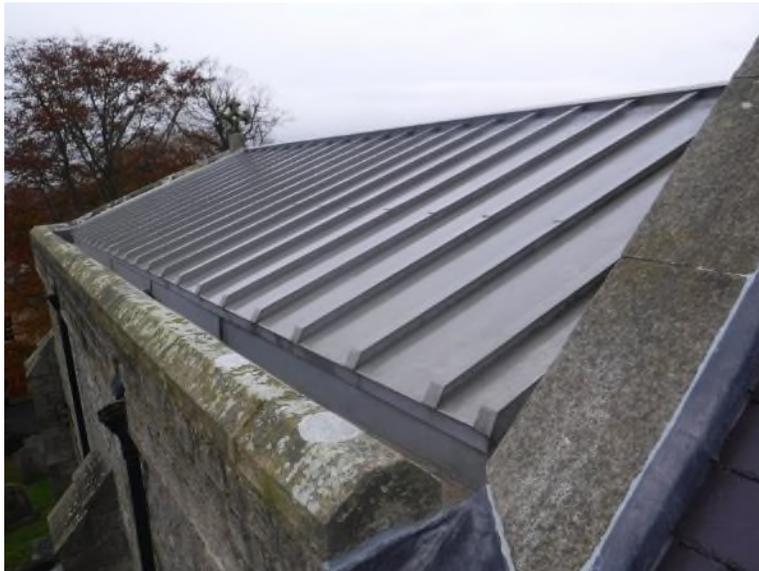
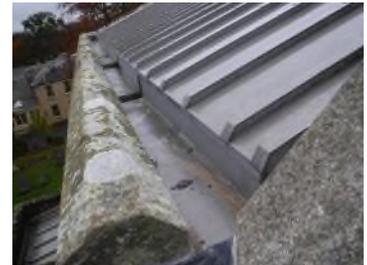
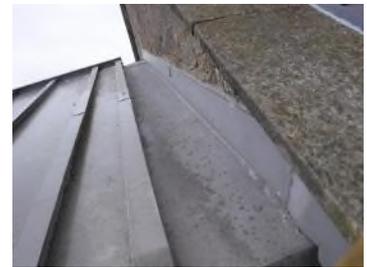
Chancel:

Recovered in 2018 with terne coated stainless steel on new sarking and insulation to lead parapet gutters, not able to be seen from the ground but the north side was seen on the 2020 works and appeared ok.

Recommendation: none

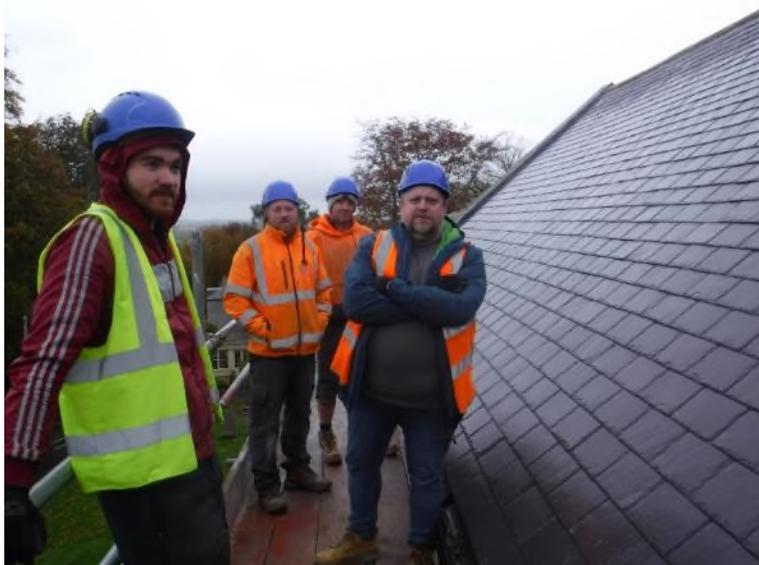
B Nave:

Re-slatted in 2020 in new Welsh slate on new roofing felt, no insulation was able to be added as the plaster ceiling is fixed straight to the underside of the slating battens and there wasn't an economic way of achieving this. Re-bedded ridges all look ok.

There is a possible problem in the nave south side junction to the tower buttress. It was remade as it was originally shaped but its performance suggests that it should be bigger (or its clogged up). Ranson Roofing has been asked to revisit to check over the gutter.

Recommendation: Ranson to check gutter condition

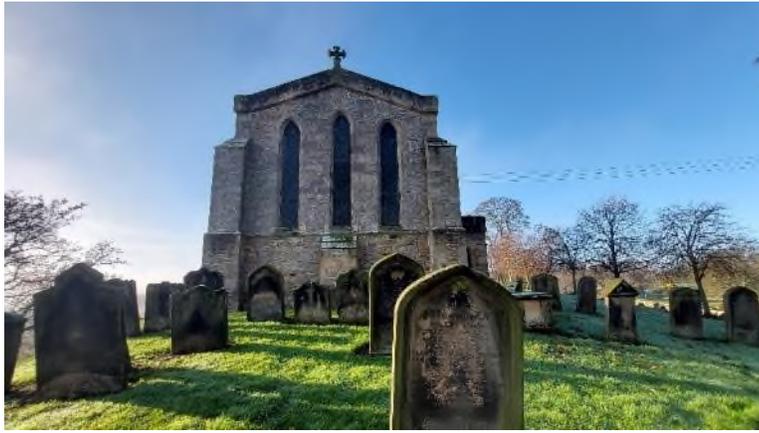
East side – The 2018 repair works have corrected the open joints and movement apparent to the tops of the windows and the oversailing raking parapet, it all looks tight now. The bottom stage of the walling was repointed, the upper stage where the windows are was left as it was, that is in cement and there is some slight hairline cracking showing at the apex of the arches, but this is due to the cement and seasonal movement, I think. The buttresses here look sound.

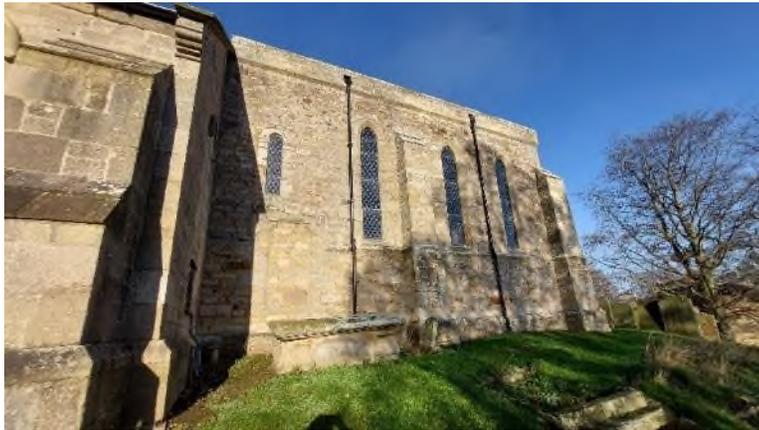
South side – The parapet was repointed in 2018 and looks ok, there is also an area of repoint up to the south aisle by the south door that is fine, the unpointed areas in the upper stage look ok, slight hairline cracking of the south east buttress and one stone breaking out between the window and downpipe I think this is cement again, there is some cracking which looks the same as the last QI on the penultimate window to the eastern end beside the downpipe but I don't think that needs any action yet, interestingly the downpipe here is just dripping into the ground, the buttresses here look ok.

Recommendation: none

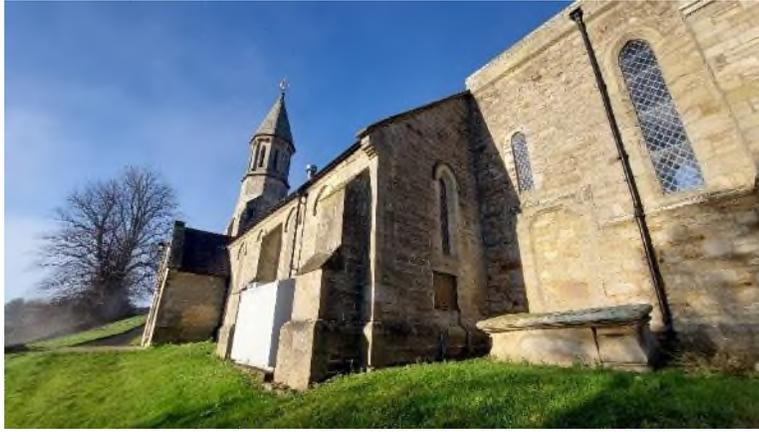
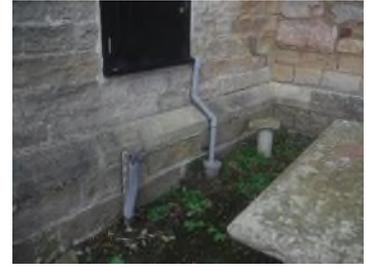
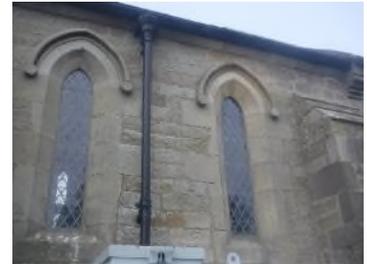
South Aisle:

East End – Watertable has been reset on leadwork and that is ok, slight bit of pointing dropping out I think just at the junction of the parapet off the chancel but not needing attention. General walling is sound.

South side – Minor open joints on the chamfered corbel under the gutters, walling generally though is sound some slight fracture stress cracks in the past but no problem now. Buttresses are ok.

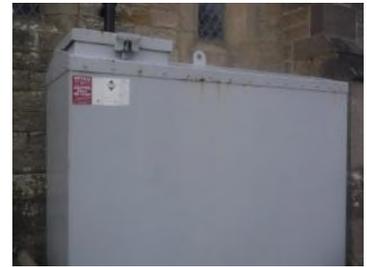
The oil tank restricts access to the walling and the paintwork is rusting now. Metal grills below the floor are rusting wide open bars and so something could get in there.

Recommendation: repair air grates

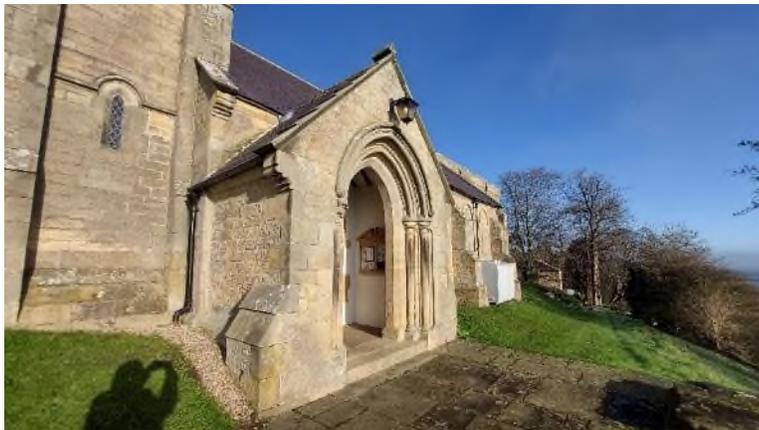
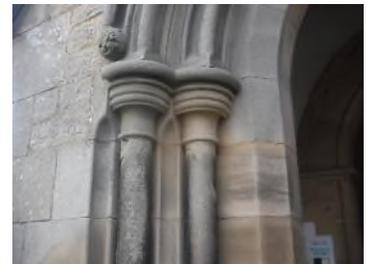
Porch:

East side – OK.

South side – Rebated watertable looks ok, some slight cracking to the open joints on the west side where the buttress is tilted slightly.

Recommendation: none

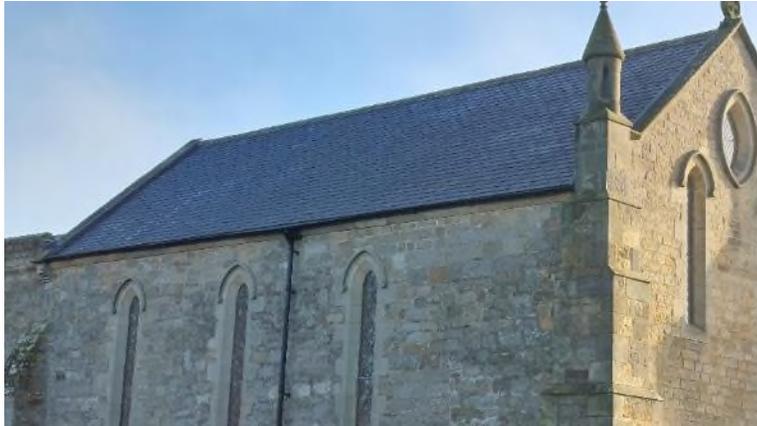
North side – Over sailing chamfered corbels gutter support ok, walling cement pointed ok, at the lower part there is two obvious areas where the stonework inexplicably is reddish and looks damp has there been fires here in the past? It doesn't seem to make sense, there has been a walled in north door entrance in the past and there is some remnant stones built-in so it is a bit higgledy-piggledy, it was repointed in 2018 but it is not clear what the problem is it might be the ground drainage perhaps. There has been damp showing inside above the dado panelling. Slight hole to part of the wall at the junction with the chancel at low level, buttress looks ok.

Recommendation: repoint nw buttress junction to walling. Point up chancel hole.

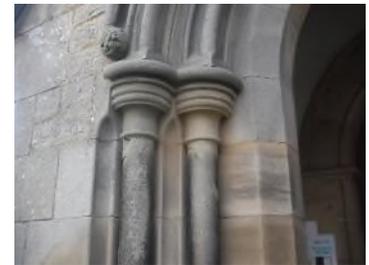
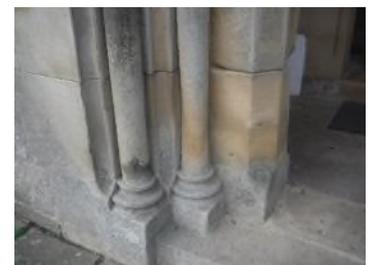
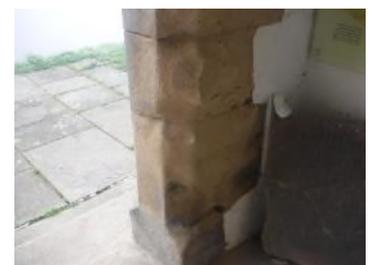
The porch entrance features two nook shafts supporting roll moulded orders and within that a chamfered door recess, some movement to the arch on the western side and that should be repointed just so we can use it as a crack monitor. Some shear cracking to the nook shafts on the western side and the inner most is wasting away a bit probably due to wind erosion. The inside of the arch has more erosion to the western side.

Recommendation: repoint west side of arch.

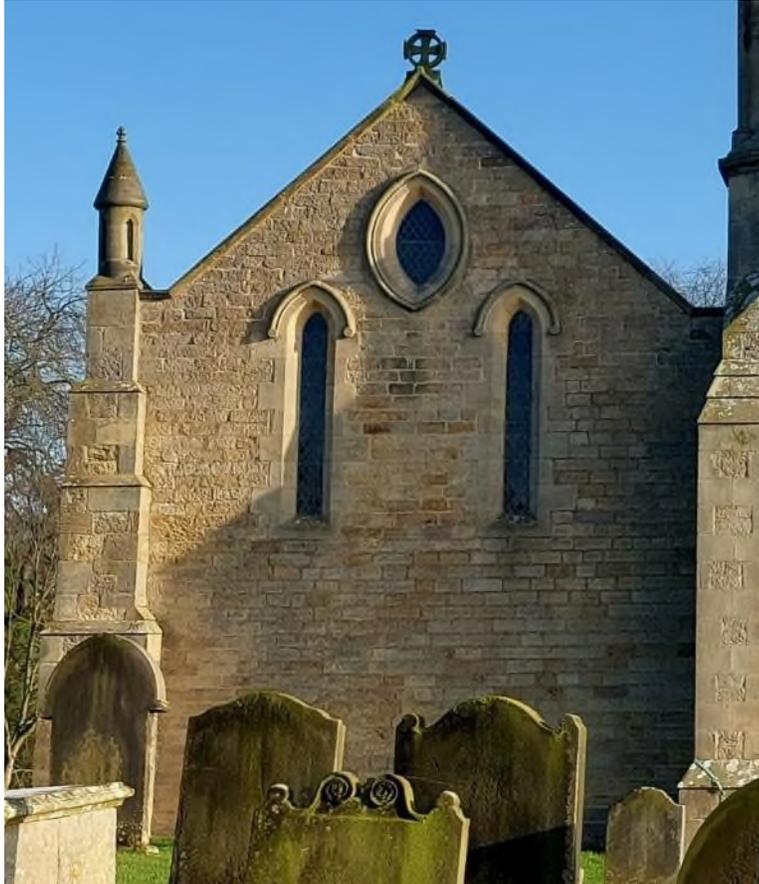
West gable – A pair of single lancets either side of a vesica window and these are ok.

All of the glass has been cement pointed in.

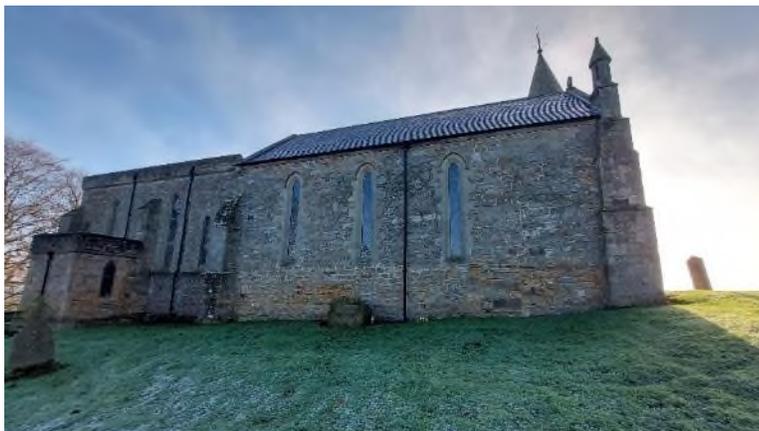
North side – Three tall Victorian style windows, same pattern as the south aisle, some slight open joints to the eastern most at the arch and perhaps the hoodmould of the middle as well.

Recommendation: none

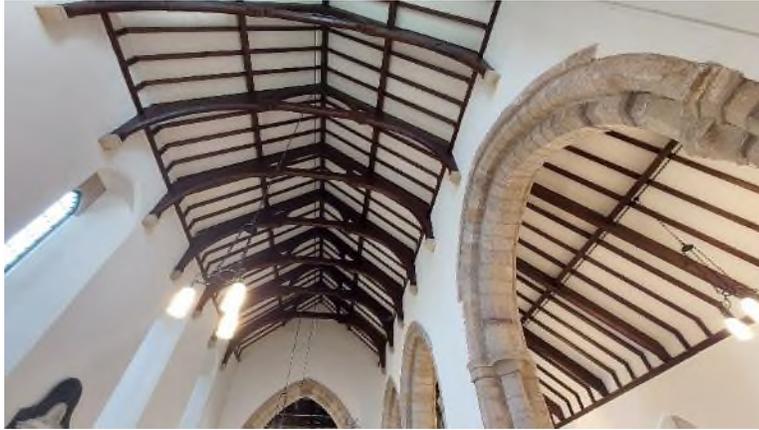
Nave:

Seven trusses of a steeper pitch and these bear onto the wall plate and have down stand struts off stone corbels all of these are sound, the rafters are visible, and these are all ok, some were repaired or replaced as part of the 2020 works.

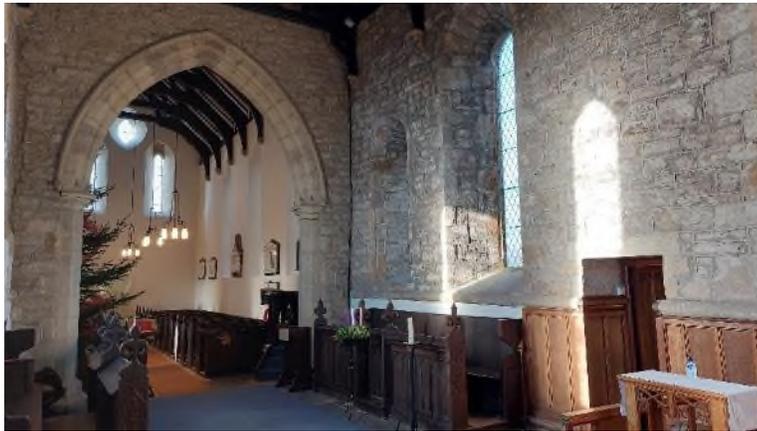
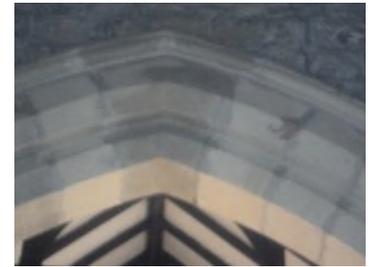
- **Chancel Arch:**

Lancet angled there is an open joint to the keystone on the north side approximately 3mm looks as if this has been pointed up in the past . The respond columns come down to octagonal bases and those all look good.

Recommendation: none

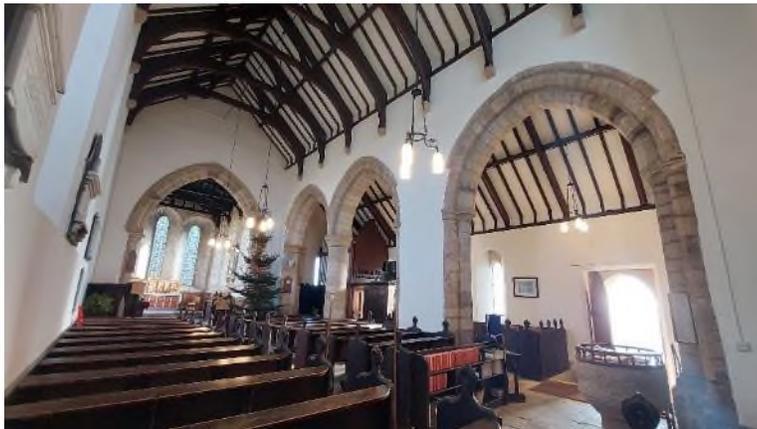
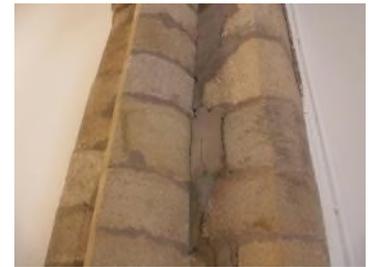
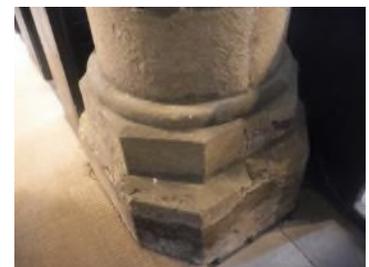
- **Arcades:**

Arcade separating the nave and the aisle, it is made up of three arches one of which is separated by a larger panel of walling rather than a column. The twin arcade arches are all good, supported centrally by a circular column down to a two-stage octagonal base, cement pointed but looks good and the arcade arches are chamfer moulded and come down to keel moulded responds. The outer moulding of the arch stops abruptly, it doesn't terminate on a springing line it stops on the central arch junction.

Single chamfered arch by the porch looks good with keel moulded responds that are ok, there is some slight cracking to the west end where it seems almost as if the abutment of the wall is coming apart but this, I think is probably because of the brittle cement, and it is probably shrinkage and that really should

be raked out and turned into lime pointed when there are other repairs to do.

Recommendation: none

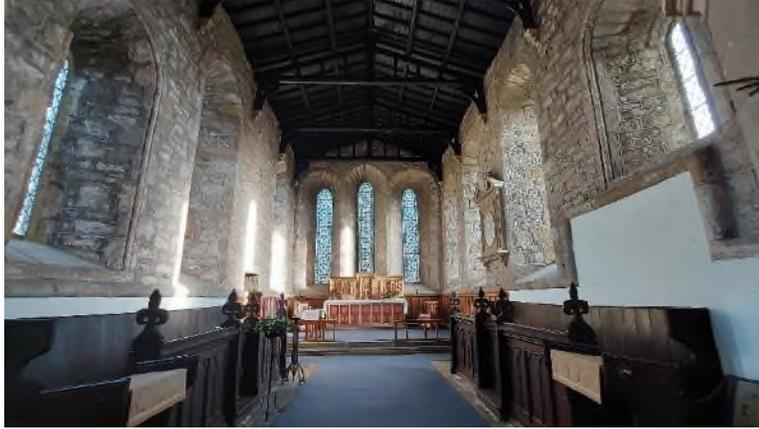
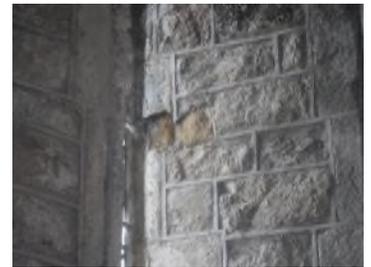
Chancel:

Exposed coursed squared random stonework, unfortunately has been strap pointed in cement and this brittle material is cracking in places. It is grey and smeared over some of the stones as well which is a disappointment, it really is a poor finish to the church. One area where the stone is shaleing slightly, is the south side western most high-level window above the blocked-in doorway as a consequence of a metal saddle bar rusting. There is also a large open joint at the south eastern most chancel east gable window sloping cill and roll moulding above the dado.

Recommendation: none

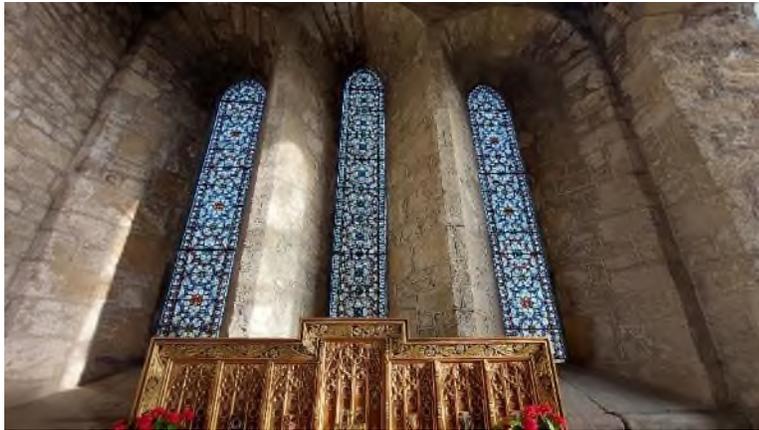
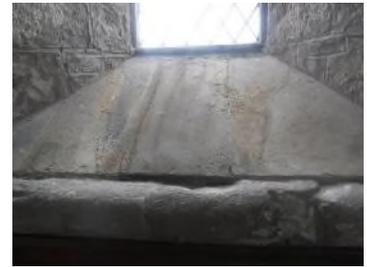
It is a very light interior as the majority of the glass is clear, there is coloured patterned glass at the east end in grisaille pattern and the remainder is clear glazing with diamond comes. There is condensation on all of the glass, and it doesn't have the cills don't have the Victorian benefit of condensation troughs and vent holes.

In the chancel at the cills there is some embedded metal frame restricting the chance for introducing that and their cementing in to the wall opening feels rather stringent, there is nothing much in the way of breaking of stonework through rusting saddlebars apart from the previously mentioned in the chancel and it is all reasonably sound.

Recommendation: consider adding ventilators

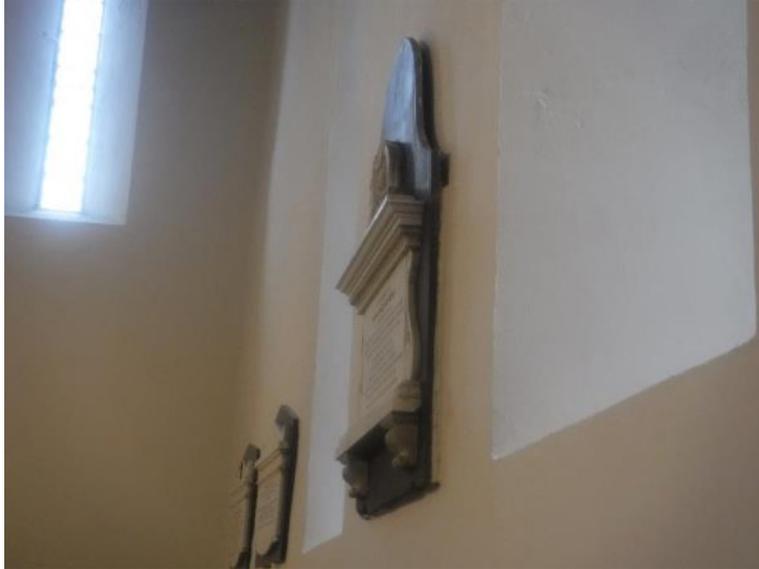
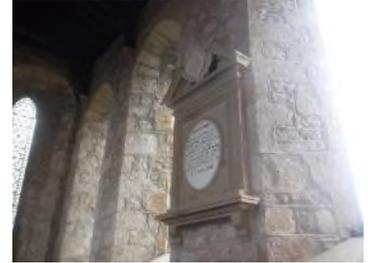
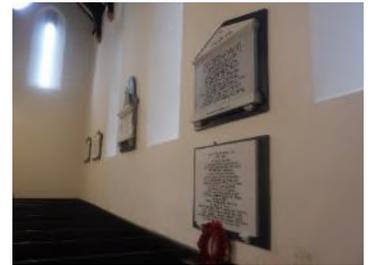
C Monuments:

There are ledger stones set into the chancel floor and nave, three of which have brass inserts. In the chancel on the south side is a classically detailed wall mounted monument to the Lancaster family.

In the nave on the north wall are five similarly styled wall tablets of black backgrounds with marble tablets, the central one to John Borne looks to be coming adrift from the wall it should be tested for stability, there is a crack to one of the support irons on the righthand side by the inscription of its maker which is possibly Ward B of York, there is also some white marking to the top of the tablet, was that caused by the decoration works?

Recommendation: check stability of John Borne monument (I suggest David France, stonemason)

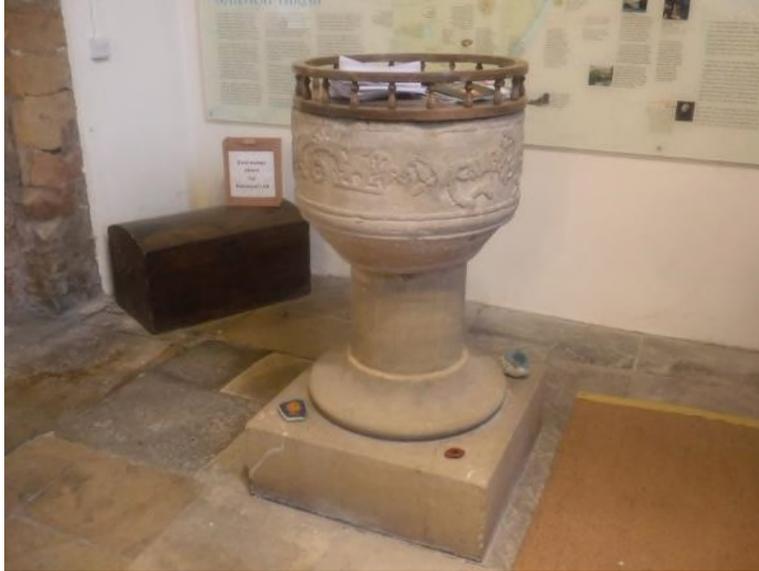
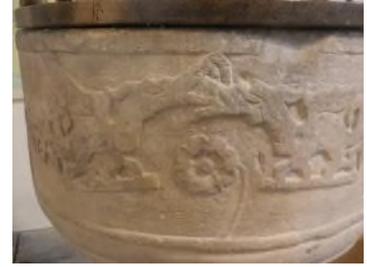
Font:

Circular font with timber galleried cover with a bit of woodworm to it (old?). Lead font liner with cork bottle top plug stopper. The pedestal base was loose and refixed by David France in 2020.

Recommendation: check cover for recent woodworm

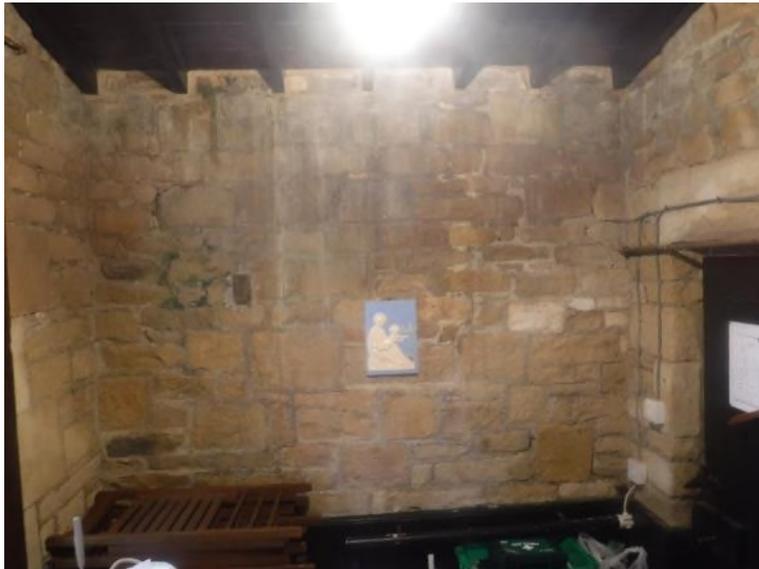
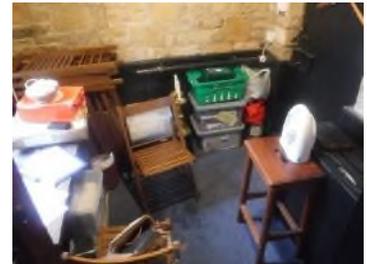
C **Vestry:**

Ceiling – Redecorated and repaired ceiling same style as the aisle.

Walls – Exposed stonework evidence of previous watermarking on the north side when the gutter failed, dado panelling at low level. Some damp showing on the western side probably as a result of poor pointing, I think.

Recommendation: tidy up and reduce draughts

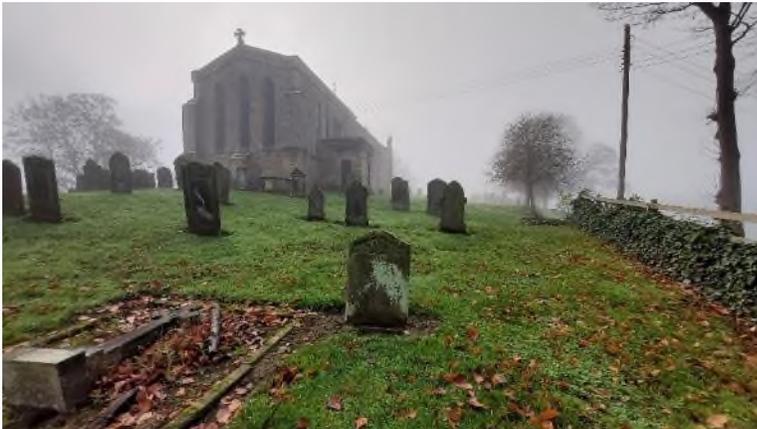
South – Stone boundary wall which contains the full height of the churchyard, has some holes in the stonework and leaning outwards along the majority of its length where some trees are giving it some assistance it might well be wise to check its condition.

Recommendation: south- check condition, west- assess impact of rusting railings on stonework, east- check ownership and maintenance responsibilities

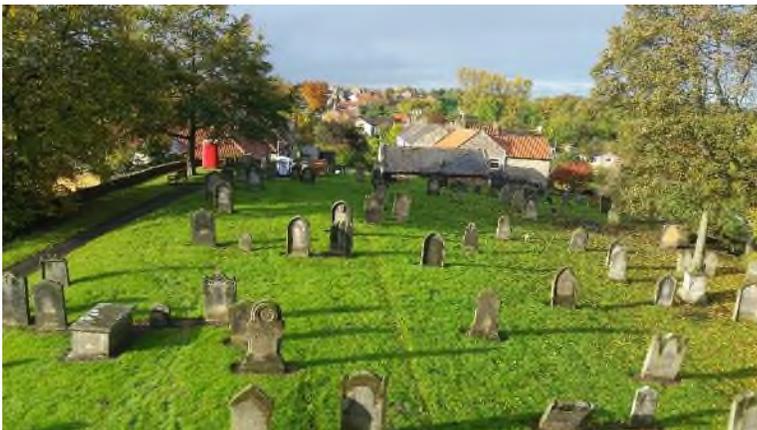
West – Metal railings on a stone wall and the rails are rusting and bursting the stone pier tops, the remainder of the boundary at

the north end is made up of the adjoining owners' garage which retains the churchyard.

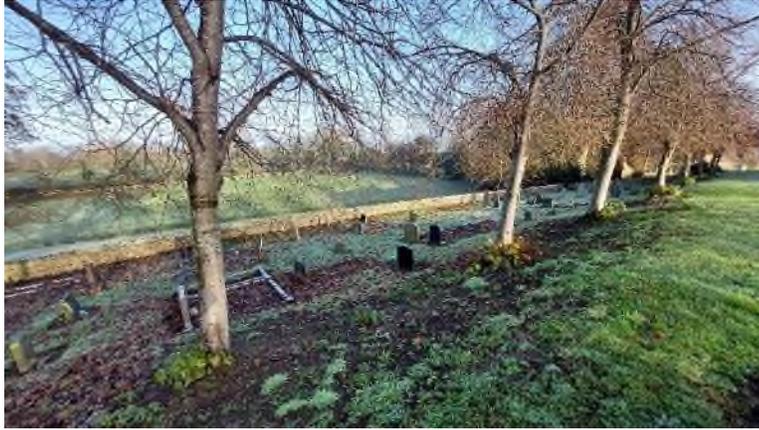
North – Stone boundary wall in good condition.

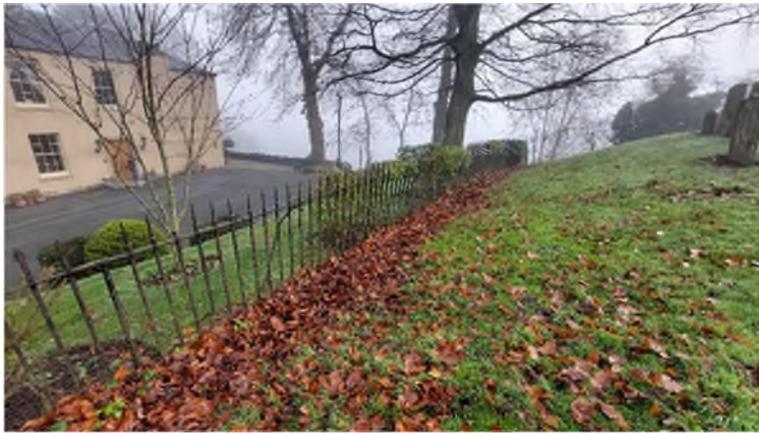
East – In the ownership of the adjoining house? The iron balustrade is set into a low stone wall, and it is rusting and coming apart.
