QUINQUENNIAL INSPECTION REPORT OF

ST. MARY, BLACKHILLS ROAD, HORDEN, SR8 4LJ

CARE OF CHURCHES & ECCLESIASTICAL JURISDICTION MEASURE 1991QUINQUENNIAL INSPECTION AND REPORT

DATE JULY 2021

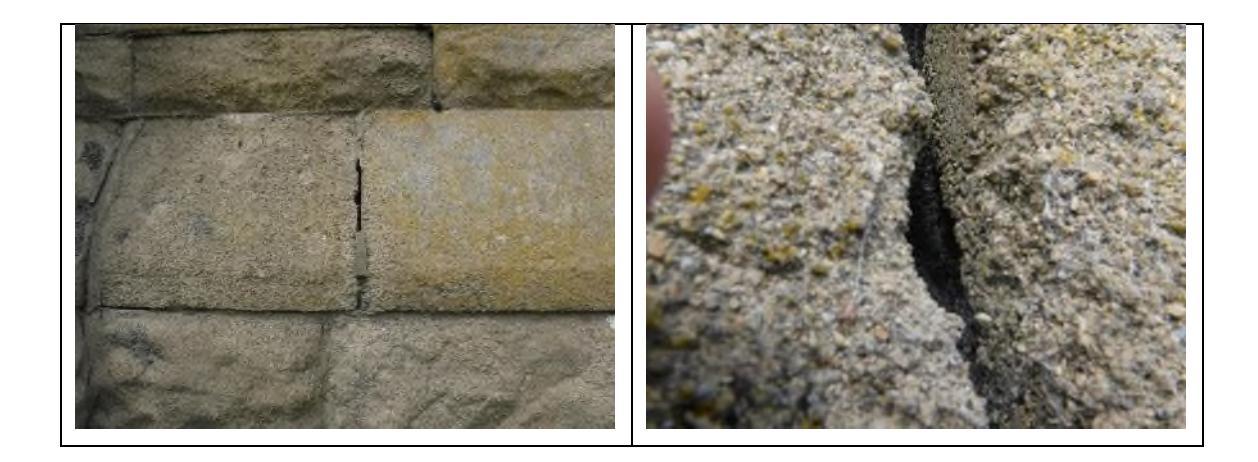
There is compelling evidence that this is exactly what is happening at sloping units at the tower, under the clerestory windows, where their cills are made of stacked sloping units and there is a major salting inside.

There's a question mark over how corners are formed - with an adequate bond or butted together? It also seems that the major pointing failure is on the sloping units and it may be these that need more attention than the general walling.

An investigation into the cast stone construction is recommended and this will help inform future repairs. There will also be a need to understand how to repair eroding stones or whether they are replaced and if so, with what.

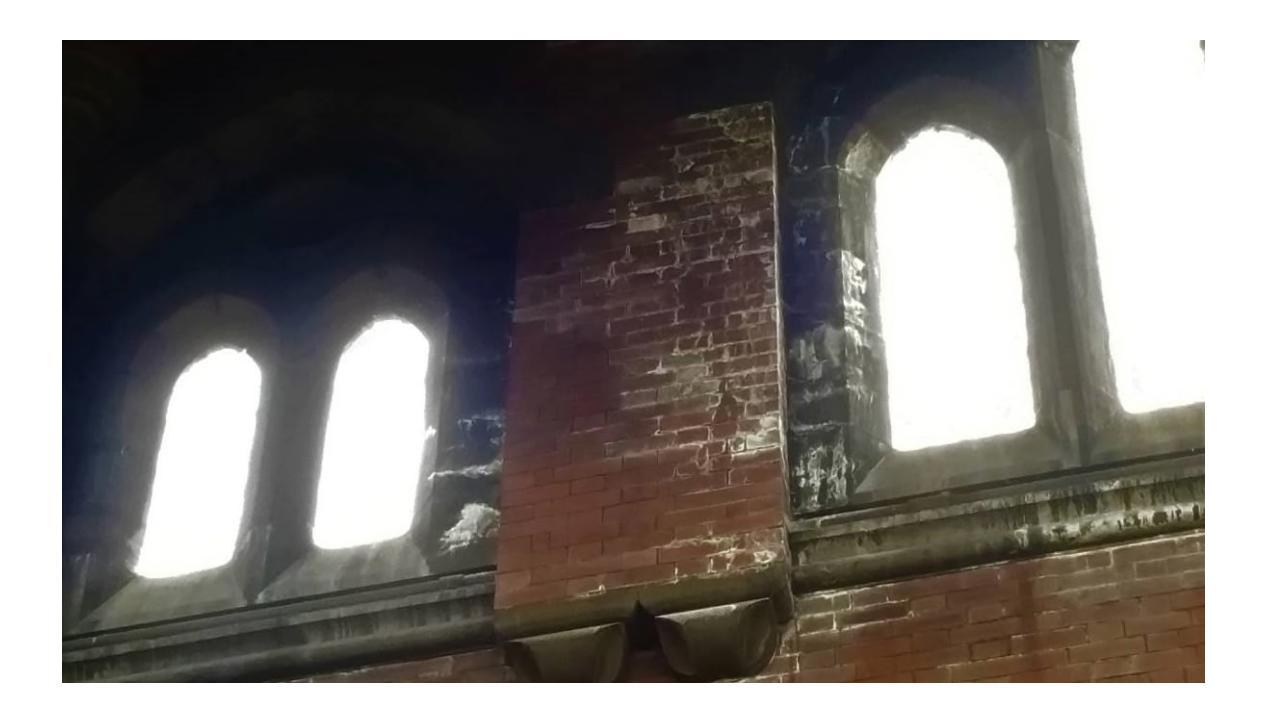
The windows and door openings have cast stone dressings and they look to be the thickness of the wall, as there is salting showing at the junctions of the inner walling and dressing. It is possible the moisture is tracking right the way through the wall. The wall looks to be solid and thin at this point. Investigation of the wall construction at a window opening would also be worthwhile.

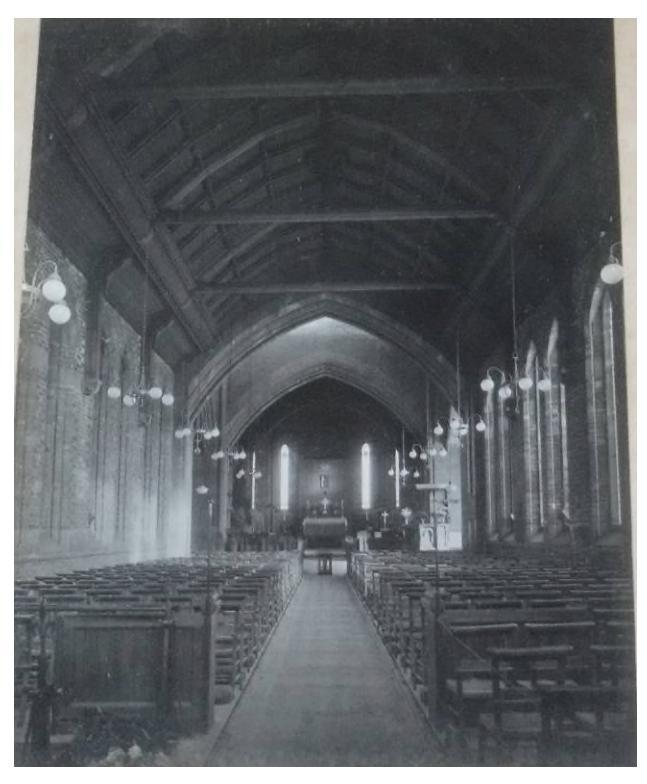
There is major staining at the tower crossing on the brickwork and cast stone and this has been there for some time. The undated image below doesn't show much at the crossing but there is salting to brickwork at high level at the n nave- maybe...

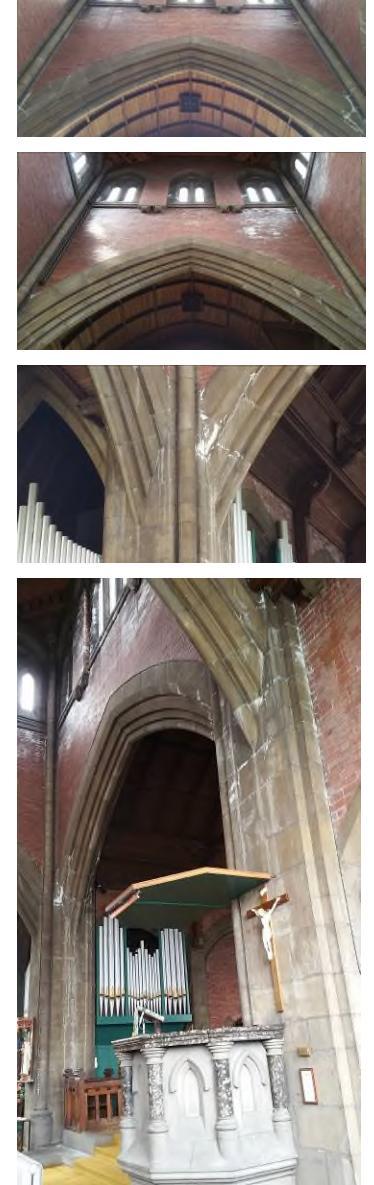
There is significant salting of the brickwork. There is a 'tide line' approximately twelve courses down on the E side. That is matched externally by the sloping clerestory cill units- suggesting that the sloping unit pointing has failed. And my guess is that the trapped water then goes into the corners and shows up on the columns. There's also water streaks that look to be from holes in the glass or cill.

Staining on the N side E corner, on the W side S corner and the S side E corner.

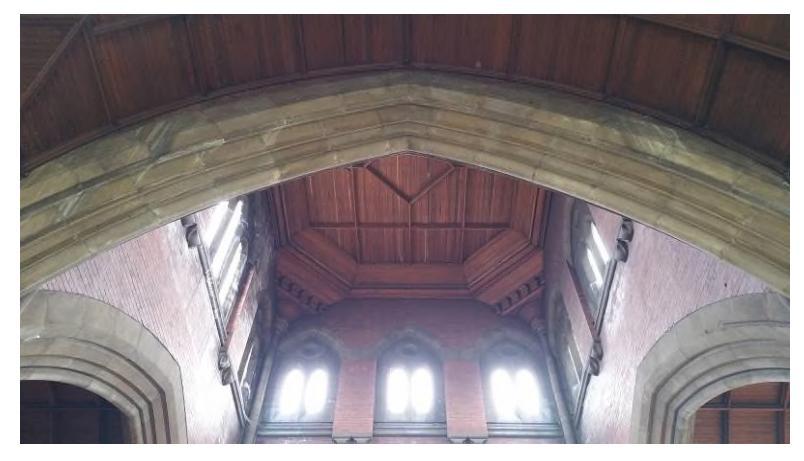
The arches are all sound, there is water staining at the springing points in all corners but less so in the N W corner, and down to the ground they are all ok.

Some quite big water staining of the chancel arch, it doesn't show on the others so there has been a big leak on the chancel arch and it looks to be both inboard and outboard of the arch so it could be both from the windows on the inside and then the roof flashing missing on the outside, and the outside pointing missing on the clerestory cills...

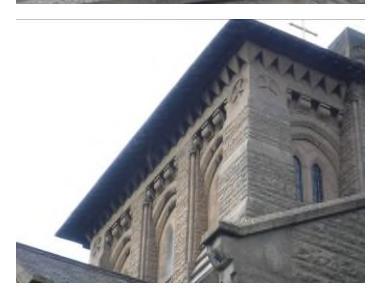
Structurally, it seems fundamentally ok but there is water penetration. Thought to be principally through the sloping cill units where pointing has failed.

Not helped by the design of the back gutters of these corner clasp buttresses. They are in the process of all being modified as funds and access permit. The south side two are still to be done.

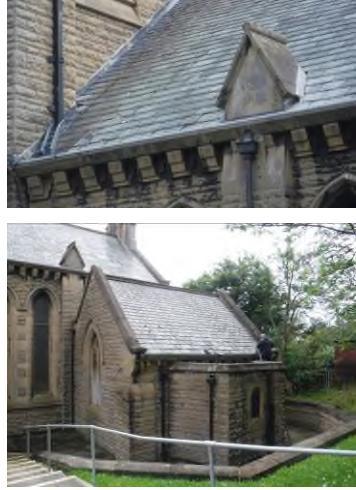
Original Westmoreland slating on all of the hipped roofs with mineral felt on the flat roof.

The tower is a hipped structure with cut hips and this has been repaired by Andrew Gibson, there are a couple of slipped slates on the N side. The overall condition of the slating is good, there is the occasional lost slipped slate, and the mineral felt flat roofs are generally sound. It is the original slating and is likely to last a few more decades yet.

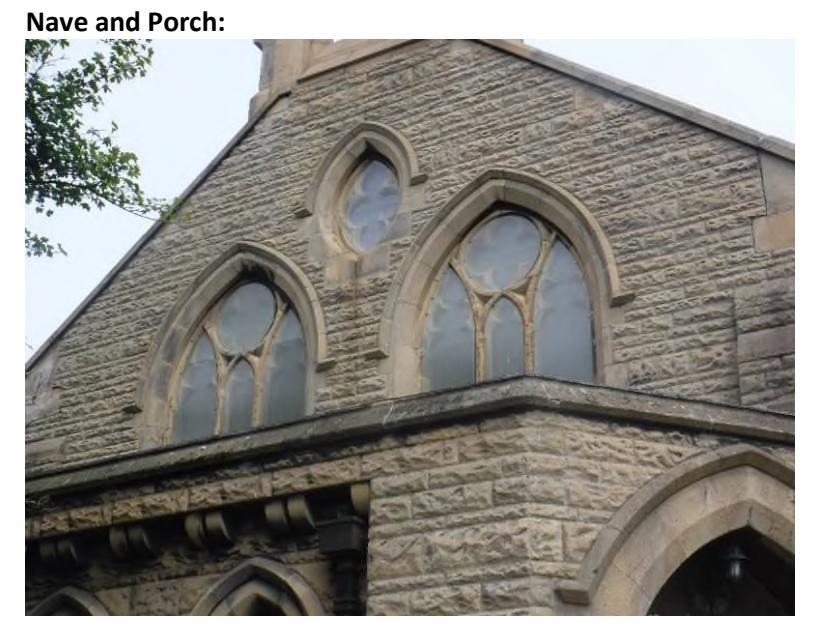
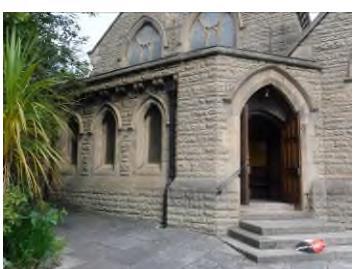
WEST ELEVATION

Gable and windows appear ok, below that is the entrance porch apart from the guttering with a bit of rust on it everything is reasonably tidy.

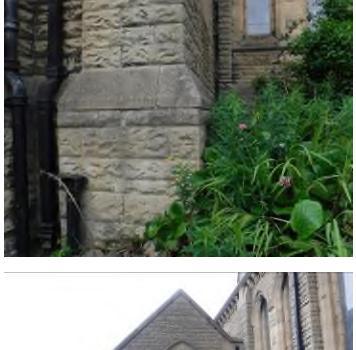
Female Vestry:

Cracking underneath the window looks the same as the last QI. Stone still missing just by the flat roof. The most extreme S W corner is cracking like before. The biggest problem is pointing missing on the bottom plinth sloping face. Here the sloping face doesn't have the rebate that we have seen over in the Lady Chapel. So they are different shapes.

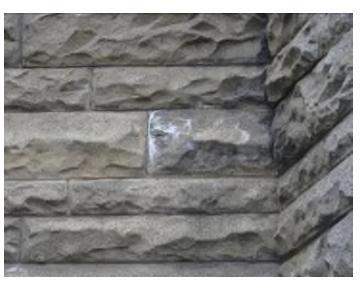
Looks much as it was on the last QI. We know there is some efflorescence showing on S side at high level so there might be a problem here with the parapet gutters.

The polycarbonate is broken to one of the windows.

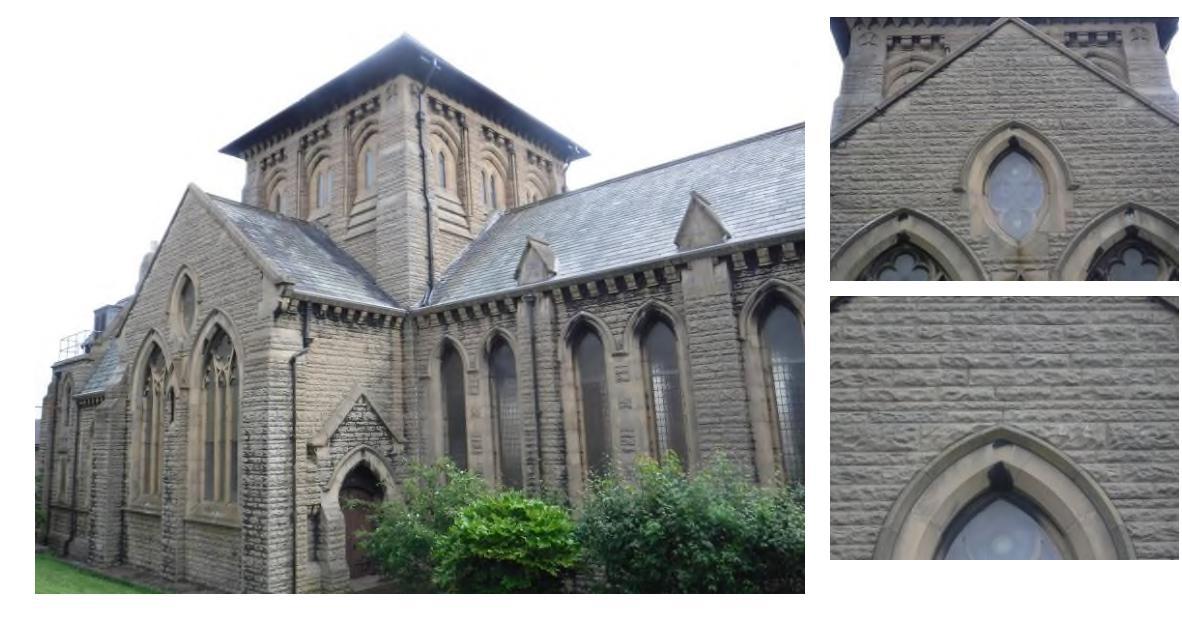
North Transept:

Water table joints look a bit open on the E side, bit of a crack above the vesica window but the condition looks much as before, it has slightly grey polycarbonate on the windows.

Recommendation: repoint water table (ask Ferguson to look over when carrying out roof repairs)

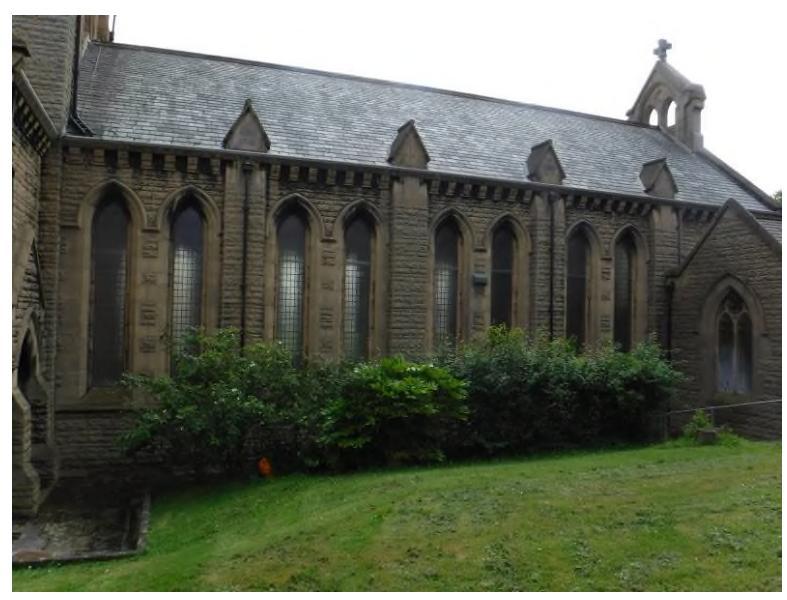
The gutter here over sails with corbels so what created the (historic) staining inside on the eaves woodwork?

The polycarbonate has lost some of its jointing perhaps at high level just below the springing. Some graffiti.

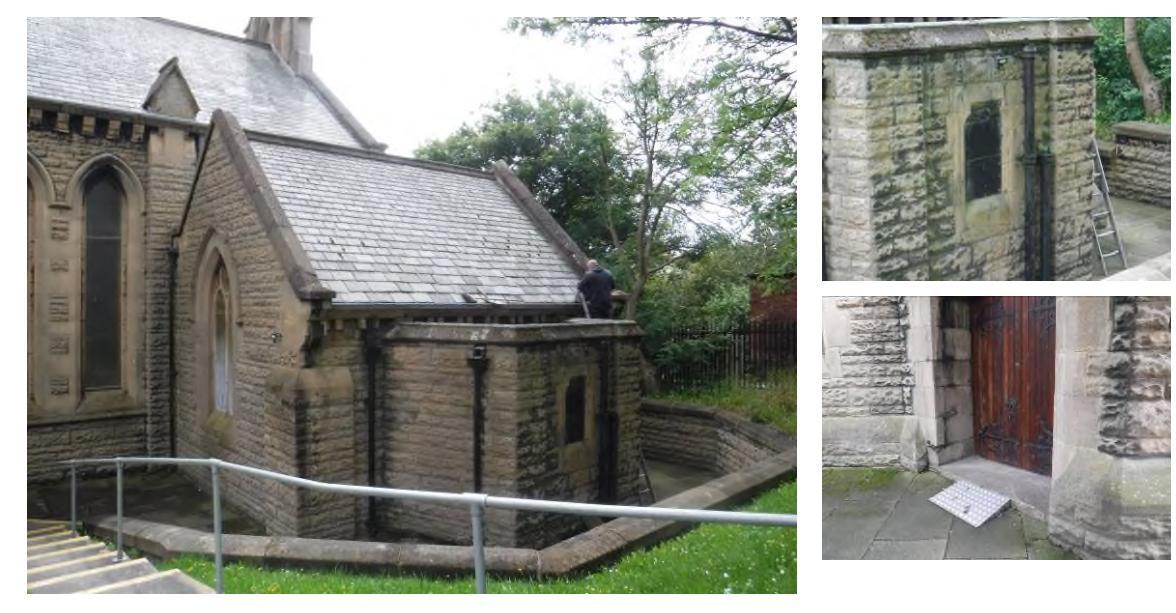
North Vestry:

The polycarbonate has had some vandal attention. The roofs are just undergoing some repair here, and cast iron vent pipe is broken on the wc extension.

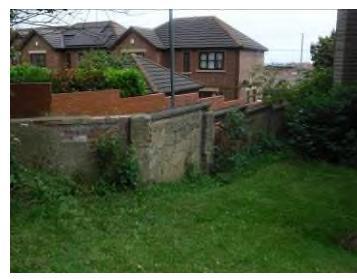
East Boundary:

Rusty railings on the low cast stone walls. Further up is a masonry wall that is in fair condition.

Recommendation: redecorate railings

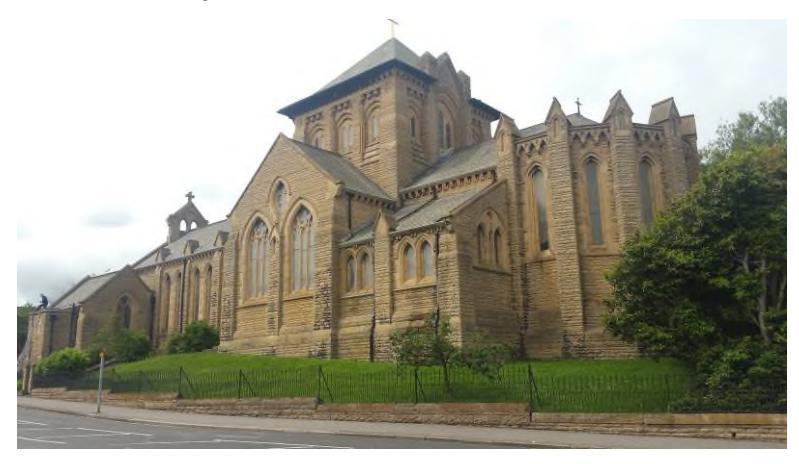
Low retaining wall (same cast stone as church) with metal railings rusting in places and the decoration is breaking down and some of the fixings are rusting and breaking the stonework.

The gate piers are bucking a bit and the gate has lost its keep, the hinges are also breaking the piers slightly.

Recommendation: restore railings and repair wall

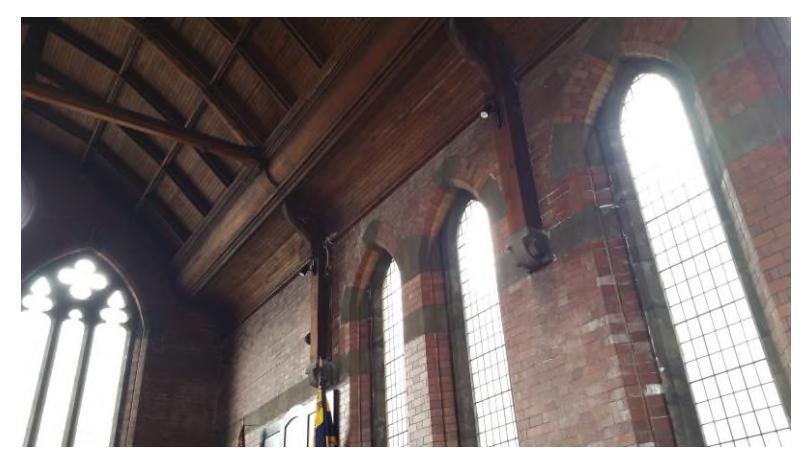
• **Ceiling** – open rafter roof, boarding is in good condition, some water marking at eaves at tower and west gable ends Clear finish has darkened with age.

Up at the eaves the major damp item in the nave is at the further most truss on the N W side and that I think is historic as well.

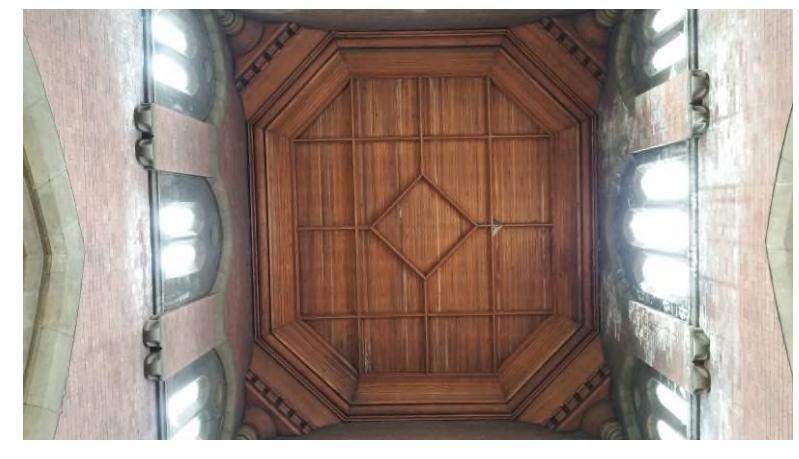
Tower Crossing:

Ceiling – At the tower crossing, the tower ceiling is timber boarded in an octagonal layout with corbels at the corners. The timber looks to be in good condition with no signs of decay or leaking. There is access above this ceiling via roof hatch on the E roof slope and it is not known if the void has been inspected in recent years. It would be worthwhile to do this when the tower roof covering repairs are carried out.

Recommendation: inspect void

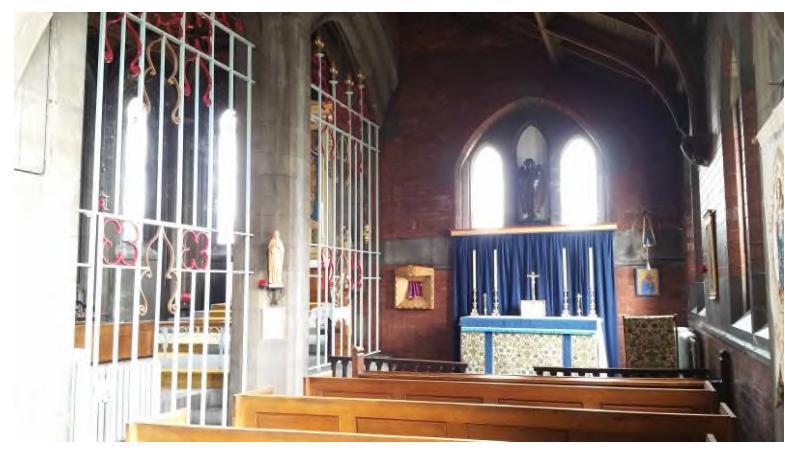
- **Ceiling** exposed rafters and purlins with boarding and these appear to be in good condition.
- Walls Same as the nave.
- **Floor** crack to the floor, left of the altar of the Lady Chapel.

Recommendation: repair floor

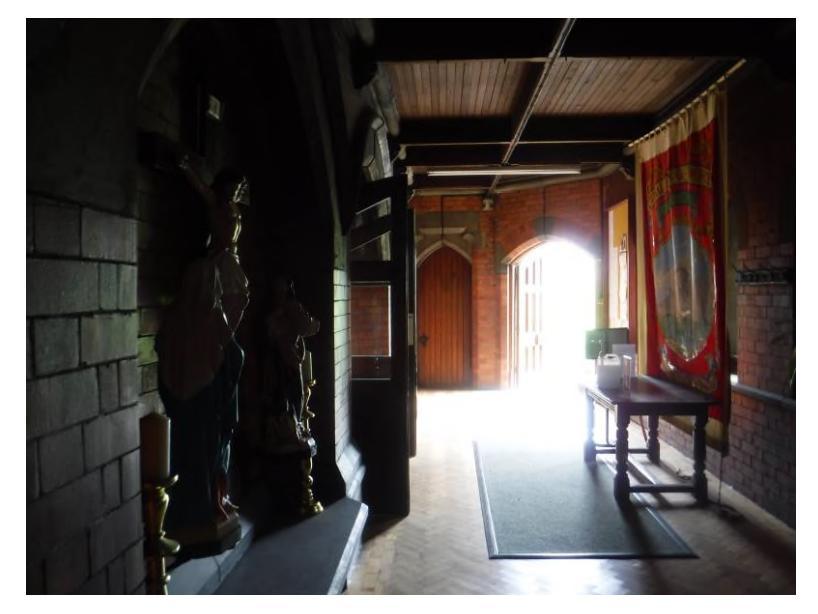
Bit of wear at the entrance double doors where the floor finish could do with a bit of a tidy up.

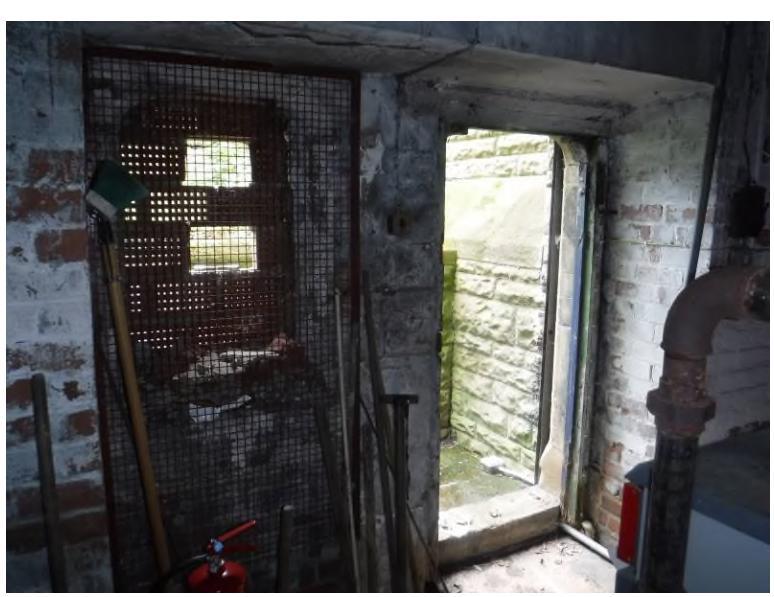
Boiler room:

- ٠
- **Ceiling** Cracking to the concrete ceiling with some holes in it. But not troublesome.
- Walls Painted brickwork, the paint is coming off.
- Floor Concrete floor is ok.
- **General** It's a little adhoc here with a poor external appearance and this is an invitation for intruders.

Recommendation: improve security
